Lake Ontario Ordnance Works

Site Inspection Report

Fact Sheet

Defense Environmental Restoration Program for
Formerly Used Defense Sites (DERP-FUDS)
June 2015

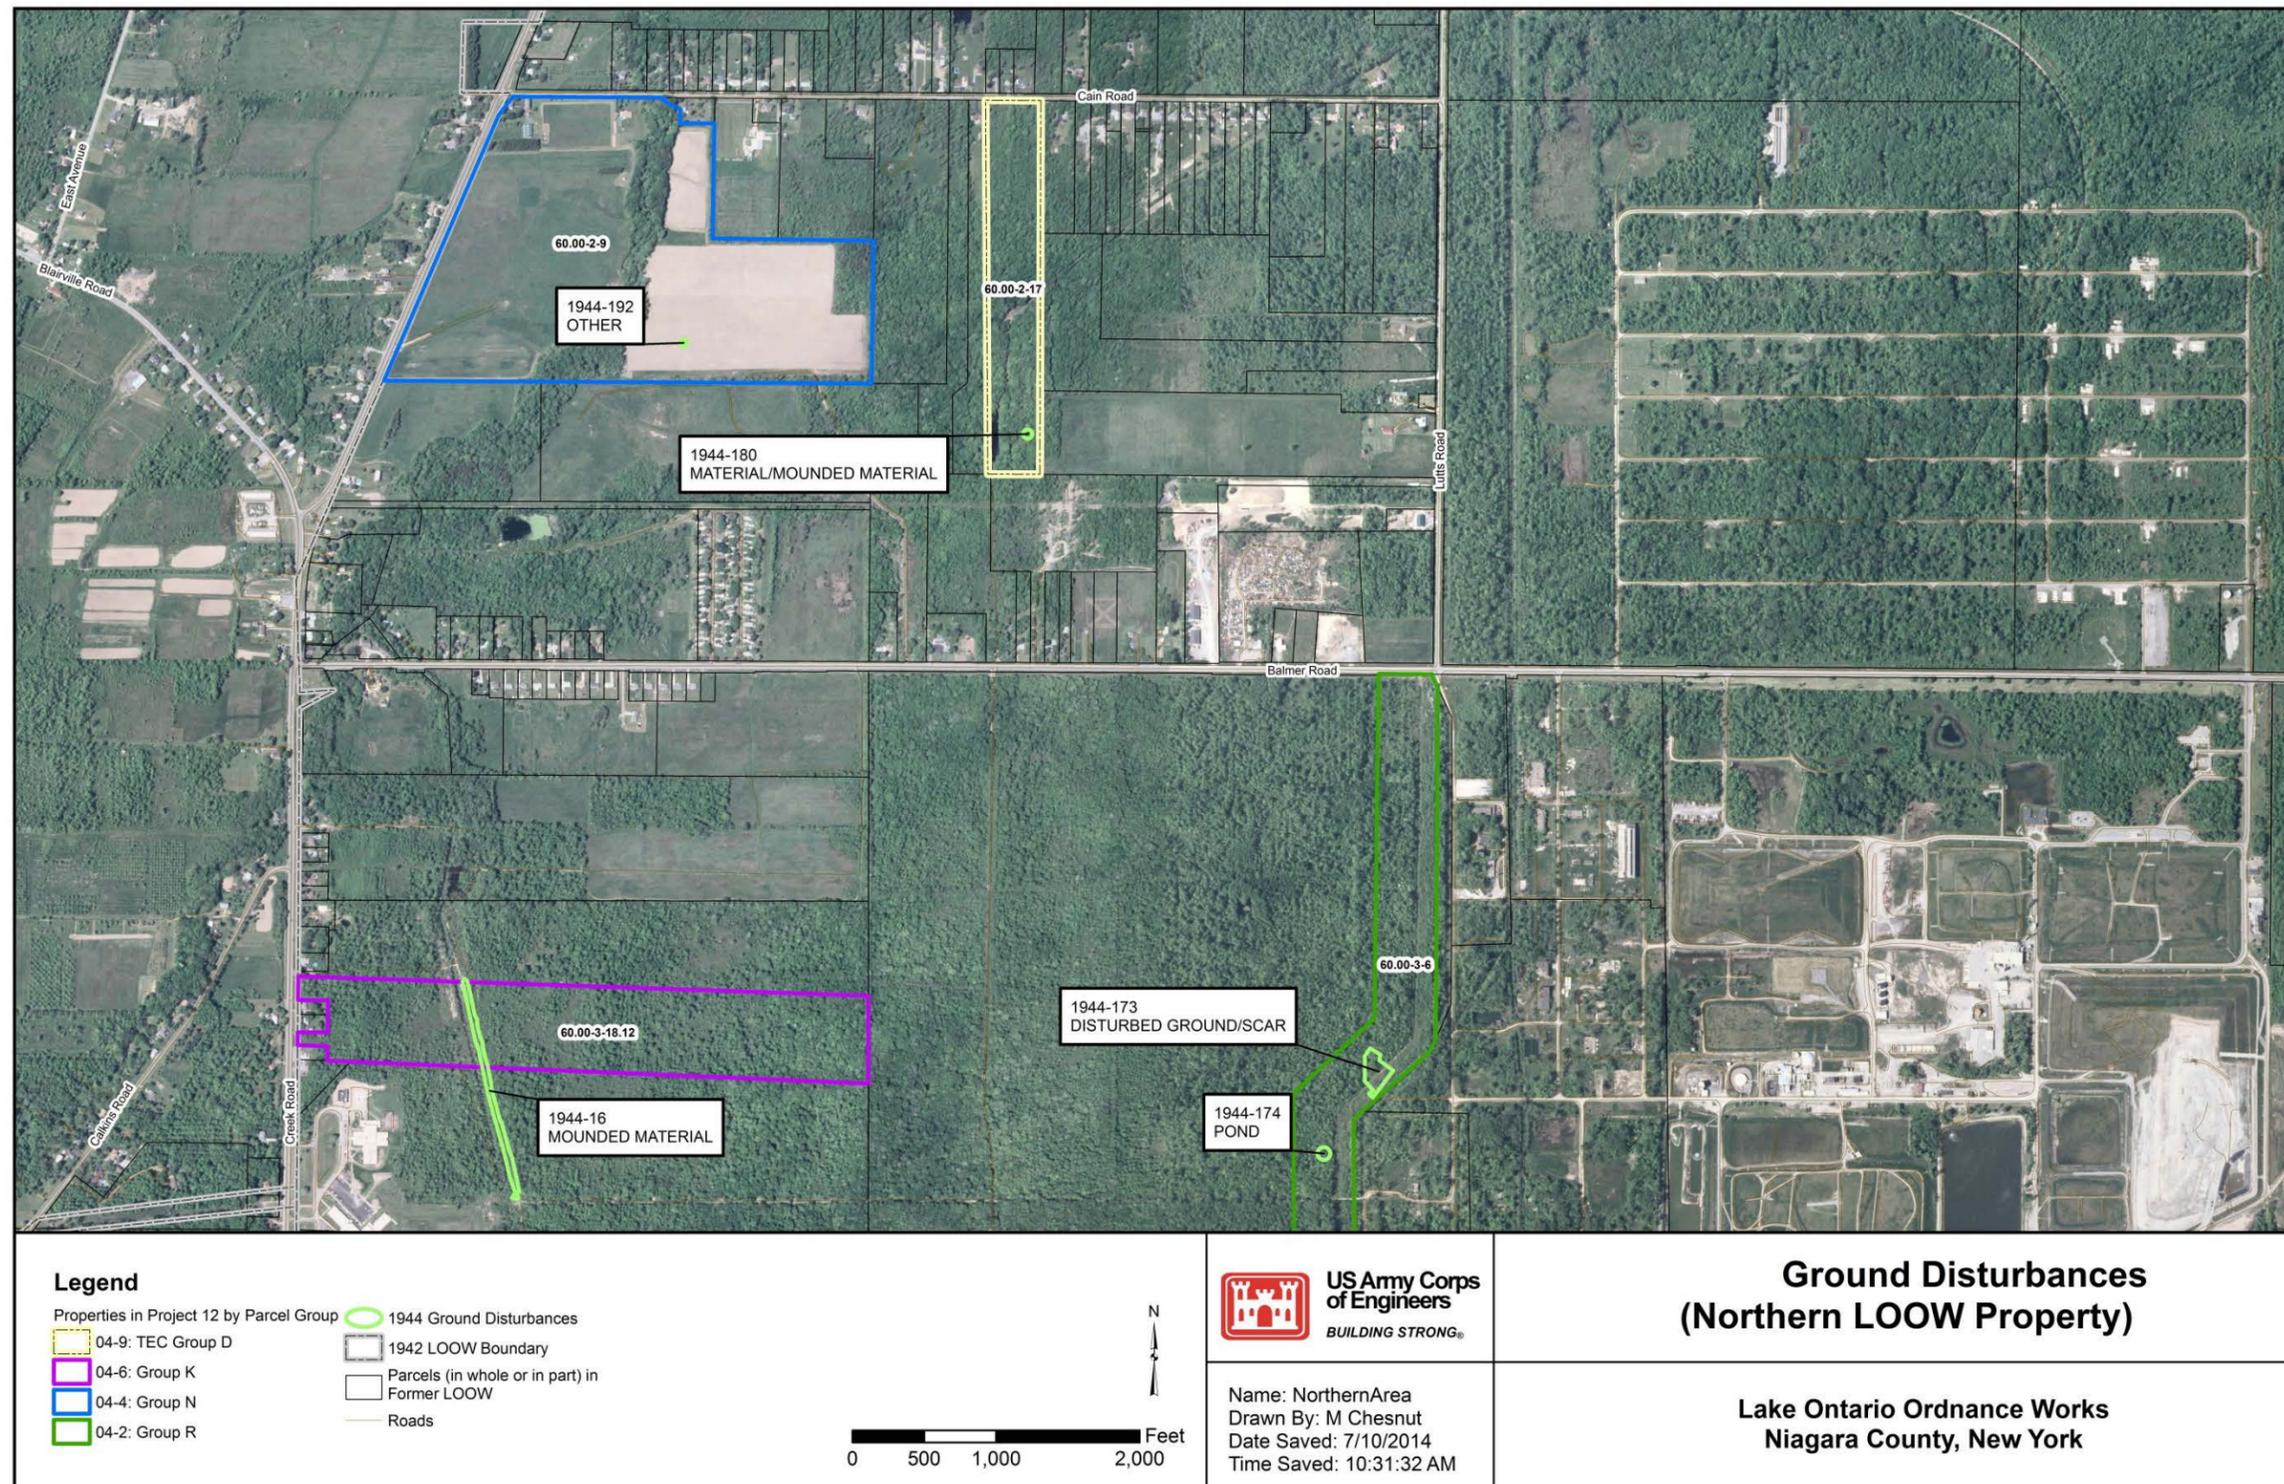
Figure 1 Ground Disturbances Inspected in the Northern Area of the Former LOOW

Ground Disturbance	Type	Figure	Property Owner	Group Name	Parcel No.	Visual Survey Date	Observations
1944-16	Mounded Material	1 & 2	Private	Group K	60.00-3-18.12	None – no ROE	Mounded material is believed to be displaced native soil from construction of the southwest drainage ditch. Previous analytical data from similar ground disturbances did not identify contamination.
1944-45	Berm	2	Guardian Corporation	Support Facility Administrative Offices	74.00-1-4	24 April 2014	The berm appeared to be constructed with native soil; it surrounded a slurry pond for a former freshwater treatment plant. No DoD marker compounds were found in the former pond during a previous remedial investigation.
			Private		74.00-1-50	None – no ROE	
			National Grid		88.00-1-41	24 April 2014	
1944-46	Trench	2	Guardian Corporation	Support Facility Administrative Offices	74.00-1-4	24 April 2014	The trench appeared to be an area where native soils were excavated to construct the berm (described above).

1944-173	Disturbed Ground/Scar	1	National Grid	Group R	60.00-3-6	23 April 2014	The walkover inspection did not identify evidence of a disturbance or a potential source of contamination.
1944-174	Pond	1 & 2	National Grid	Group R	60.00-3-6	23 April 2014	The walkover inspection did not identify evidence of a disturbance or a potential source of contamination.
1944-177	Material/Mounded Material	3	Three F Club	TEC Group B	88.00-1-46.1	23 April 2014	The walkover inspection did not identify evidence of a disturbance or a potential source of contamination.
1944-180	Material/Mounded Material	1	Private	TEC Group D	60.00-2-17	23 April 2014	A small mound of soil was observed that appeared to be displaced native soil associated with past agricultural or drainage improvement activities. The walkover inspection did not identify evidence of a potential source of contamination.
1944-192	Other	1	Private	Group N	60.00-2-9	23 April 2014	The area was previously used for clay mining activities that resulted in the removal of the upper 5 feet of soil. The area was regraded and is currently used for agricultural activities. The walkover inspection did not identify evidence of a potential source of contamination.

The SI report concluded that no further action is necessary for the evaluated ground disturbance locations.

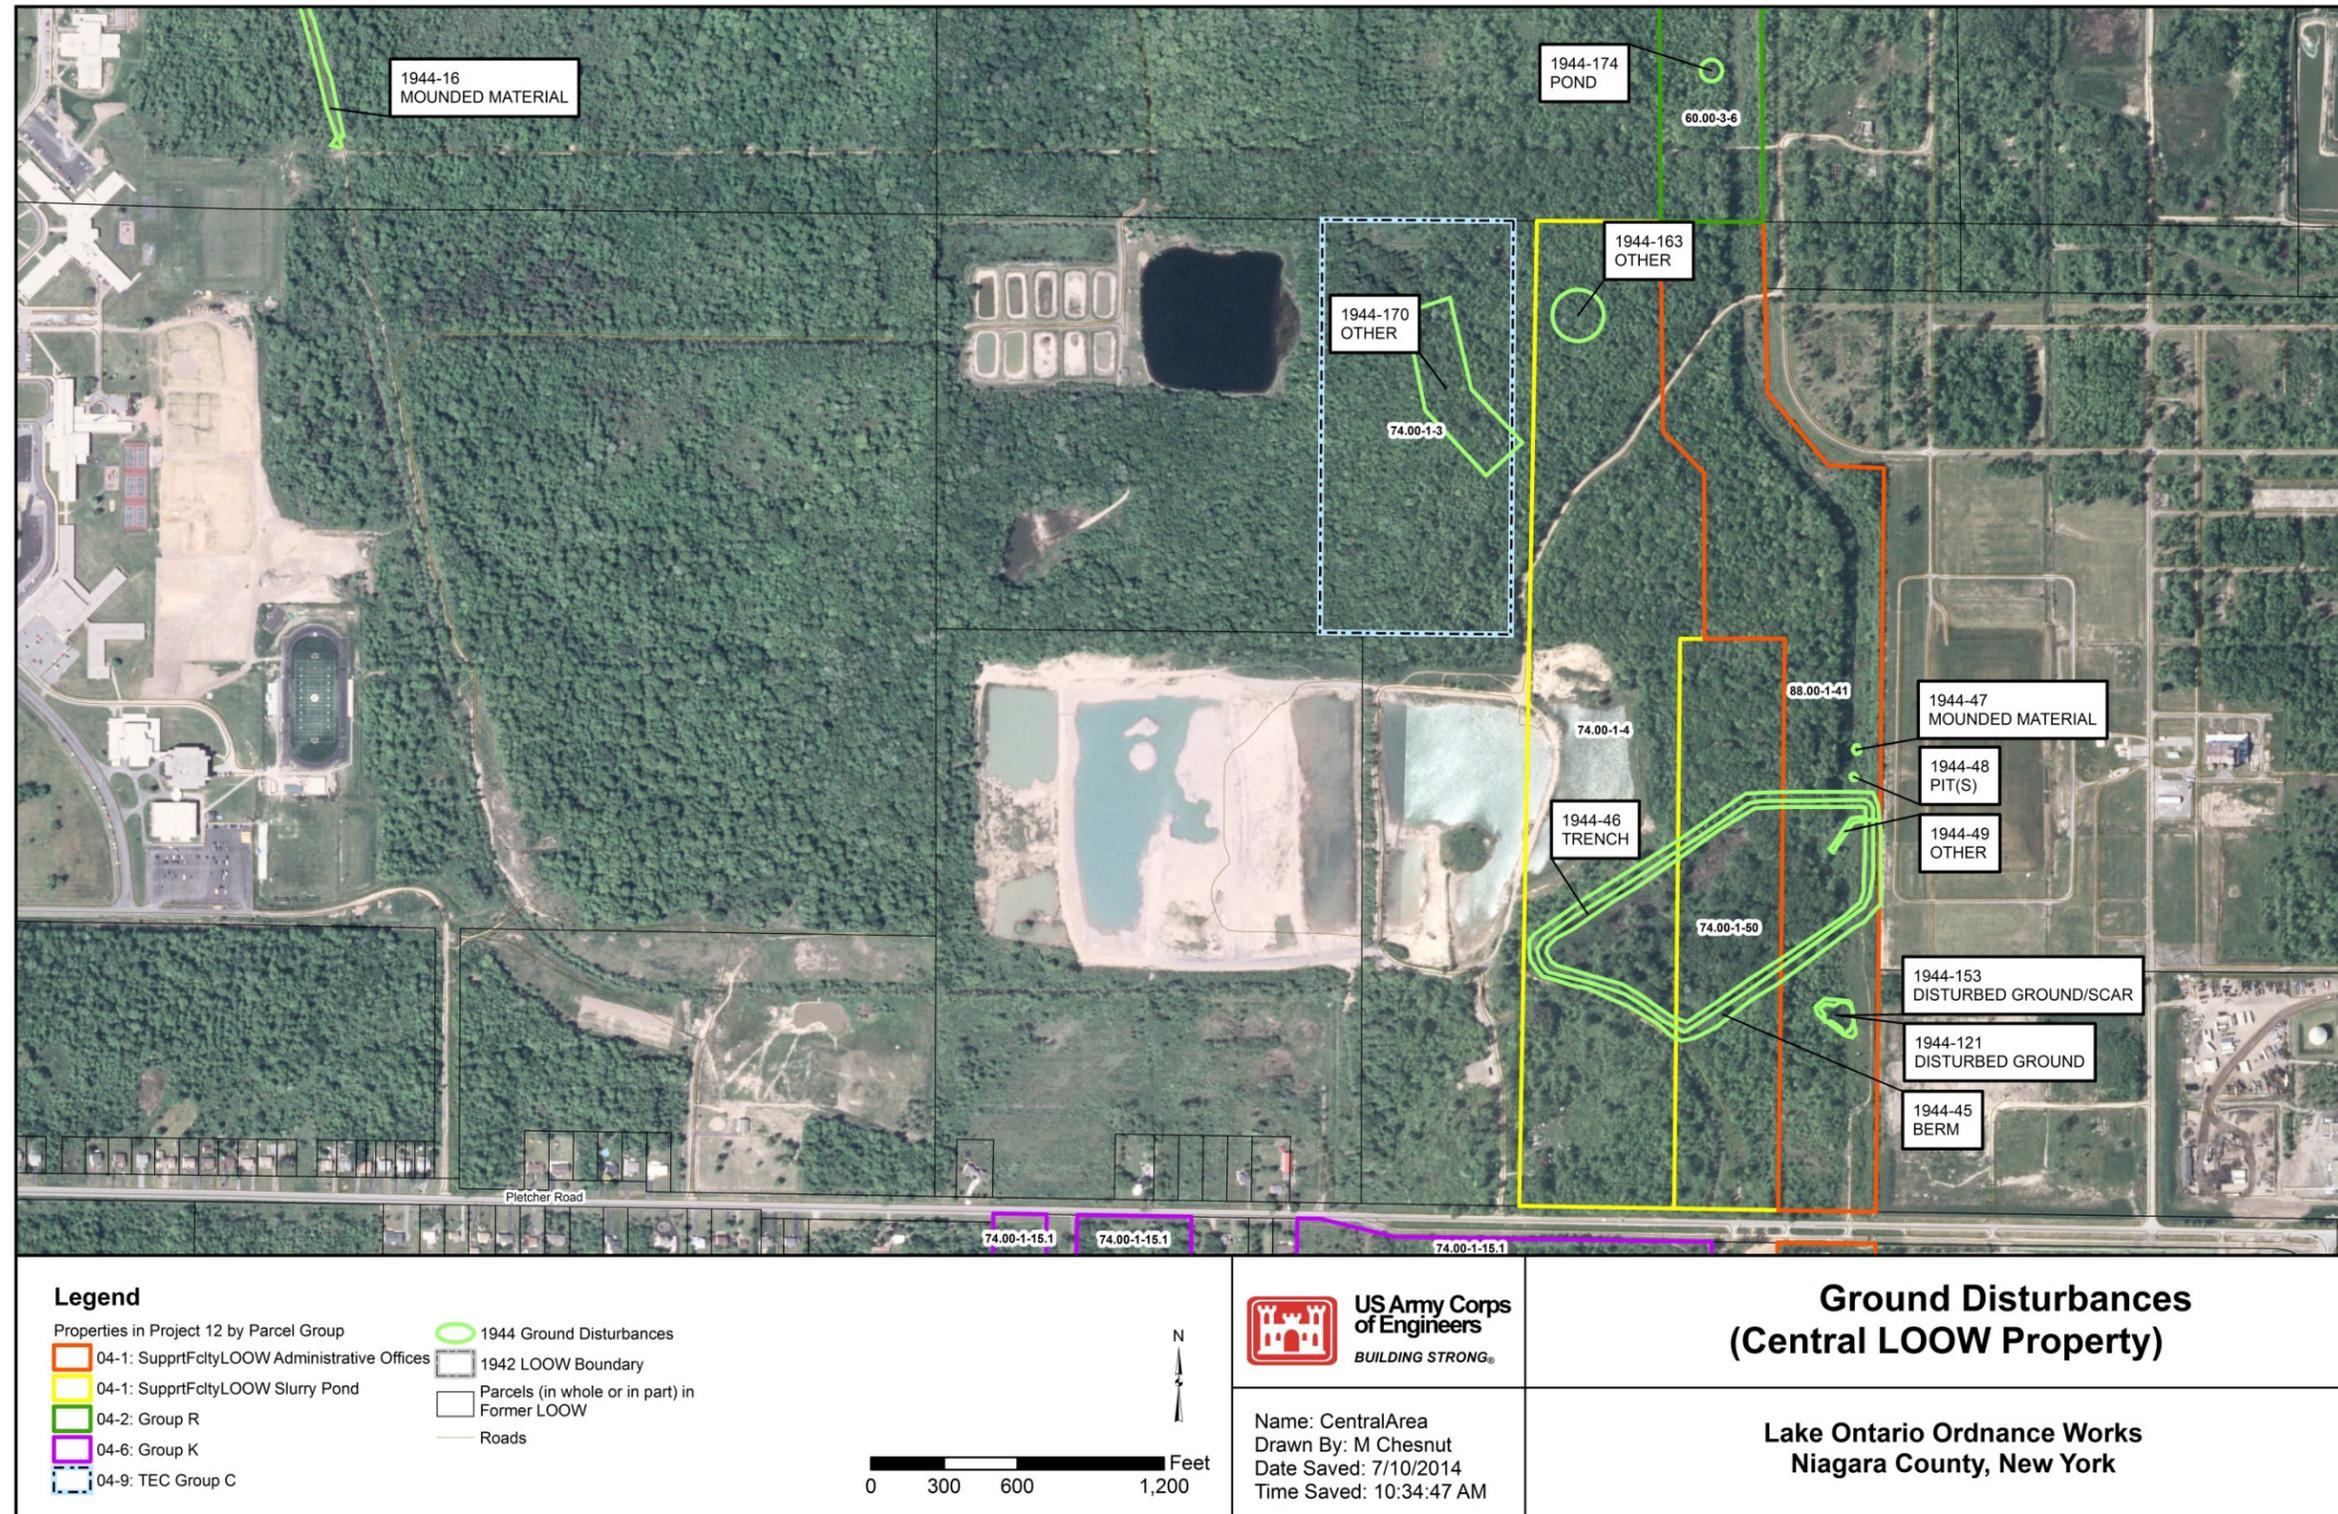
Figure 2 Ground Disturbances Inspected in the Central Area of the Former LOOW

Private		74.00-1-50	None – no ROE	
			National Grid		88.00-1-41	24 April 2014	
1944-47	Mounded Material	2	National Grid	Support Facility Administrative Offices	88.00-1-41	23 April 2014	The TEC report indicates that many of the “mounded material” disturbances may have been associated with farming. The walkover inspection did not identify evidence of a disturbance or a potential source of contamination.
1944-48	Pit(s)	2	National Grid	Support Facility Administrative Offices	88.00-1-41	23 April 2014	The walkover inspection did not identify evidence of a disturbance or a potential source of contamination.
1944-121	Disturbed Ground/Scar	2	National Grid	Support Facility Administrative Offices	88.00-1-41	23 April 2014	The walkover inspection did not identify evidence of a disturbance or a potential source of contamination.
1944-137	Material/Mounded Material	3	Private	TEC Group B	88.00-1-5	None – no ROE	The TEC report indicates that many of the “mounded material” disturbances may have been associated with farming. Current aerial photography indicates that this area is actively farmed, which suggests that the ground disturbance (if present) is not a potential source of contamination.

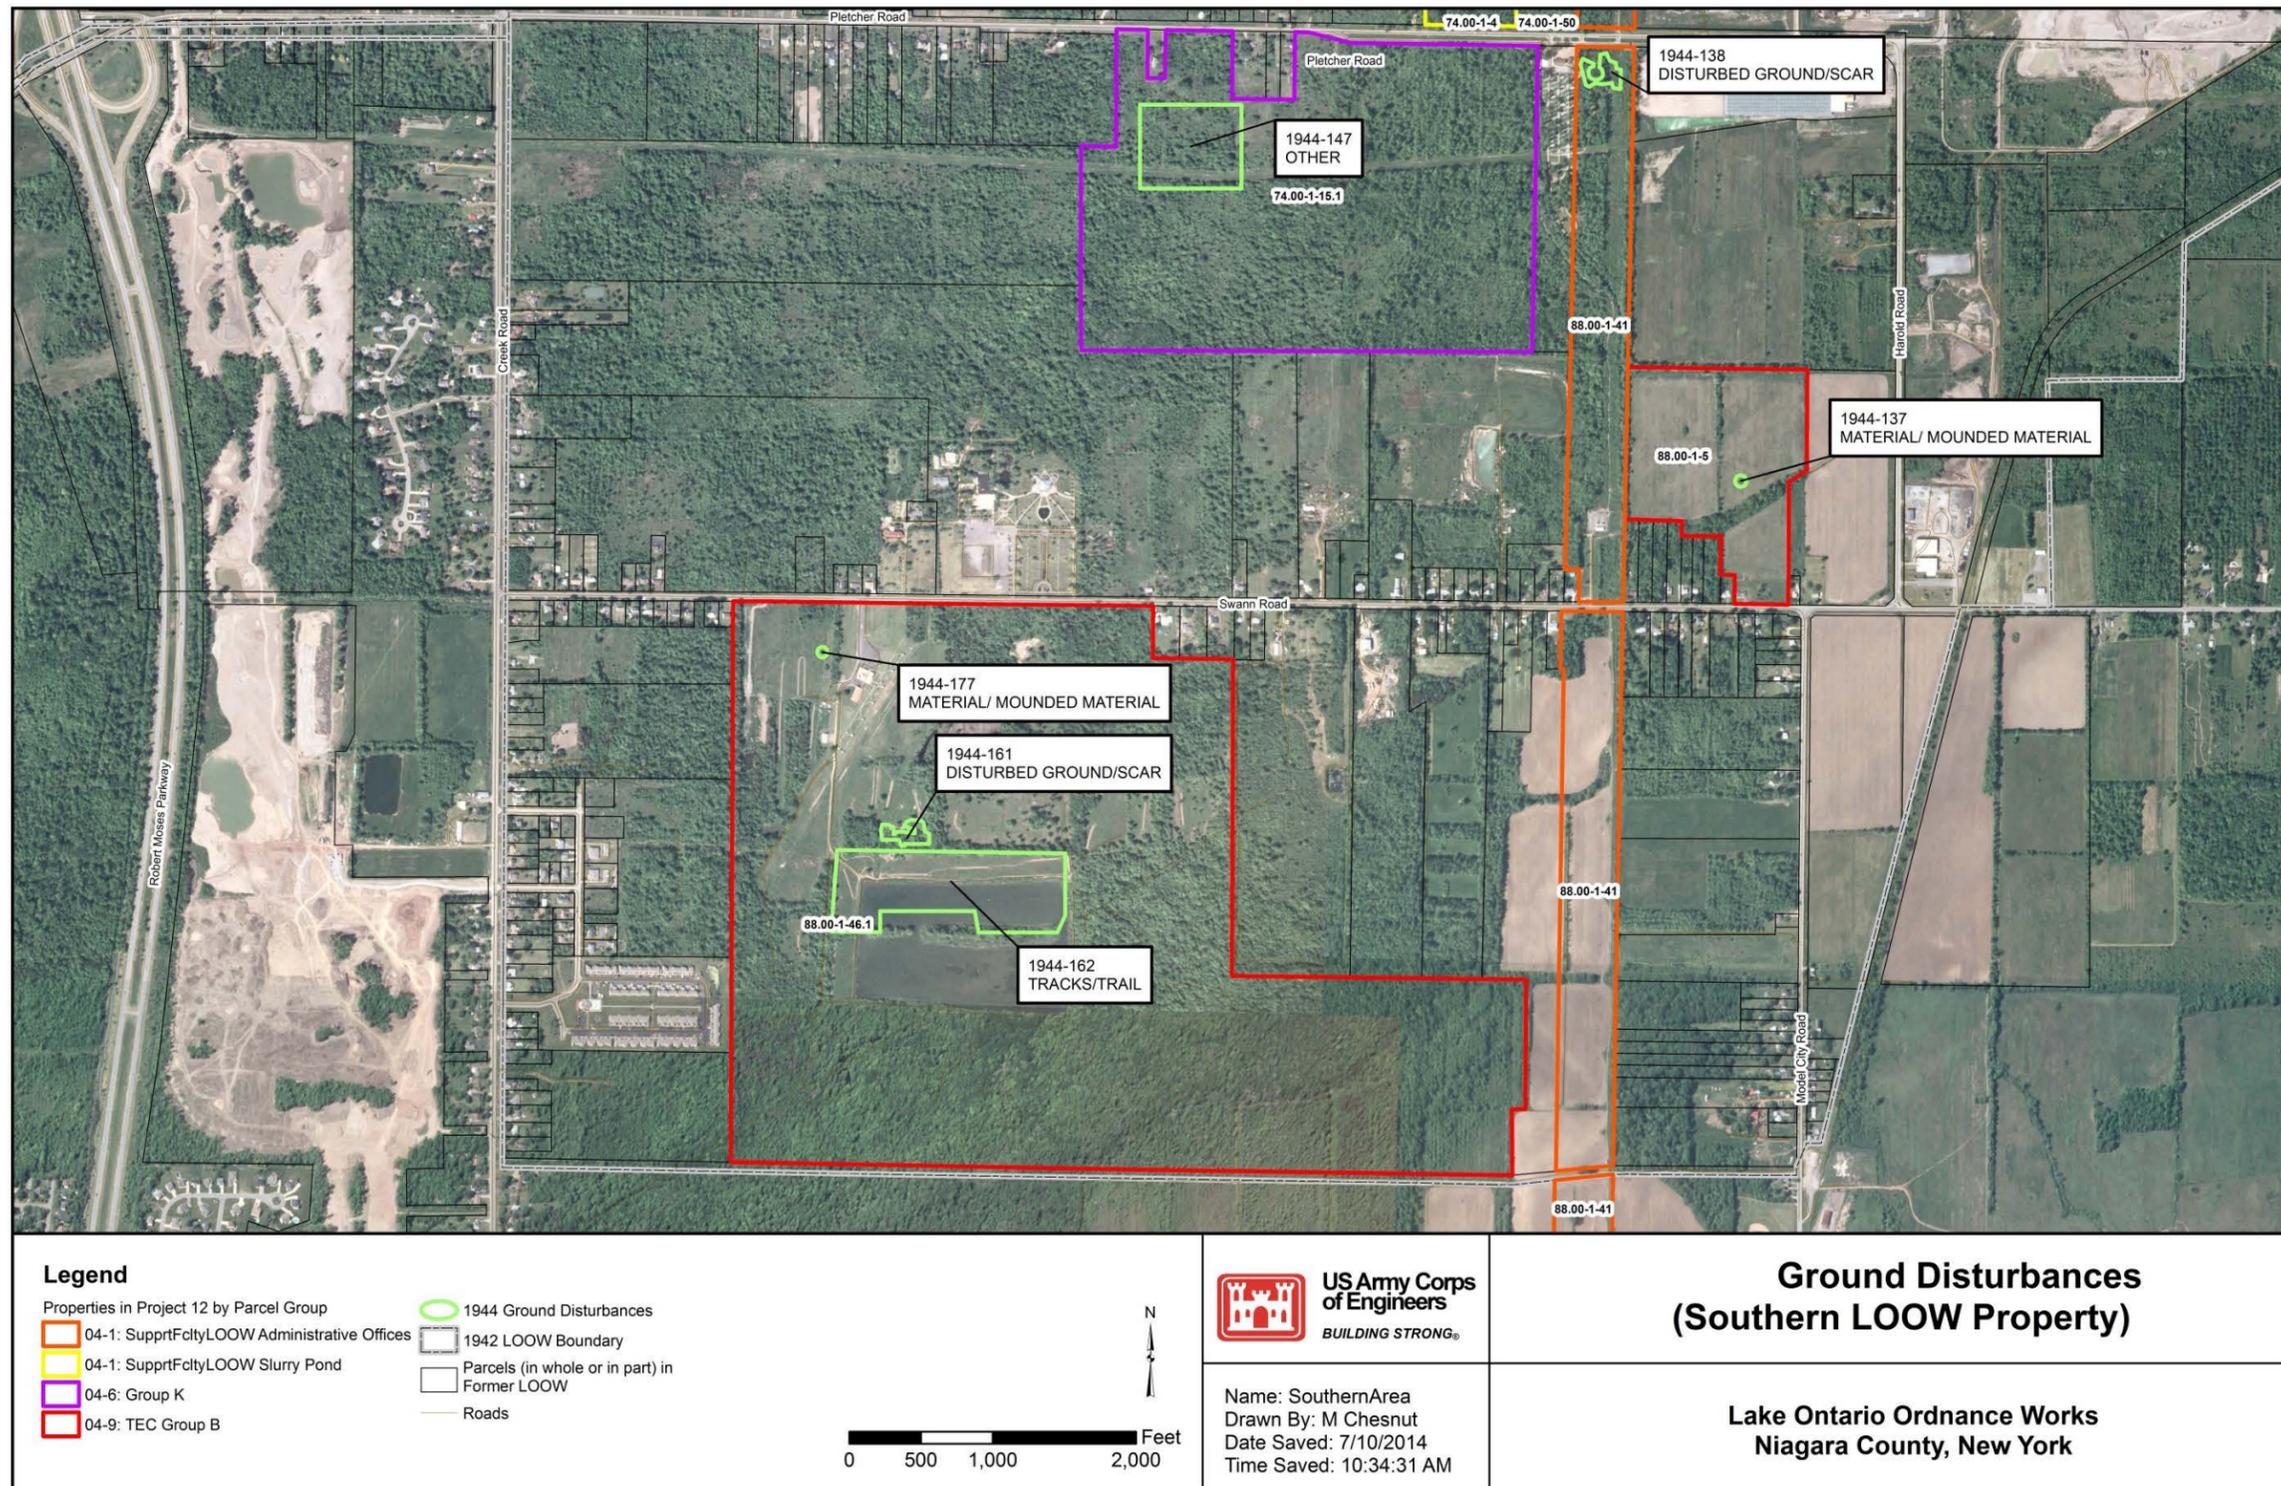
Figure 3 Ground Disturbances Inspected in the Southern Area of the Former LOOW

1944-138	Disturbed Ground/Scar	3	National Grid	Support Facility Administrative Offices	88.00-1-41	23 April 2014	The walkover inspection did not identify evidence of a disturbance or a potential source of contamination.
1944-147	Other	3	Modern Landfill, Inc.	Group K	74.00-1-15.1	6 May 2014	The walkover inspection did not identify evidence of a disturbance or a potential source of contamination.
1944-153	Disturbed Ground/Scar	2	National Grid	Support Facility Administrative Offices	88.00-1-41	23 April 2014	The walkover inspection did not identify any evidence of a disturbance or a potential source of contamination.
1944-161	Disturbed Ground/Scar	3	Three F Club	TEC Group B	88.00-1-46.1	23 April 2014	A small mound of rocks was observed during the walkover inspection. There was no evidence of a potential source of contamination.

Ground Disturbance	Type	Figure	Property Owner	Group Name	Parcel No.	Visual Survey Date	Observations
1944-162	Tracks/Trail	3	Three F Club	TEC Group B	88.00-1-46.1	23 April 2014	Numerous tracks and trails were observed during the walkover survey that appeared to be related to recent activities by the property owner. Construction and demolition debris from recent site improvements was also present at the eastern end of the area. The walkover inspection did not identify a potential source of contamination attributed to previous DoD activities.
1944-163	Other	2	Guardian Corporation	Support Facility Administrative Offices	74.00-1-4	24 April 2014	The walkover inspection did not identify evidence of a disturbance or a potential source of contamination.
1944-170	Other	2	Private	TEC Group C	74.00-1-3	24 April 2014	Vehicle tire tracks were observed; no improvements, structures, distressed vegetation, or stained soil were observed. The walkover inspection did not identify evidence of a potential source of contamination.
