## **PRELIMINARY ASSESSMENT / SITE INSPECTION**

Former Guterl Specialty Steel Corporation  
Lockport, New York

U.S. Army Corps Of Engineers  
Buffalo District  
1776 Niagara Street  
Buffalo, NY 14207  
04/13/01

FUSRAP - GUTERL SPECIALTY STEEL CORPORATION, LOCKPORT, NY  
STRUCTURAL INSPECTION  
EXCISED BUILDINGS NUMBERS 1-6, 8, 9, and 35

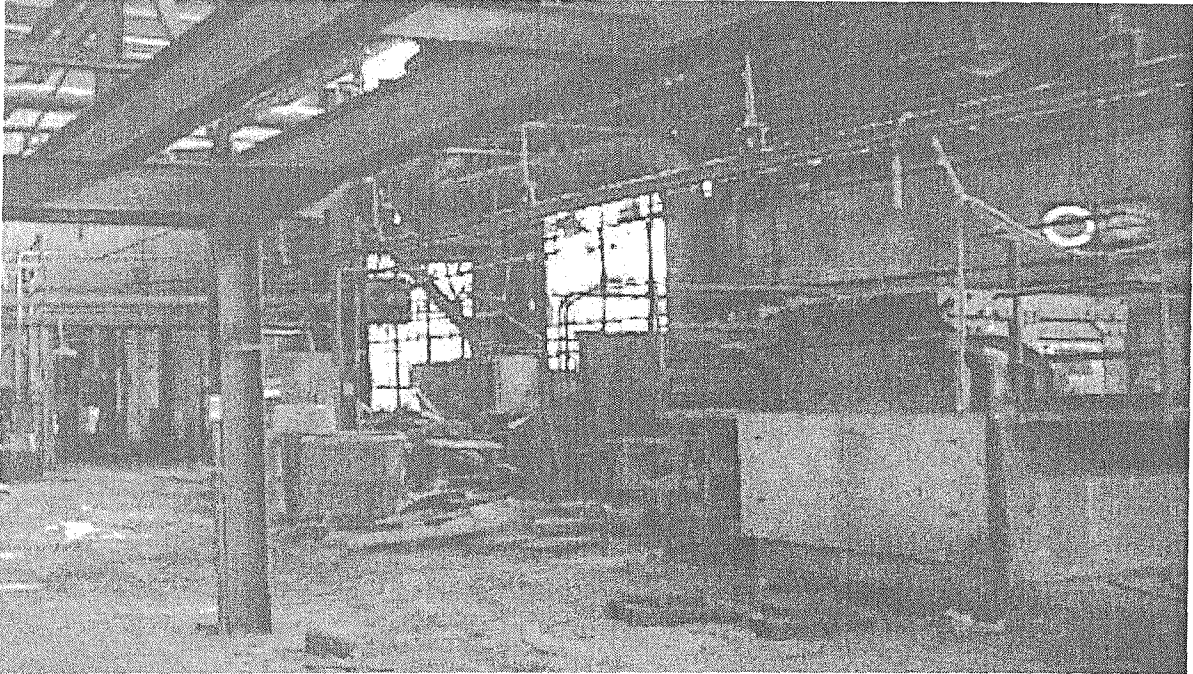
2.4.5 Observations: Massive holes are present in the corrugated sheet metal roof. See Photograph 1. More corrosion seems present in this building than in Building 1. Most metal rolling/mill buildings produce incredible amounts of heat, which in turn produces moderate to heavy amounts of condensation. This condensation can, in turn, produce substantial amounts of corrosion. This building may have experienced this phenomenon. Years of exposure to the elements may also attribute to the corrosion witnessed. Although the corrosion in Building 2 is higher than in the other excised buildings, it does not appear to be detrimental to the structural stability of Building 2. See Photographs 2-7.

Photograph 1 - Building 2 - East Interior Wall Center Section

2.4.6 Specific Conclusions/Recommendations: No significant structural distresses present in Building Number 2.

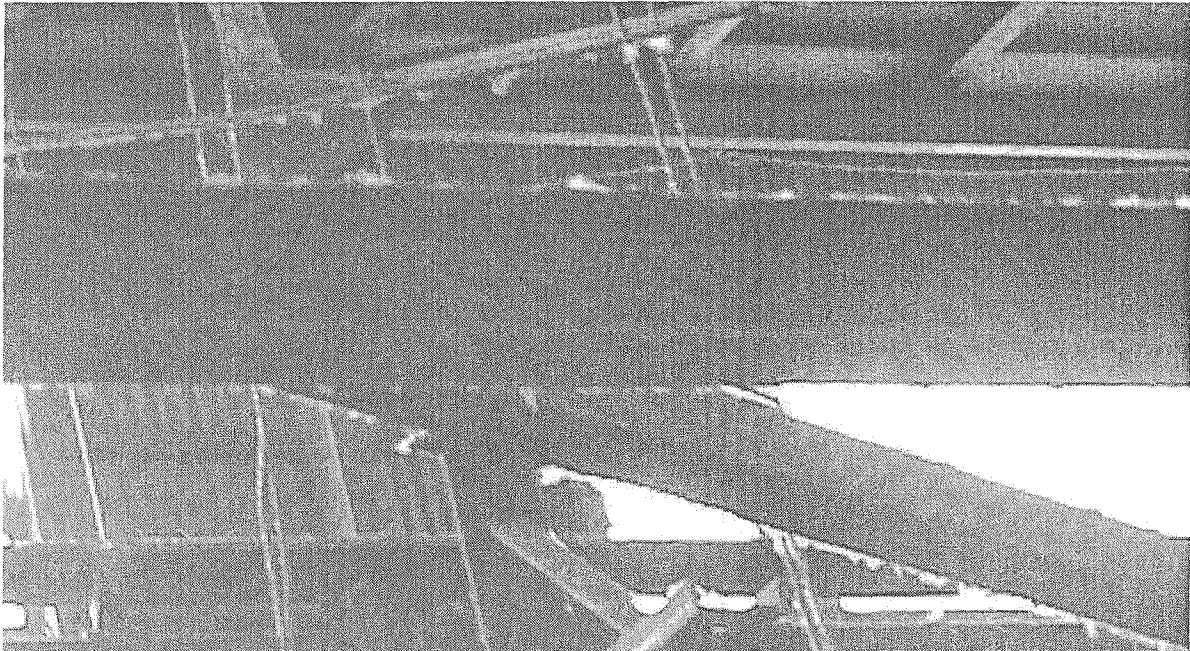
Photograph 2 - Building 2 - East Interior Wall Connection & Roof

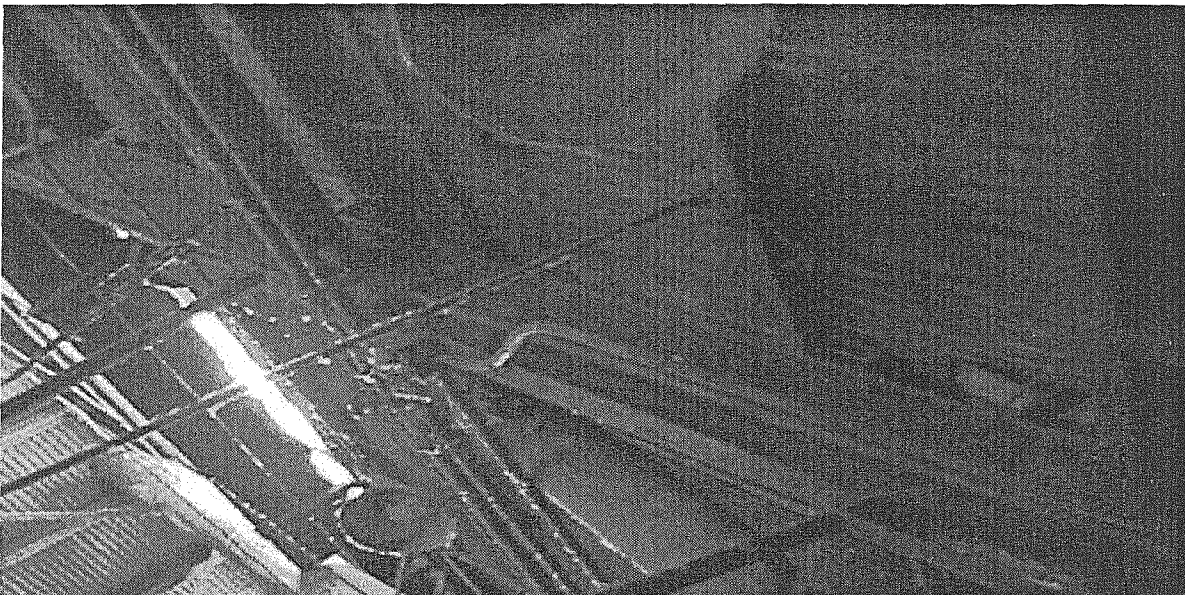
Photograph 3 - Building 2 - Roof

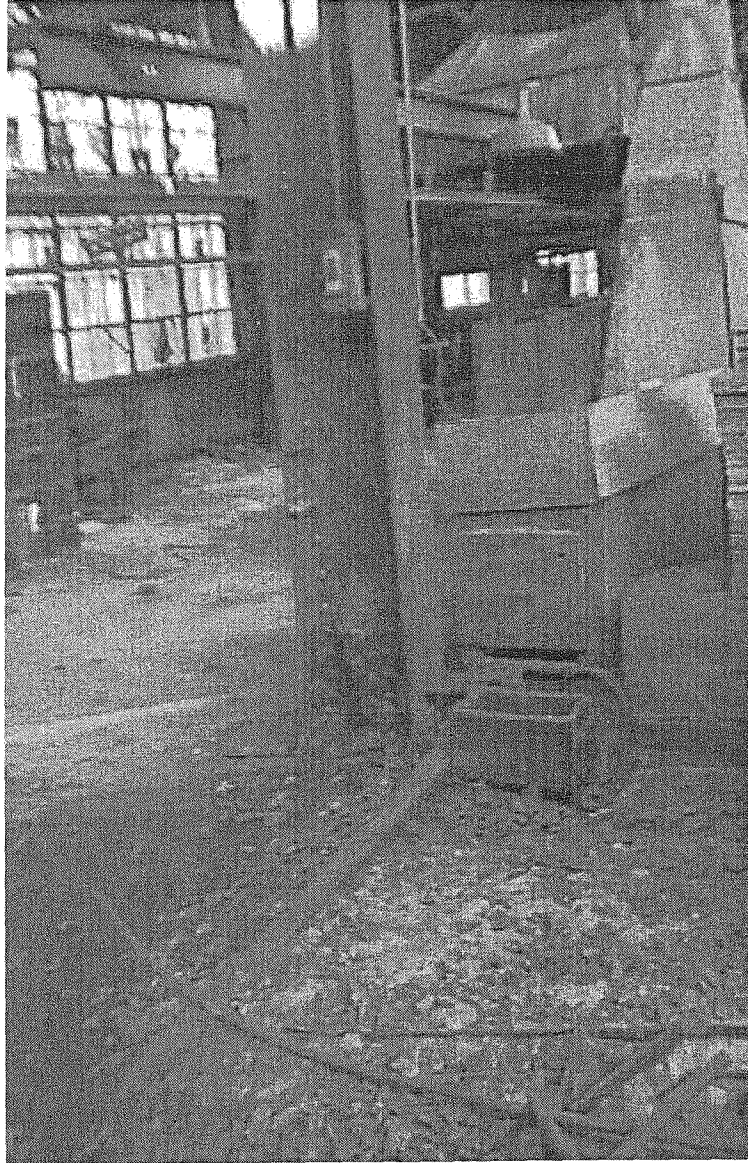
Photograph 5 - Building 2 - Typical Built-up Column

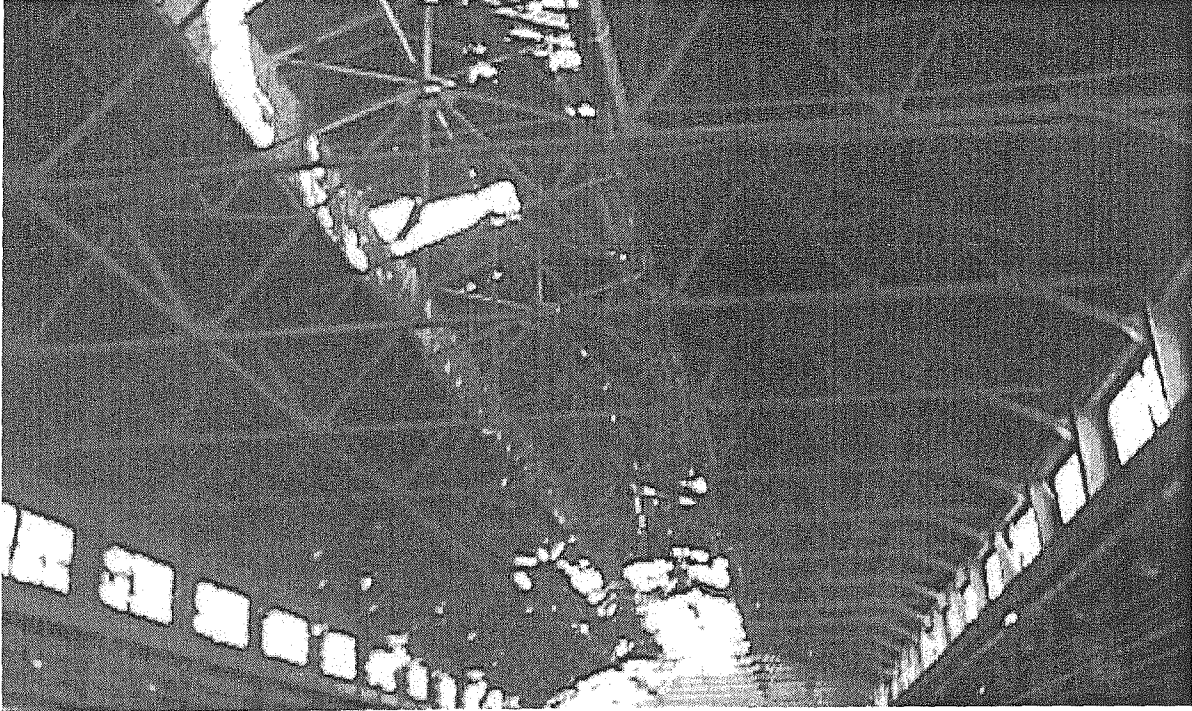
Photograph 6 - Building 2 - Typical Roof openings

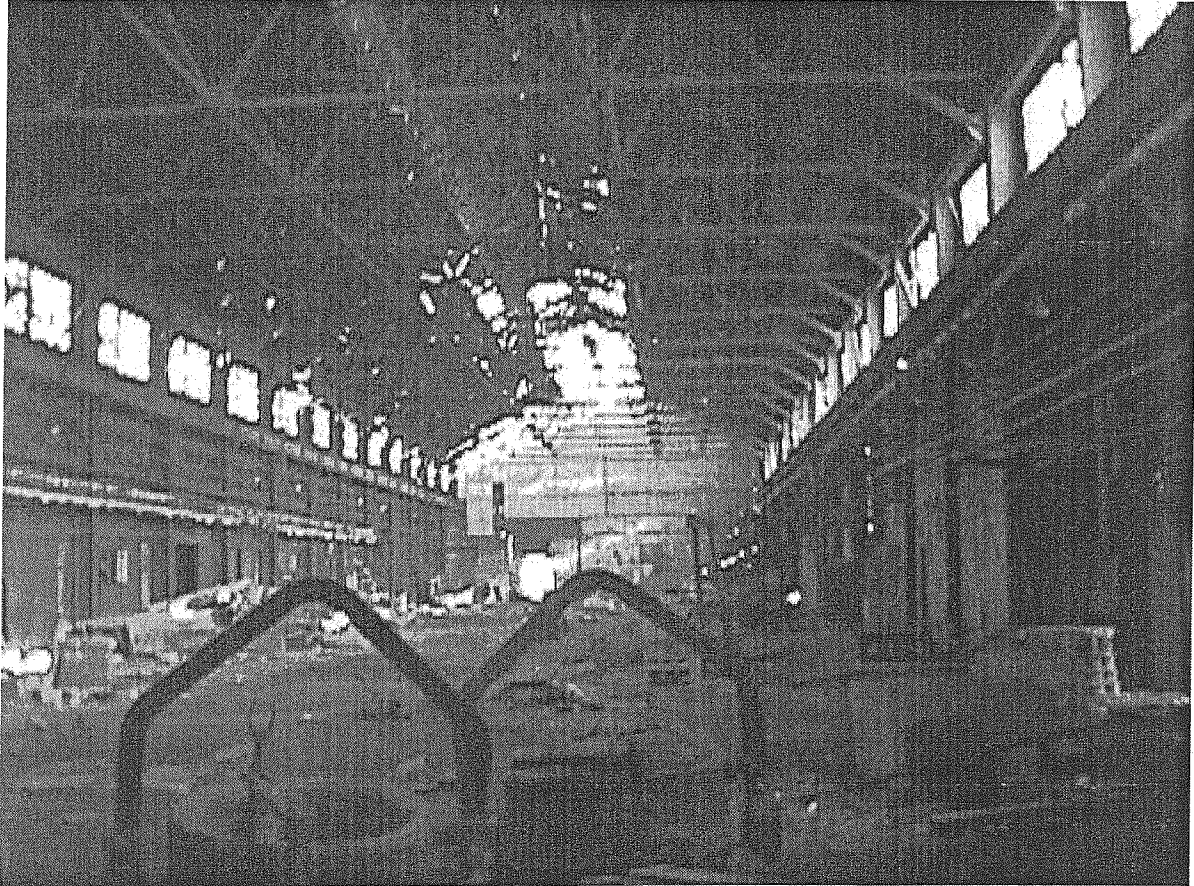
Photograph 7 - Building 2 - Overall Building View facing north

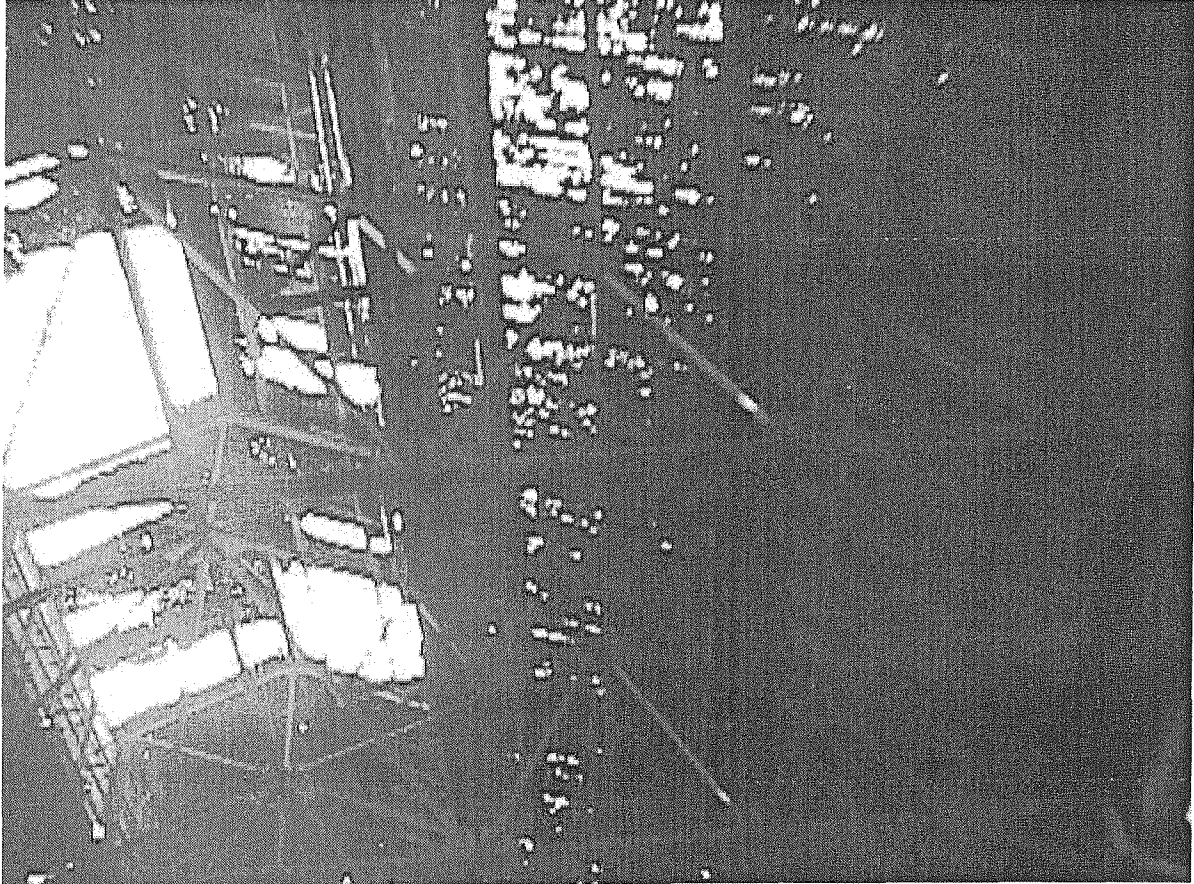
Photograph 8 - Building 1 - Typical Roof Openings

2.3.6 Specific Conclusions/Recommendations: Loose parts of the corrugated metal roof create a non-structural hazard. Extreme care should be practiced when inside this larger bay area. The lower level should be investigated with only the proper caution and PPE. This area should also be roped off to avoid someone stumbling down the stairs. The structural integrity of exterior and masonry wall and interior steel frame system appears adequate. A detailed evaluation of the roof trusses was not performed since access up to the trusses was not possible. No apparent structural deficiencies were discovered with Building 1.

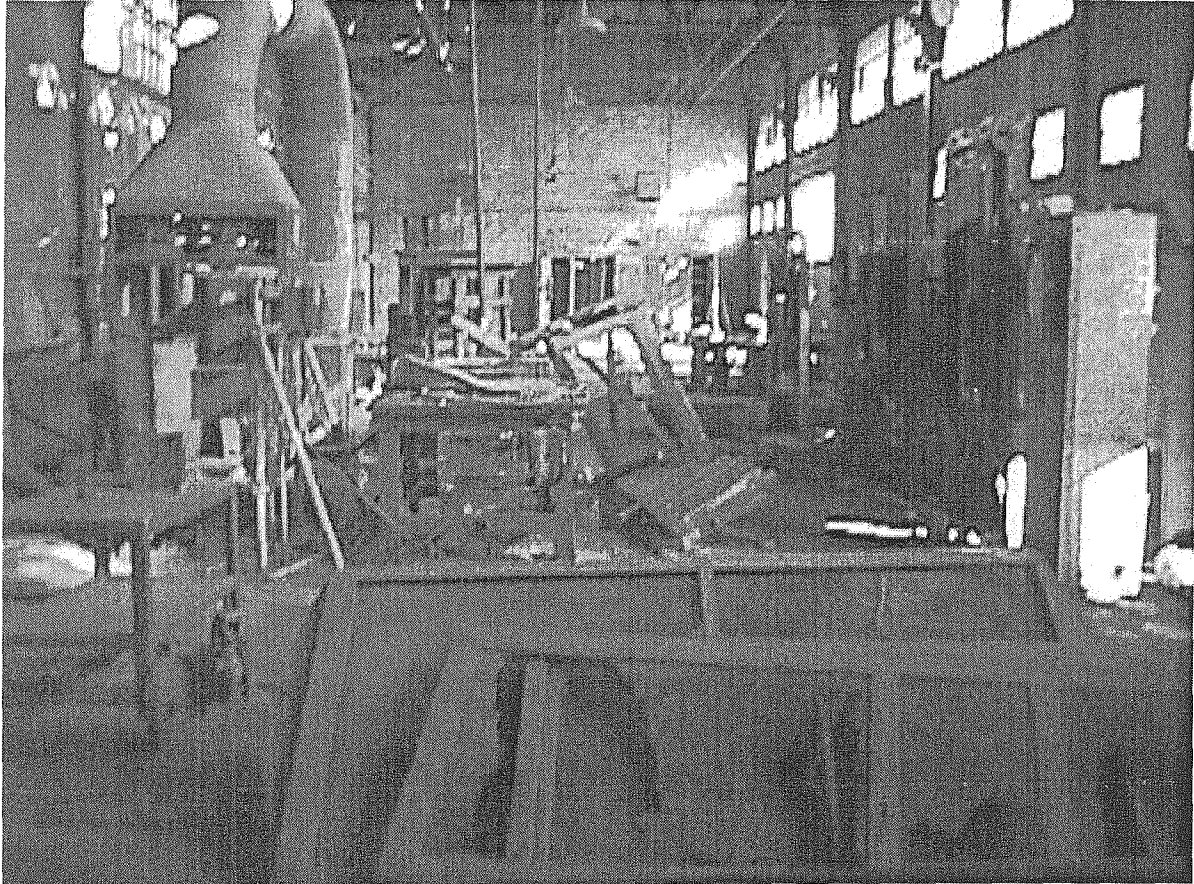
Photograph 9 - Building 1 - Center Room facing north

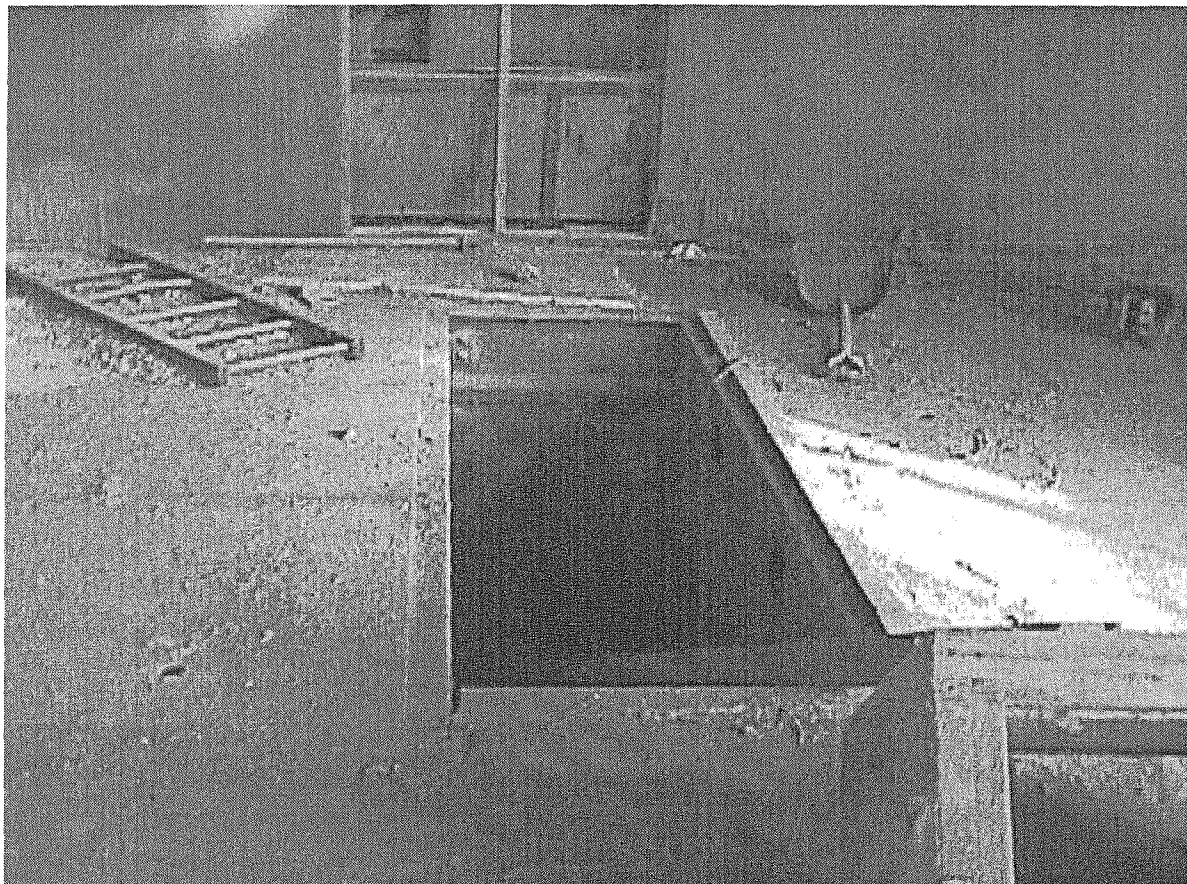
Photograph 10 - Building 1 - South Room facing north  
Note access down to pit or trench

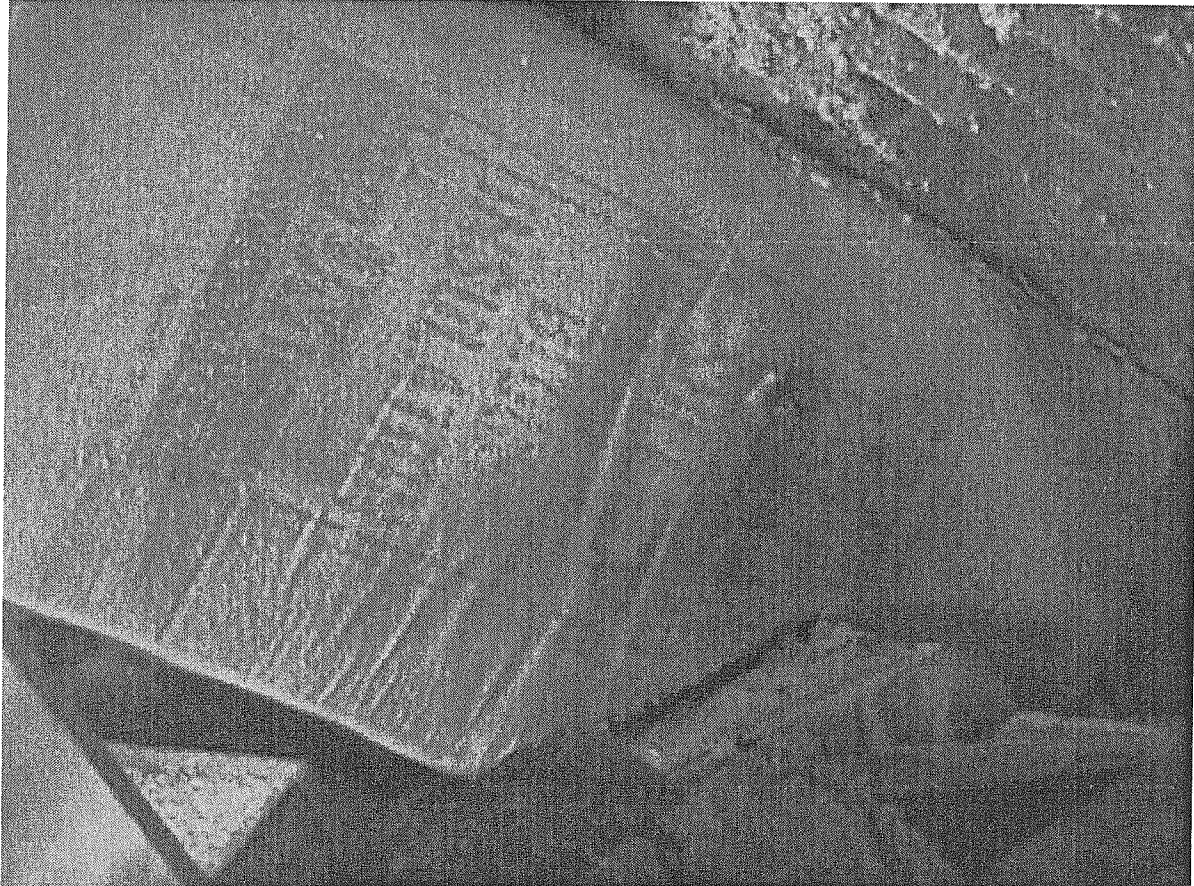
Photograph 11 - Building 1 - Insulation Close-up in Work Room

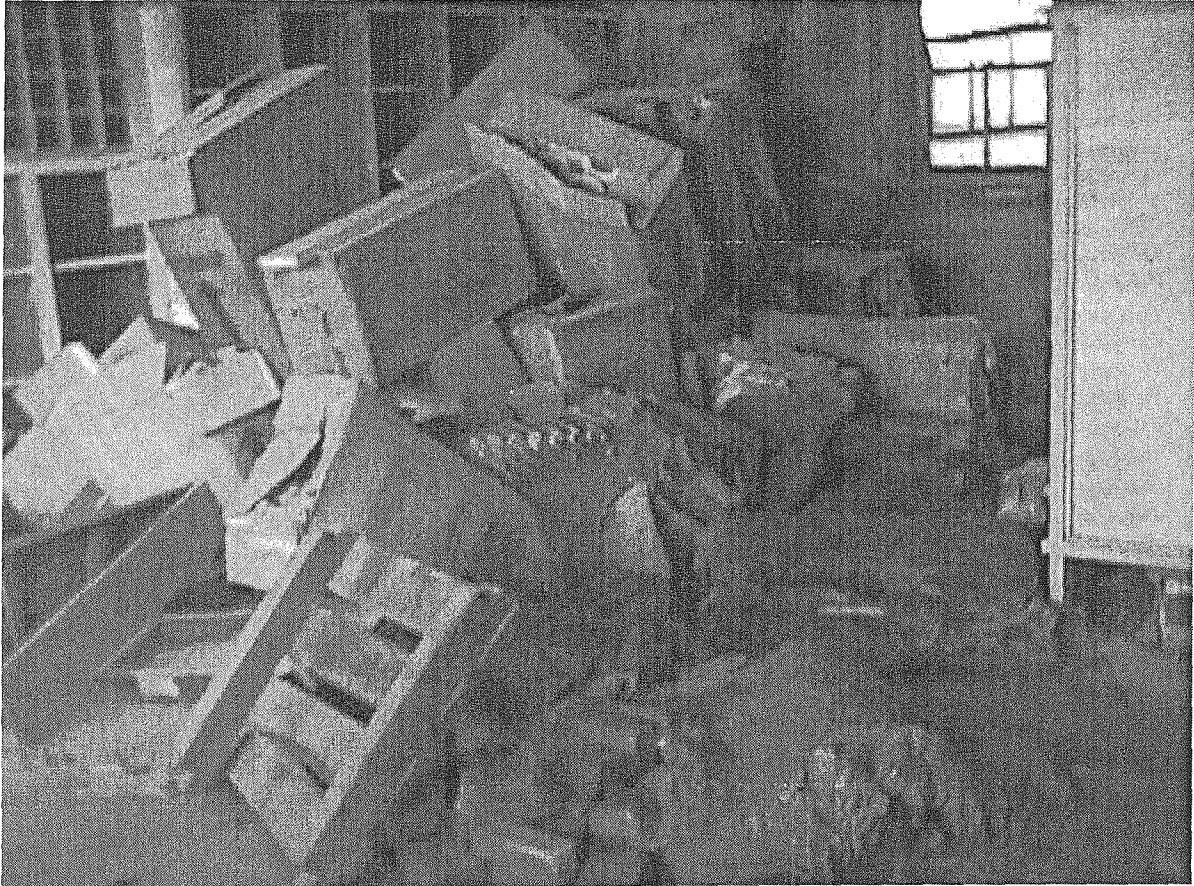
Photograph 12 - Building 1 - Work Room Insulation Stockpile

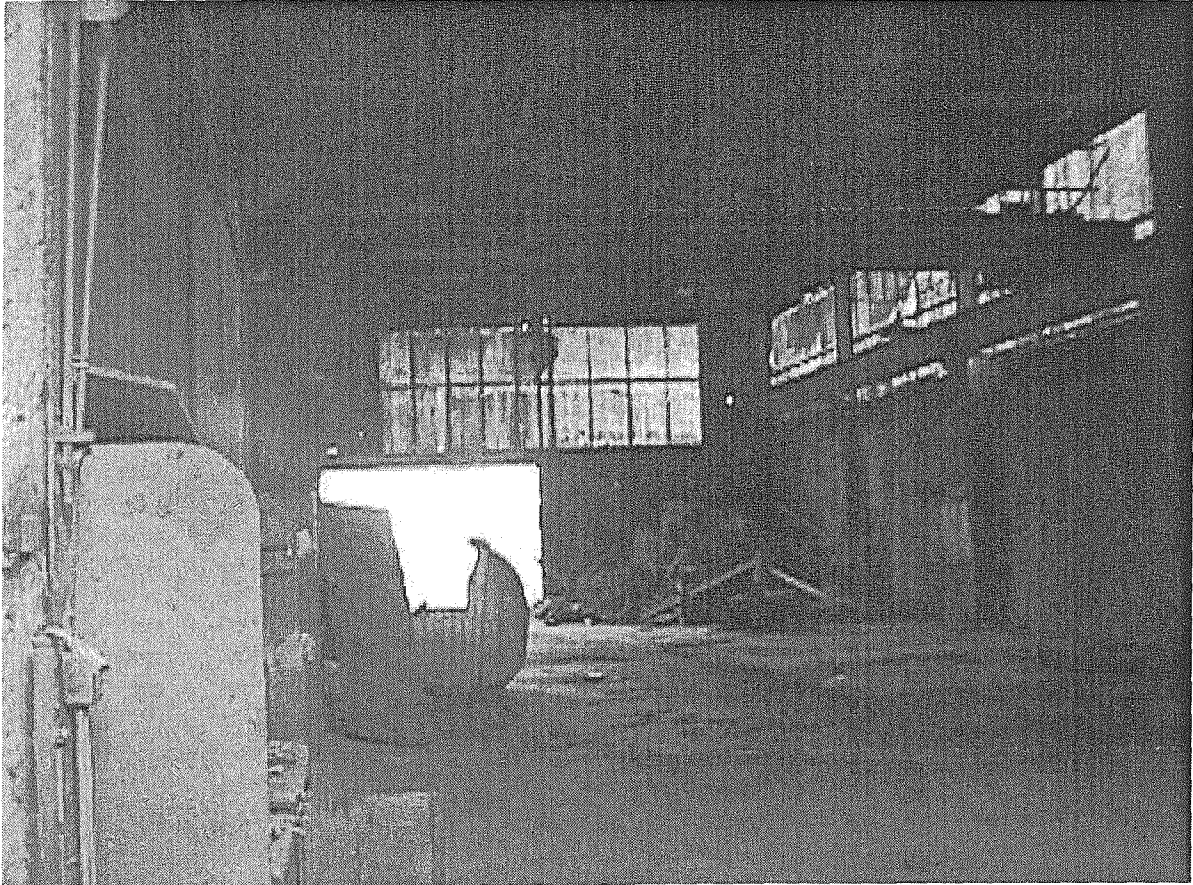
2.9.5 Observations: Although some minor water damage is present in both the exterior mortar and brick near the northeast corner of the building, no deficiencies can be found. The interior also is very good condition. See Photograph 13.

Photograph 13 - Building 35 - facing north

2.9.6 Specific Conclusions/Recommendations: No significant structural deficiencies are present. Access to this building should not be limited solely due to structural and non-structural deficiencies.

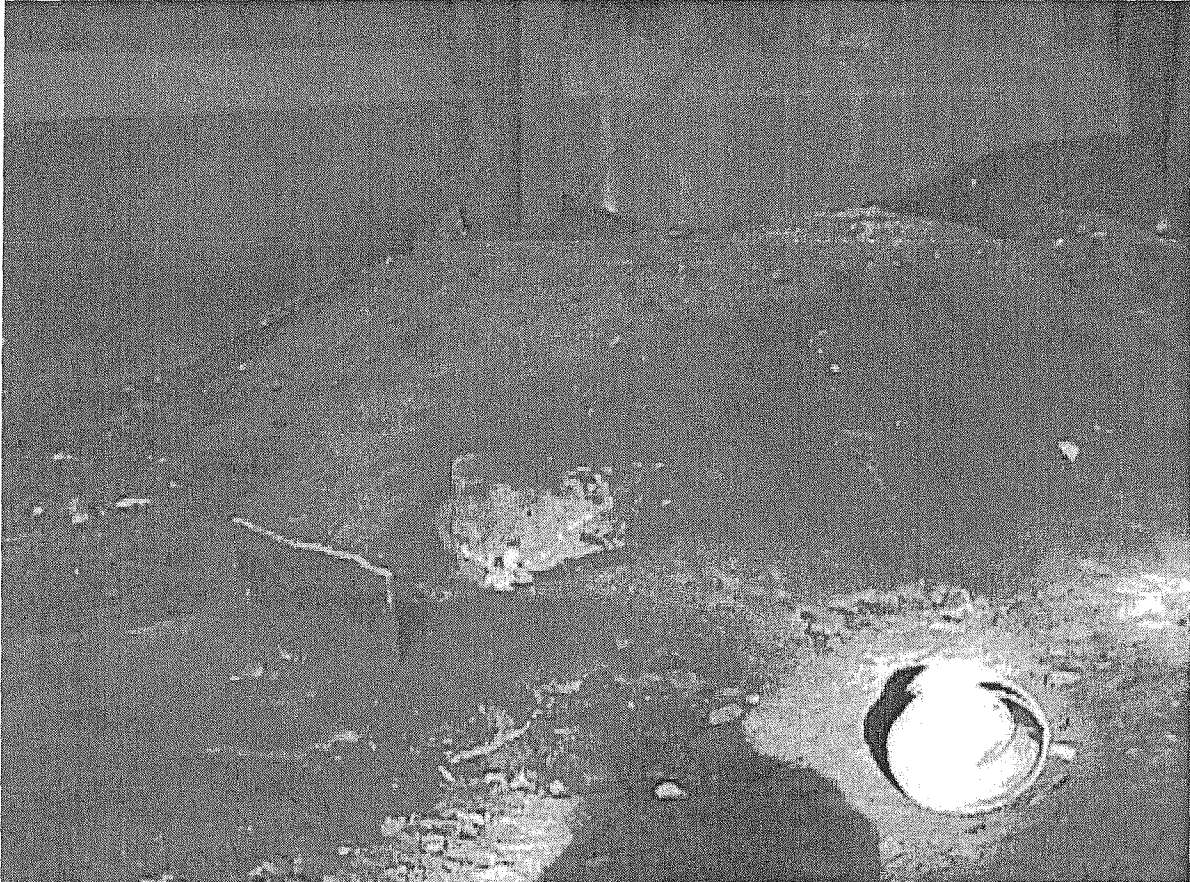
Photograph 14 - Building 3 - North Section - East Wall near  
Building 8 - Post rolling debris/waste?

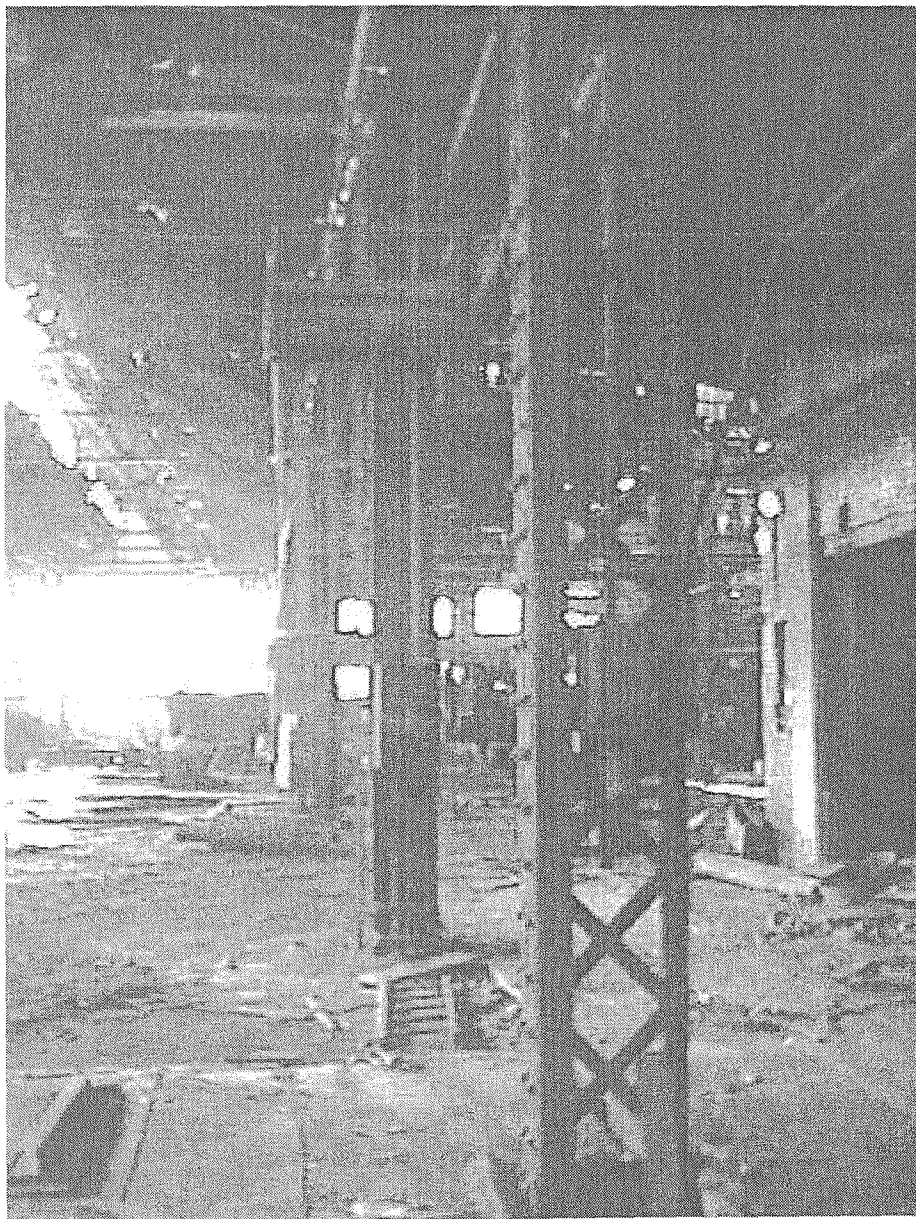
2.8.5 Observations: Most of this area was "roped off" with Danger Radioactive signs and no entrance to this area was made during this inspection. Although the eastern side of these buildings was inspected along the interface with Building Number 3 See Photograph 15. Although some corrosion exists on the original columns and later installed columns that support the roof, this corrosion does not threaten the stability of the columns or the roof trusses they support. Several areas also have uneven walking surface. It appears as though heavy vehicles have caused the sub-based material to compress and have caused ruts on the laid brick floor. Caused should be exercised near Building Numbers 6 & 8.

Photograph 15 - Buildings 6 & 8 - Typical Built-up Columns along Building 3 interface - facing south - Note furnace in background

2.8.6 Specific Conclusions/Recommendations: A more detailed structural inspection, with the correct PPE and HP supervision, is required for both these buildings if more information is desired.

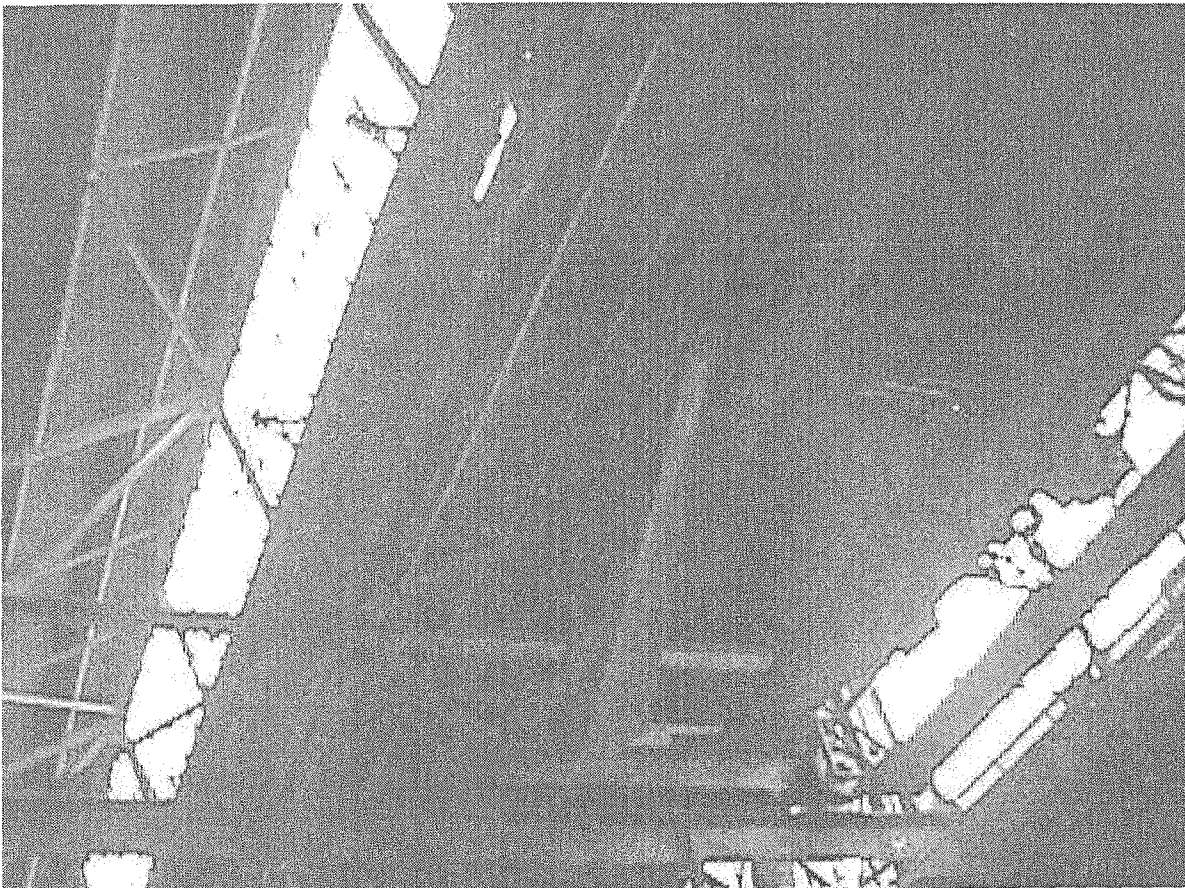
2.6.5 Observations: Some very small holes openings in the roof. Potential for falling pieces of roofing presents a non-structural hazard. See Photographs 16-21. Some coating or material seems to be peeling off the roof. The structural impacts from the loss of this material is unknown. (Could this be fire insulation?) The potential health impacts are also unknown.

Photograph 16 - Buildings 4 & 9 - Typical roof trusses, vents, and roof openings

2.6.6 Specific Conclusions/Recommendations: No significant structural deficiencies are present. Access to this building should not be limited solely due to structural and non-structural deficiencies.

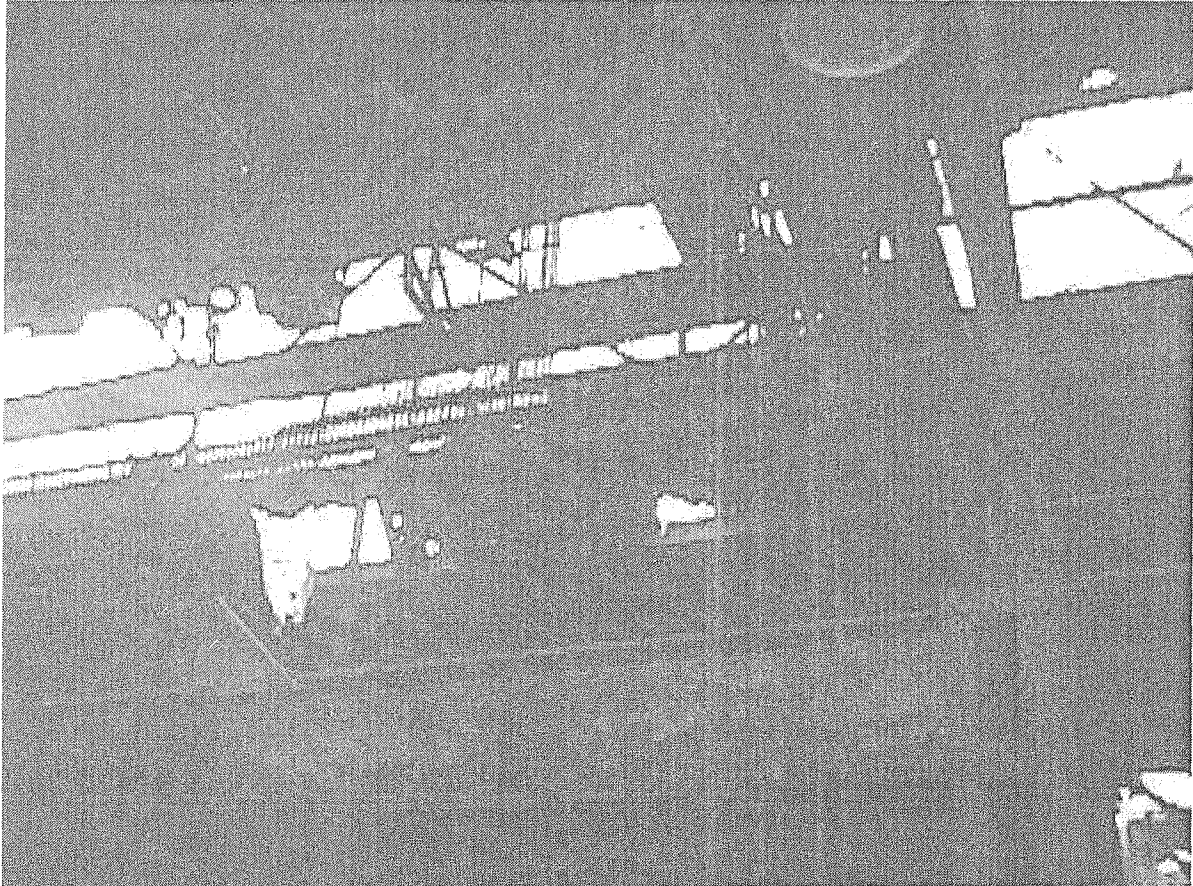
Photograph 17 - Buildings 4 & 9 - Typical roof openings

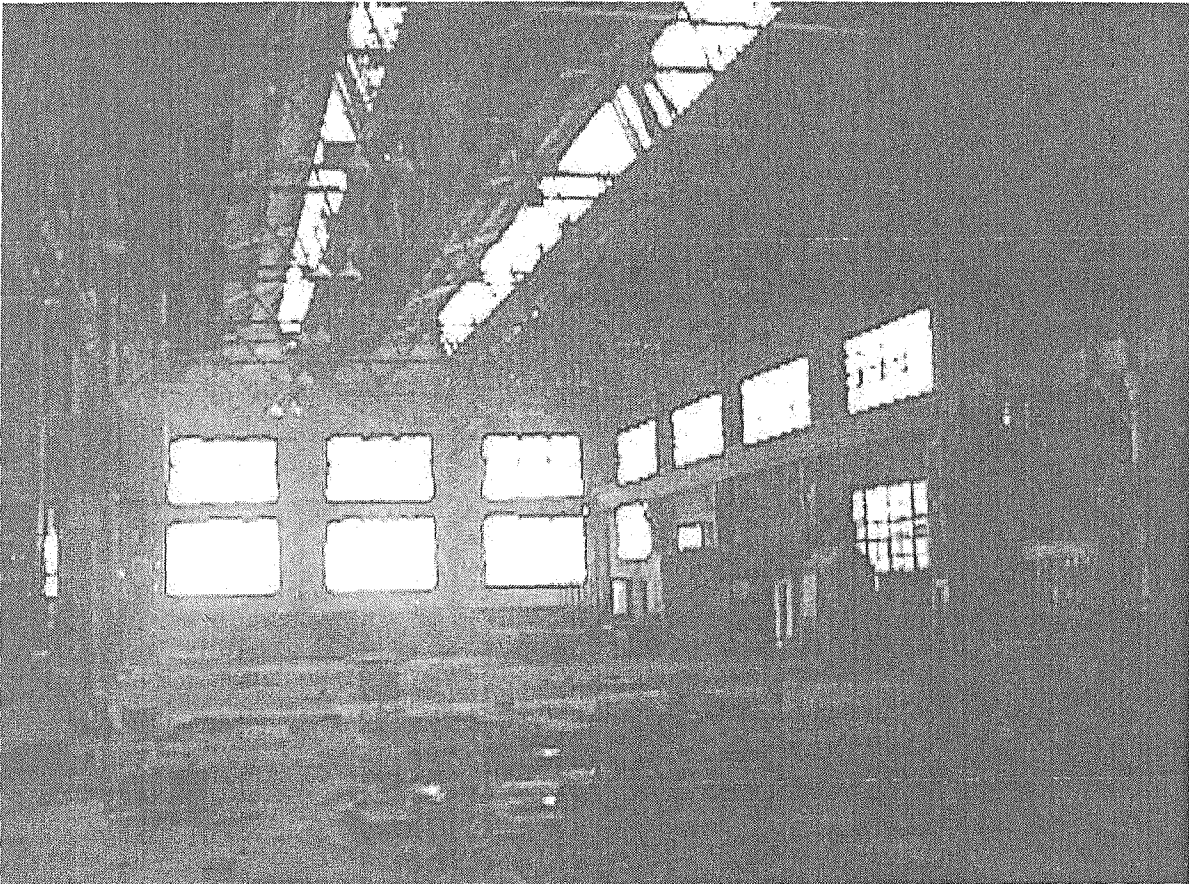
Photograph 18 - Buildings 4 & 9 - Facing north at Loading Dock Area

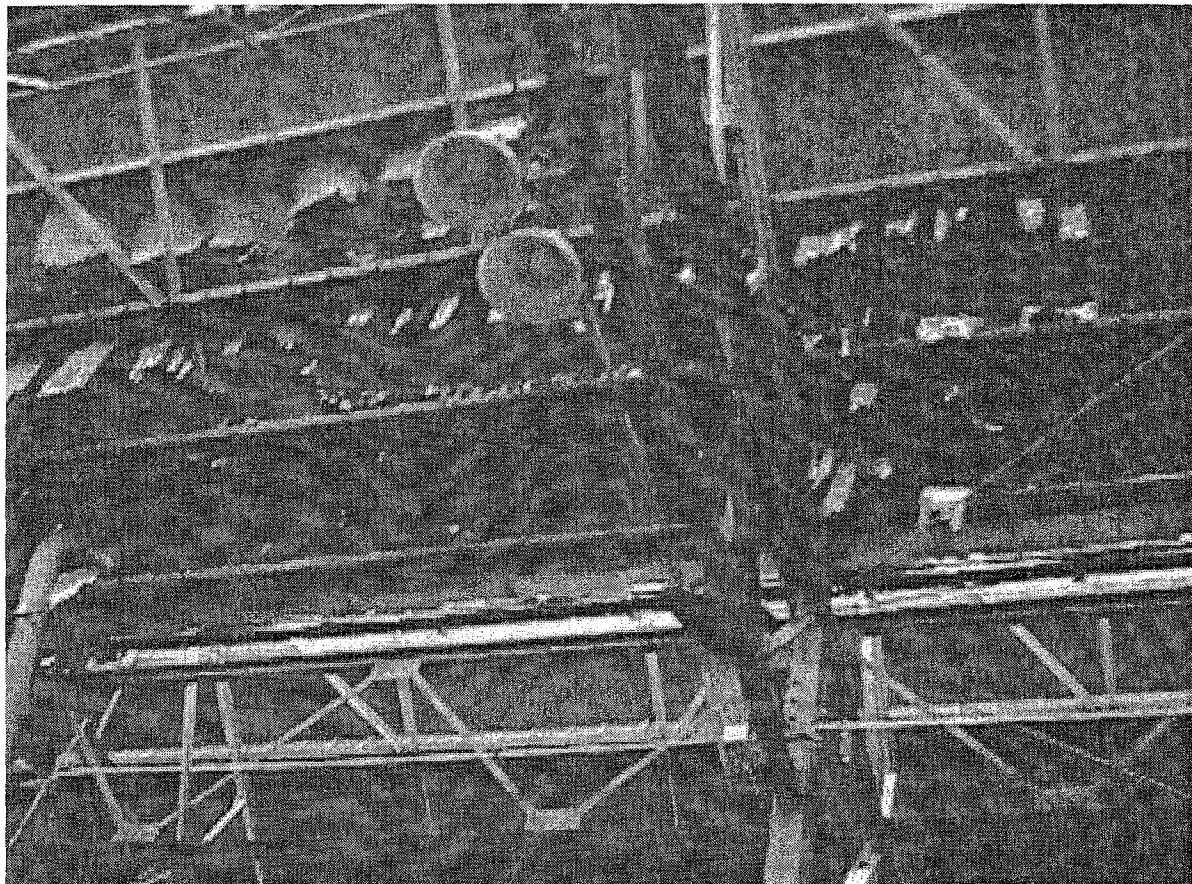
Photograph 19 - Buildings 4 & 9 - Typical peeling of roof material

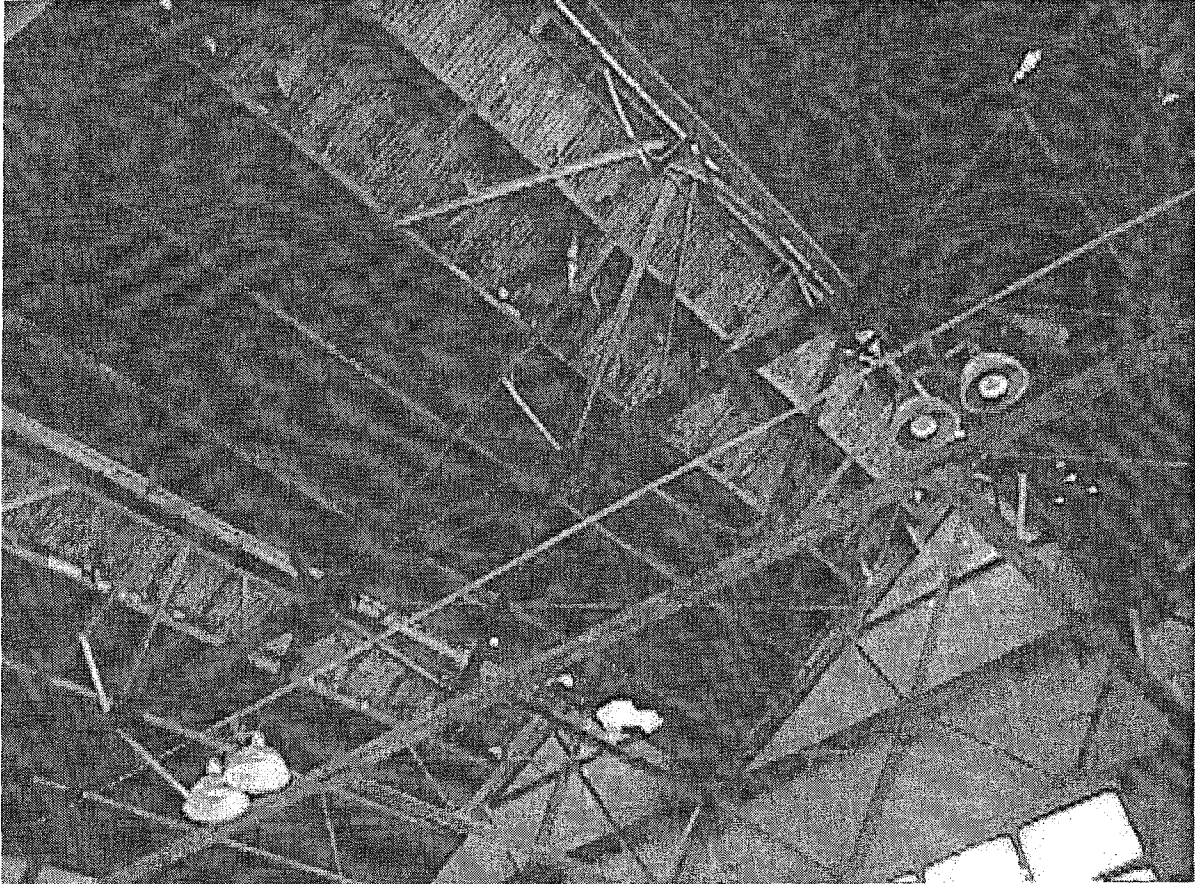
Photograph 20 - Buildings 4 & 9 - Typical peeling of roof material

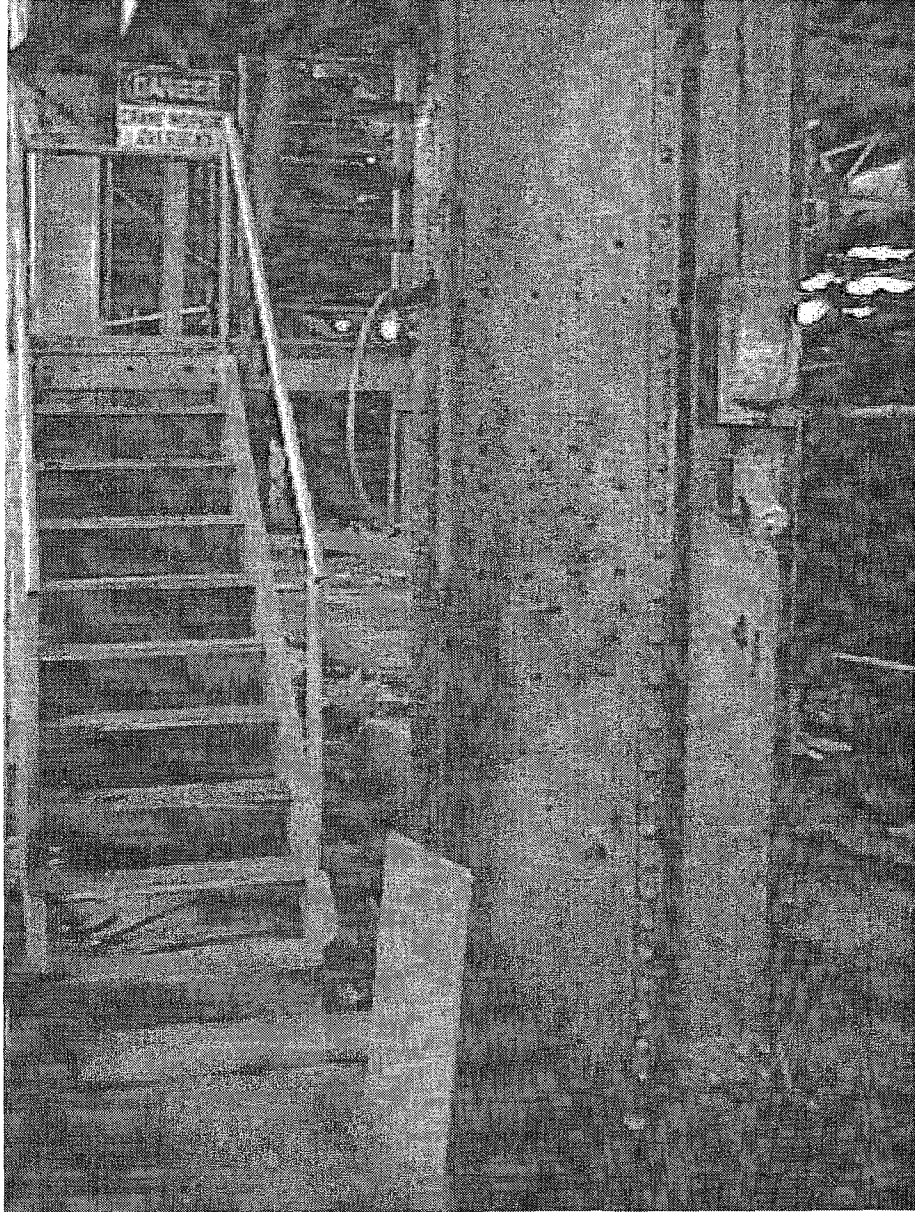
Photograph 21 - Building 4 & 9 - Typical Built-up  
Column

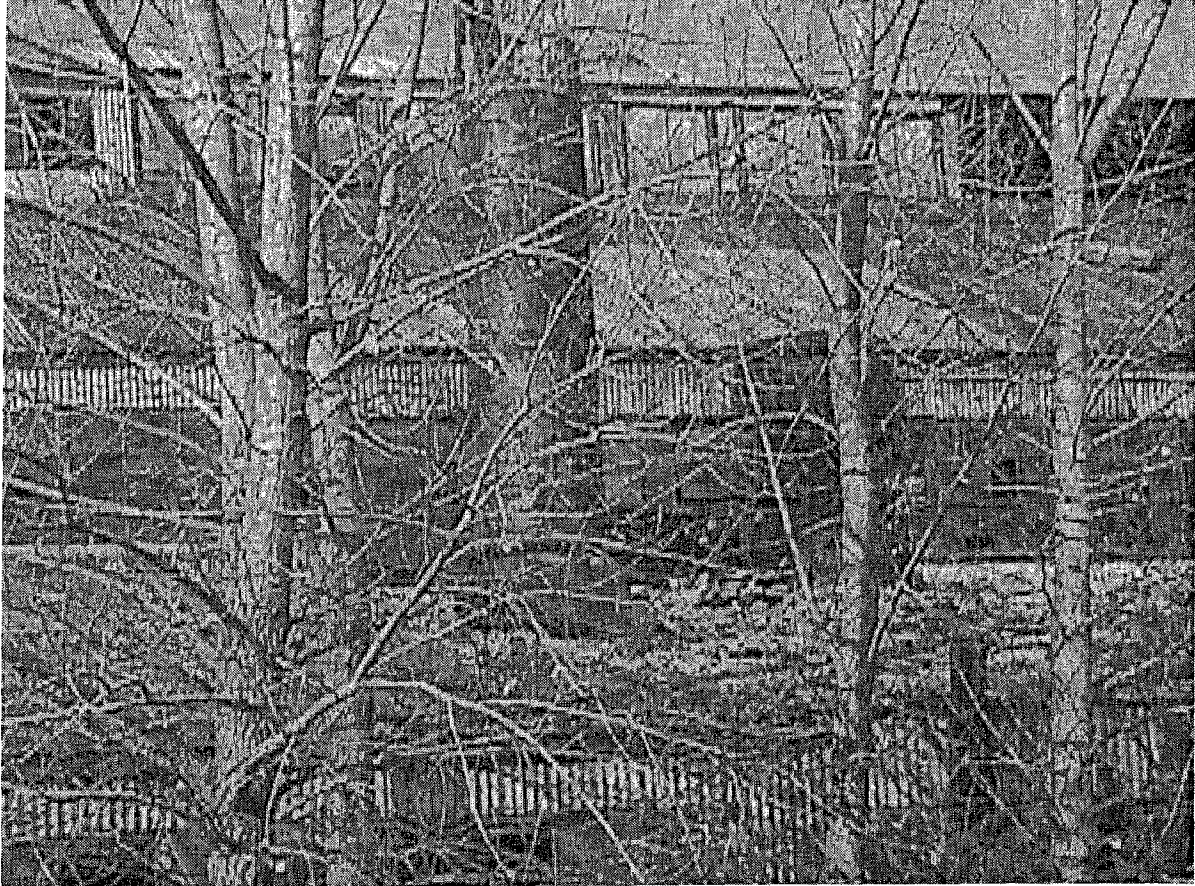
2.5.5 Observations: Some small holes openings in the roof. Potential for falling pieces of roofing presents a non-structural hazard. Some unknown fluorescent yellow material seems to be deposited at the end of the remnants of some type of production area. See Photograph 14. Several trenches are present and they are uncovered or are covered but have simple plywood spanning over them. Care should be taken in and around all trenches. No exploration was made of these trenches during this inspection. The smokestack above the south section of Building 3 has deteriorated. Some of the insulation brick is beginning to crumble and is another falling hazard.

Photograph 22 - Building 3 - South Smokestack Deterioration

significant structural distresses present in Building Number 3. Recommend roping off the exterior south east area of this building until the smokestack is brought down.
