PRELIMINARY ASSESSMENT / SITE INSPECTION

**Former Guterl Specialty Steel Corporation
Lockport, New York**

U.S. Army Corps Of Engineers
Buffalo District
1776 Niagara Street
Buffalo, NY 14207
04/13/01

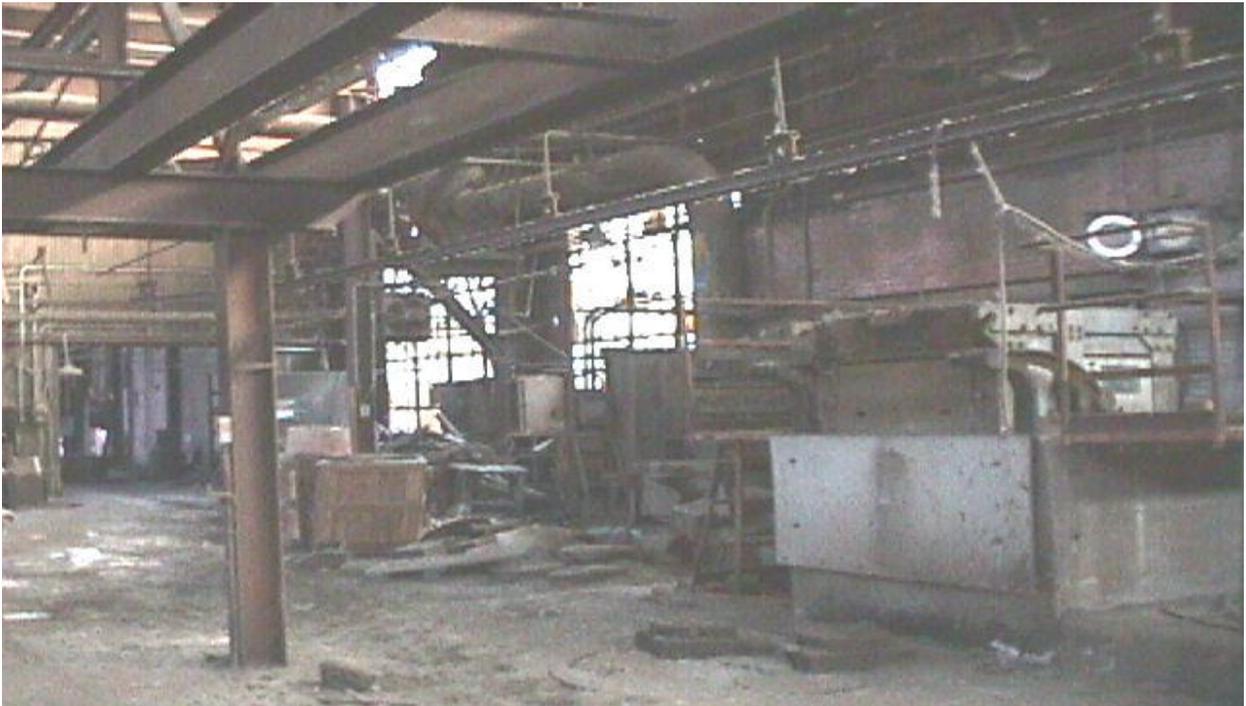
2.4.5 Observations: Massive holes are present in the corrugated sheet metal roof. See Photograph 1. More corrosion seems present in this building than in Building 1. Most metal rolling/mill buildings produce incredible amounts of heat, which in turn produces moderate to heavy amounts of condensation. This condensation can, in turn, produce substantial amounts of corrosion. This building may have experienced this phenomenon. Years of exposure to the elements may also attribute to the corrosion witnessed. Although the corrosion in Building 2 is higher than in the other excised buildings, it does not appear to be detrimental to the structural stability of Building 2. See Photographs 2-7.

Photograph 1 - Building 2 - East Interior Wall Center Section

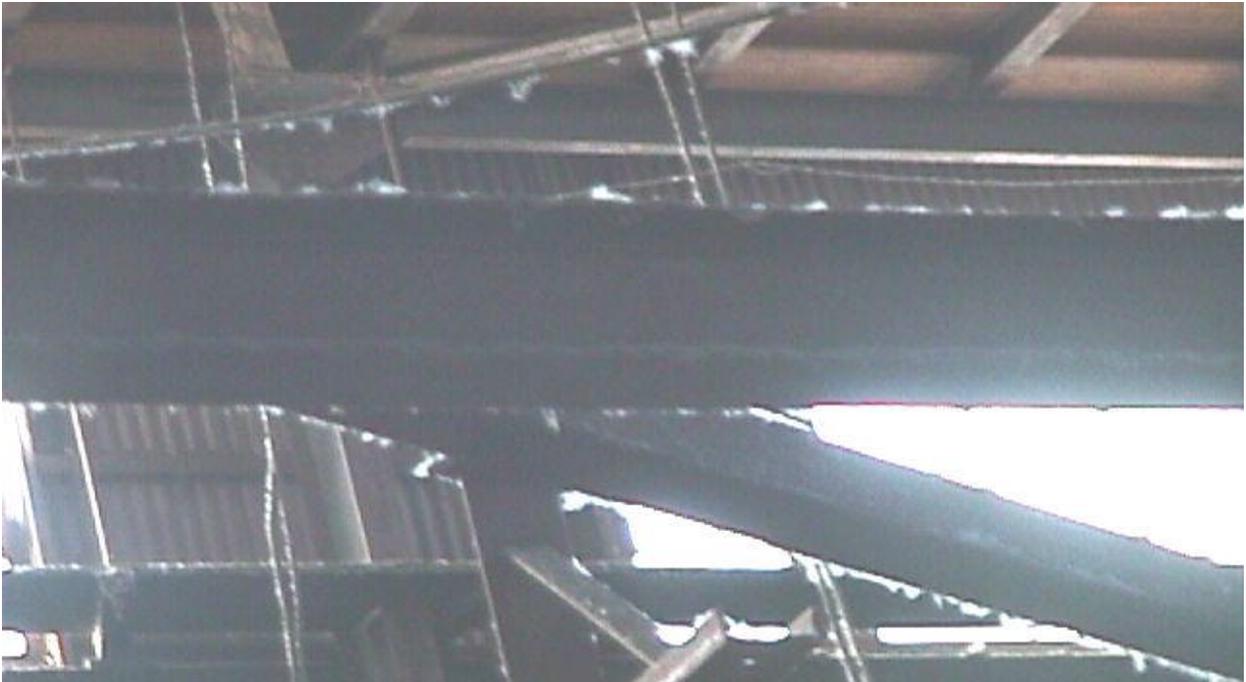
Photograph 2 - Building 2 - East Interior Wall Connection & Roof

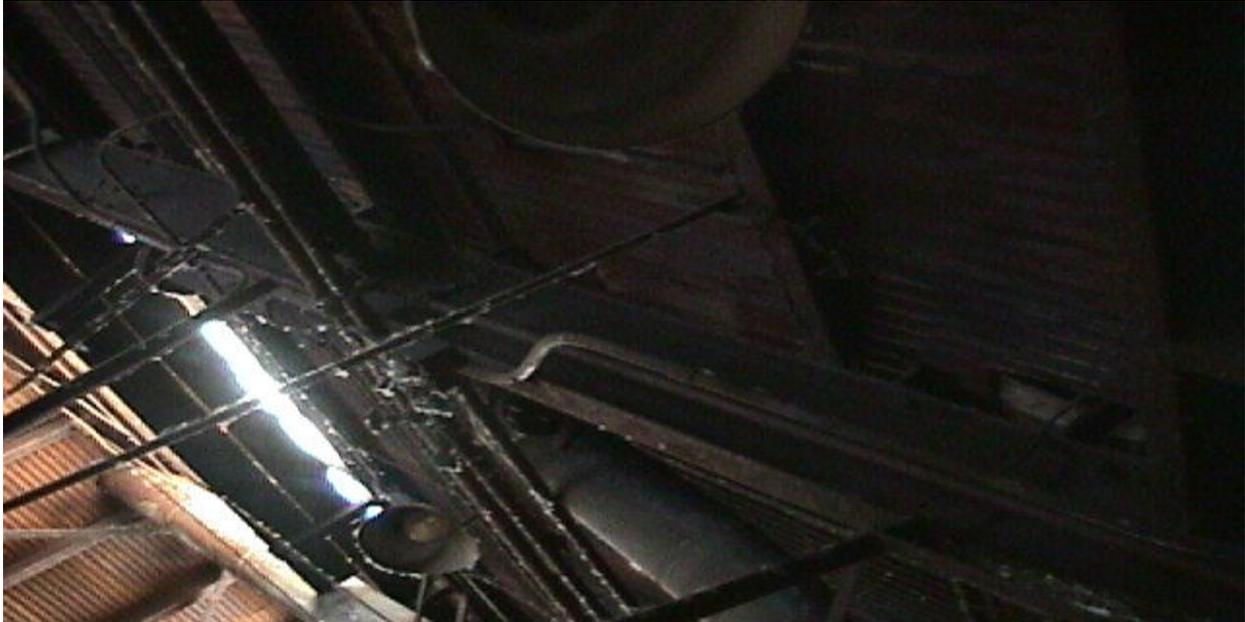
Photograph 3 - Building 2 - Roof

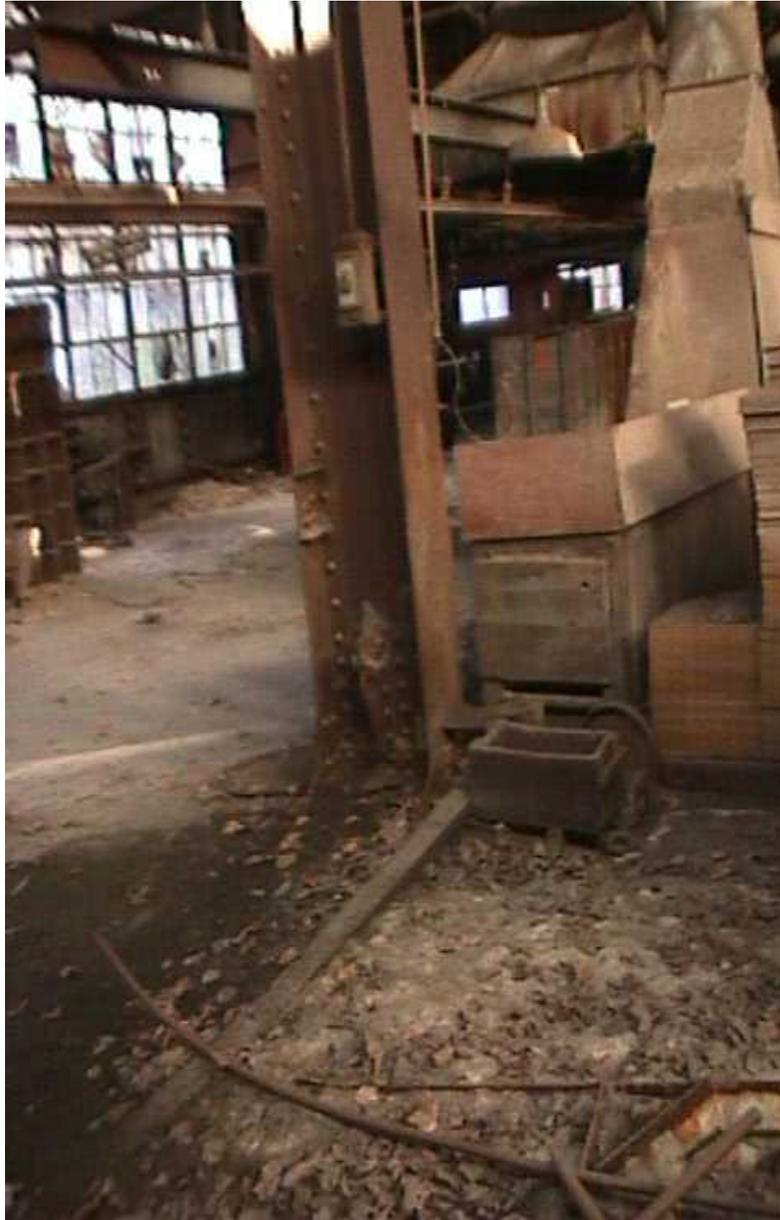
Photograph 5 - Building 2 - Typical Built-up Column

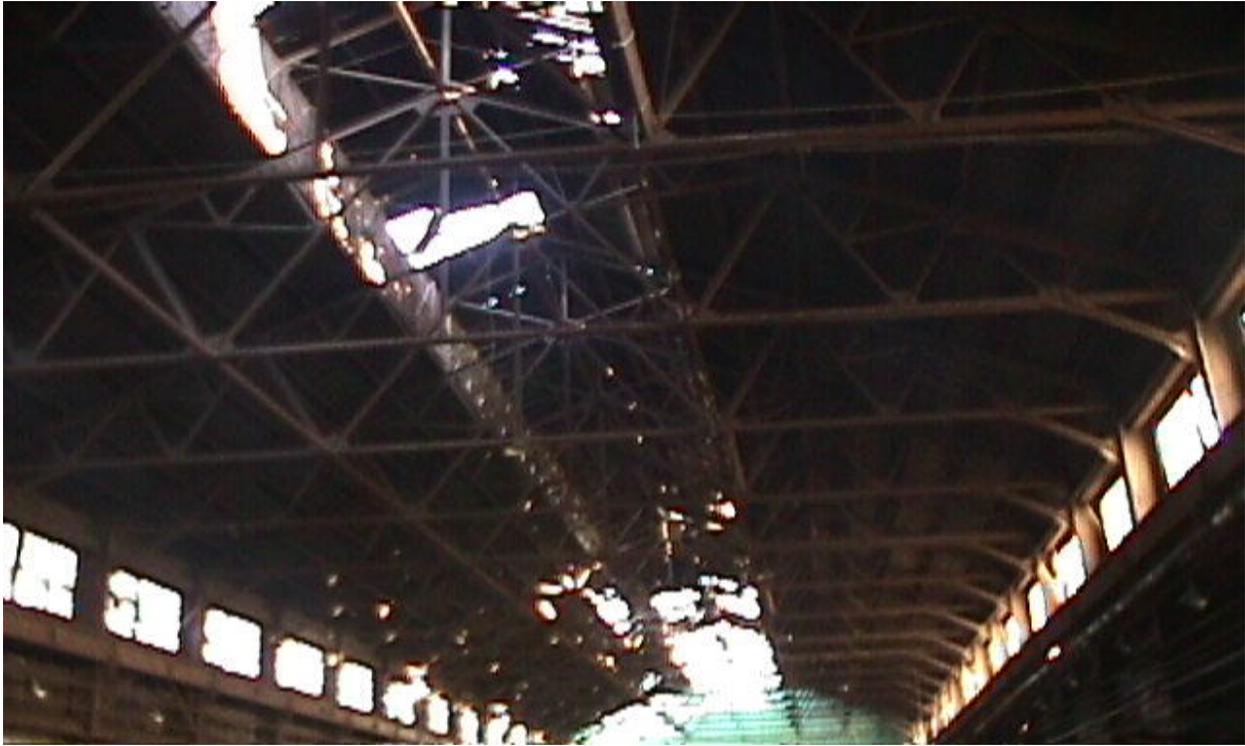
Photograph 6 - Building 2 - Typical Roof openings

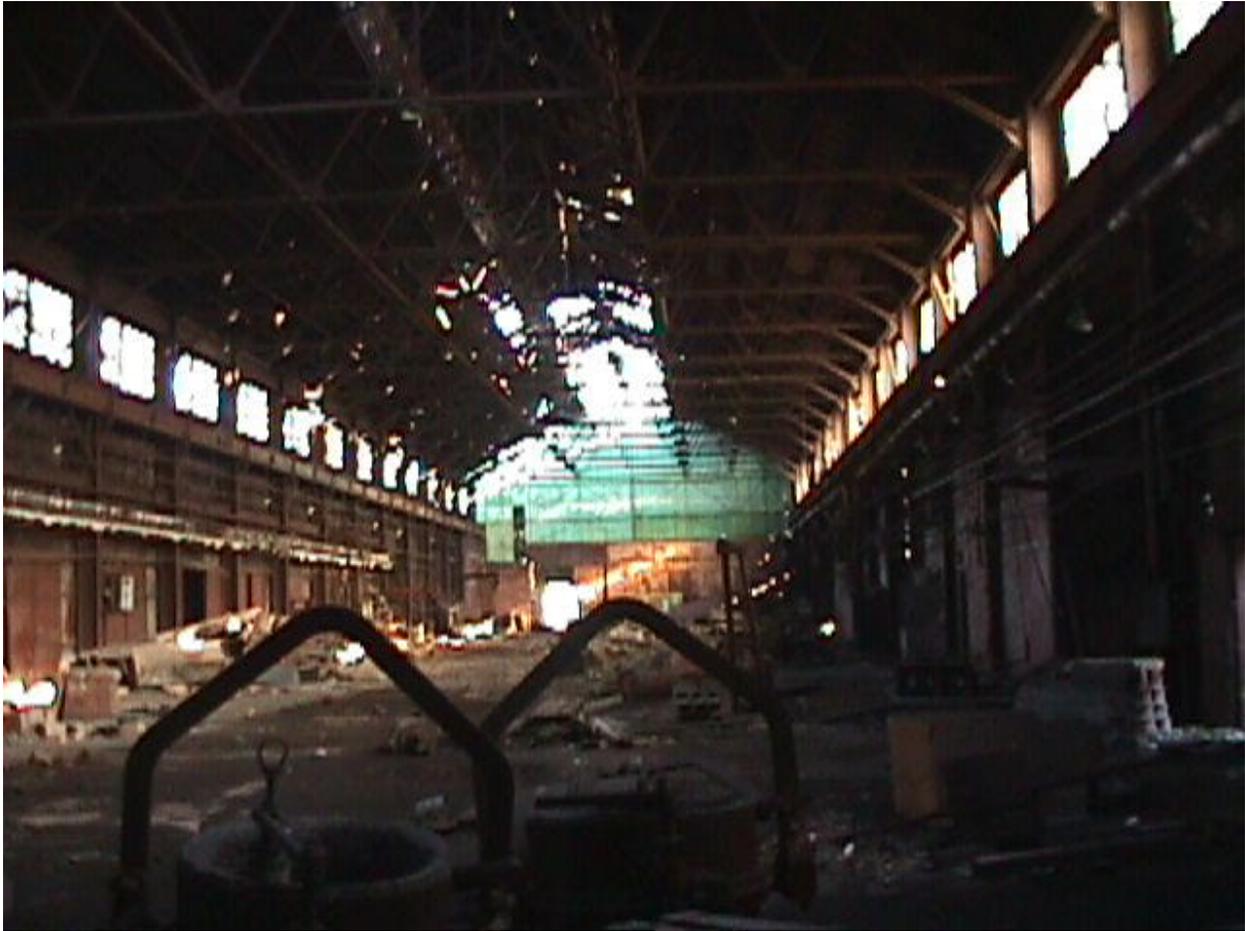
Photograph 7 - Building 2 - Overall Building View facing north

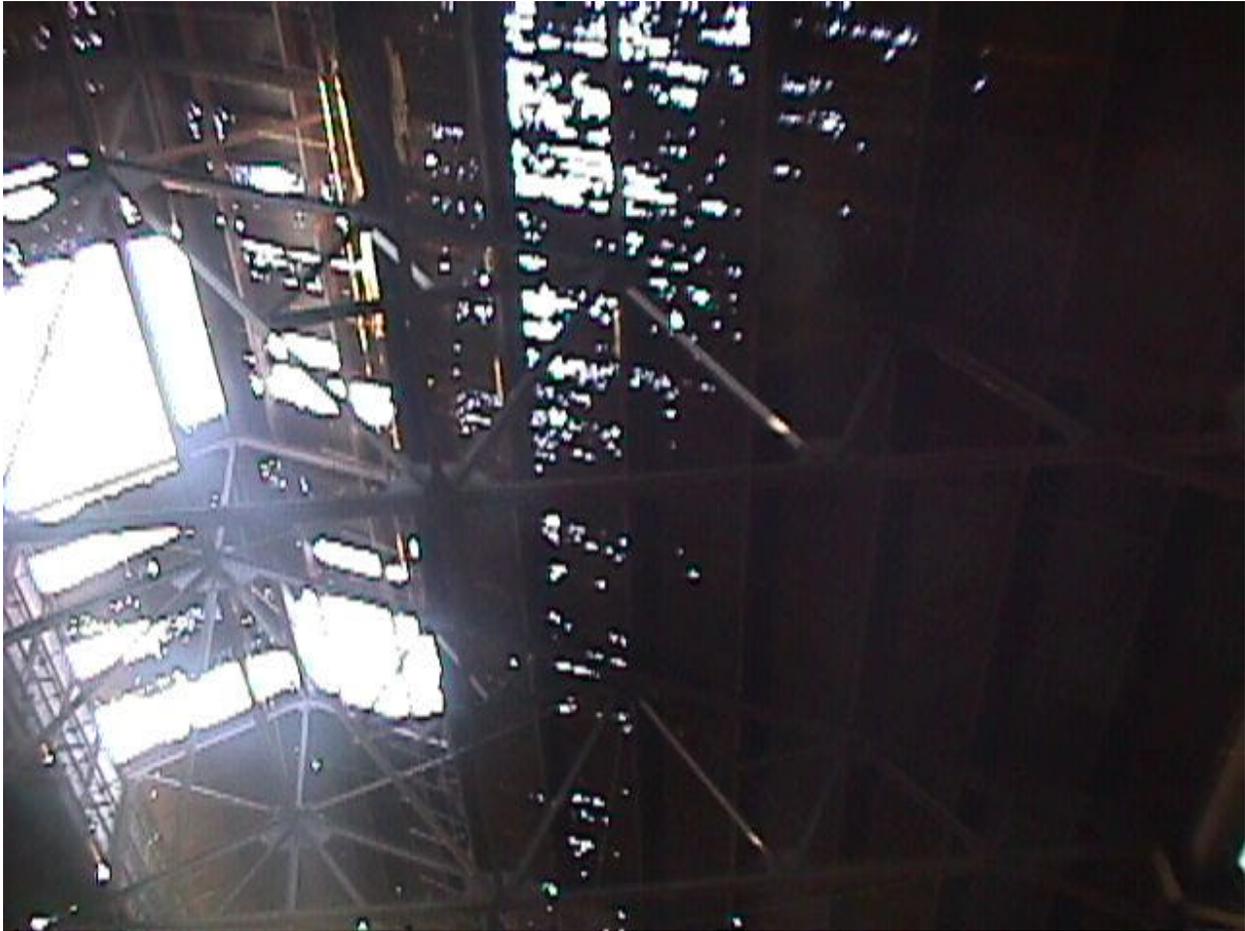
Photograph 8 - Building 1 - Typical Roof Openings

2.3.6 Specific Conclusions/Recommendations: Loose parts of the corrugated metal roof create a non-structural hazard. Extreme care should be practiced when inside this larger bay area. The lower level should be investigated with only the proper caution and PPE. This area should also be roped off to avoid someone stumbling down the stairs. The structural integrity of exterior and masonry wall and interior steel frame system appears adequate. A detailed evaluation of the roof trusses was not performed since access up to the trusses was not possible. No apparent structural deficiencies were discovered with Building 1.

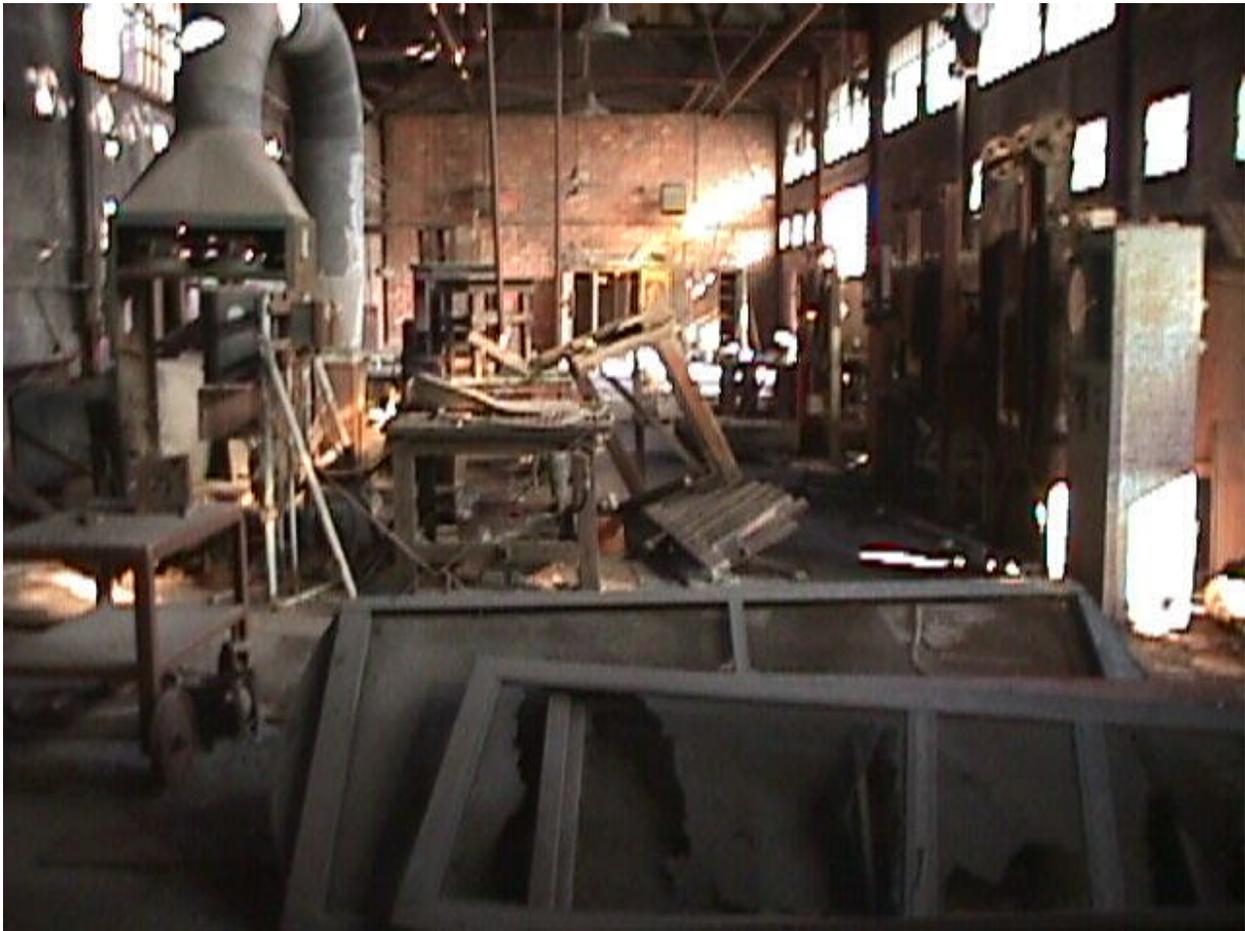
Photograph 9 - Building 1 - Center Room facing north

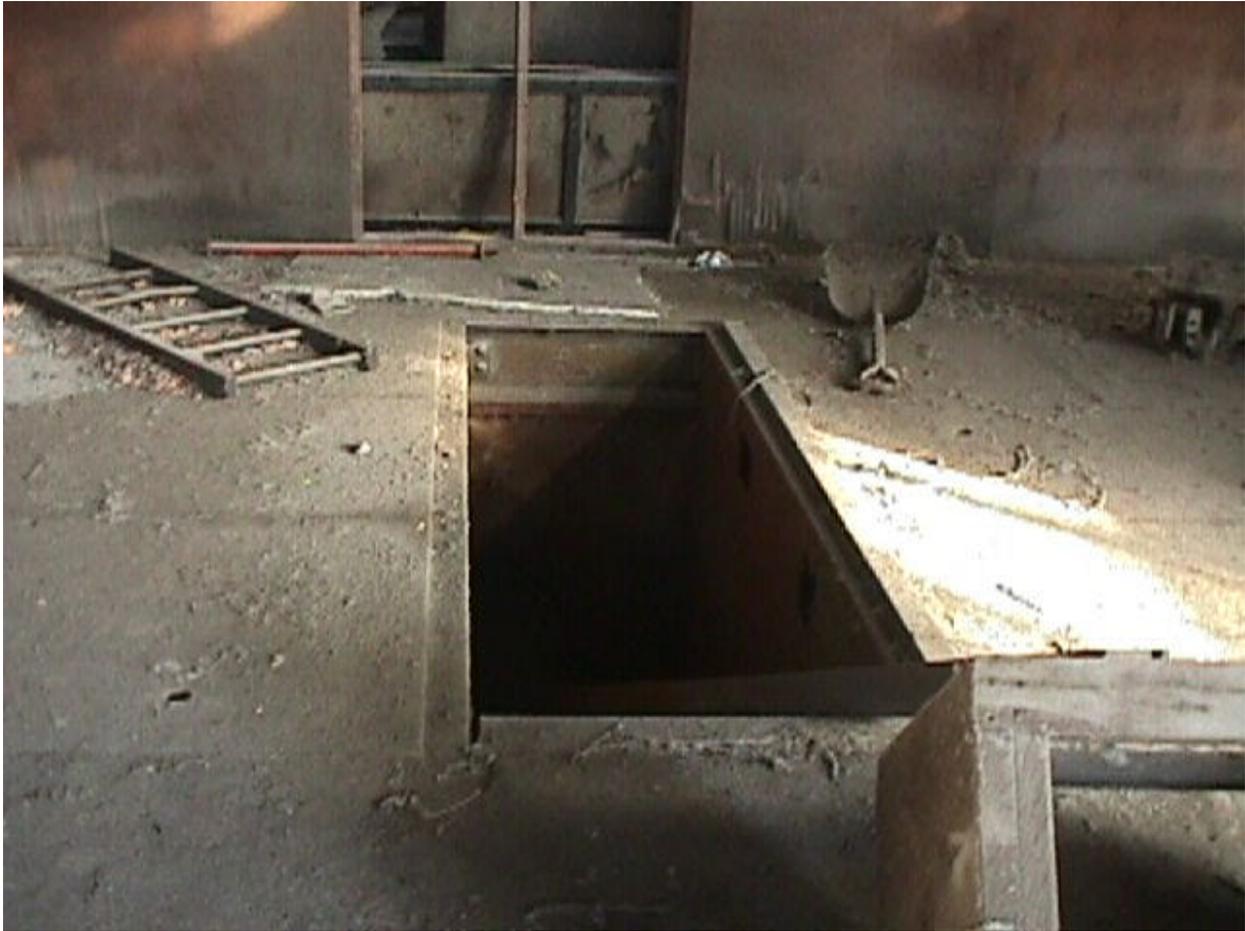
Photograph 10 - Building 1 - South Room facing north
Note access down to pit or trench

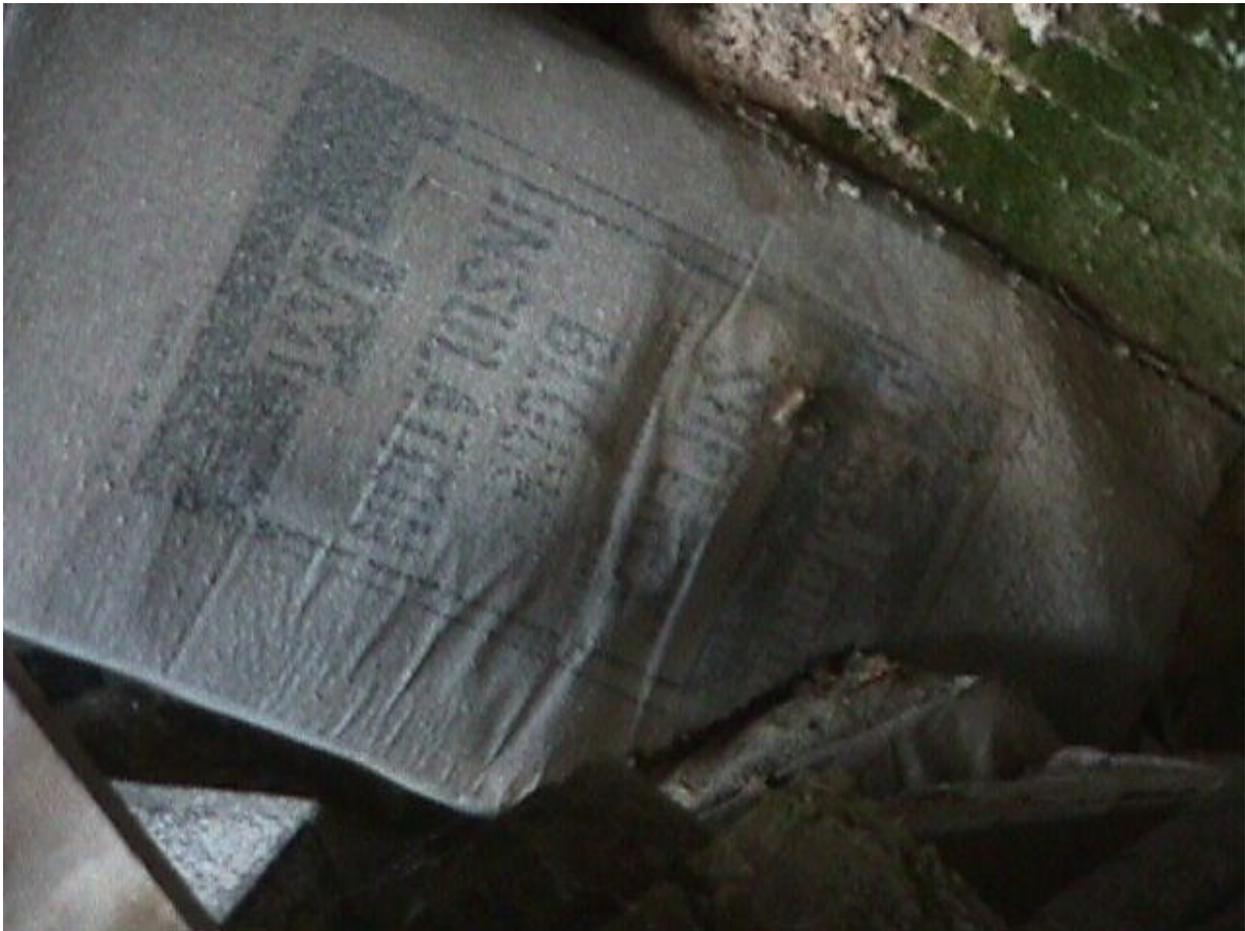
Photograph 11 - Building 1 - Insulation Close-up in Work Room

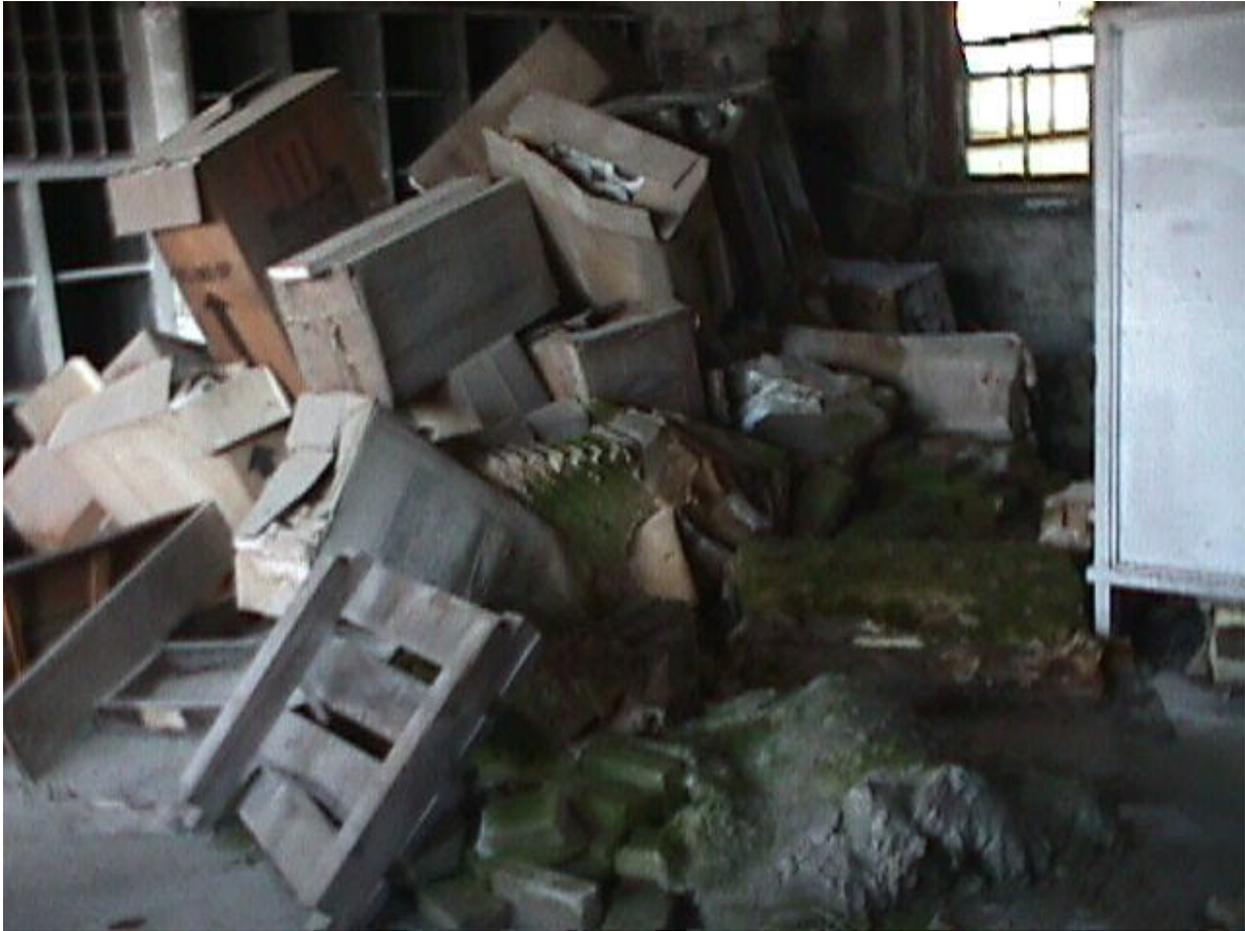
Photograph 12 - Building 1 - Work Room Insulation Stockpile

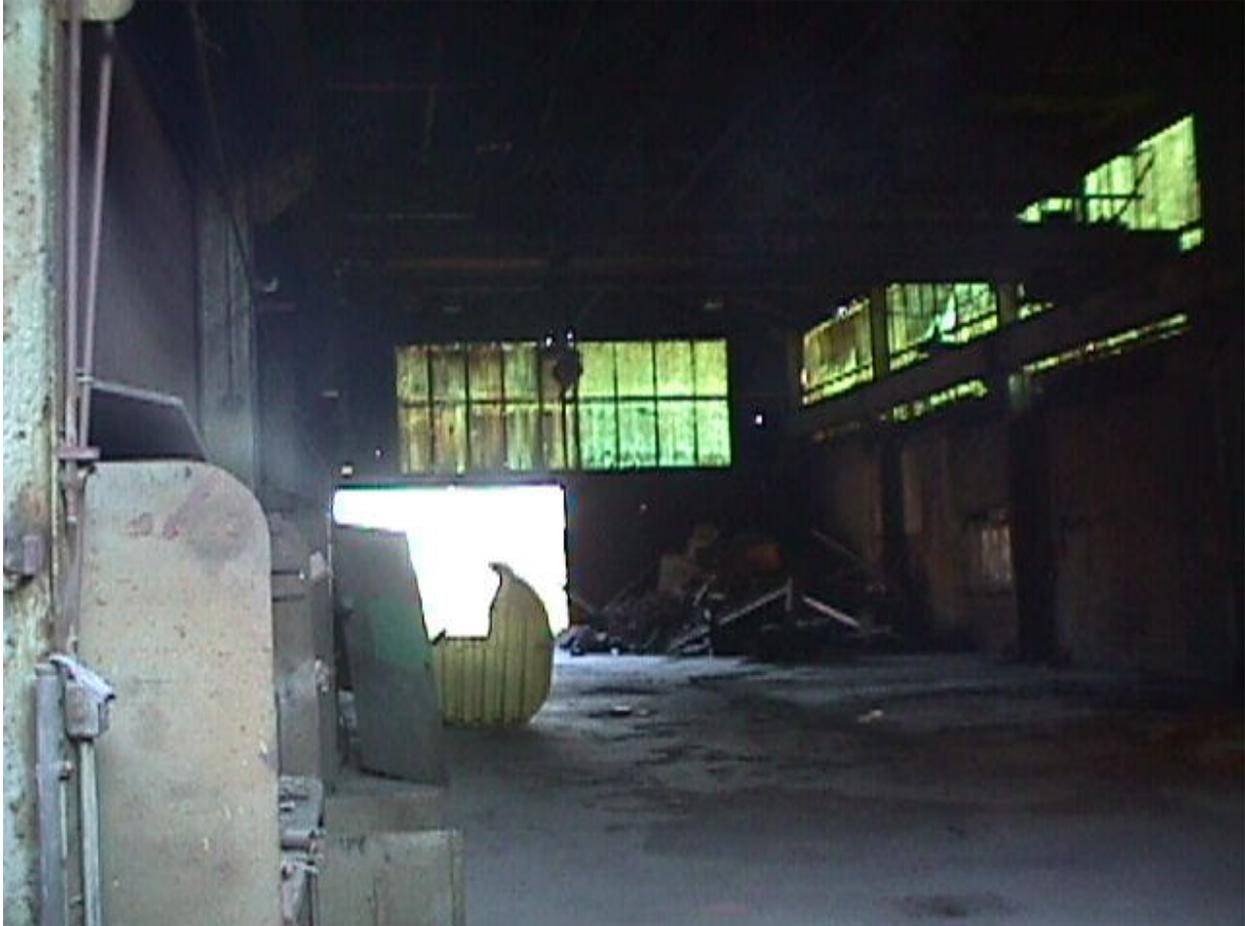
2.9.5 Observations: Although some minor water damage is present in both the exterior mortar and brick near the northeast corner of the building, no deficiencies can be found. The interior also is very good condition. See Photograph 13.

Photograph 13 - Building 35 - facing north

2.9.6 Specific Conclusions/Recommendations: No significant structural deficiencies are present. Access to this building should not be limited solely due to structural and non-structural deficiencies.

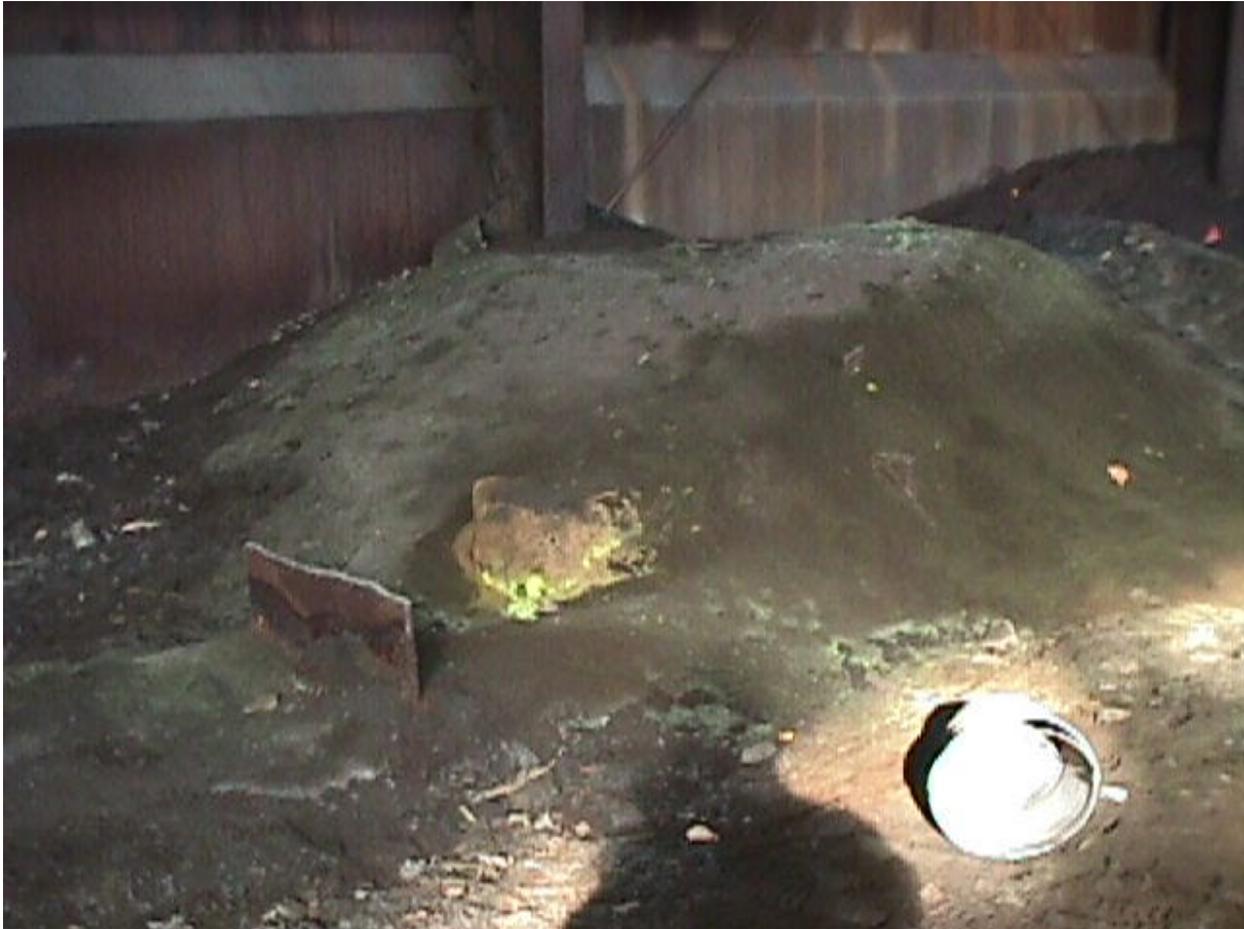
2.5.5 Observations: Some small holes openings in the roof. Potential for falling pieces of roofing presents a non-structural hazard. Some unknown fluorescent yellow material seems to be deposited at the end of the remnants of some type of production area. See Photograph 14. Several trenches are present and they are uncovered or are covered but have simple plywood spanning over them. Care should be taken in and around all trenches. No exploration was made of these trenches during this inspection. The smokestack above the south section of Building 3 has deteriorated. Some of the insulation brick is beginning to crumble and is another falling hazard.

Photograph 14 - Building 3 - North Section - East Wall near Building 8 - Post rolling debris/waste?

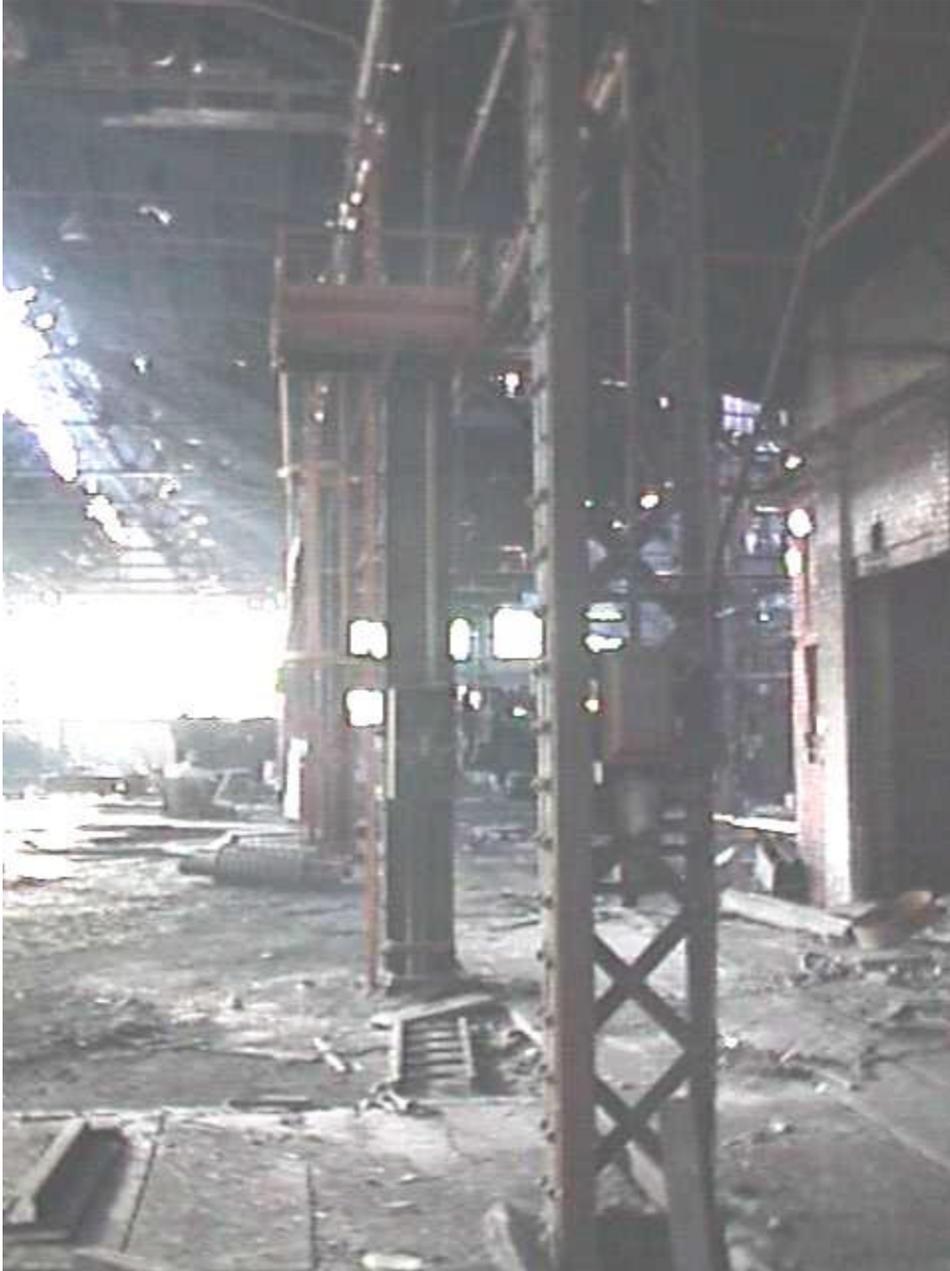
2.8.5 Observations: Most of this area was "roped off" with Danger Radioactive signs and no entrance to this area was made during this inspection. Although the eastern side of these buildings was inspected along the interface with Building Number 3 See Photograph 15. Although some corrosion exists on the original columns and later installed columns that support the roof, this corrosion does not threaten the stability of the columns or the roof trusses they support. Several areas also have uneven walking surface. It appears as though heavy vehicles have caused the sub-based material to compress and have caused ruts on the laid brick floor. Caused should be exercised near Building Numbers 6 & 8.

Photograph 15 - Buildings 6 & 8 - Typical Built-up Columns along Building 3 interface - facing south - Note furnace in background

2.8.6 Specific Conclusions/Recommendations: A more detailed structural inspection, with the correct PPE and HP supervision, is required for both these buildings if more information is desired.

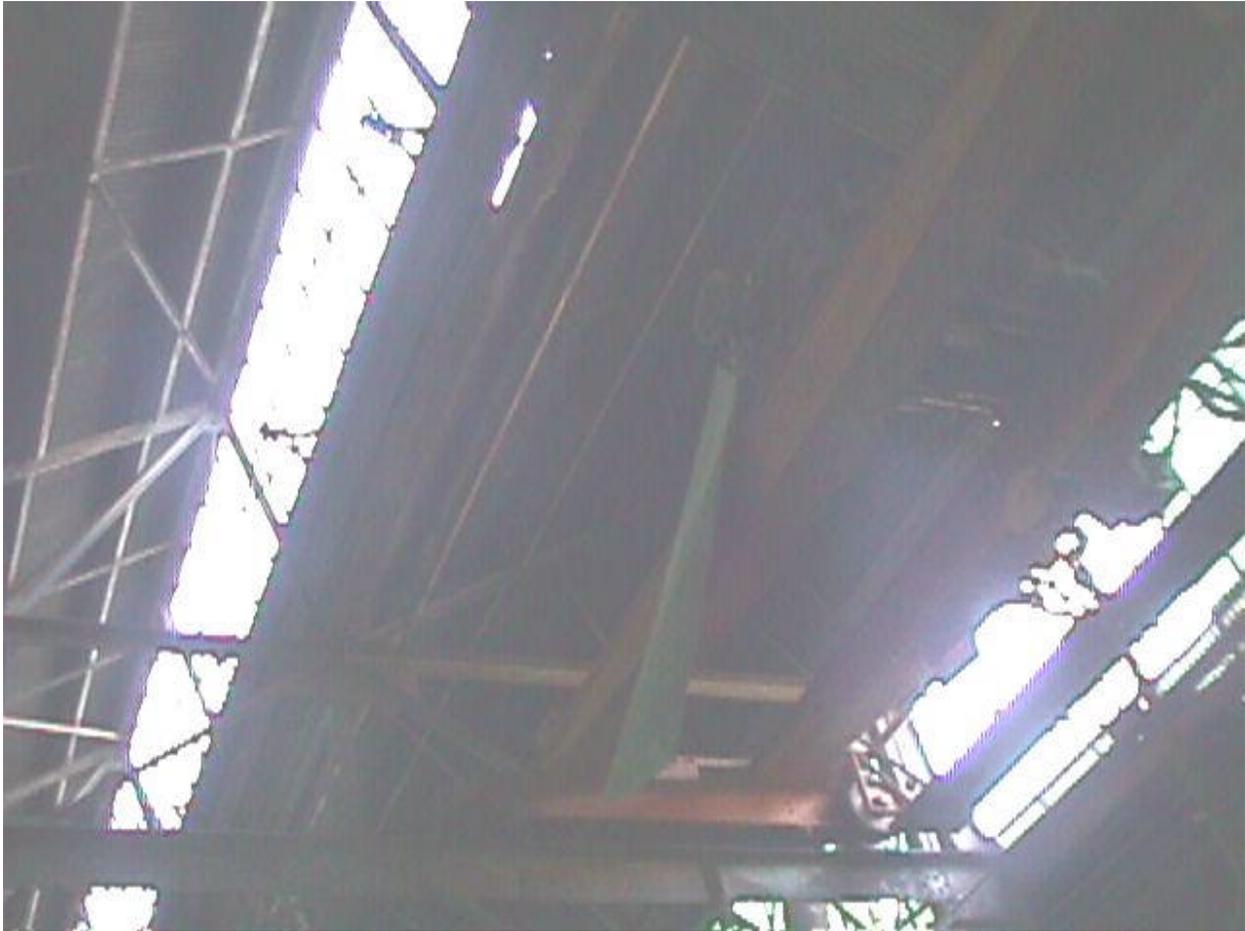
2.6.5 Observations: Some very small holes openings in the roof. Potential for falling pieces of roofing presents a non-structural hazard. See Photographs 16-21. Some coating or material seems to be peeling off the roof. The structural impacts from the loss of this material is unknown. (Could this be fire insulation?) The potential health impacts are also unknown.

Photograph 16 - Buildings 4 & 9 - Typical roof trusses, vents, and roof openings

2.6.6 Specific Conclusions/Recommendations: No significant structural deficiencies are present. Access to this building should not be limited solely due to structural and non-structural deficiencies.

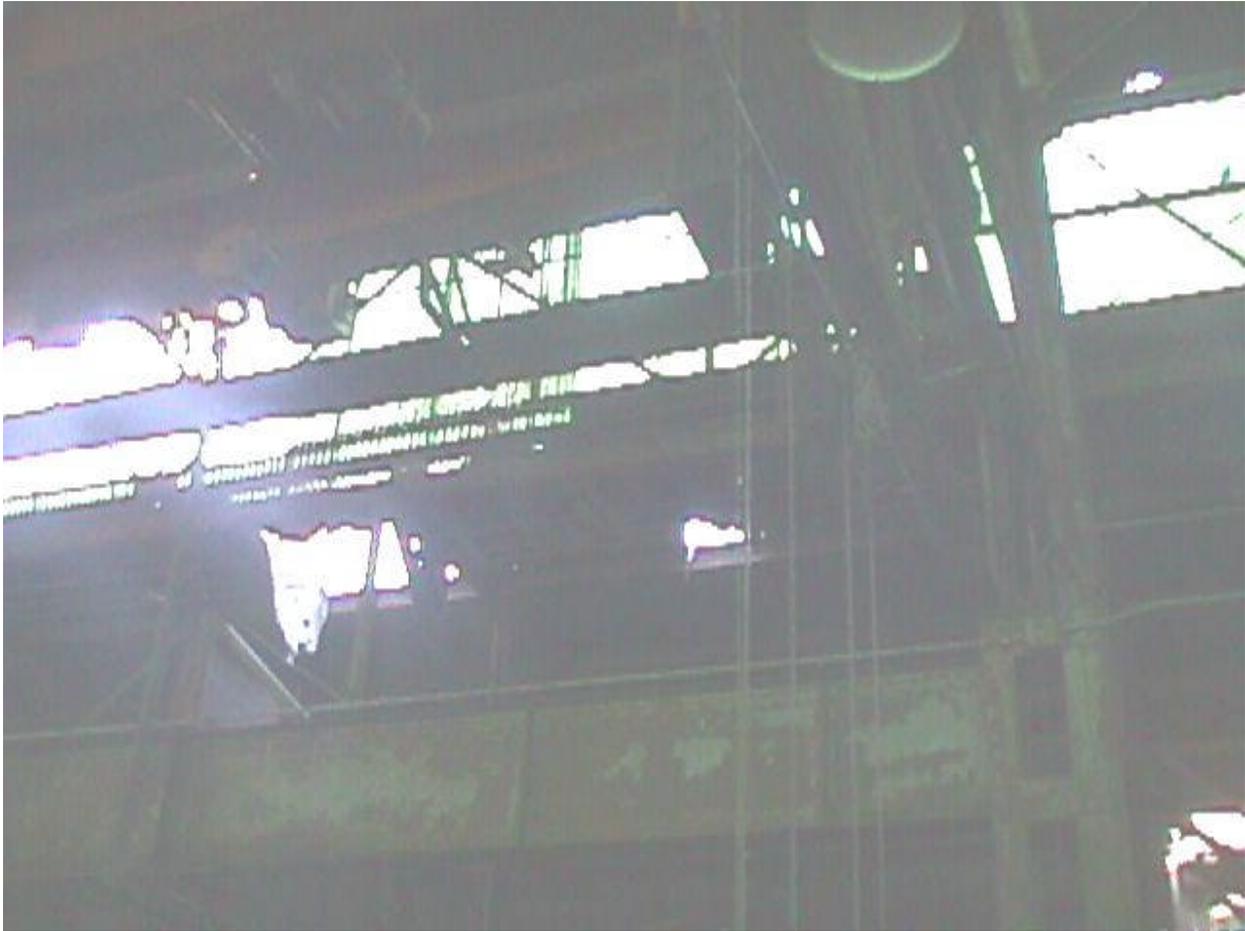
Photograph 17 - Buildings 4 & 9 - Typical roof openings

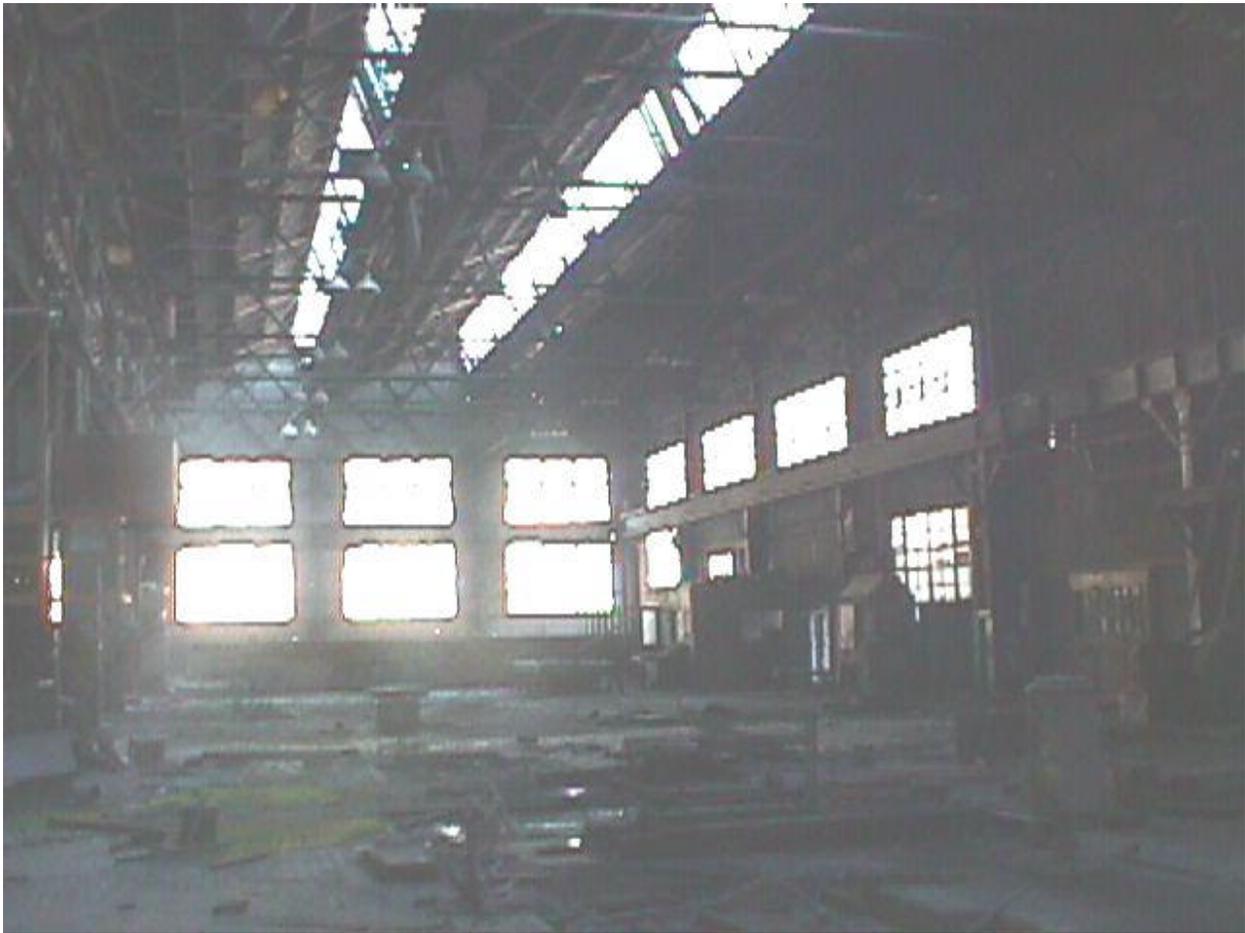
Photograph 18 - Buildings 4 & 9 - Facing north at Loading Dock Area

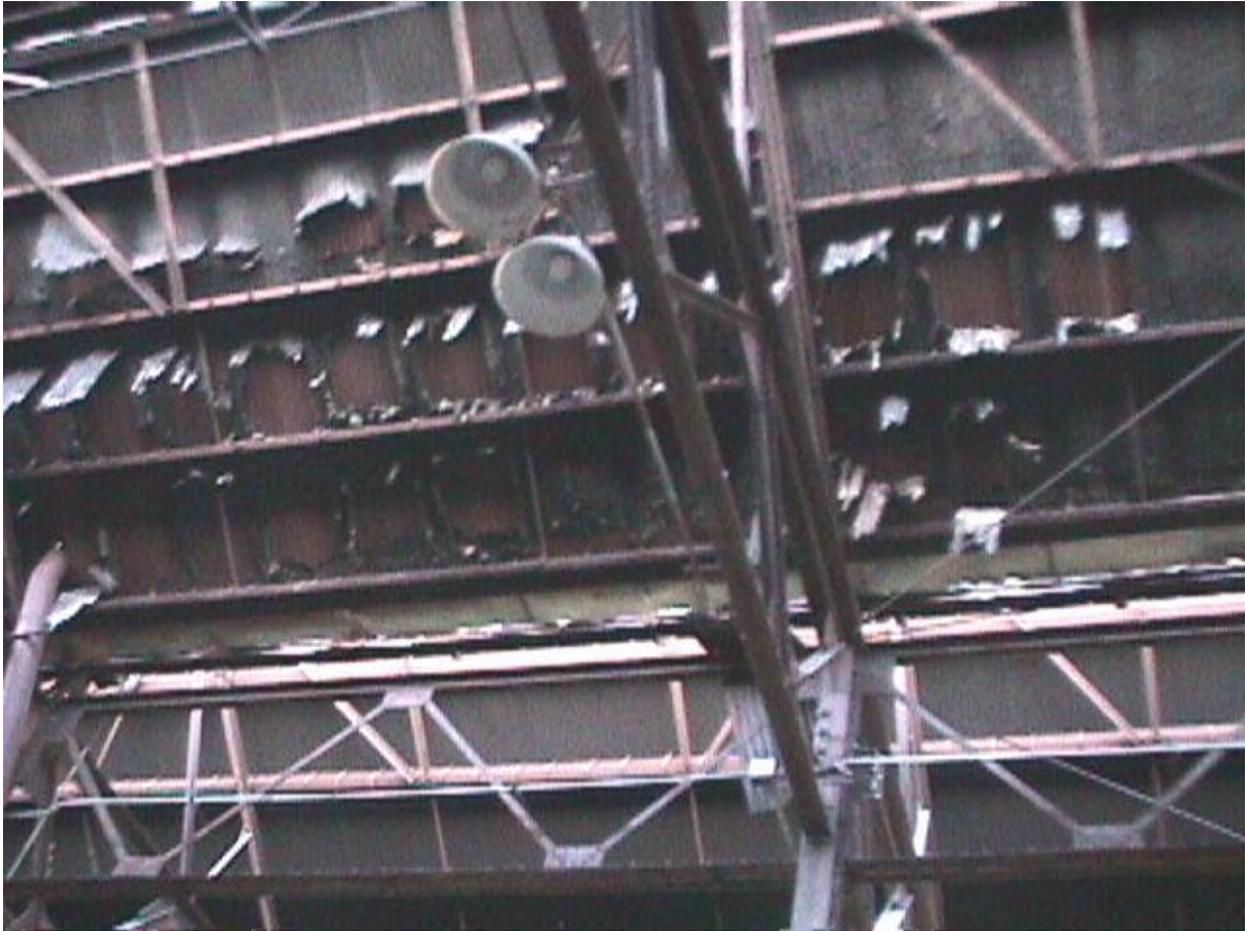
Photograph 19 - Buildings 4 & 9 - Typical peeling of roof material

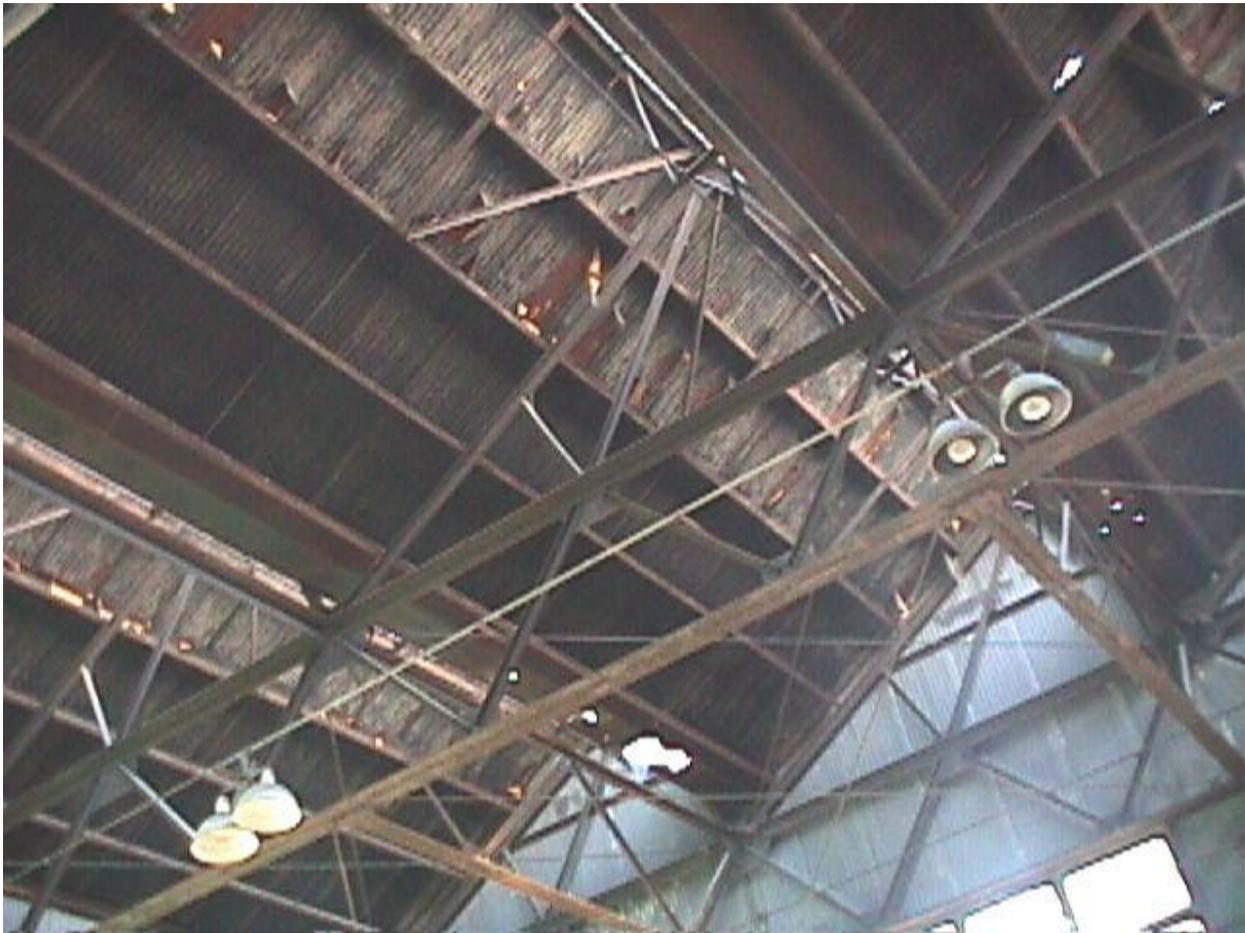
Photograph 20 - Buildings 4 & 9 - Typical peeling of roof material
