PRELIMINARY ASSESSMENT / SITE INSPECTION

**Former Guterl Specialty Steel Corporation
Lockport, New York**

U.S. Army Corps Of Engineers
Buffalo District
1776 Niagara Street
Buffalo, NY 14207
04/13/01

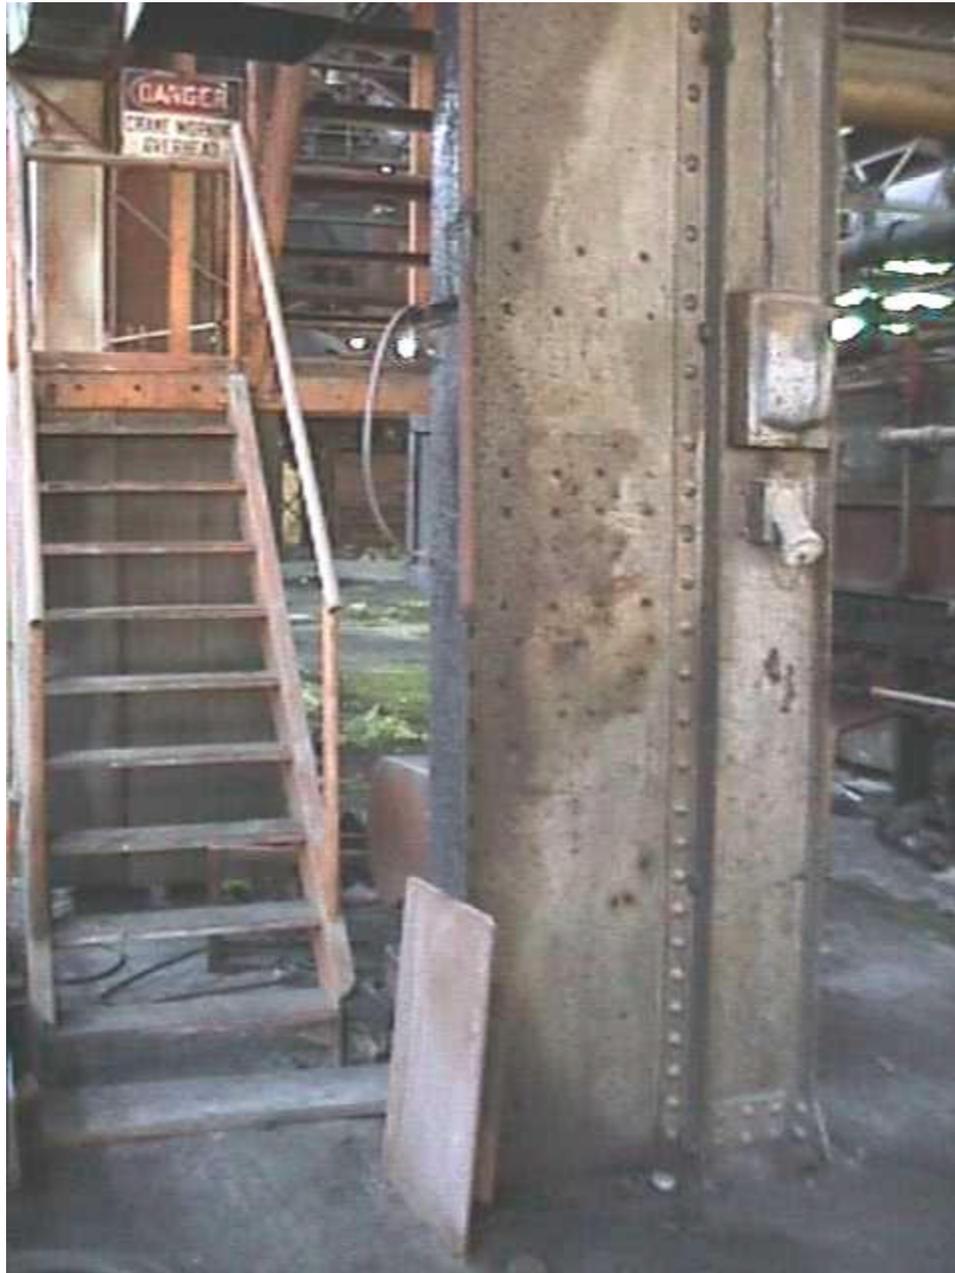
2.6.5 Observations: Some very small holes openings in the roof. Potential for falling pieces of roofing presents a non-structural hazard. See Photographs 16-21. Some coating or material seems to be peeling off the roof. The structural impacts from the loss of this material is unknown. (Could this be fire insulation?) The potential health impacts are also unknown.

Photograph 21 - Building 4 & 9 - Typical Built-up
Column

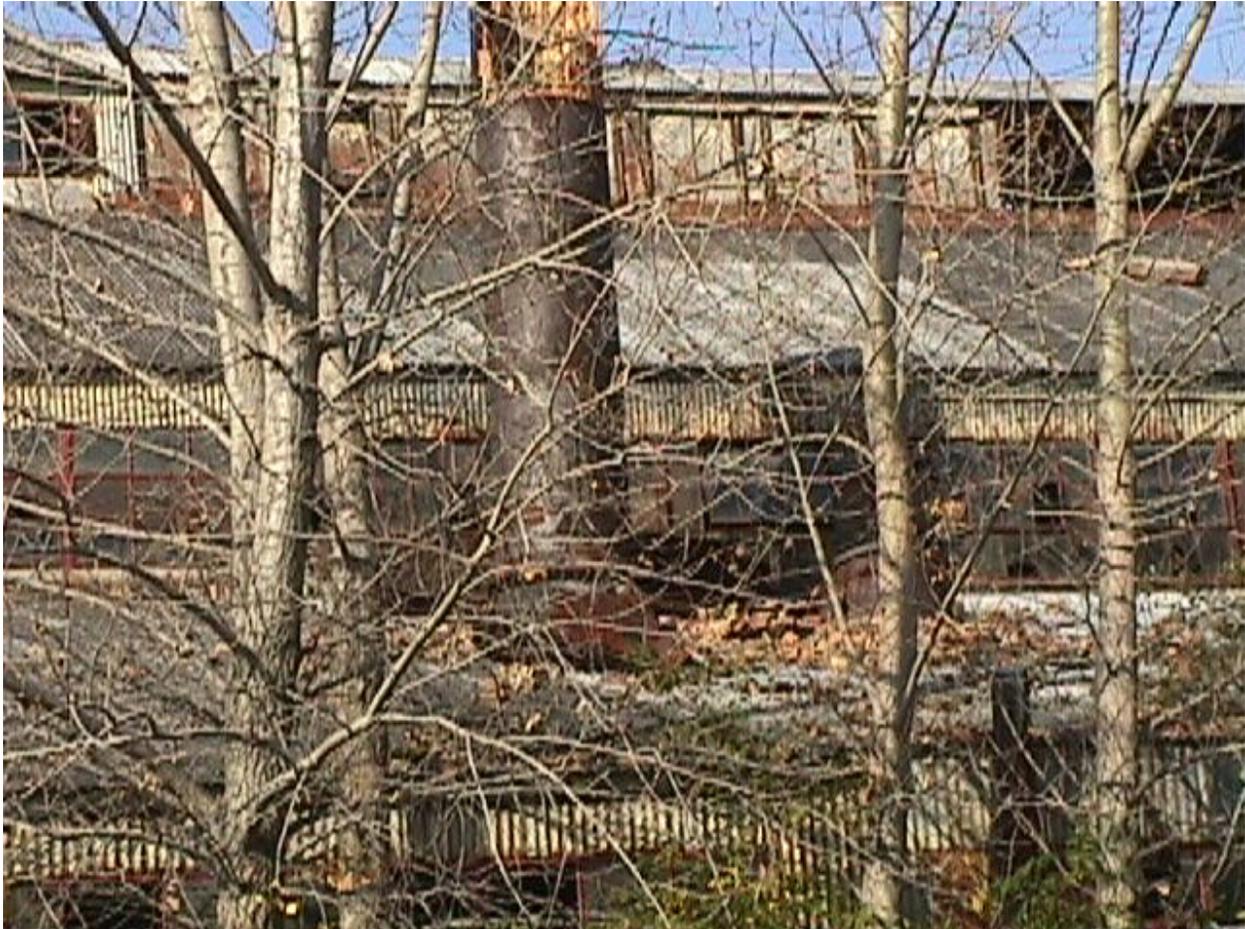
2.5.5 Observations: Some small holes openings in the roof. Potential for falling pieces of roofing presents a non-structural hazard. Some unknown fluorescent yellow material seems to be deposited at the end of the remnants of some type of production area. See Photograph 14. Several trenches are present and they are uncovered or are covered but have simple plywood spanning over them. Care should be taken in and around all trenches. No exploration was made of these trenches during this inspection. The smokestack above the south section of Building 3 has deteriorated. Some of the insulation brick is beginning to crumble and is another falling hazard.

Photograph 22 - Building 3 - South Smokestack Deterioration

significant structural distresses present in Building Number 3. Recommend roping off the exterior south east area of this building until the smokestack is brought down.
