New York State Department of Environmental Conservation

Re: Lake Ontario Ordnance Works, Component 2 - Phase 1 Interim Removal Action

On October 15, 1998, I visited the property owned by the Somerset Group, located in Model City, New York, which is the subject of interim removal action (IRA) administered by the U.S. Army Corps of Engineers (USACE). This property was formerly part of the Lake Ontario Ordnance Works and Air Force Plant 68. The purpose of my visit was to view progress on the IRA.

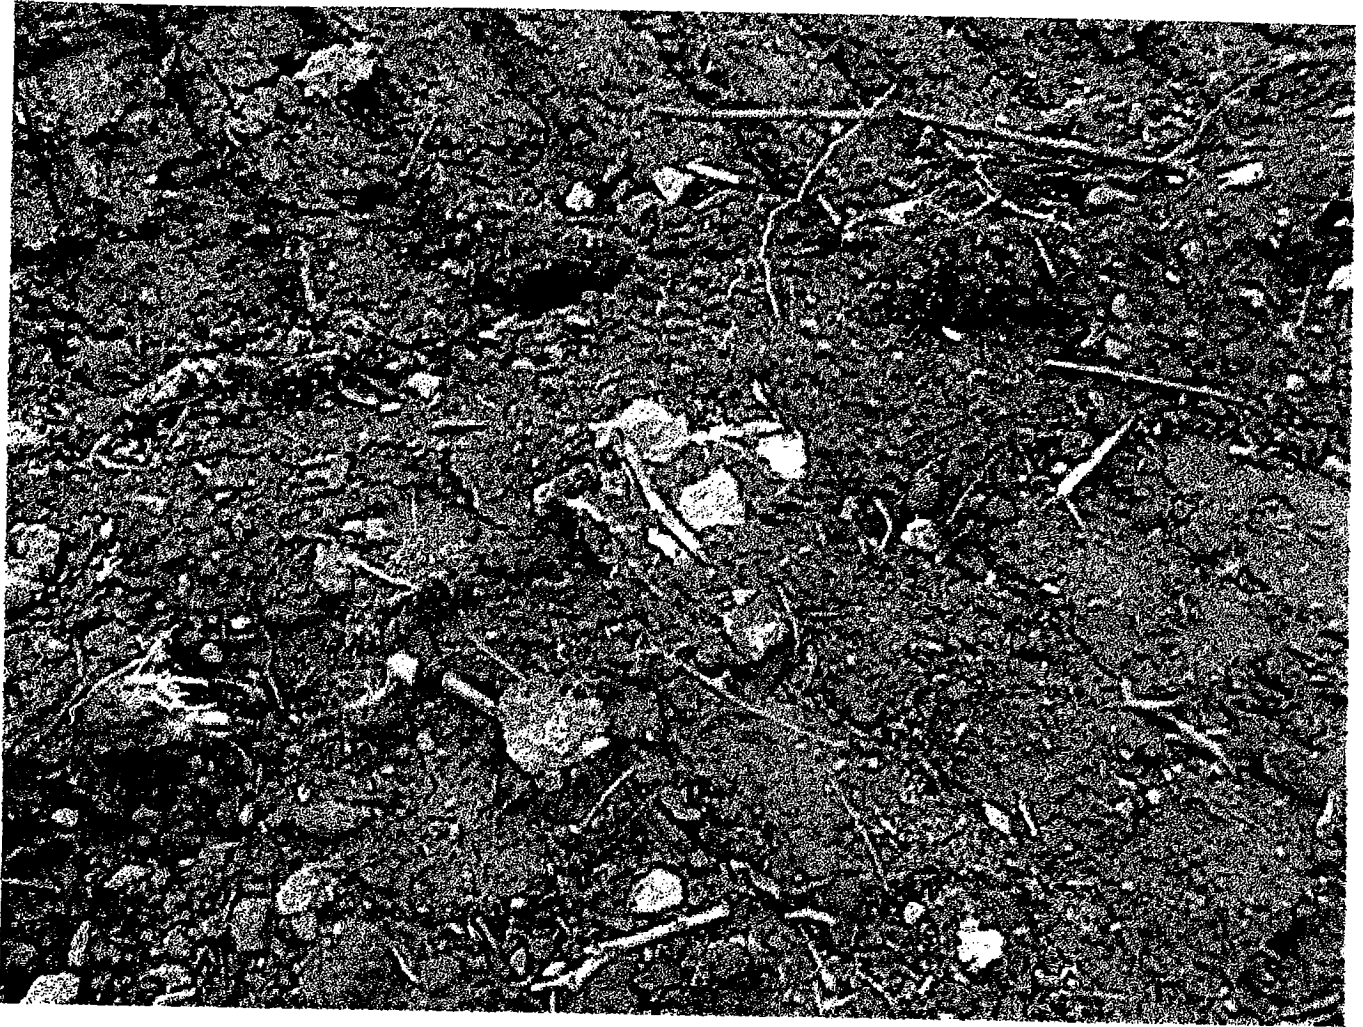
Photo #1

1. Pieces of potential asbestos containing materials (PACM) (pipe insulation, broken transite panel) were noted in areas which have been excavated (Photo # 1). Additional measures need to be taken to clean up areas which remain to be visually contaminated after excavation.
2. The depth of soil excavation is not a uniform 6 inches as called for in the specifications. Actual excavation depths ranged from <1" to 6". In order to assure that soils have been removed in accordance with the specified depths, the areas should be surveyed before and after excavation activities.
3. PACM was noted in areas beyond the proposed limits of excavation (south fence line) (Photo #2). The area of excavation should be expanded to the fence line, to address the impacted areas.

Asbestos containing material within excavated area E

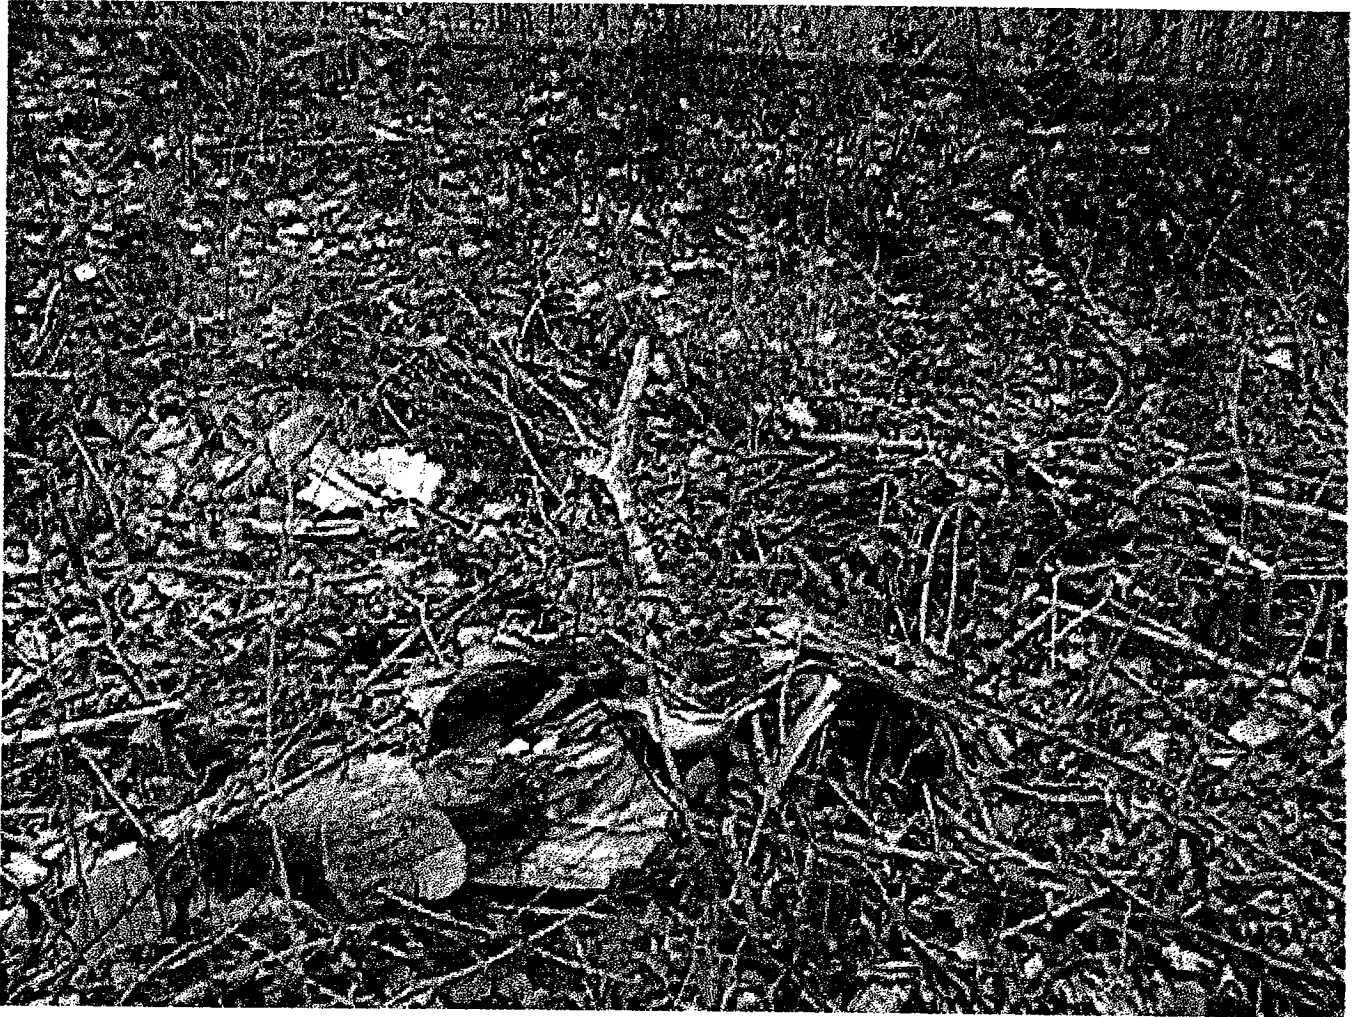
Photo #2

**Asbestos Containing Material adjacent to south property fence
(Outside proposed excavation limits)**

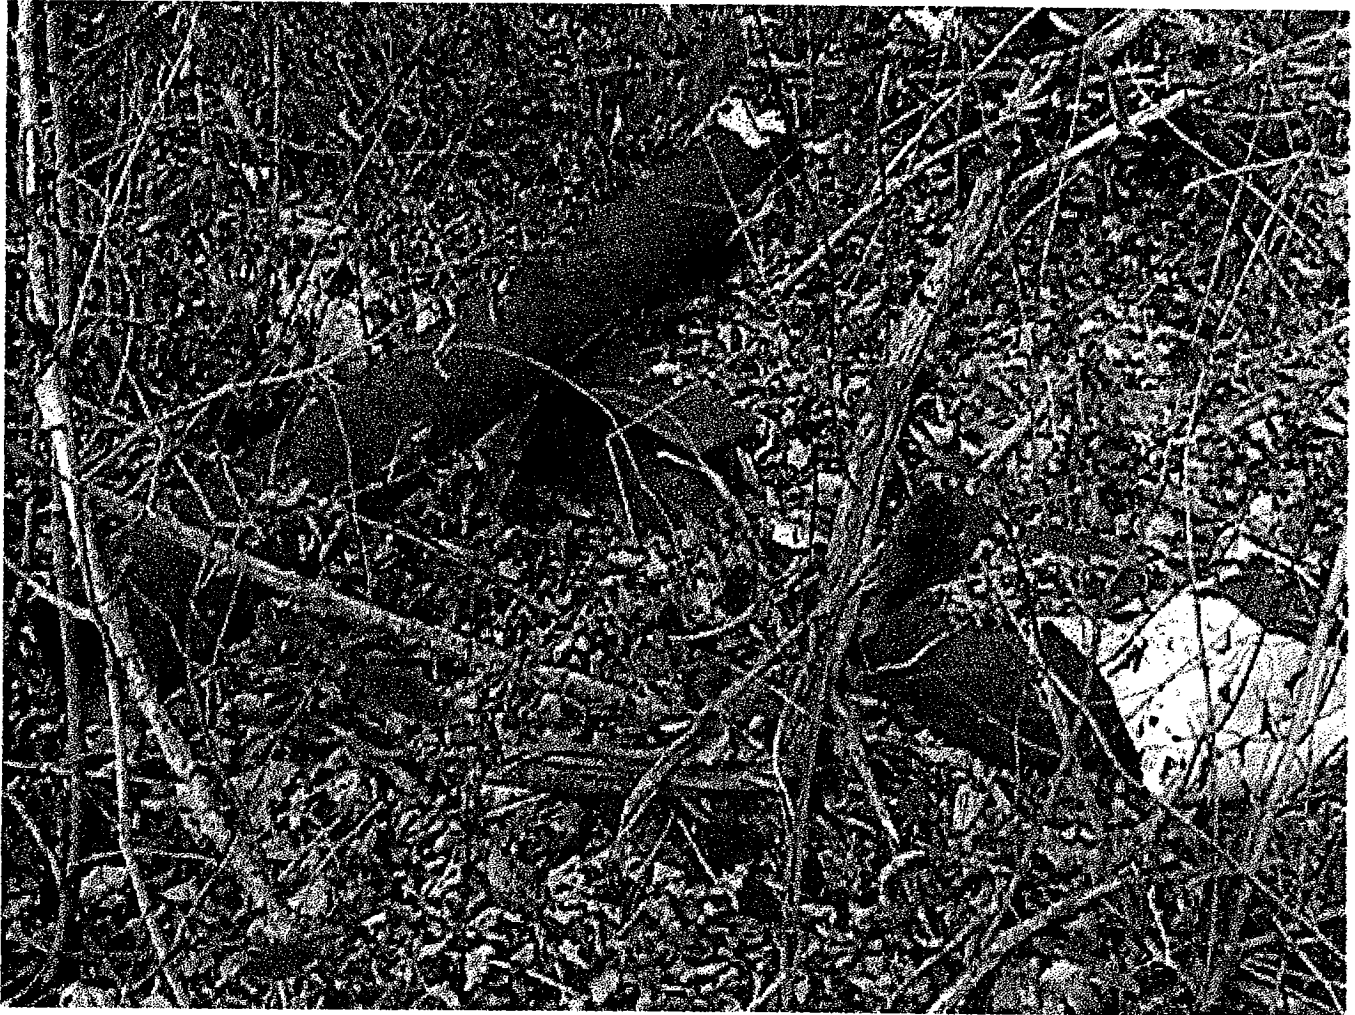
Photo #3

4. A debris pile, west of Building 30A (depicted on Plate 4 of the 100% Design Report and Photo #3) containing ACM pipe insulation needs to be addressed. This area must be adequately addressed.

6. Friable ACM was noted in soils scheduled to be excavated (Photos #3 & 4). The presence of friable ACM exposed to the elements increases the need for wetting down of areas prior to and during excavation. Additional measures may also be required for the abatement of degraded asbestos thermal insulation present on jacketed pipes within the excavation areas.

Debris Pile of West of Building 30A containing ACM

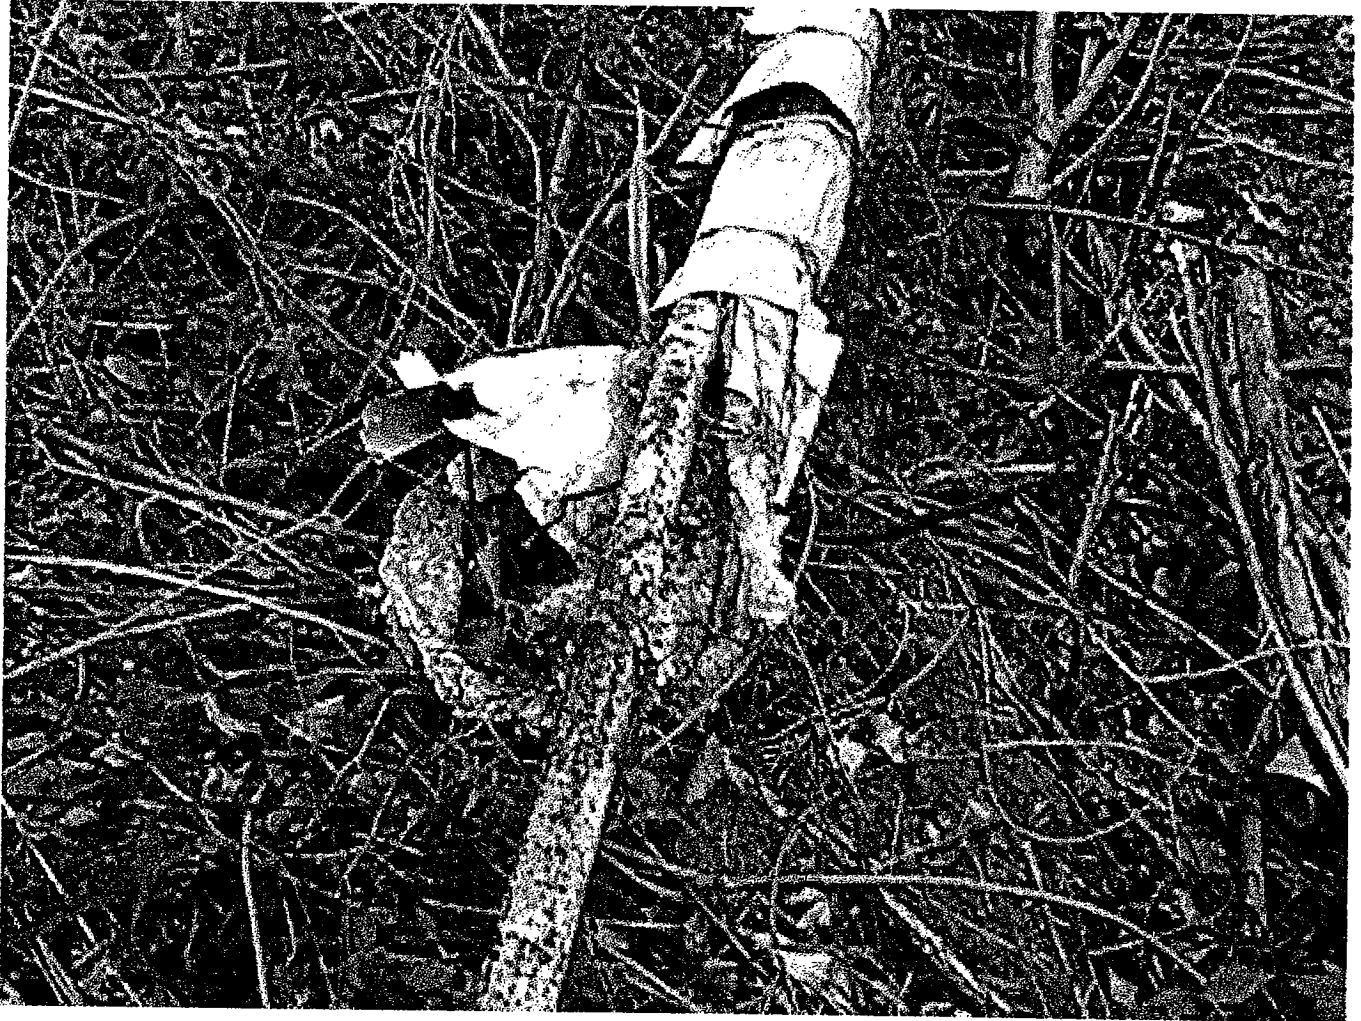
Photo # 4

Friable ACM with in Area 3

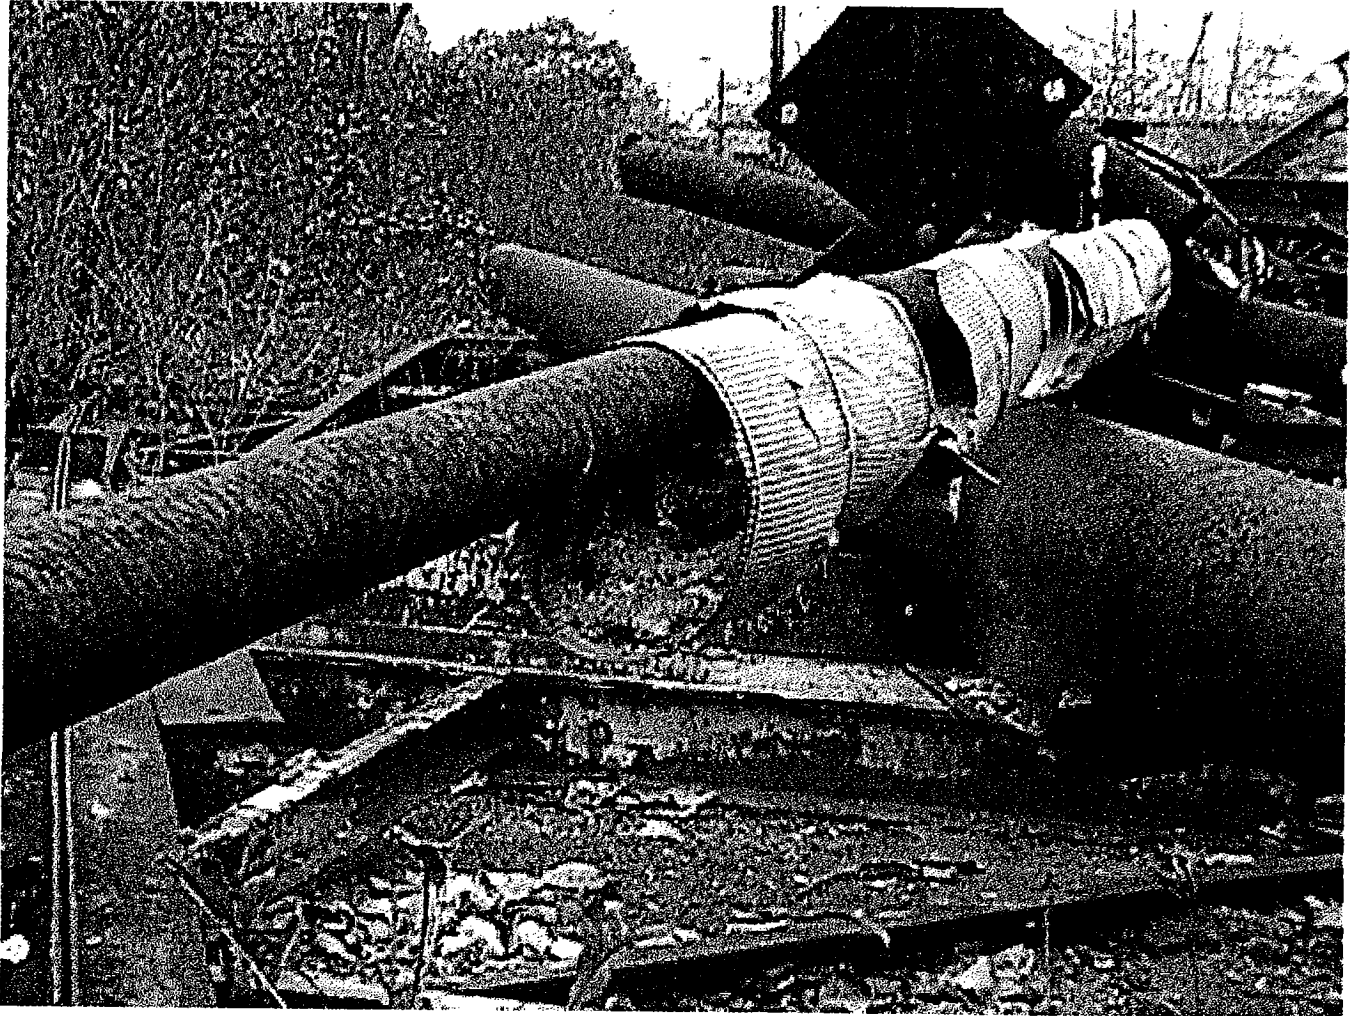
Photo #5

Friable ACM in side pipe jacketing, Area North of Beech Street

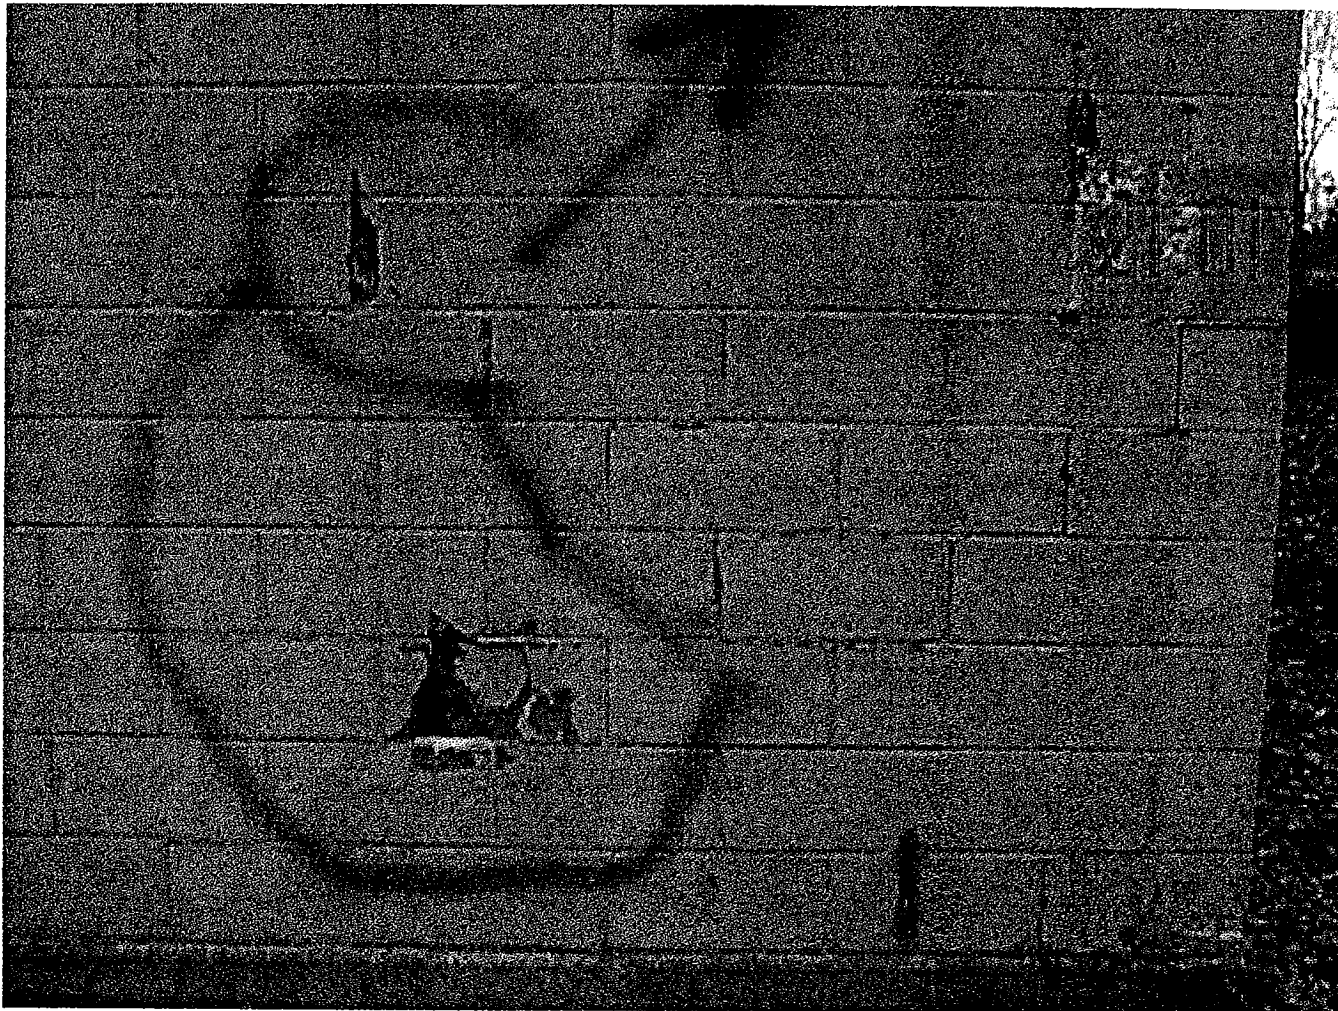
Photo # 6

13. Building 21-01 (Photo #6), groundwater monitoring wells north of Area 18N and a fire hydrant west of Area 18 N (Excavation Area E) have been damaged by heavy equipment. Property damages caused by USACE contractors must be properly repaired.

Damage from construction equipment, Building 21-01
