September 18, 1998

Re: Lake Ontario Ordnance Works, Component 2 -Phase 1 Interim Removal Action

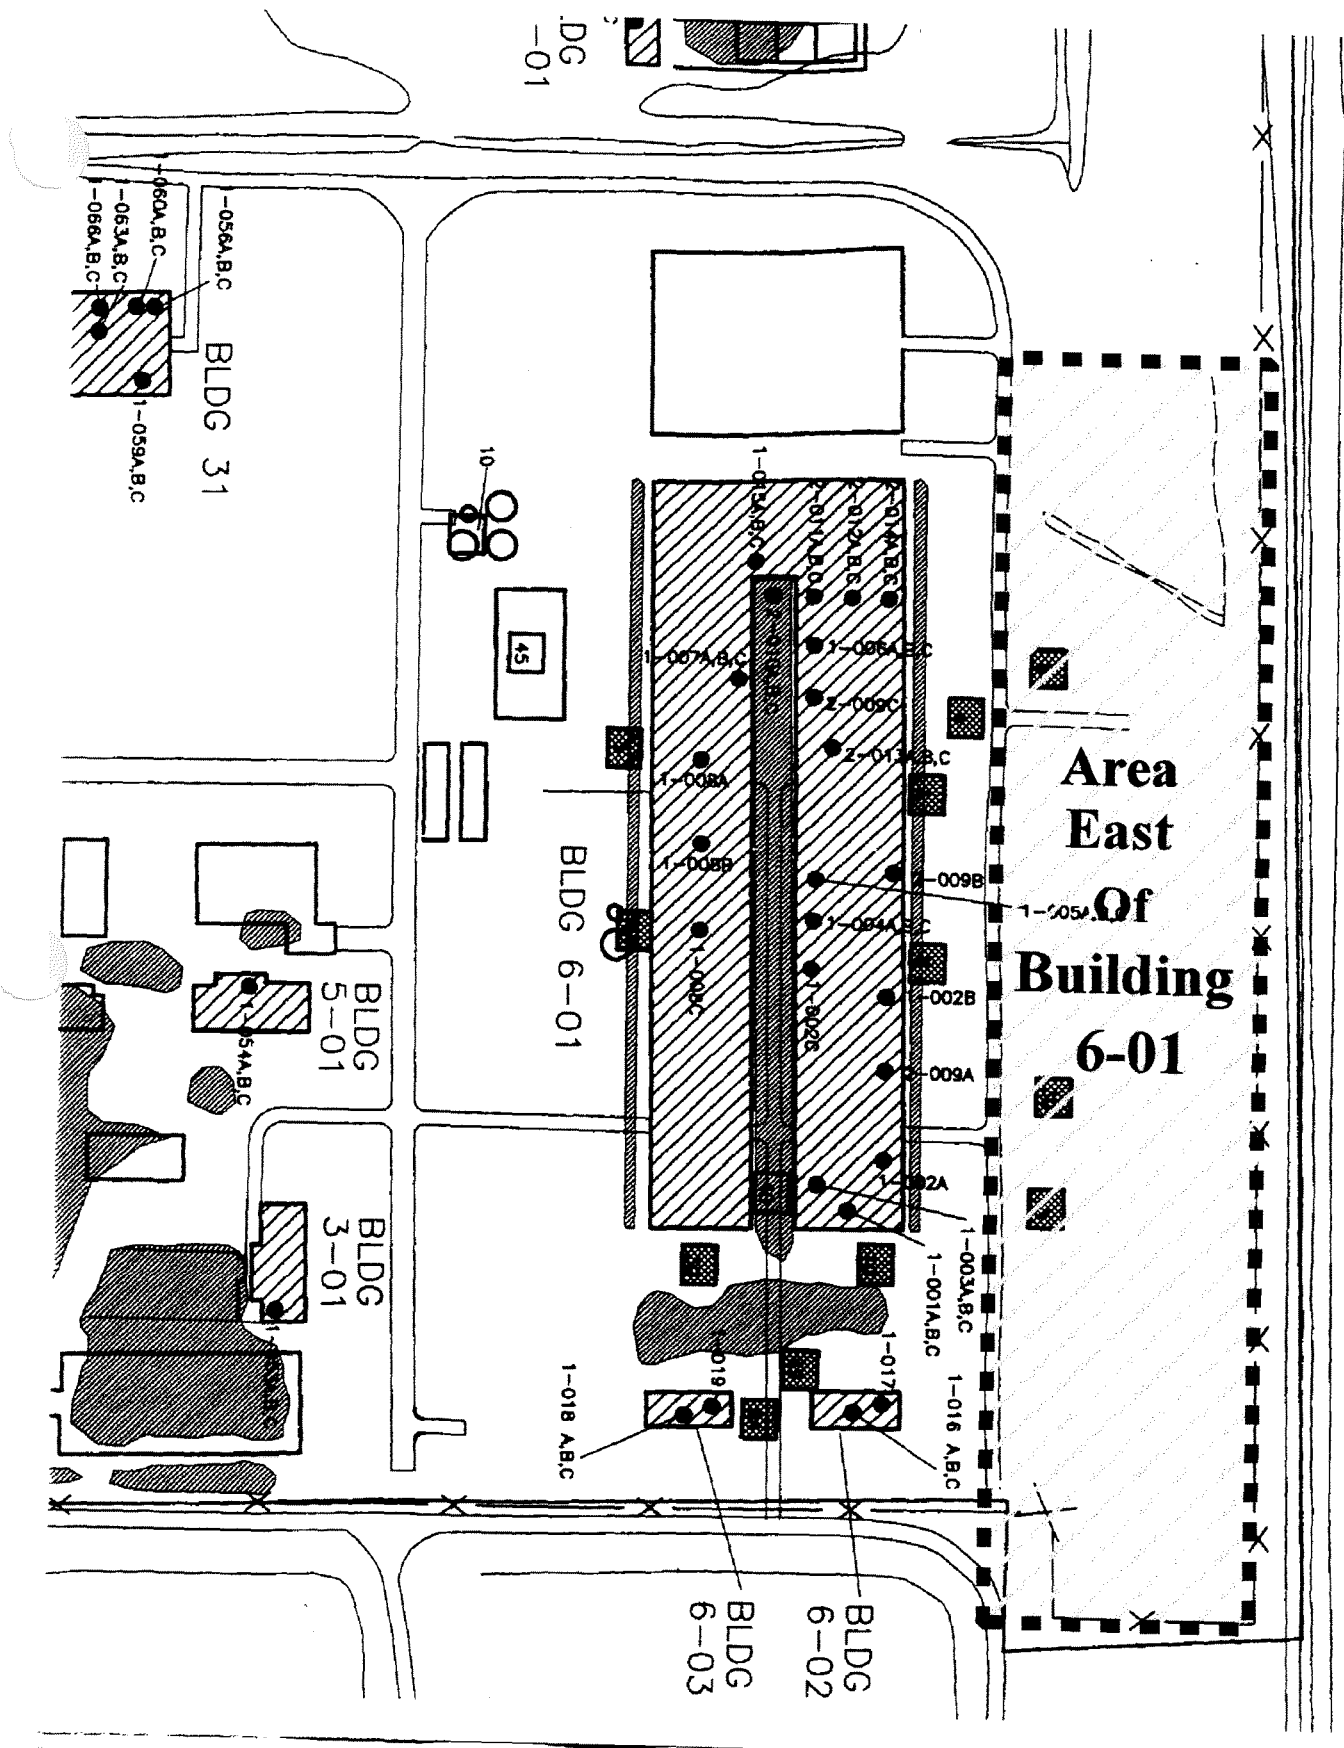
Figure 1

Areas East of Building 6-01: This area is delineated by a roadway on the west and the property fenceline on the east of building 6-01 (Figure 1). Based on the Asbestos Survey Report (Acres International, June 1998) this area has not been designated for remediation. However, review of the sample information contained in Appendix B of the report indicate that the applicable sample locations (S-095 through S-100) are "Along N/S line running through E wing of bldg 6-01". In addition the sample locations for the survey are non-biased based on a 100-ft grid. During the walkover of this area numerous pieces of aluminum pipe jacketing were noted (Photos #1 & #2). This jacketing covered pipe insulation containing asbestos. White, discolored soil was noted underneath the jacketing (Photo #3). Several stacks of asbestos containing transite panels, whose removal is part of IRA Phase I, are located within this area (Photo #4). Some broken pieces of transite panels were also noted within this area. Finally there is a debris pile in the far southern portion of this area. Pipe jacketing and pieces of transite panels were noticed in the pile.

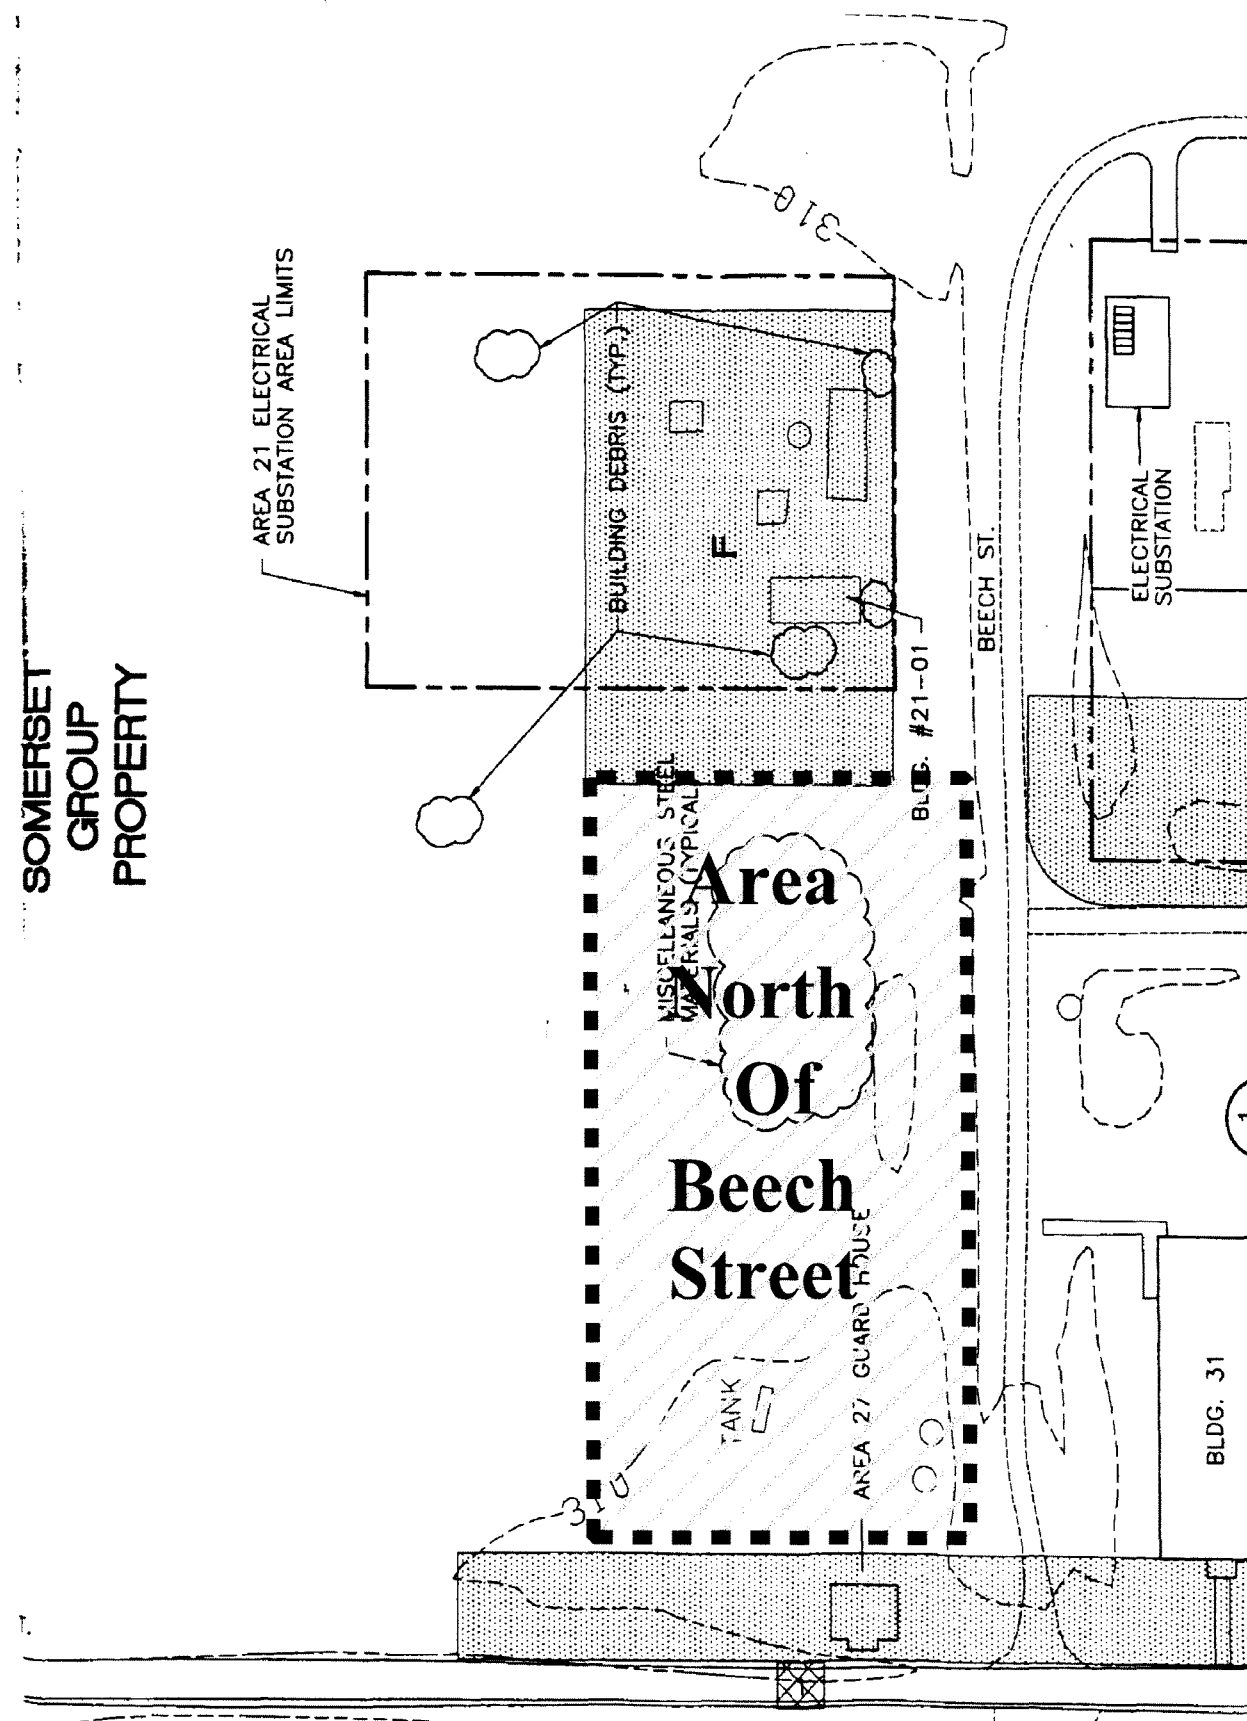
Figure 2

Area North of Beech Street: This area is bounded by Beech Street on the south, Area 21-former electrical substation on the east and the Area 27 guard house on the west (Figure 2). Based on the Asbestos Survey Report this area has not been designated for remediation. During the walkover, several stacks of asbestos containing transite panels were noted within this area (Photo #5). In addition, numerous pieces of jacketed pipe were also noted. PACM pipe insulation was noted underneath the jacketing (Photo #6). Broken pieces of transite panels were also noted within this area.

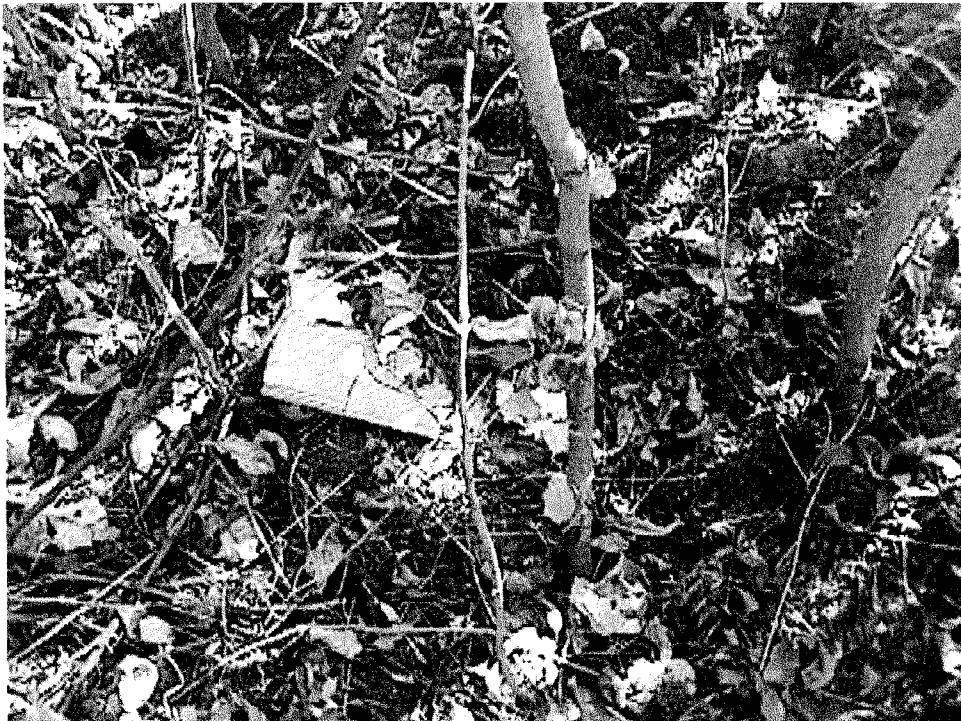
Photo #1

Aluminum Pipe Jacketing in wooded area east of Building 6-01

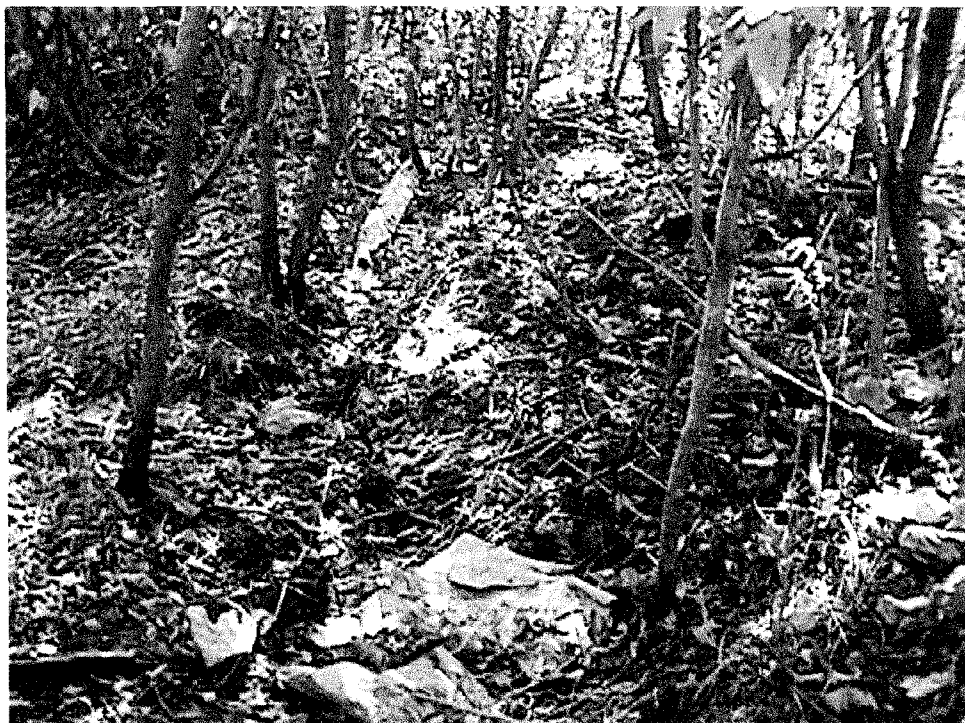
Photo #2

Aluminum Pipe Jacketing in area east of Building 6-01

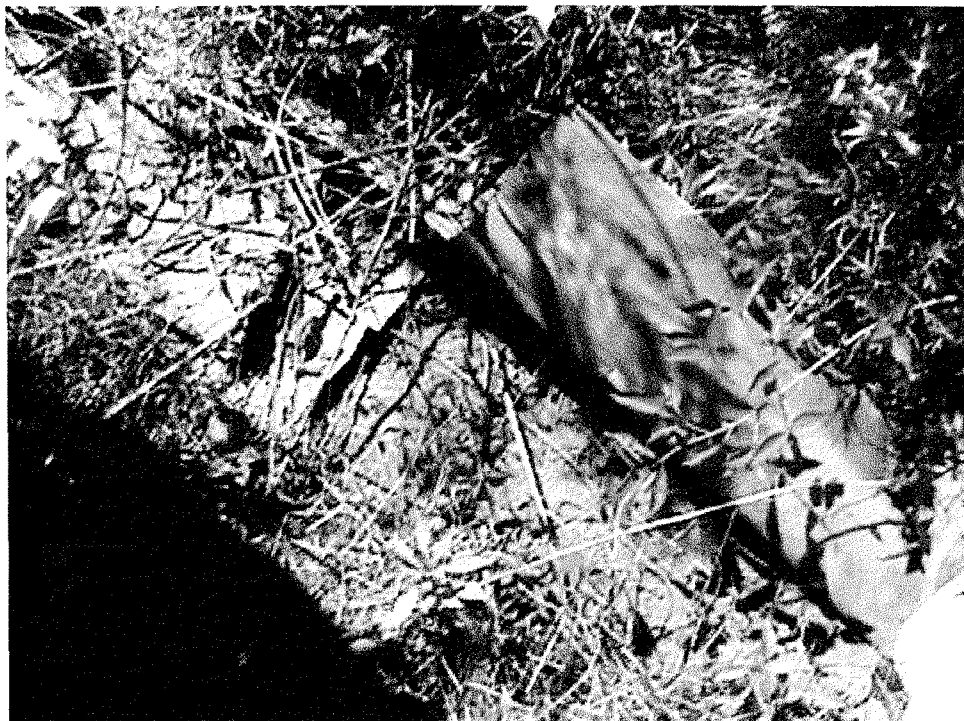
Photo #3

Discolored soil beneath Aluminum Pipe Jacketing

Although the Asbestos Survey Report serves as a tool to provide the data necessary to quantify and qualify ACMs at the site, so that an accurate estimate of the proposed asbestos removal effort can be made, the non-biased methodology for the collection of soil samples is not sufficient when the contamination occurs at discrete locations as noted above. Therefore, the USACE must, at a minimum, remove all transite panels and pipe insulation remaining on dismantled piping found on the site. Also representative samples must be collected of soil beneath and adjacent to PACM found in the above described areas.

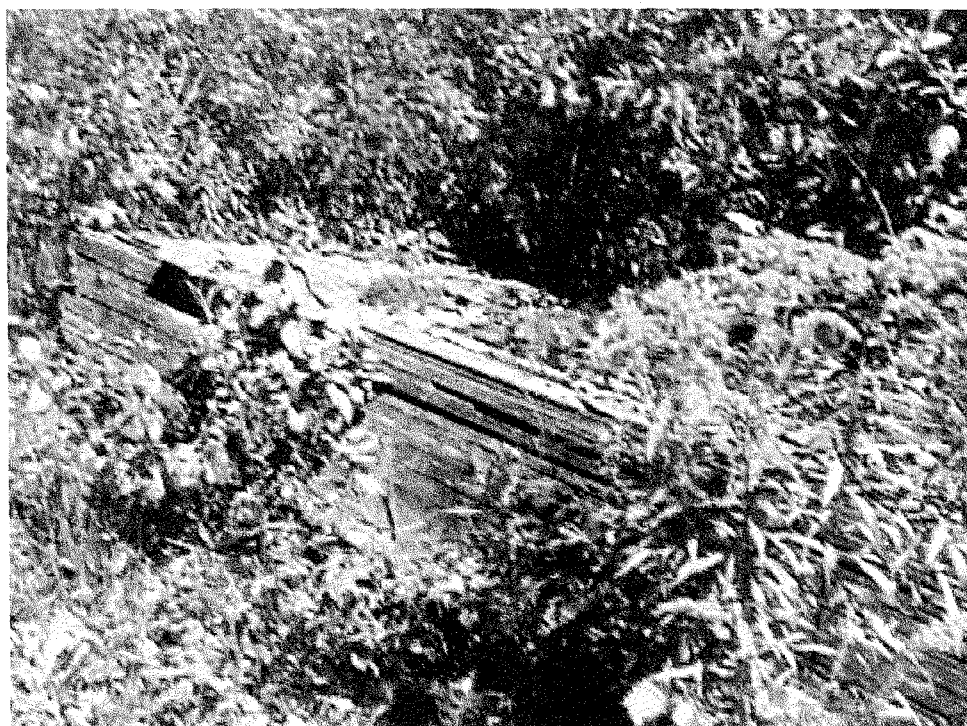
Photo #4

Asbestos containing Transite panels stacked along roadway

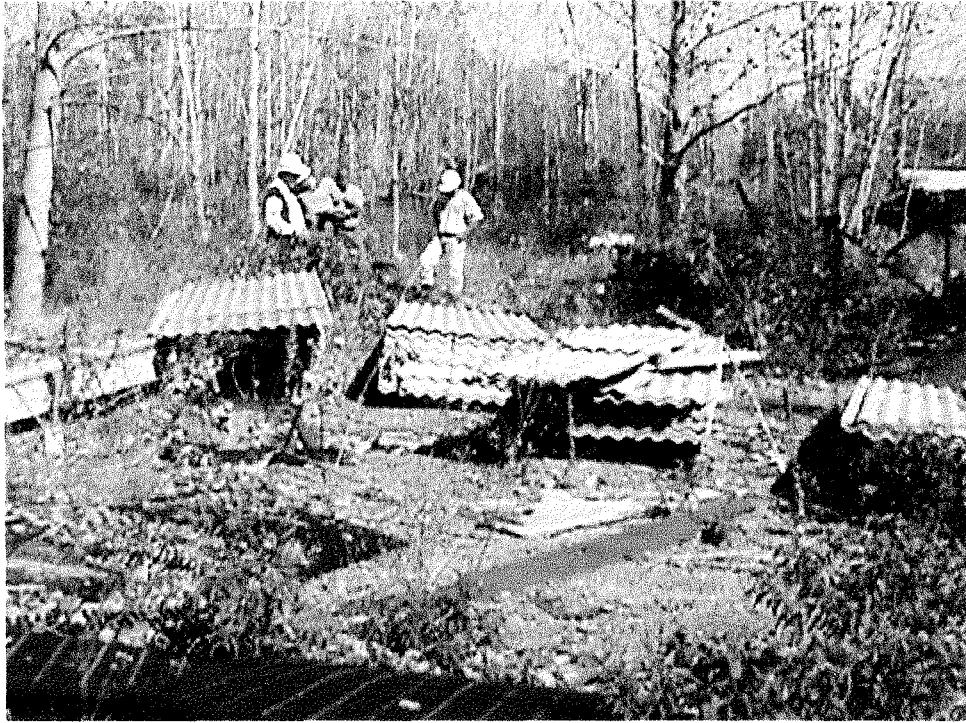
Photo #5
Piles of Transite panels in Area north of Beech Street

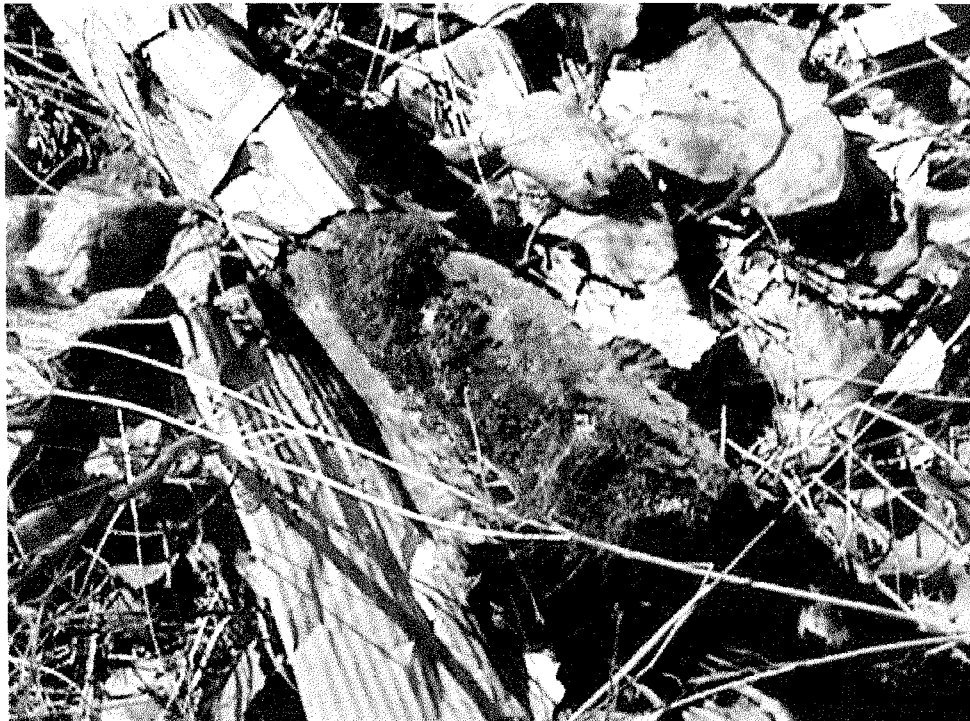
Photo #6
Pipe insulation on pipe in Area North of Beech Street

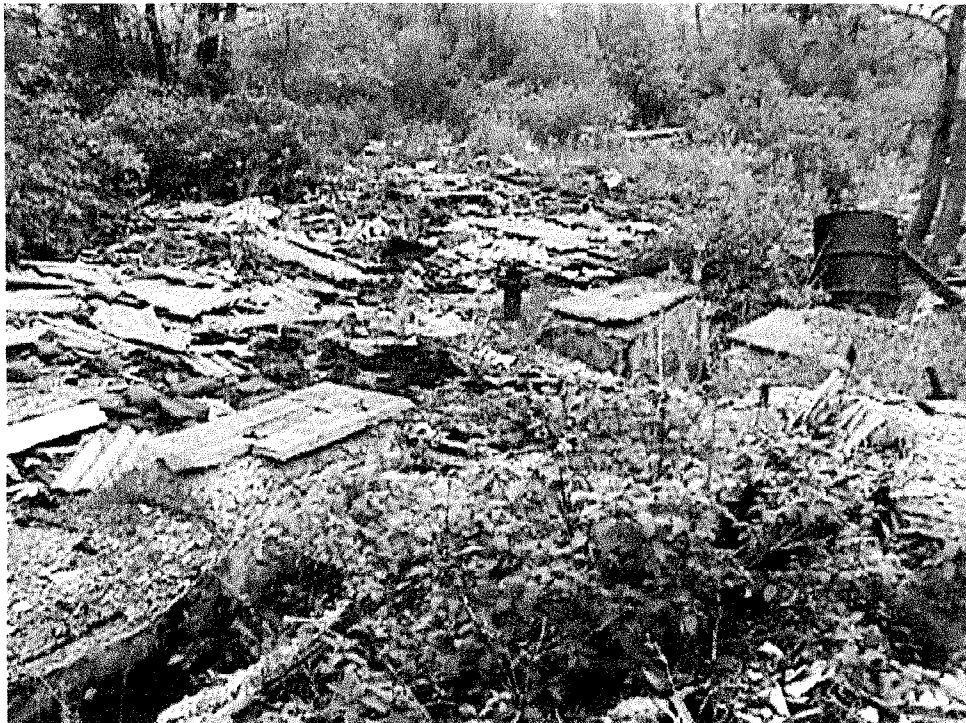
Photo #7

In addition, it is the position of the Department that ACM on the portions of the former Air Force Plant -68 currently owned by CWM Chemical Services (CWM) must also be addressed. Extensive contamination of this property by ACM related to the use of this property by the Federal Government has been documented (Photos #7 & #8). Although ACMs are not covered by the Defense Environmental Restoration Program, the USACE has received an exception for the removal of ACMs from the Somerset Group property. ACMs on the CWM property are from the same origin and should be eligible for the same exception.

PACM and debris at Former AFP-68 Area 7 - Pyrolysis (CWM Property)

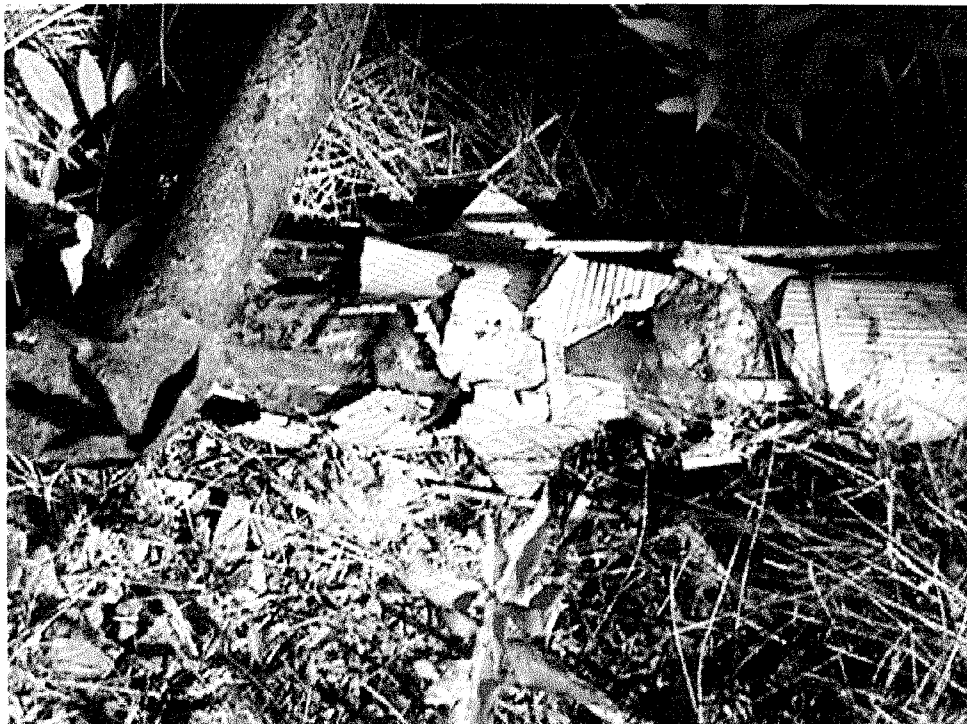
Photo #8

PACM pipe insulation located near former AFP-68-Area 16 (Refrigeration & Steam Plant)
