**Remedial Design of Interim Remedial Measures
Operable Units 1 and 2
Former Lake Ontario Ordnance Works
Lewiston/Porter, Niagara County, NY**

**Asbestos Survey Report
Somerset Group Property**

June 1998

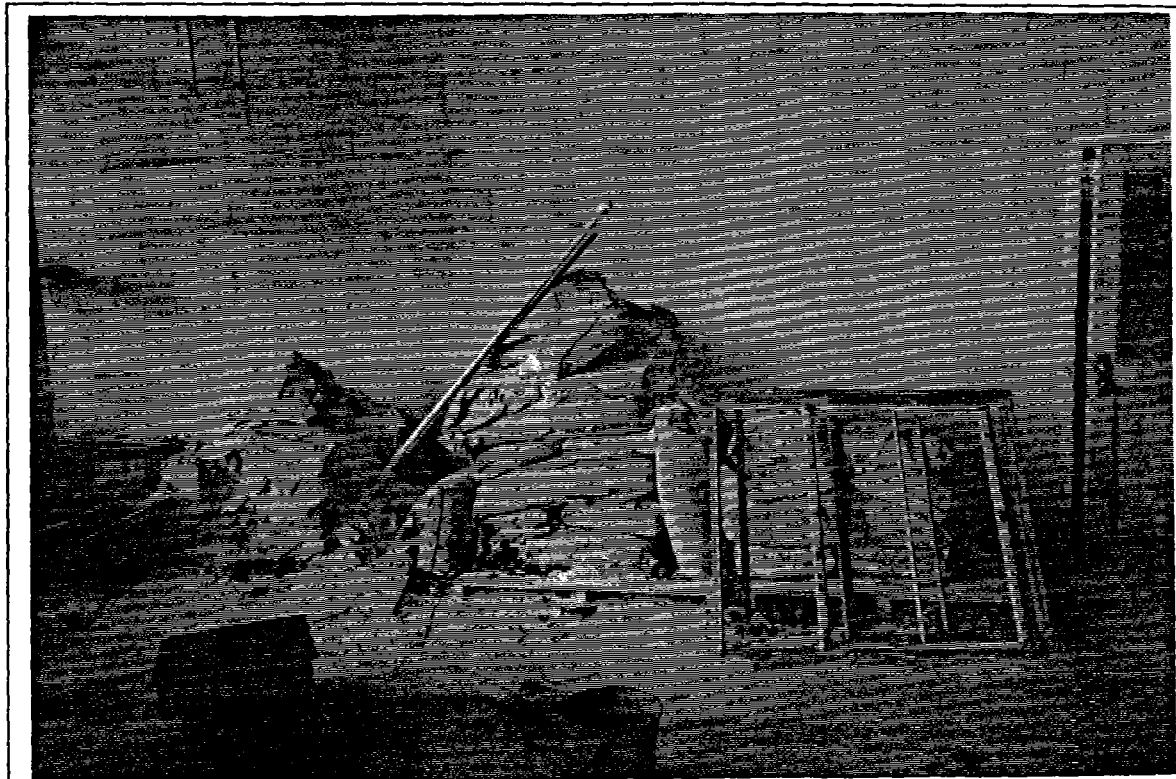
Photo 1 - Building 6-01 - East wing, southern area. Material identified as Johns Manville HYFLO Super-Cel mortar stacked against west wall (approximately thirty-two 50 lb. bags) (Sample No. 1-001). Sample found not to contain asbestos.

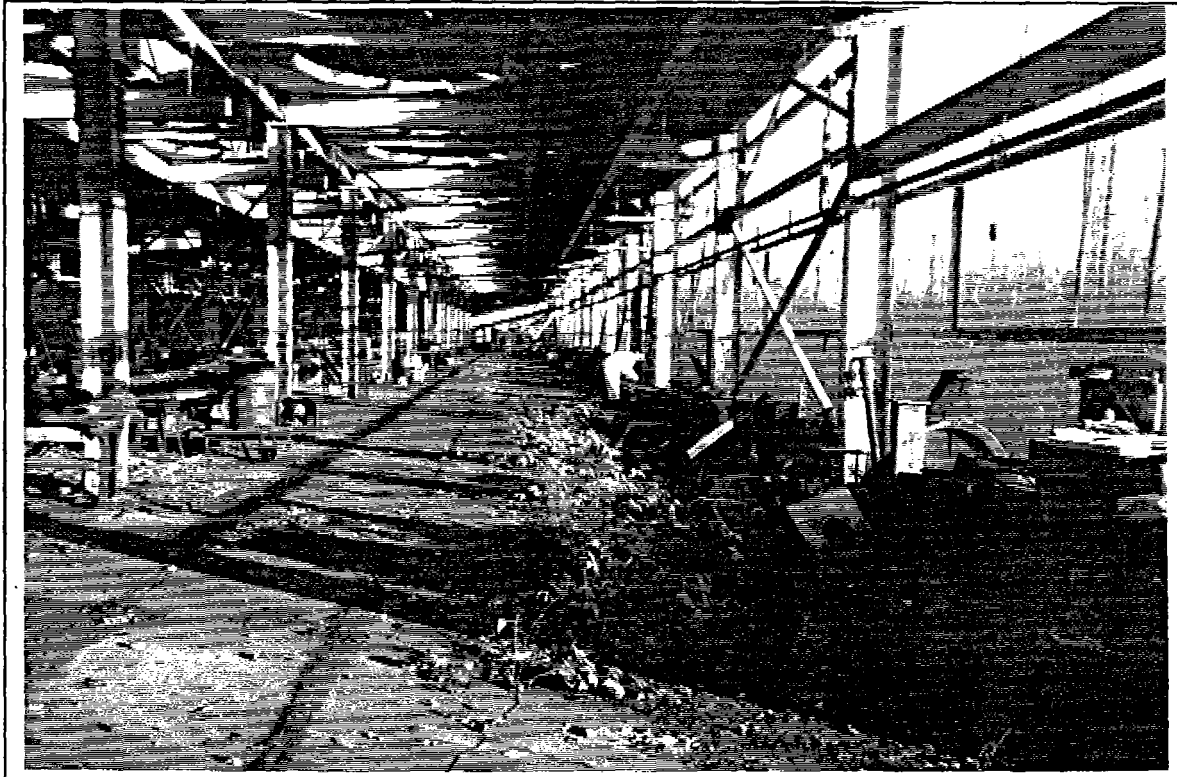
Photo 3 - Building 6-01 - East wing looking north. Note open sides of building which expose ACMs to elements. Also note pipe along exterior wall with only trace TSI remaining.

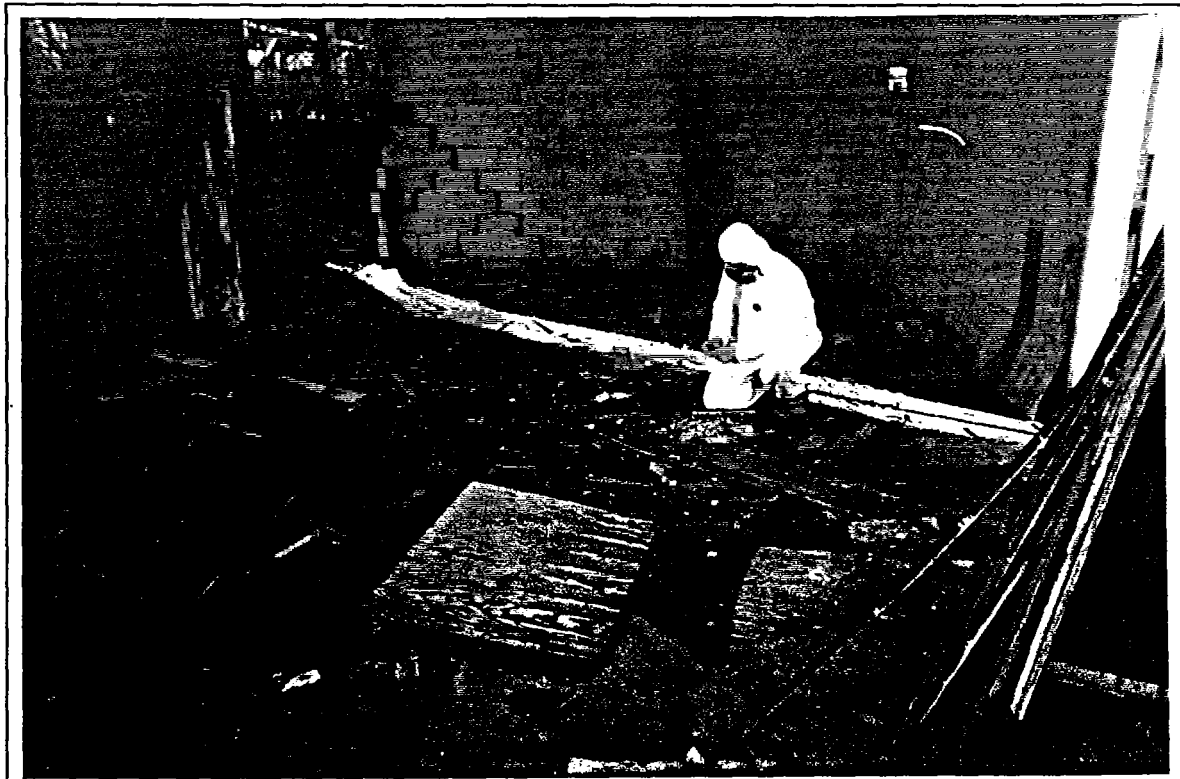
Several small piles of miscellaneous loose, fibrous, friable debris of unknown origin are found scattered throughout the building. Two triplicate samples of this material were collected and designated as Samples 1-003 and 1-005. Sample 1-003 was analyzed and found to contain between 42 and 45 percent asbestiform minerals, almost equally divided between Amosite and Chrysotile. Sample 1-005 was found to contain between 21 and 27 percent Chrysotile. These miscellaneous piles are likely to have originated from fallen pipe insulation that has softened and weathered through the years. Both debris piles are subject to wind and rain action.

Photo 4 - Building 6-01 - East wing, southwest corner. Interior of partitioned area with miscellaneous debris on floor. Acres personnel sampling loose debris on floor (Sample No. 1-003). Sample analyzed positive for asbestos.

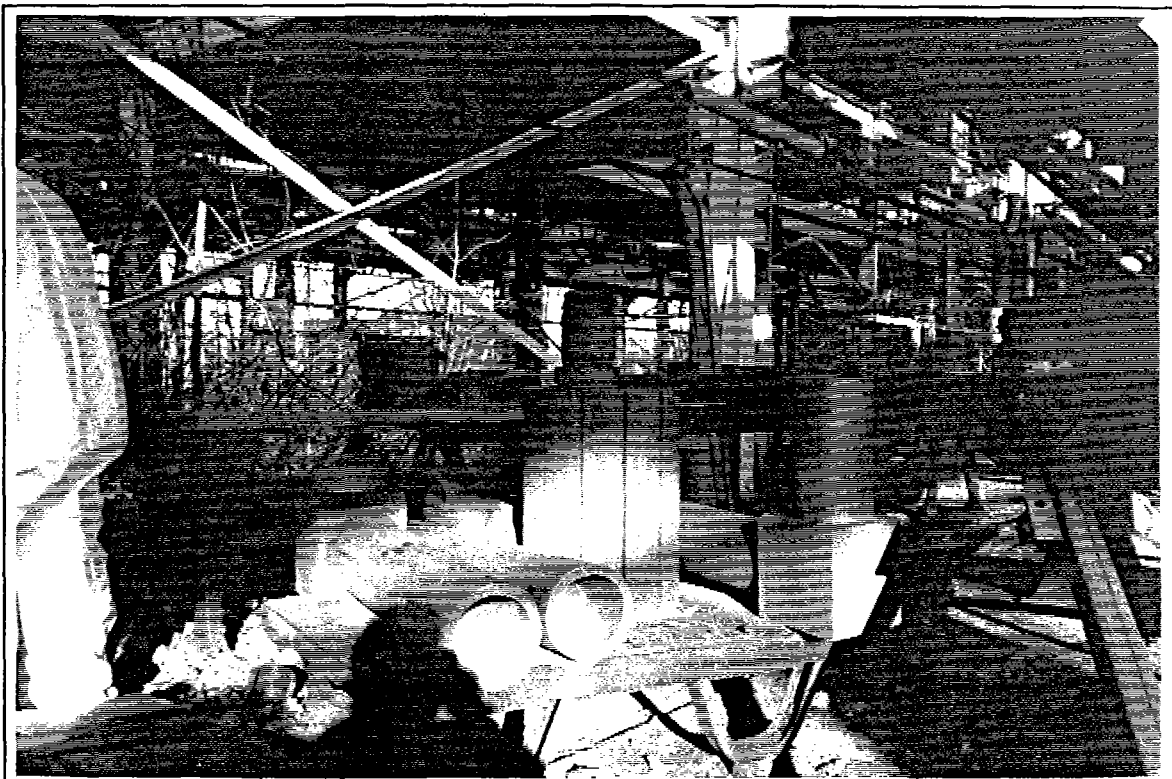
Photo 5 - Building 6-01 - East wing. Vitreous-type threaded pipe from dismantled process line stacked on cart (approximately 15 l.f.) (Sample No. 1-004). Does not contain asbestos.

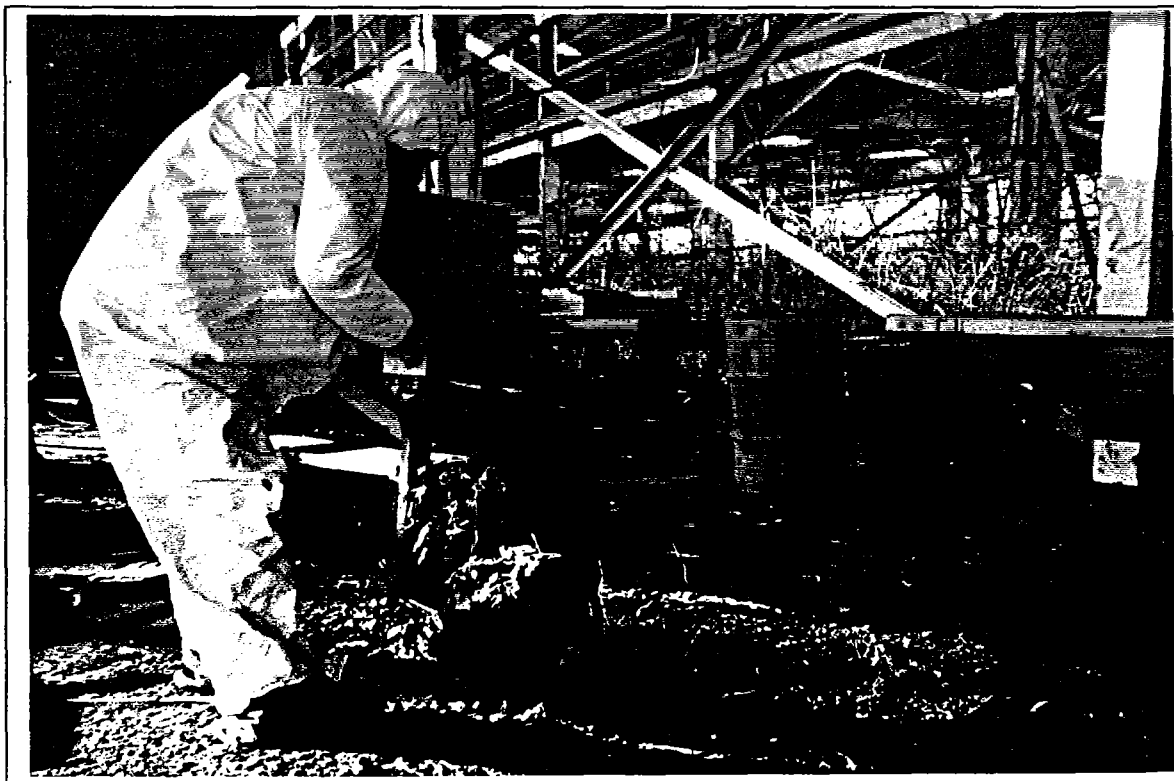
Photo 6 - Building 6-01 - East wing. Acres personnel sampling large amount of fibrous asbestos-containing debris (approximately cu. ft.) (Sample No. 1-005).

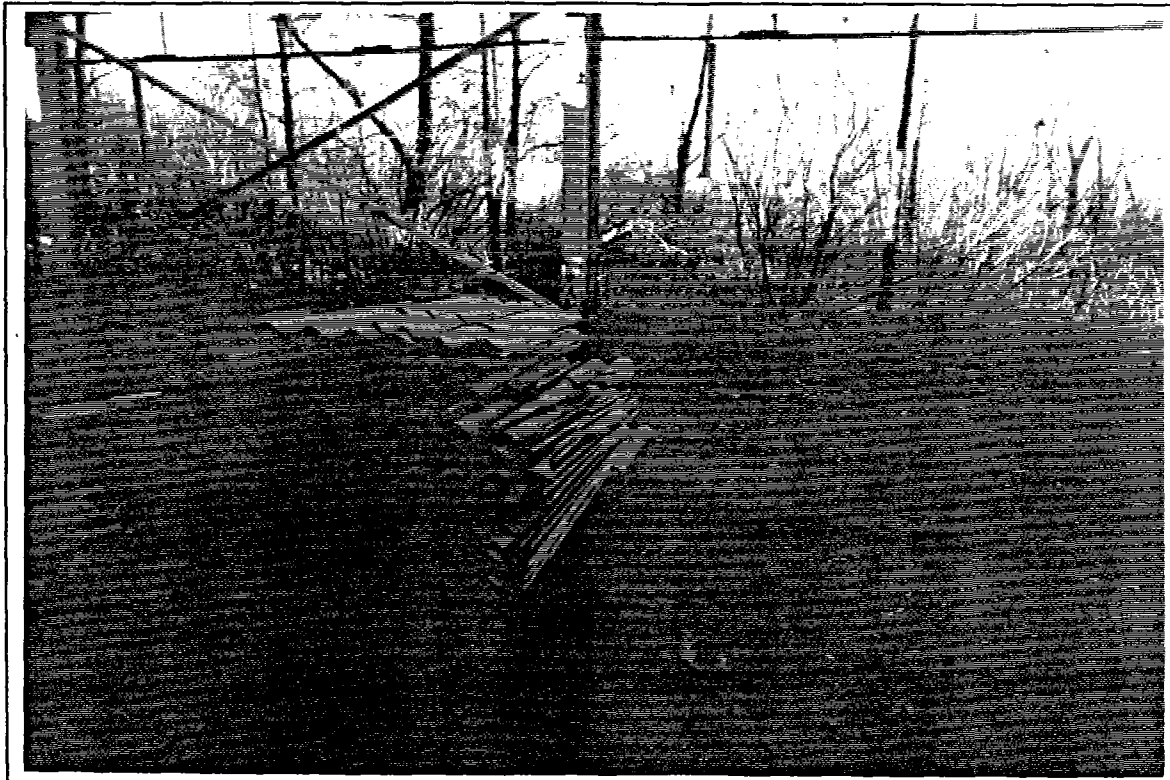
Two triplicate samples of the corrugated transite panels were collected and designated as Samples 1-008 and 2-009 (see Table 3-3). Analytical results indicate that the panels contain between 28 and 36 percent Chrysotile. Though non-friable, many of the panels have been exposed to the elements for over 40 years and are showing signs of mold and algae growth and softening of the matrix. The condition of the panels ranged from good to poor. The panels represent the bulk (80 to 90 percent) of the ACM in the building. Numerous small, broken pieces are found scattered around the perimeter of the building, with some partially buried and overgrown with vegetation.

Photo 9 - Building 6-01 - West wing. Typical accumulation of corrugated asbestos transite siding removed from walls of Building 6-01 (Sample No. 1-008).

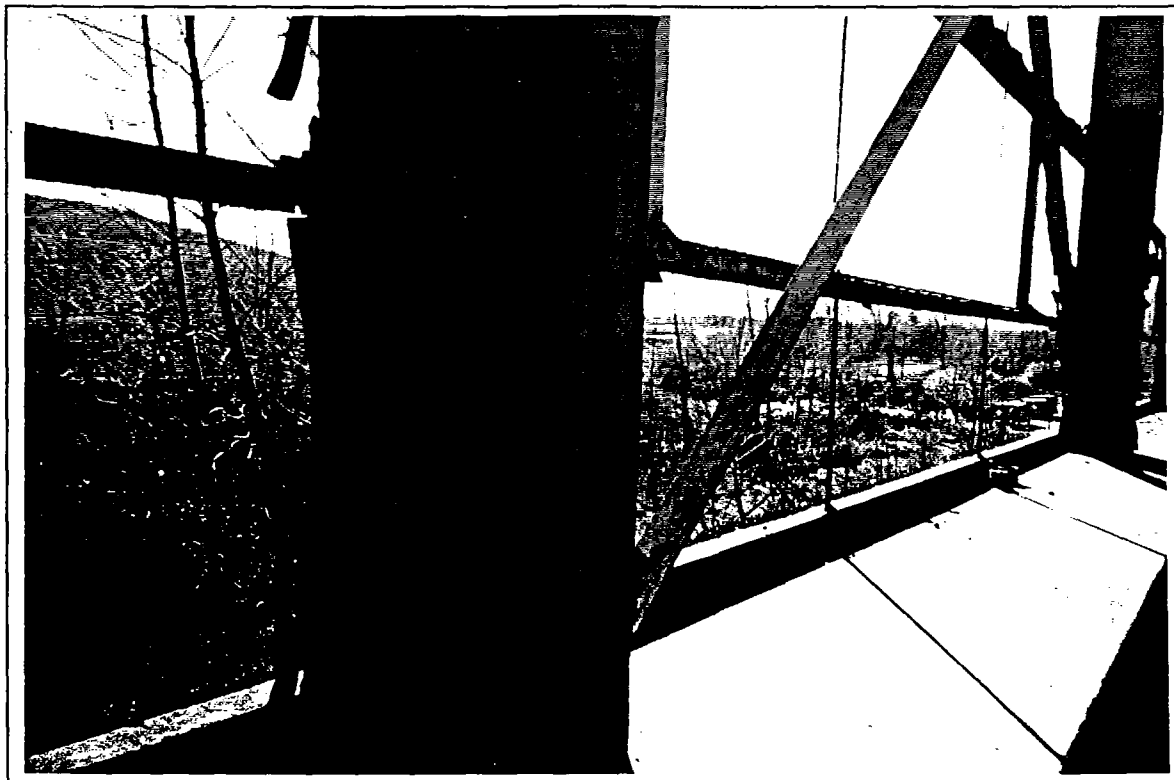
Photo 10 - Building 6-01 - East wing, upper level. Sample of asbestos transite board fastened to outer building columns on upper level (Sample No. 2-009).

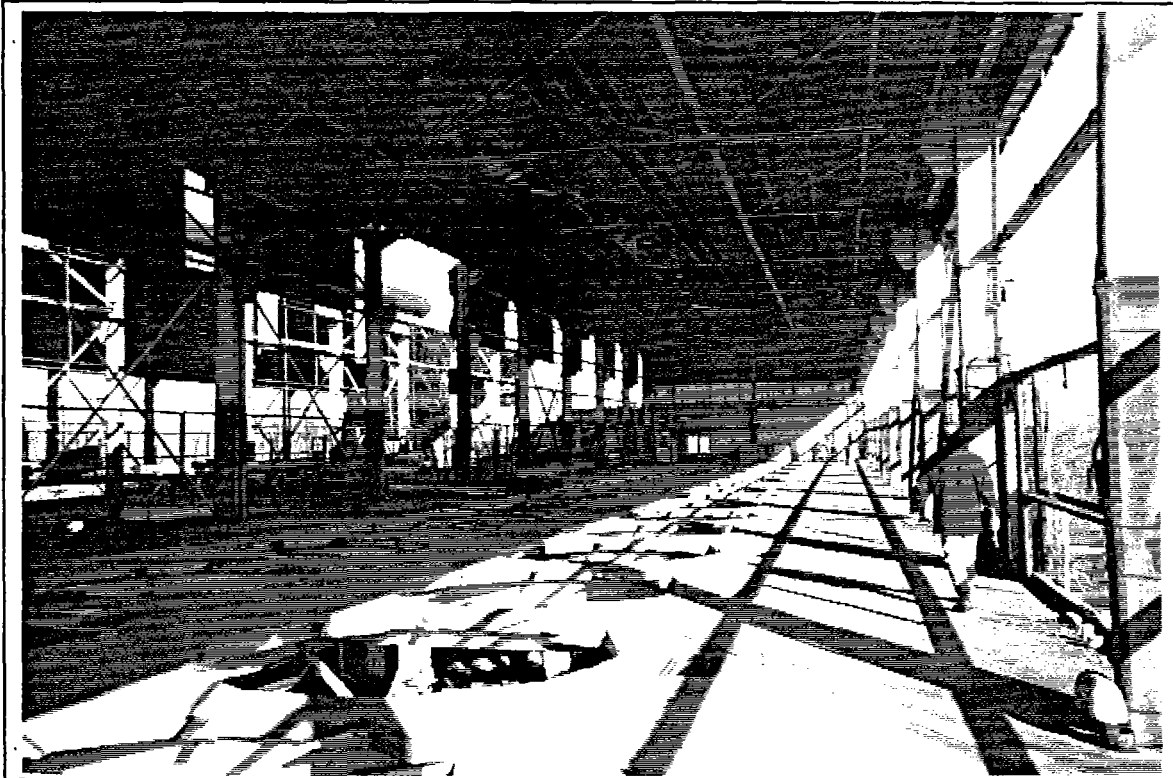
Photo 11 - Building 6-01 - East wing, upper level. View of upper level of building looking north. Note open sides of building.

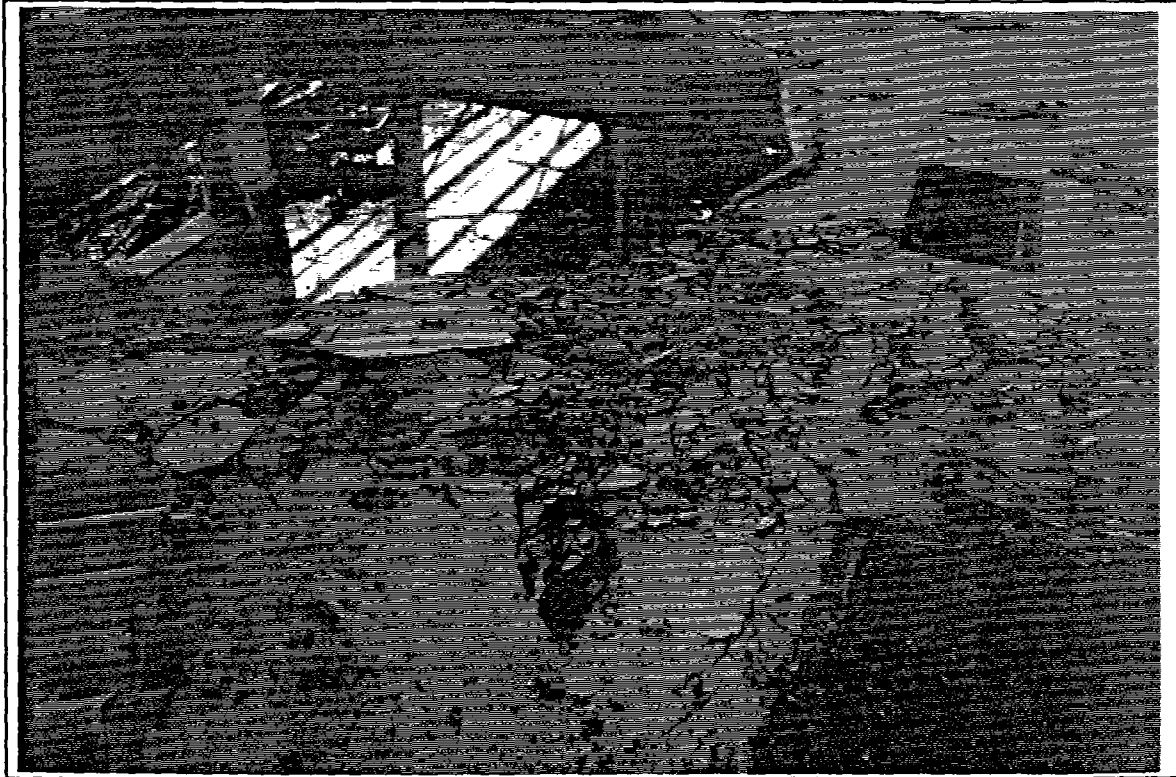
Photo 15 - Building 6-01 - Spalling non-asbestos concrete on upper level at floor penetrations (Sample No. 2-013).

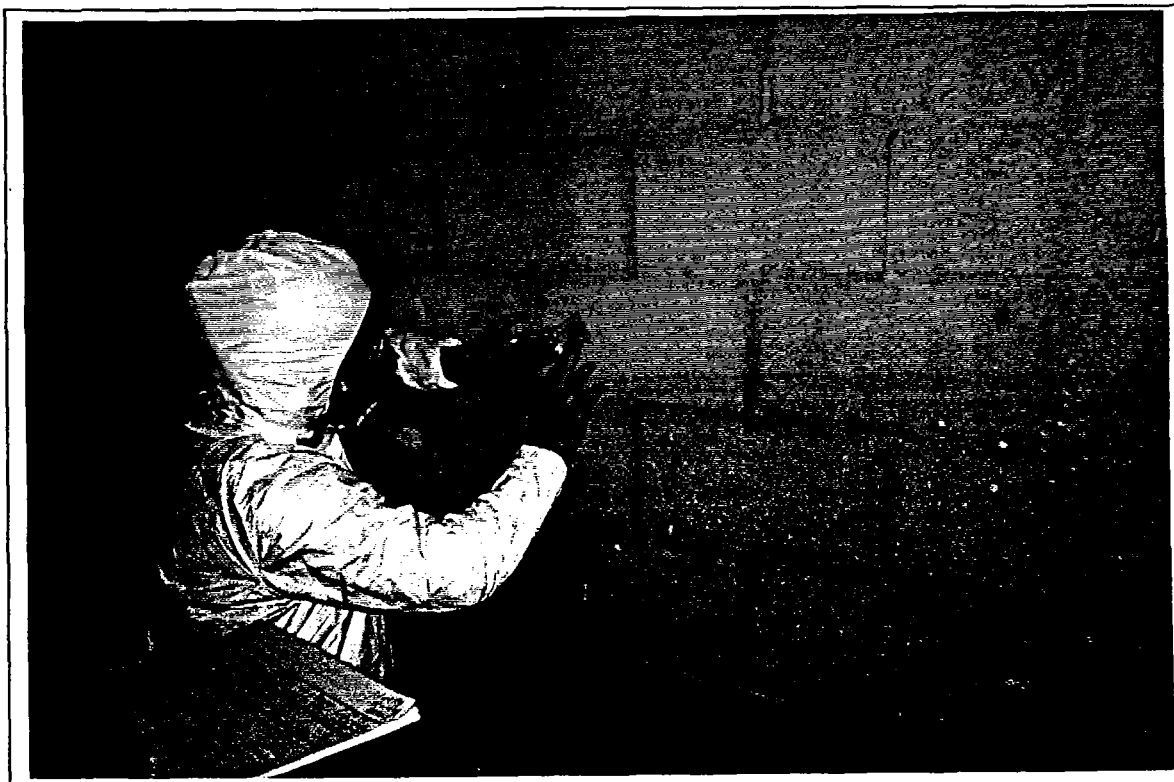
Photo 20 - Building 6-02 - Acres personnel taking asbestos swipe sample from interior building wall (Sample No. 1-017).

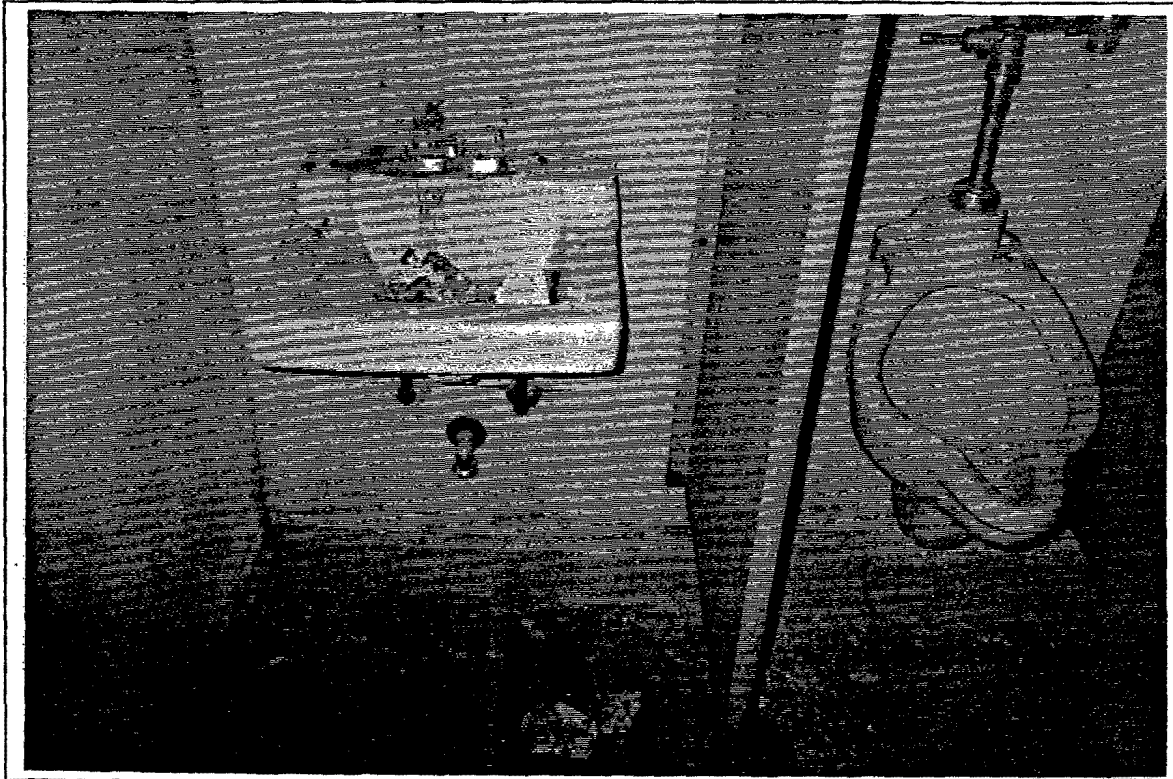
Photo 27 - Building 30 - Men's bathroom area on building's east side. Note that non-asbestos plaster ceiling in this room has collapsed completely due to water intrusion from roof (Sample No. 1-024).

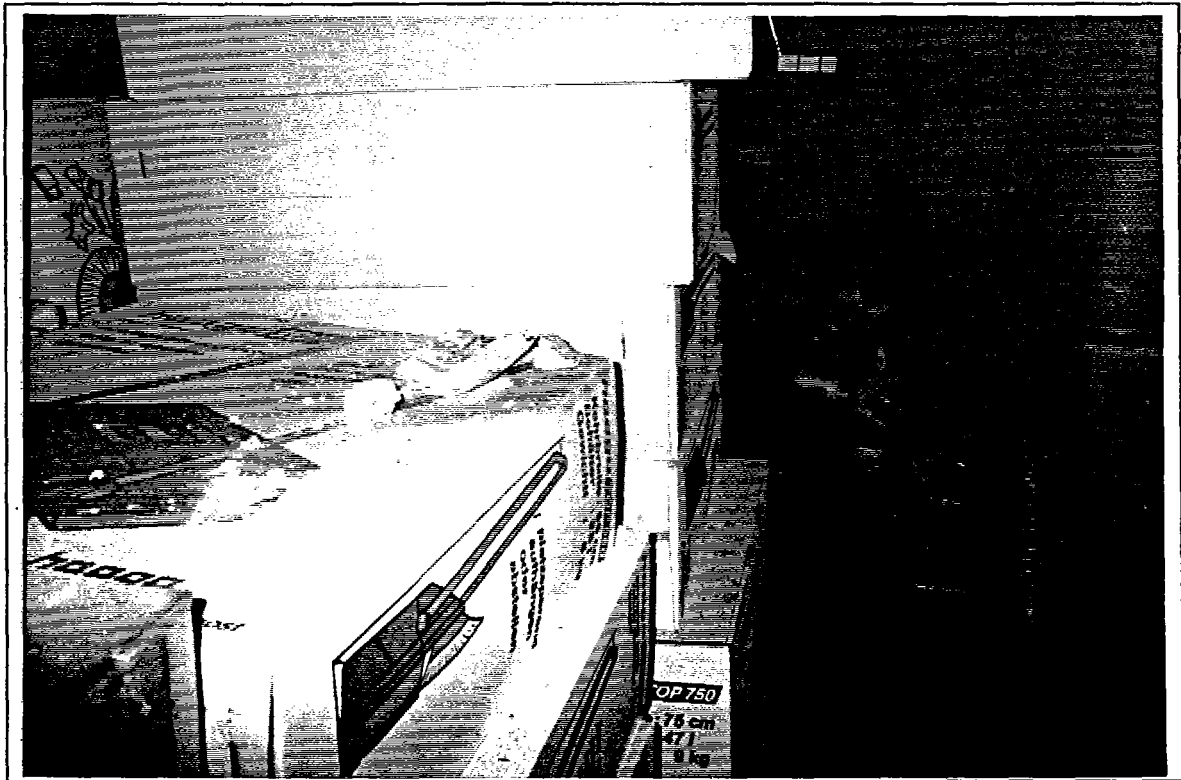
Photo 31 - Building 30 - Stockpiles of stored equipment in main area of warehouse where asbestos pipe TSI has fallen from piping and collected on top of stockpiles (Sample No. 1-022).

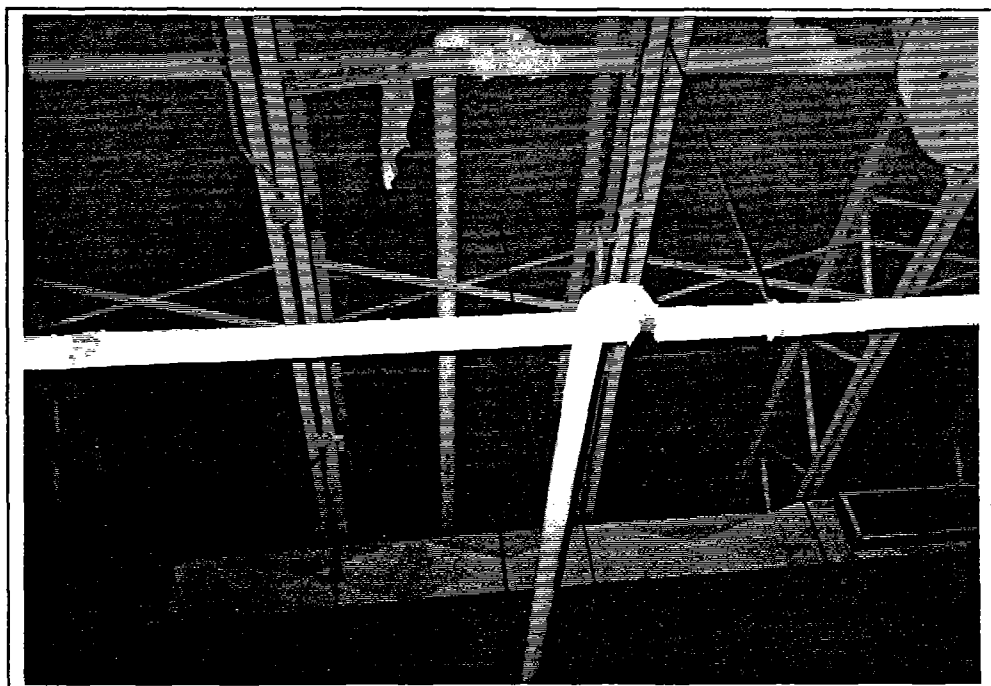
Photo 37 - Building 41 - Hot water distribution piping where Sample No. 1-027 was taken. Sample analyzed negative for asbestos.

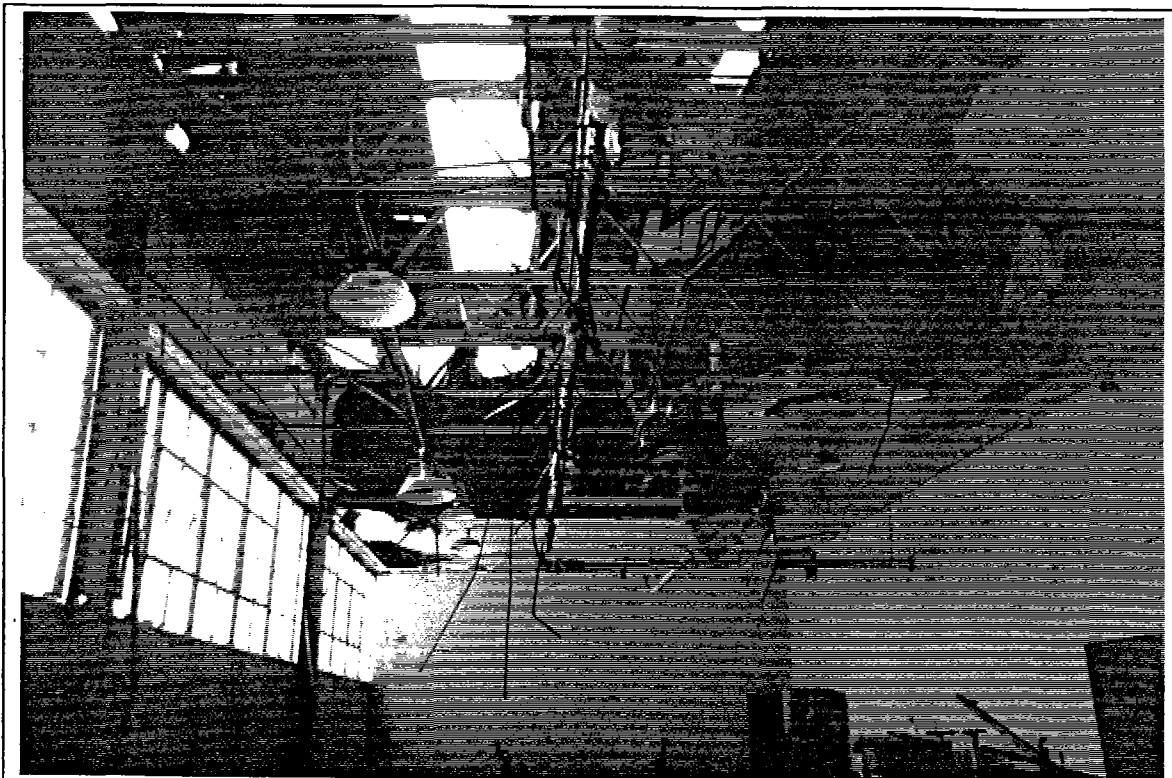
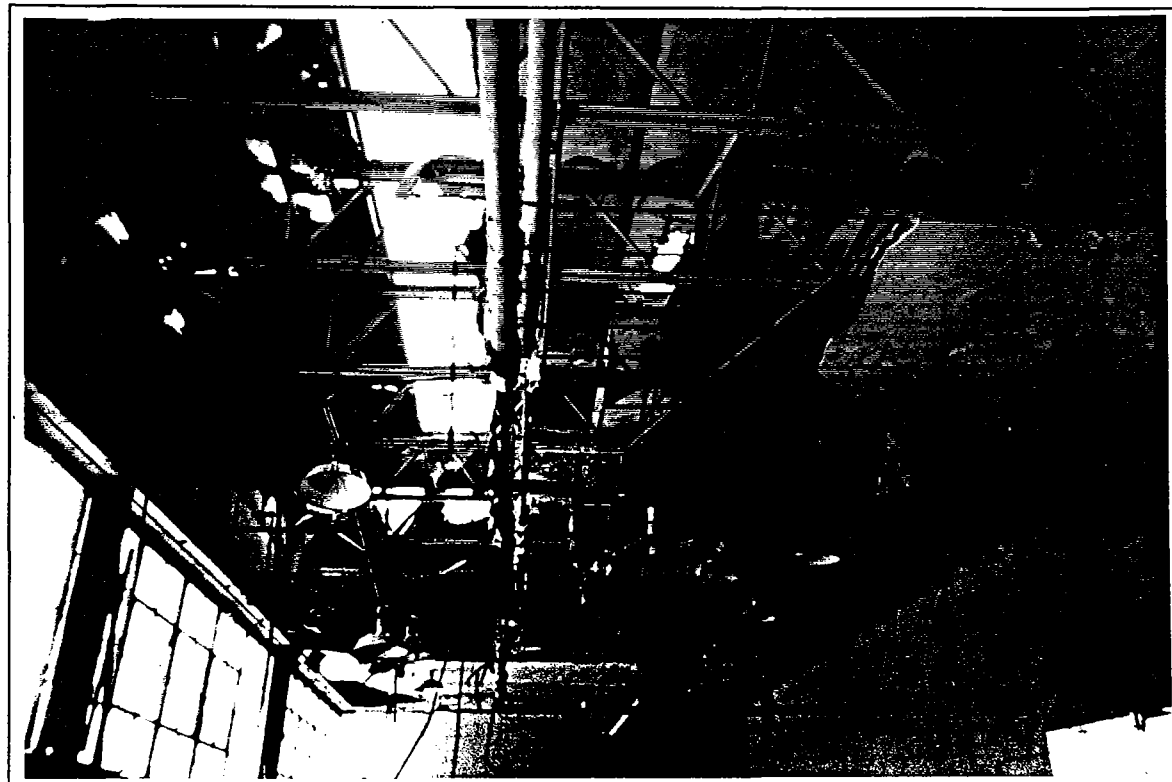
Photo 38 - Building 41 - East side of building where water intrusion has caused collapse of non-asbestos plaster ceiling (Sample No. 1-029), non-asbestos concrete roof panels (Sample No. 1-030), and non-asbestos roof flashing material (Sample No. 1-031)

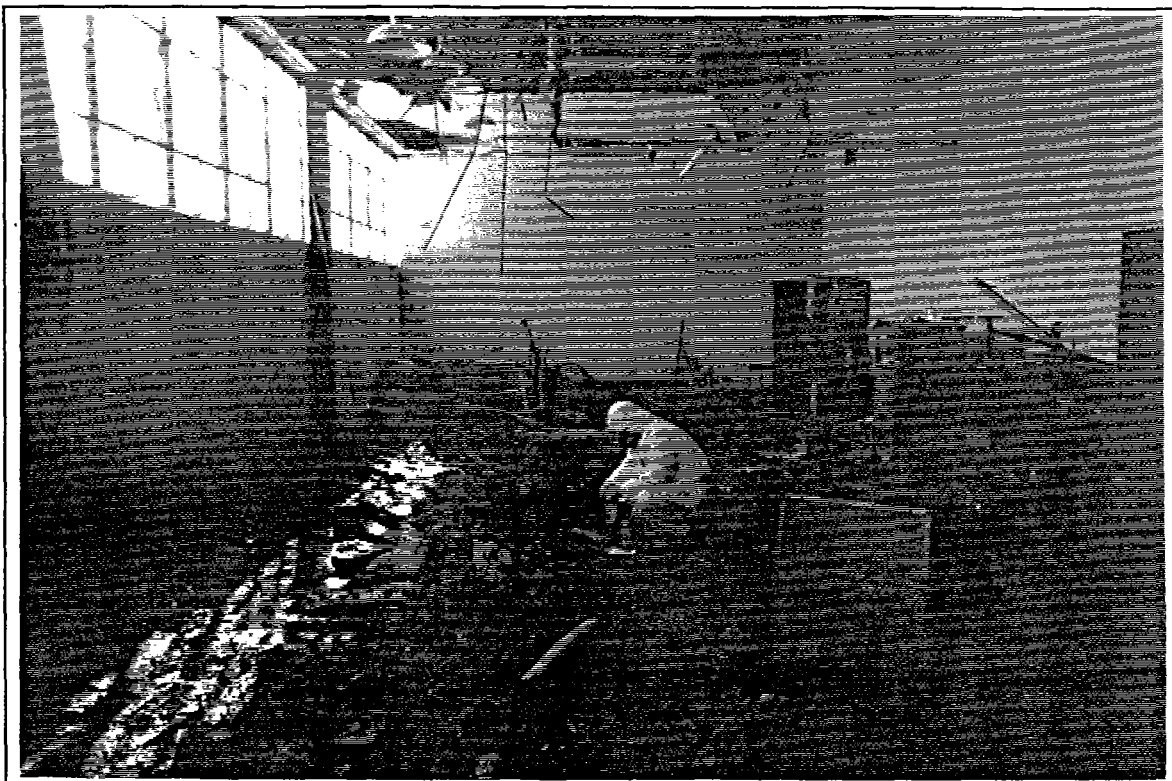
Photo 40 - Building 41 - East side of building where water intrusion has caused collapse of non-asbestos plaster ceiling (Sample No. 1-029), non-asbestos concrete roof panels (Sample No. 1-030), and non-asbestos roof flashing material (Sample No. 1-031)

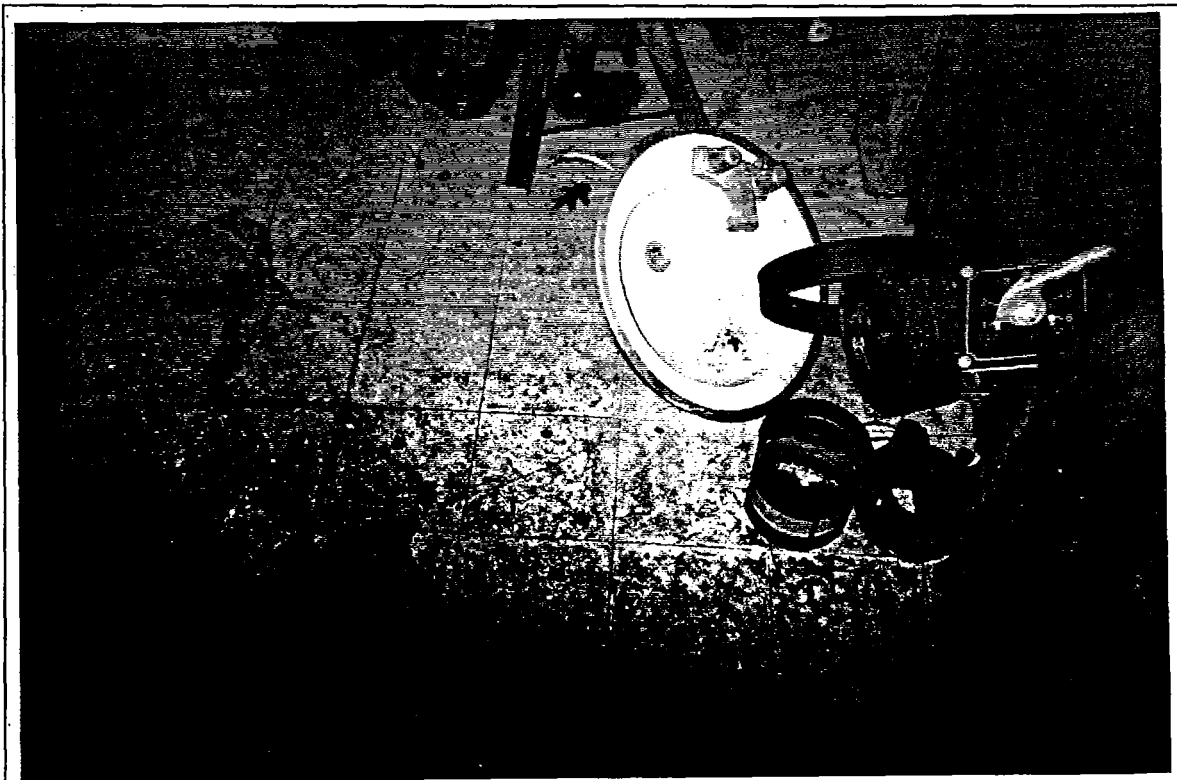
Photo 41 - Building 41 - 9 inch x 9 inch yellow VAT in area adjacent to bathroom area next to boiler room area (Sample No. 1-033).

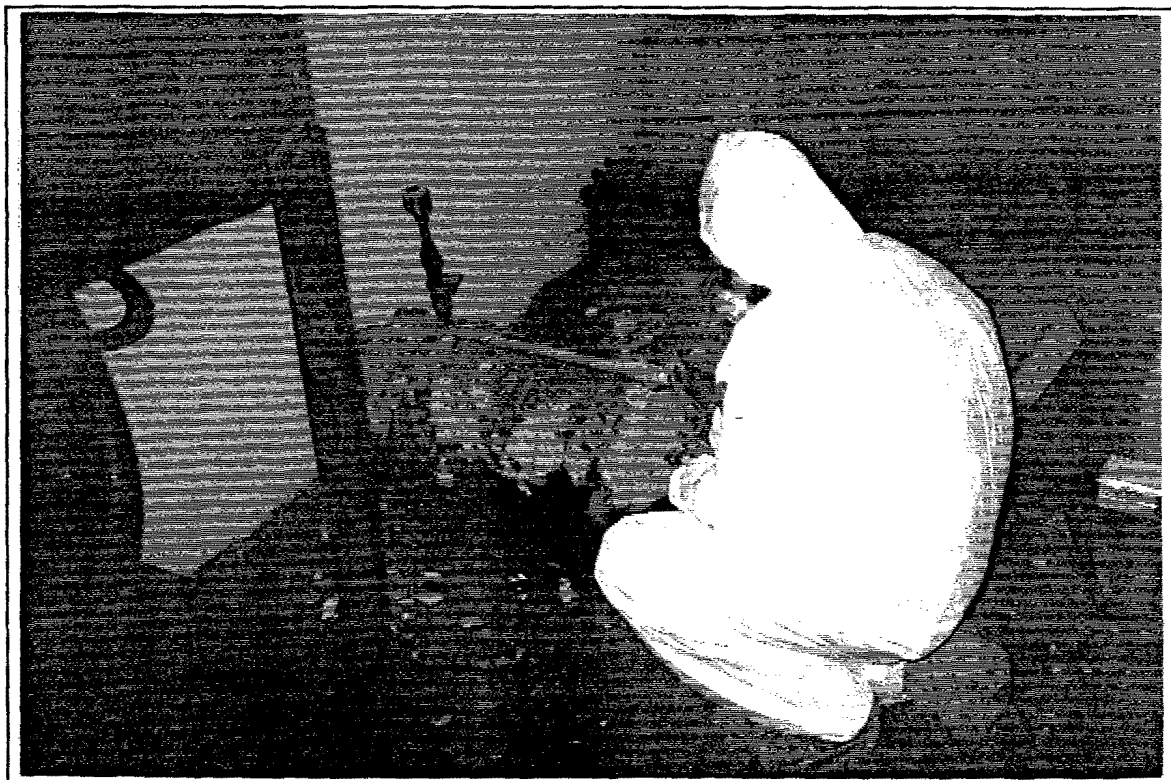
Photo 42 - Building 41 - East side of building, 18-inch diameter by 36-inch long pressure vessel from which Sample No. 1-034 was taken. Sample analyzed negative for asbestos.

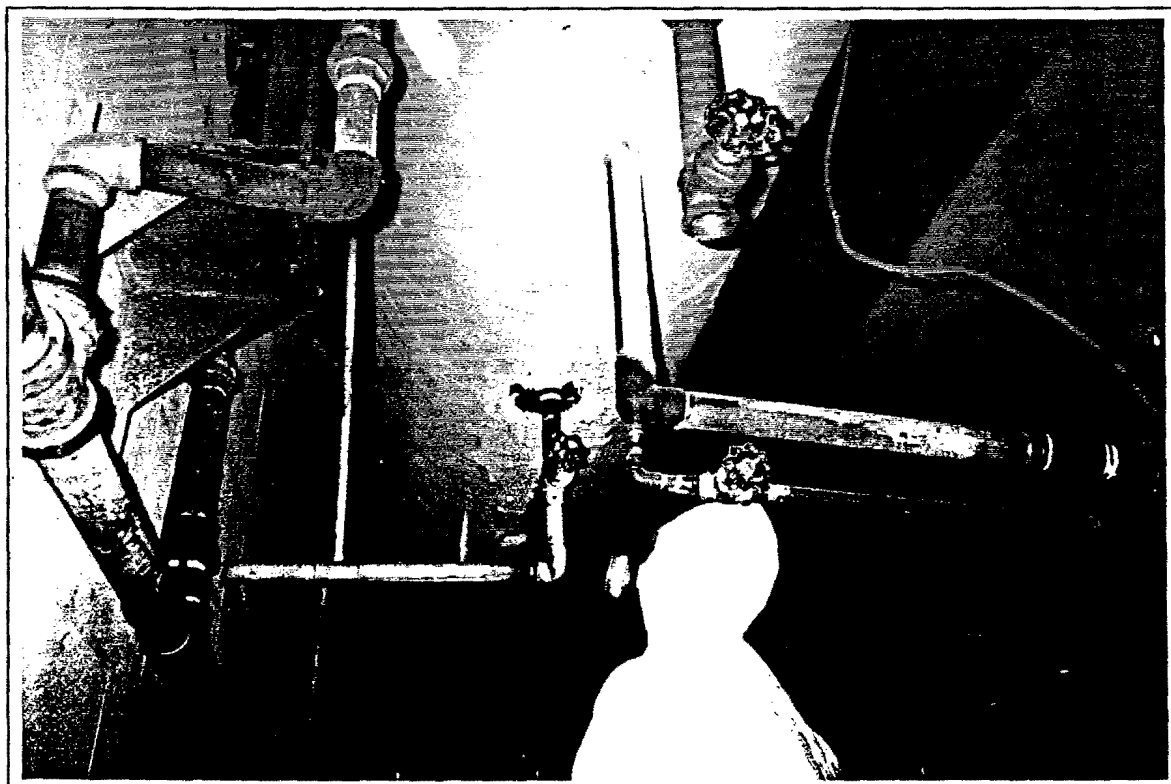
Photo 43 - Building 41 - Boiler room. Make-up water tank asbestos TSI from which Sample No. 1-035 was taken.

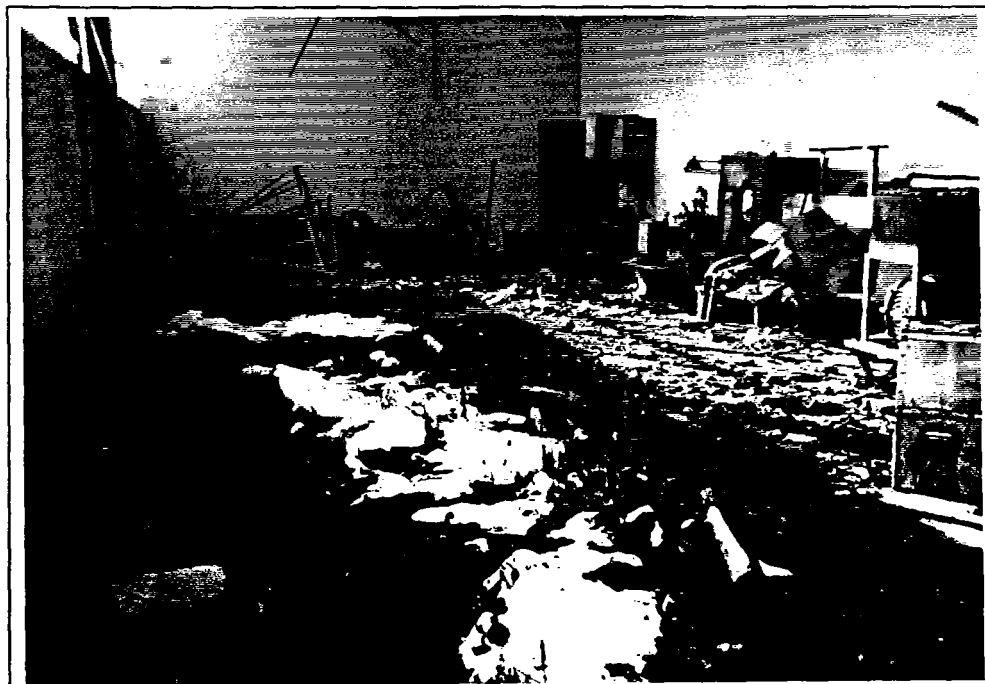
Photo 45 - Building 41 - East side of building where water intrusion has caused collapse of non-asbestos plaster ceiling (Sample No. 1-029), non-asbestos concrete roof panels (Sample No. 1-030), and non-asbestos roof flashing material (Sample No. 1-031).

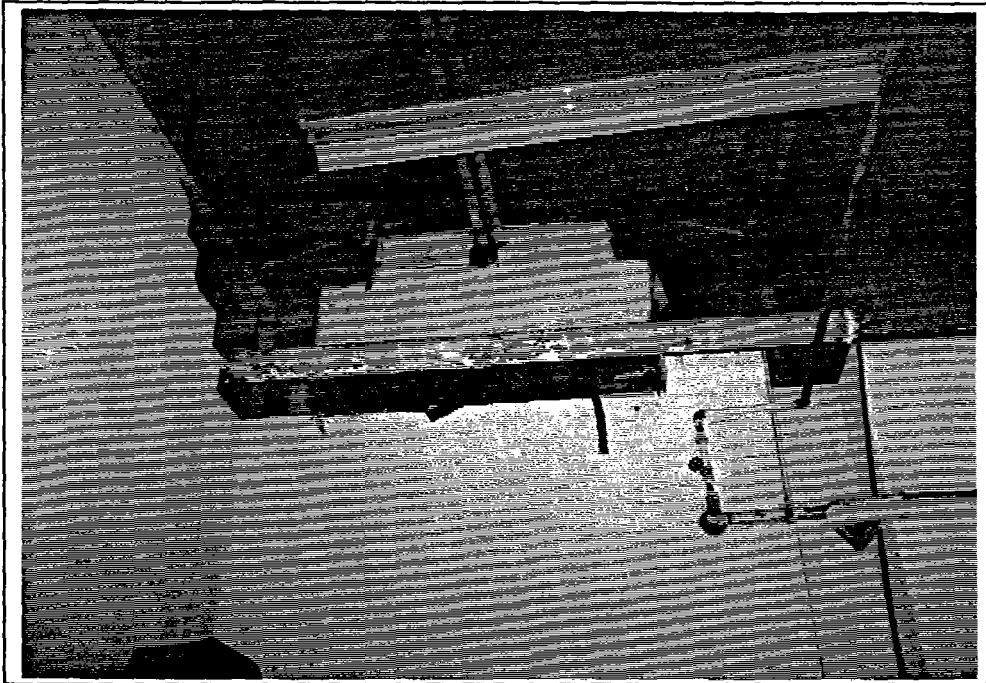
Photo 46 - Building 41 - Entrance to boiler room. End of ductwork over boiler room. Sample 1-037 was taken from this duct wrap within boiler room and was found to contain asbestos.

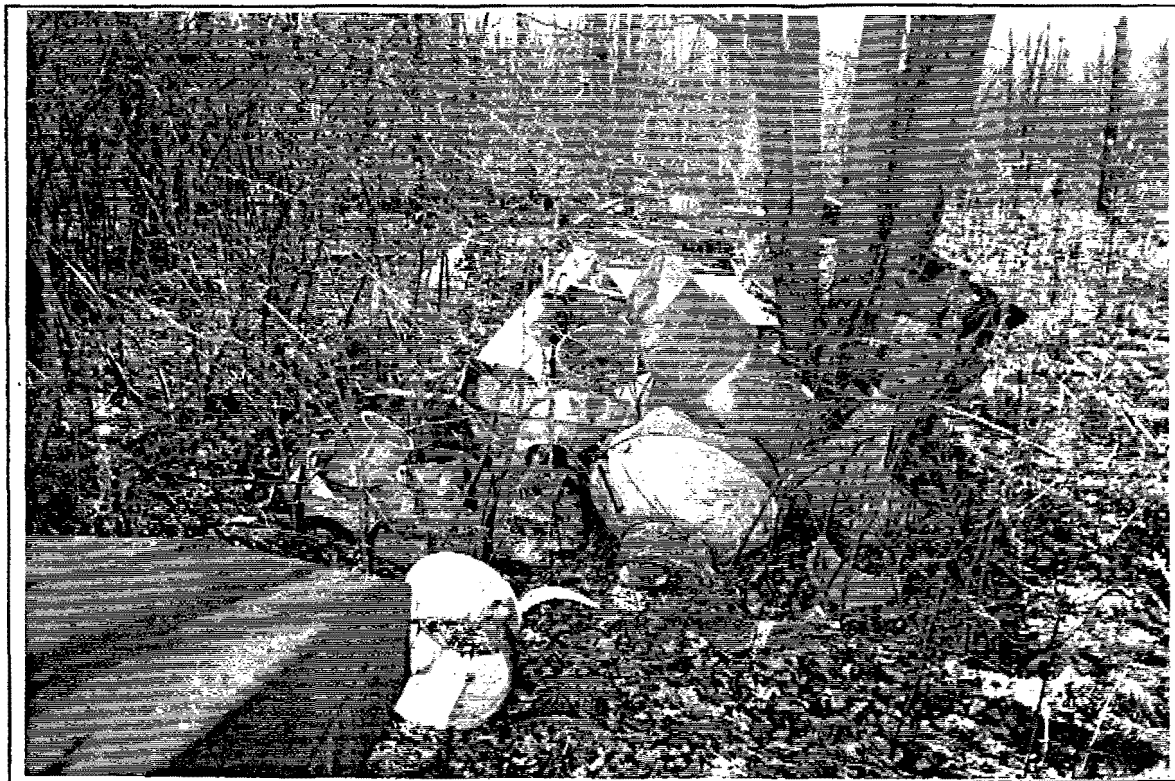
Photo 51 - Building 30A - Building exterior, east side of building. Photo of steam line asbestos TSI taken in Sample No. 1-047.

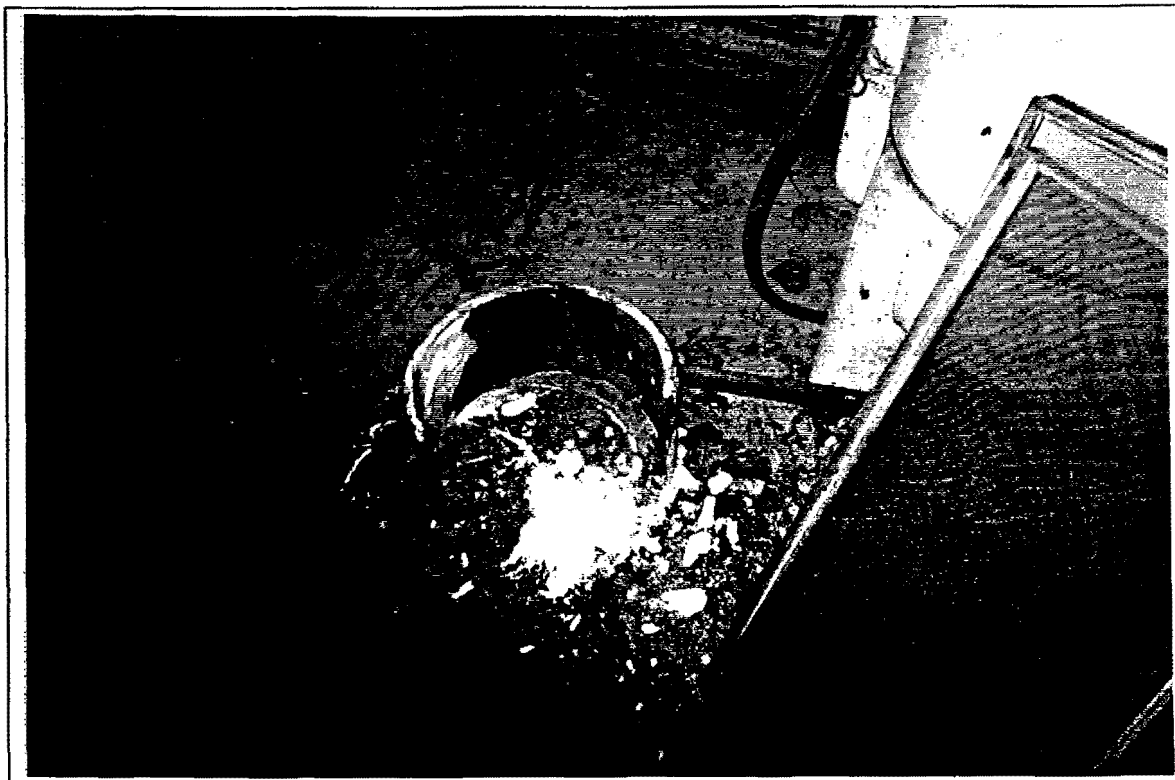
Photo 52 - Building 30A - Circular asbestos transite ductwork found on east side of building (Sample No. 1-048), approximately 14-inch diameter.

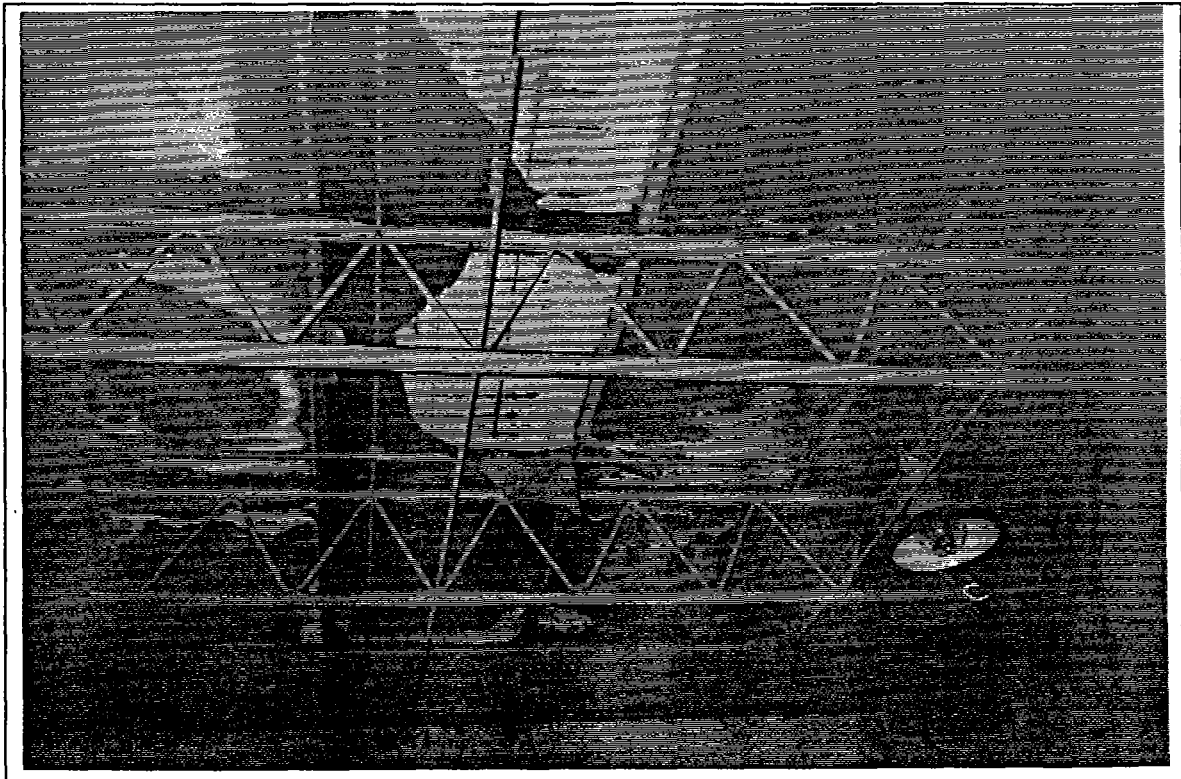
Photo 58 - Building 30A - Interior of concrete panel ceiling. Note deterioration due to water infiltration (Sample No. 1-044).
