**Remedial Design of Interim Remedial Measures
Operable Units 1 and 2
Former Lake Ontario Ordnance Works
Lewiston/Porter, Niagara County, NY**

**Asbestos Survey Report
Somerset Group Property**

June 1998

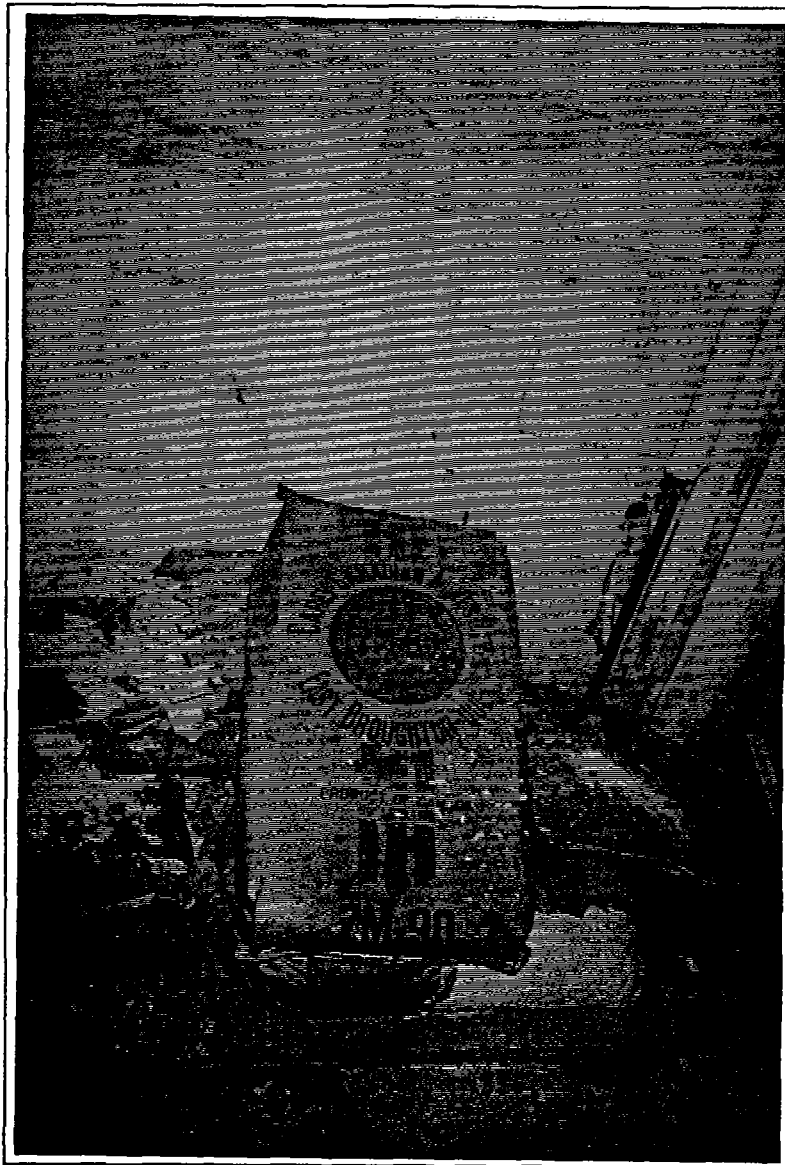
Photo 59 - Building 30A - Asbestos mortar found inside building and sampled in Sample No. 1-042.

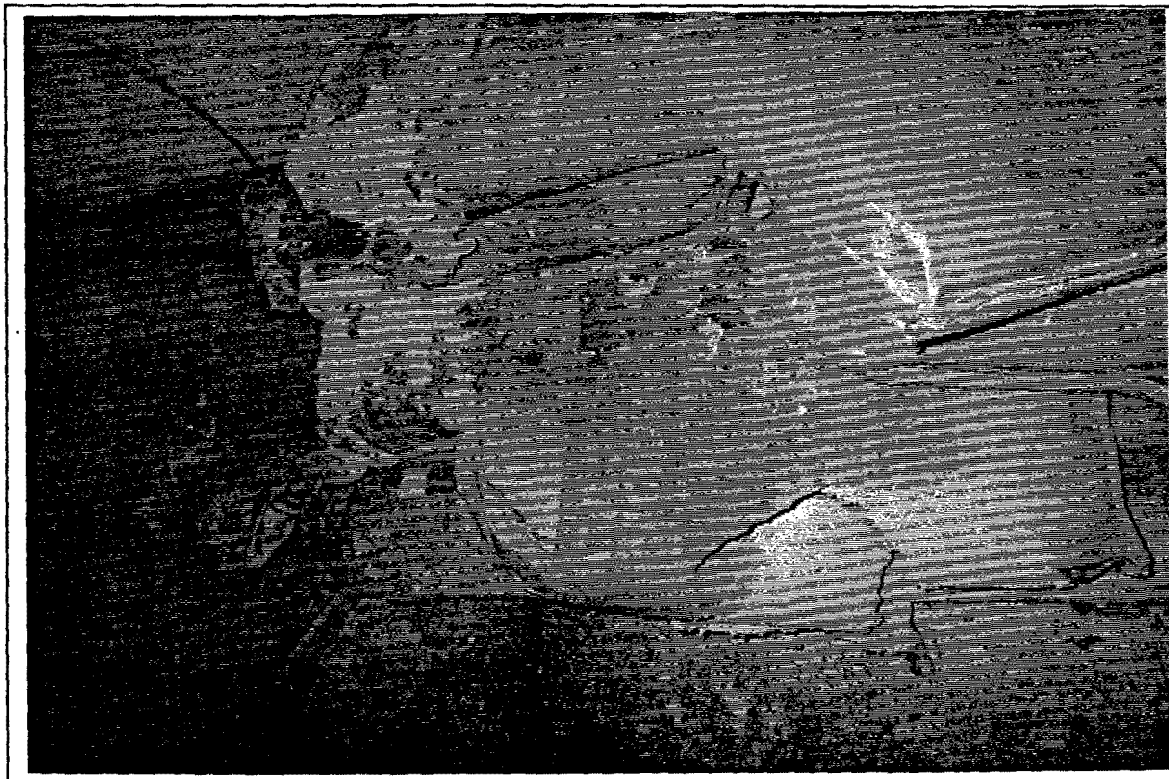
Photo 60 - Building 30A - Asbestos mortar found inside building and sampled in Sample No. 1-042.

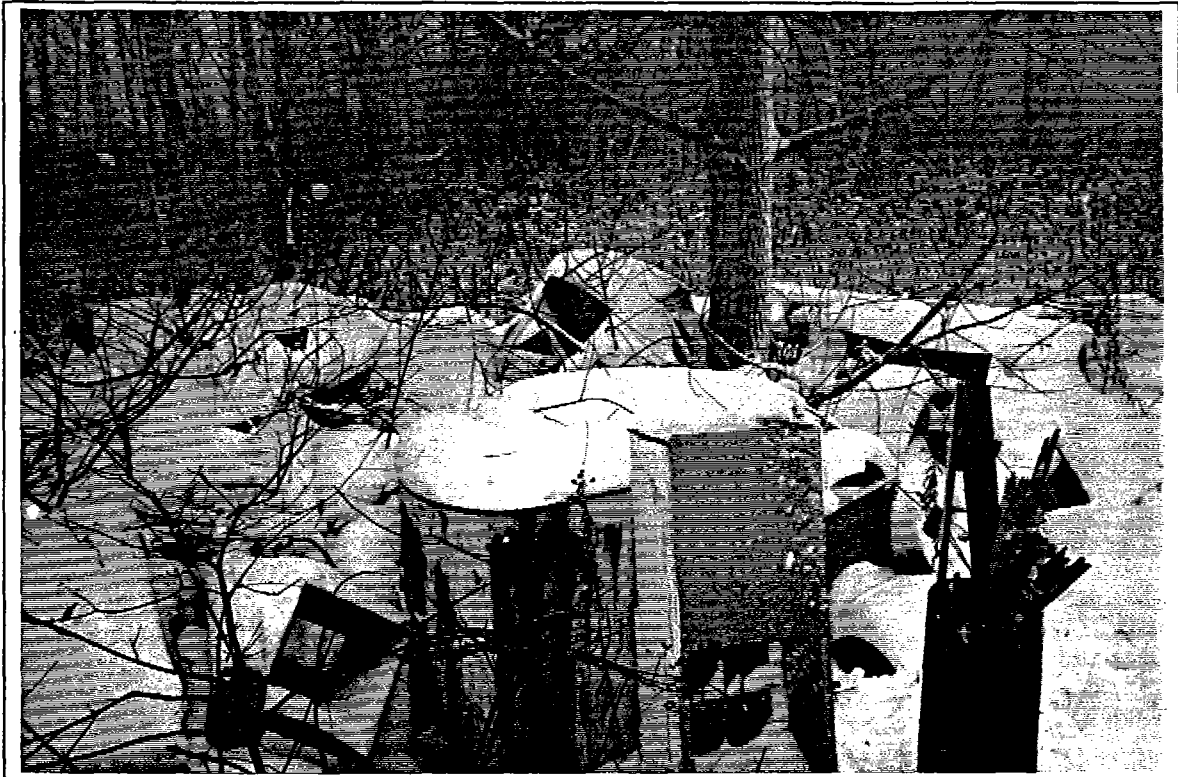
Photo 66 - Building 30A - Building exterior, north side of building where large amount of accumulated debris has been placed. Unclear if any consists of ACM.

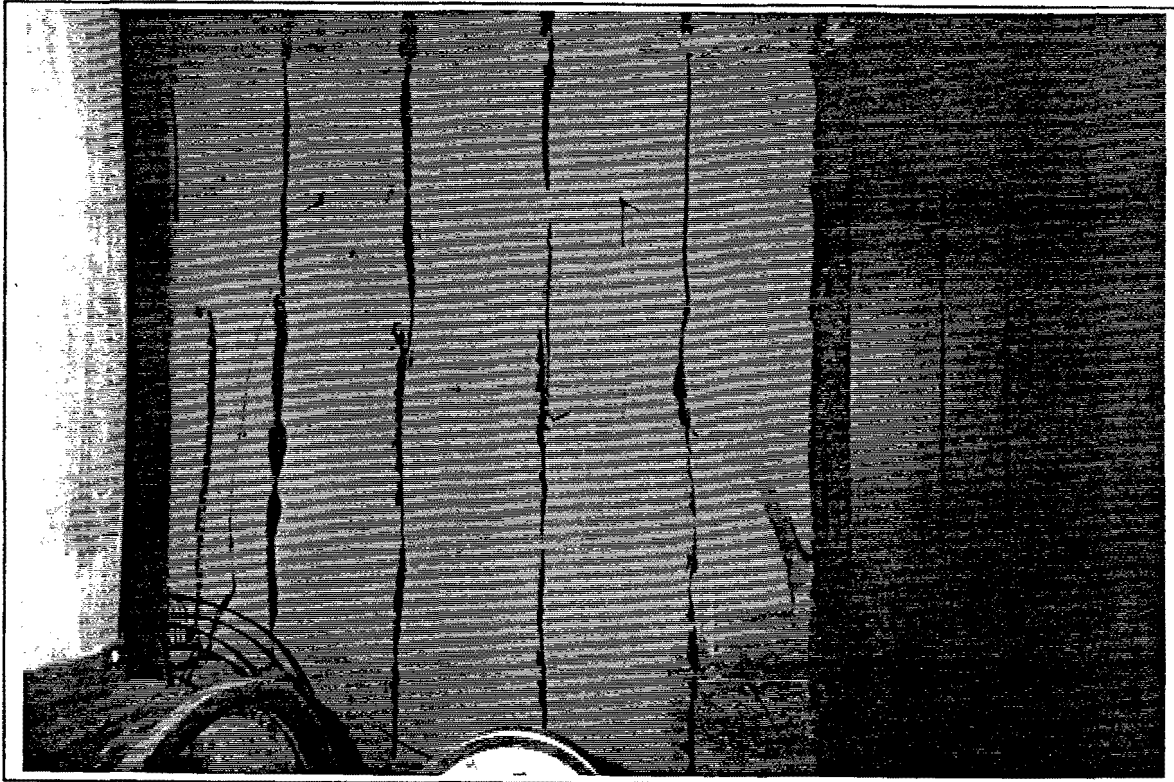
Photo 67 - Building 31 - Asbestos paneling mastic on north side wall where Sample No. 1-055 was taken.

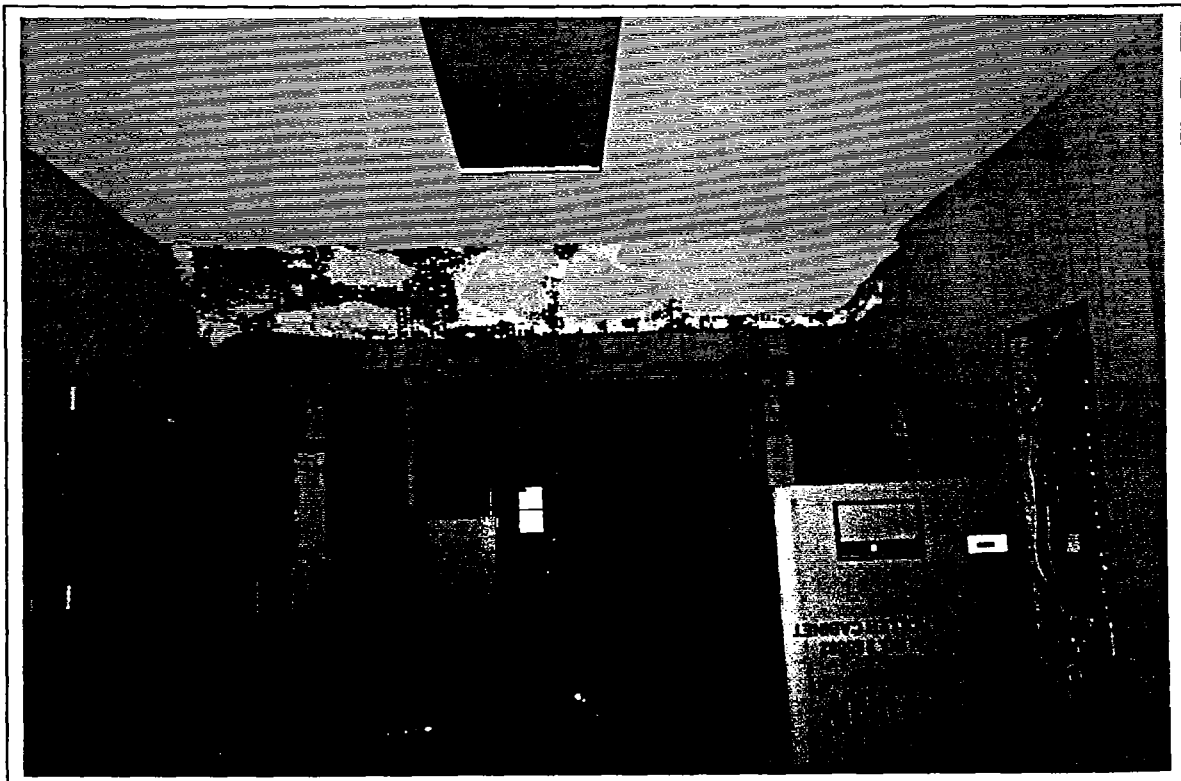
Photo 70 - Building 31 - Deteriorating plaster ceiling in main corridor (Sample No. 1-058).

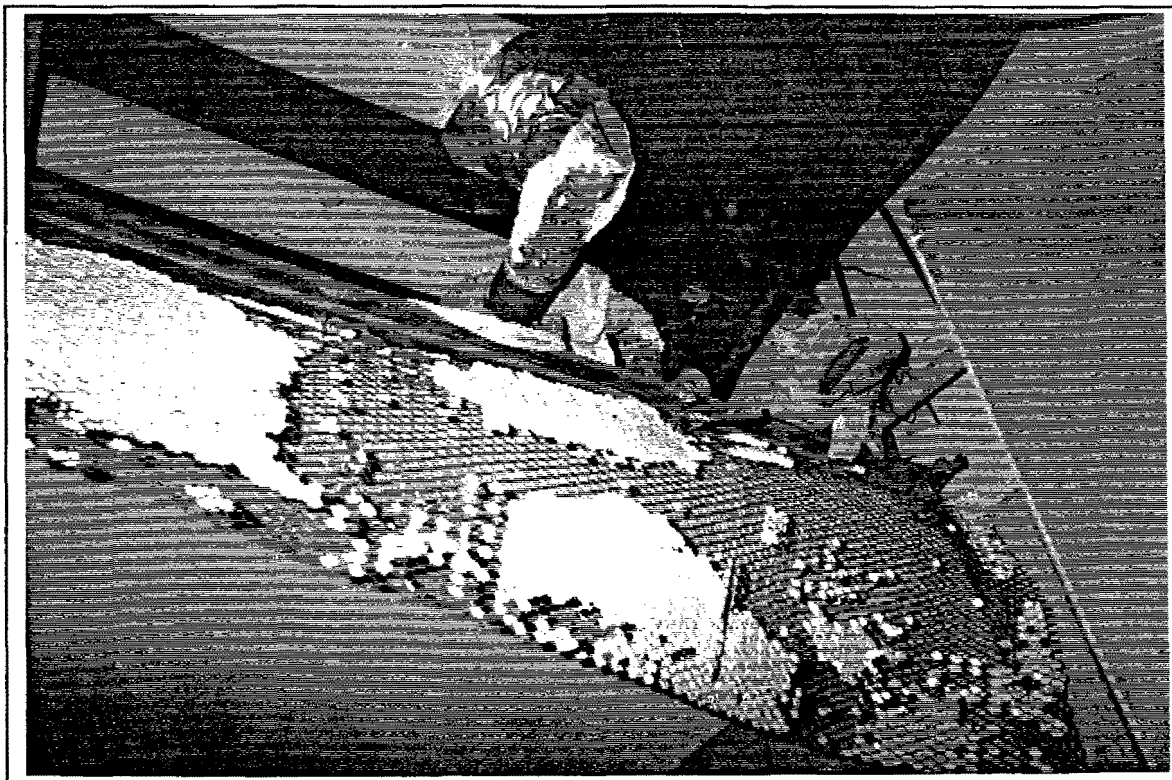
Photo 73 - Building 31 - Asbestos-containing plaster elbow insulation taken from above plaster ceiling in main corridor (Sample No. 1-061).

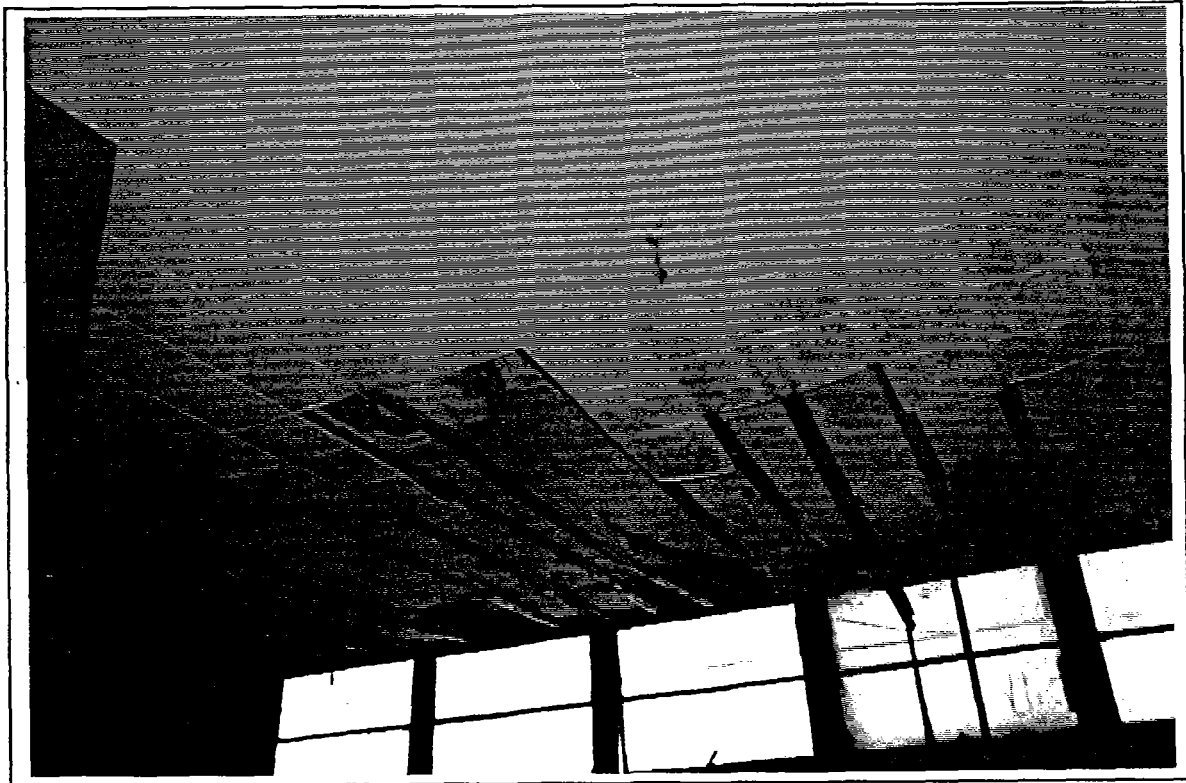
Photo 75 - Building 31 - 12 inch x 12 inch tongue-in-groove non-asbestos ceiling tile from room on north side of building. Tile as well as plaster ceiling above and concrete roof panels have all collapsed into building at this location (Sample No. 1-063).

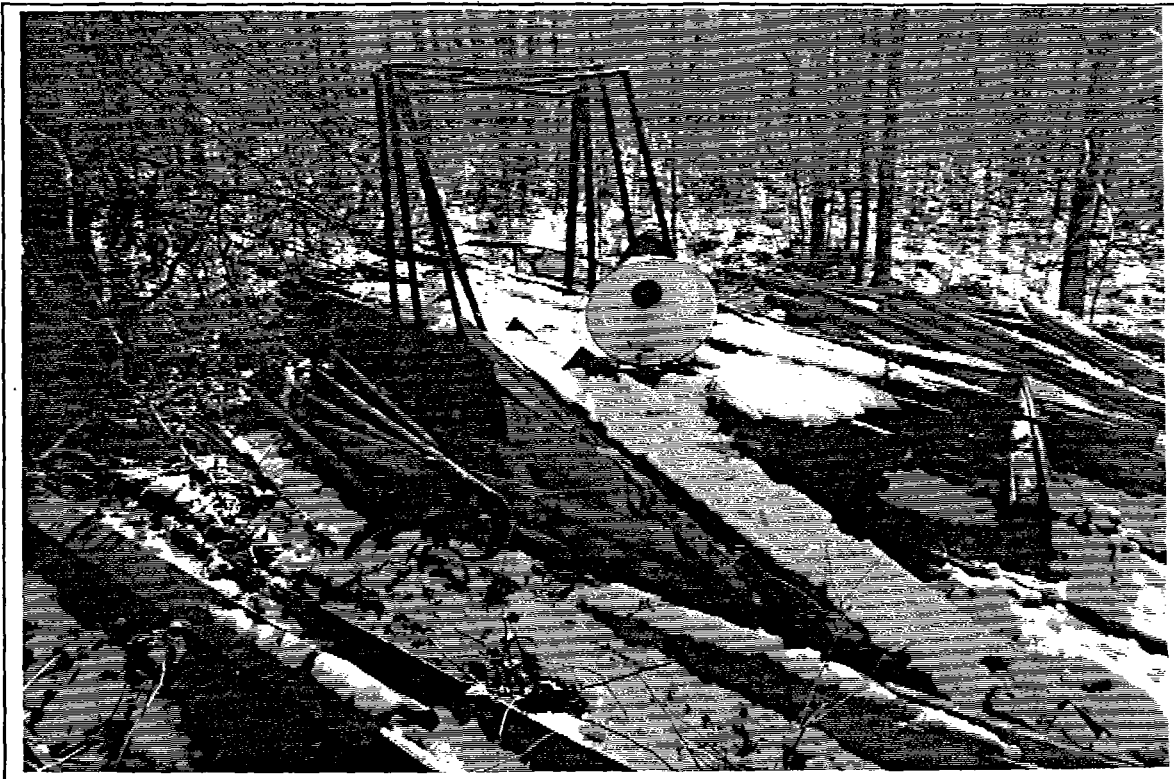
Photo 78 - Area T-2 - Large corrugated asbestos transite panels and semi-circular transite lap panels accumulated in this area.

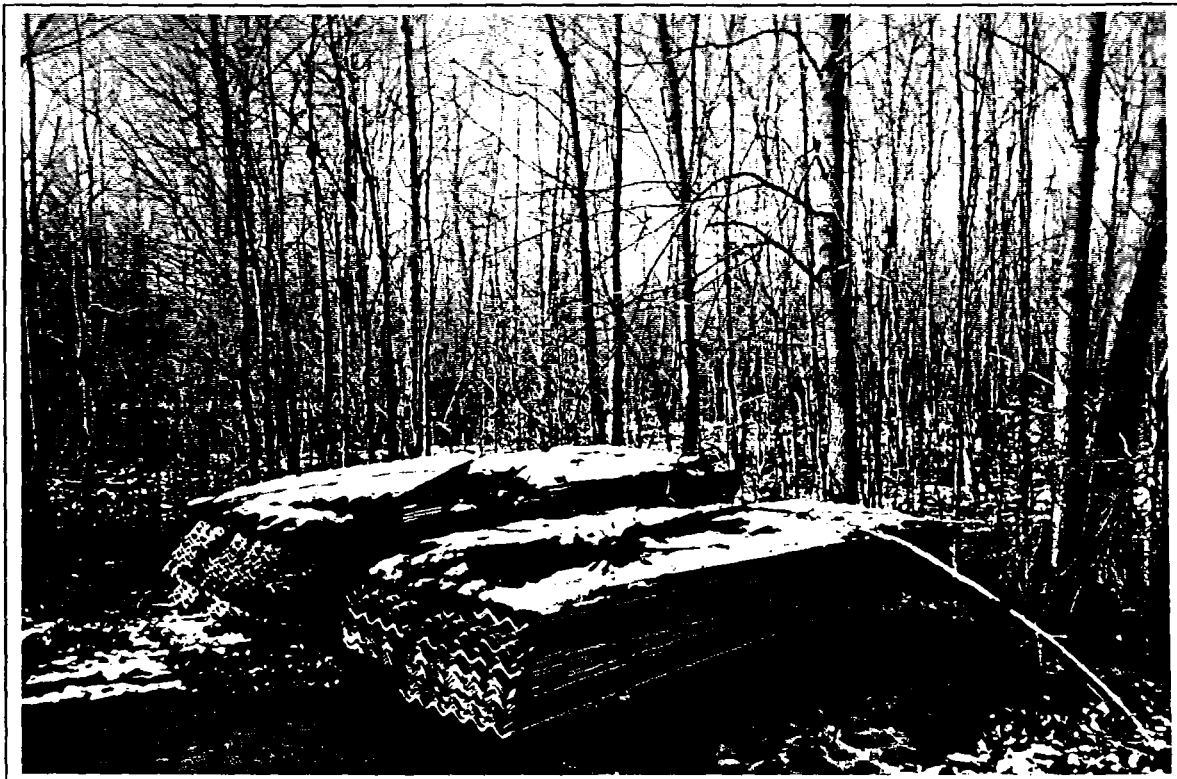
Photo 79 - Area T-2 - Large corrugated asbestos transite panels accumulated in this area.

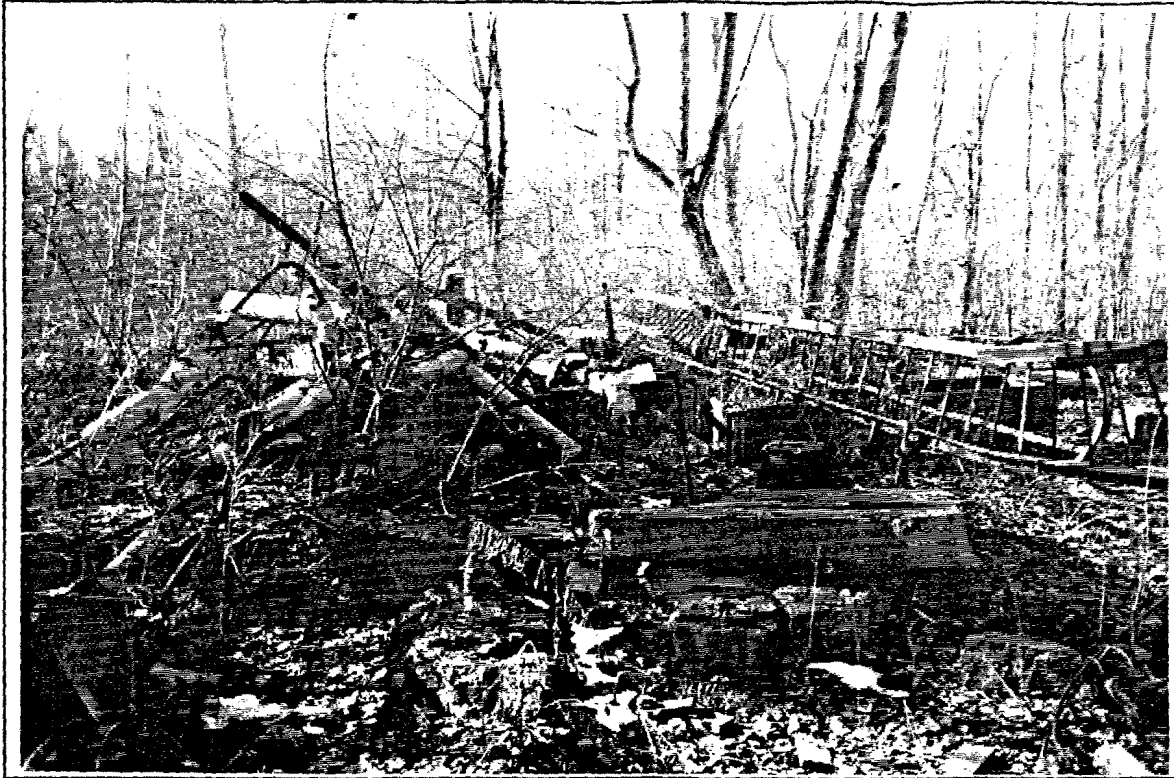
PACM debris was found outside Building 5-01 on the west and south sides. The area north of the building had scrap materials, consisting primarily of piping, piled on a former concrete process area foundation. No PACMs were found in the inspection of this debris. Along the west side of the building, ACMs were noted to be spread across process area foundations and the former electrical substation. The area to the south contained PACM debris which consisted primarily of piping and pipe insulation. (Note that these PACMs were identified as belonging to the same homogeneous categories as materials sampled in Area 6 and, therefore, were not resampled in this area).

Photo 80 - Vicinity of Building 5-01 (looking west). Large accumulation of metal scrap and asbestos TSI wrapped piping deposited here. TSI has deteriorated due to weather exposure and has fallen from piping onto the ground.

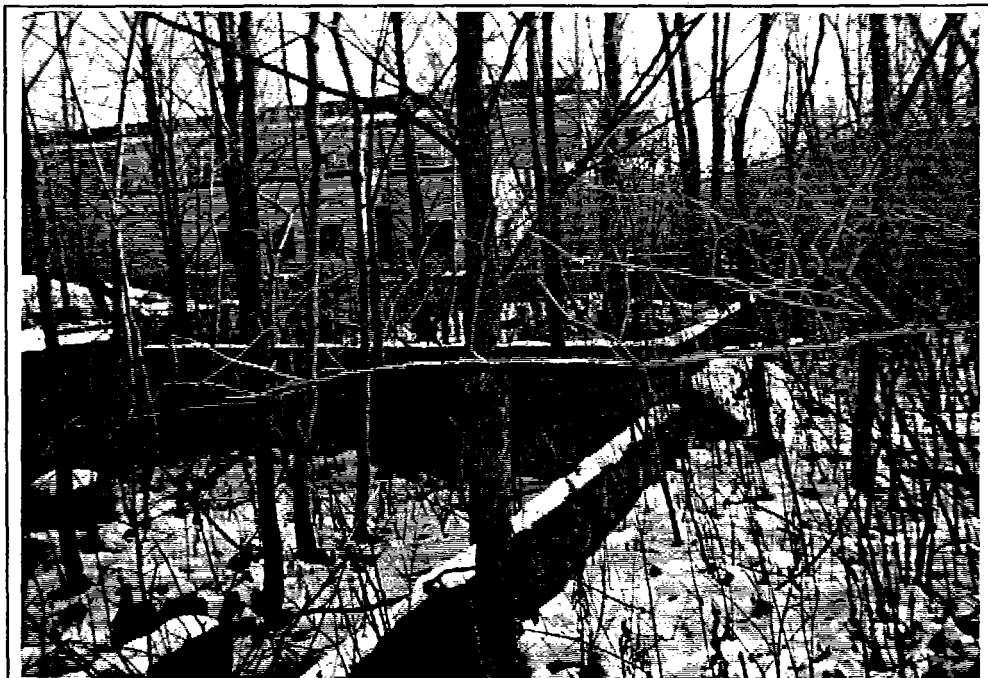
Extensive PACM debris was found outside surrounding Building 3-01, particularly on the north, west, and south sides. Along the west side, PACM debris was spread across the process area foundations almost to the main access road that bisects the property into east and west portions. To the south, the debris is spread across pipe footers and is present within and to the south of the former tank farm. PACM debris consists primarily of steam pipe insulation, water pipe insulation, pipe elbows, and transite panels, and is mixed amongst scrap metal and building debris. The building debris includes structural steel, concrete, and masonry that ranges in size from small rubble to large chunks of concrete and steel weighing several tons. The heterogeneous mixture of the debris made a detailed estimation of PACM difficult for this area.

Photo 84 - Vicinity of Building 3-01. West side of tank farm adjacent to Building 3-01 looking east. Tank farm was found to be littered with large amounts of asbestos pipe TSI which has fallen from pipes and has been covered by soil.

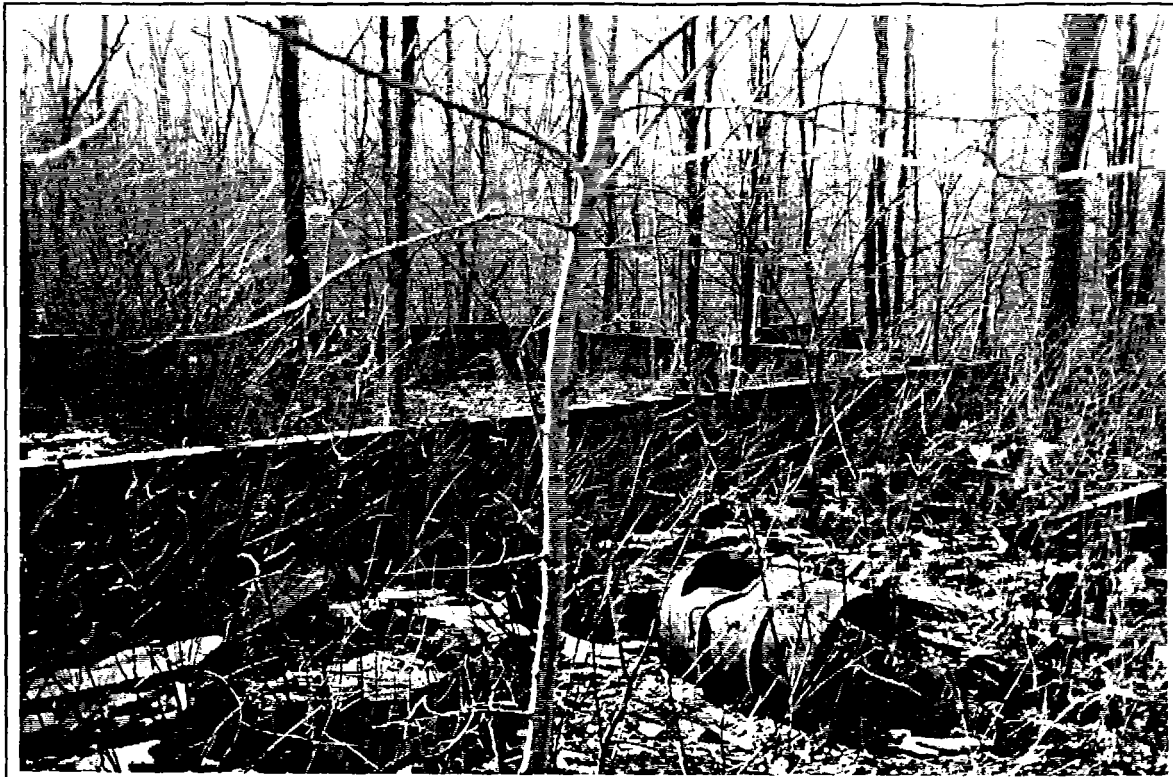
Photo 85 - Vicinity of Building 3-01. Same as Photo 84 above, looking southwest.
