Re: Settlement of Damages Caused to Somerset Group Property
During August-December 1998 Asbestos Removal Project

SUBJECT: Contract No. DACW49-98-D-0003, SPIDT, DO 1 Asbestos Removal Project Phase I & II Somerset Property, Former Lake Ontario Ordnance Works, Lewiston, NY

SUBJECT: Asbestos Removal Project, Somerset Property, Former Lake Ontario Ordnance Works, Lewiston, New York - Contract No. DACW49-98-D-0003, SPIDT, Delivery Order 01

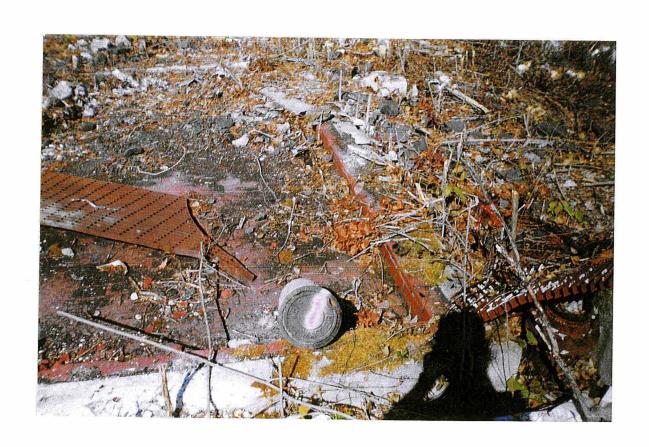
Exhibits3

4.	Seven (7) shut-off valves that stuck up out of the ground were driven over with tractors and shut off valves were snapped off and are no longer visible. See Exhibit 3. [NOTE 1: Unfortunately, there is only one picture of this damage because the stems are no longer present; this picture shows part of one of the valve sleeves lying on the ground]. [NOTE 2: Corps' October 21st letter states that only five (5) valves were destroyed]. Even though there is no potable or non-potable water supplied to the facility at the current time, this damage further eliminates the possibility of water being supplied to the site after the remediation is complete.	\$4,200.00 Estimate reflects value to replace valves

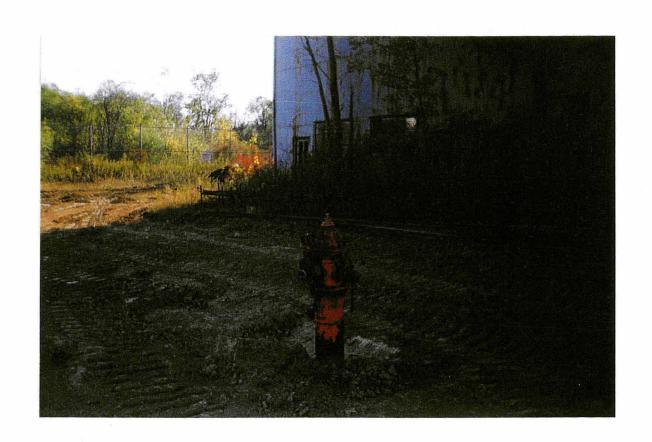
. 4

5.	One fire hydrant was broken off of its sleeve pipe in Area E and the valves of another fire hydrant in Area 18-N were broken. See Exhibit 4, which only includes the second hydrant. This damage further diminishes the value of the site from being a reusable industrial park with safety controls such as fire hydrants.	\$ 350.00 Estimate is based on verbal quote from Churchill Valve Co.

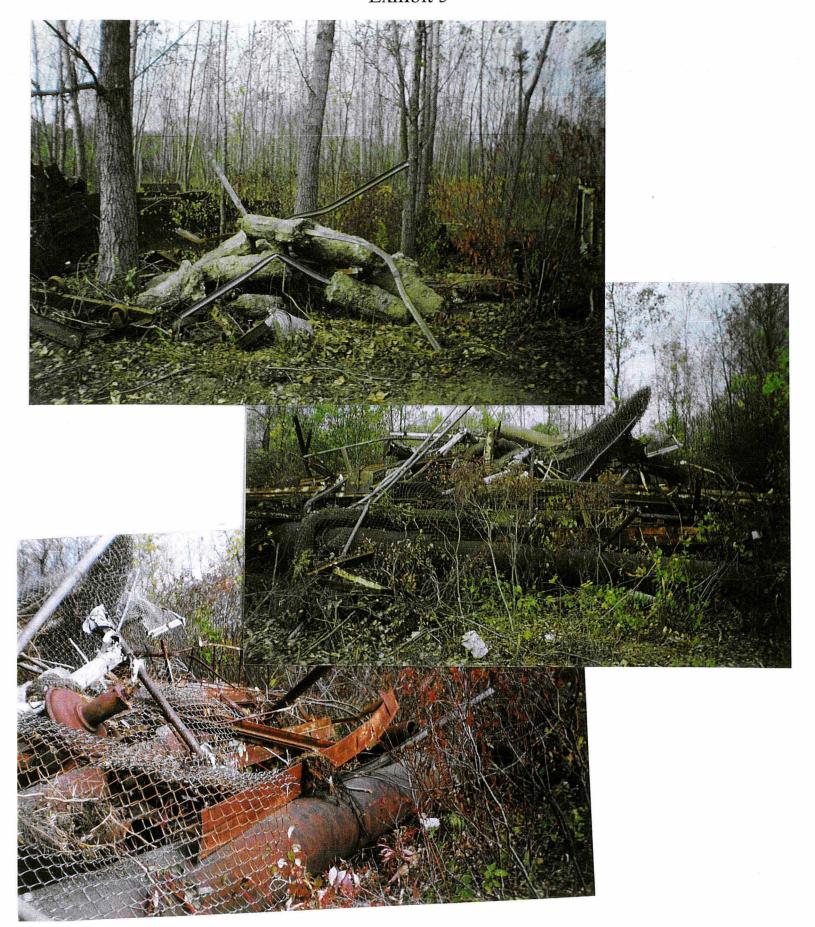
Exhibit 5

7.	The subcontractor intentionally tore down a 16' steel chain link fence and the fence posts that surrounded the power distribution area because the fence allegedly interfered with movement around the site. The fence posts were left on-site in a heap and the fencing material was thrown on another pile of steel parts. See Exhibit 5. [NOTE: Pipes with asbestos wrapping materials are visible in the second photograph].	\$1,600.00 Estimate reflects original value of fencing material and does not reflect current value, which would have been higher

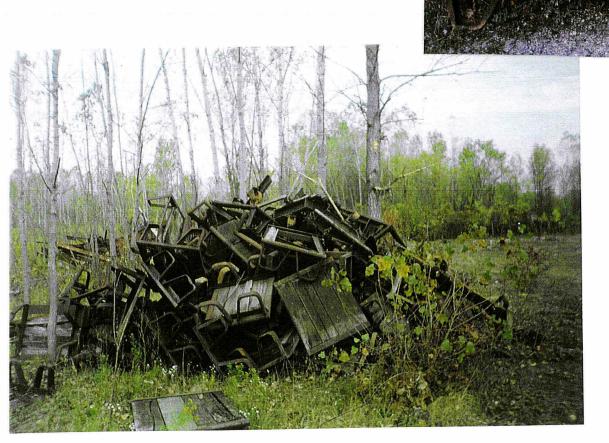
9.	Subcontractors intentionally removed steel that was being stored inside the building in Area 6, pushed the steel into various piles, damaging original steel beams and parts, as well as pallets, in order to sell such material as scrap metal. This work was not necessary to perform under the terms of the contract with the Corps and was done without Somerset Group approval. Mr. Syms, on behalf of Somerset Group and his other businesses, purchased these materials new some years ago. They were rusty but useable before they were pushed into heaps. He did intend to use them someday in the future. The damage to these items has permanently destroyed their usefulness. See Exhibit 7.	\$11,000.00 Estimate is based on original purchase price of steel beams parts and pallets and does not reflect current value, which would have been higher. For example, steel frame pallets were purchased for approx. \$55 each & current price would be approx. \$140

Pallets pushed into pile by Contractor

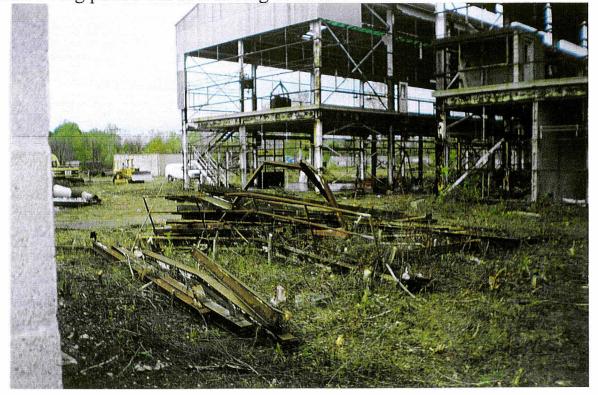
Exhibit 7

Steel Beams Being pulled out of Building in Area 6

Steel Beams & Parts Being Pushed into a Pile by Contractors Equipment

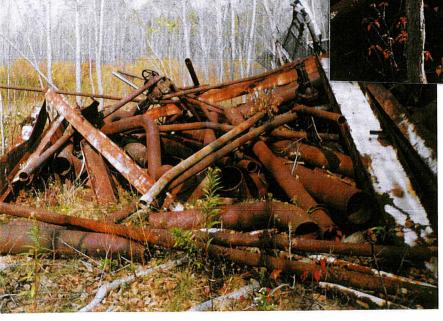
Another view of Material Bent & Destroyed

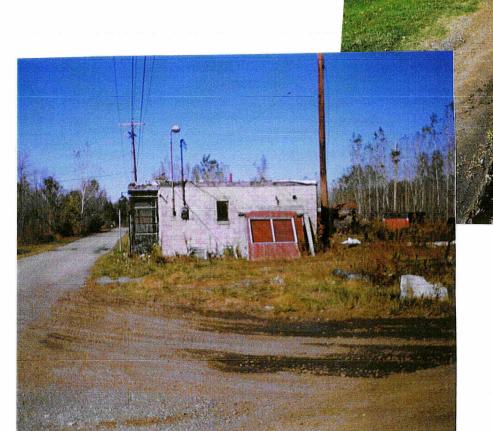
View of Road Section East to West North of Office (roads with (remaining pavement visible)

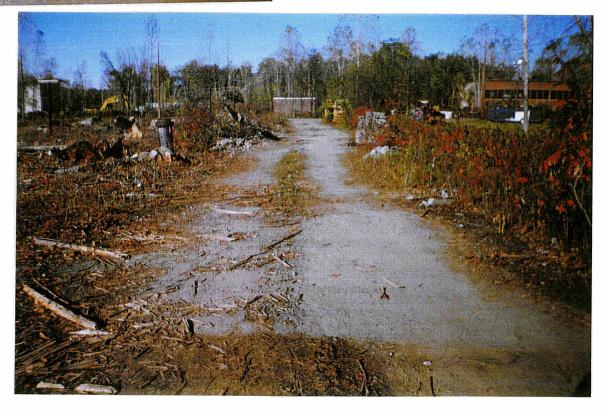
East to West Road South of Office North of Area C

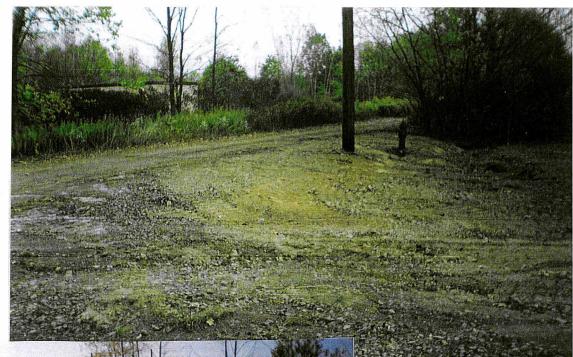
Exhibit 8

Damaged Road West & North of Area 6

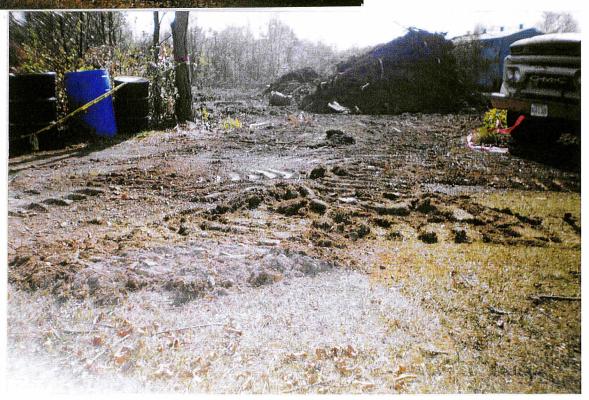
Another view of Damaged Road with Truck

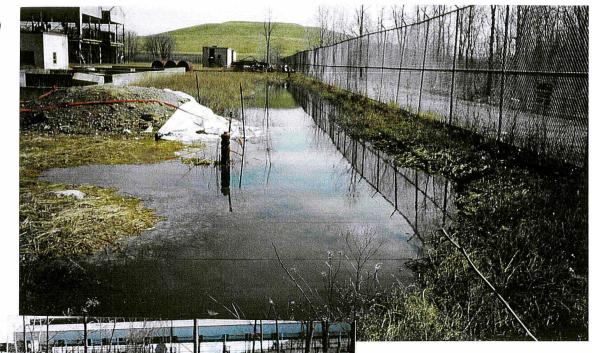
11.	A number of drainage ditches were damaged during the project. Contractors filled in ditches to cross over them and never restored the ditches in accordance with terms of the contract. See Exhibit 9 (page 1). Contractor also removed one culvert pipe, crushed another and plugged one with wood and other debris. See Exhibit 9 (page 2). Please note that 17 dead frogs were found on April 12, 2000 in the ditch near Building 30 A marked in Exhibit 9. The New York State Department of Environmental Conservation informed Mr. Syms that you were made aware of this situation the day after the discovery on April 13, 2000.	\$18,700.00 + \$6,000.00 to replace culverts not included in January 8, 1999 estimate

Flooding from Plugged Ditch at South Fence Line

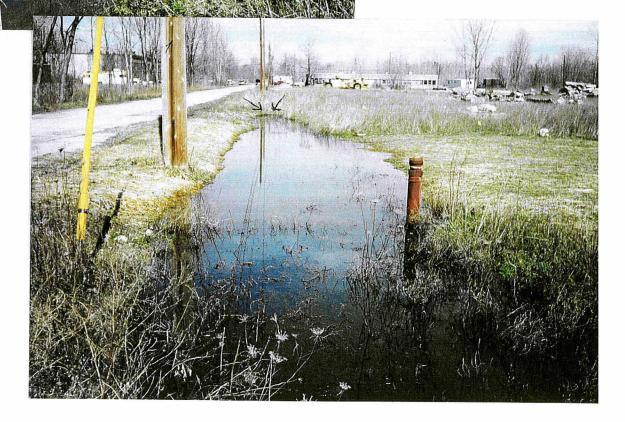
View of Plugged Ditch South of Bldg. 30A; note Debris at East End

On April 12, 2000, 17 dead frogs were found in this ditch.

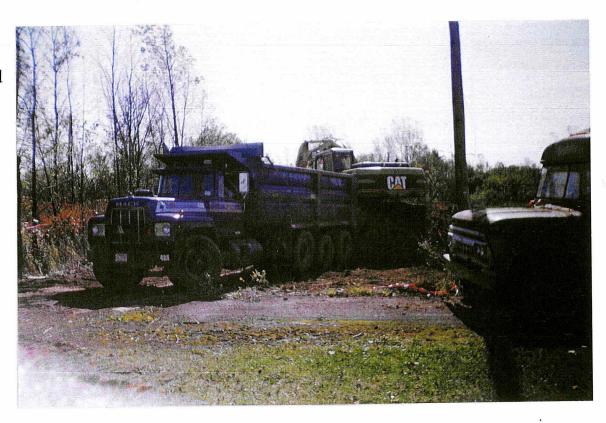
Exhibit 10

DAMAGES	CLAIM
12.	Two final pictures illustrate the sloppy housing practices of the contractors during the project. See Exhibit 10. The first picture shows the contractors driving over contaminated soil, tracking asbestos around the site. This and other violations of law and regulation are revealed in the Army Corps of Engineers inspector report. See Exhibit D. The second picture is outside of an oil tank borrowed from Somerset Group to store the contractors fuel for their vehicles. The contractors never cleaned the fuel oil spilled during their use of the tanks. The fuel oil may have seeped into the ground through any cracks in the concrete.	Damages from these incidents cannot be calculated until these areas are further investigated. Somerset Group believes the remaining on-site asbestos contamination and any fuel oil contamination should be investigated during the RI and reserve the right to renew any claims associated with the incidents revealed in the final two pictures.

Truck Being Loaded on Contaminated Ground Area 18

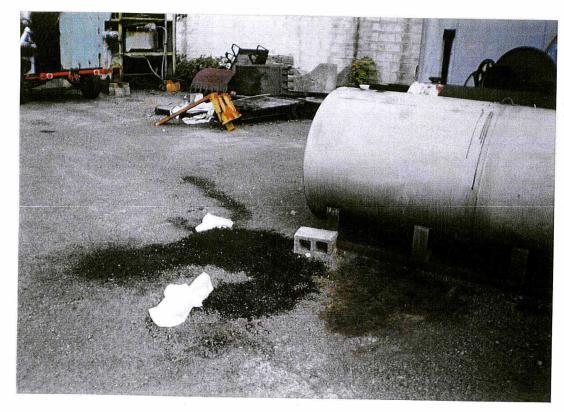
Shot of Fuel Oil Spill In Area West of Bldg. 41
