US Army Corps of Engineers
Buffalo District

NFSS and Surrounding Properties (LOOW)

**Niagara Falls Storage Site
Gamma Walkover Survey**

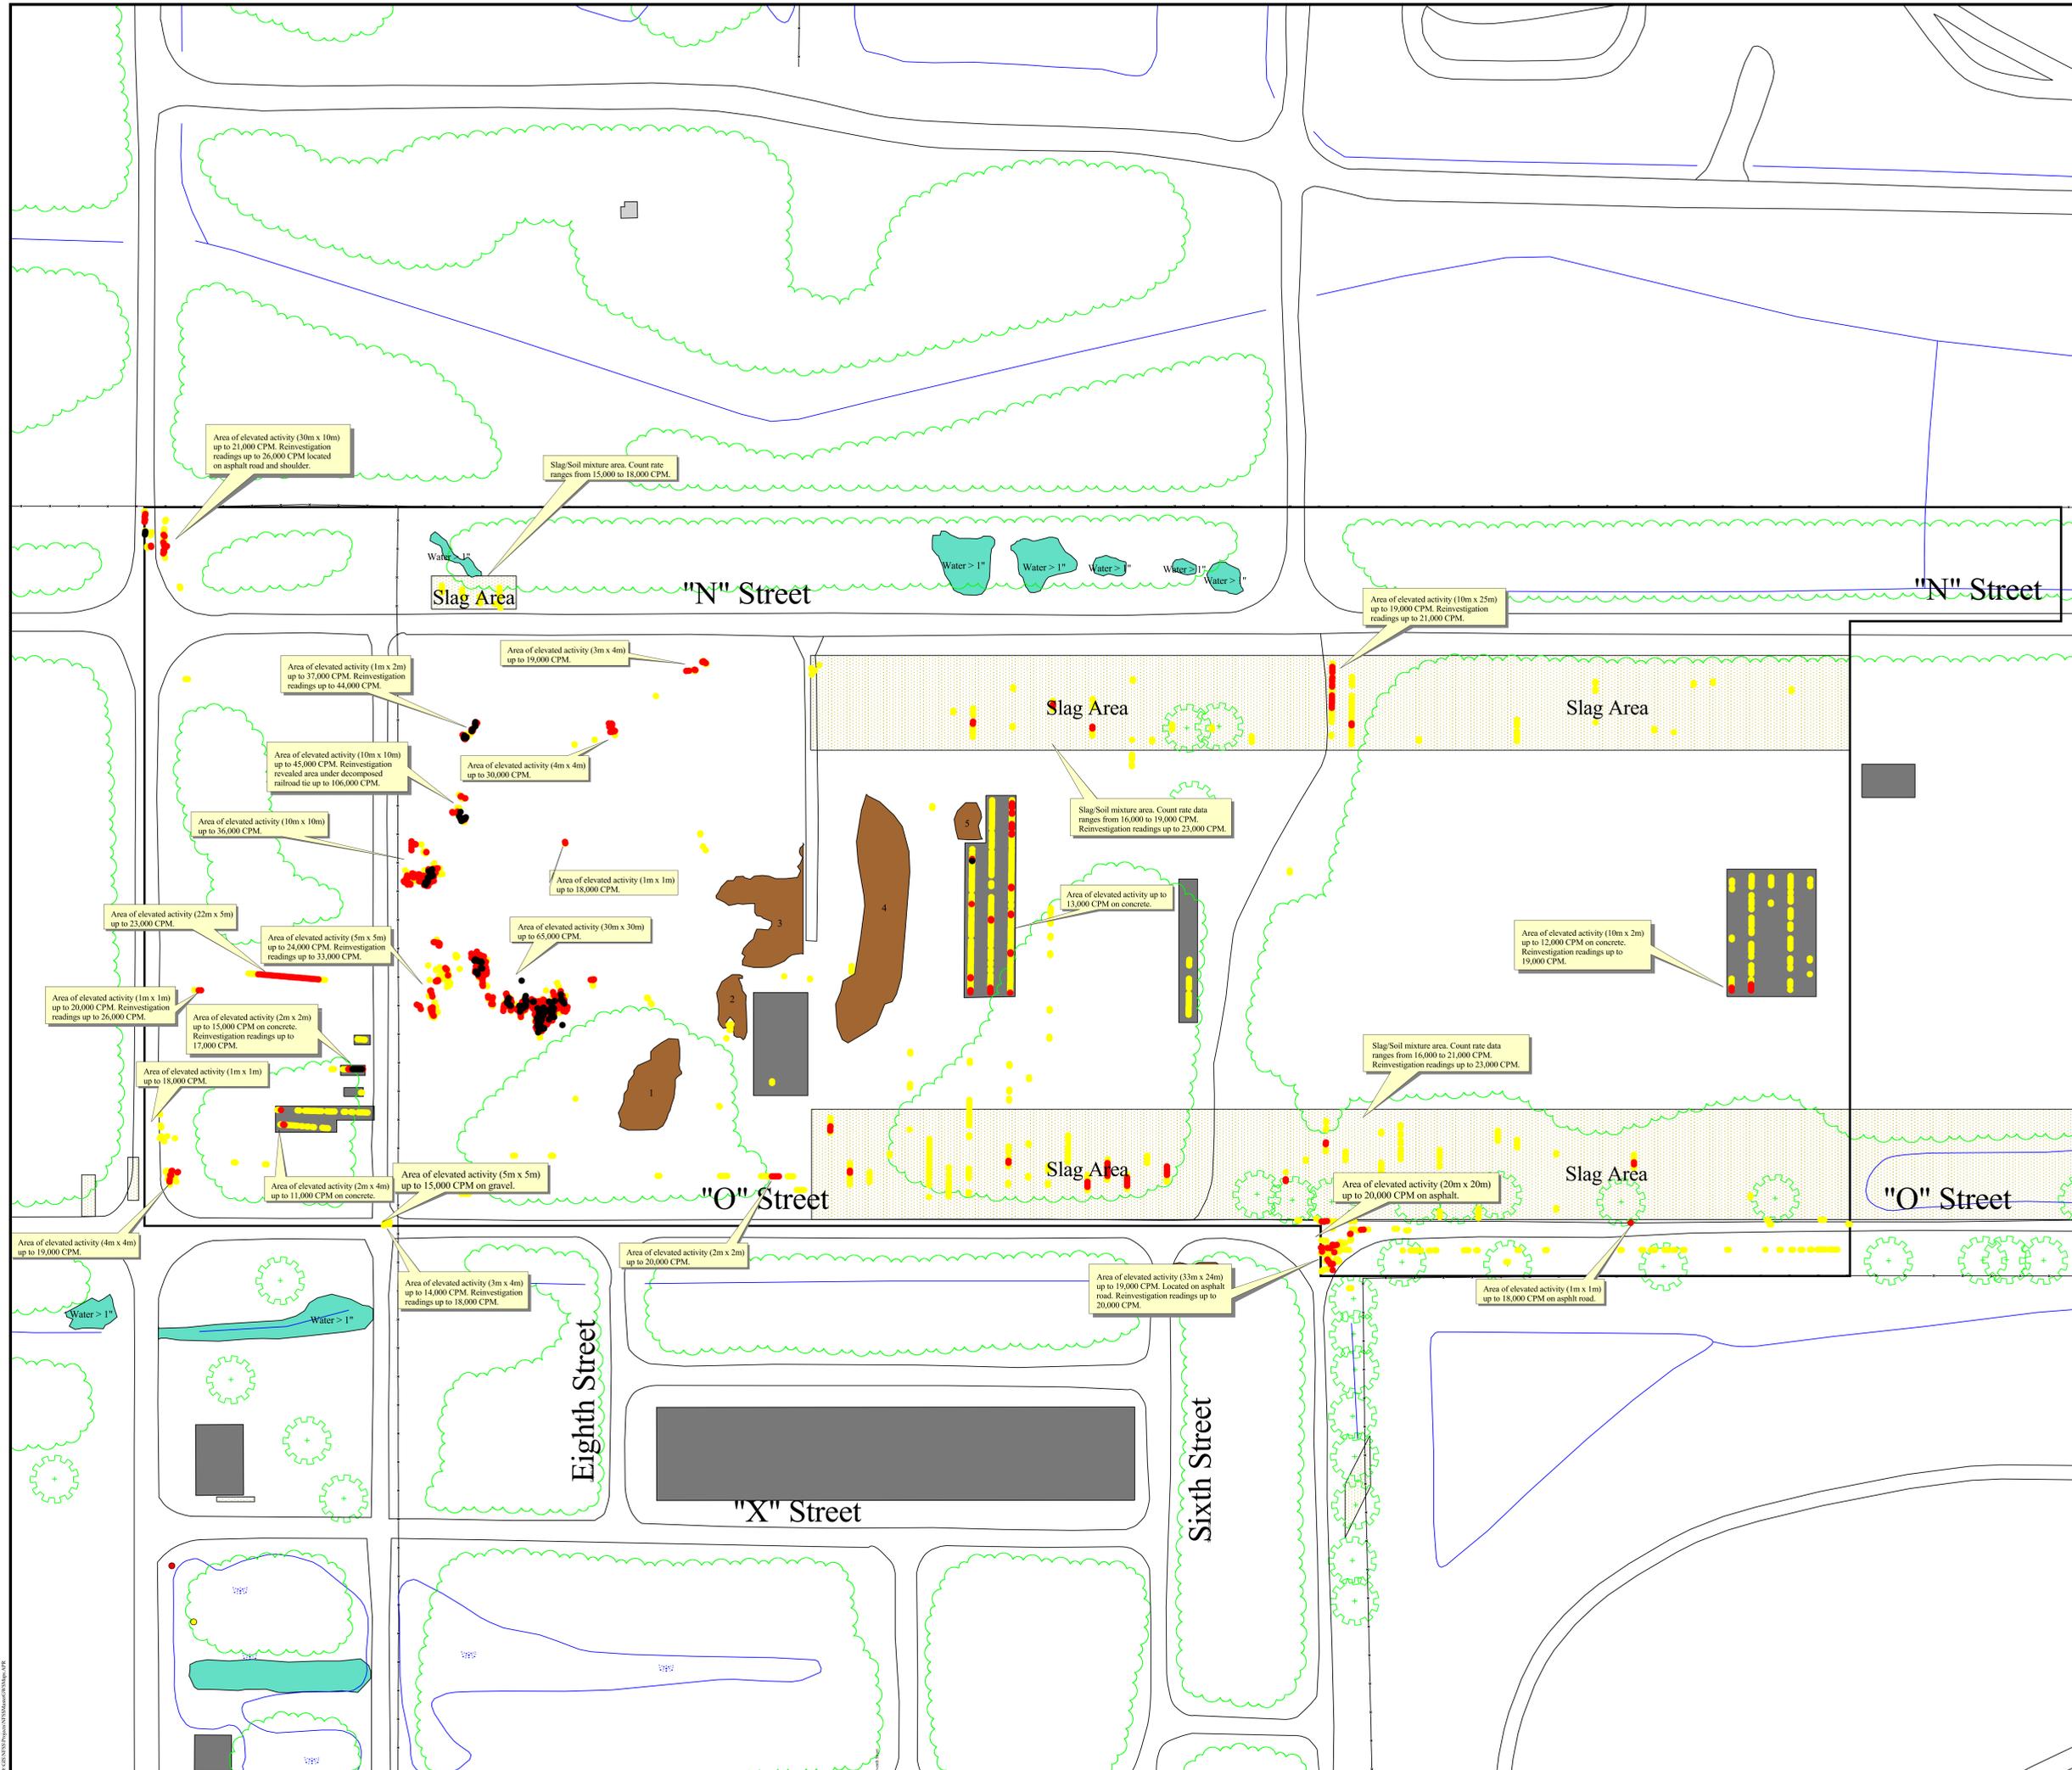
Figure 3-2

- General Notes:
- 1) Debris pile 1: inaccessible due to piles of rebar, concrete, and sharp metal debris.
Debris pile 2: inaccessible due to brush debris mixed with chainlink fencing and concrete piles.
Debris pile 3: inaccessible due to sharp scrap metal concrete pile and old culverts.
Debris pile 4: inaccessible due to concrete piles, asphalt pile and unknown piles of rubble.
Debris pile 5: inaccessible due to concrete piles, asphalt pile and unknown piles of rubble.
 - 2) Natural radioactivity in concrete may be higher than that of reference area concrete.
 - 3) Areas of Slag/Soil use the Soil background.

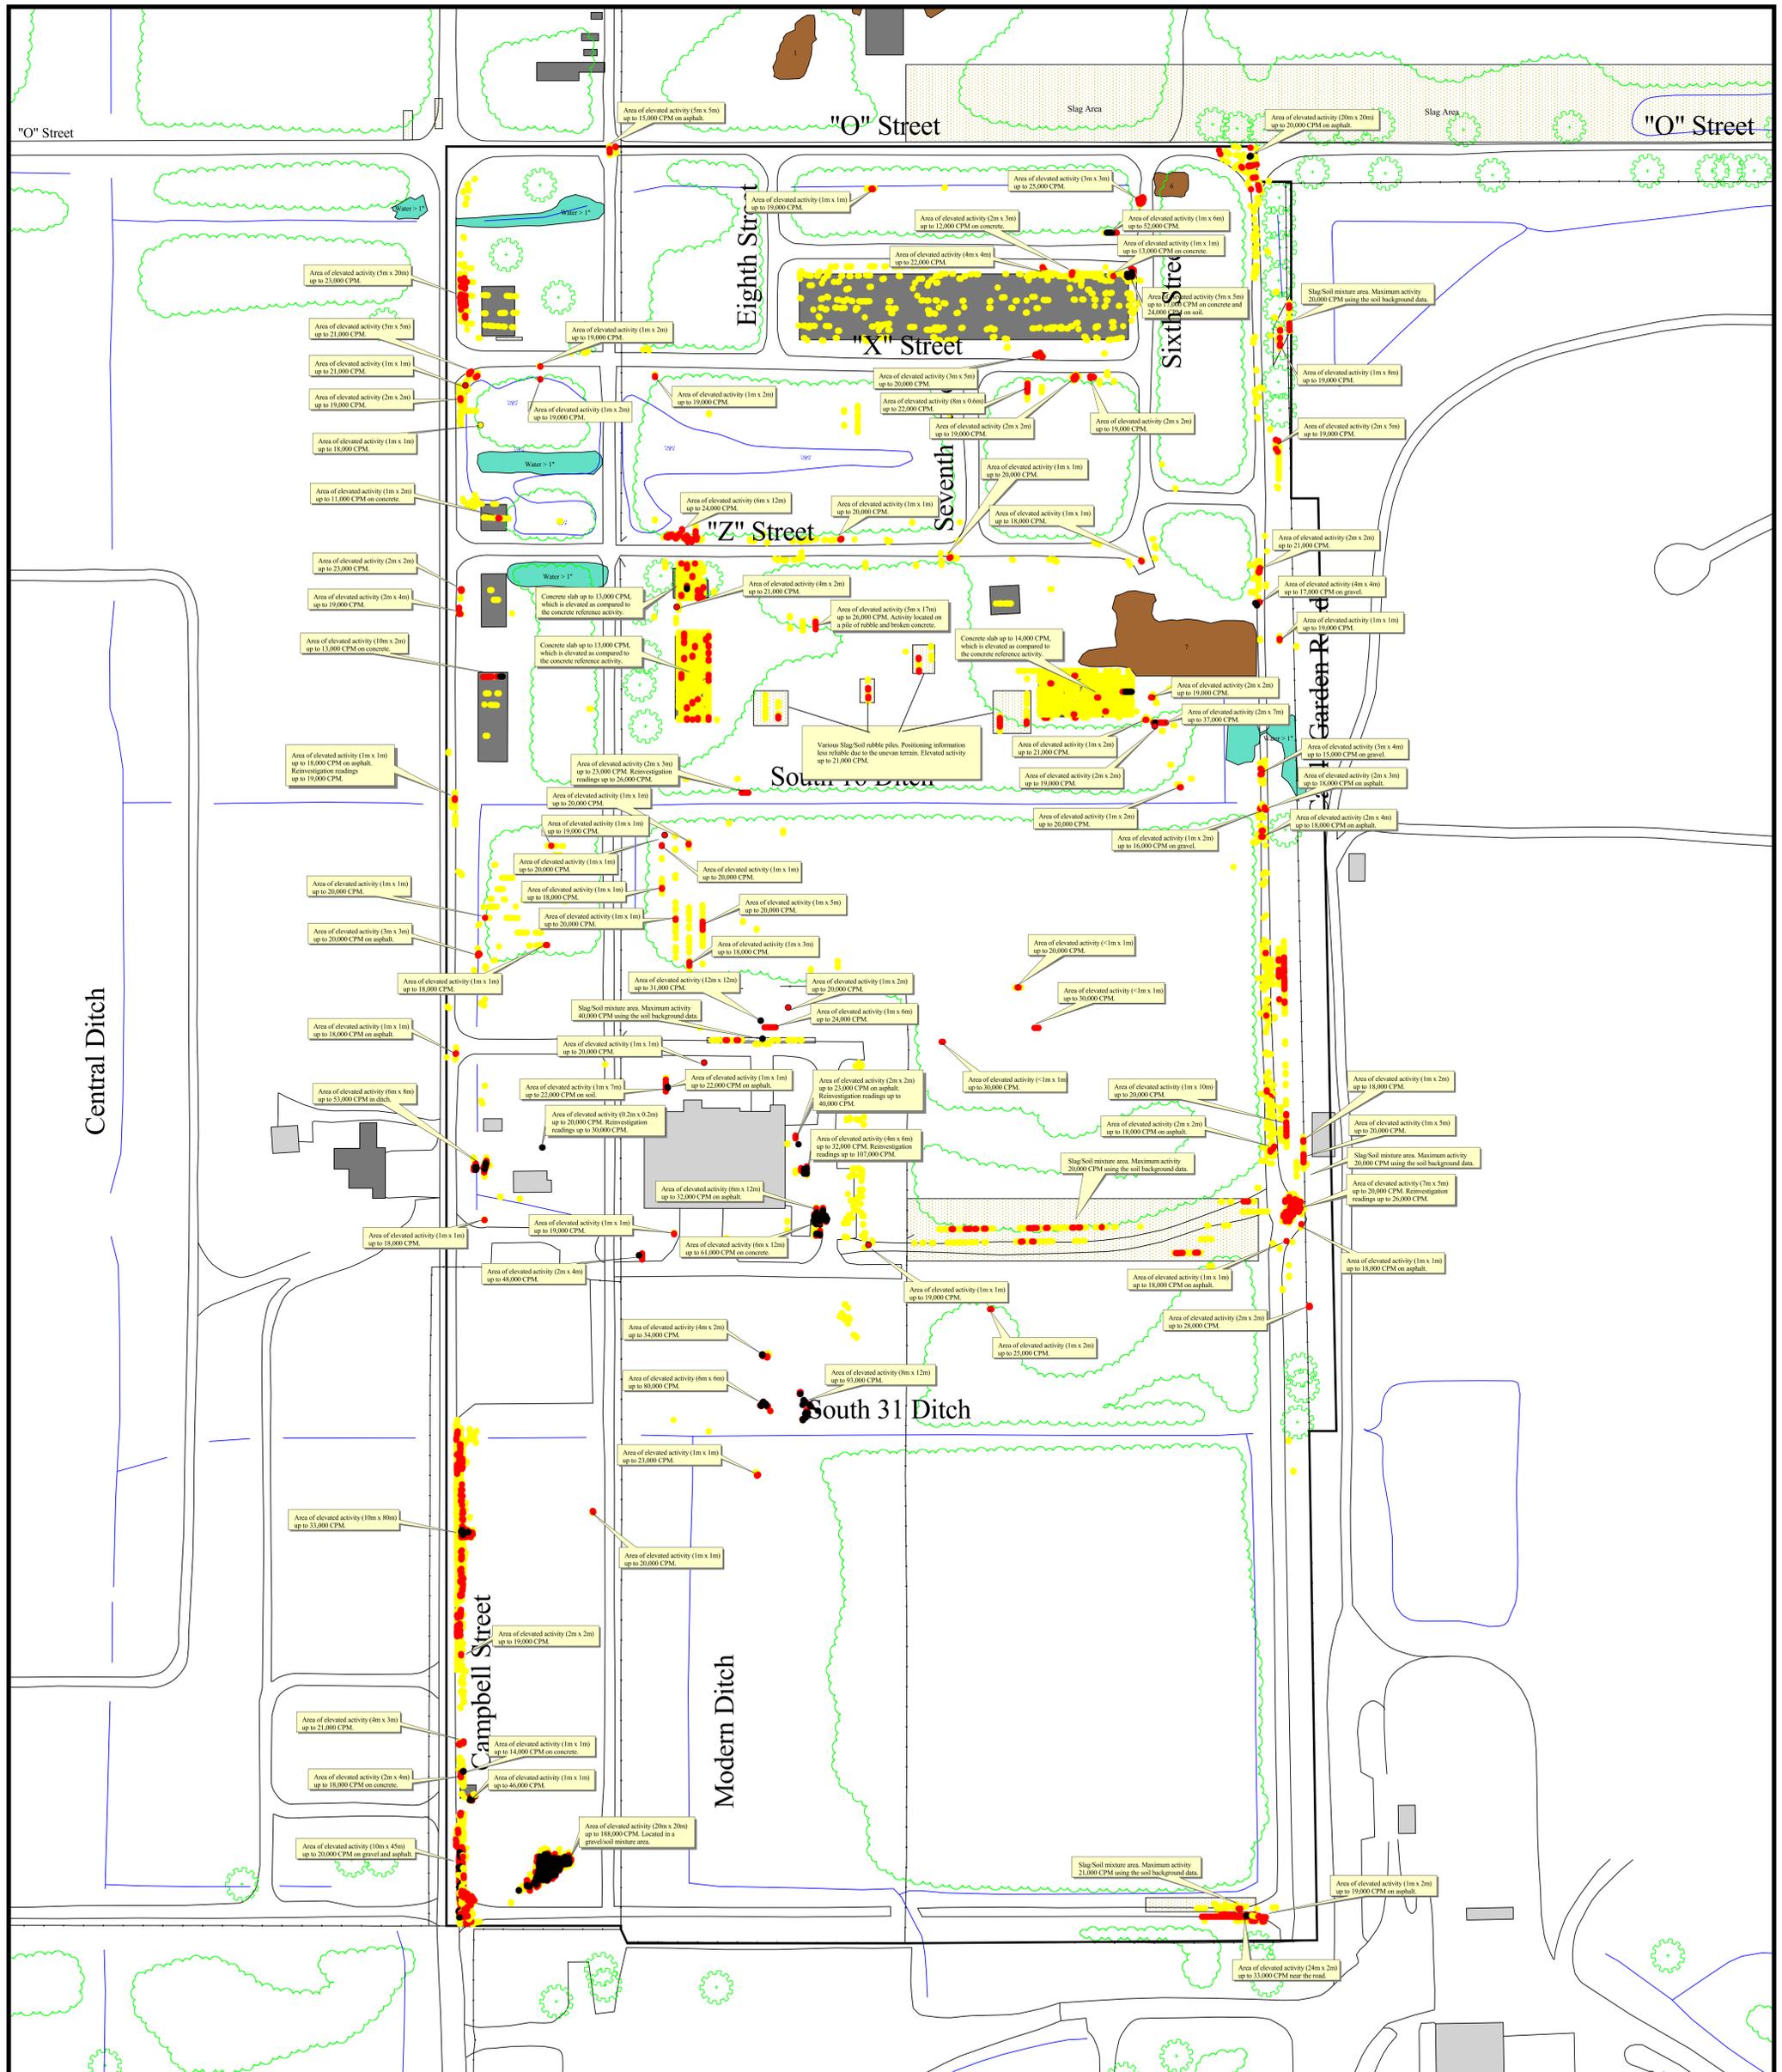
Figure 3-5
 Source: SAIC 2003

General Notes:
 1) Debris pile 6: inaccessible area due to construction and demolition piles including broken concrete with rebar, asphalt piles, and brush piles.
 Debris pile 7: inaccessible area due to construction and demolition piles including broken concrete with rebar, asphalt piles, and brush piles.

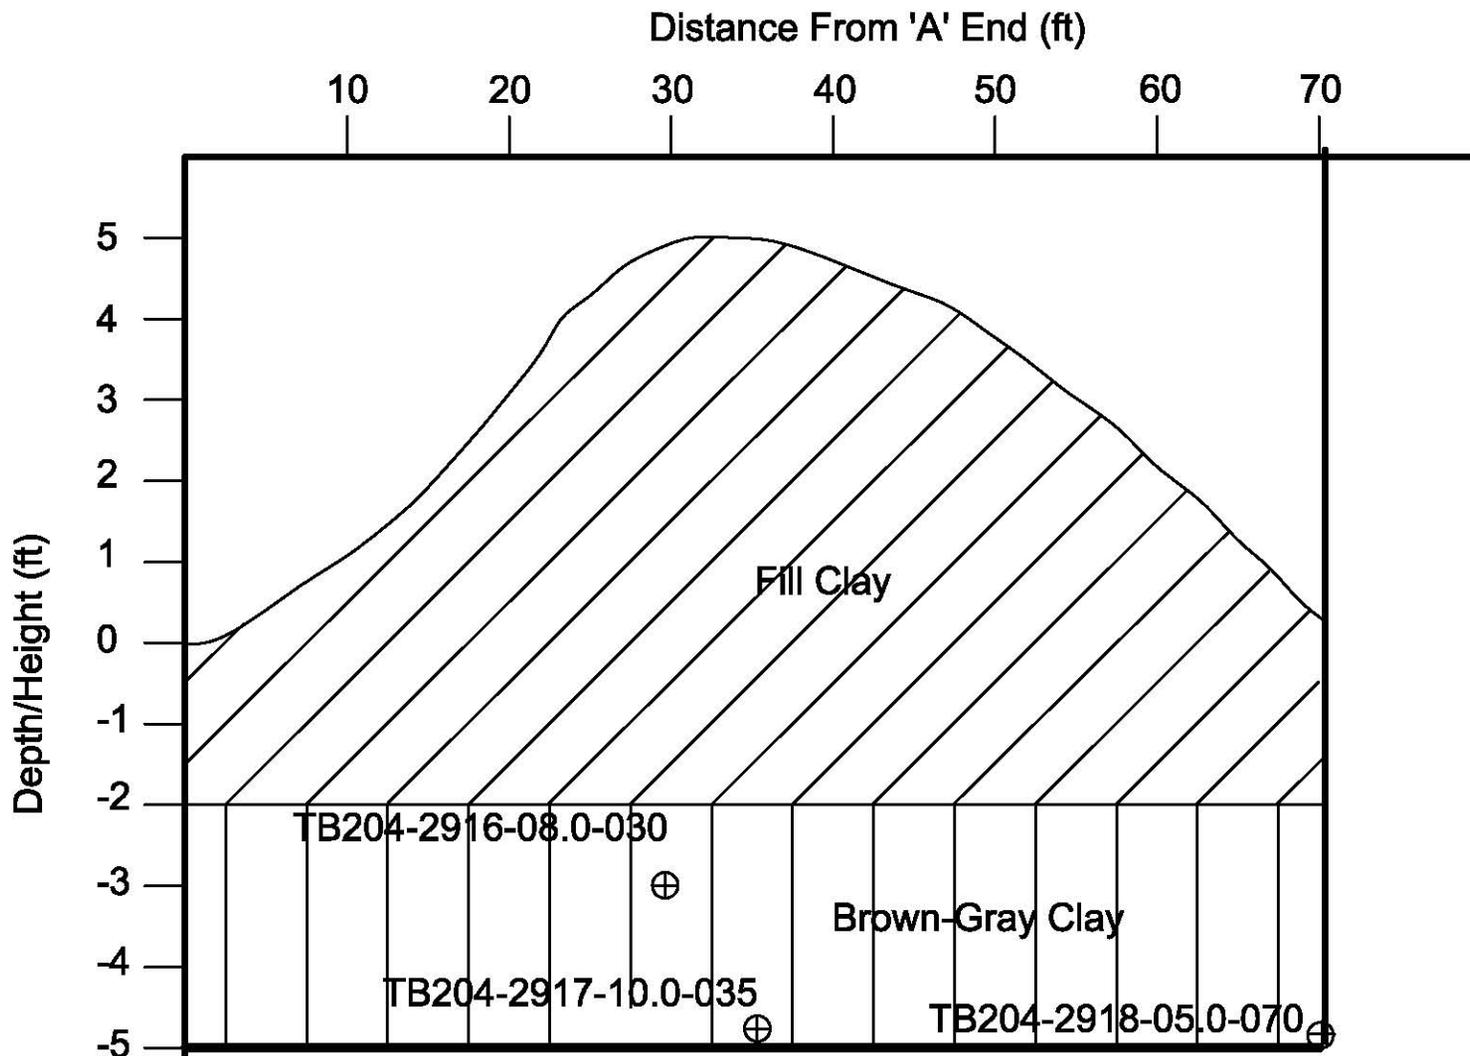
TRENCH 204
 NIAGARA FALLS STORAGE SITE

Trench 204
 Trench Length: 70'
 Trench Depth: 10'

Notes: Trench excavated through spoils pile located south of building 401.
 No Magnetic Anomalies Found
 No Gamma Radiation Exceeded Background
 No Elevated PID measurements

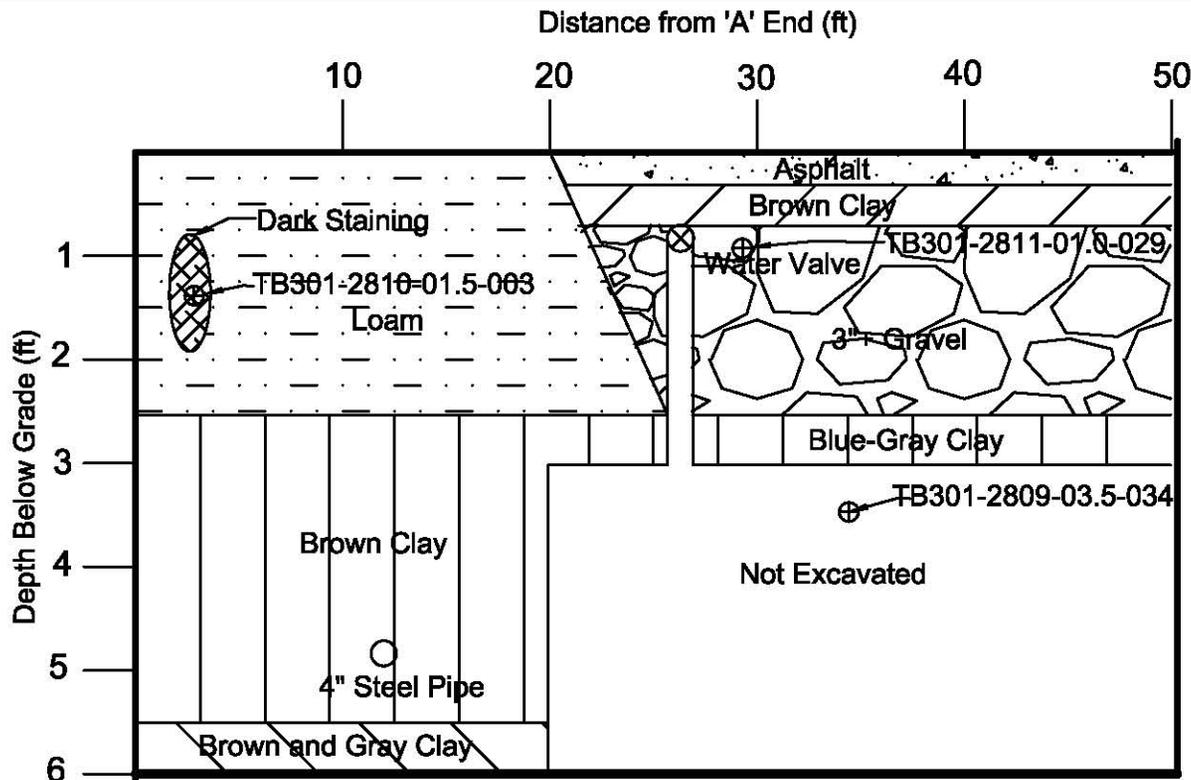
Trench 301
 Trench Length: 50'
 Trench Depth: 7'

Notes: Because of Infiltrating groundwater trench not excavated below 3' BGL between 0+20' and 0+50'
 Trench not excavated below 1' BGL from 0+27' to 0+28' because of water valve.
 Gamma hotspot of 31kcpm detected and sampled at 0+29'
 No elevated PID measurements
 Magnetic anomalies detected between 0+00' and 0+20'.
 Attributed to steel pipe and rebar.

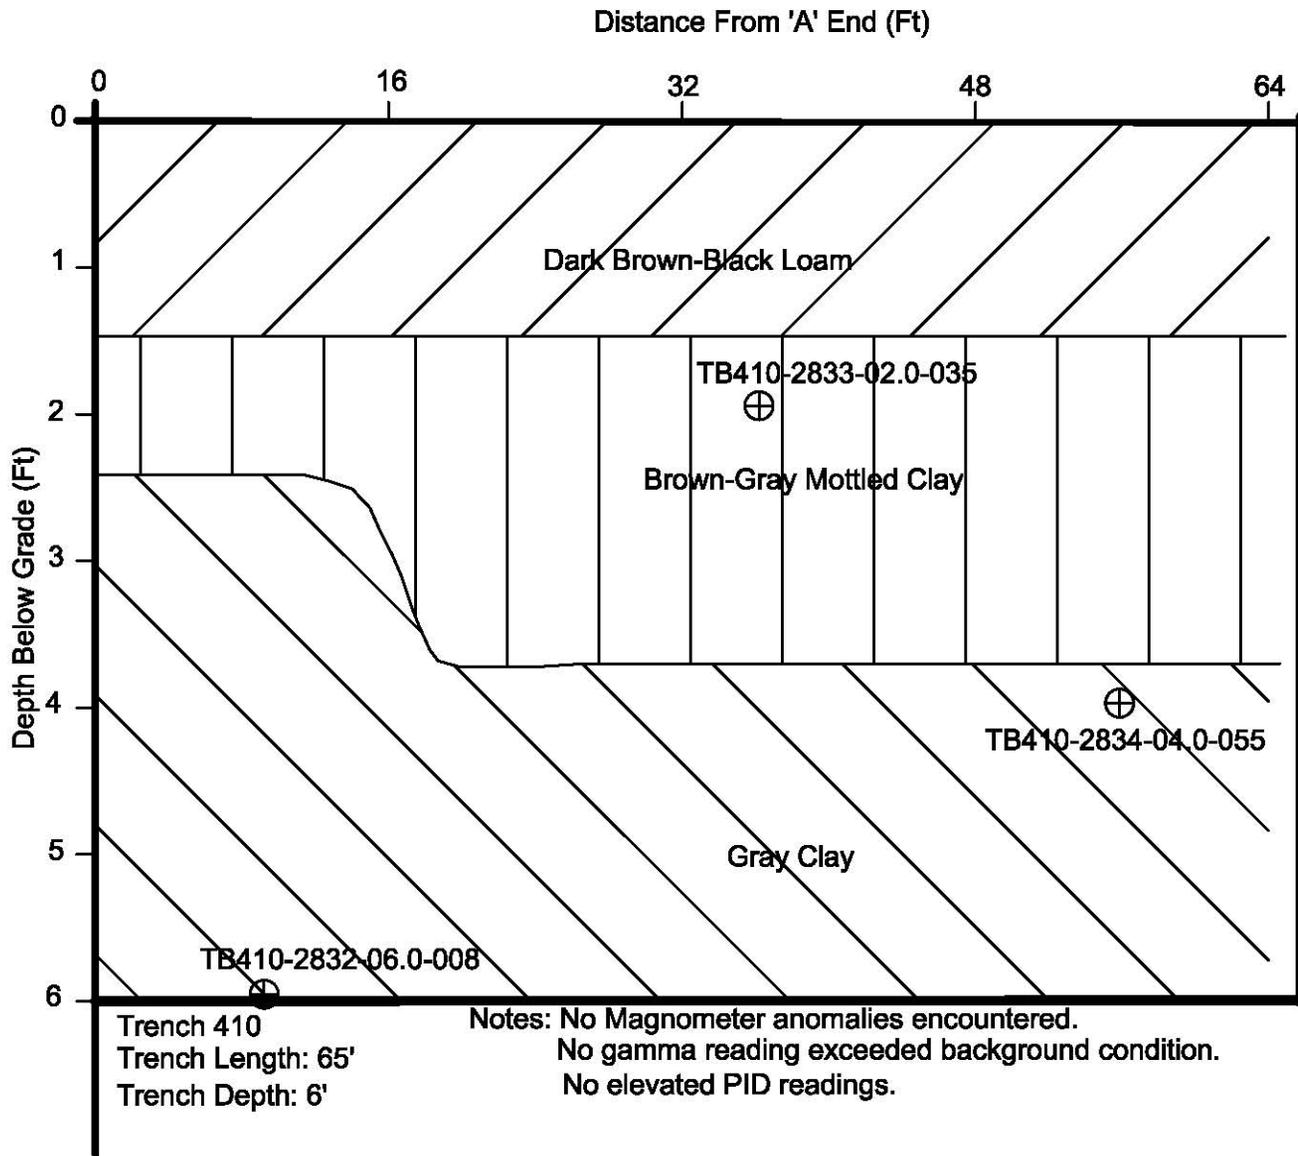
Trench 410
 Trench Length: 65'
 Trench Depth: 6'

Notes: No Magnometer anomalies encountered.
 No gamma reading exceeded background condition.
 No elevated PID readings.

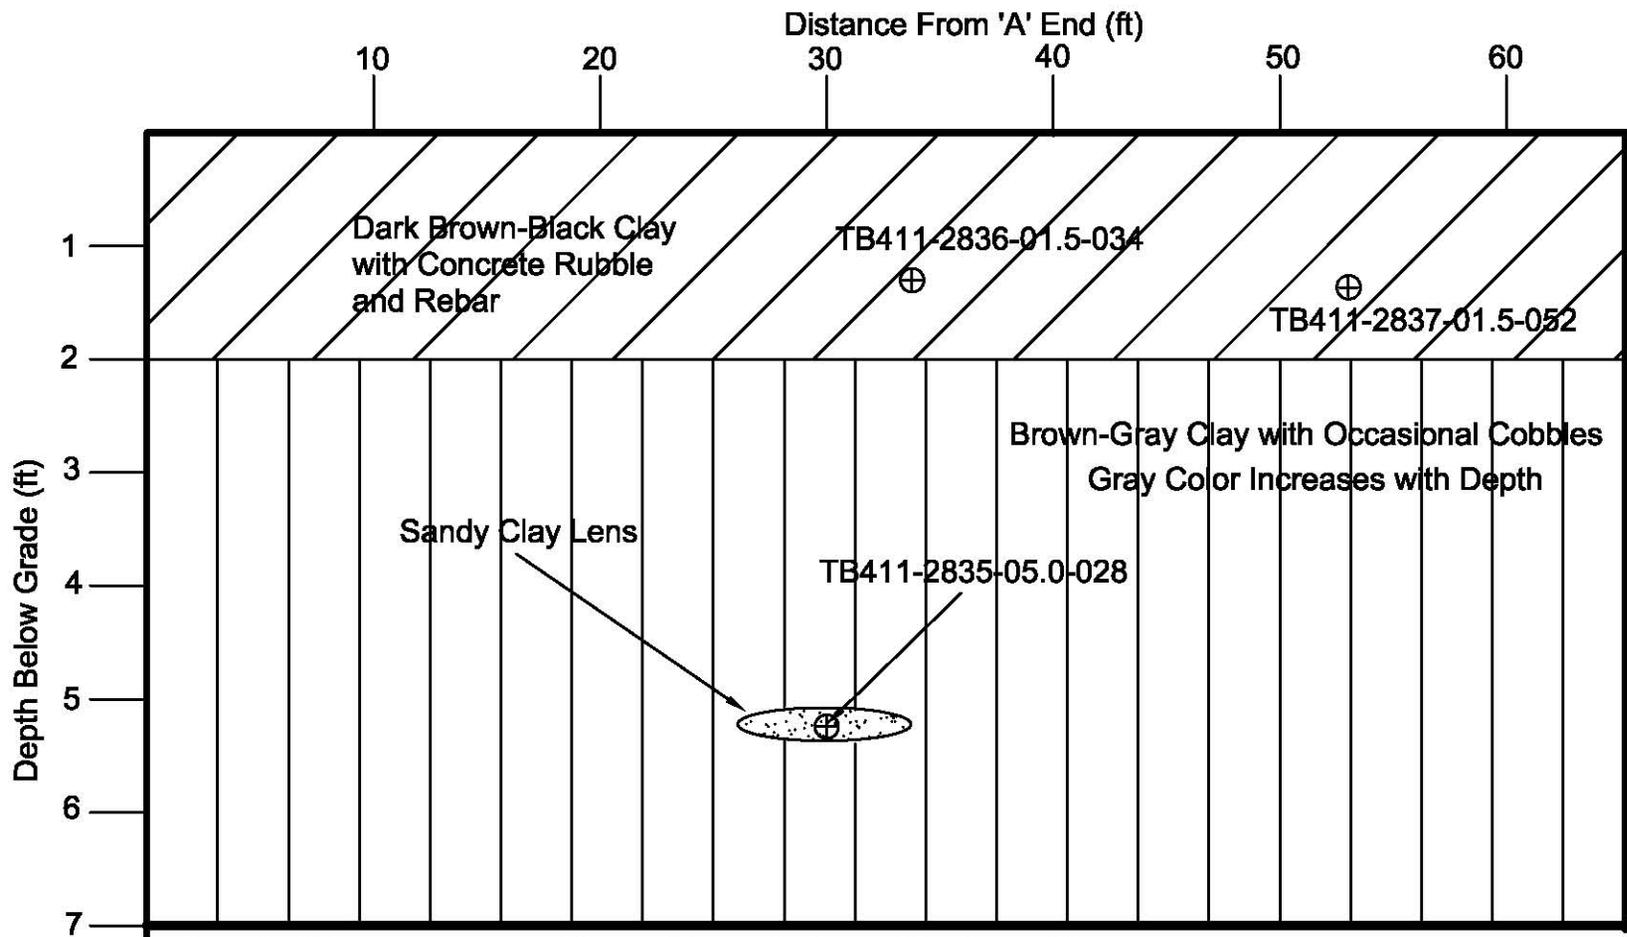
Trench 411
 Trench Length: 65'
 Trench Depth: 7'

Notes: Magnetic Anomalies in top 2'
 caused by rebar
 No Elevated PID measurements
 Gamma Radiation at TB411-2836
 -01.5-034 was 17.5 kcpm
 Gamma radiation at TB411-2837
 -01.5-052 was 20 kcpm
 Gamma radiation at other location
 was at or below background

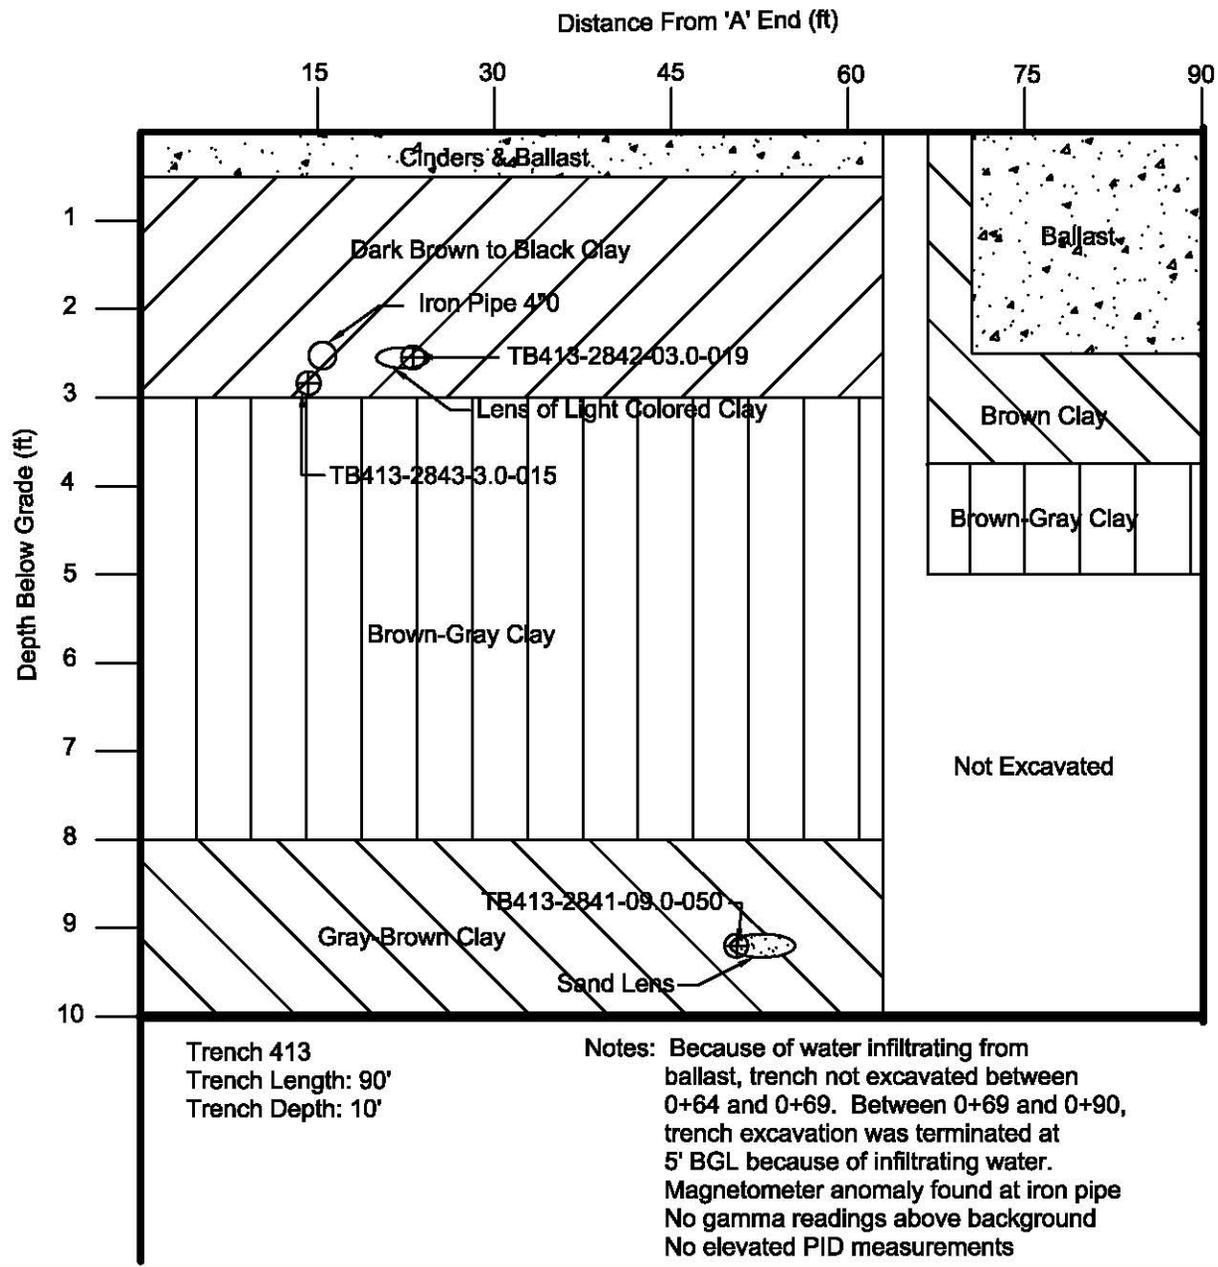
Trench 413
 Trench Length: 90'
 Trench Depth: 10'

Notes: Because of water infiltrating from ballast, trench not excavated between 0+64 and 0+69. Between 0+69 and 0+90, trench excavation was terminated at 5' BGL because of infiltrating water. Magnetometer anomaly found at iron pipe. No gamma readings above background. No elevated PID measurements.

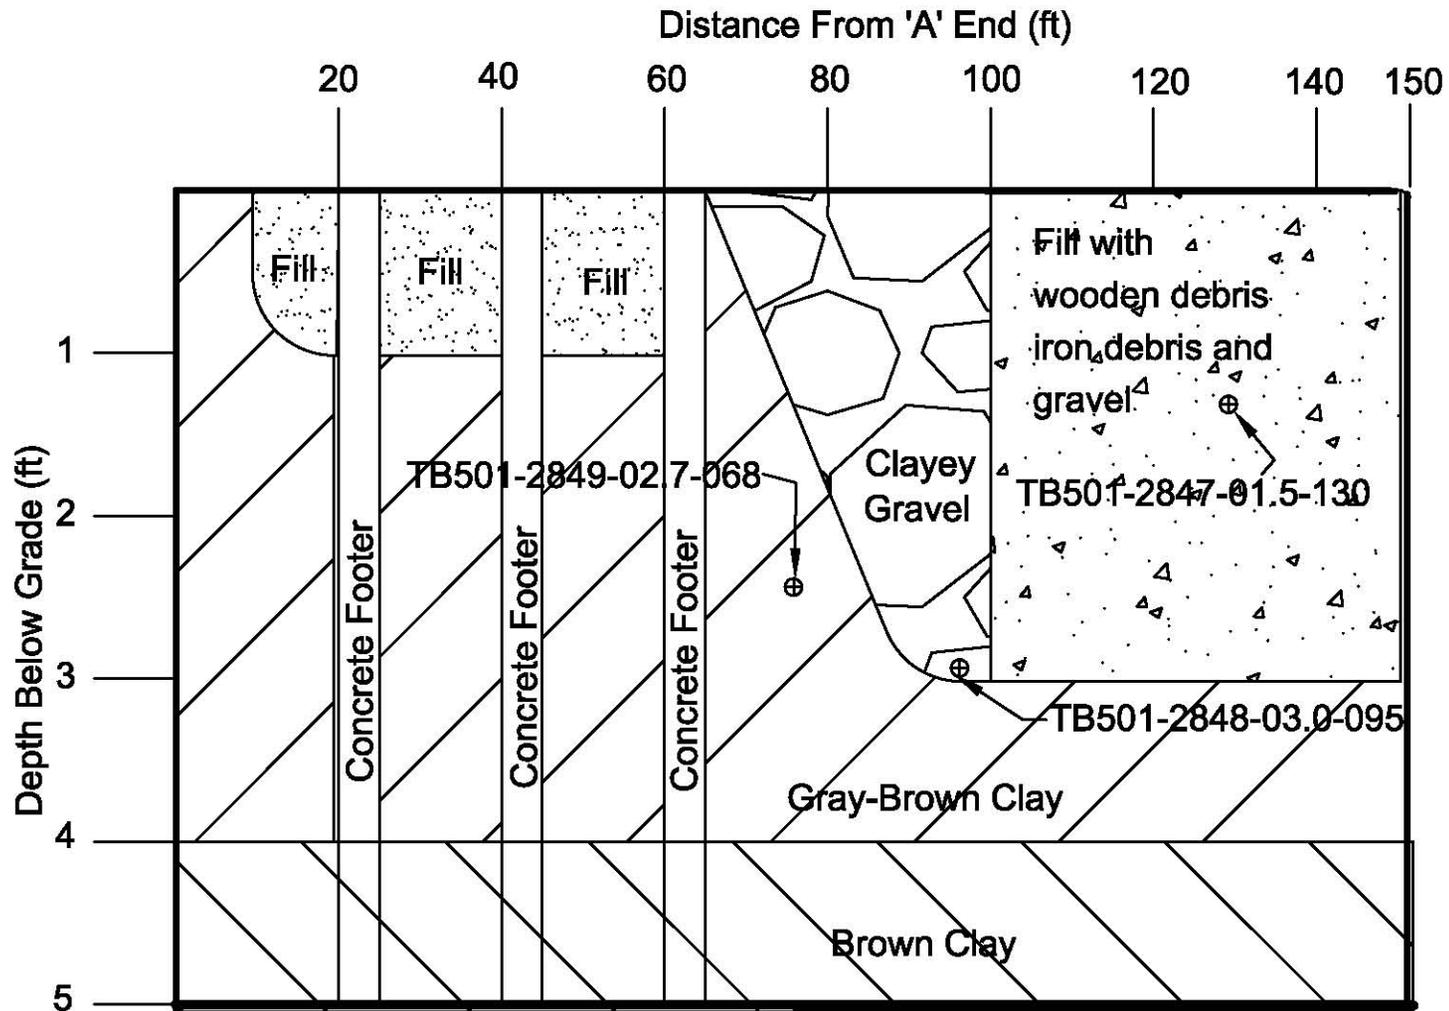
Trench 501
 Trench Length: 150'
 Trench Depth: 5'

Notes: Numerous small metallic items found especially prevalent between 1+35' and 1+50'
 No elevated gamma readings.
 No elevated PID measurements

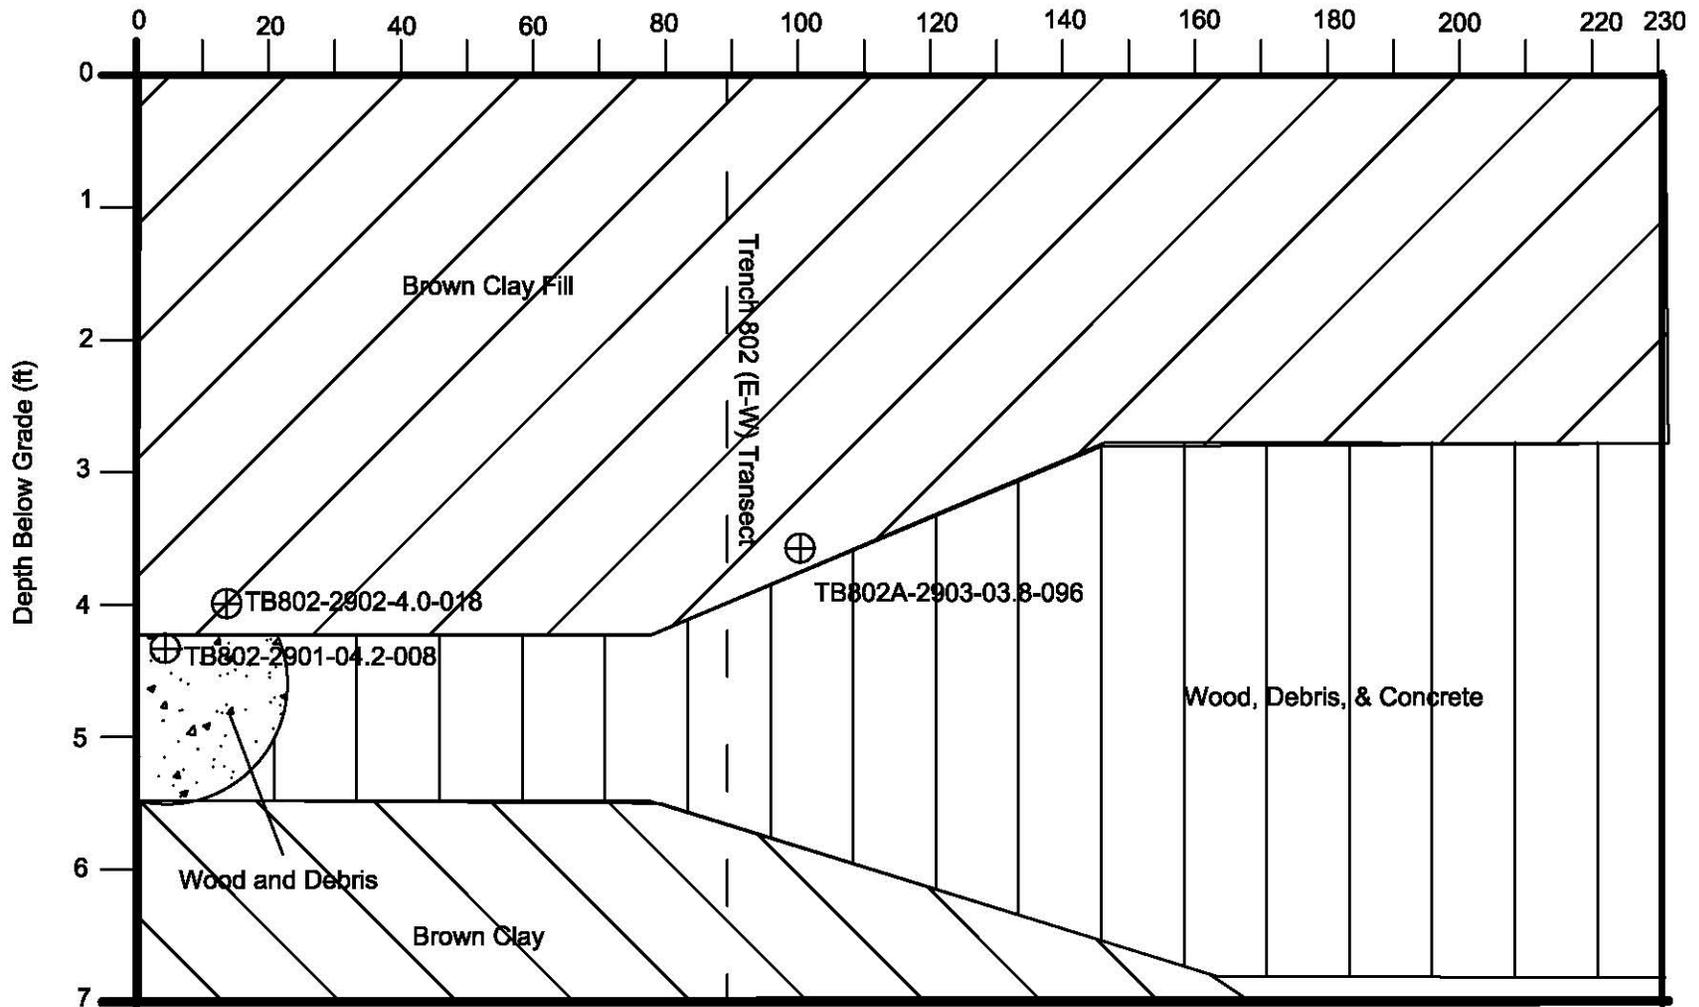
Trench 802 (N-S)
Trench Length: 230'
Trench Depth: 7'

Notes: Numerous magnetic anomalies from debris.
Numerous elevated gamma readings.
Fill and debris from 0+00 to 0+230, surface to approx 6'.

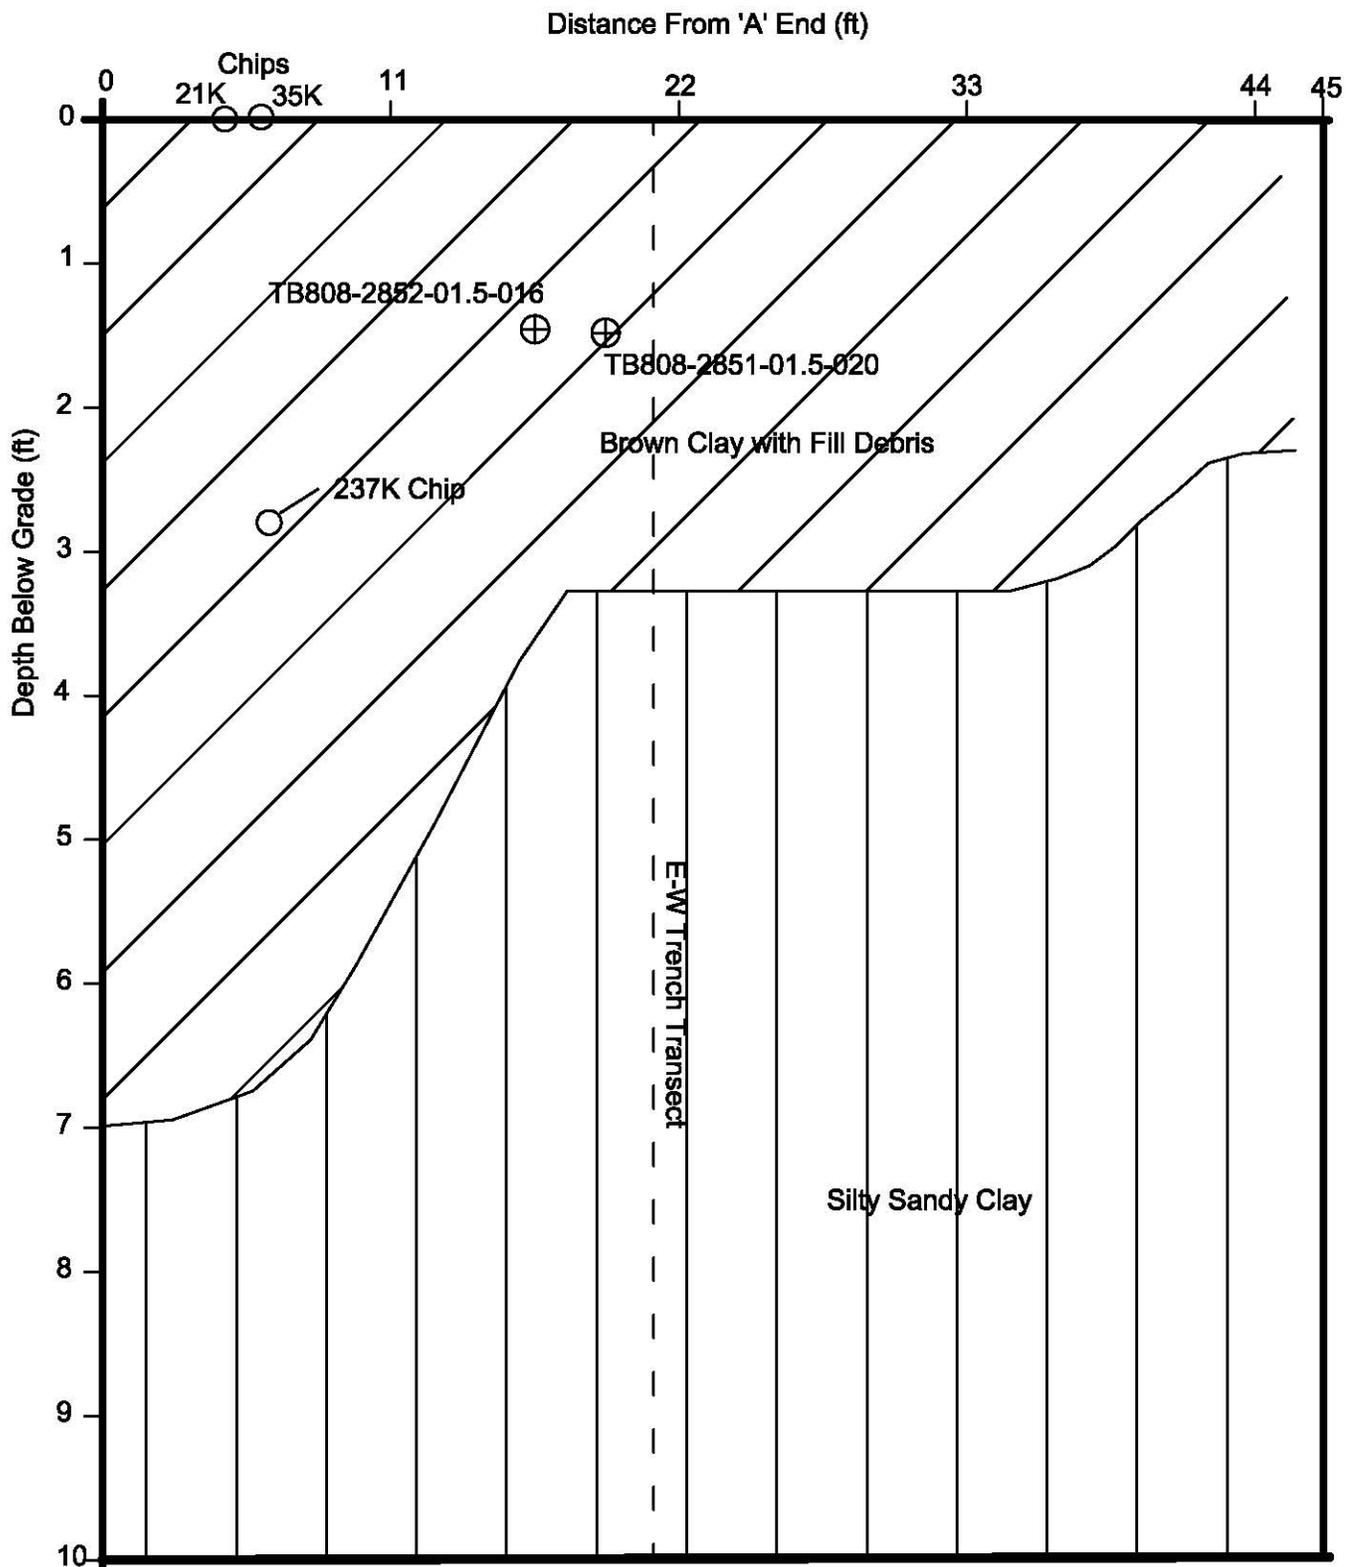
Trench 808
 Trench Length: 45'
 Trench Depth: 10'

Notes: No magnetic anomalies.
 Several chips found with elevated gamma readings.
 No elevated PID readings.

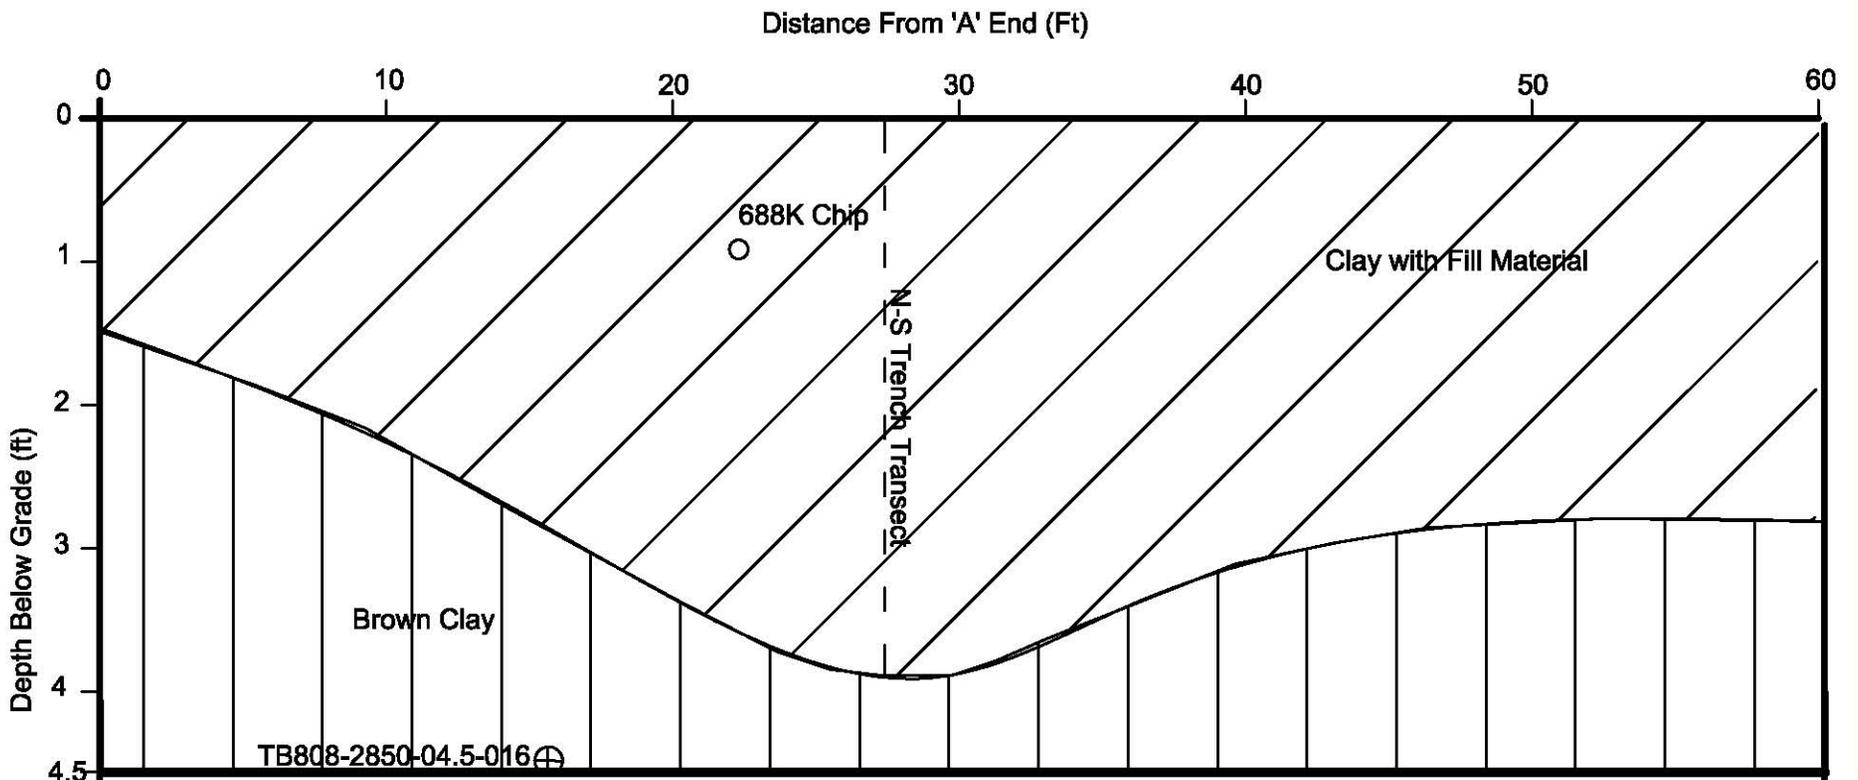
Trench 808 (E-W)
 Trench Length: 60'
 Trench Depth: 4.5'

Notes: Several small magnetic anomalies.
 Slightly elevated gamma readings in trench wall at 0+21, 2.3' deep.
 No elevated PID readings.
 3 Chips found
