**U.S. Department of Energy  
Office of Environmental Management**

**Type B Accident Investigation Report**

**Radiological Contamination Event  
During Separations Process Research  
Unit Building H2 Demolition  
September 29, 2010**

**November 23, 2010**

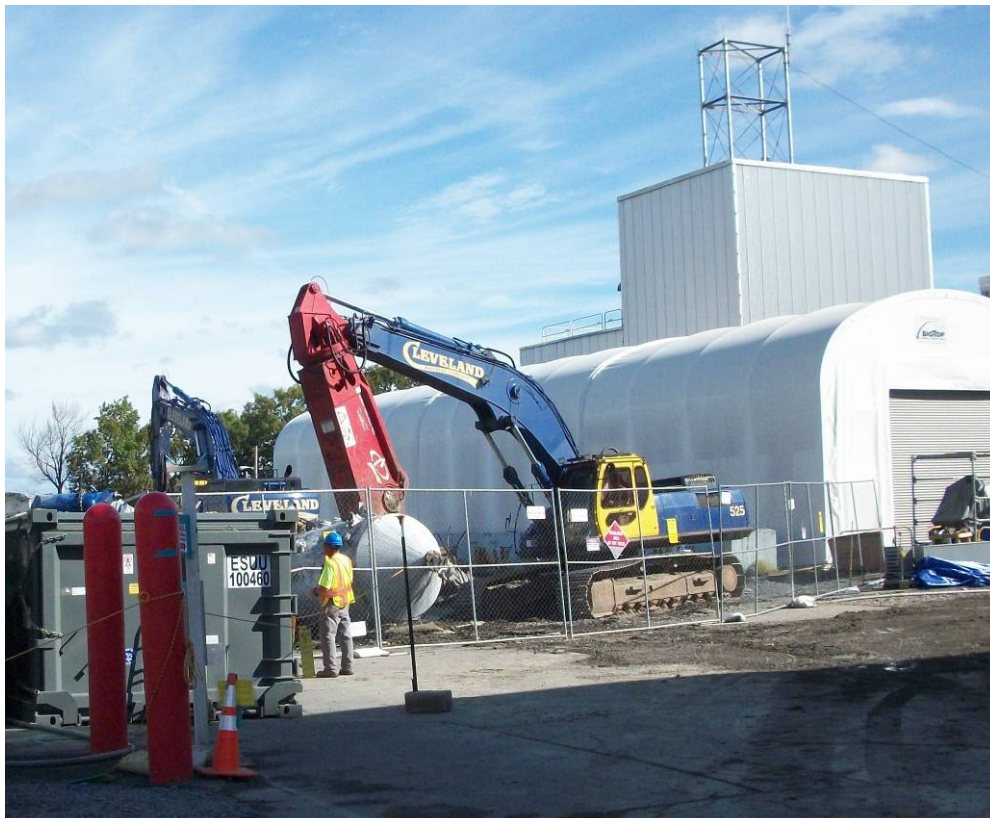
Following the meeting, the Cleveland Wrecking work group, with WGI concurrence, proceeded to remove the following components from the north end of building footprint: evaporator condensers/columns 221-A and 221-B, and columns 112-A, 112-B, and 113-B, which extended from the lower elevations of the building up above ground level, and size reduced condenser/columns 221-A, 221-B, and column 113-B prior to identifying the spread of contamination event.

**Figure 2-3: Flash Column being Size Reduced**

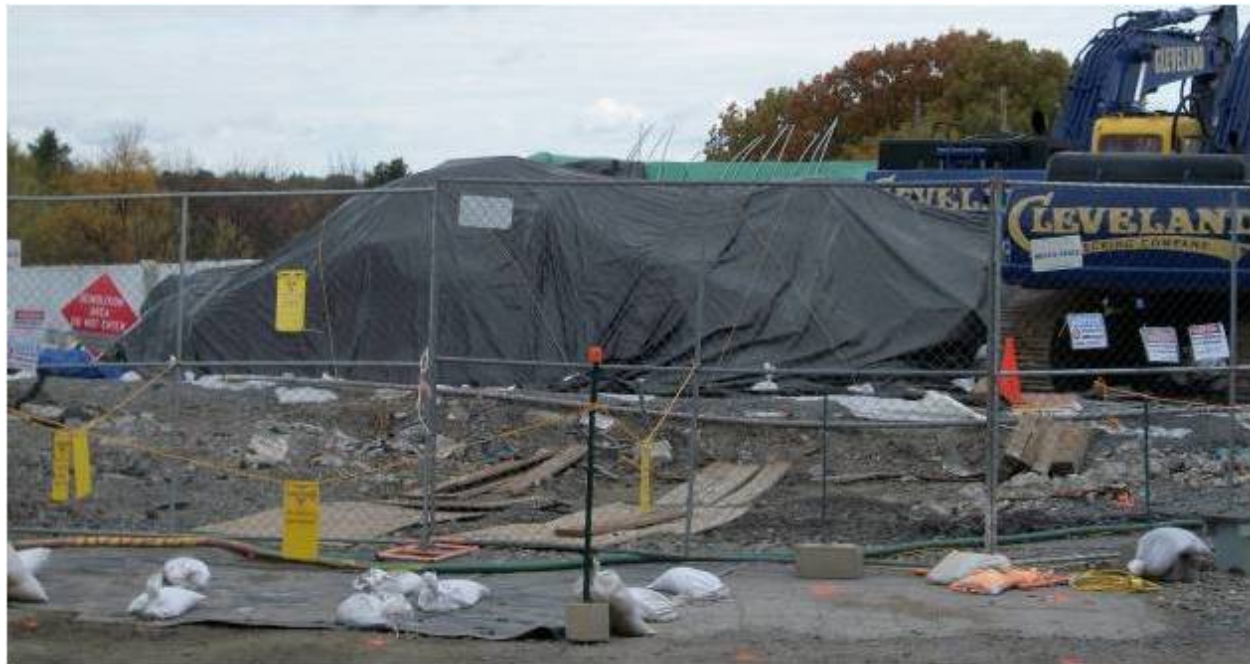
Building H2 debris was stabilized by moving all of the waste into a pile within the footprint with heavy equipment. Fixative was liberally applied to the pile several times. After Tropical Storm Nicole passed, openings in process system columns were covered. Several days later the sharp edges were mitigated by placing pallets and hay bales where potential problems were identified prior to covering the debris pile with tarps. Layers of tarps were then placed over the pile and secured with sandbags. A John Deere excavator was surveyed and released from the area to the south end of the building. Building H2 footprint remains posted as a Contamination Area. D&D operations remain suspended, pending completion of a comprehensive corrective action plan.

**Figure 2-4: Building Footprint Taken Afternoon of October 23, 2010**

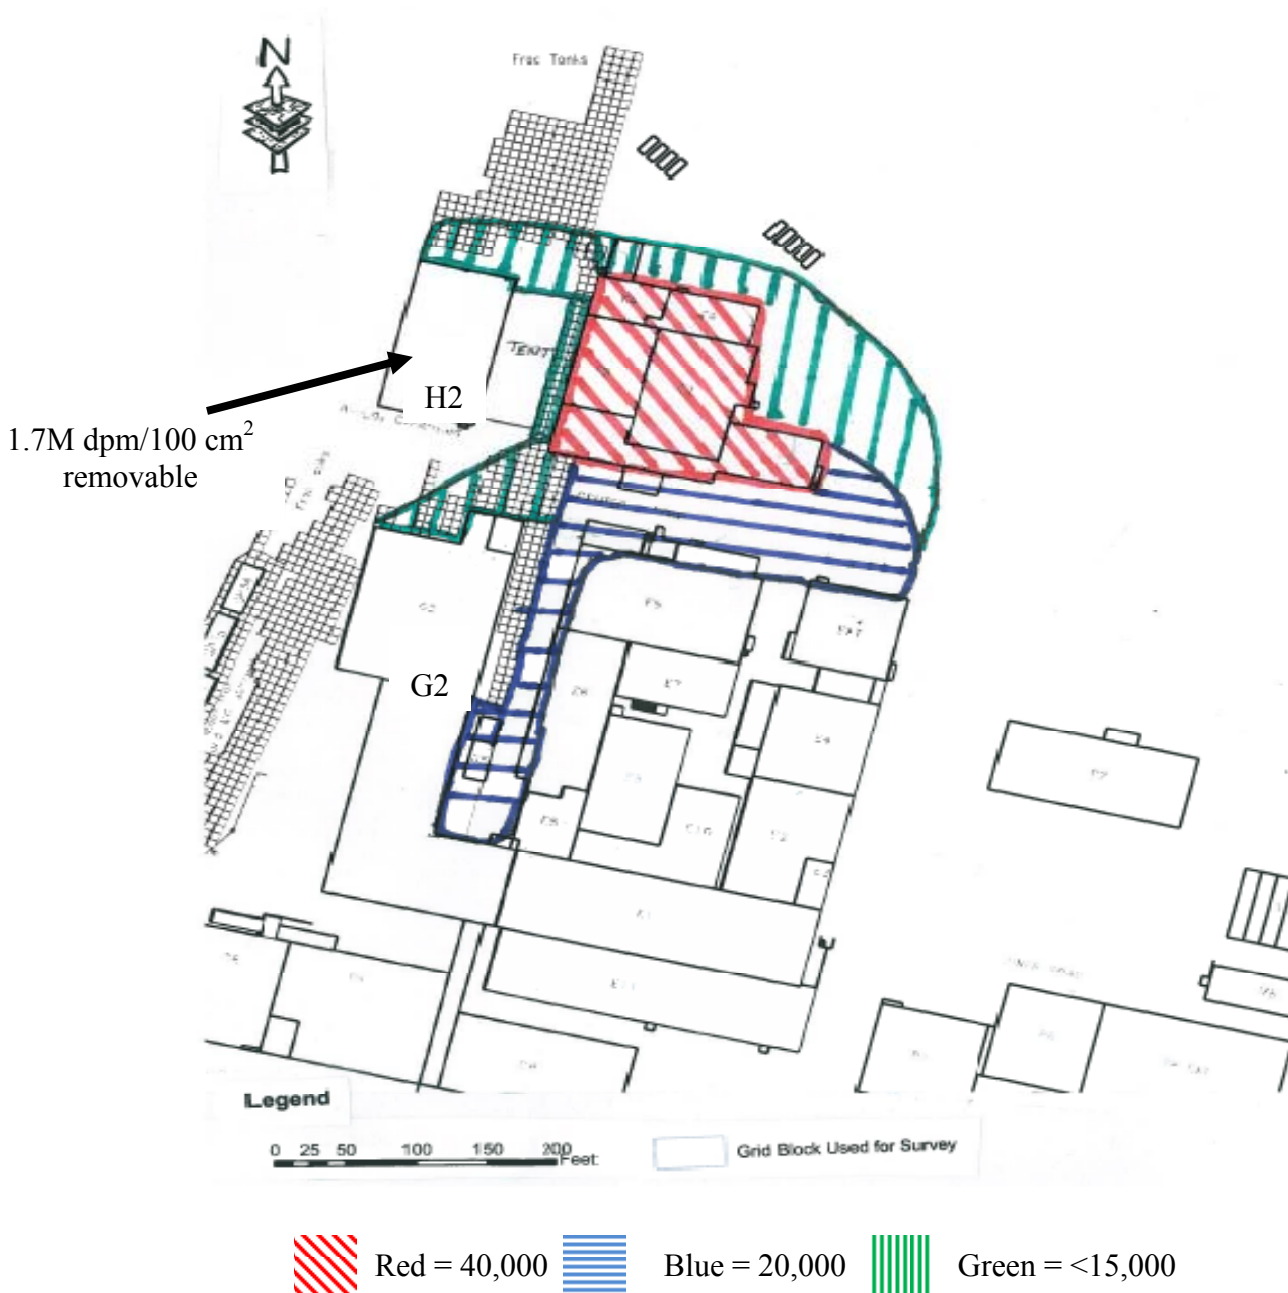
An NRLFO representative stated that contamination was found over an area of approximately 104,000 square feet on the KAPL site as a result of the incident. Review of KAPL post September 29, 2010, survey results shows that there were numerous small areas spread over approximately one half of the 104,000 square feet that had average readings of 20,000 to 40,000 dpm/100 cm<sup>2</sup> beta/gamma. There was one small area with an elevated reading of approximately 150,000 dpm/100 cm<sup>2</sup> beta/gamma.

**Figure 2-5: Approximate Area of Contamination**

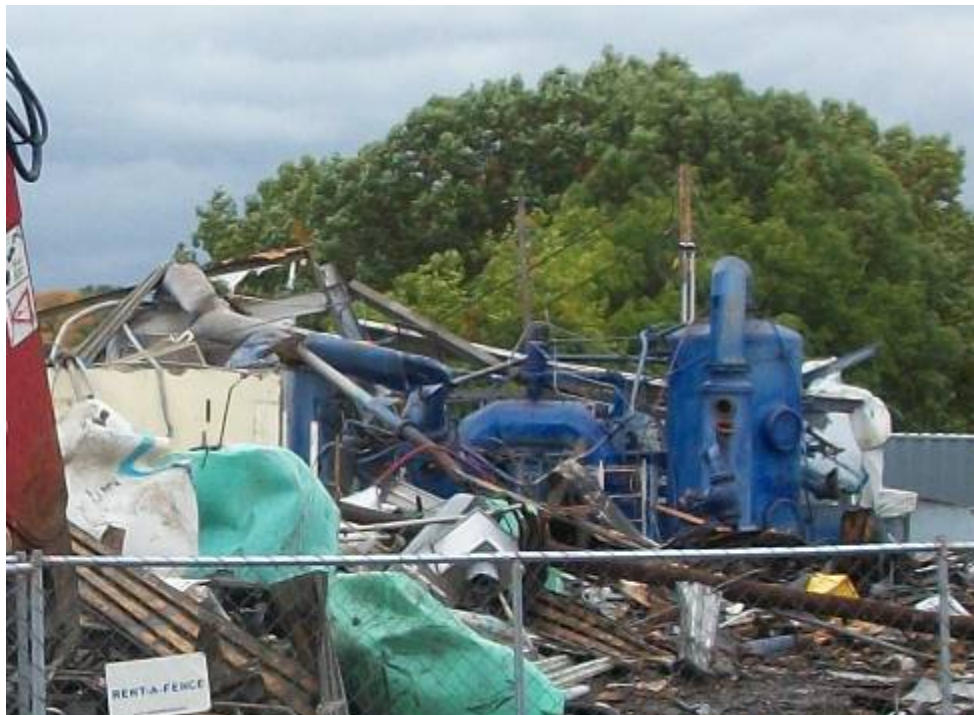
The spraying of “fixative” appears to have been associated with a belief that doing so would preclude the possibility of any spread of radioactive contamination, so much so, that the term “locked down” was frequently and generally used by management, staff, and workers to describe how the fixative was used for contamination control; a clear over-reliance on the application methodology. The Board noted that Figure 2-3, Figure 3-1 and Figure 3-2 illustrate that fixative was not applied to several surfaces of the evaporator system components.

**Figure 3-1: Incomplete Application of Fixative to Separator Columns September 29, 2010**

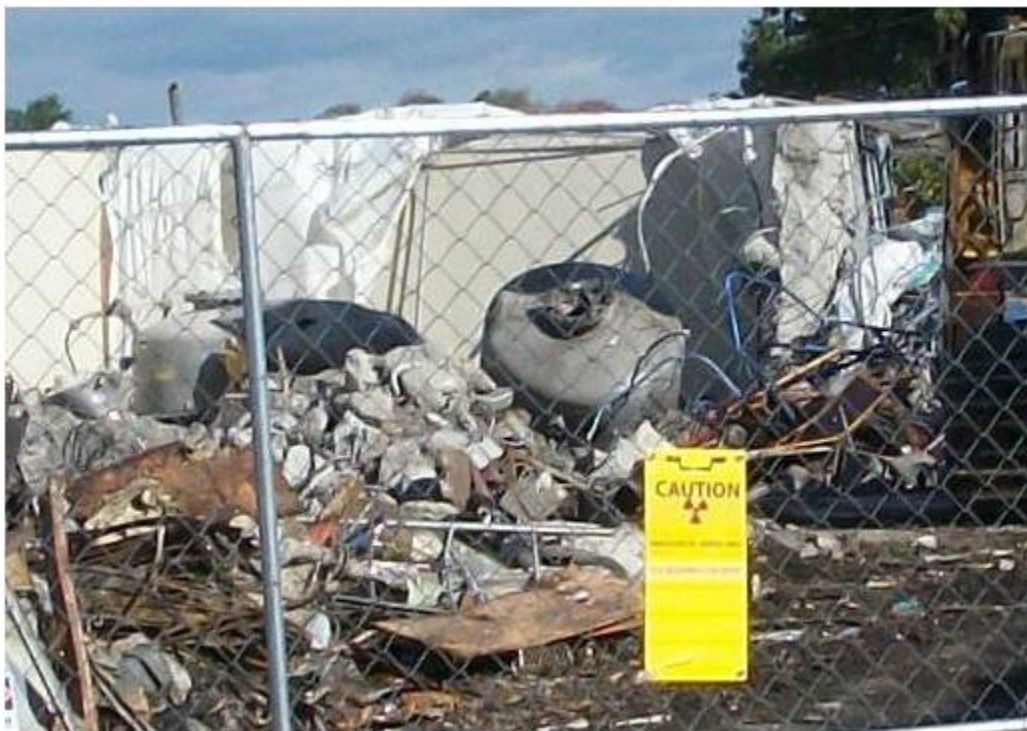
**Figure 3-2: September 29, 2010 Post Column 113-A Removal**
