**ASBESTOS SURVEY
FOR THE
ASBESTOS ABATEMENT OF BUILDING 401
NIAGARA FALLS STORAGE SITE
LEWISTON, NEW YORK**

**DEPARTMENT OF THE ARMY
CORPS OF ENGINEERS, BUFFALO DISTRICT
BUFFALO, NEW YORK
CONTRACT DACW 49-00-D-007**

Jacobs Engineering Group, Inc. – Eastern Federal Operations
125 Broadway Street
Oak Ridge, TN 37830

February 2002

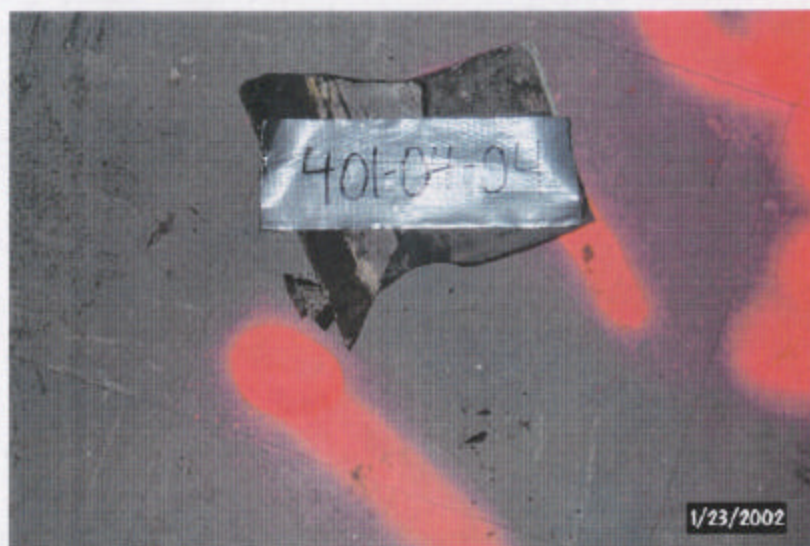
Baseboard and mastic

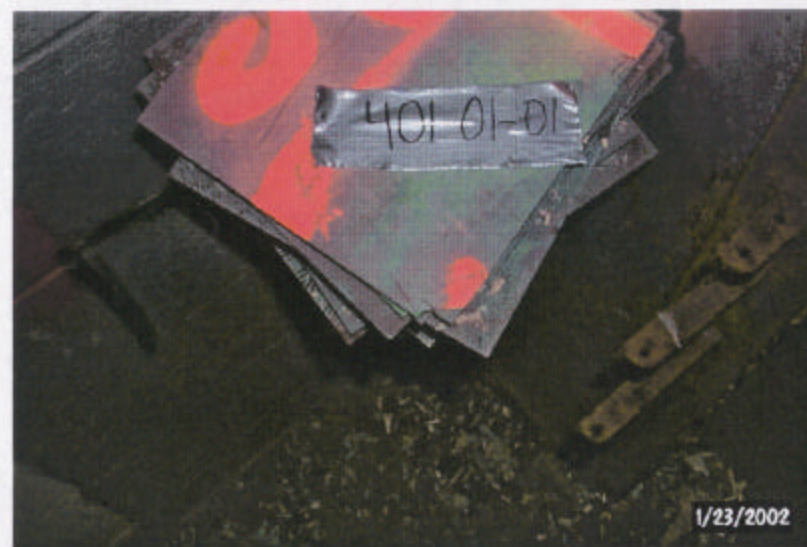
Floor Tile

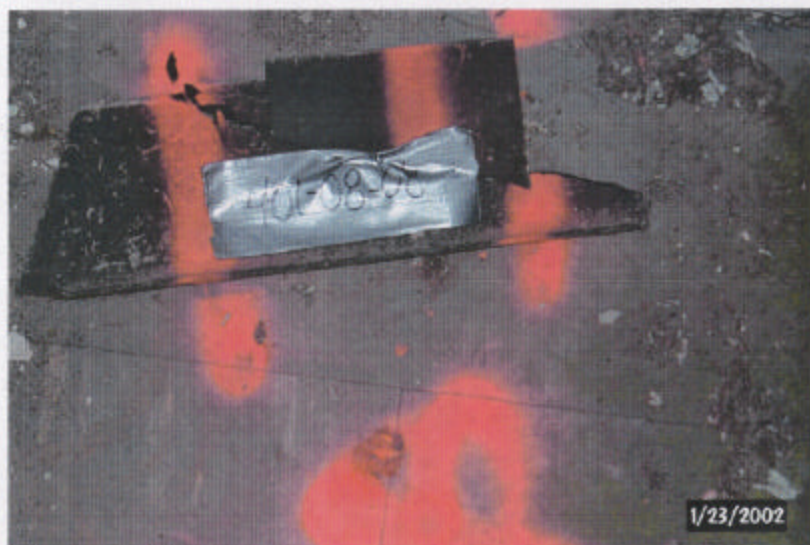
Baseboard and mastic

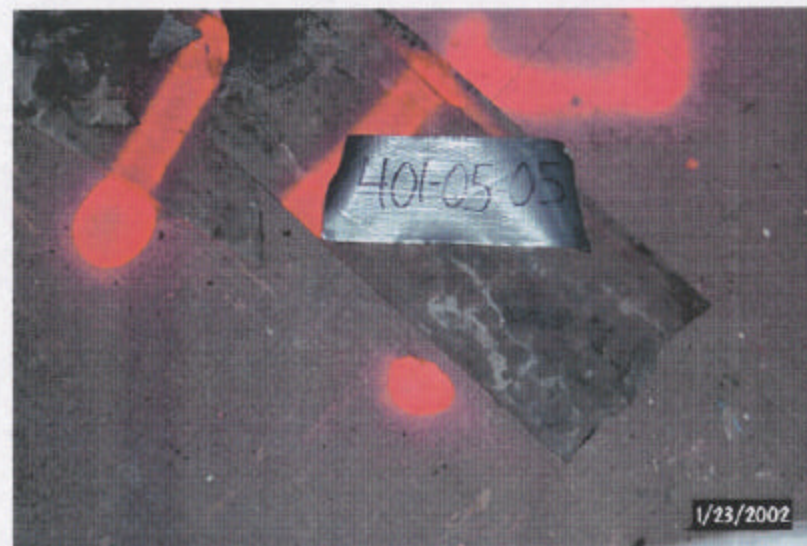
Floor Tile

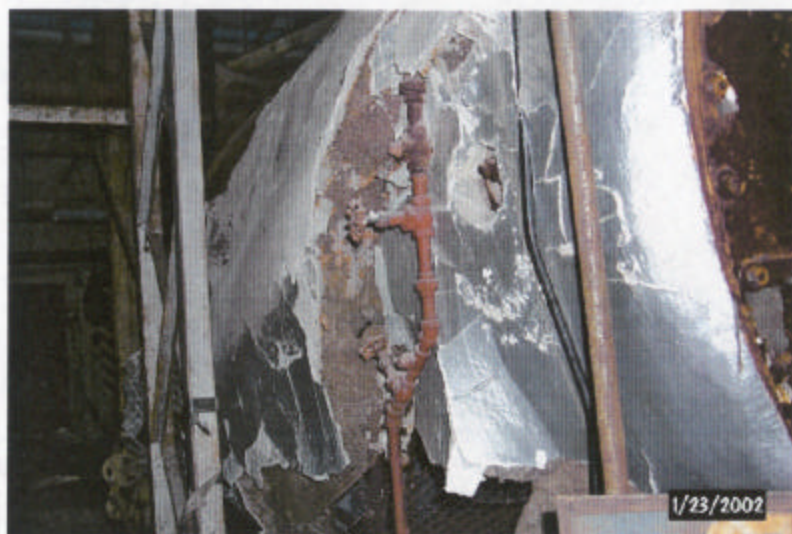
A condition assessment of asbestos containing materials was performed during the field survey of the boiler room area. The insulation on boilers 1 and 2 was significantly damaged and insulation debris was located on the floor around each boiler. The insulation on the water tank, located at the sump, had deteriorated and fallen off into the water filled sump. The pipe and fitting insulation was damaged throughout the room and ACM insulation debris was observed to be the majority of the boiler room floor debris. ACM debris was also noted below the floor grating. The insulation on the two elevated water tanks was in good condition.

Friable Boiler Tank Insulation

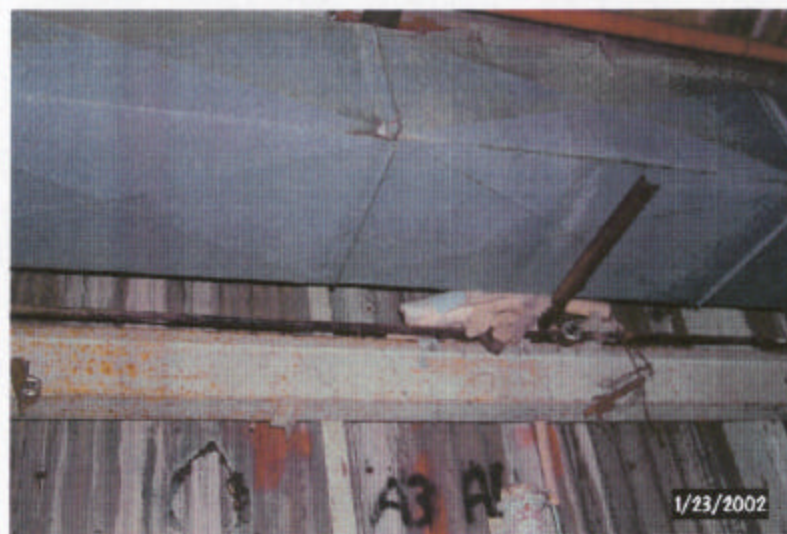
Friable Insulation Under HVAC Ducts

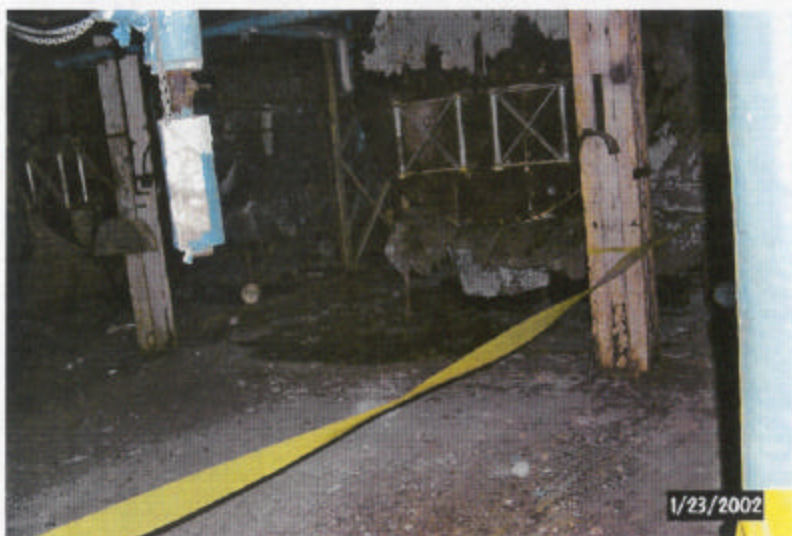
Friable Pipe Insulation

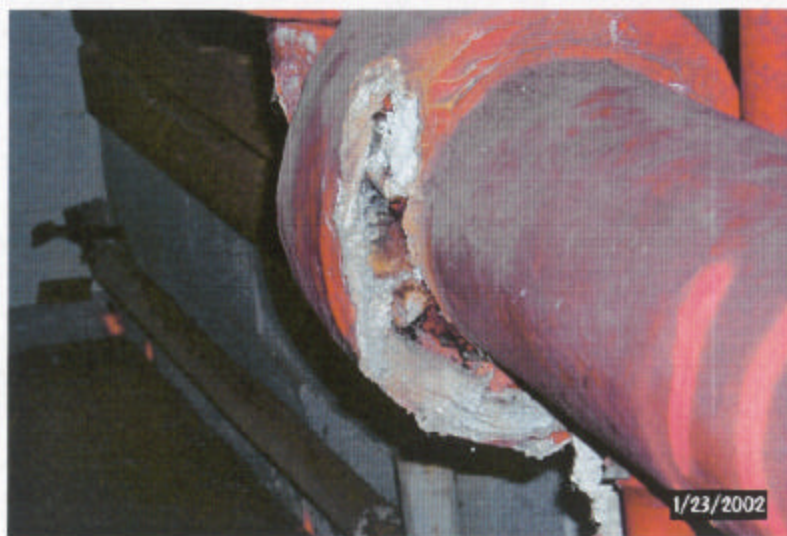
Friable Pipe Insulation

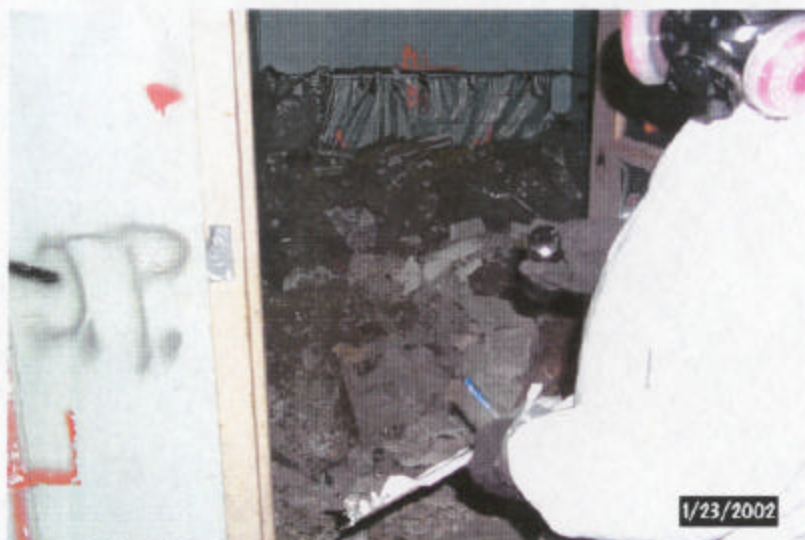
Room With Friable Insulation Throughout

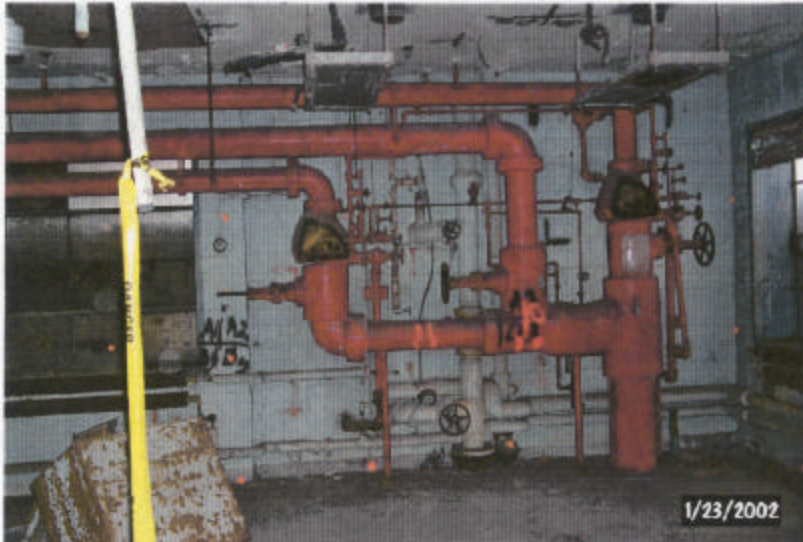
Thermal System Insulation

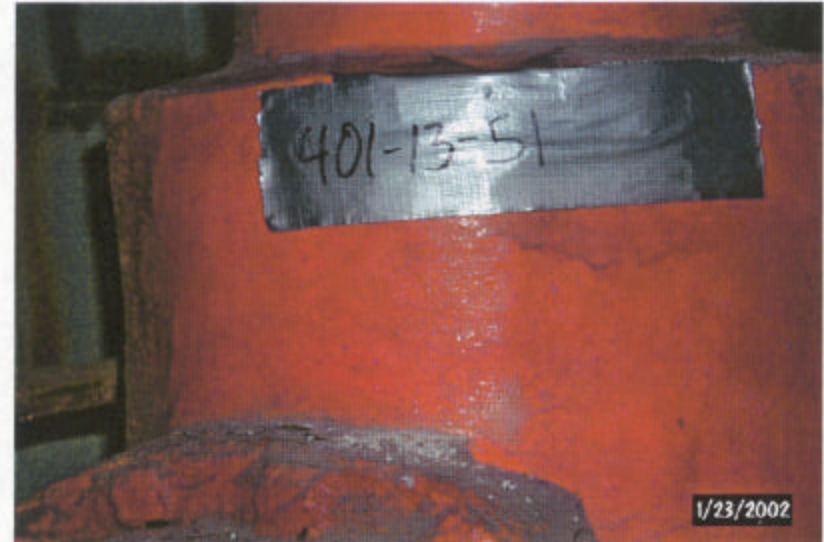
Thermal System Insulation – (suspect pipe insulation)

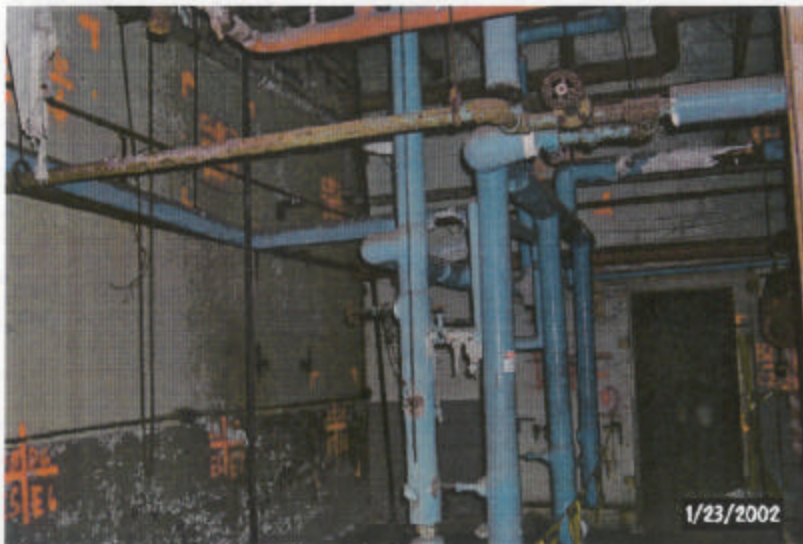
Thermal System Pipe Insulation

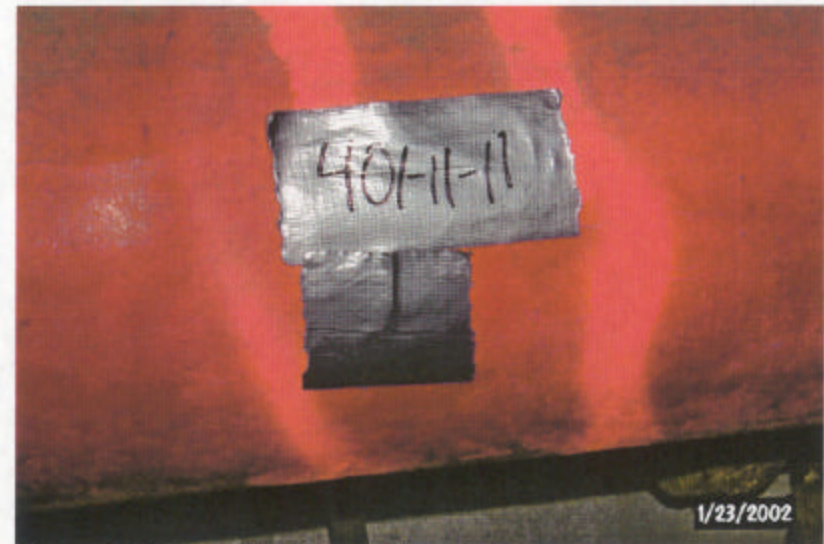
Thermal System Pipe Insulation
