Notice to Navigation Interests

L 13 – 14	June 4, 2014
Notice No.	Date
<hr/>	
Waterway

Condition of Federal Navigation Channel Ashtabula Harbor, Ashtabula, Ohio

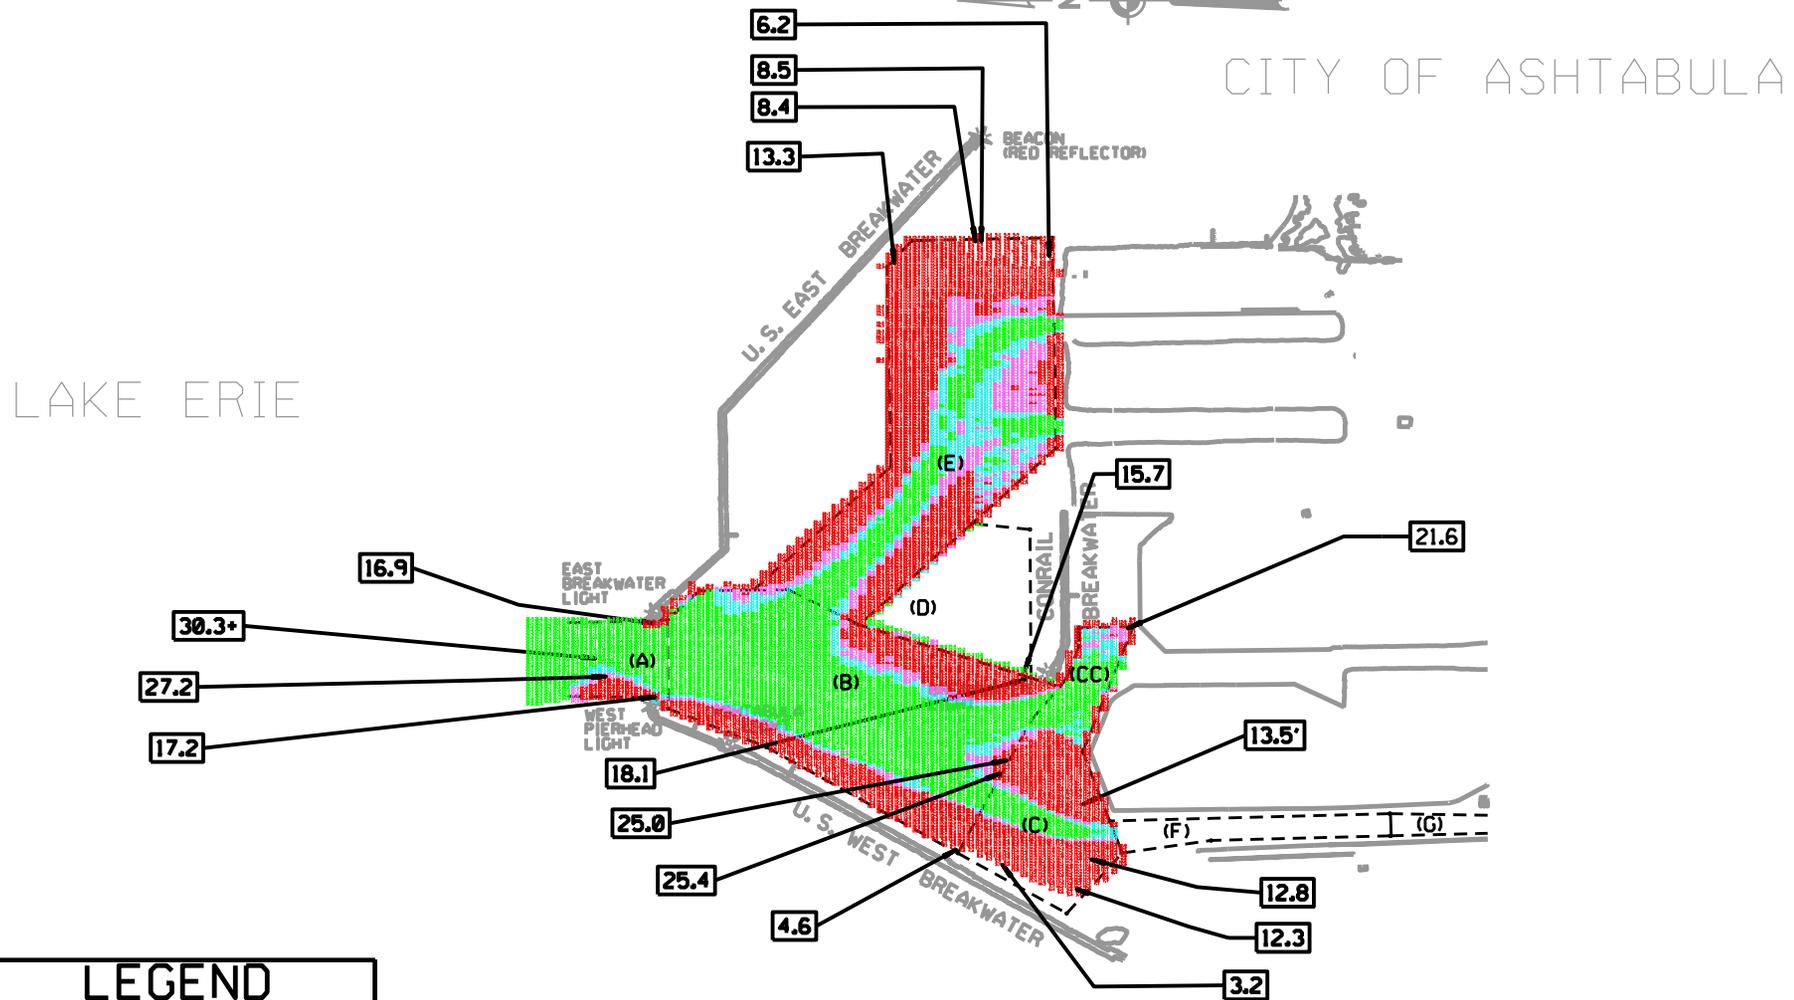
ASHTABULA HARBOR, OHIO
 HARBOR SECTIONS A THROUGH E
 CHANNEL CONDITIONS
 SCALE OF FEET

1. Condition surveys performed within the Federal Navigation Channel at Ashtabula Harbor, Ashtabula, Ohio during the month of May 2013 indicate shoaling has reduced depths to those shown on the attached standard tabular form and channel condition drawings.
