Notice to Navigation Interests

L 15-02	April 23, 2015
Notice No.	Date
<hr/>	
Waterway

Condition of Federal Navigation Channel
Rochester Harbor, Rochester, New York

ROCHESTER HARBOR, NY
CHANNEL CONDITIONS

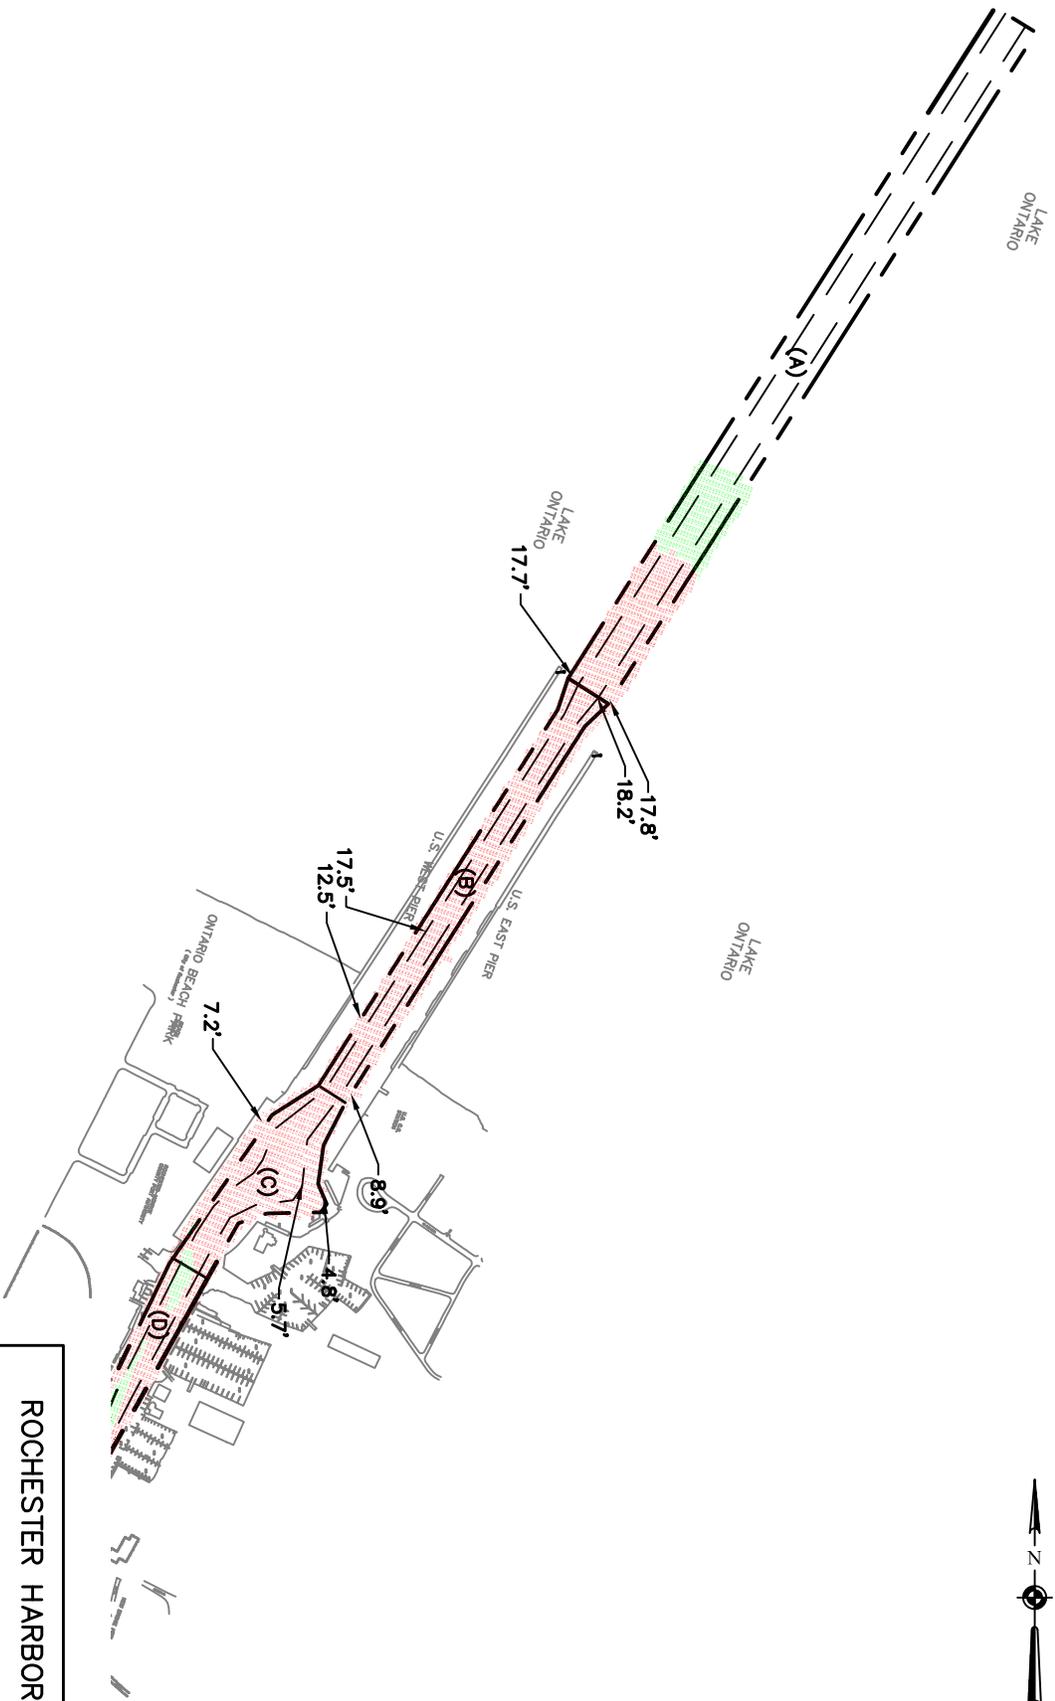
1. Condition surveys performed within the Federal Navigation Channel at Rochester Harbor, Rochester, New York during the month of April 2015 indicate shoaling has reduced depths to those shown on the attached standard tabular form and channel condition drawings.
