Notice to Navigation Interests

L 14 – 17	August 12, 2014
Notice No.	Date
<hr/>	
Waterway

Condition of Federal Navigation Channel Sandusky Harbor, Sandusky, Ohio

SANDUSKY HARBOR OHIO
CHANNEL CONDITIONS
CORPS OF ENGINEERS, BUFFALO, N. Y.

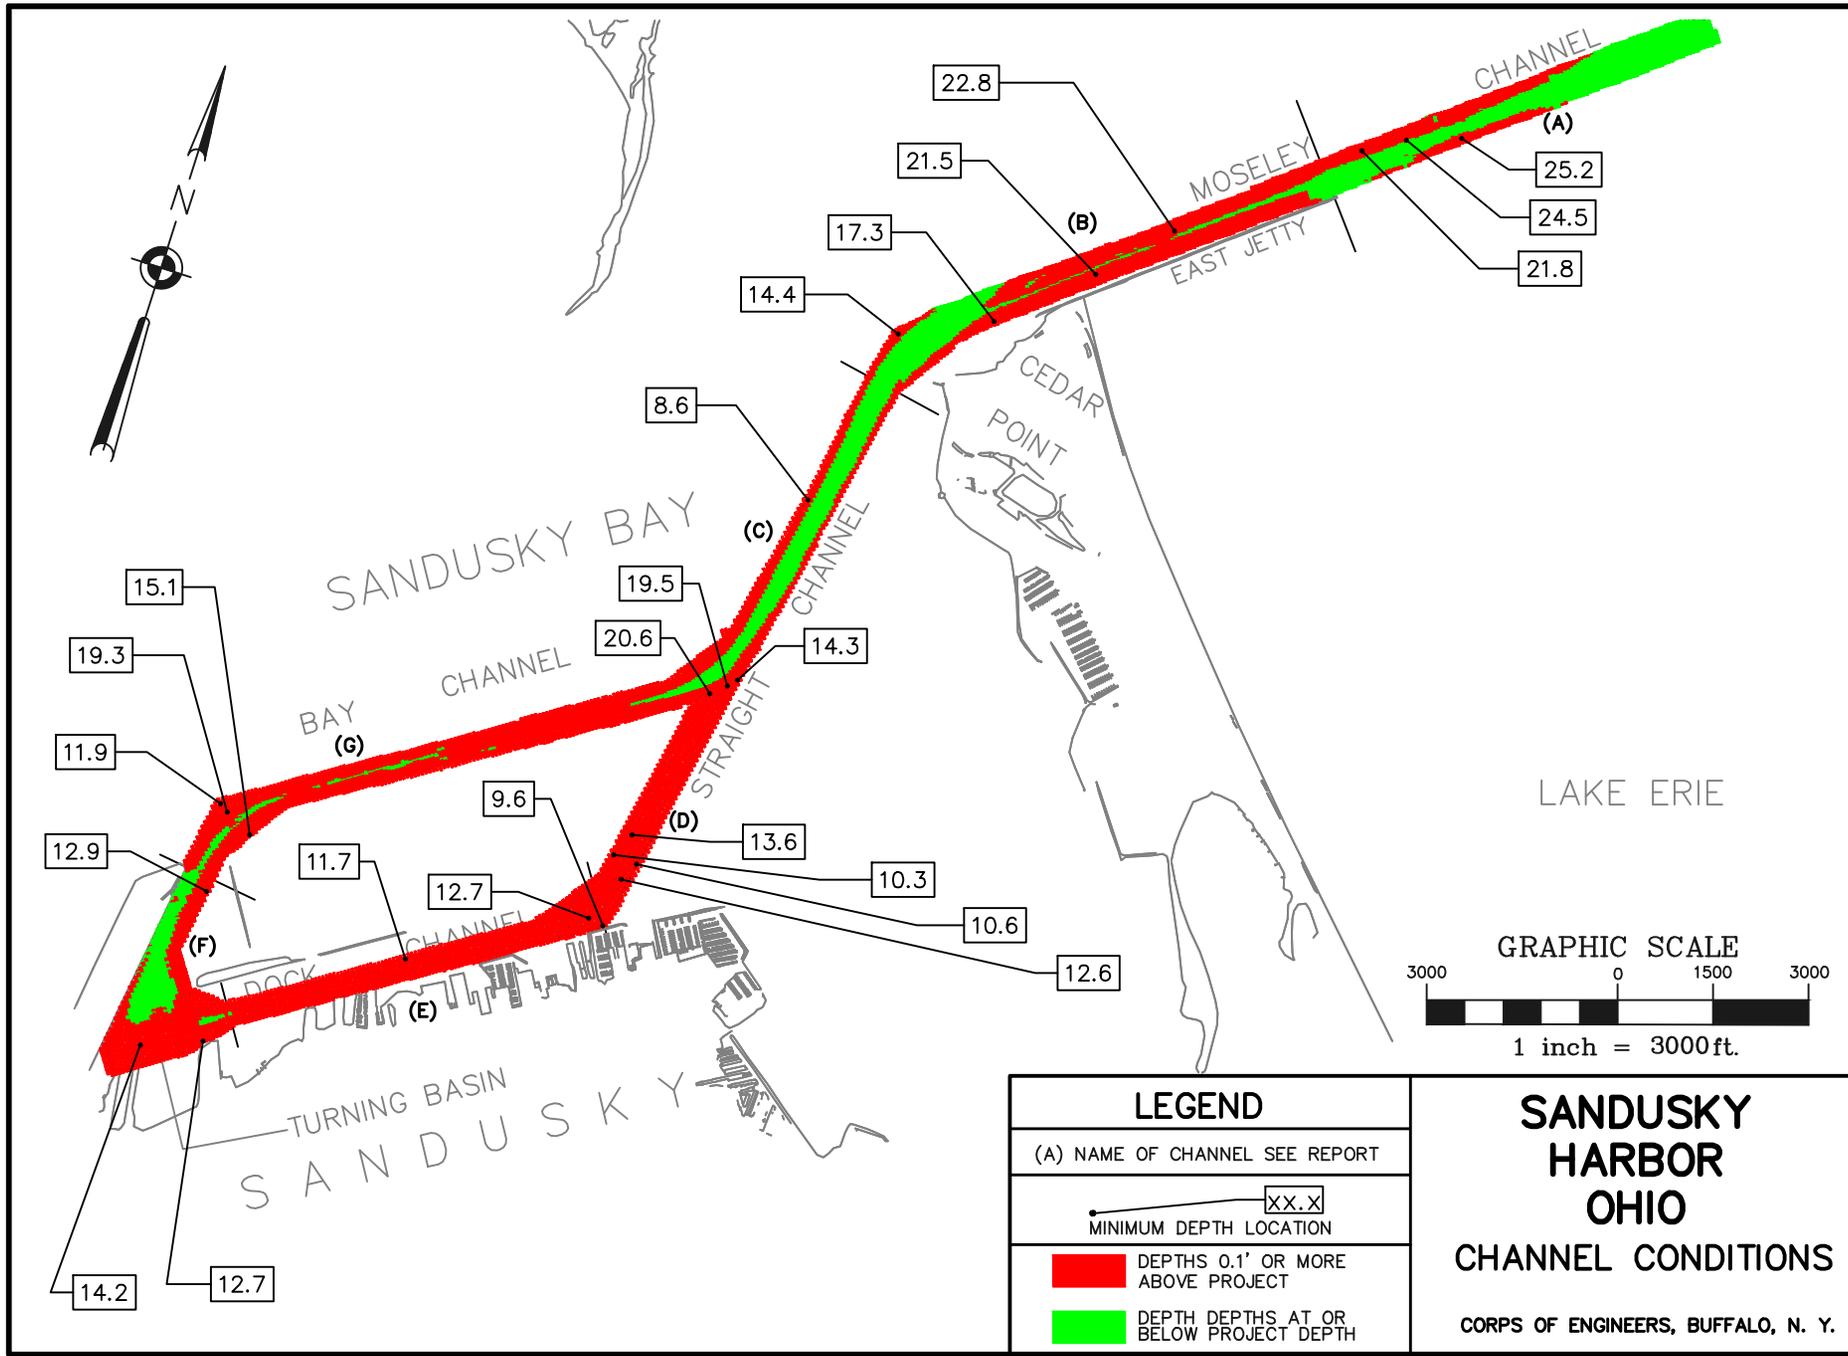
1. Condition surveys performed within the Federal Navigation Channel at Sandusky Harbor, Sandusky, Ohio during the months of July and August 2014 indicate shoaling has reduced depths to those shown on the attached standard tabular form and channel condition drawings.

3. Vessel operators are advised to use caution when navigating in this area.
4. Copies of the sounding print for Sandusky Harbor, Sandusky, Ohio consisting of (7) sheets, San14VH101 to 107, at a cost of \$2.50 per sheet will be furnished upon receipt of a check in the full amount made payable to: USACE Finance and Accounting. Requests should be addressed to: District Commander, U.S. Army Engineer District, Buffalo, ATTN: NY/PA O&M Office, 1776 Niagara Street, Buffalo, New York 14207, requesting exact number or copies of sheets by file number. A point of contact and phone number must be indicated to facilitate response to the request. To download the same information and other related materials at no cost, simply point your web browser to <http://www.lrb.usace.army.mil/WhoWeAre/WaterMgmt/survey/survey.html> click on the year and then locate the harbor on the table of harbors.
