Notice to Navigation Interests

L 15 – 17	September 30, 2015
Notice No.	Date
<hr/>	
Waterway

Condition of Federal Navigation Channel Sandusky Harbor, Sandusky, Ohio

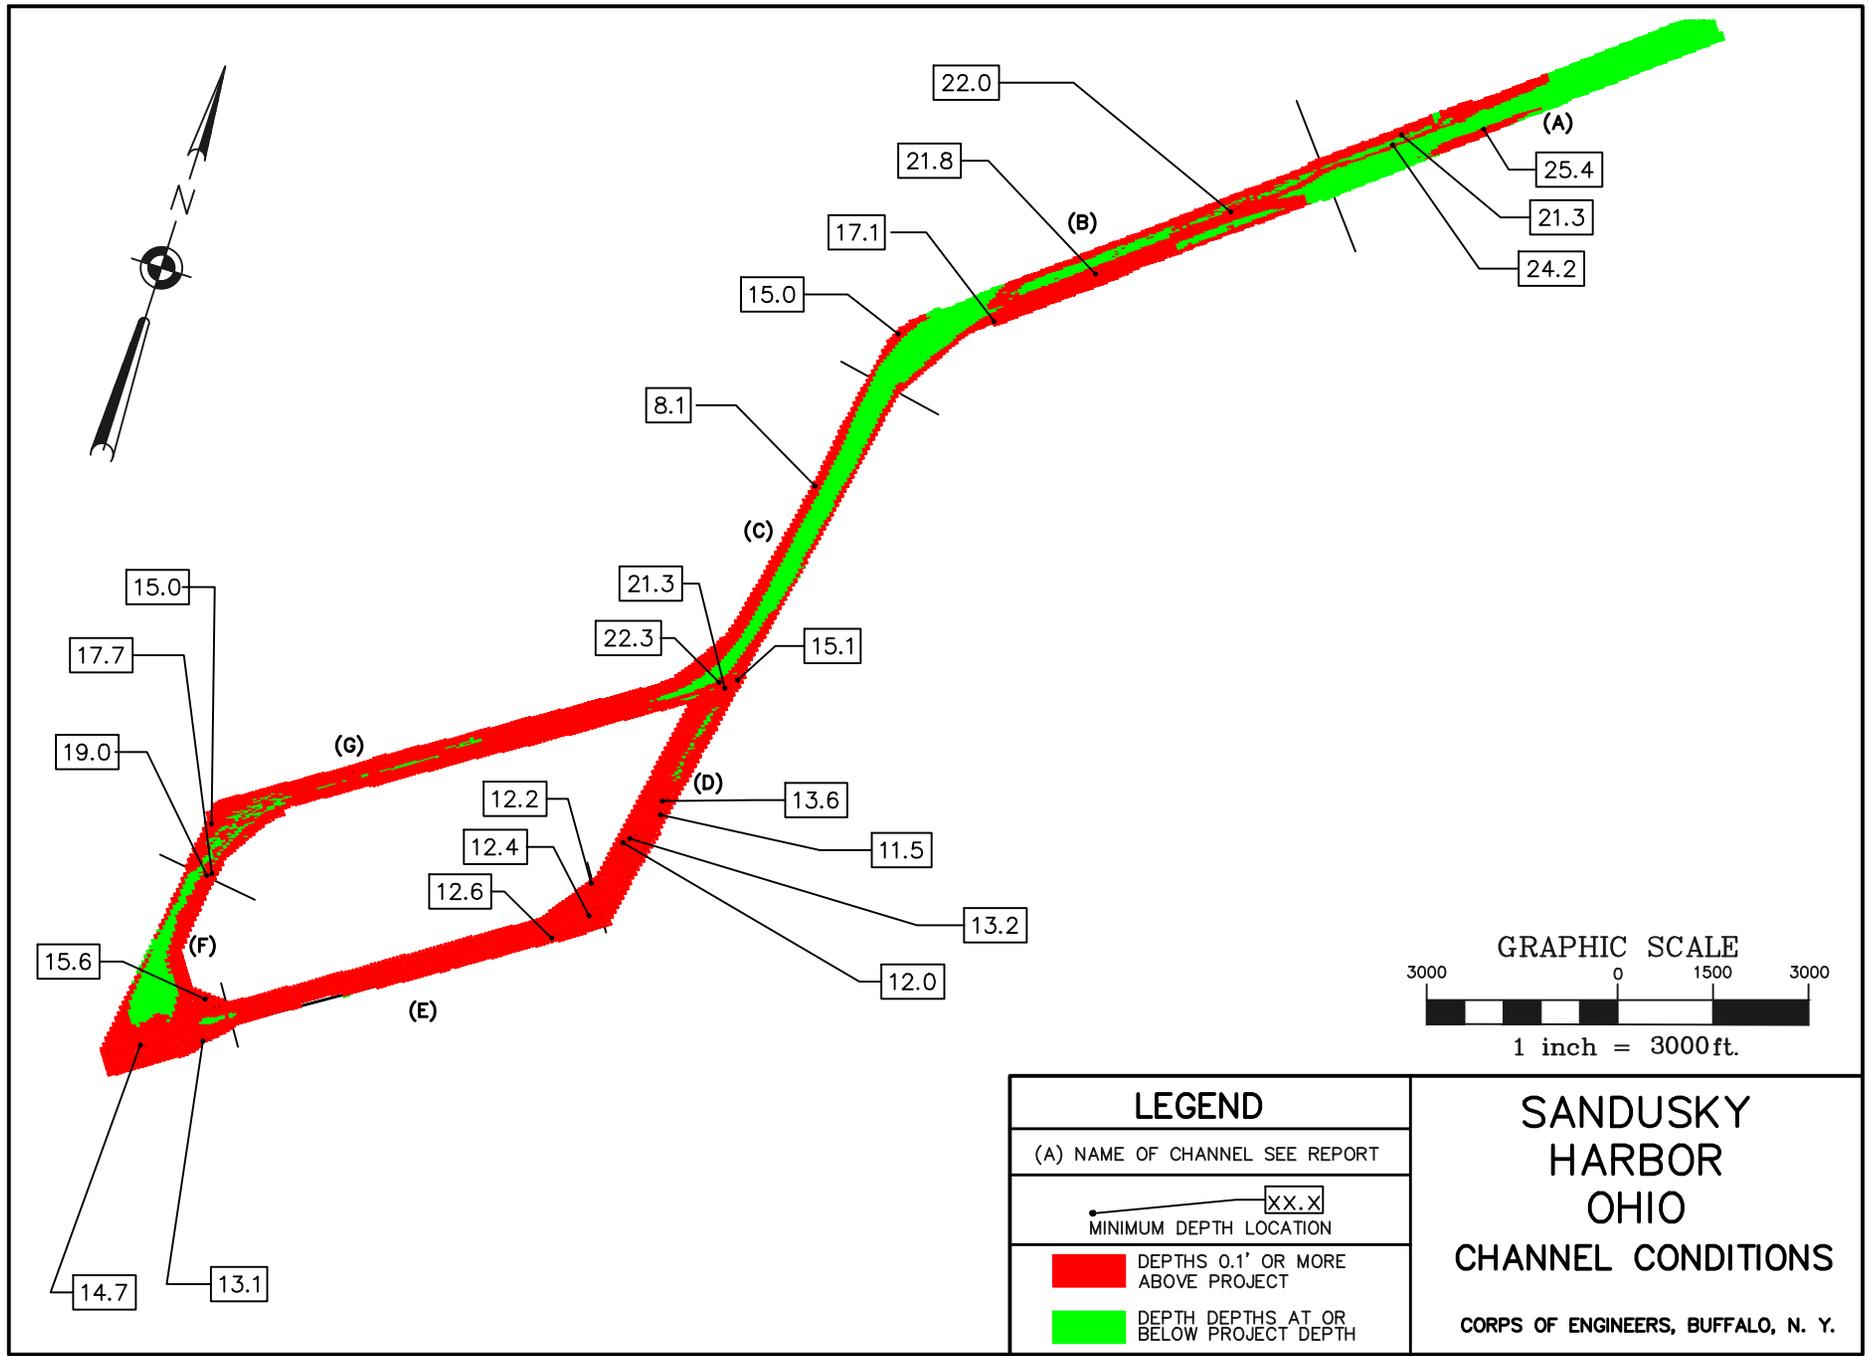
**SANDUSKY
HARBOR
OHIO
CHANNEL CONDITIONS**

1. Condition surveys performed within the Federal Navigation Channel at Sandusky Harbor, Sandusky, Ohio during the months of July thru September 2015 indicate shoaling has reduced depths to those shown on the attached standard tabular form and channel condition drawings.

3. Vessel operators are advised to use caution when navigating in this area.
4. Copies of the sounding print for Sandusky Harbor, Sandusky, Ohio consisting of (7) sheets, San15VH101 to 107, at a cost of \$2.50 per sheet will be furnished upon receipt of a check in the full amount made payable to: USACE Finance and Accounting. Requests should be addressed to: District Commander, U.S. Army Engineer District, Buffalo, ATTN: NY/PA O&M Office, 1776 Niagara Street, Buffalo, New York 14207, requesting exact number or copies of sheets by file number. A point of contact and phone number must be indicated to facilitate response to the request. To download the same information and other related materials at no cost, simply point your web browser to <http://www.lrb.usace.army.mil/WhoWeAre/WaterMgmt/survey/survey.html> click on the year and then locate the harbor on the table of harbors.
