Post-Remedial Action Report Area 21

Figure 4.16-1
Summary of Features, Contamination, and Post-Remedial Conditions

Linde Site, Tonawanda, New York

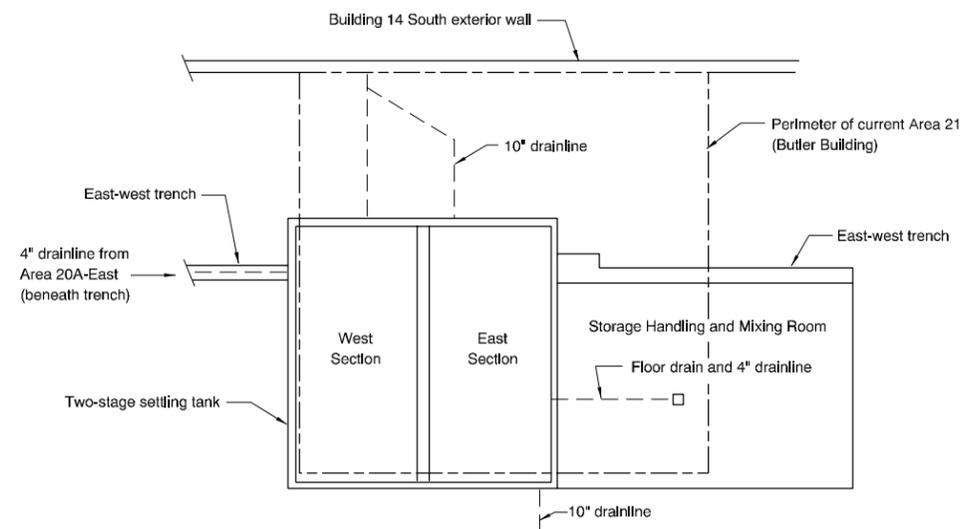
Subsurface MED Features in Area 21

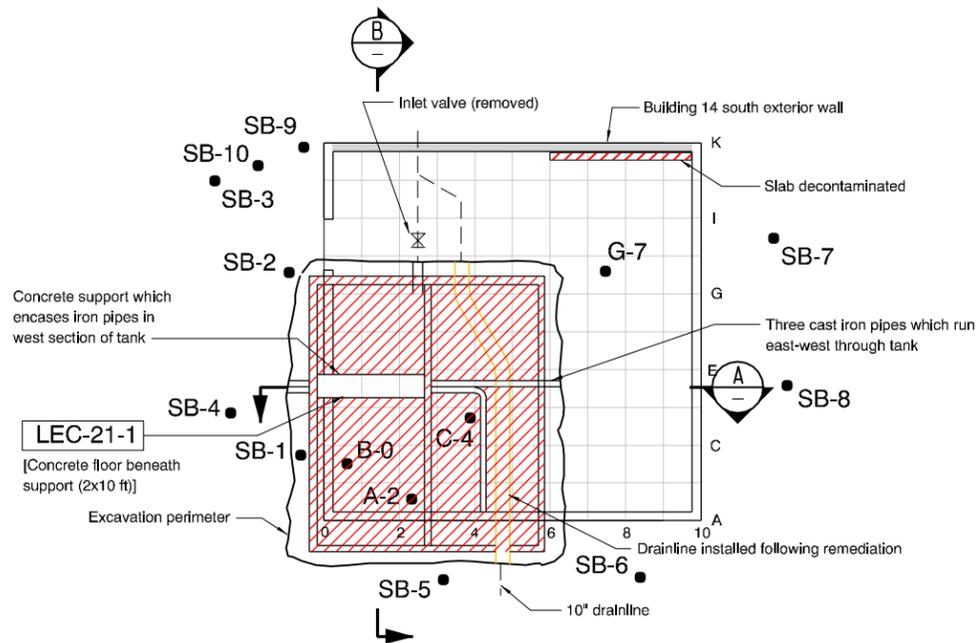
Conceptual Illustration of Contamination
