**New York State Department of Environmental Conservation  
Division of Solid and Hazardous Materials**

September 18, 1998

Re: Lake Ontario Ordnance Works, Component 2 -Phase 1 Interim Removal Action

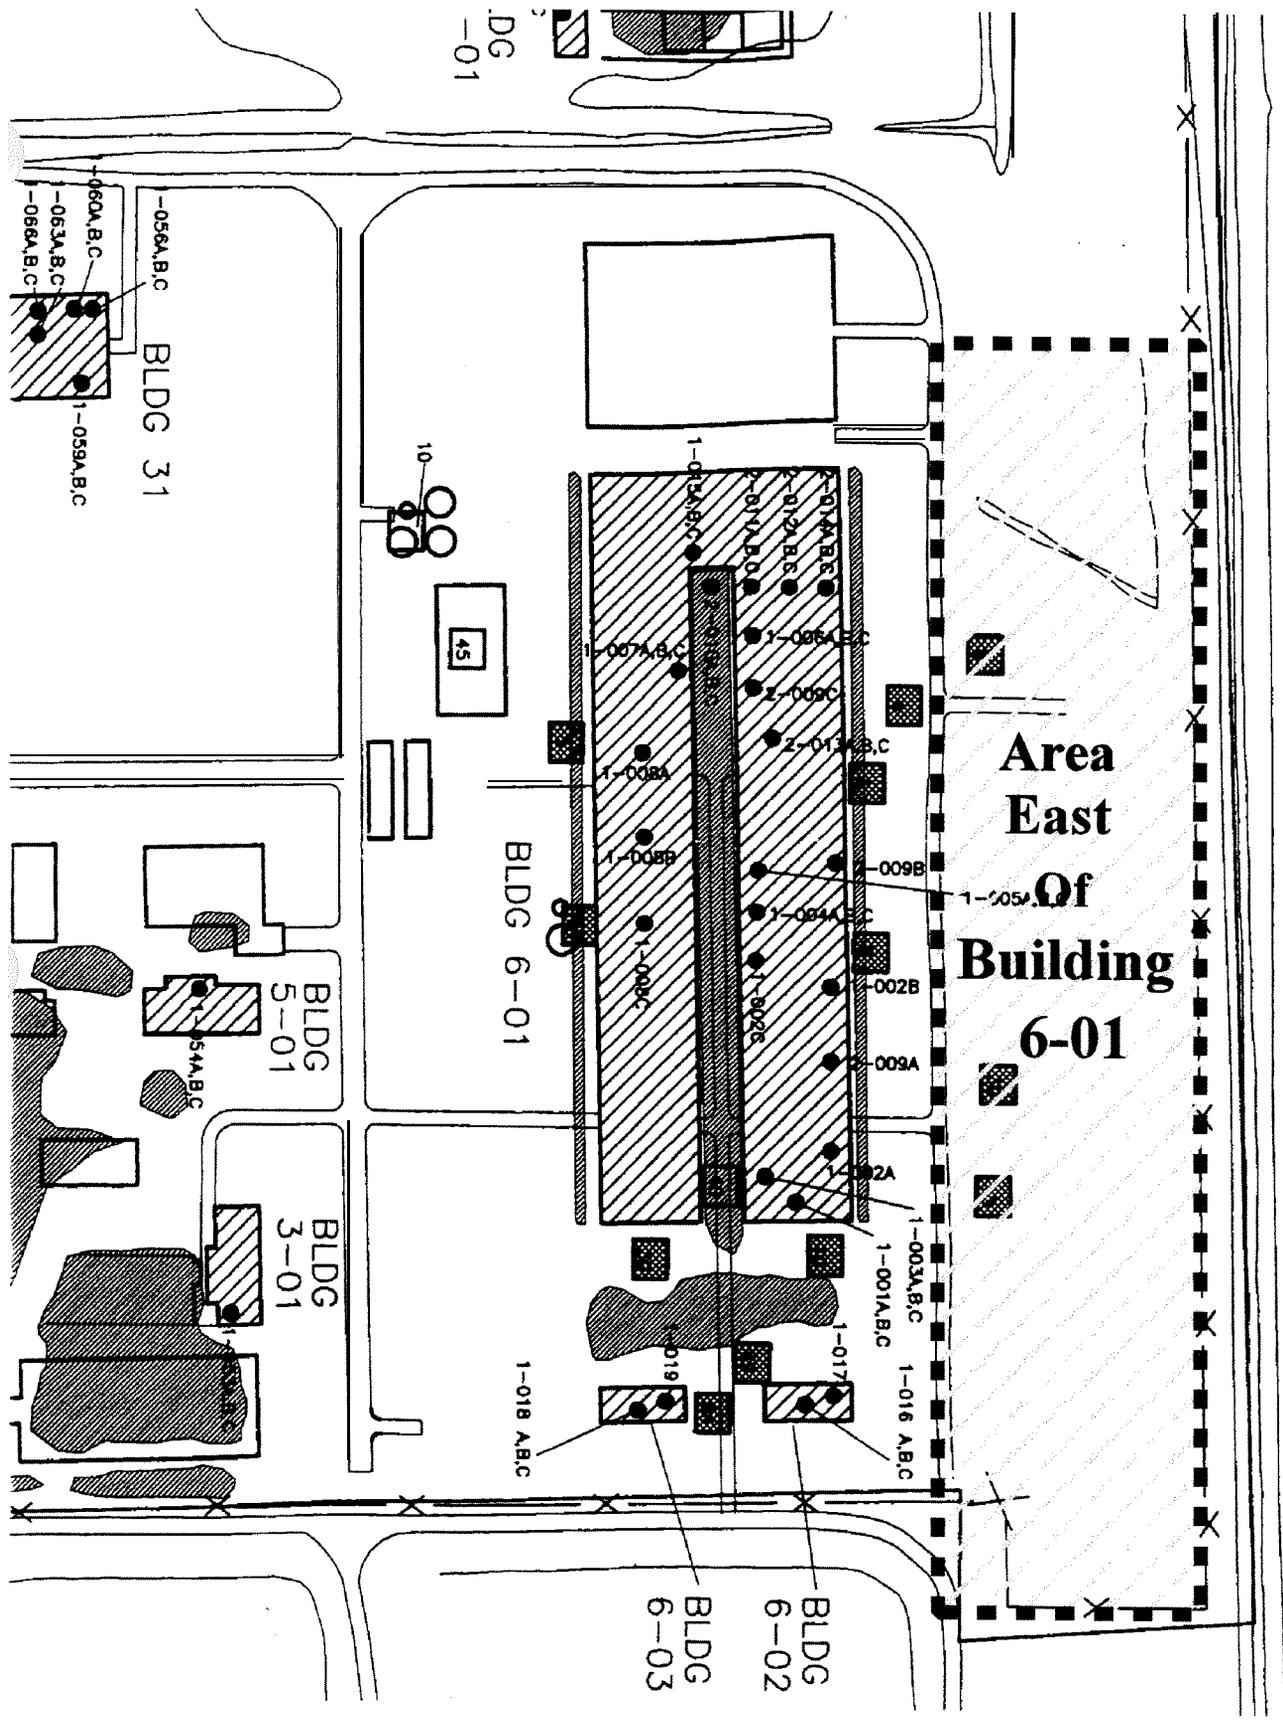
Figure 1

Areas East of Building- 6-01: This area is delineated by a roadway on the west and the property fence line on the east of building 6-01 (Figure 1). Based on the Asbestos Survey Report (Acres International, June 1998) this area has not been designated for remediation. However, review of the sample information contained in Appendix B of the report indicate that the applicable sample locations (S-095 through S-100) are "Along N/S line running through E wing of bldg 6-01". In addition the sample locations for the survey are non-biased based on a 100-ft grid. During the walkover of this area numerous pieces of aluminum pipe jacketing were noted (Photos #1 & #2). This jacketing covered pipe insulation containing asbestos. White, discolored soil was noted underneath the jacketing (Photo #3). Several stacks of asbestos containing transite panels, whose removal is part of IRA Phase I, are located within this area (Photo #4). Some broken pieces of transite panels were also noted within this area. Finally there is a debris pile in the far southern portion of this area. Pipe jacketing and pieces of transite panels were noticed in the pile.

Although the Asbestos Survey Report serves as a tool to provide the data necessary to quantify and qualify ACMs at the site, so that an accurate estimate of the proposed asbestos removal effort can be made, the non-biased methodology for the collection of soil samples is not sufficient when the contamination occurs at discrete locations as noted above. Therefore, the USACE must, at a minimum, remove all transite panels and pipe insulation remaining on dismantled piping found on the site. Also representative samples must be collected of soil beneath and adjacent to PACM found in the above described areas.

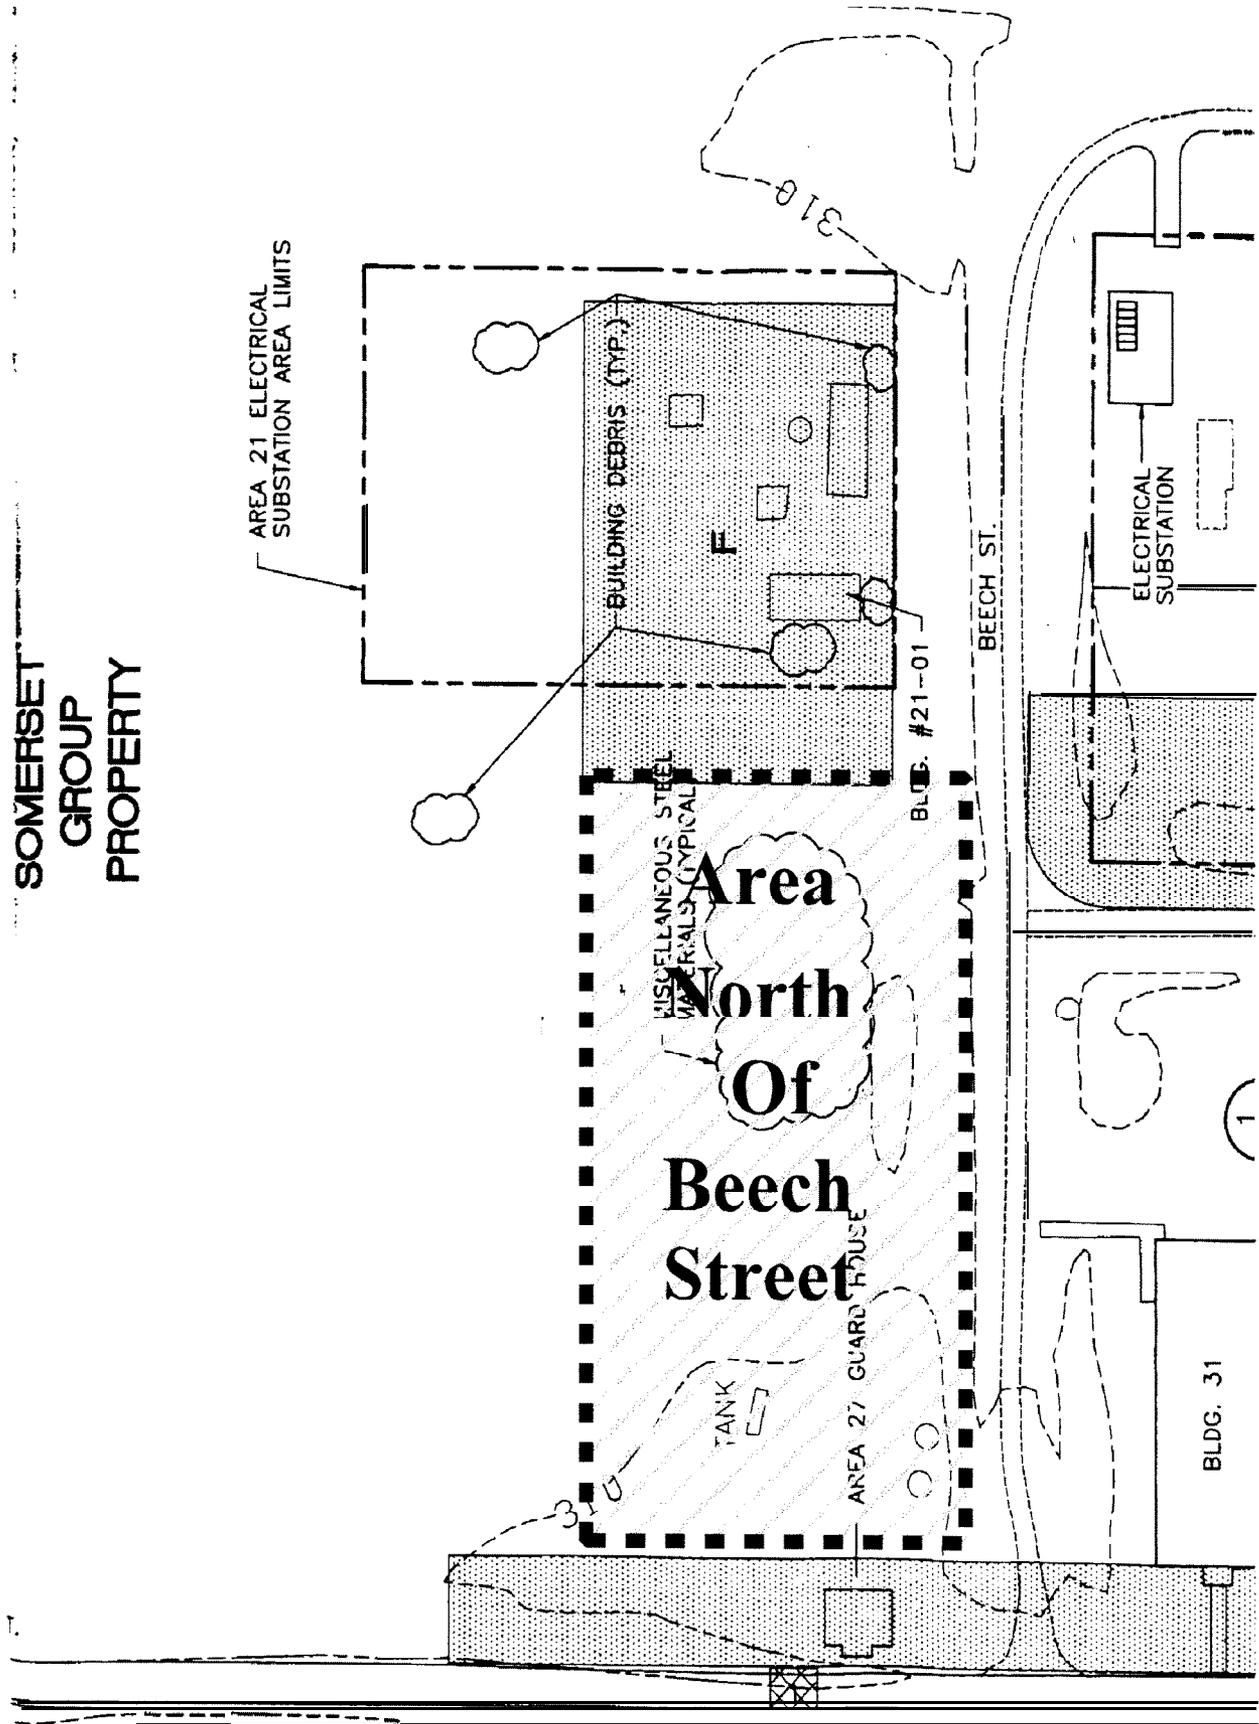
**Figure 2**

Area North of Beech Street: This area is bounded by Beech Street on the south, Area 21-former electrical substation on the east and the Area 27 guard house on the west (Figure 2). Based on the Asbestos Survey Report this area has not been designated for remediation. During the walkover, several stacks of asbestos containing transite panels were noted within this area (Photo #5). In addition, numerous pieces of jacketed pipe were also noted. PACM pipe insulation was noted underneath the jacketing (Photo #6). Broken pieces of transite panels were also noted within this area.

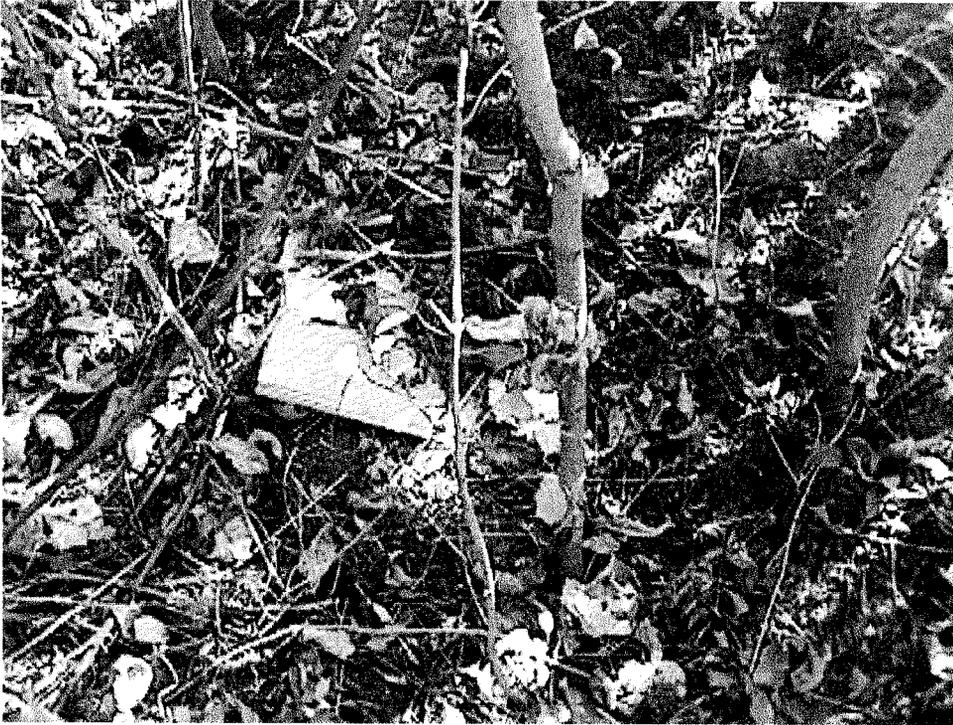
**Photo #1**  
Aluminum Pipe Jacketing in wooded area east of Building 6-01

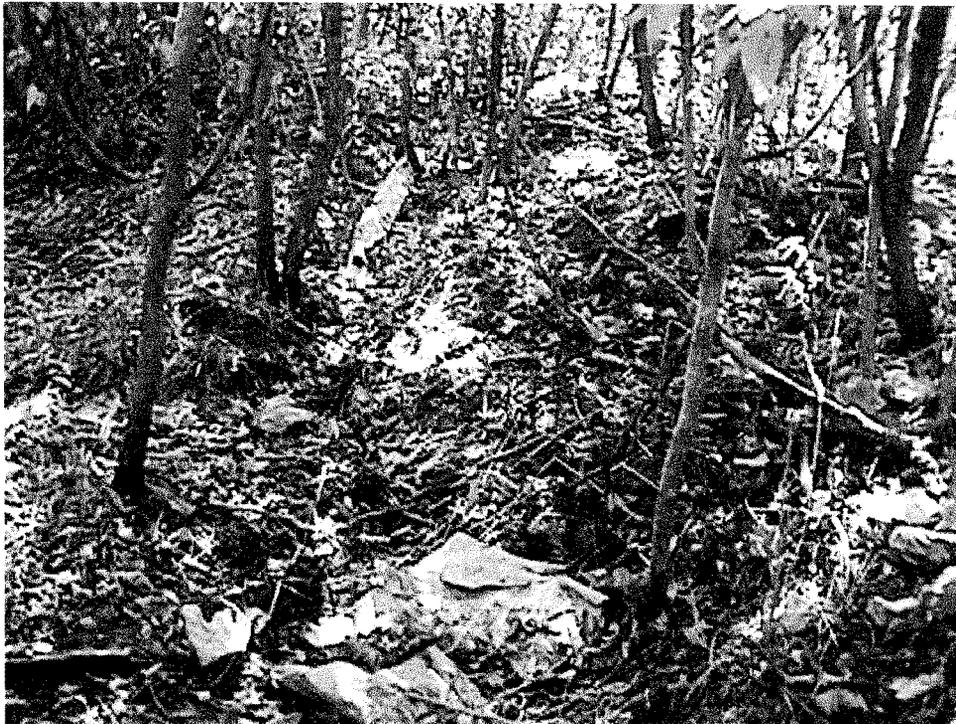
**Photo #2**  
Aluminum Pipe Jacketing in area east of Building 6-01

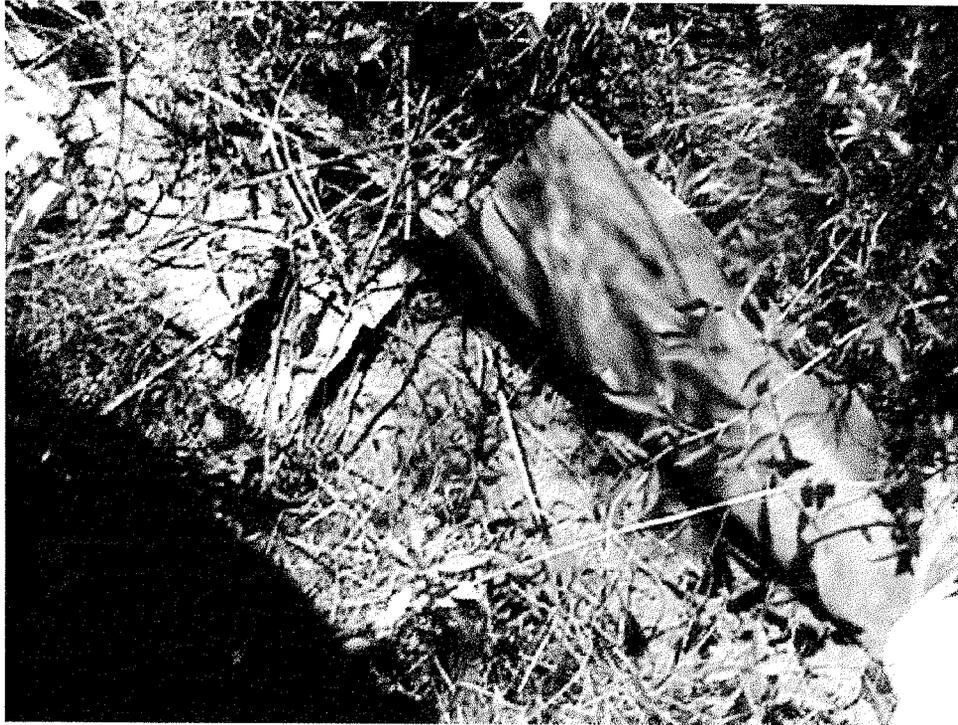
**Photo #3**  
Discolored soil beneath Aluminum Pipe Jacketing

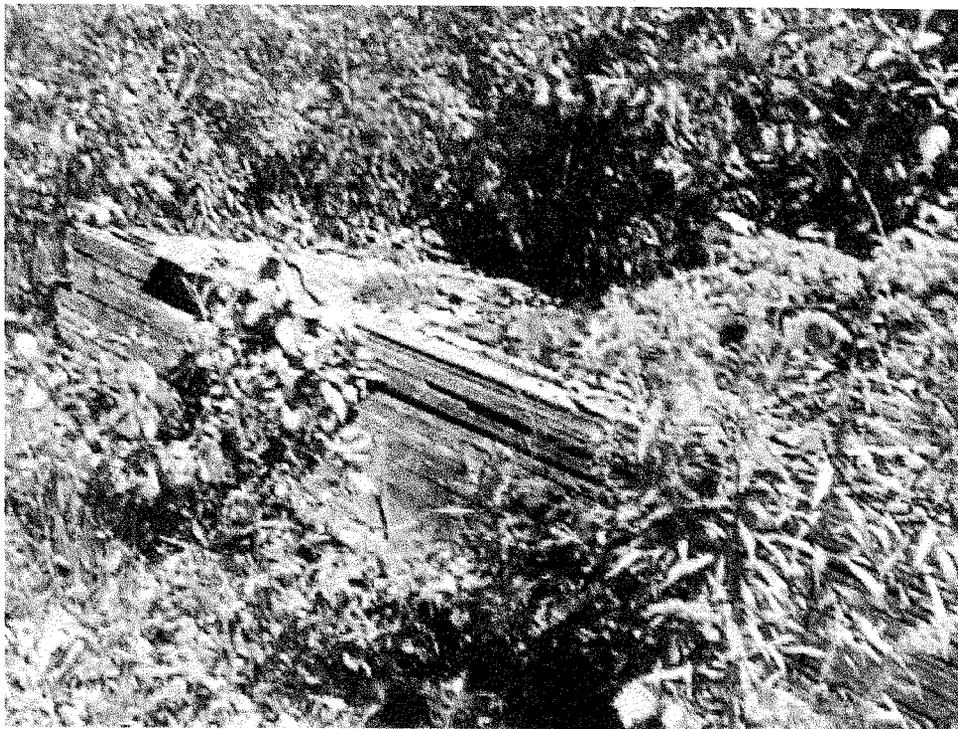
**Photo #4**  
Asbestos containing Transite panels stacked along roadway

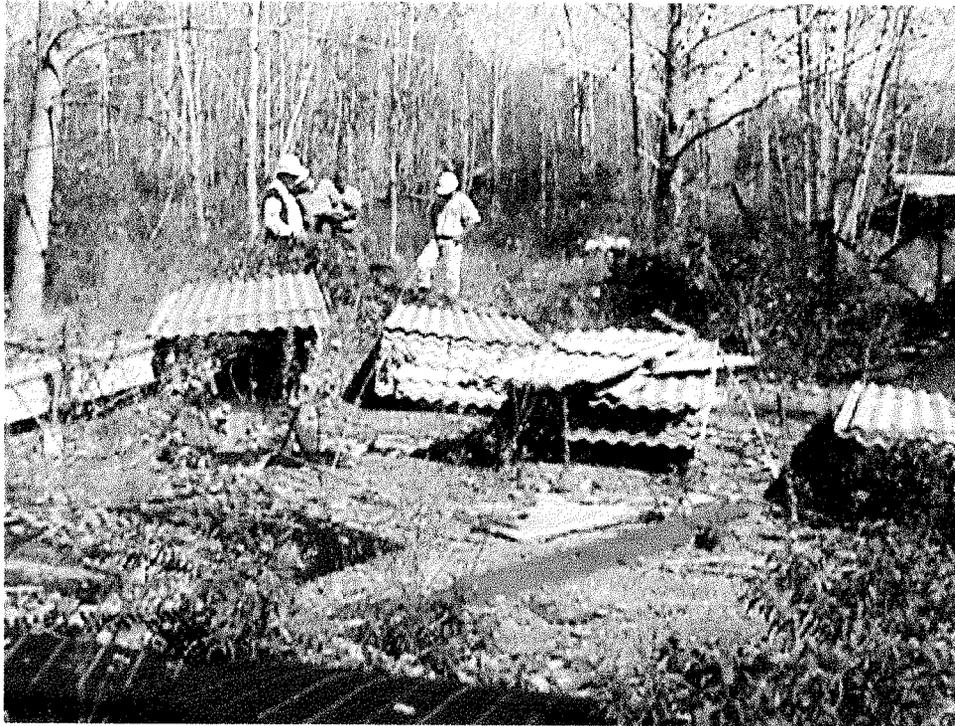
**Photo #5**

Piles of Transite panels in Area north of Beech Street

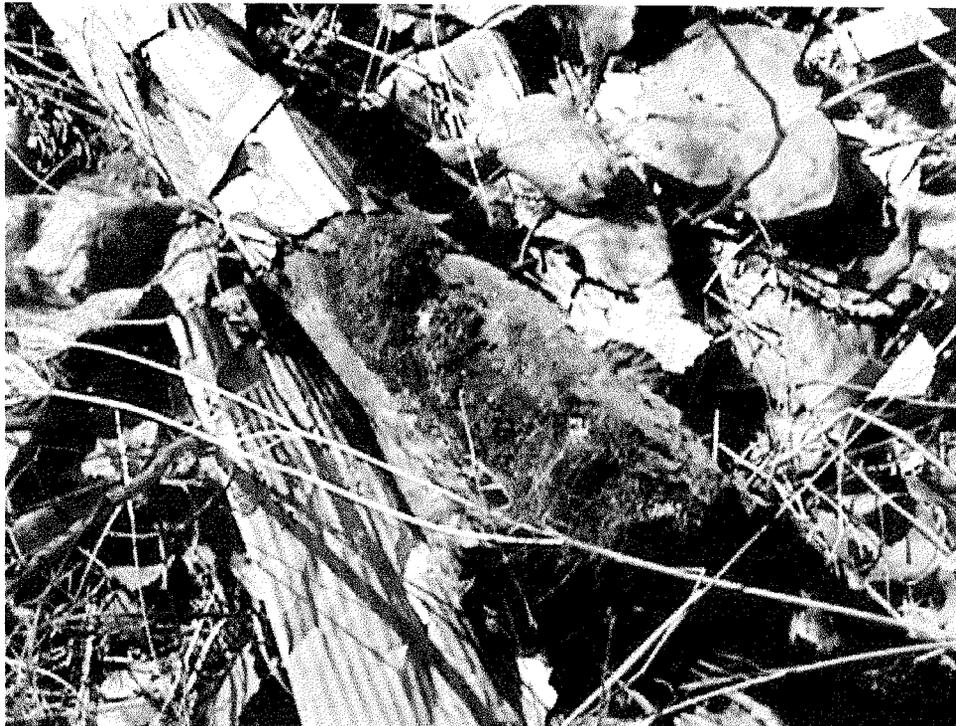
**Photo #6**

Pipe insulation on pipe in Area North of Beech Street

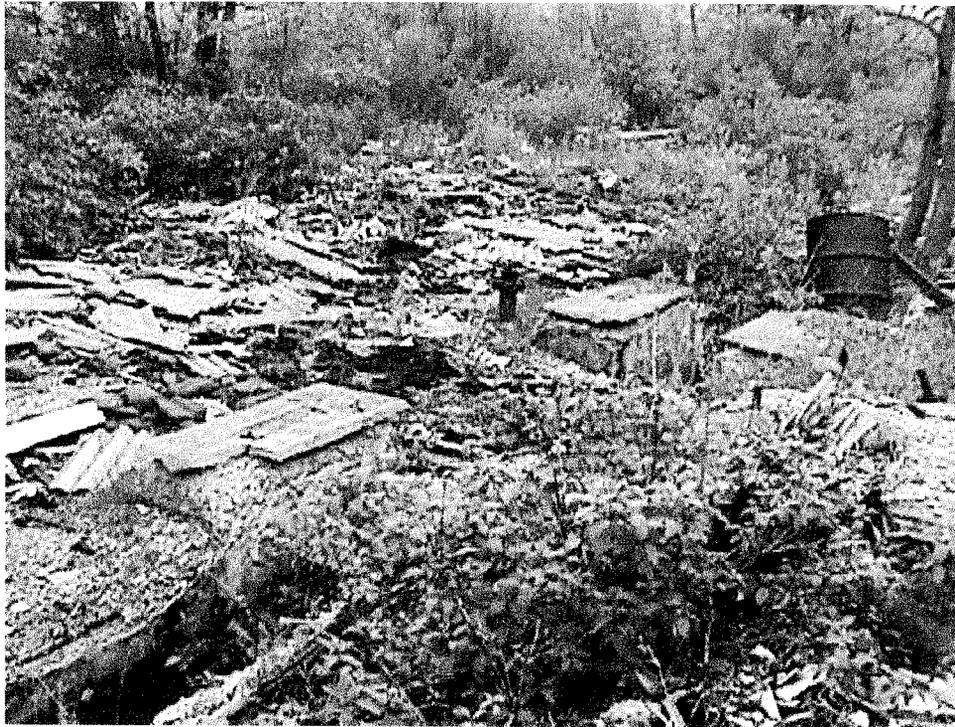
**Photo #7**

In addition, it is the position of the Department that ACM on the portions of the former Air Force Plant -68 currently owned by CWM Chemical Services (CWM) must also be addressed. Extensive contamination of this property by ACM related to the use of this property by the Federal Government has been documented (Photos #7 & #8) . Although ACMs are not covered by the Defense Environmental Restoration Program, the USACE has received an exception for the removal of ACMs from the Somerset Group property. ACMs on the CWM property are from the same origin and should be eligible for the same exception.

PACM and debris at Former AFP-68 Area 7 - Pyrolysis (CWM Property)

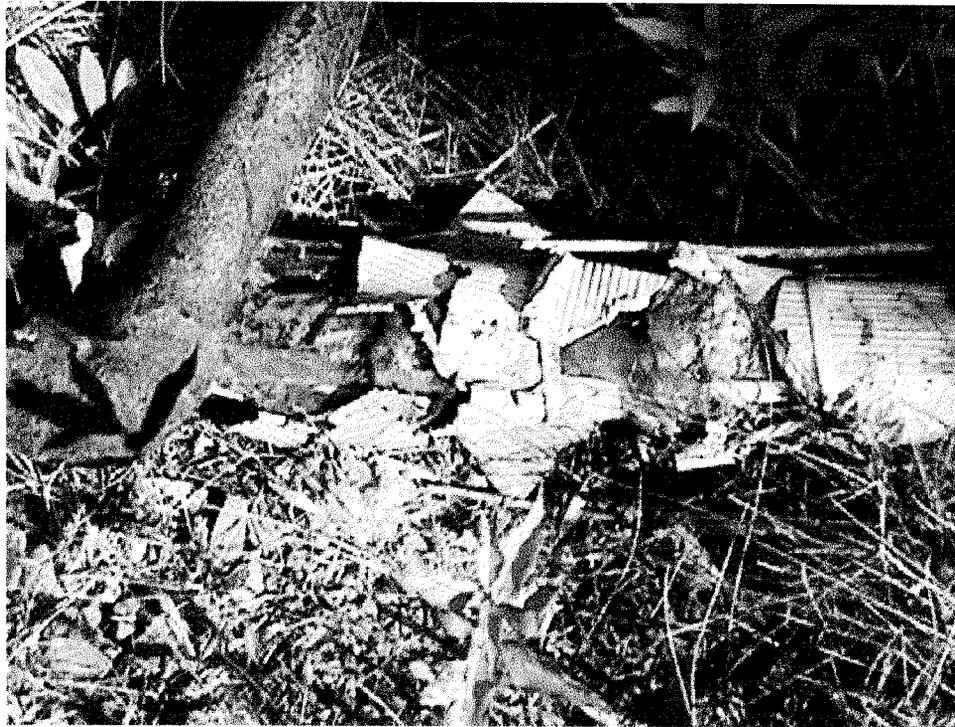
**Photo #8**

PACM pipe insulation located near former AFP-68-Area 16 (Refrigeration & Steam Plant)
