APPENDIX E

Subject: Friable Asbestos Survey Performed on the Guterl Steel Mill

**Building Feature Survey
Remedial Investigation
Former Guterl Specialty Steel Corporation FUSRAP Site
Lockport, New York
May, 2009**

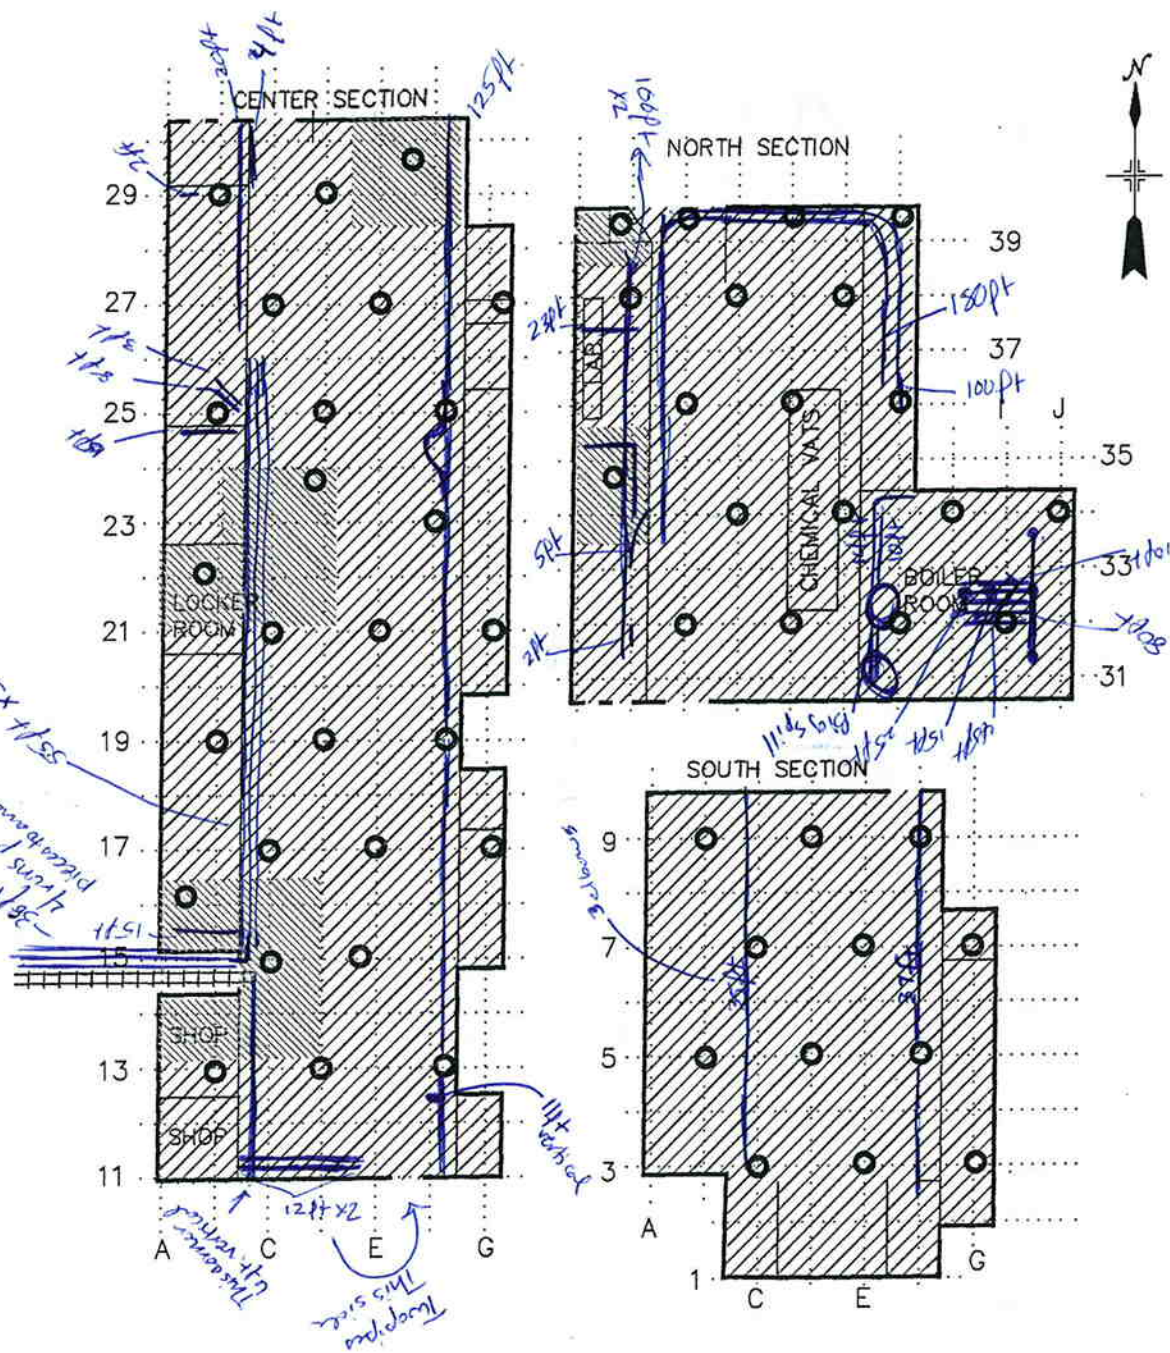
\bigcirc = large spill areas

20 ft on more pipes
 20 ft on top of
 each boiler unit
 Center tank
 covered in acm
 insulation. Back
 of boiler fan
 has friable ACM
 everywhere

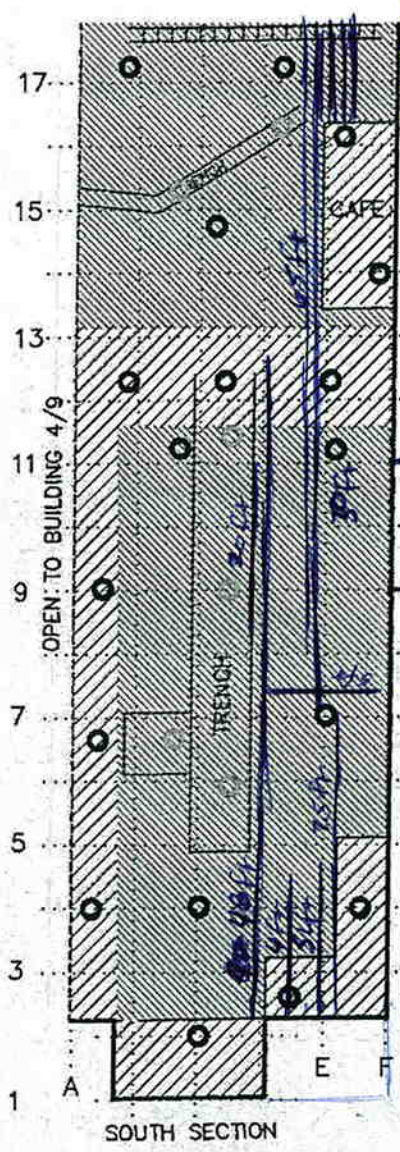
debris everywhere
pipes by sewerage on bottom of room
20 ft x 4 ft doors

3x6 ft 4 doors for bath - broken

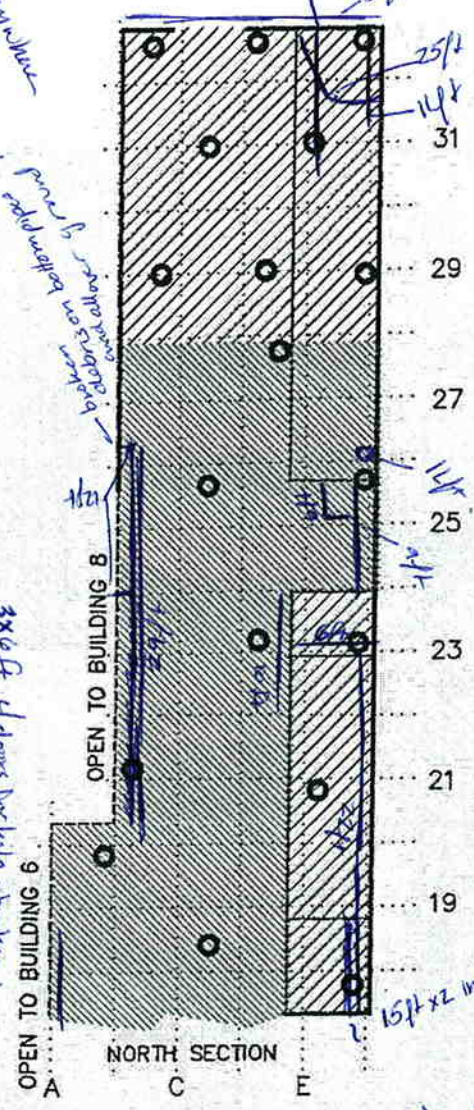
outside 3 - tanks - all pipes ACH
as well as potential contaminants

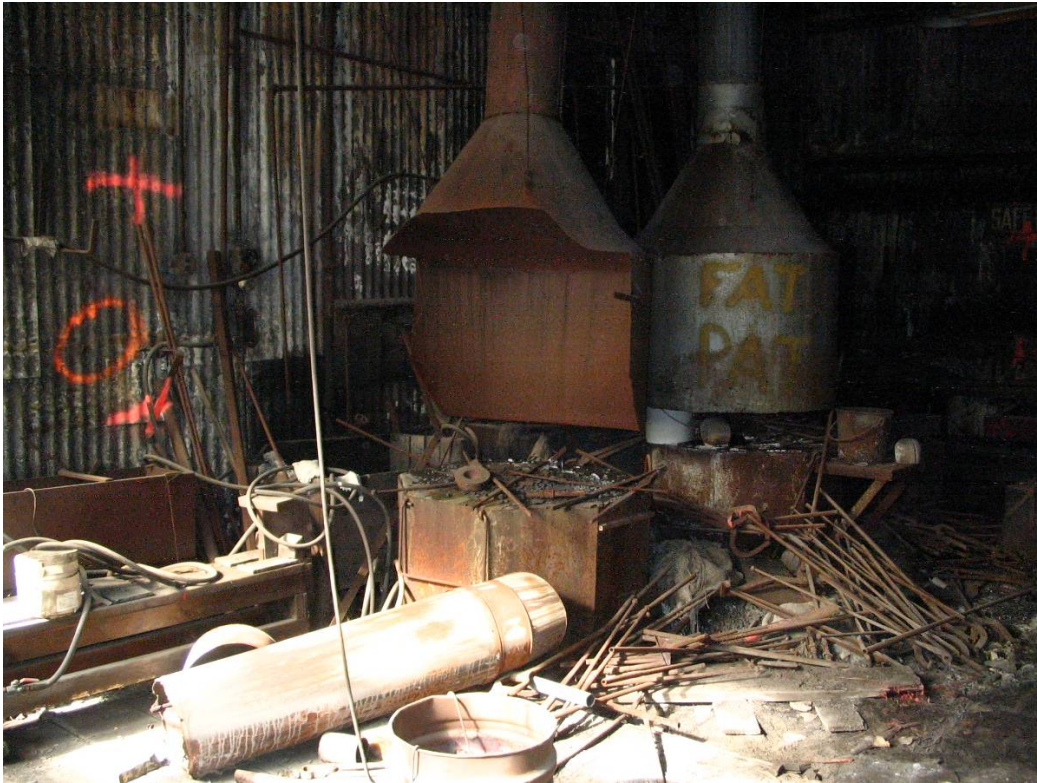
Building	Photo ID	Location within Building	Feature Number	Feature/Item	Material	Approximate Dimension or Volume	Notes
3	B3P4SW	east side of Building 3 (north section)	F5	metal machinery (hoods, grinders, misc.)	metal	5 CY	
3	B3P5S	north east corner of Building 3	F6	misc. equipment & debris	wood & metal	2CY	
3	B3P6SE	east side of Building 3 (north section), across from Building 8	F7	steel rolls	metal	55 @ 5' long x 1.5' diameter 37 @ 4' long x 1.5' diameter 5 @ 8' long x 1.5' diameter	
3	B3P7SW	west side of Building 3 (north section), next to Building 6	F8	steel rolls	metal	73 @ 4-8' long x 1.5-2' diameter	
3	B3P8S	east side of Building 3 (North section), across from Feature 8 (F8)	F9	misc. equipment & debris	wood & metal	3 CY	
3	B3P9N	east side of Building 3 (north section), across from Building 6	F10	misc. equipment & debris	wood & metal	2 CY wood 6 CY metal	
3	B3P10S	south of Feature 10 (F10)	F11	misc. equipment & debris	metal	15 CY equipment 2 CY debris

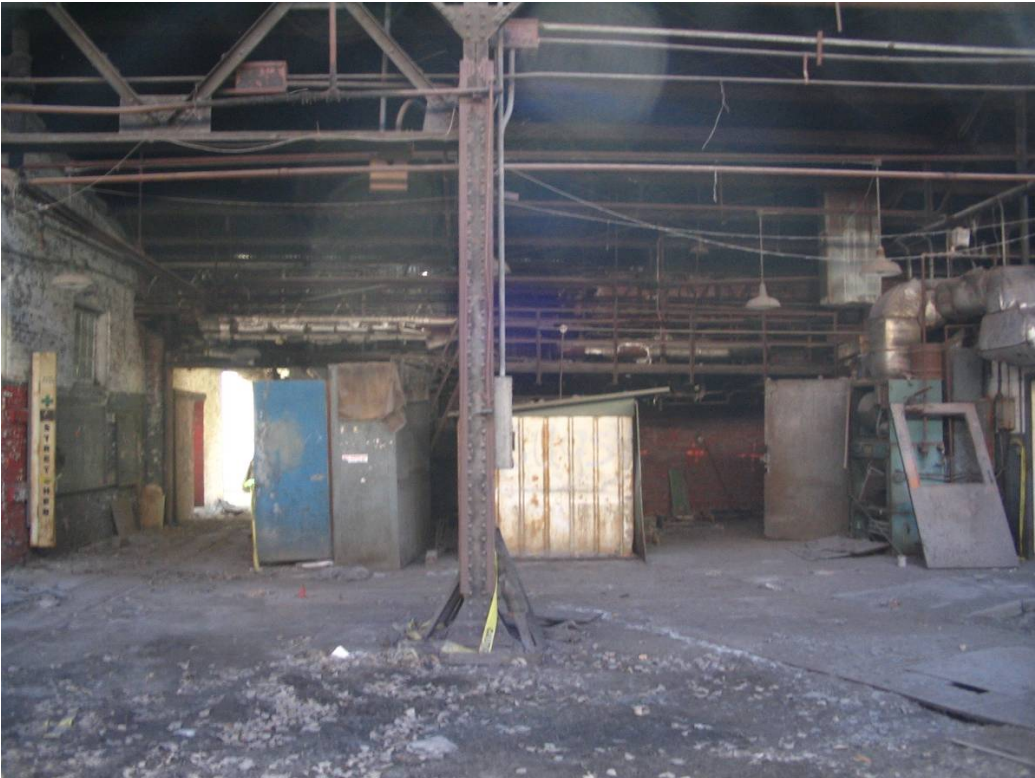
3	B3P11E	east side of Building 3, below hopper tracks	F12	cabinets & cafeteria heater	metal	3 CY	
3	B3P12S	Building 3 (E-W oriented trench)	F13	misc. debris	wood & metal	1 CY wood 1CY metal	
3	B3P13N	south section of cafeteria	F14	cafeteria kitchen	metal	5 CY	
3	B3P14S	N-S oriented trench (south section Building 3)	F15	trench rubble	wood & metal	2 CY wood 15 CY metal	
3	B3P15NE	east side of Building 3 (south section), next to N-S oriented trench	F16	3 furnaces	brick & metal	3 @ 12' x 8' x 30'	photo is only of the northern most furnace
3	B3P15NE	east side of Building 3 (south section), next to N-S oriented trench	F17	misc. debris	wood & metal	5 CY	no new photo for this feature - yardage is cumulative for debris located between the 3 furnaces in Feature 16 (F16)
3	B3P16SE	east side of Building 3 (south section), near southern extent of N-S oriented trench	F18	furnace	brick & metal	25' x 15' x 6'	northeast of press in Feature 19 (F19)

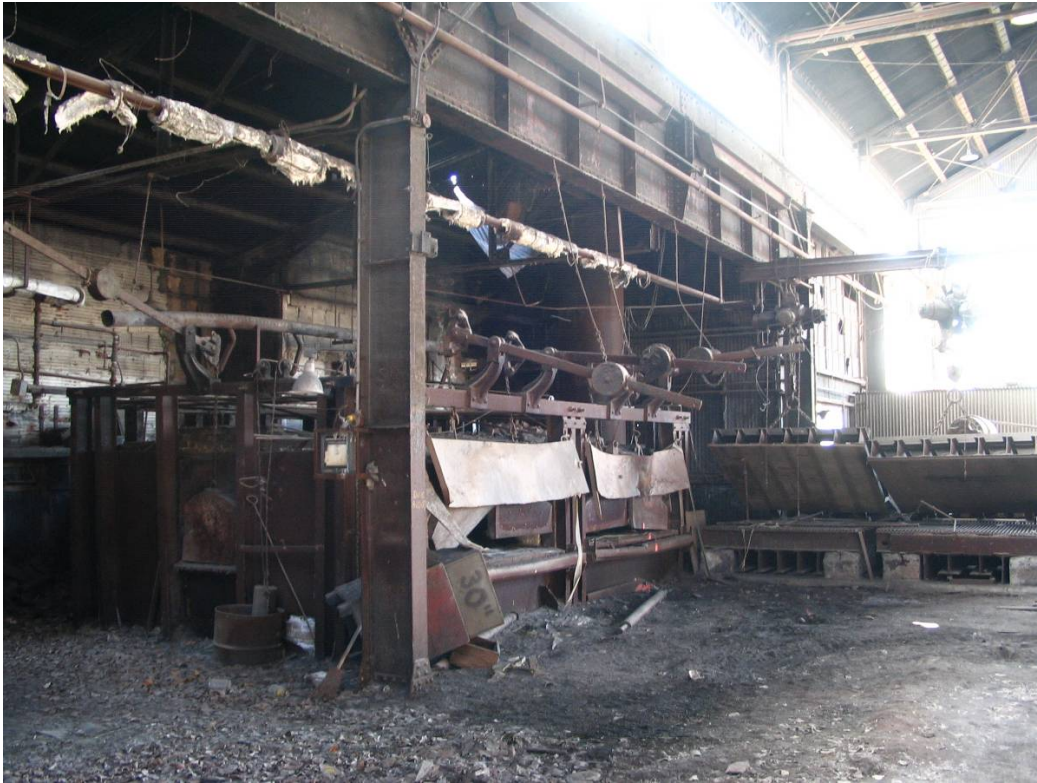
3	B3P16SE	east side of Building 3 (south section), near southern extent of N-S oriented trench	F19	press	metal with concrete base	20' x 15' x 4'

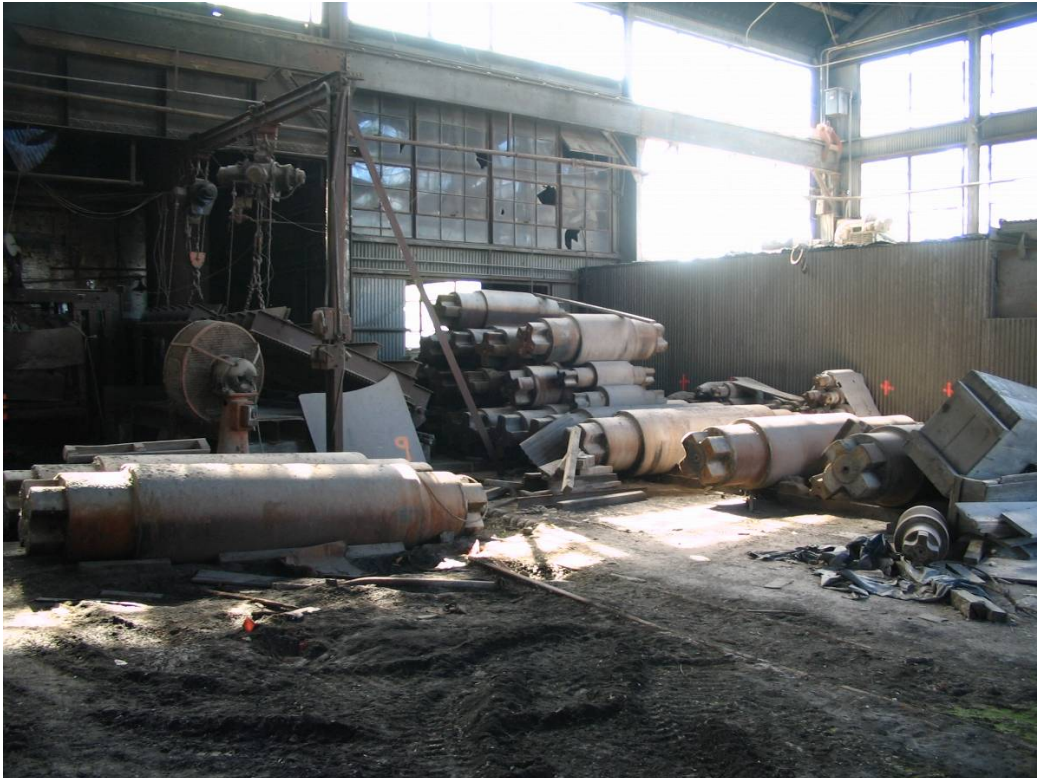
Building	Photo ID	Location within Building	Feature Number	Feature/Item	Material	Approximate Dimension or Volume	Notes
3	B3P17SE	south end of Building 3	F20	steel rolls	metal	65 @ 4' long x 1' diameter 10 @ 4' long x 1.5' diameter 9 @ 6' long x 2' diameter 8 @ 12' long x 2.5' diameter	
3	B3P18E	small room in south east corner of Building 3	F21	misc. debris	wood & metal	2 CY wood 2 CY metal	
3	B3P19W	small room at south end of Building 3	F22	equipment (steel rolls, lathes)	metal	50 @ 3-4' long x 1' diameter 3 lathes each 5' x 6' x 20'	
3	B3P20NE	photo of a single lathe	F22	lathe	metal	-----	no new feature associated with this photo
5	B5P1E	inside Building 5	F1	electrical equipment	metal	2/3 of building (2/3 * 140' long x 30' wide)	
5	B5P2W	inside Building 5	F1	electrical equipment	metal	2/3 of building (2/3 * 140' long x 30' wide)	
6	B6P1NW	intersection area of Buildings 3, 6, & 8	F1	furnace	brick & metal	6' x 12' x 8'	not field measured, dimensions estimated from Oise drawings and photo.

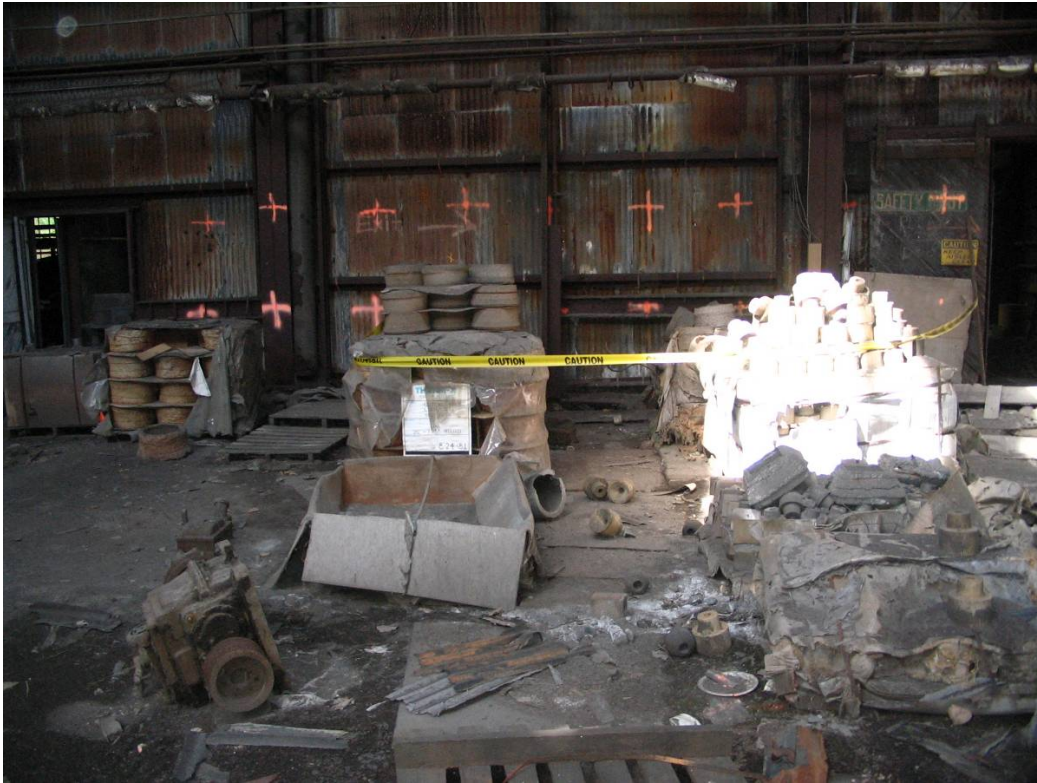
2	B2P8W	southern part of Building 2 (center section)	F11	ceramic material	ceramic	10 CY	
2		southern part of Building 2 (center section)	F12	15-ton overhead crane	metal	-----	no direct photo of this feature
2	B2P9S	room south of the locker room, Building 2 (center section)	F13	misc. debris	wood & metal	10 CY wood 5 CY metal

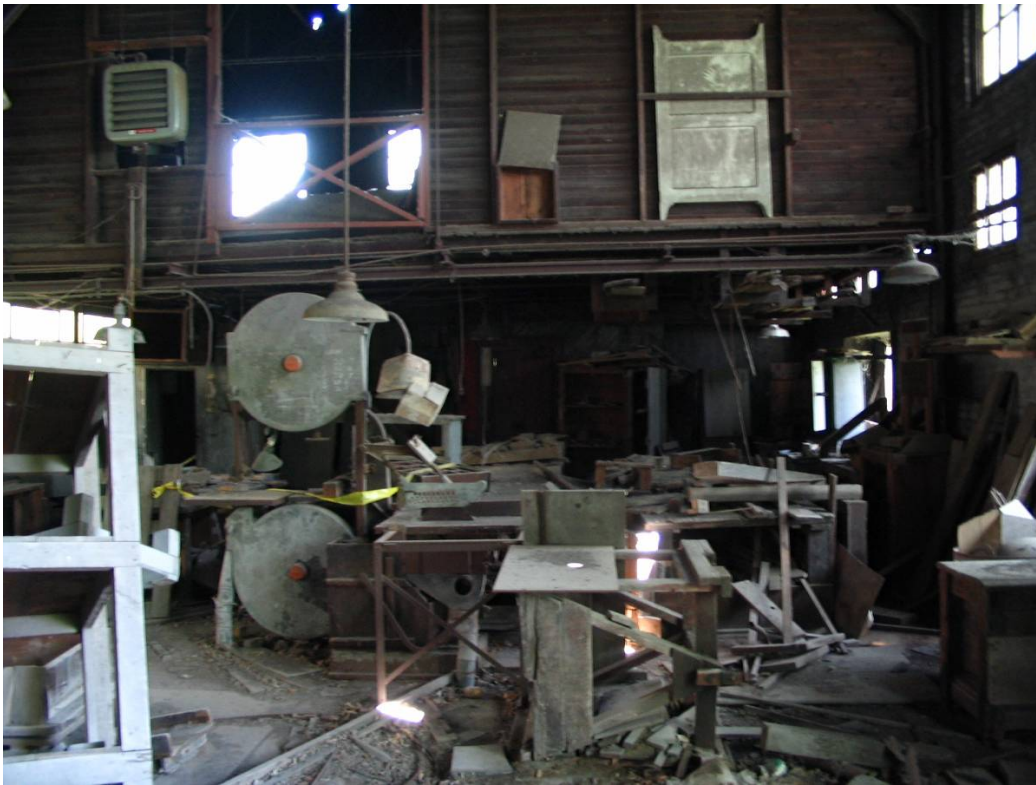
Building	Photo ID	Location within Building	Feature Number	Feature/Item	Material	Approximate Dimension or Volume	Notes
1	B1P1N	north room of Building 1, facing north	F1	misc. debris	wood & metal	10 CY wood 2 CY metal	
1	B1P2S	north room of Building 1, facing south	-----	misc. debris	wood & metal	-----	no new feature, different view of north room in building 1
1	B1P3S	center room of Building 1	F2	misc. equipment & debris (includes smelters & furnaces)	wood & metal	5 CY wood 10 CY metal	2 smelters and 3 furnaces in this room
1	B1P4NW	small elevated work room in southwest corner of Building 1	F3	asbestos materials & misc. debris	asbestos material, wood, metal	3 CY	
1	B1P5S	south room of Building 1	F4	misc. debris	wood & metal	5 CY	includes debris in small room at southern extent of building 1
2	B2P1S	Building 2 (north section), main room	F1	15-ton overhead crane	metal	-----	
2	B2P1S	Building 2 (north section), main room	F2	chemical vats & associated piping	metal	65' x 30' x 6'	not field measured, estimated from Orise drawings and field photo
