APPENDIX C

Guterl Steel RI Report
Remedial Investigation Photographs

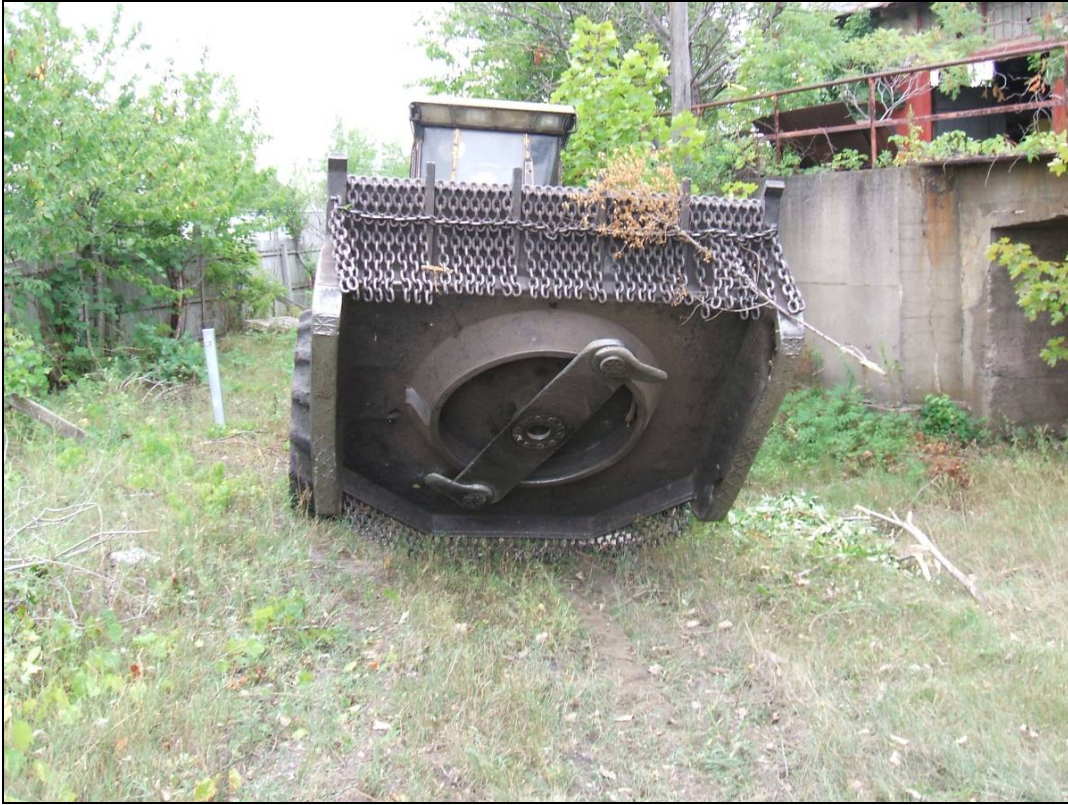
Photo 1: Clearing and grubbing activity with Hydro-Ax.

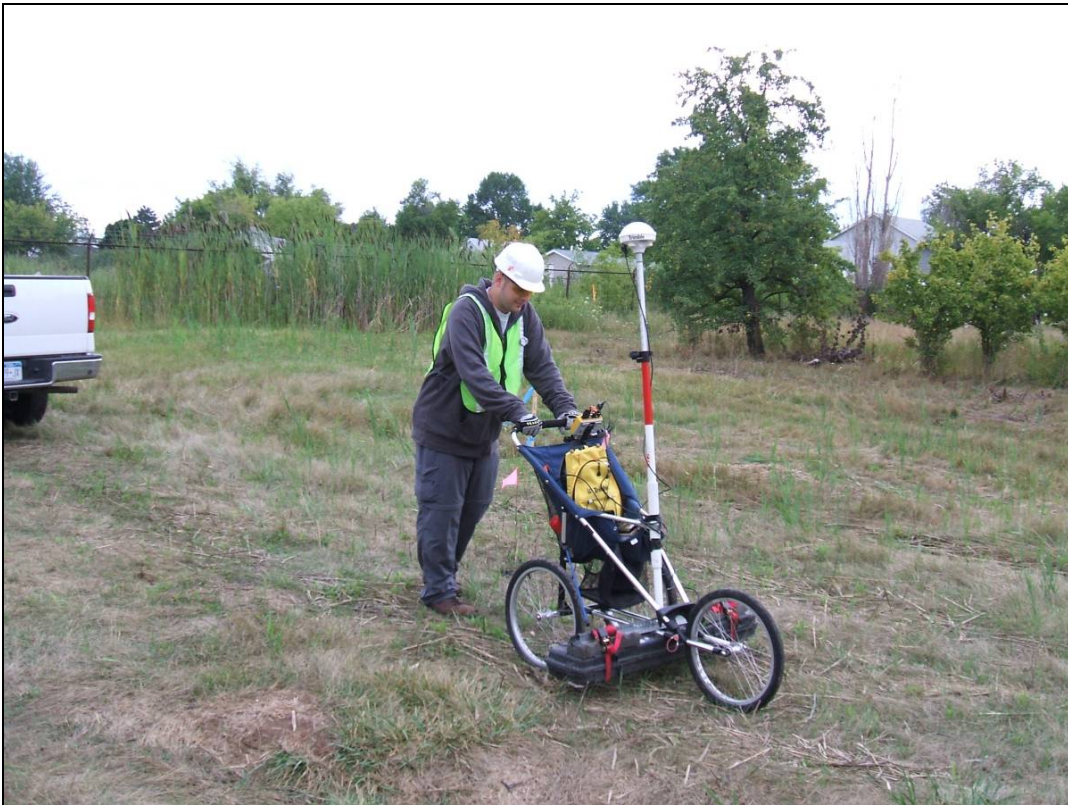
Photo 2: Gamma walk over survey activity performed with a buggy-mounted instrument.

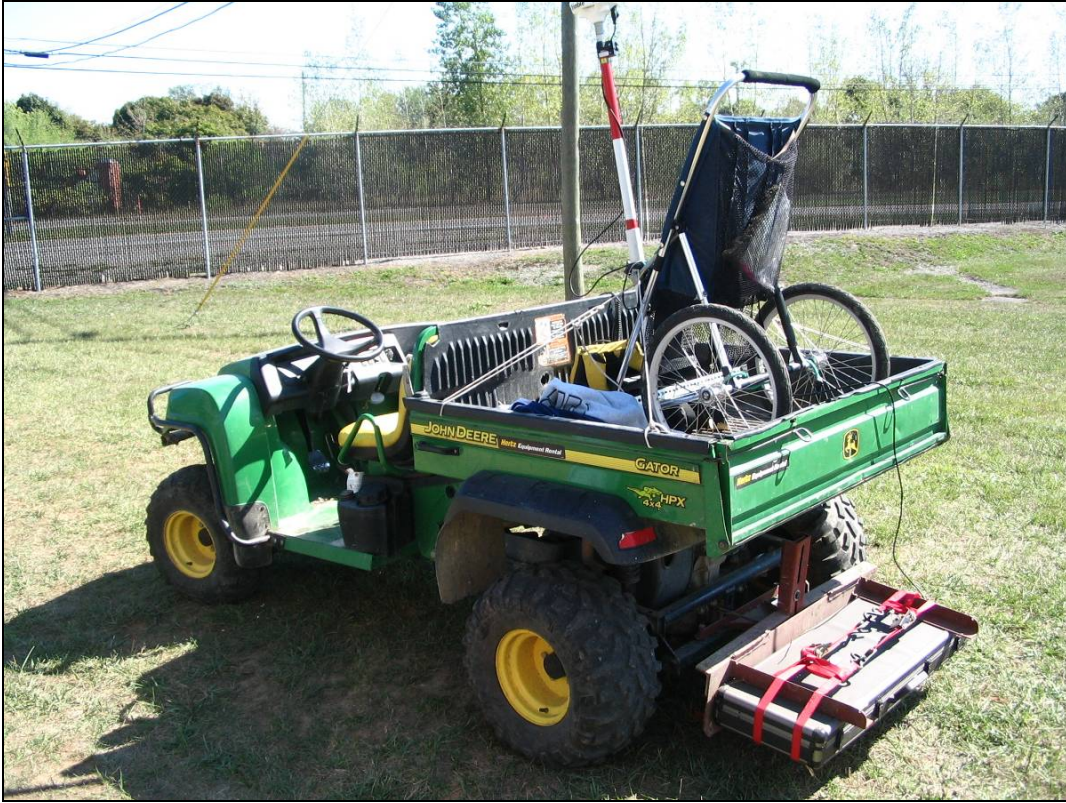
Photo 3: Gamma walk over survey equipment mounted on a Gator.

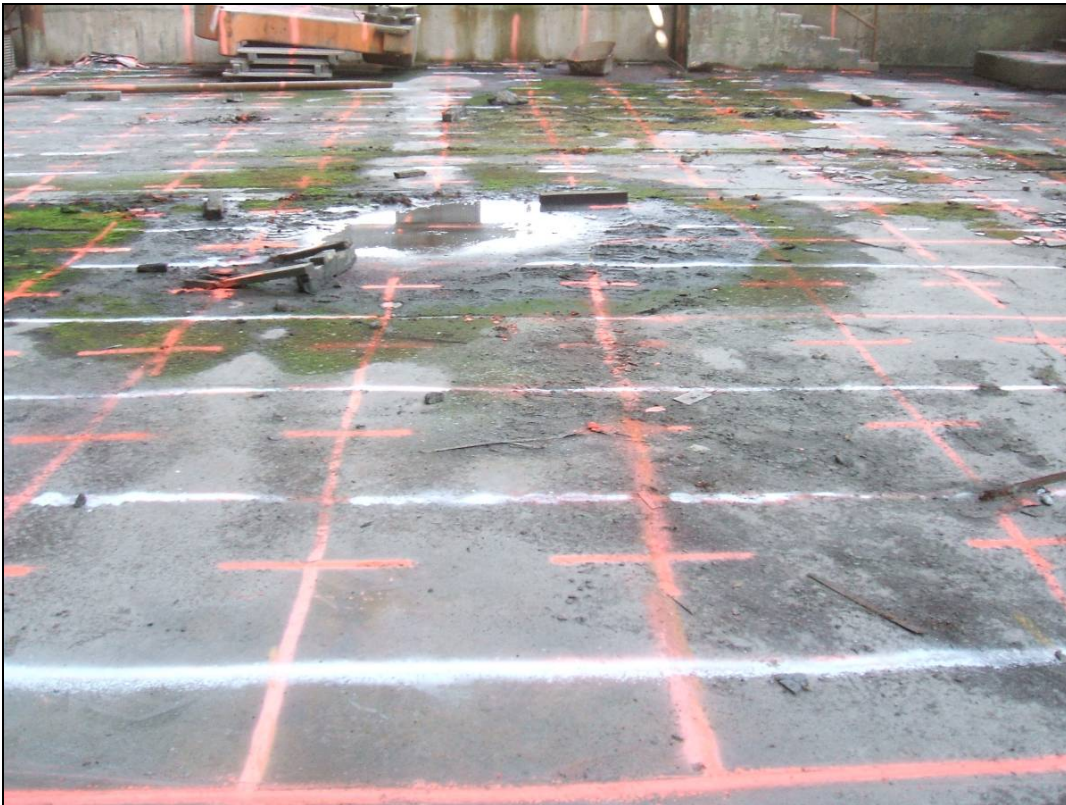
Photo 4: Floor grid in Building 4/9 establish for scan survey.

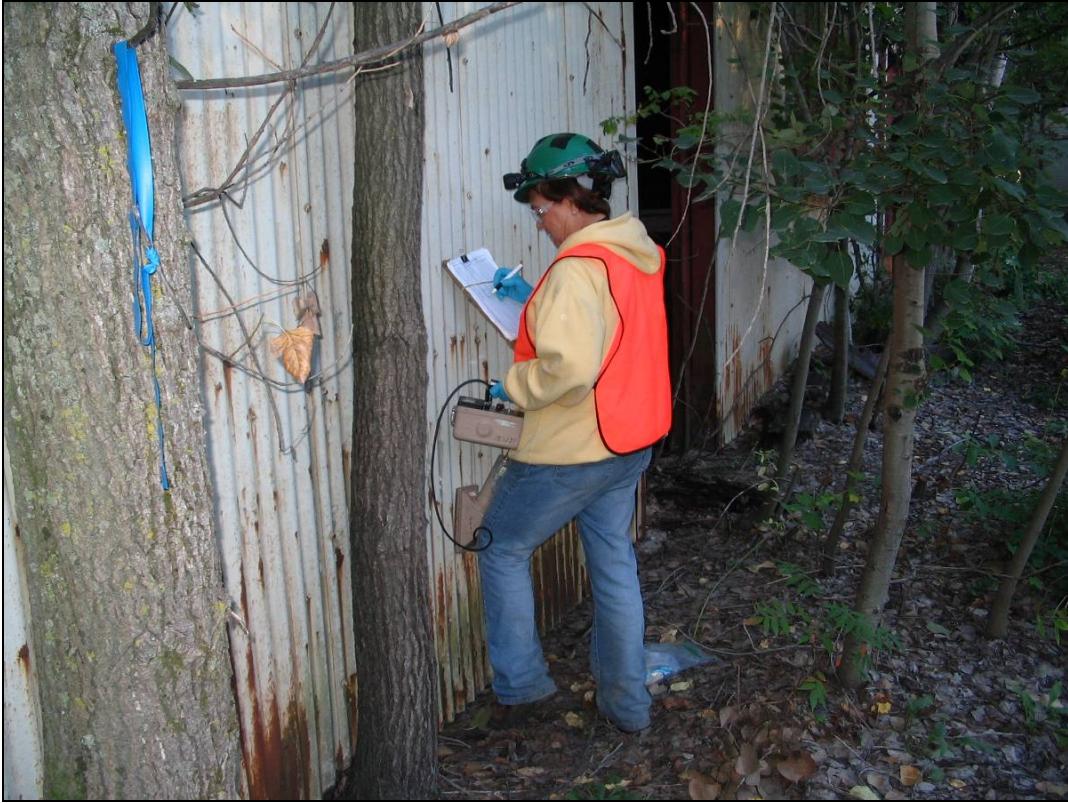
Photo 5: Surface scanning, direct measurement, and swipe testing of building exterior.

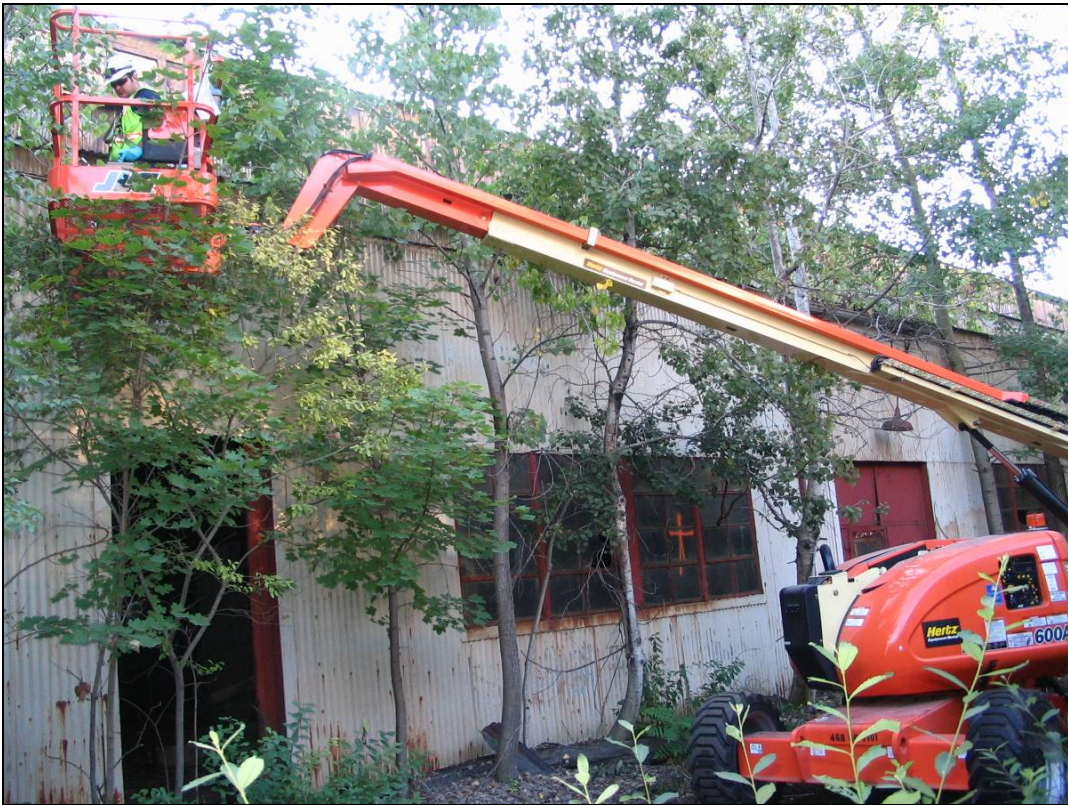
Photo 6: Surface scanning, direct measurement, and swipe testing of building exterior.

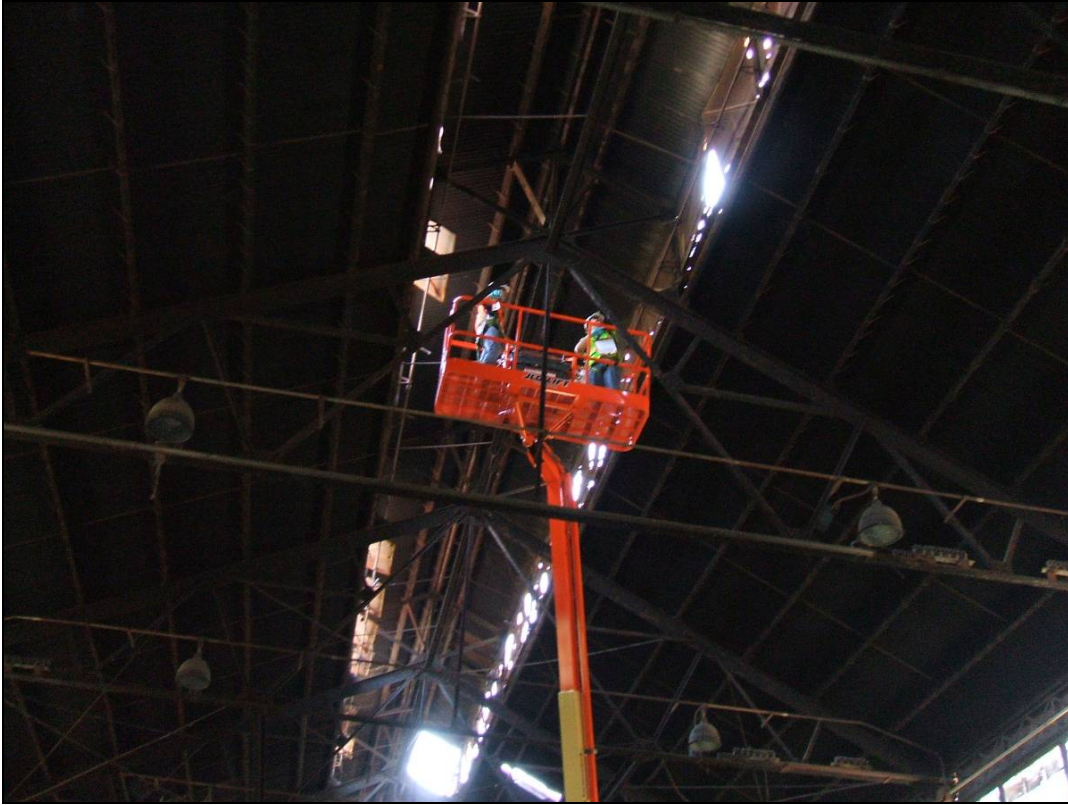
Photo 7: Surface scanning, direct measurement, and swipe testing of building interior.

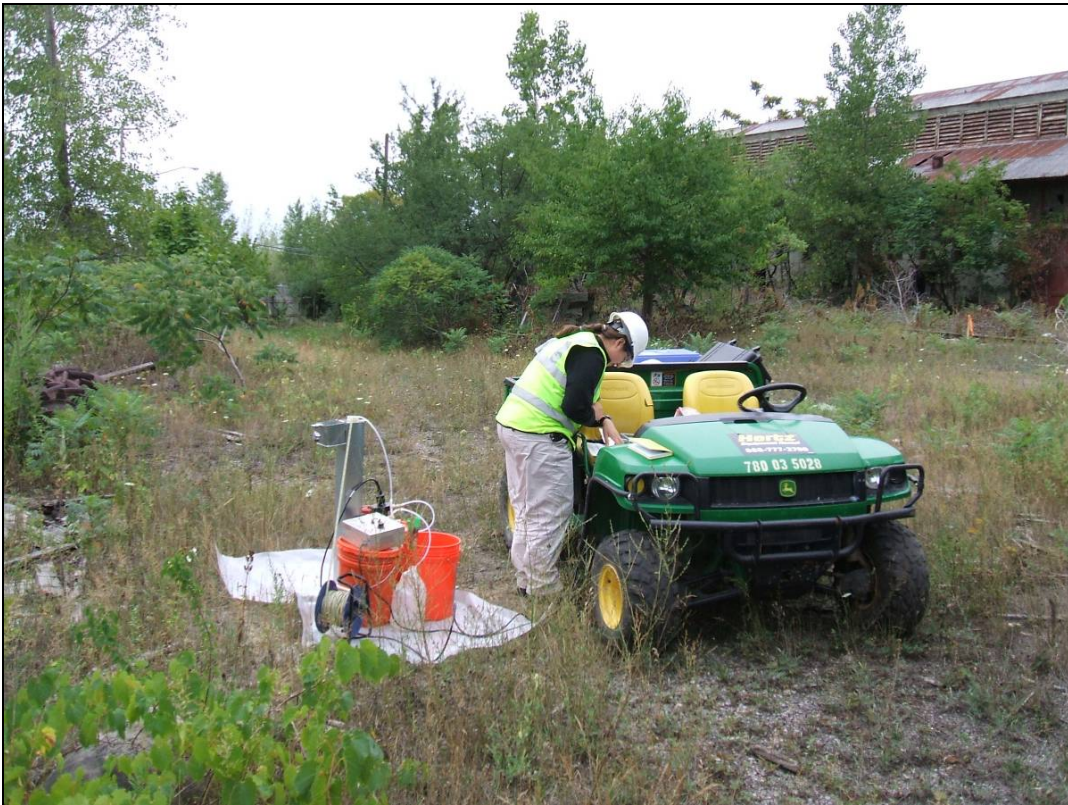
Photo 8: Low flow groundwater sampling activities at MW-08.

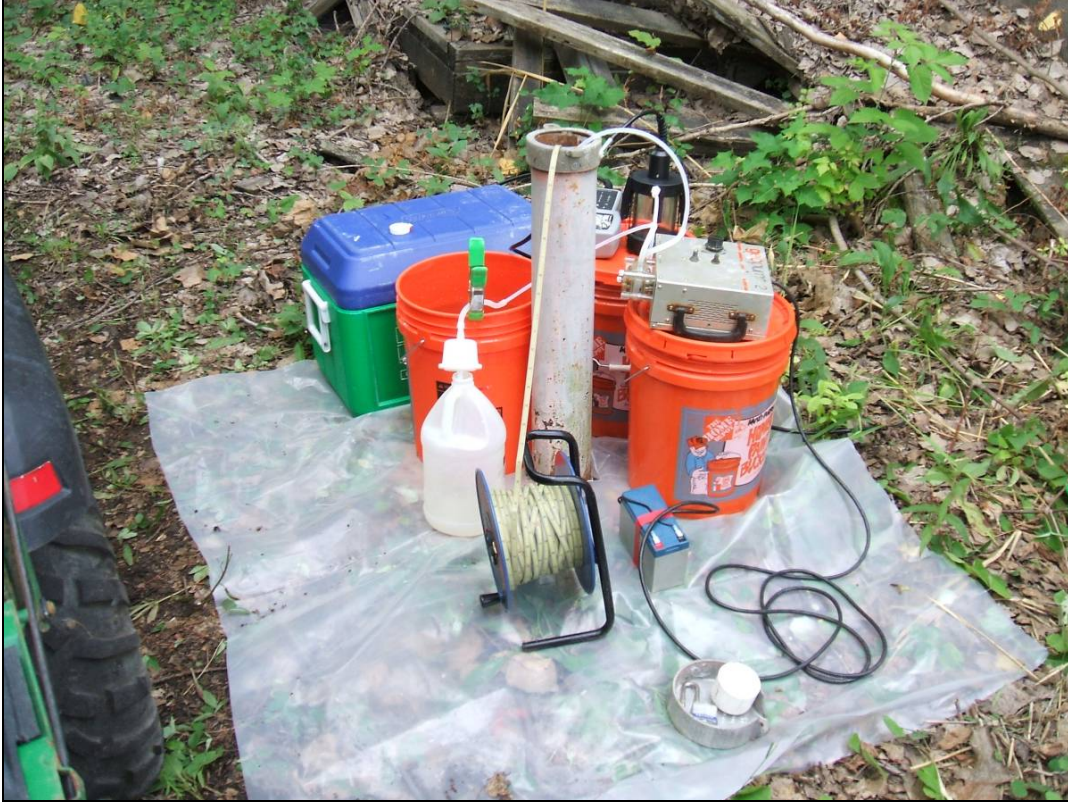
Photo 9: Low flow groundwater sampling activities at MW-5.

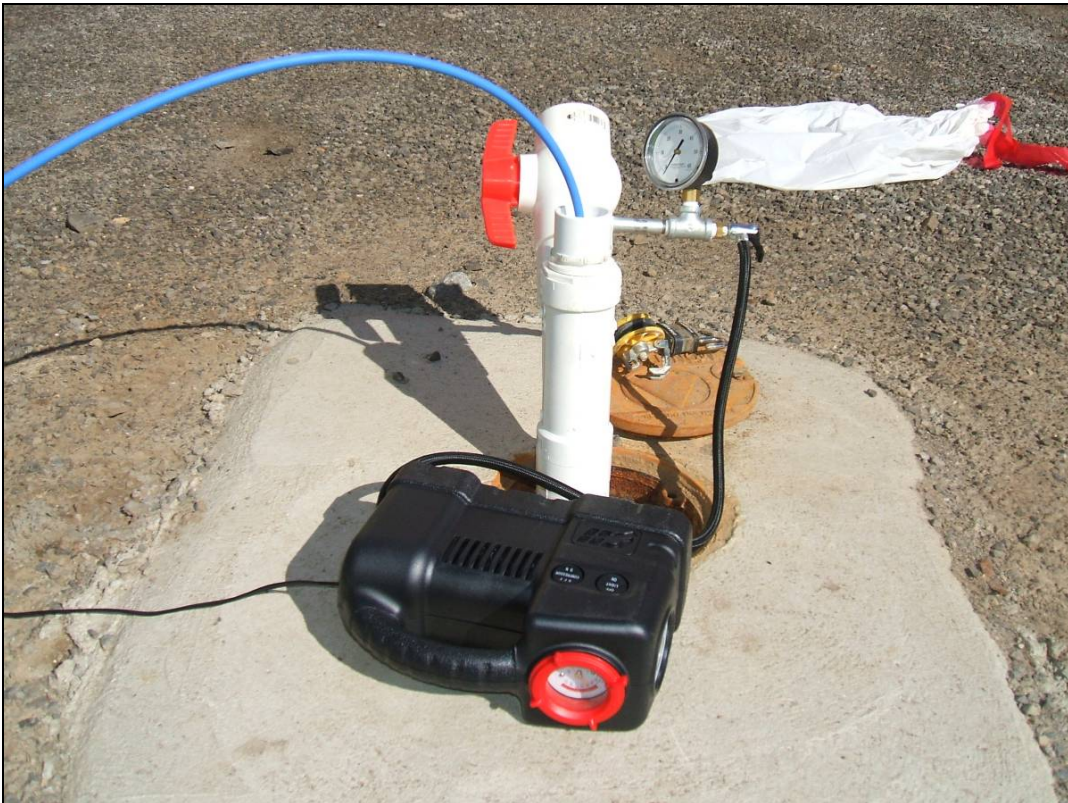
Photo 10: Aquifer testing activities at MW-605D.

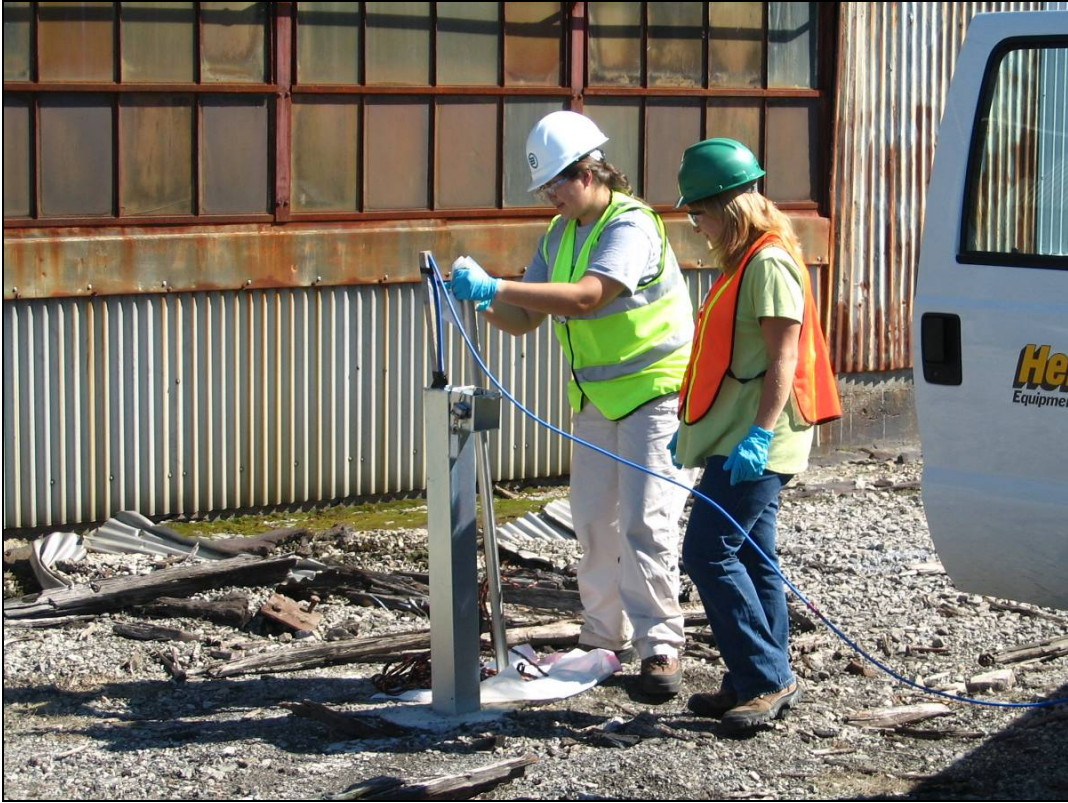
Photo 11: Aquifer testing activities at MW-23.

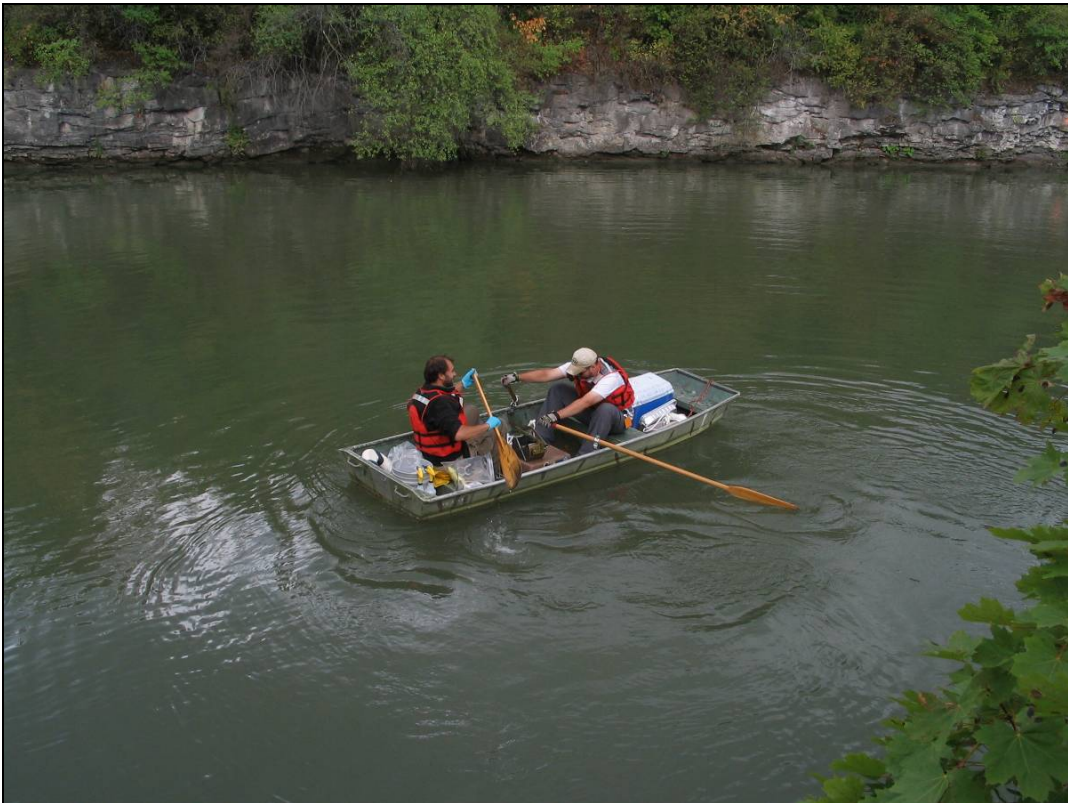
Photo 12: Sediment and water column sampling activities at the Erie Canal.

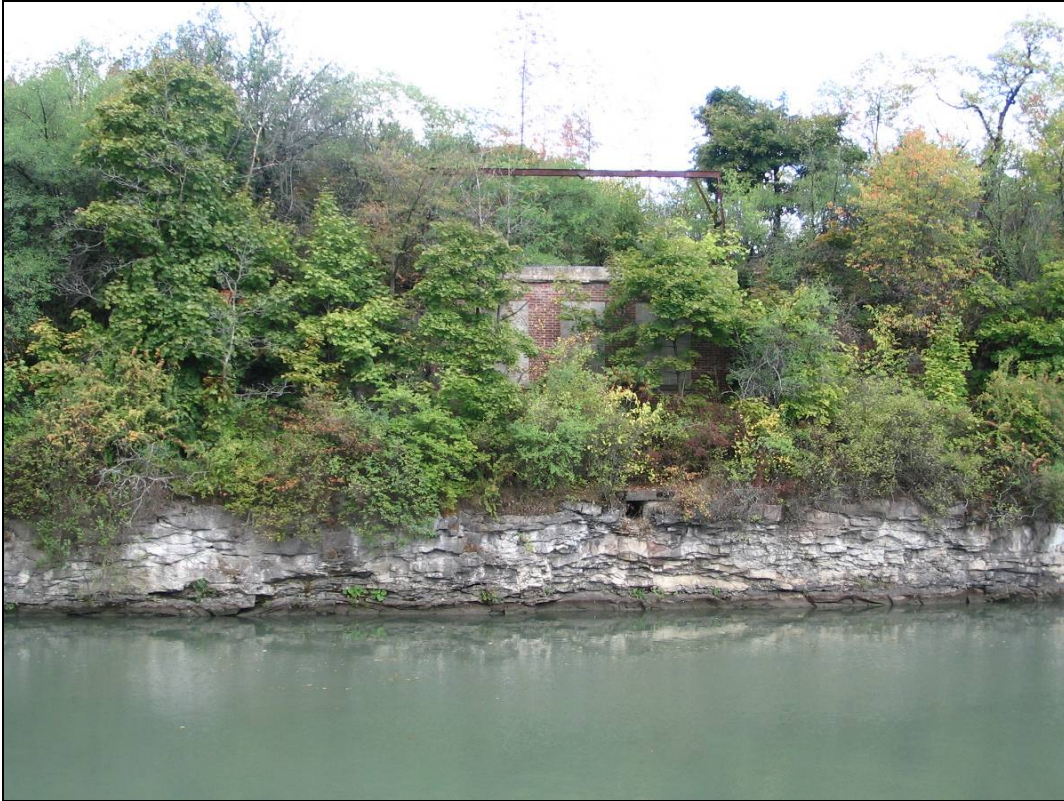
Photo 13: View northwest of the Guterl Steel pump house and outfall.

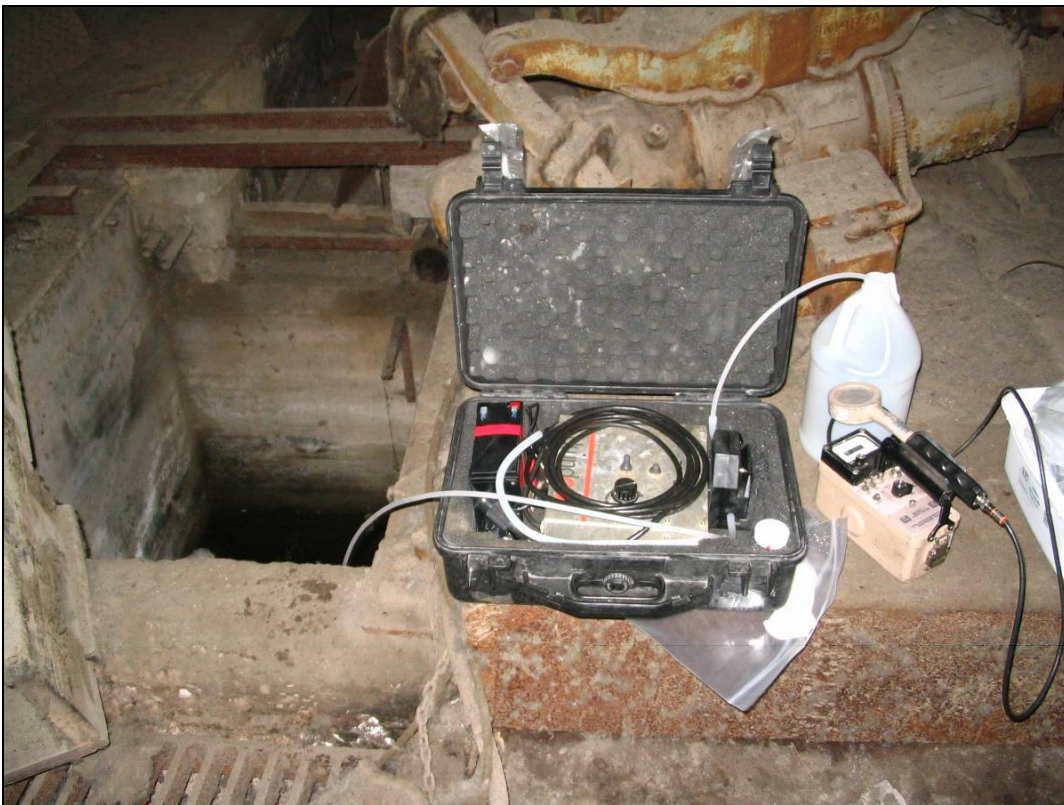
Photo 14: Surface water sampling activity in Building 2.

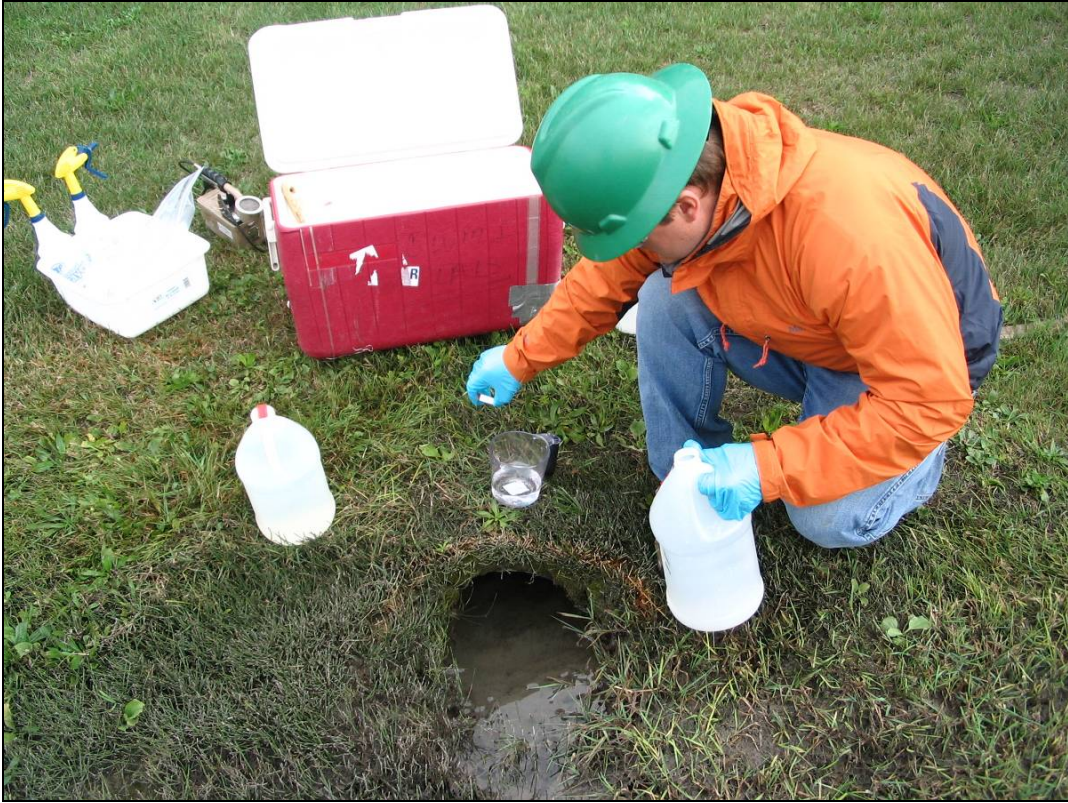
Photo 15: Surface water sampling activity at culvert on the west side of Building 4/9.

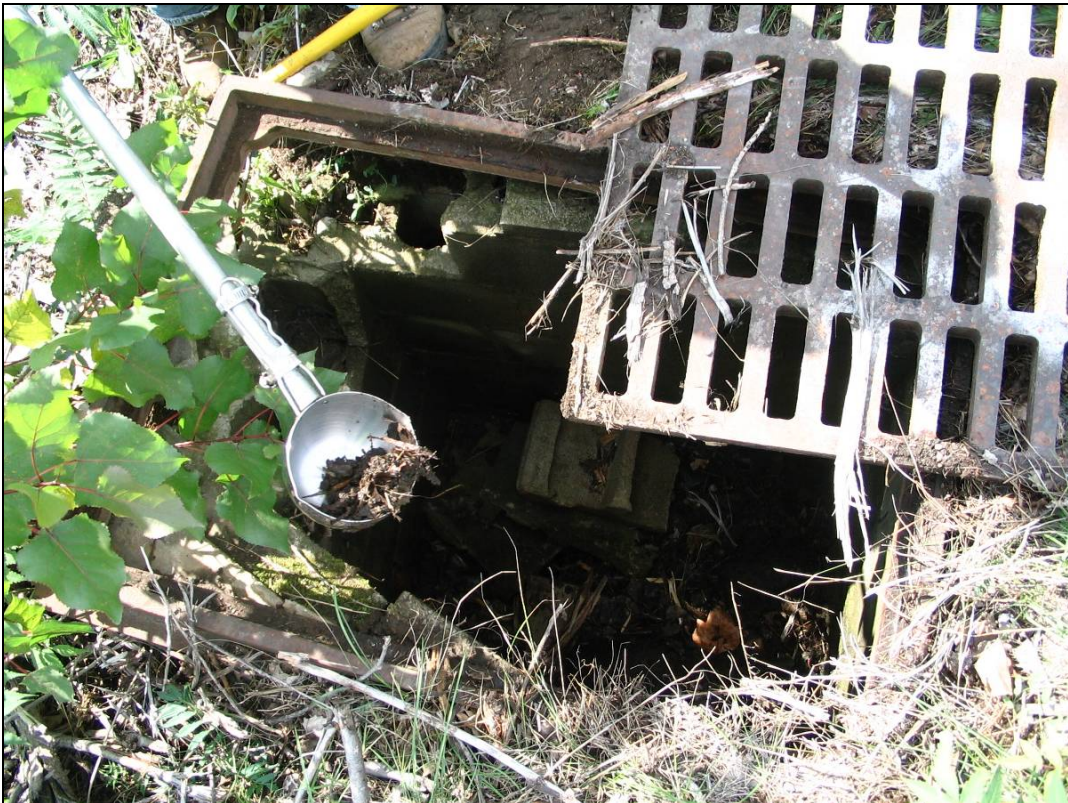
Photo 16: Sediment sampling activity a catch basin located on the east side of Building 24.

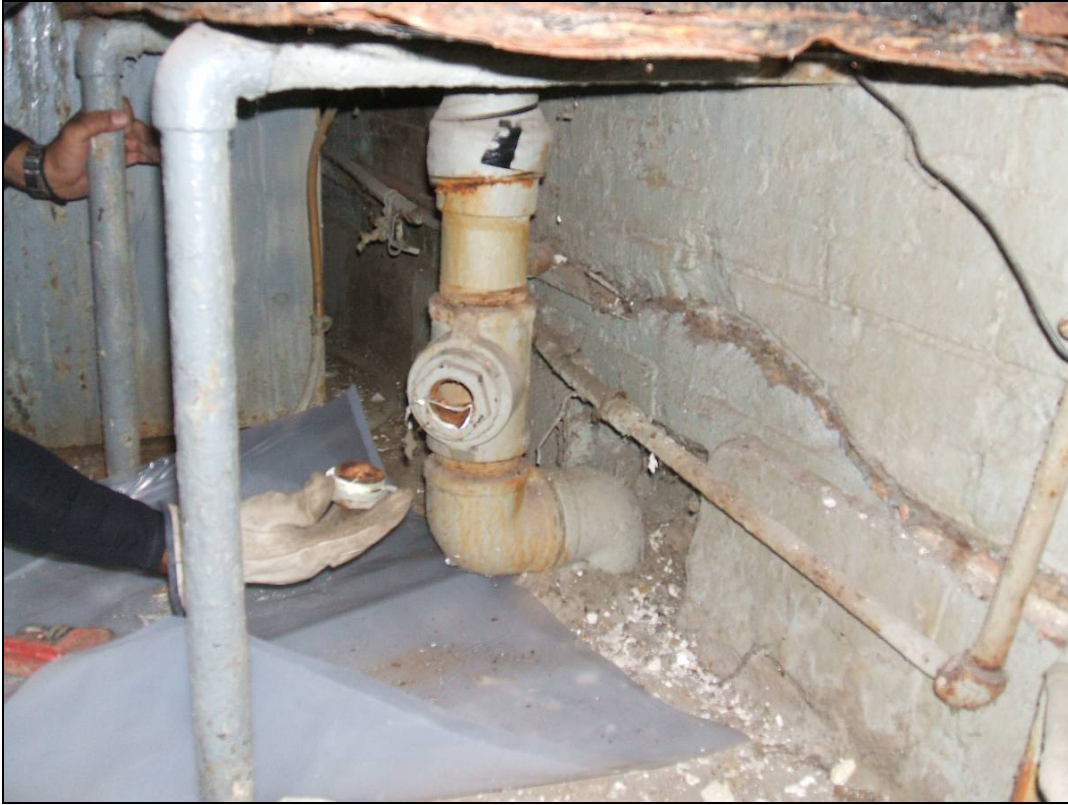
Photo 17: Sampling activities of a sink drain.

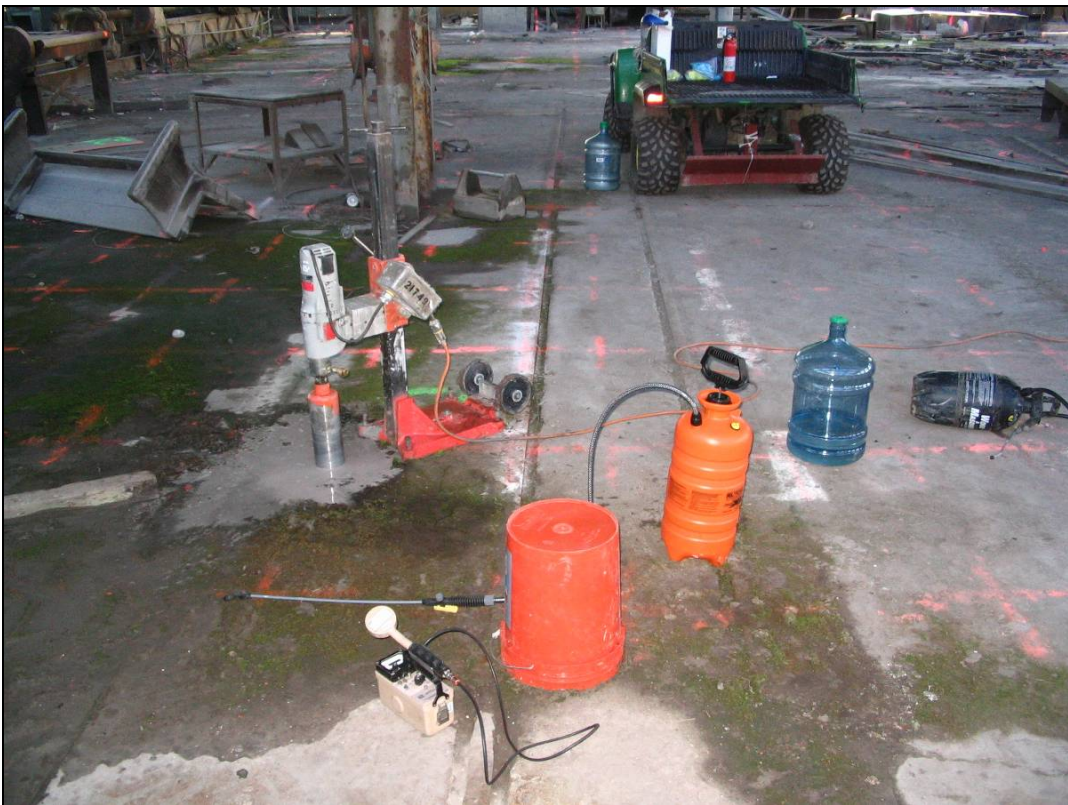
Photo 18: Concrete coring activity in Building 4/9.

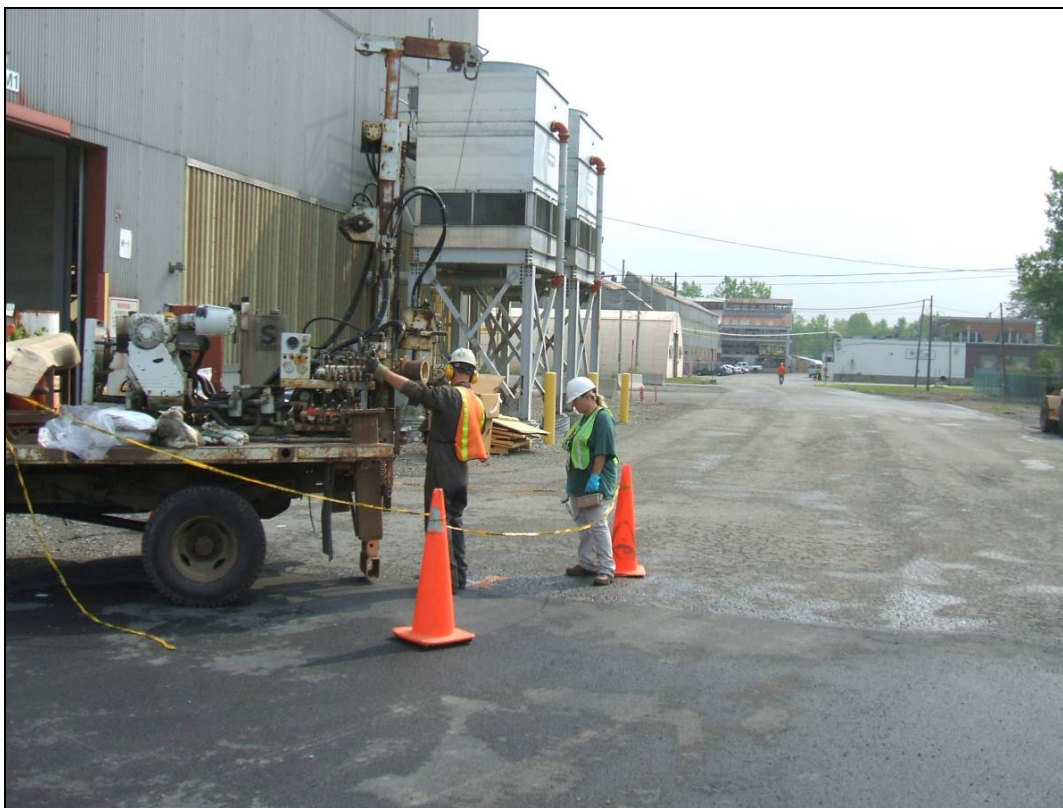
Photo 19: DPT sampling activity on the south side of Building 14.

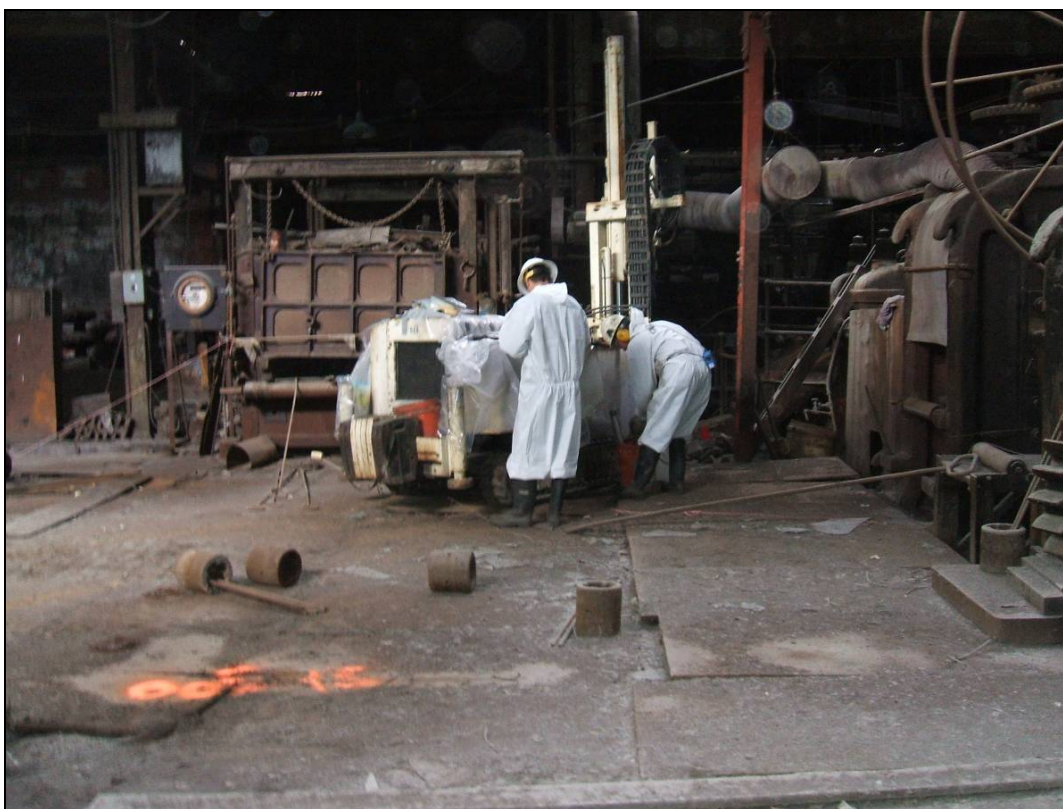
Photo 20: DPT sampling activities with a track-mounted rig in Building 6.

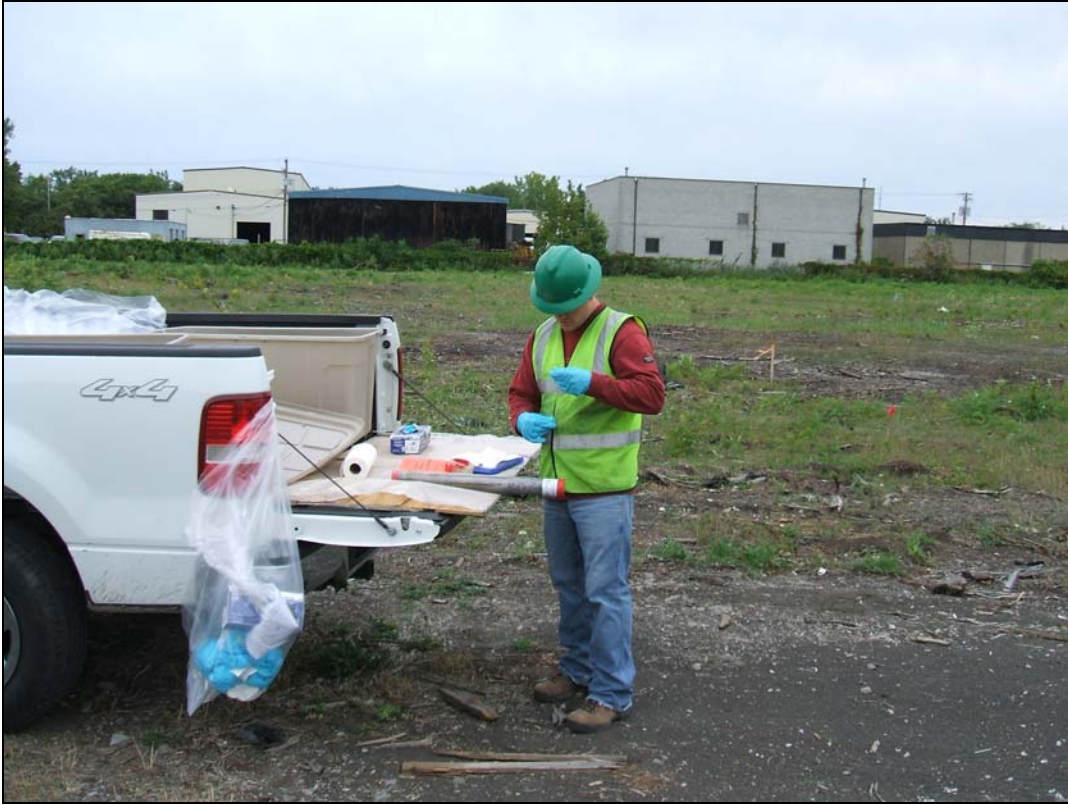
Photo 21: Core management activities.

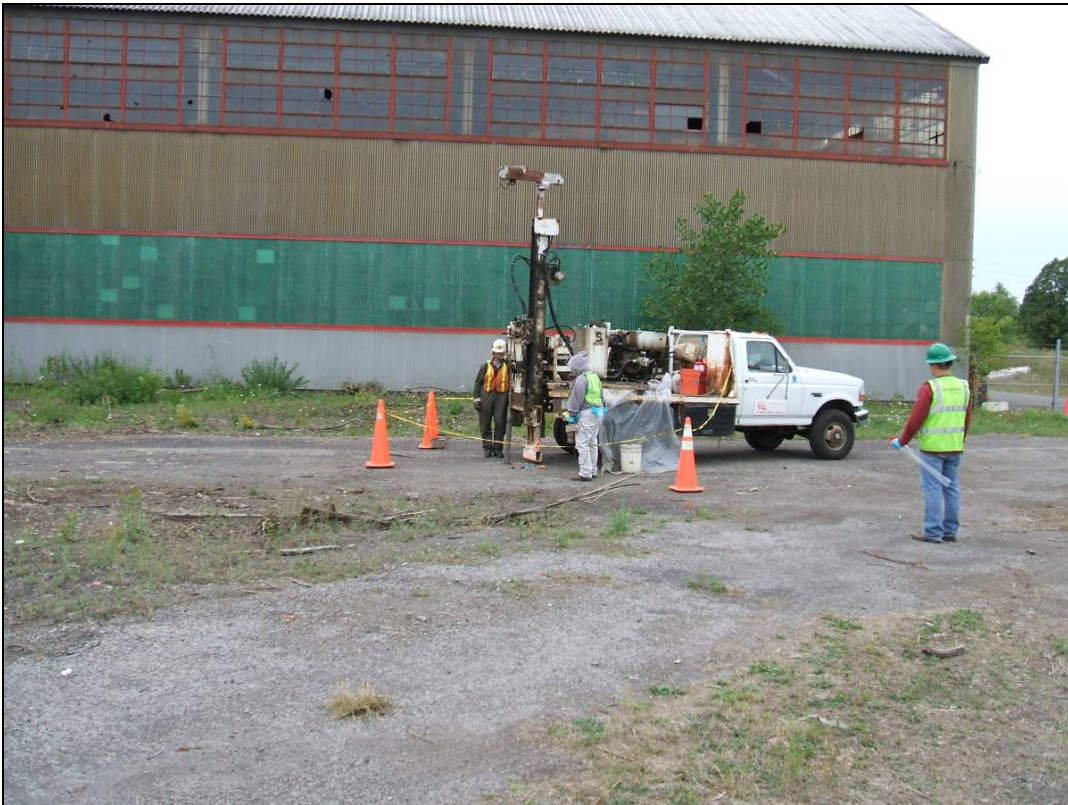
Photo 22: DPT sampling activities with a truck-mounted rig on the west side of Building 24.

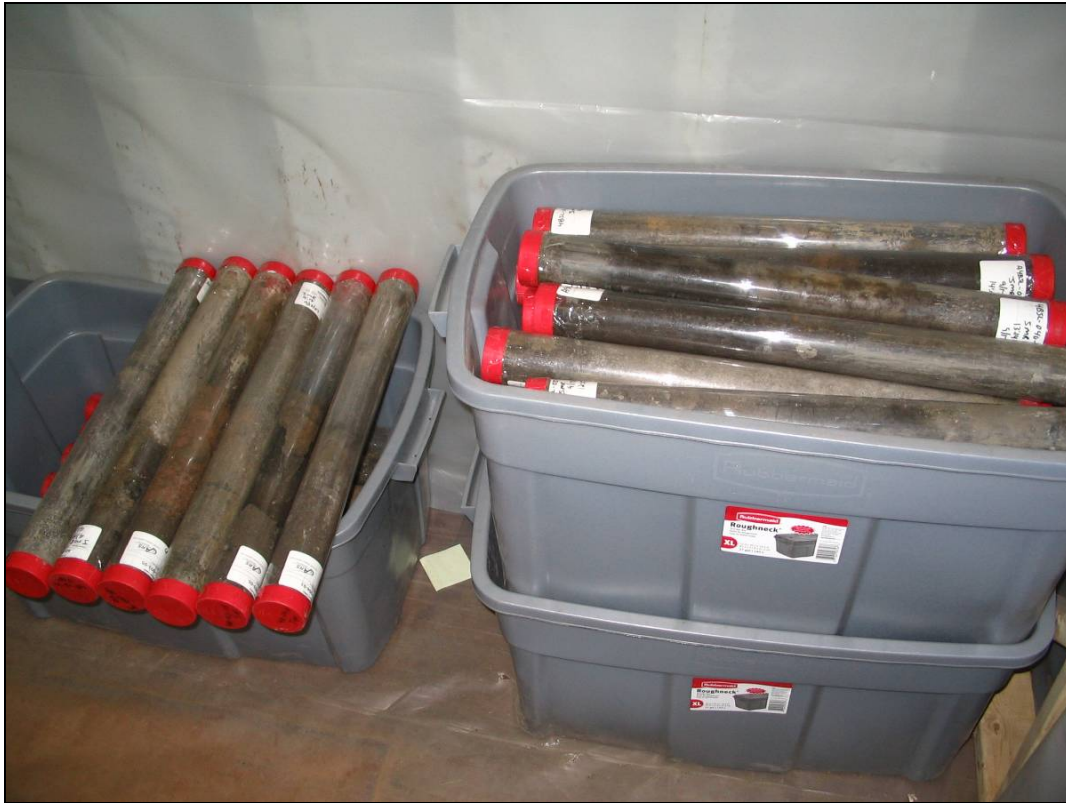
Photo 23: Soil cores collected with direct push technology rig prepared for core scanner.

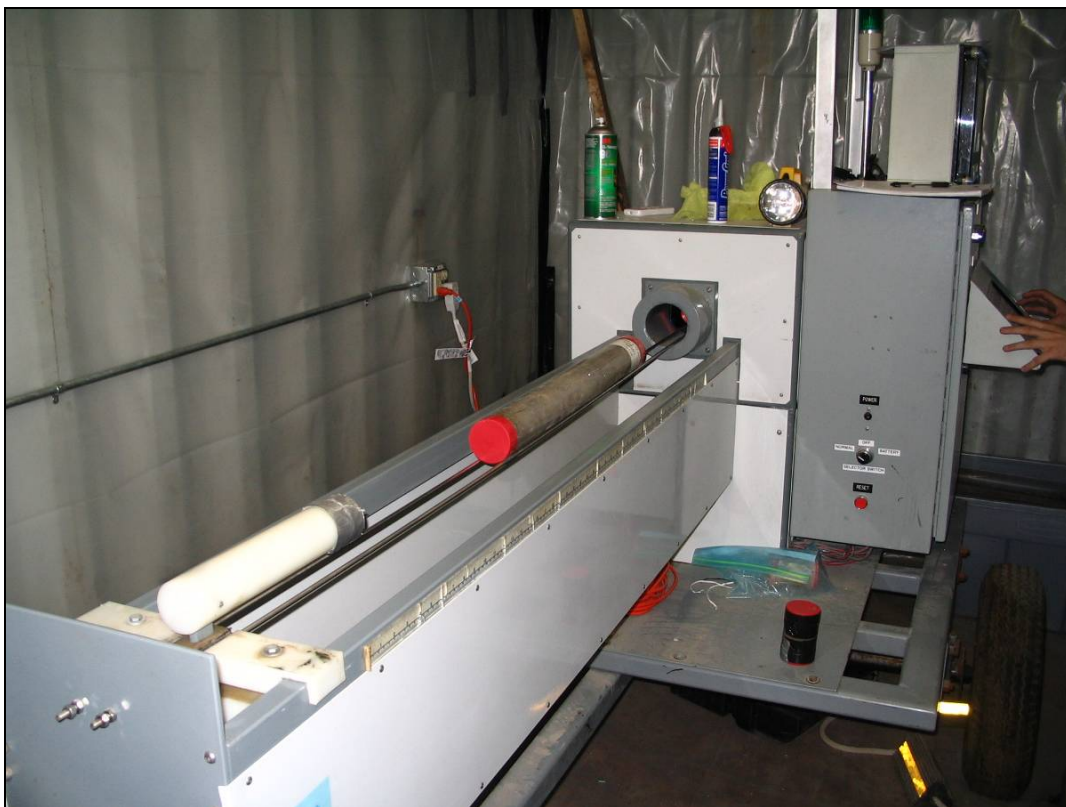
Photo 24: Soil core scanning activity.

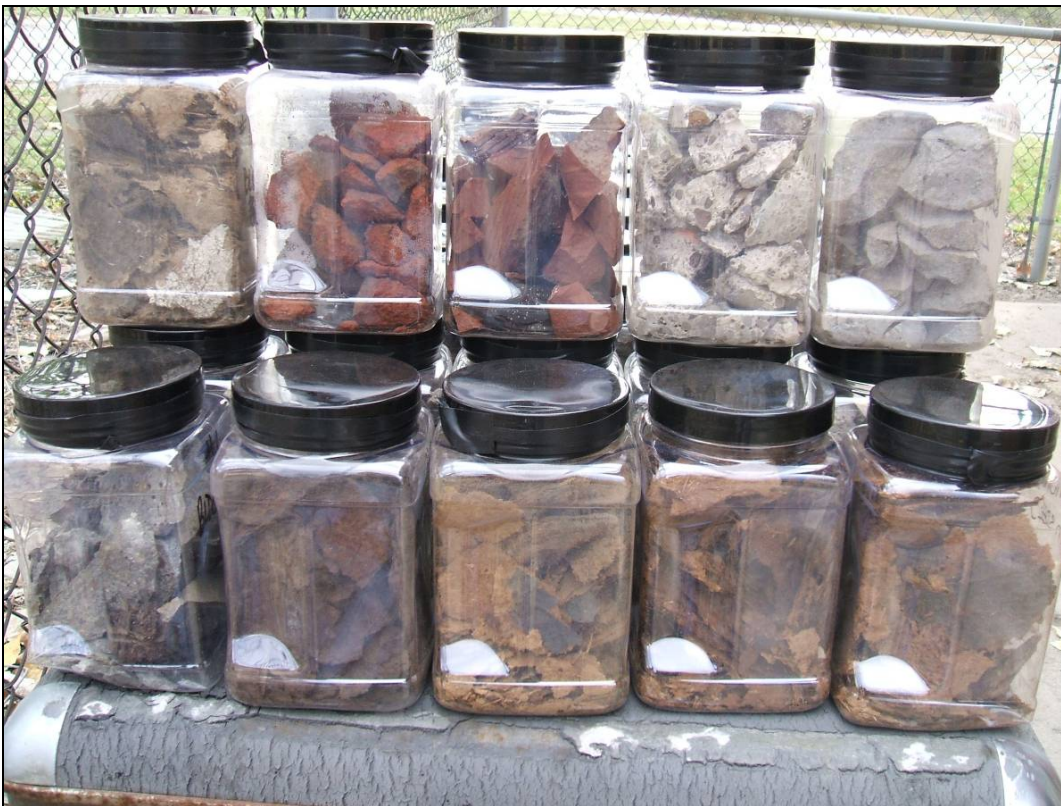
Photo 25: Building material samples collected for laboratory analysis.

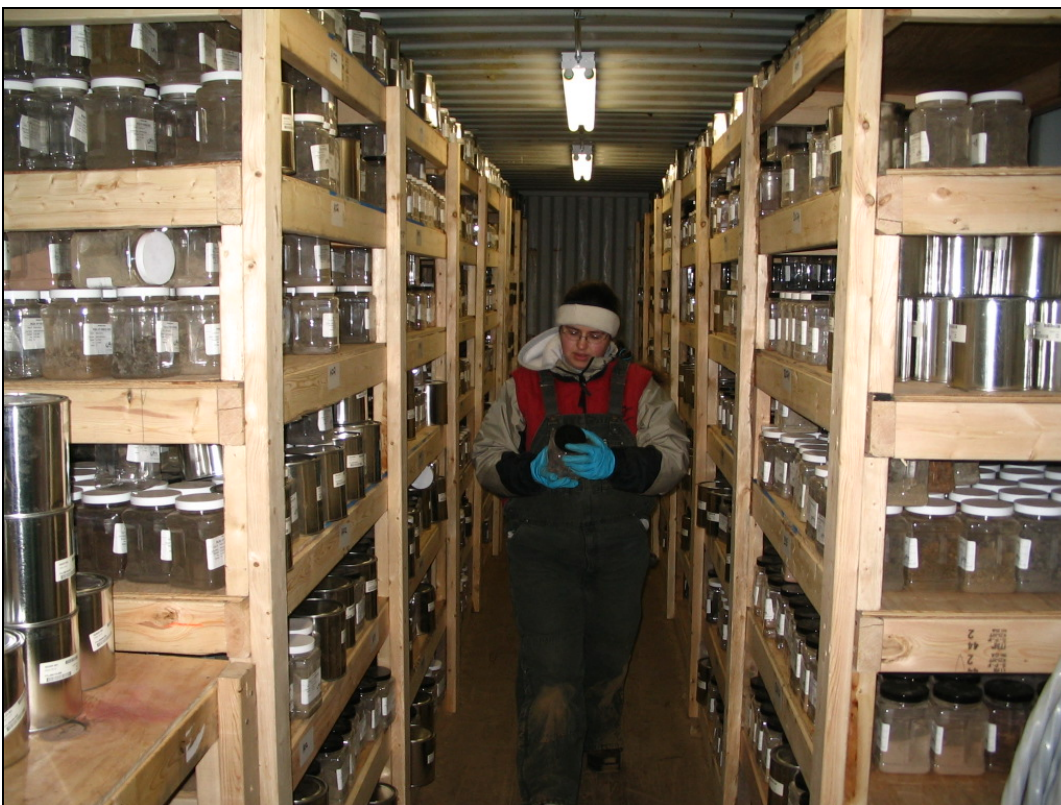
Photo 26: Soil sample archiving activities.
