APPENDIX C

Guterl Steel RI Report
Remedial Investigation Photographs

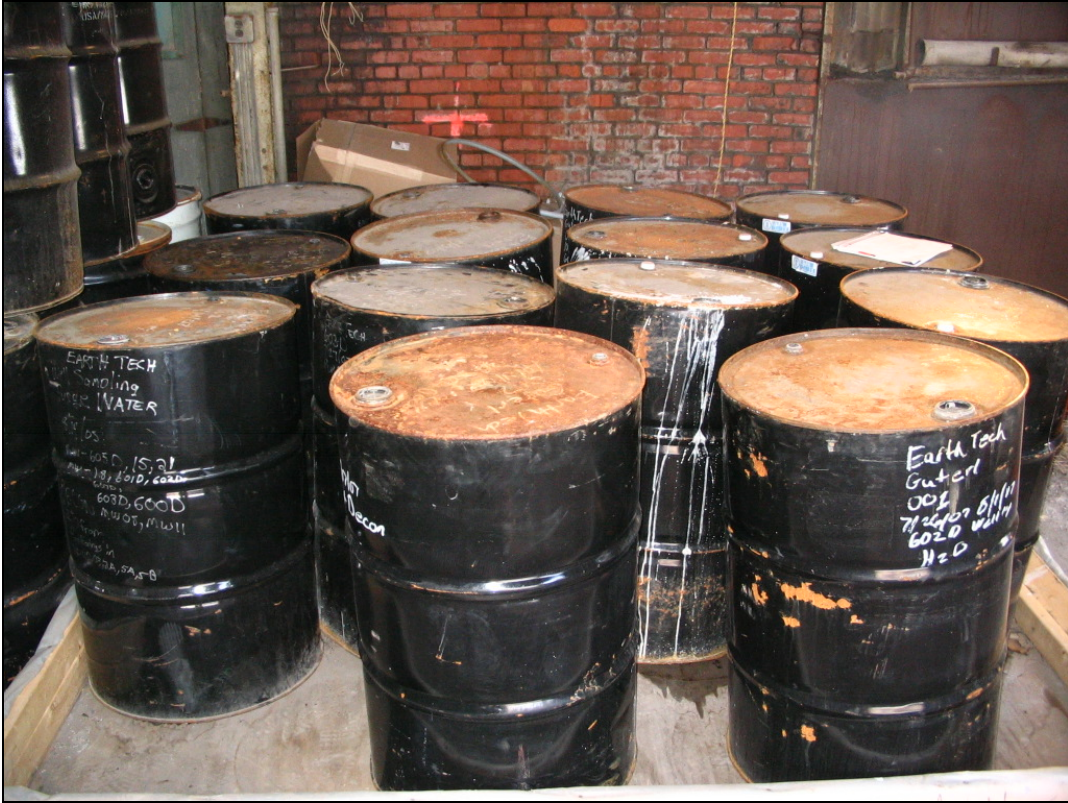
Photo 27: Drum storage containment pad in Building 35.

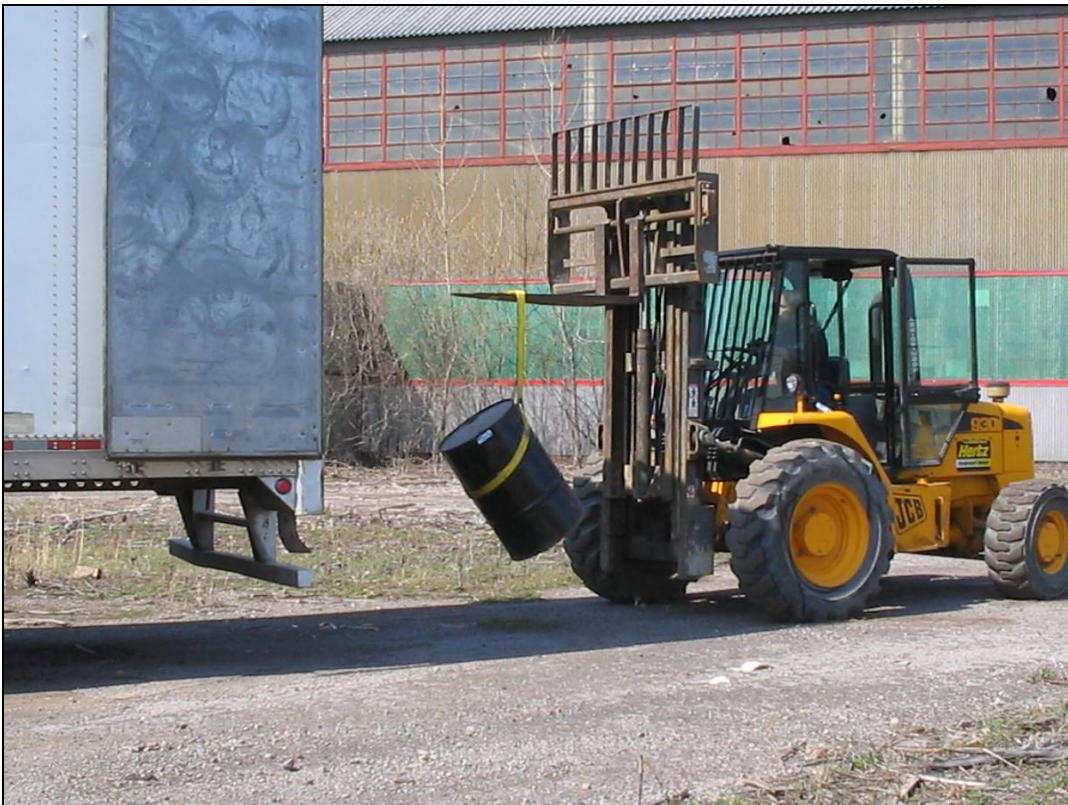
Photo 28: Loading IDW drums into truck for off site disposal.
