## **APPENDIX W**

## PHOTOS - Parcel IAO1 & IAO2

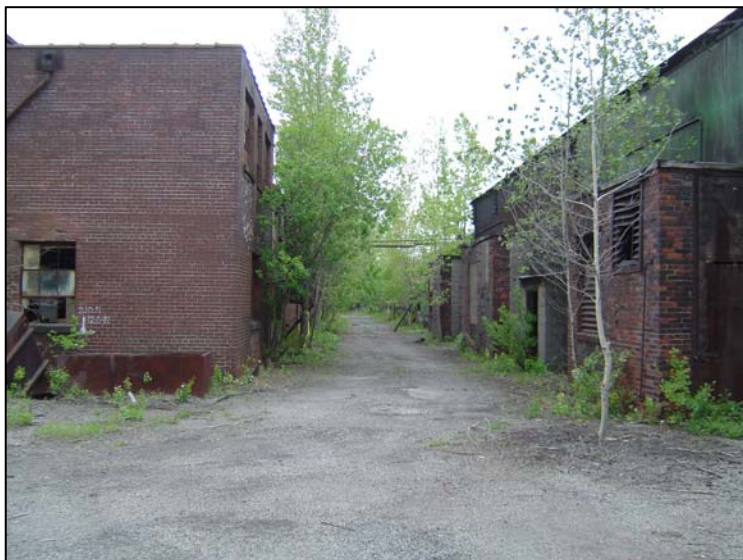
Photo 1 – View of the abandoned buildings and access ways within the parcel.

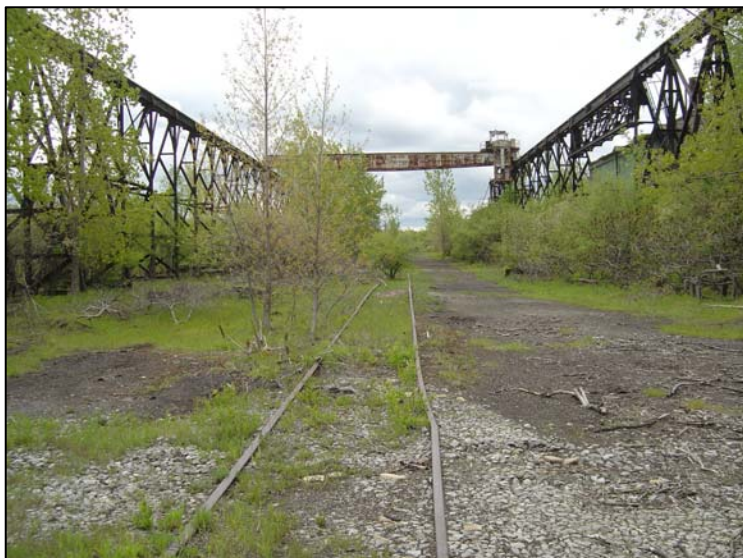
Photo 2 – View of the abandoned rail spur and opportunistic vegetation within the parcel.

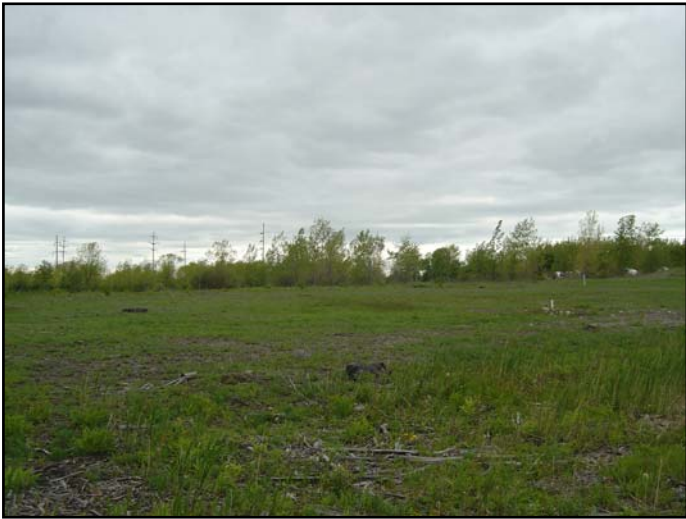
Photo 1 – View of the upland young fields within the parcel.

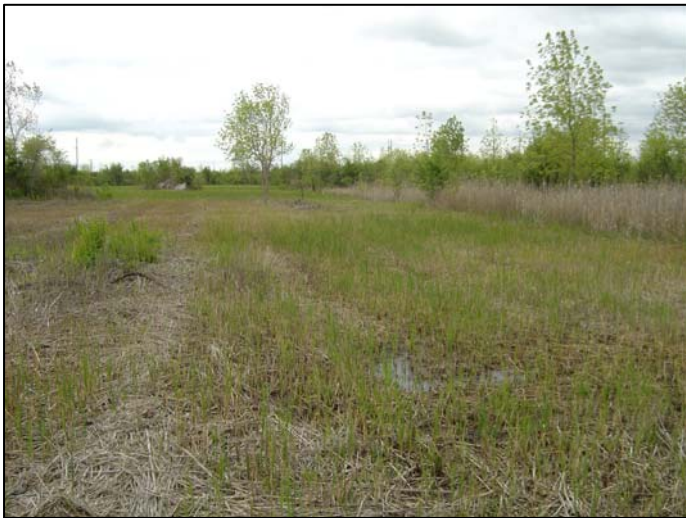
Photo 2 – Common reed wetlands in the western portion of the parcel. The area appears to be semi-maintained/ mowed.

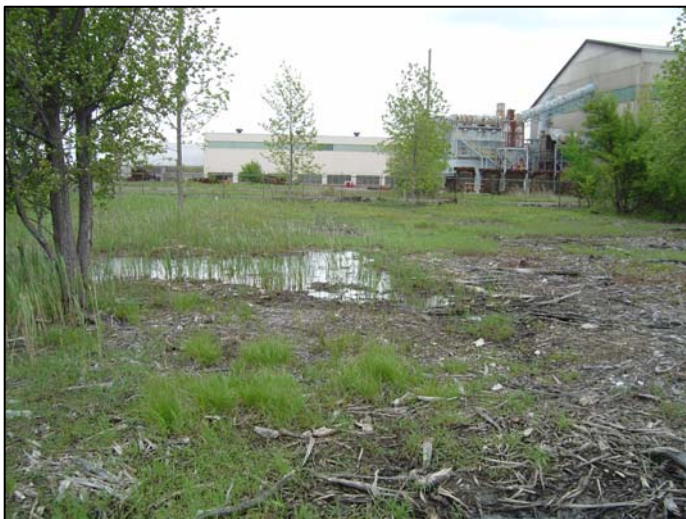
Photo 3 – Wet depressional areas within the southern portion of the parcel. Wetlands may be ephemeral depending on annual level or precipitation and level of disturbance.

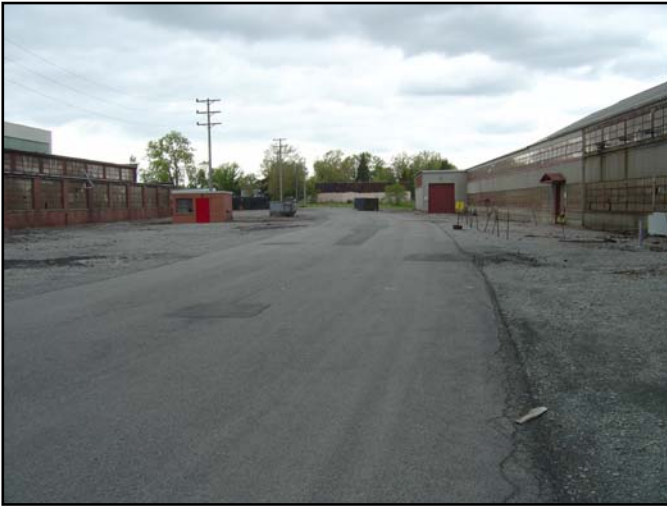
Photo 1 – Photo of the access roads and factories that comprise the central portion of the site.

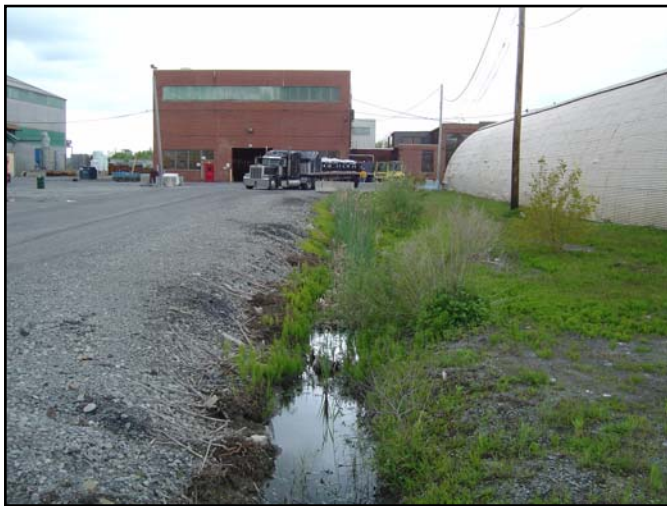
Photo 2. View of emergent wetlands near Bldg 3. The vegetation in the ditch is dominated by hydric species (e.g., cattails, horsetail, etc.). The ditch drains south to the wooded area and wetlands in the southern portion of the parcel.

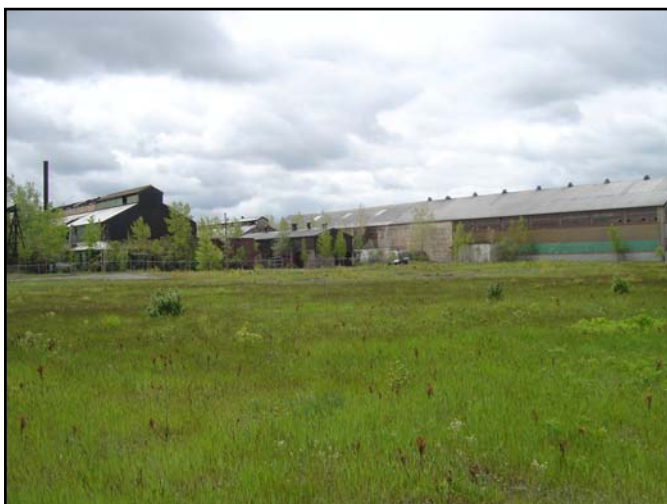
Photo 3 – View of the young field located in the northwest portion of the parcel.

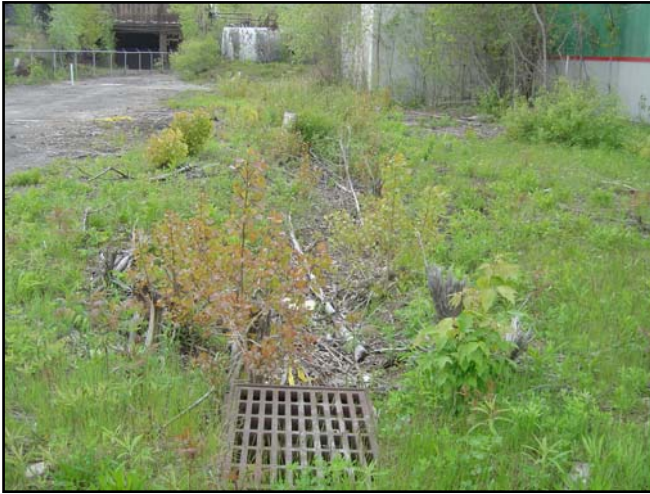
Photo 4 – View of a wet depressional area northwest of Bldg 35. The area is associated with a drainage swale.

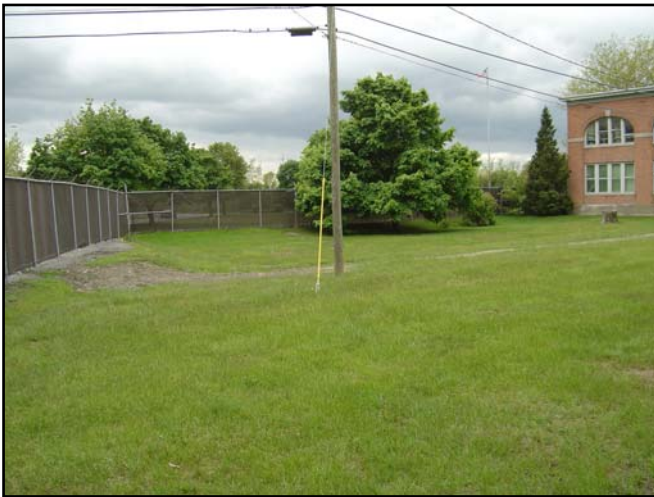
Photo 5 – View of maintained grass lawns and ornamental tree species in the southeast portion of the site.

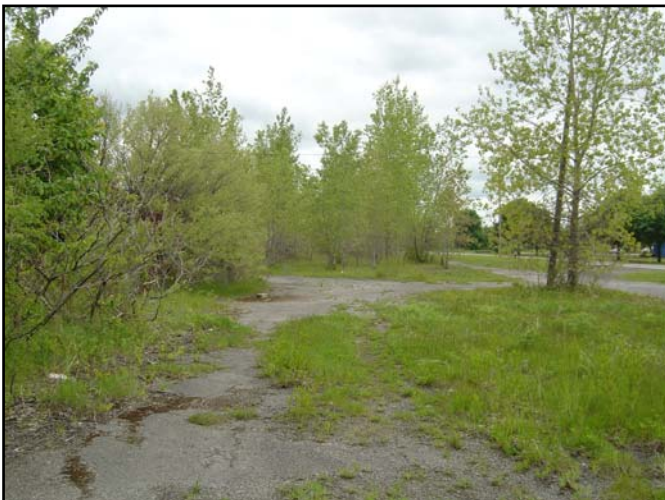
Photo 6 – View of the remnant paved area east of Ohio Street in the extreme southeast portion of the parcel.

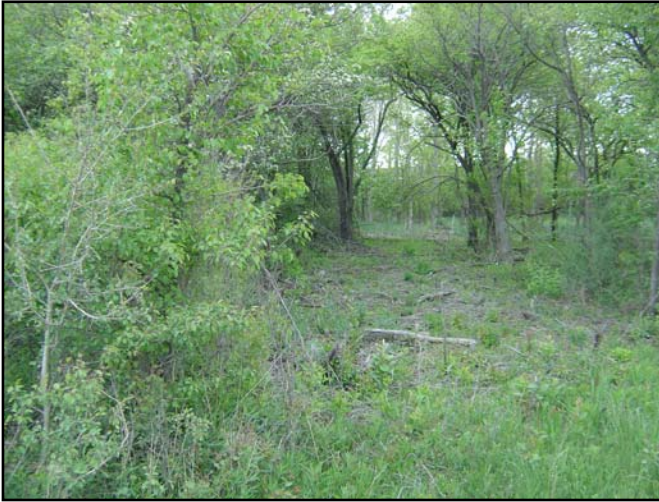
Photo 7 – View of the wooded area and fields south of Bldg 14.

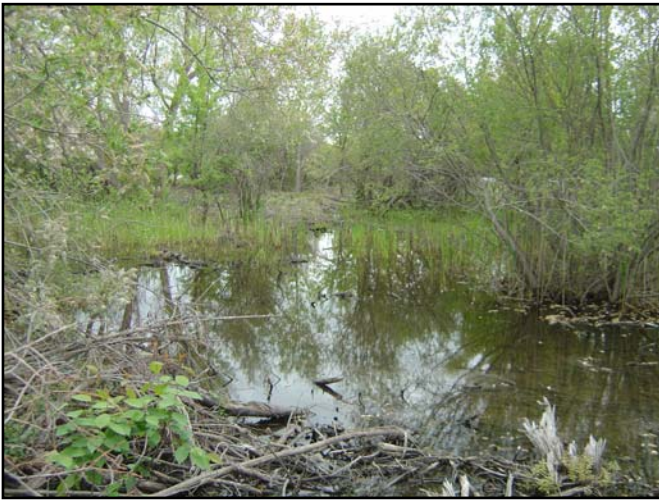
Photo 8 – View of emergent, scrub/shrub, forested wetlands in the southeast portion of Parcel IAO4.

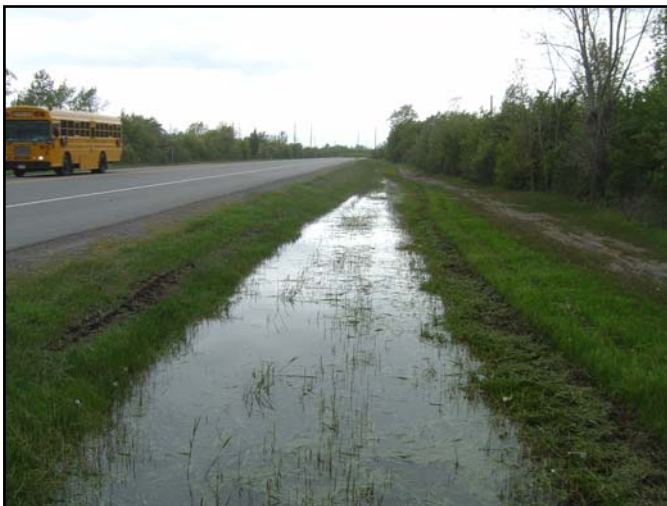
Photo 9 – View of the drainage swale located east of the Rt 93 bypass.

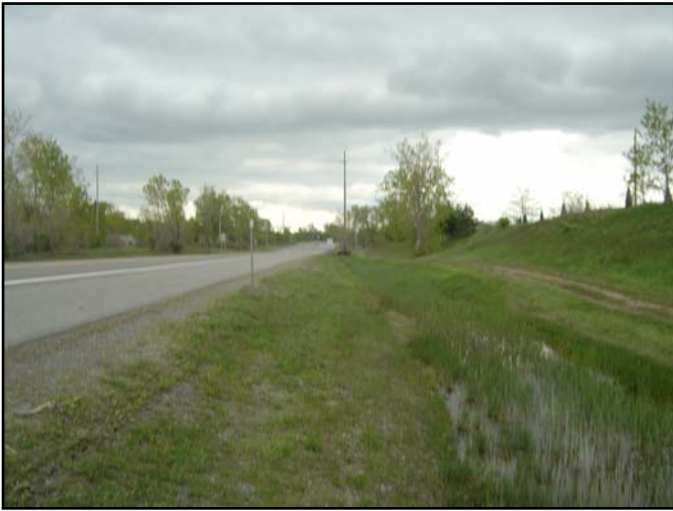
Photo 10 – View of the drainage ditch that is west of the Rt 93 Bypass.

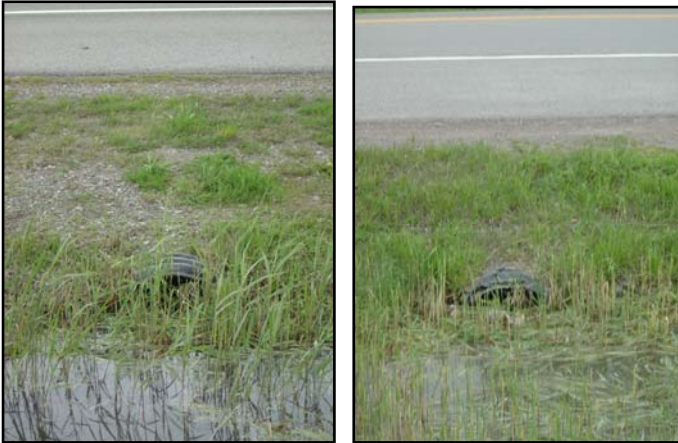
Photo 11 – View of the pipes that appear to connect the ditch east of the Rt 93 Bypass (left) with the ditch that is west of the Bypass (Right).

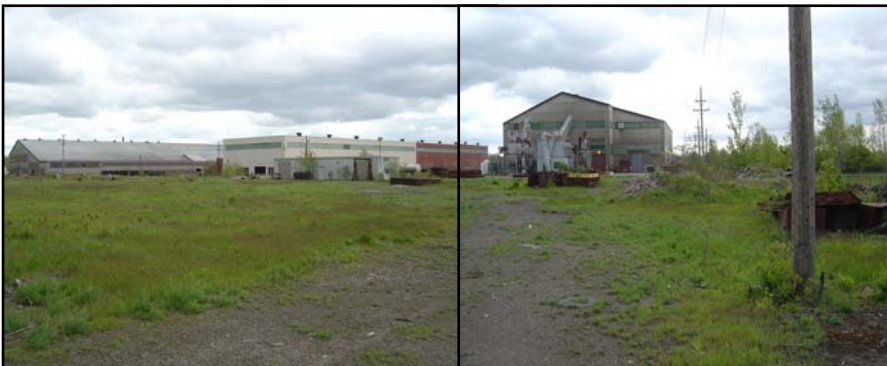
Photo 12 – View of the young field in the northeast portion of the parcel.

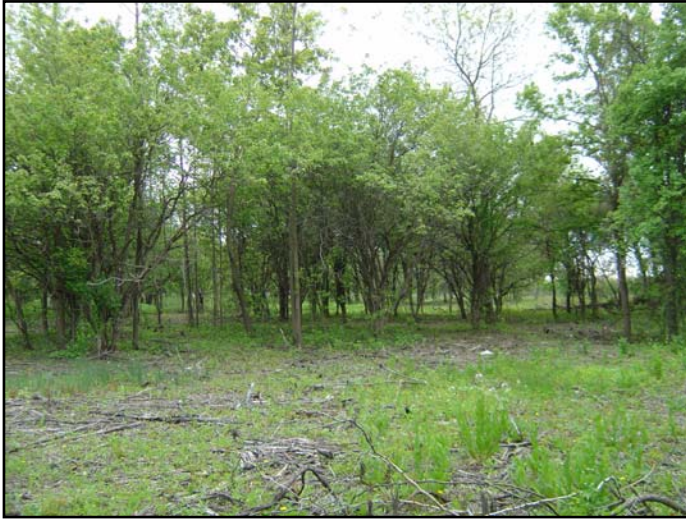
Photo 1 – View of the semi-maintained fields and small wooded area in the parcel.

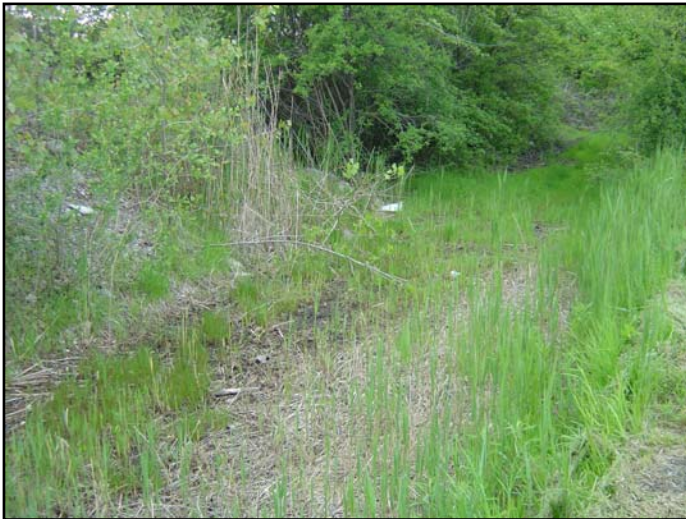
Photo 2 – View of wet depressional areas within the abandoned railroad bed.

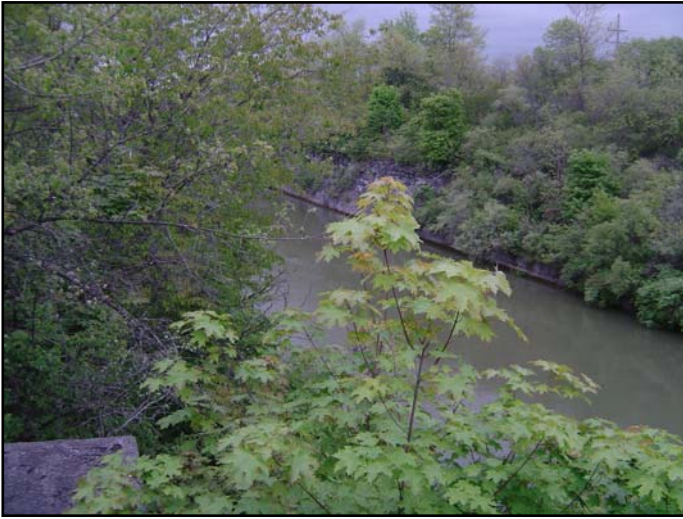
Photo 1 - View of the Erie Canal. Note the vertical, cut bedrock banks.
