ATTCHMENT B
Photographic Log

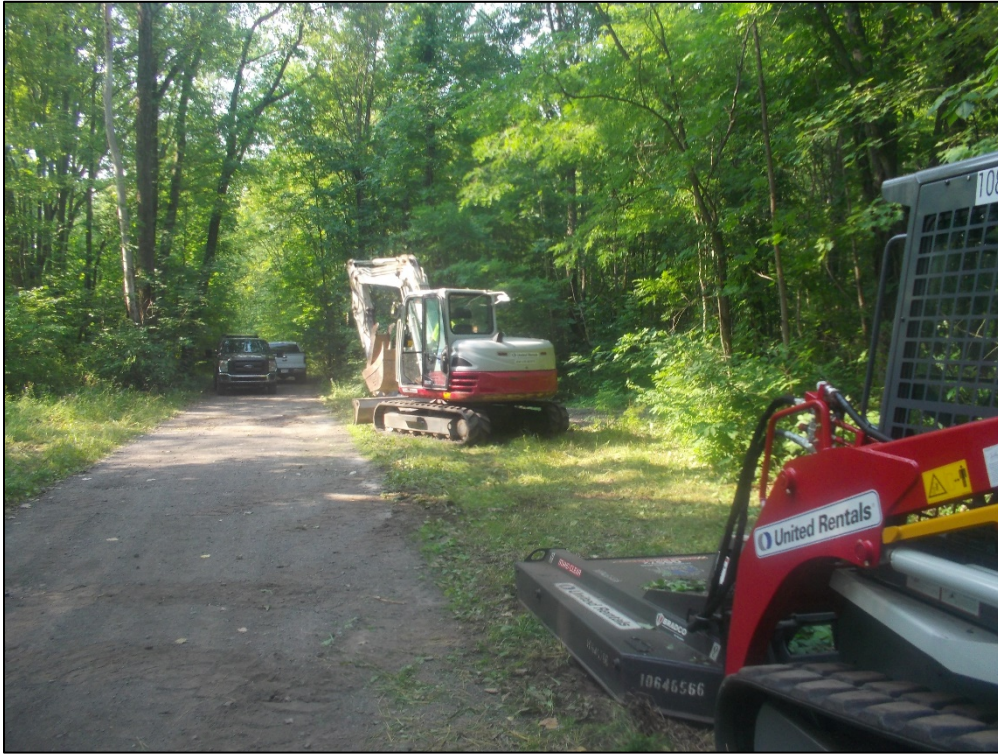
Photograph 1 View of the access road, looking north, alongside of AOC 1 following pre-mob meeting prior to construction activities.

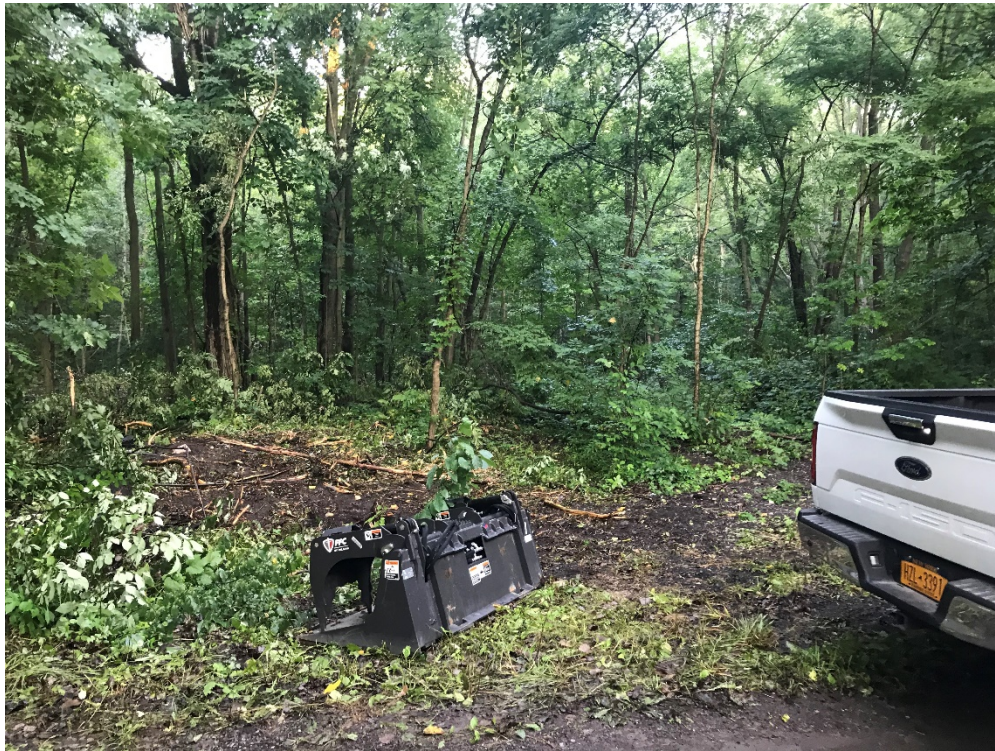
Photograph 2 View of AOC 1 at beginning of vegetation clearance

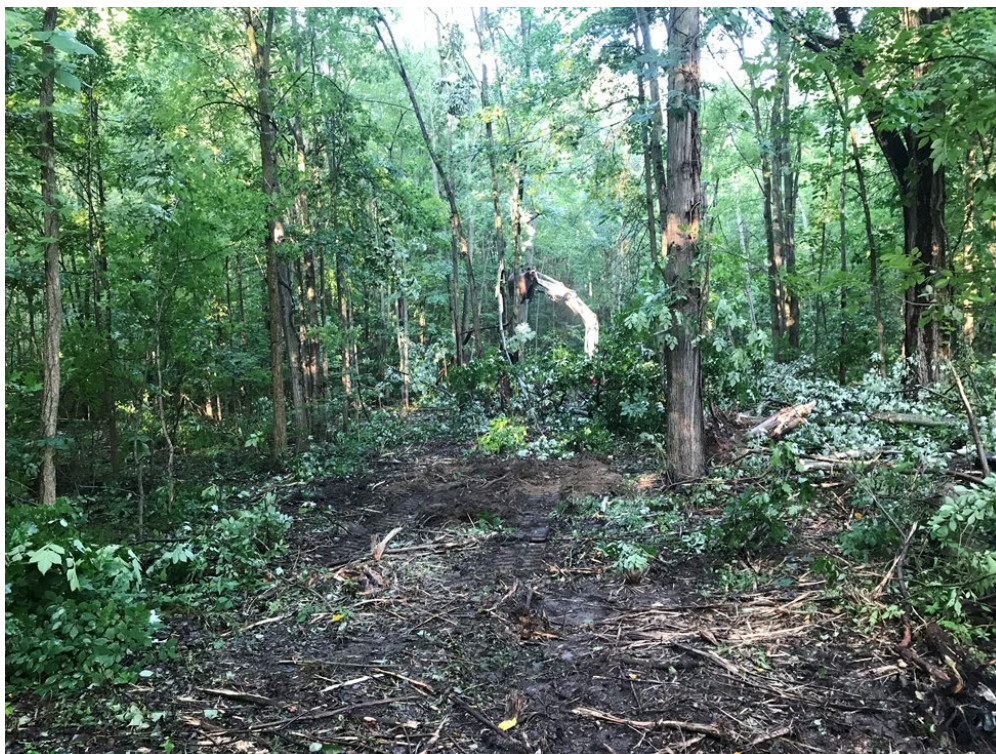
Photograph 3 AOC 1 during vegetation clearance and debris pile delineation.

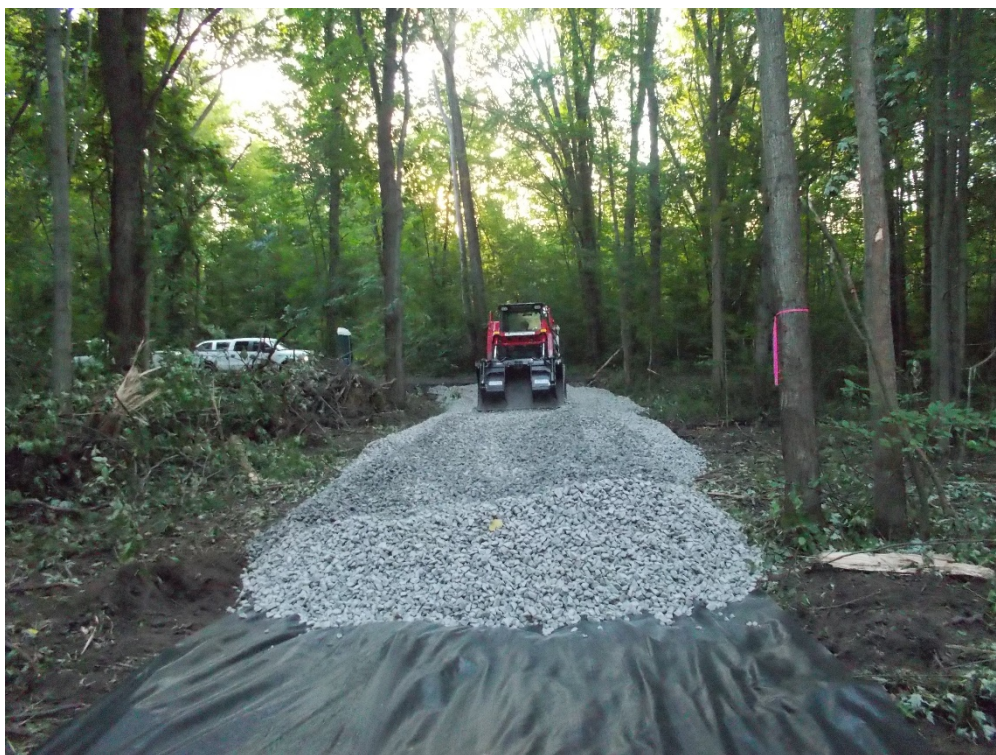
Photograph 4 Installation of construction access road into AOC 1.

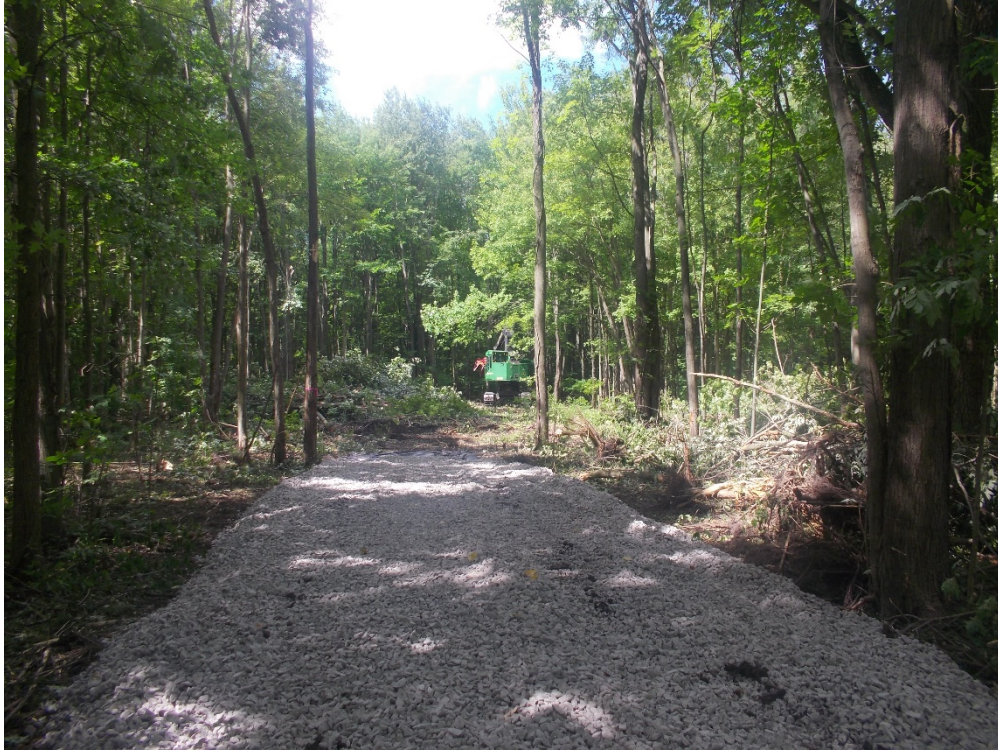
Photograph 5 Start of tree removal and remaining vegetation clearance of AOC 1.

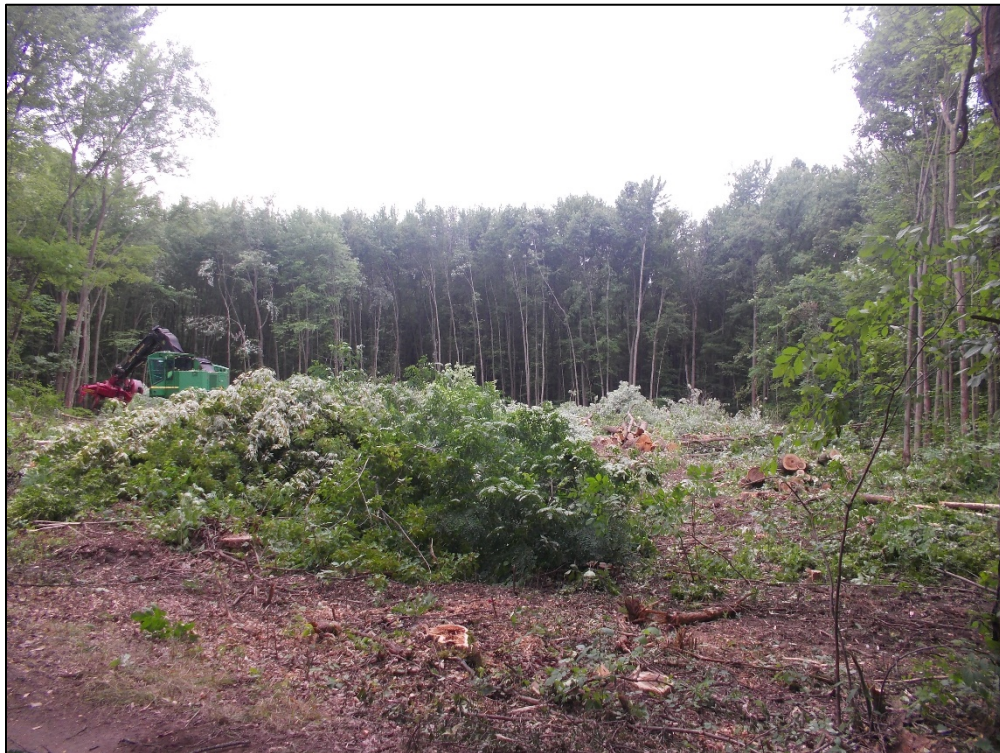
Photograph 6 View of AOC 1 looking west from access road during tree clearance activities.

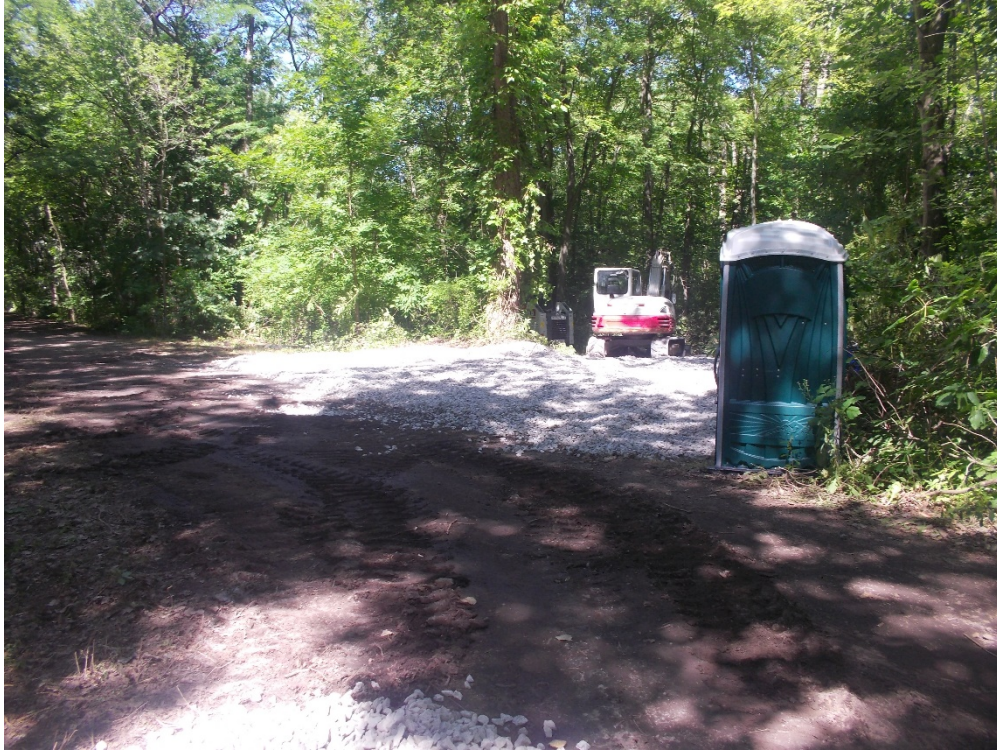
Photograph 7 Construction of staging area east of the NRAA access road adjacent to AOC 1.

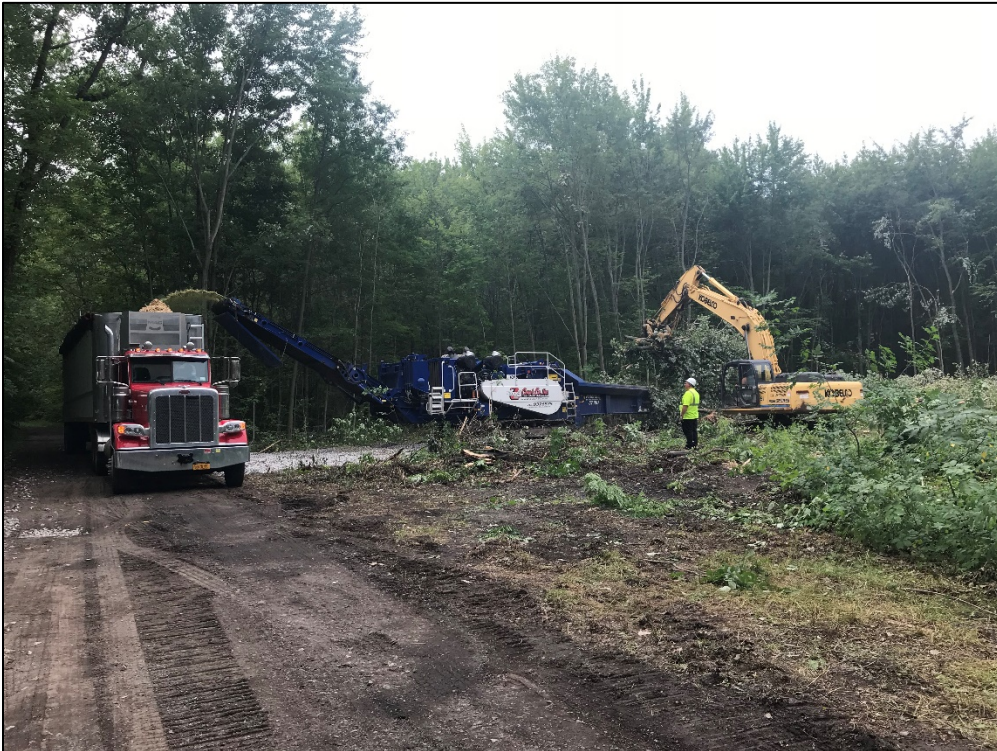
Photograph 8 View of AOC 1 looking southwest showing chipping and transport of cleared trees.

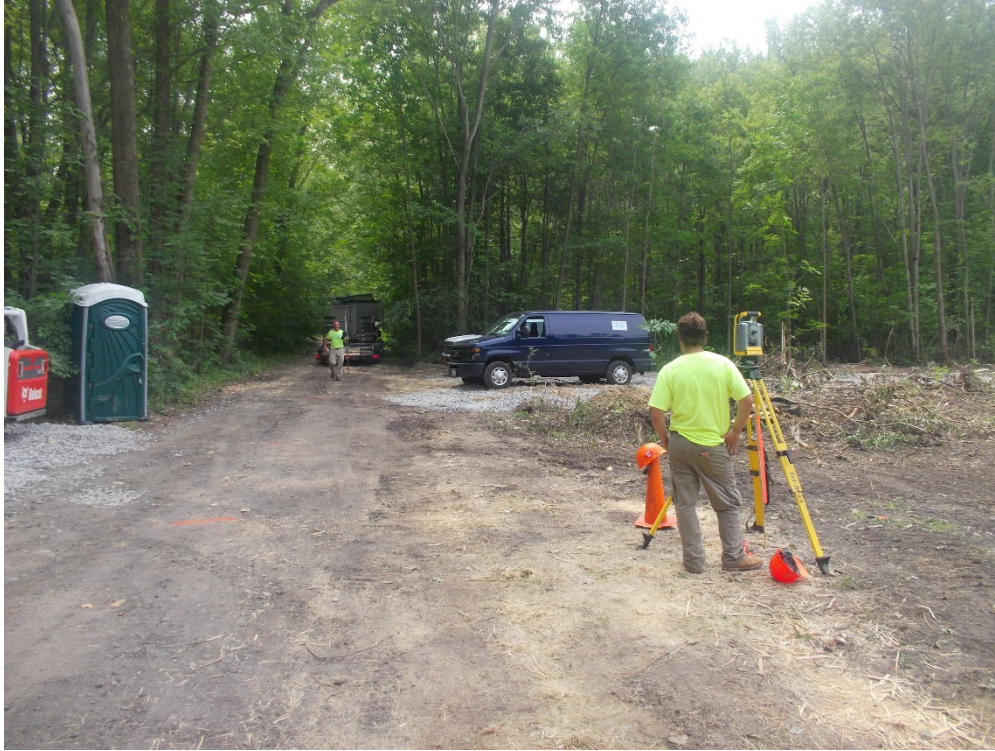
Photograph 9 McIntosh & McIntosh conducting pre-mobilization land survey.

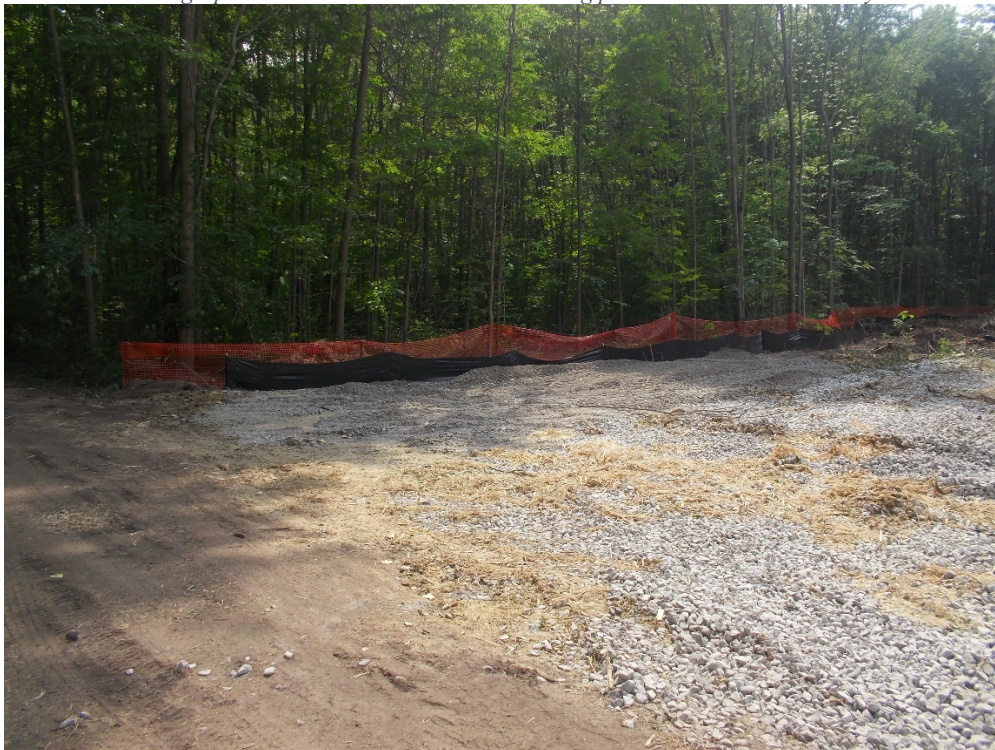
Photograph 10 Installation of silt-fence and orange construction safety fence.

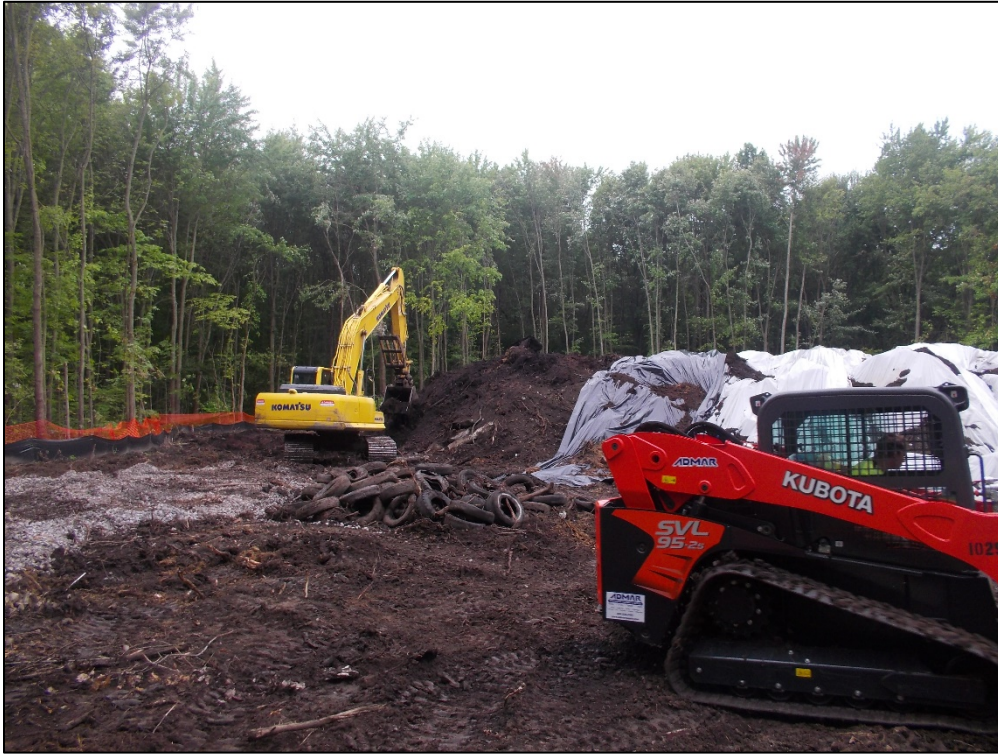
Photograph 11 View of AOC 1 looking northwest during first excavation activities in September 2018.

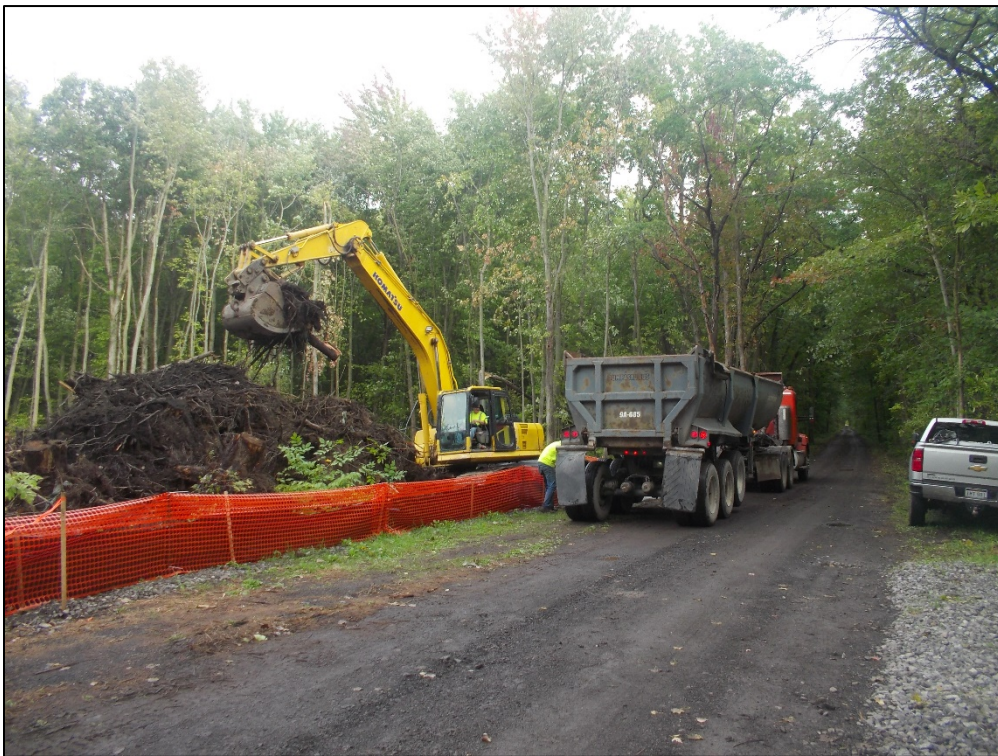
Photograph 12 View of AOC 1 looking northwest from access road showing removal and transport of root balls.

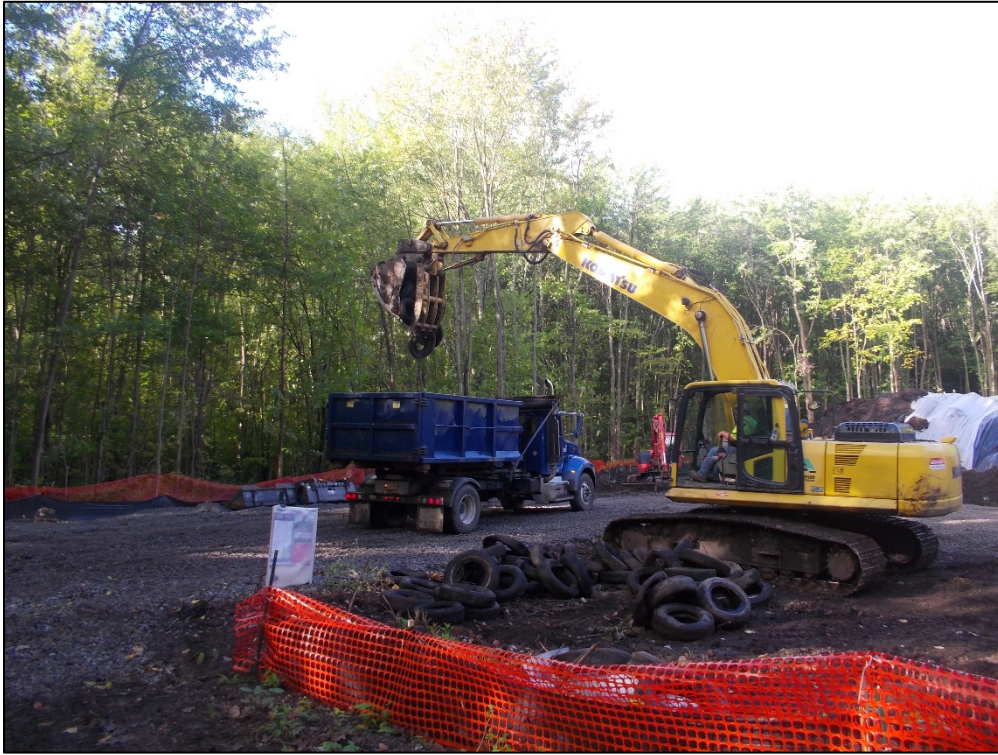
Photograph 13 View of AOC 1 looking southwest from access road showing removal and transport of tires and debris.

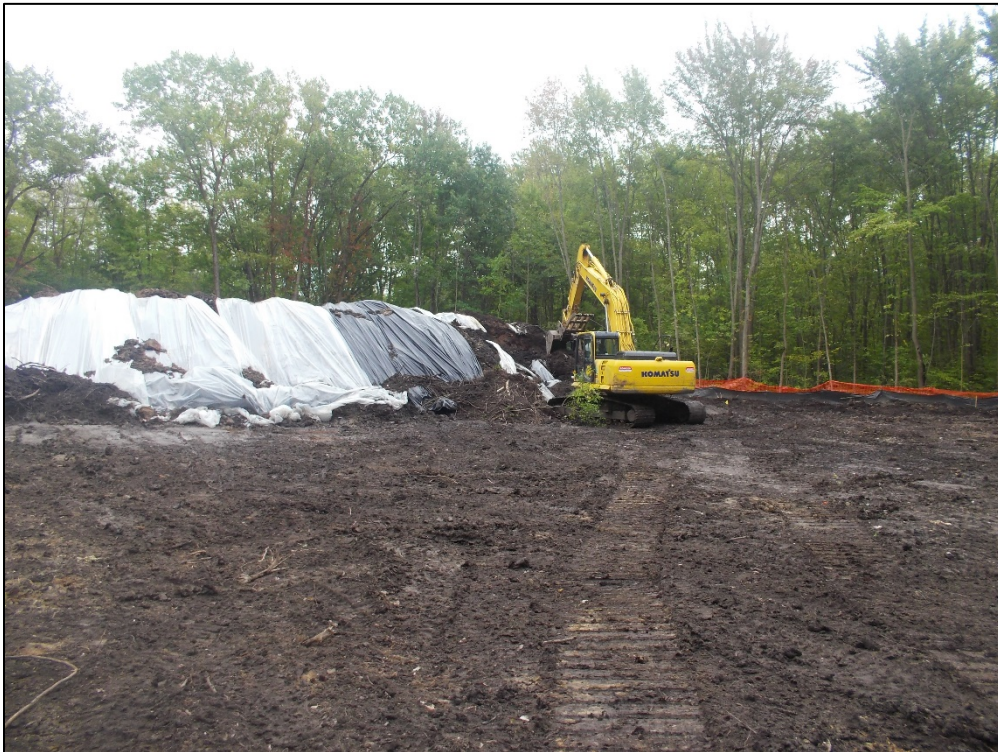
Photograph 14 View of AOC 1 looking northwest from access road of excavated, stockpiled soil.

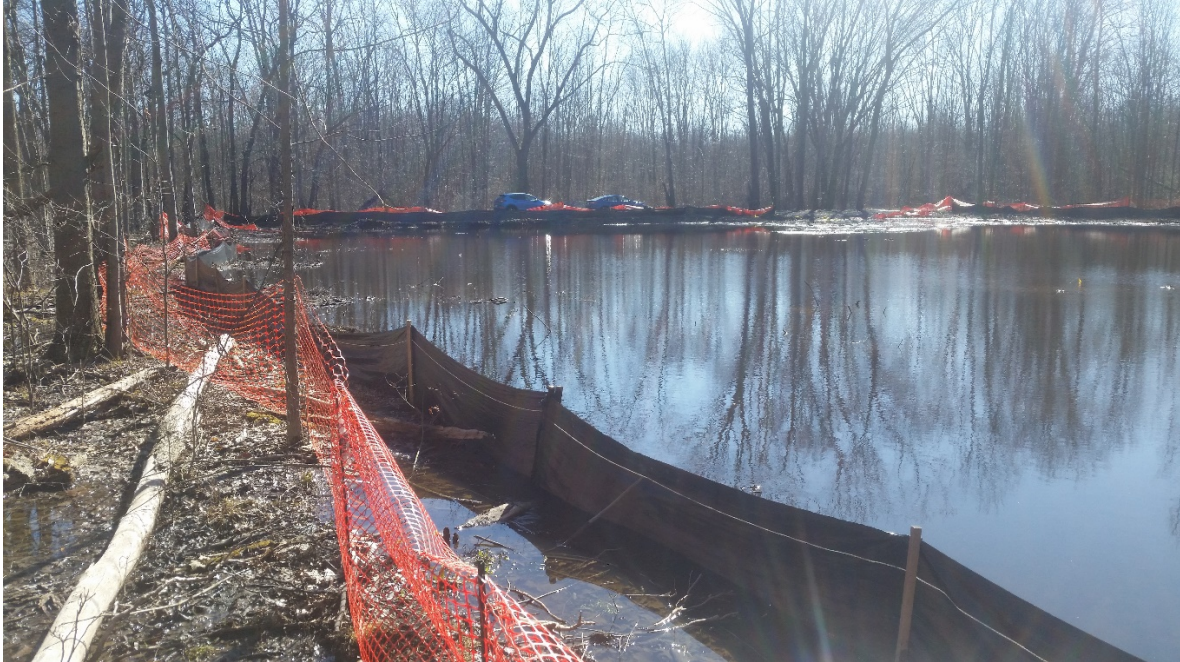
Photograph 15 Excavation area in November 2018.

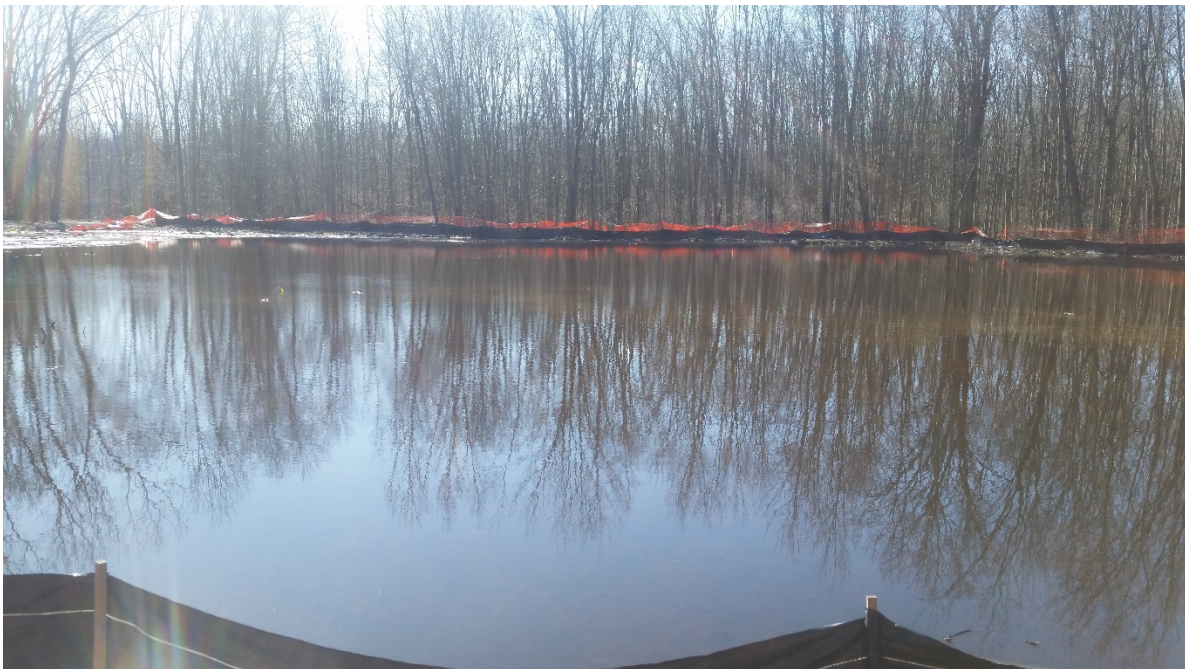
Photograph 16 Excavation area in November 2018.

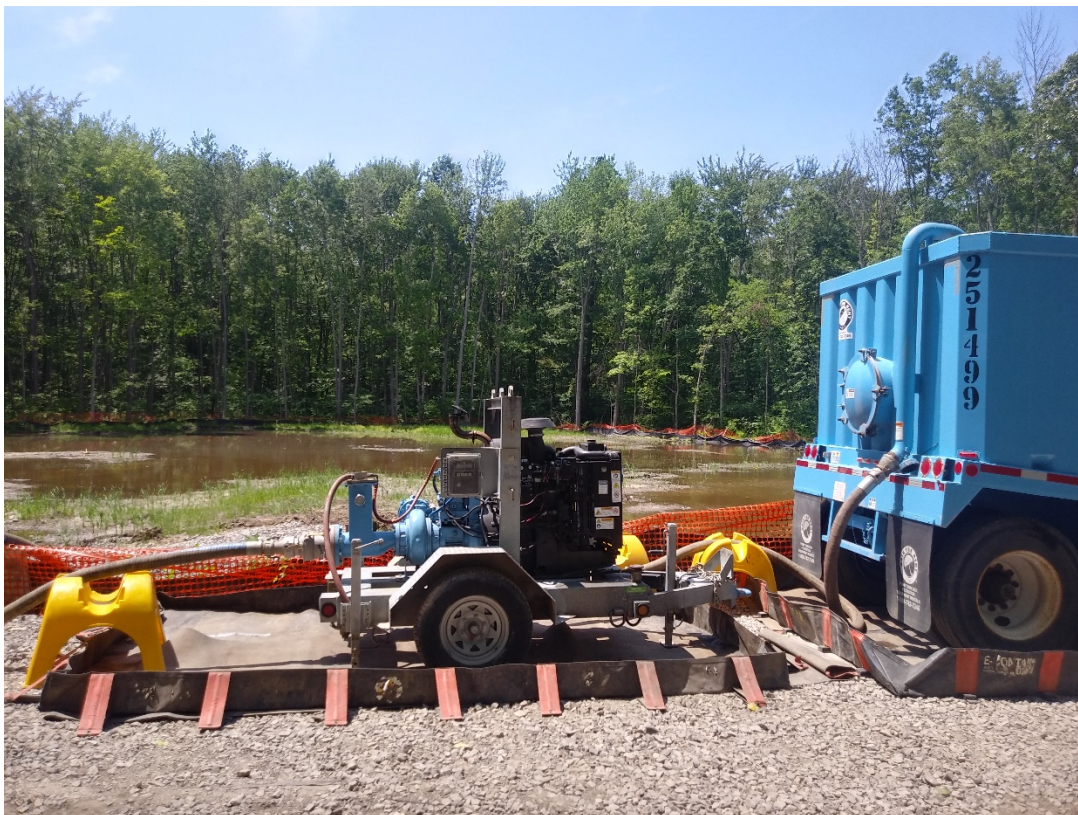
Photograph 17 Beginning of dewatering system. Excavation water is pumped into weir tank.

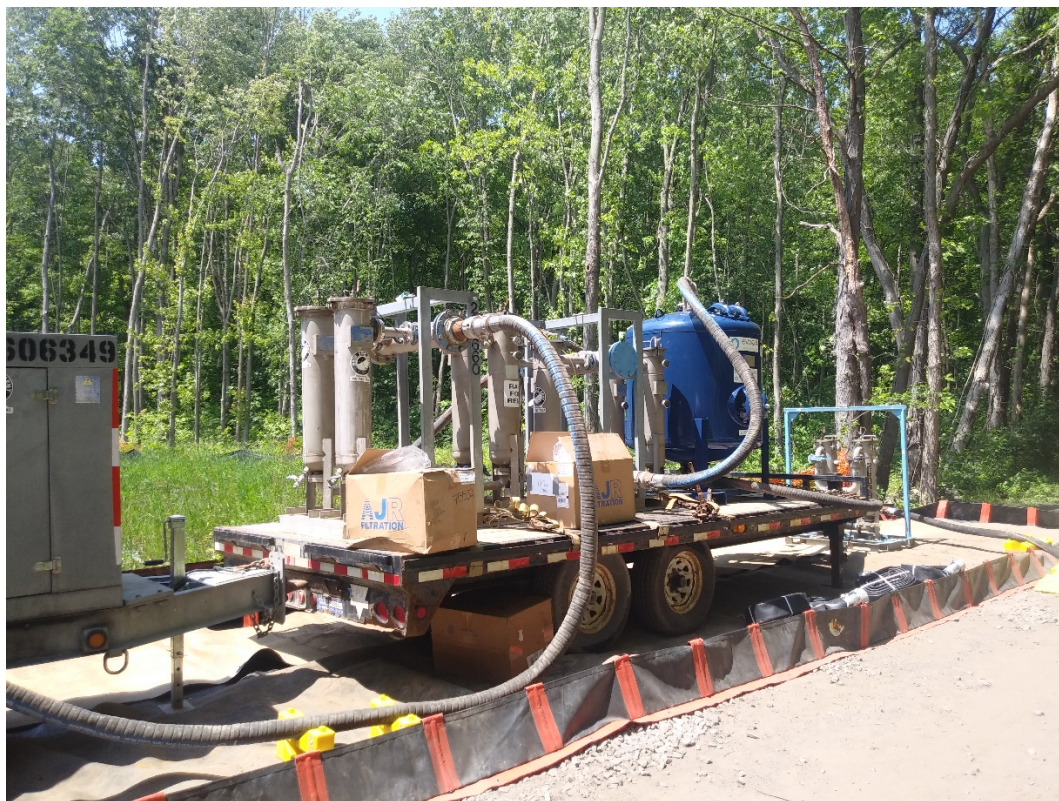
Photograph 18 Water is pumped from weir tank through sediment filter bags and into the carbon vessel.

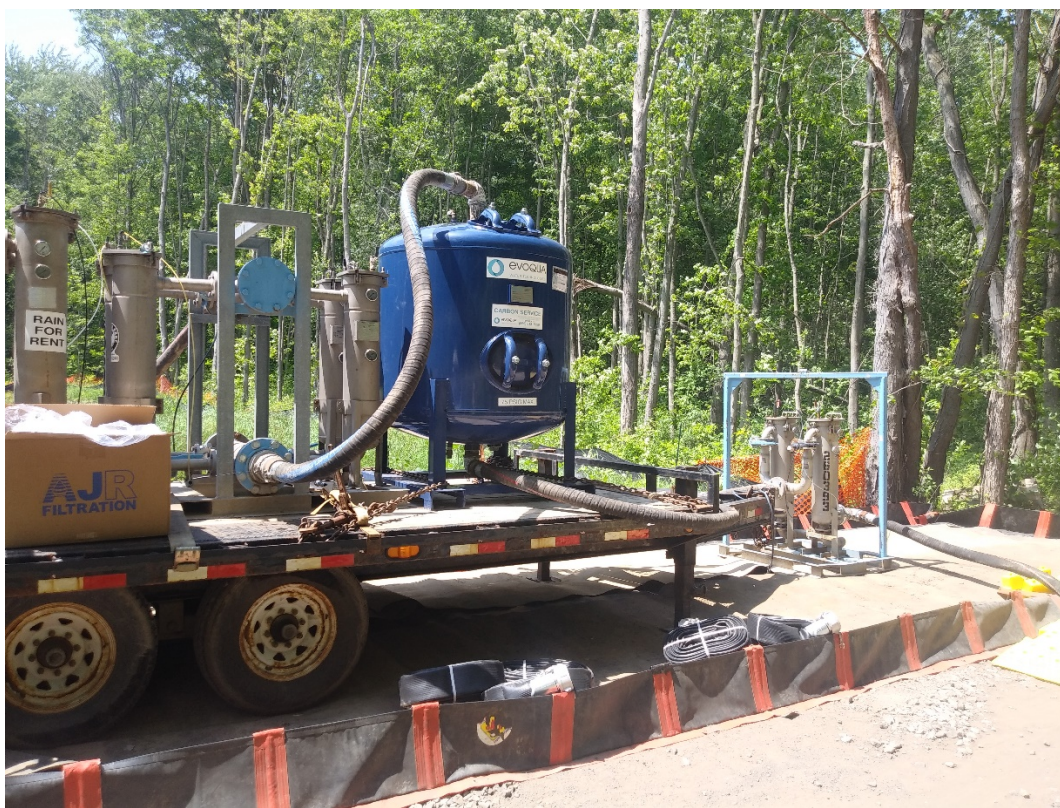
Photograph 19 Water leaves carbon vessel, passes through another filter-bag and is discharged back into excavation until samples confirm sufficient filtration.

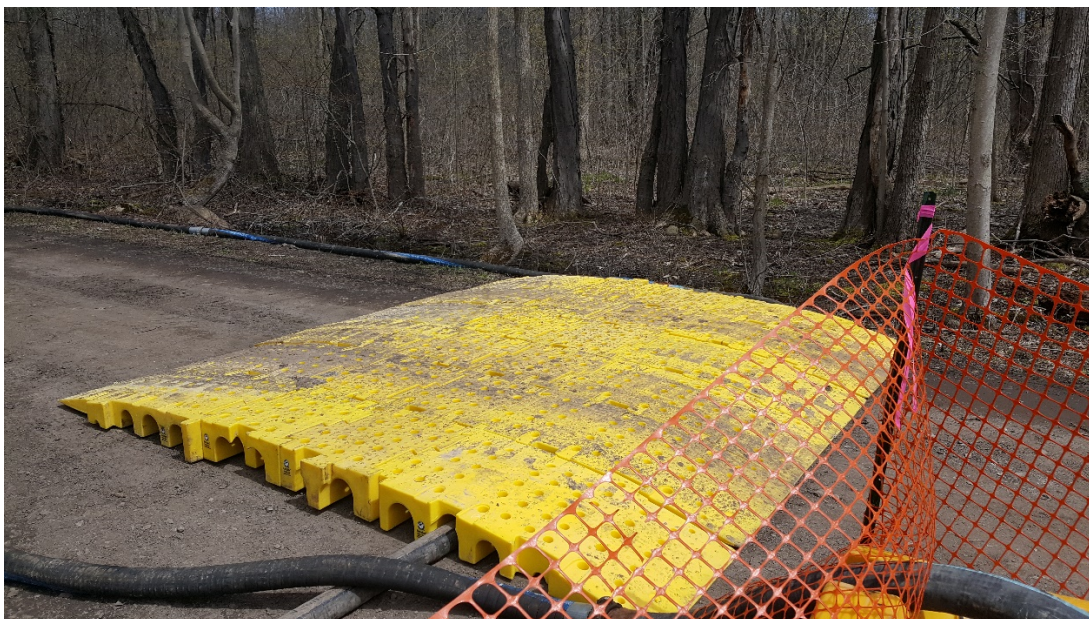
Photograph 20 Drop-trak hose protector allowing NRAA access road to remain accessible during dewatering operations.

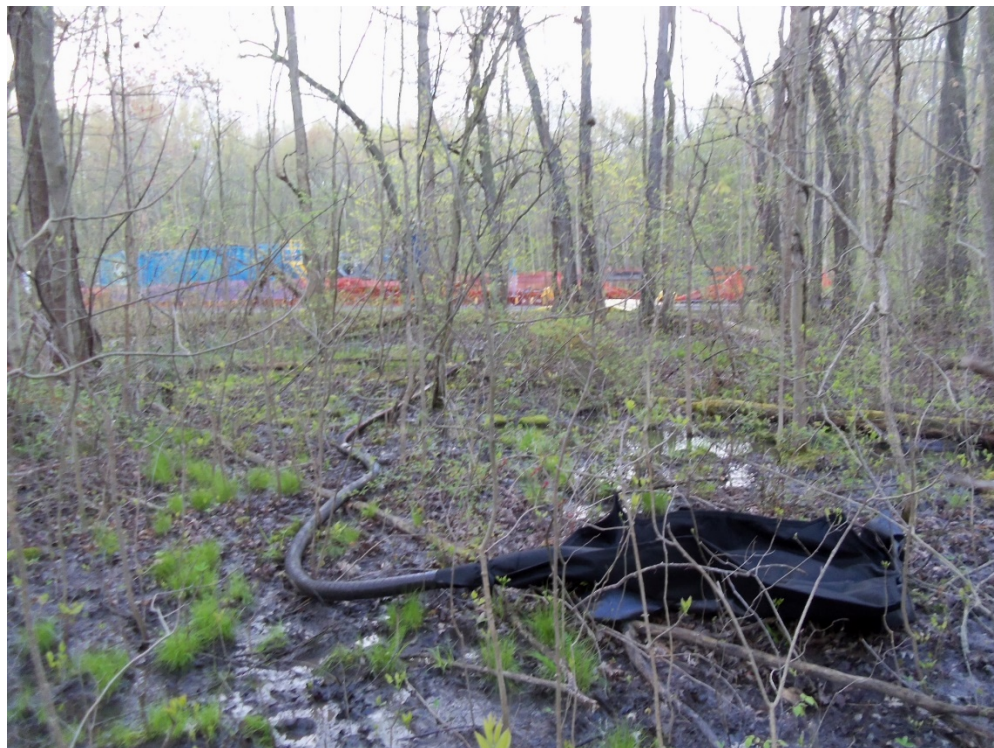
Photograph 21 Discharge location downgradient from AOC 1 with dewatering bag.

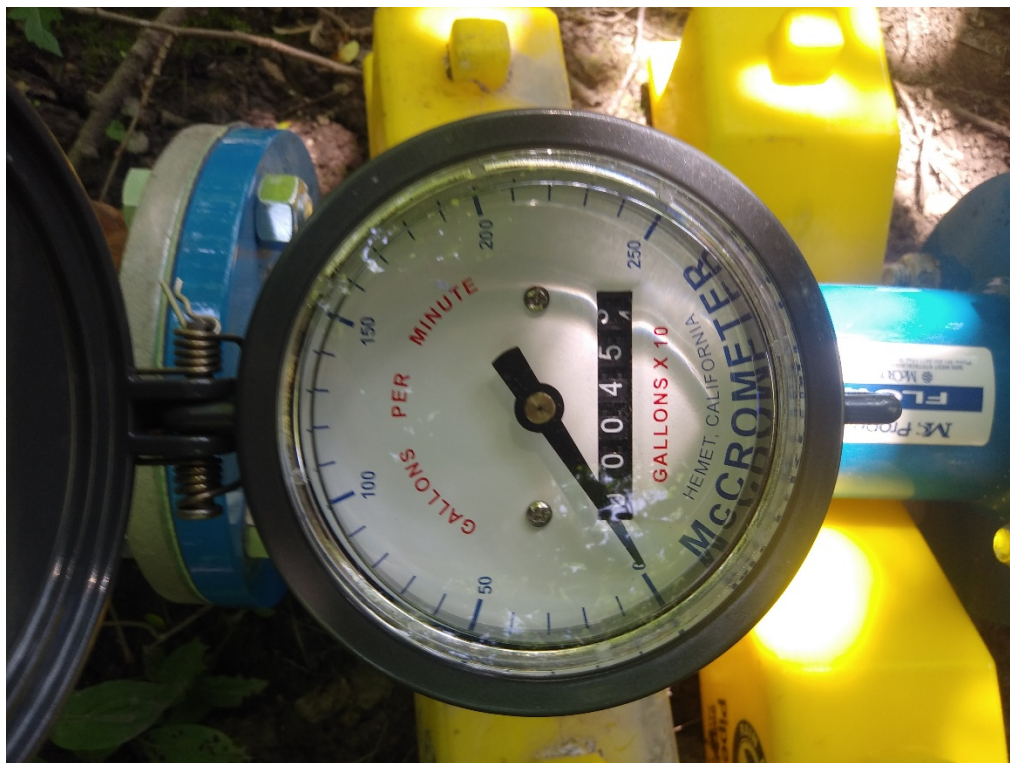
Photograph 22 Flow meter attached to discharge line used to keep track of flow-rate and total gallons discharged.

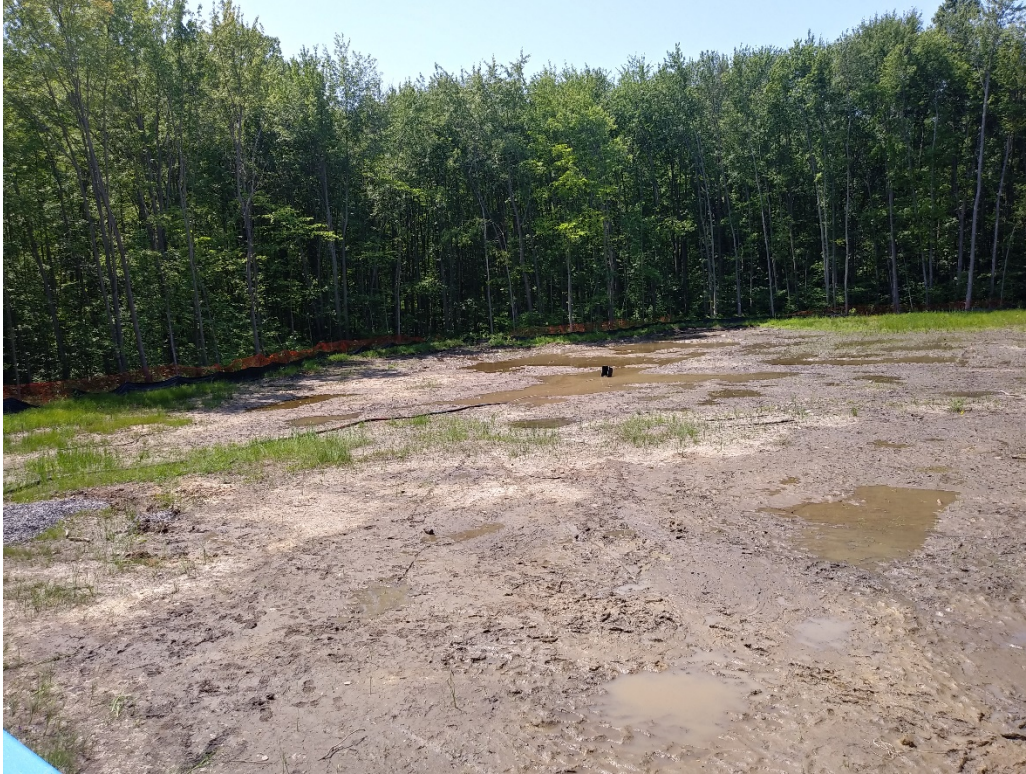
Photograph 23 AOC 1 after dewatering operations viewed from the NRAA access road, looking west.

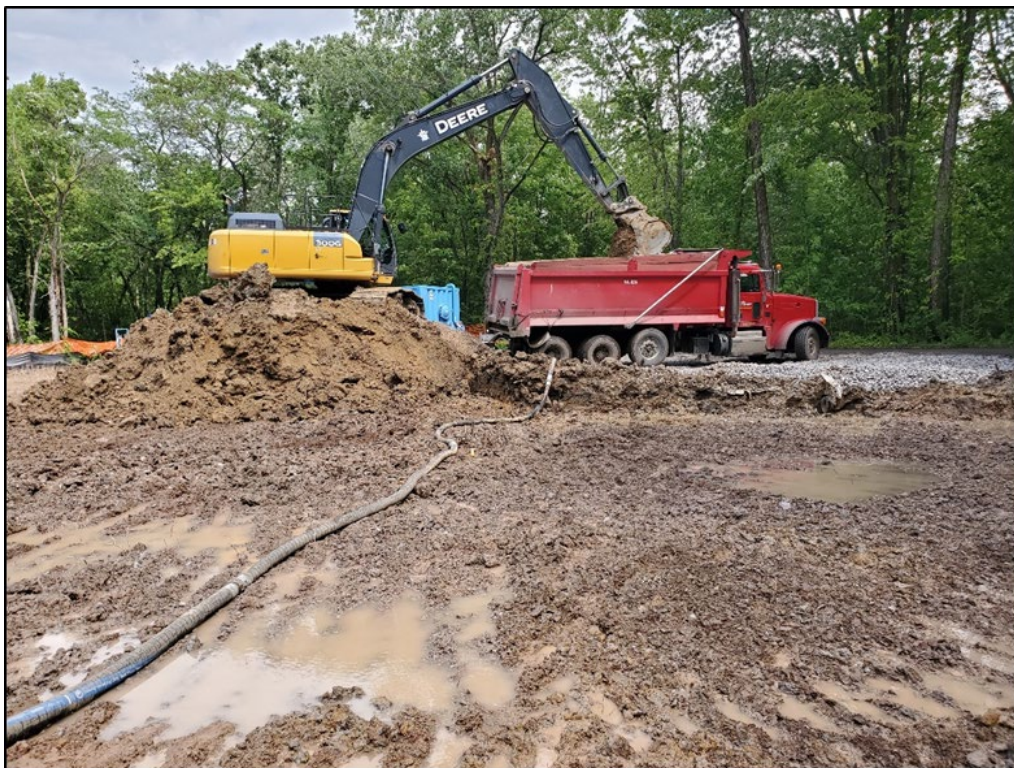
Photograph 24 Final soil remediation being live-loaded into tri-axes

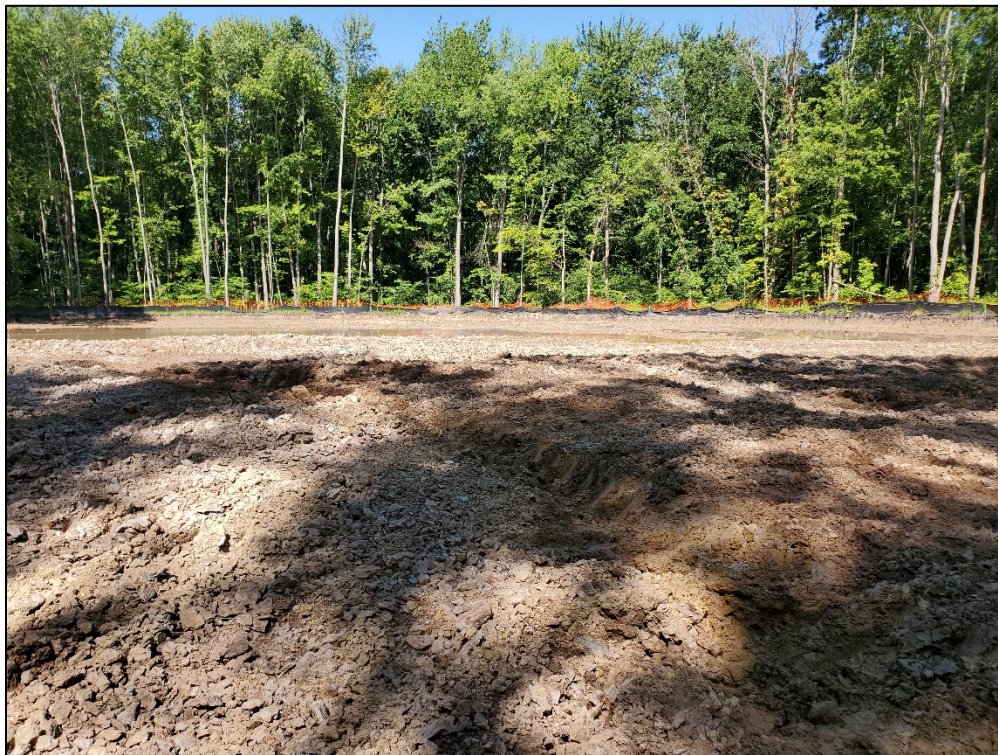
Photograph 25 View of AOC 1 looking west following the final excavation in August 2019

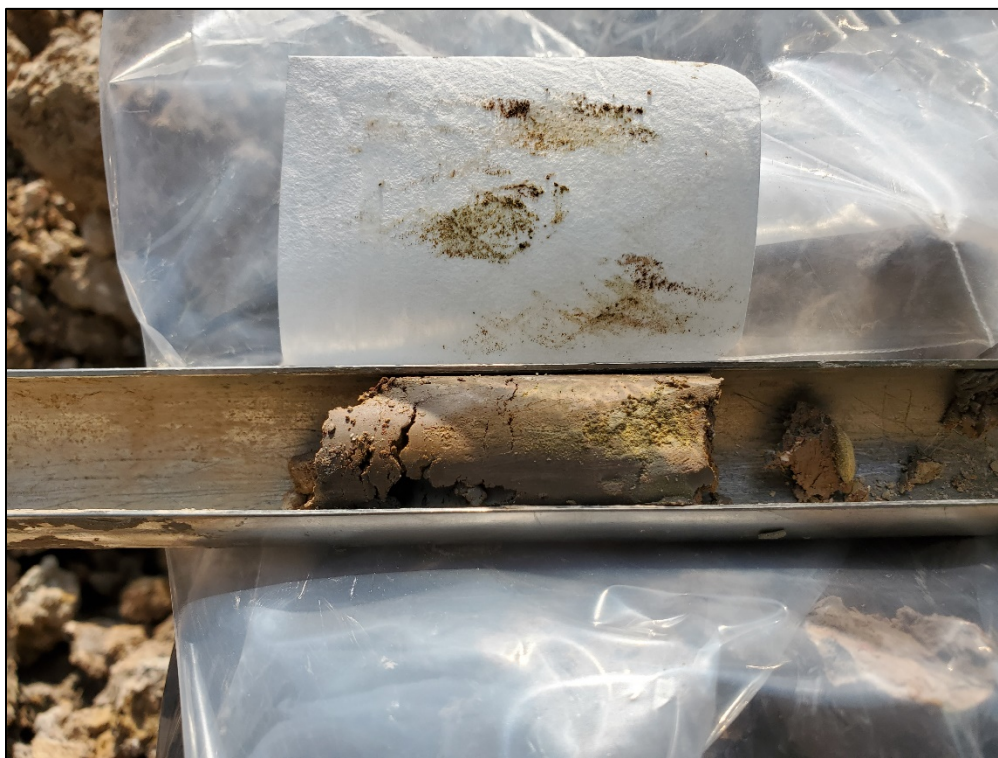
Photograph 26 View of core sample taken from AOC 1 during ISM sampling conducted in August 2019.

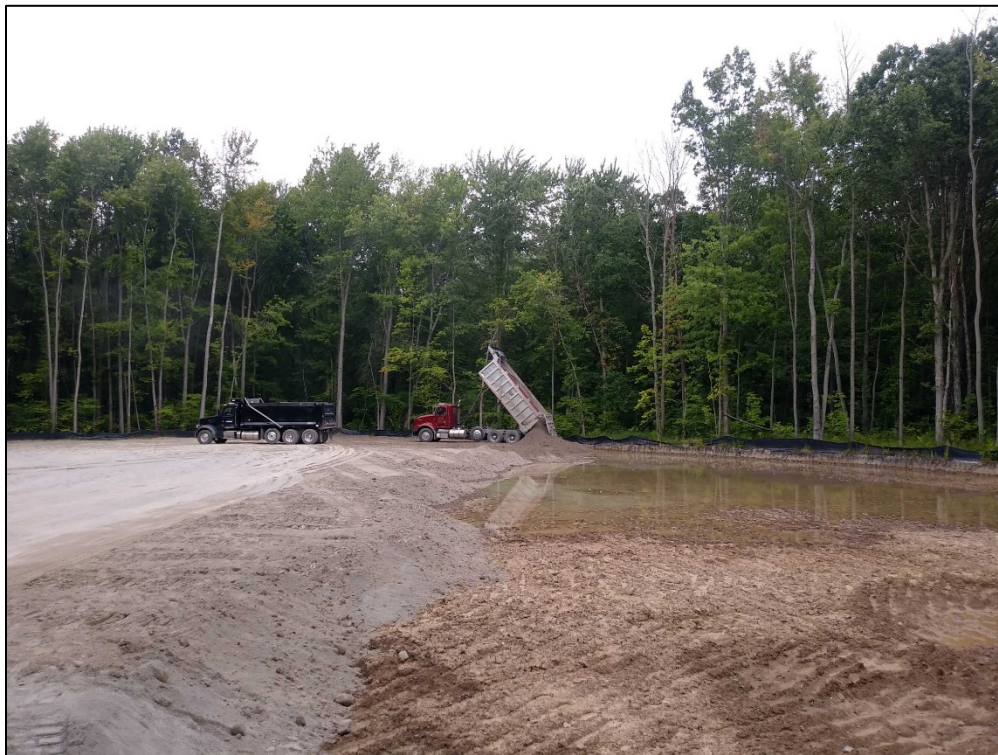
Photograph 27 View of AOC 1 looking west from access road during backfill activities.

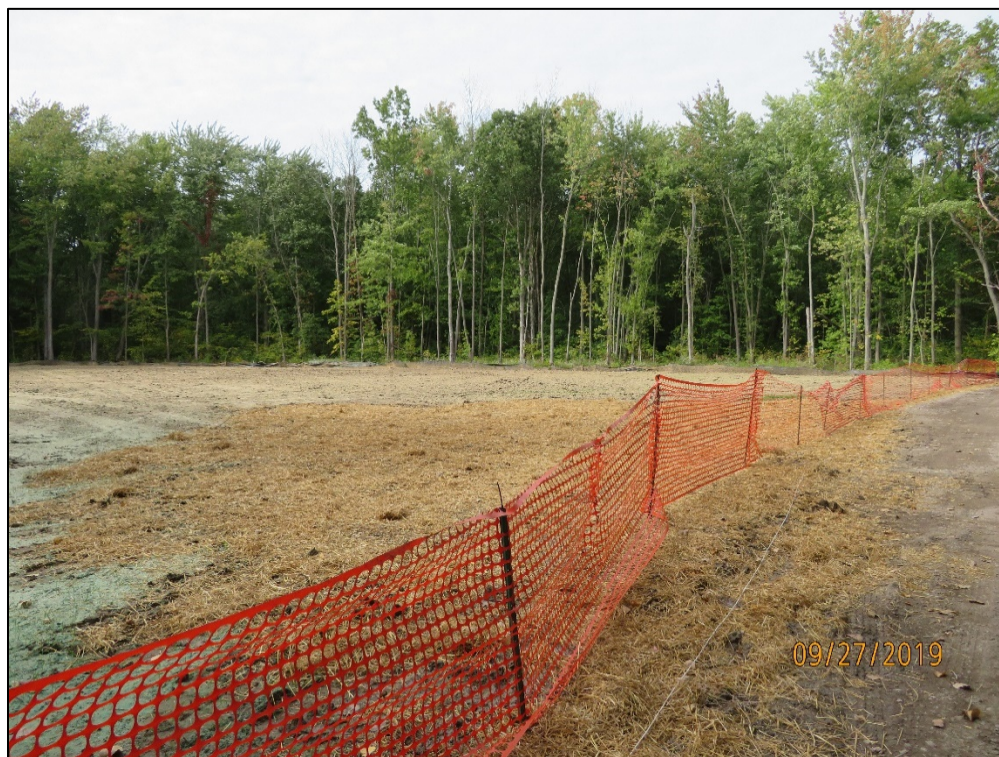
Photograph 28 View of AOC 1 looking northwest from access road following restoration and hydroseeding activities.

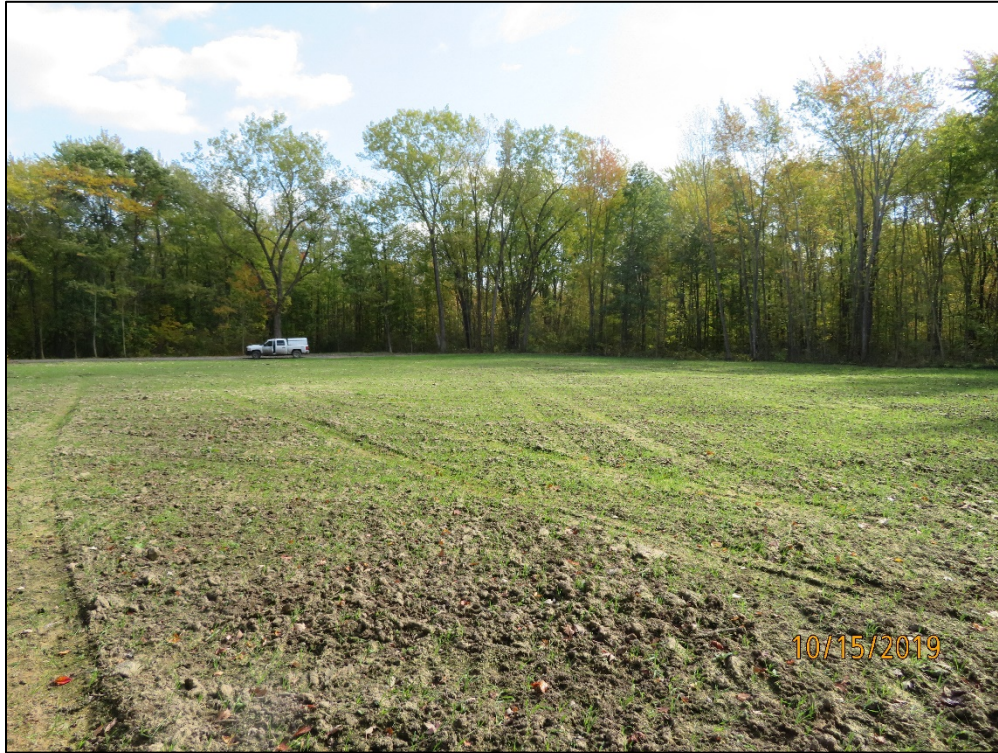
Photograph 29 View of AOC 1 looking east towards access road following final site inspection.
