# Appendix J

## Pipeline Excavation Logs

## EXCAVATION LOG

**Project:** Niagara Falls Storage Site  
(Lewiston, NY) BOP Field Investigation

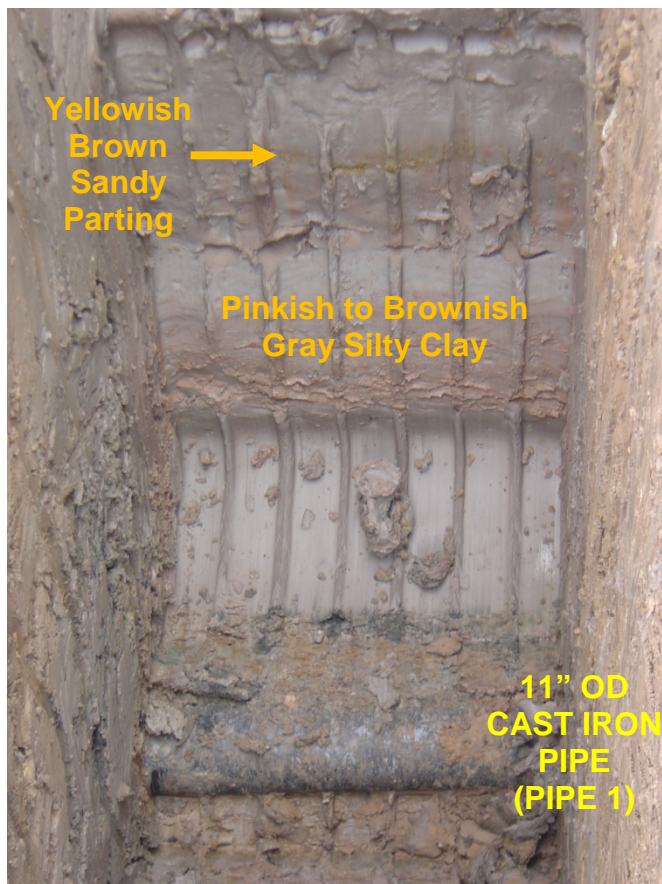
**Photo No.**  
PE1-4

A northwestward view of the bottom of trench PE-1 showing the pipe encountered and the surrounding soils.

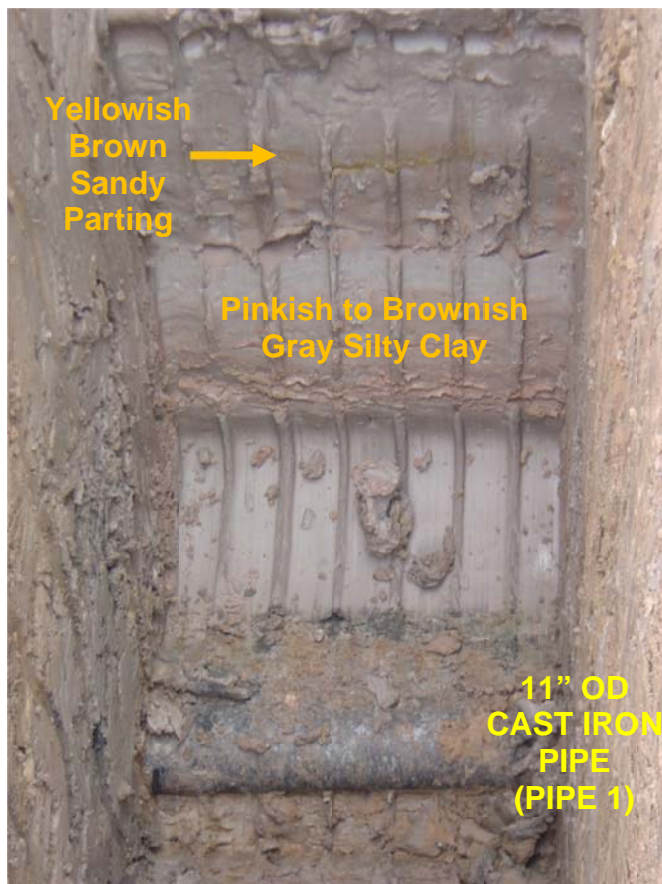
**Photo No.**  
PE1-4

A northwestward view of the bottom of trench PE-1 showing the pipe encountered and the surrounding soils.

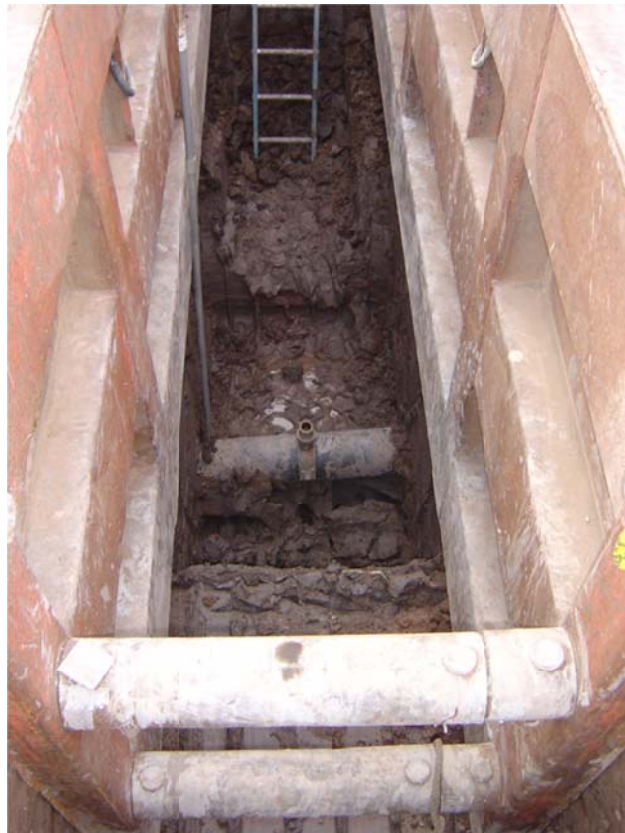
**Photo No.**  
PE1-6

A southeastward view of the inside of trench PE-1 showing PIPE 1, which was encountered at ~14' below ground surface. A brass saddle clamp with valve was installed on the pipe to evaluate if the contents were under pressure: the contents of PIPE 1 were under pressure and ~1625 gallons of water were pumped from PIPE 1 to lower the head enough to permit sealing of the pipe.

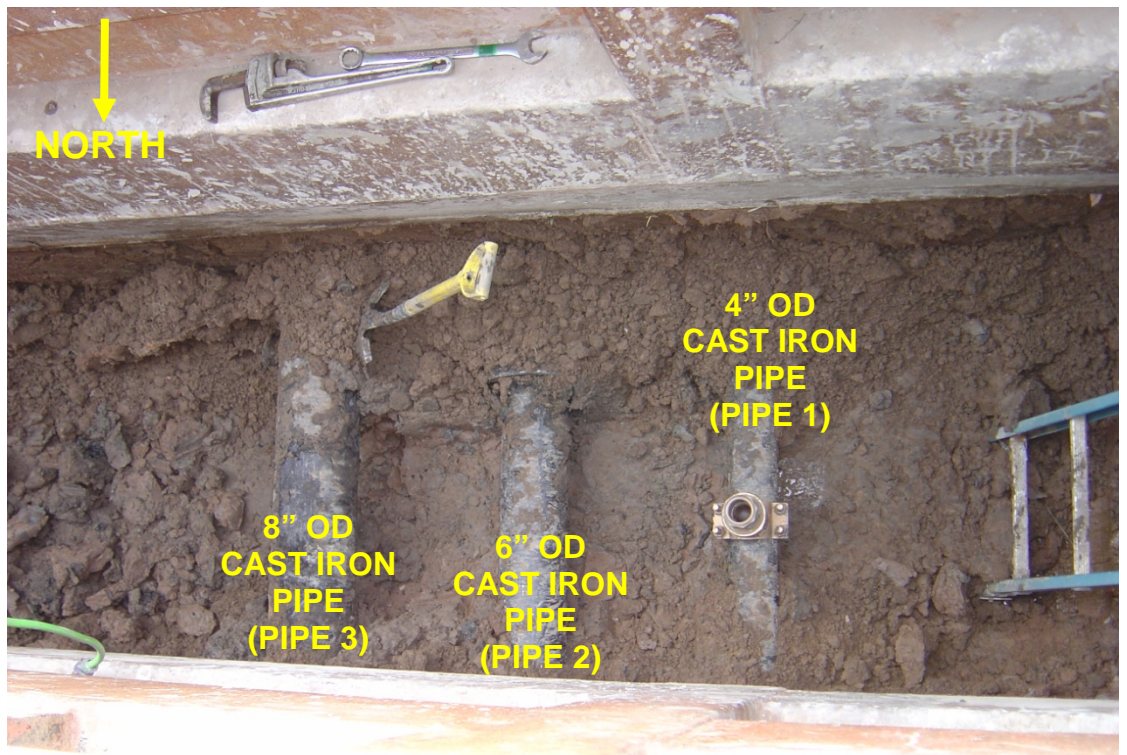
**Photo No.**  
PE2-4

A view of the bottom of trench PE-2 showing the 3 pipes encountered. Tops of pipes were at ~8' below ground surface (bgs). Brass saddle clamps with valves were installed on the pipes to evaluate if the contents were under pressure: contents of PIPE 1 were under pressure (~525 gallons of water were pumped from PIPE 1 to lower the head enough to permit sealing of the pipe); contents of PIPE 2 were under pressure (~300 gallons of water were pumped from PIPE 2 to lower the head enough to permit sealing of the pipe); and contents of PIPE 3 were under pressure (~1,550 gallons of water were pumped from PIPE 3 to lower the head enough to permit sealing of the pipe).

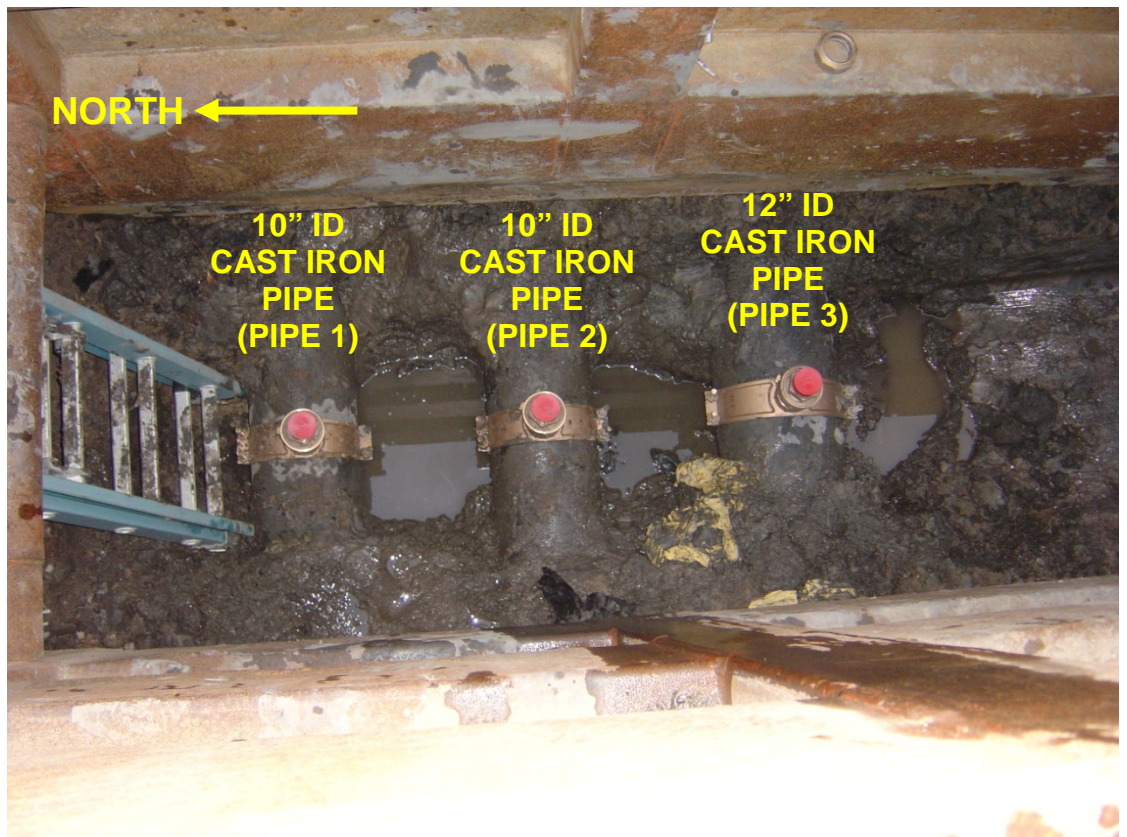
**Photo No.**  
PE3-4

Four cast iron pipes were found, from north to south: 10" ID [PIPE 1]; 10" ID [PIPE 2]; 12" ID [PIPE 3]; and 36" ID [PIPE 4]. All pipes crossed the trench in an east-west orientation. No bedding material was found around PIPES 1-3. The pipes appeared to be backfilled with native silty clay soils. The southern 36" ID pipe had some angular gravel in a clay matrix beneath the pipe and wooden cribbing pieces around the pipe.

A view of the bottom of the north end of trench PE-3 showing the 3 pipes encountered. Tops of pipes were at ~6.5' below ground surface (bgs). Brass saddle clamps with valves were installed on the pipes to evaluate if the contents were under pressure: PIPE 1 contained some gas under pressure, but liquid contents did not flow out of pipe; contents of PIPE 2 were not under pressure; and contents of PIPE 3 were under pressure (~450 gallons of water were pumped from PIPE 3 to lower the head enough to permit sealing of the pipe).

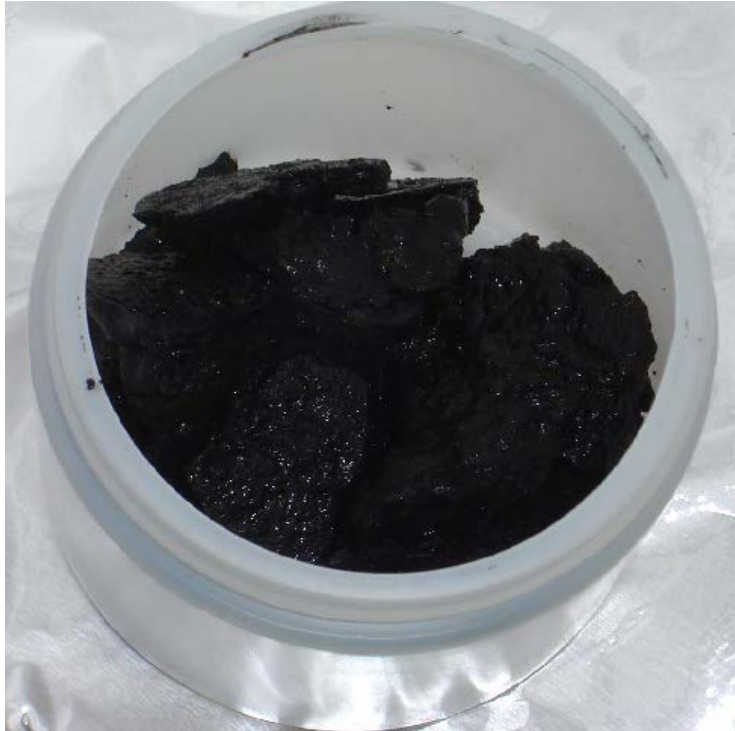
PE3PIPE2SED-0108	11/14/2012 11:55	inside pipe	Sediment	Limited volume - gamma spec/iso-U/iso-Th only	None	Sediment sample from around inside of PIPE 2; hard clumps of black scale, wet on outer surface, no odor, botryoidal texture on outer surface
PE3PIPE3SED-0109	11/14/2012 13:55	inside pipe	Sediment	List 1	None	Sediment sample from bottom of PIPE 3; black silt-clay size sediment, wet, slight petroleum hydrocarbon odor, slight sheen, inky/sticky/staining; PID = 0.0 ppm

Sample PE3PIPE2SED,  
hard black scale  
collected from the inside  
of PIPE 2.

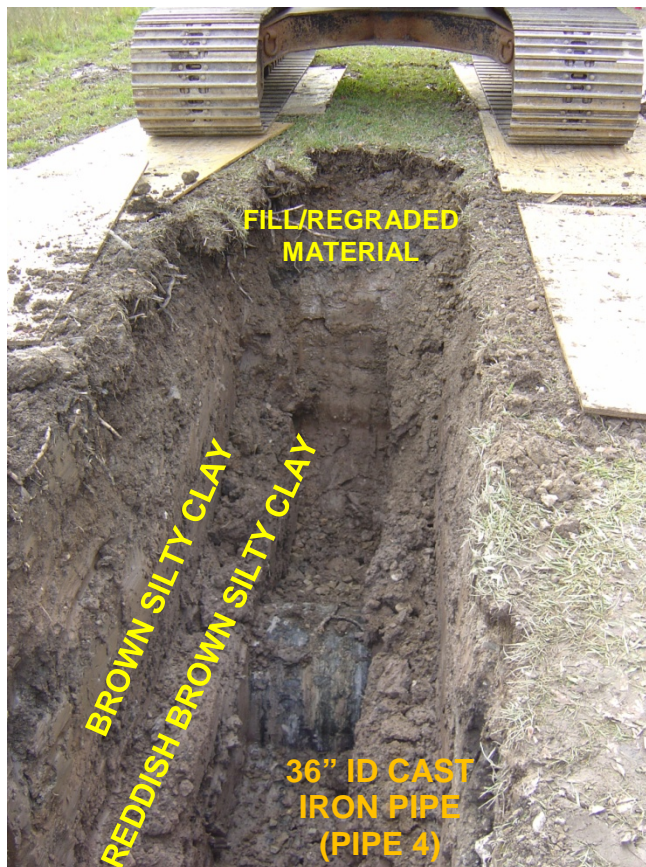
**Photo No.**  
PE3-9

A southward view of the south end of trench PE3 showing the excavation of the 36" ID pipe (PIPE 4). The top of the pipe was encountered at ~6.5' bgs.

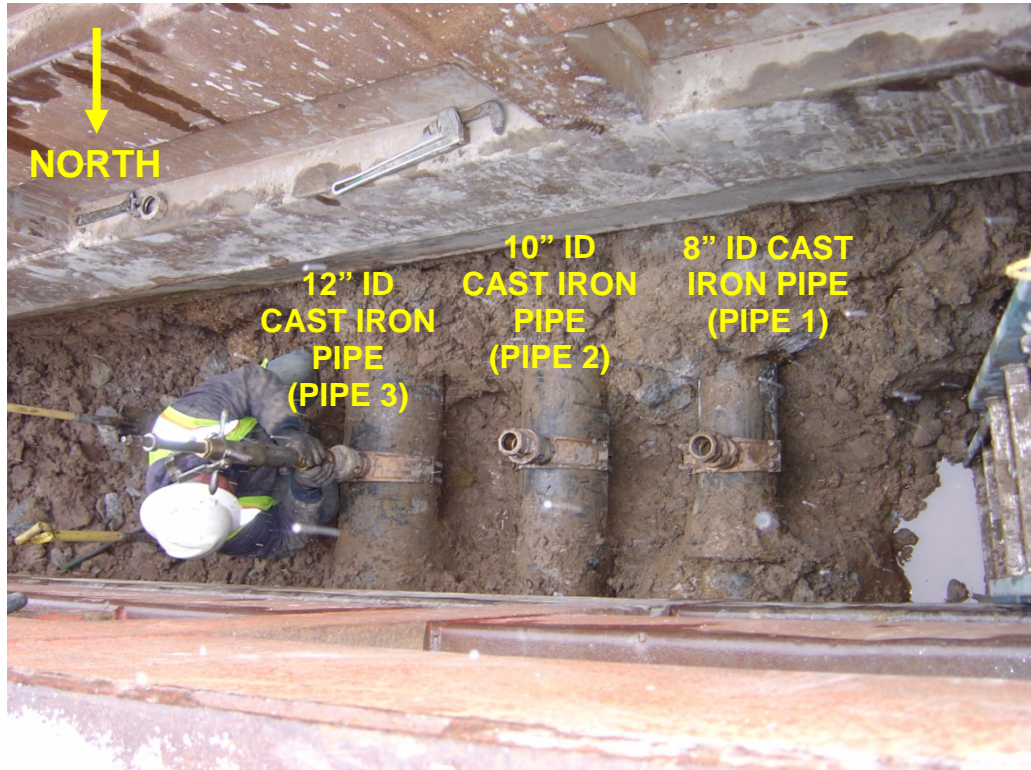
Four cast iron pipes, from west to east: 8" ID [PIPE 1]; 10" ID [PIPE 2]; 12" ID [PIPE 3]; and 36" ID [PIPE 4] crossed the trench in an north-south orientation. PIPE 1 had some concrete encasement around hubs (former repair?).

A view of the bottom of the west end of trench PE-4 showing the 3 pipes encountered. Tops of pipes were at ~6.2-6.3' below ground surface (bgs). Brass saddle clamps with valves were installed on the pipes to evaluate if the contents were under pressure: contents of PIPE 1 were under pressure (~425 gallons of water were pumped from PIPE 1 to lower the head enough to permit sealing of the pipe); contents of PIPE 2 were under pressure (~525 gallons of water were pumped from PIPE 2 to lower the head enough to permit sealing of the pipe); and contents of PIPE 3 were under pressure (~725 gallons of water were pumped from PIPE 3 to lower the head enough to permit sealing of the pipe).

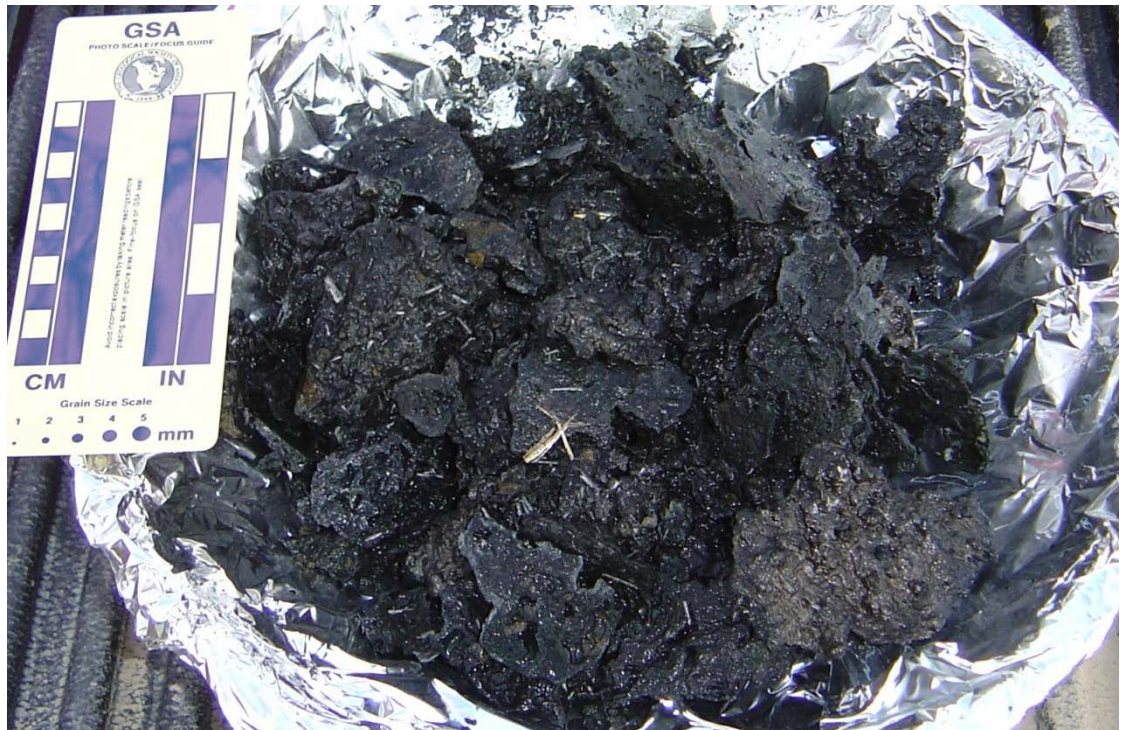
**Photo No.**  
PE4-4

Sample PE4PIPE2SED, hard black scale collected from the inside of PIPE 2.

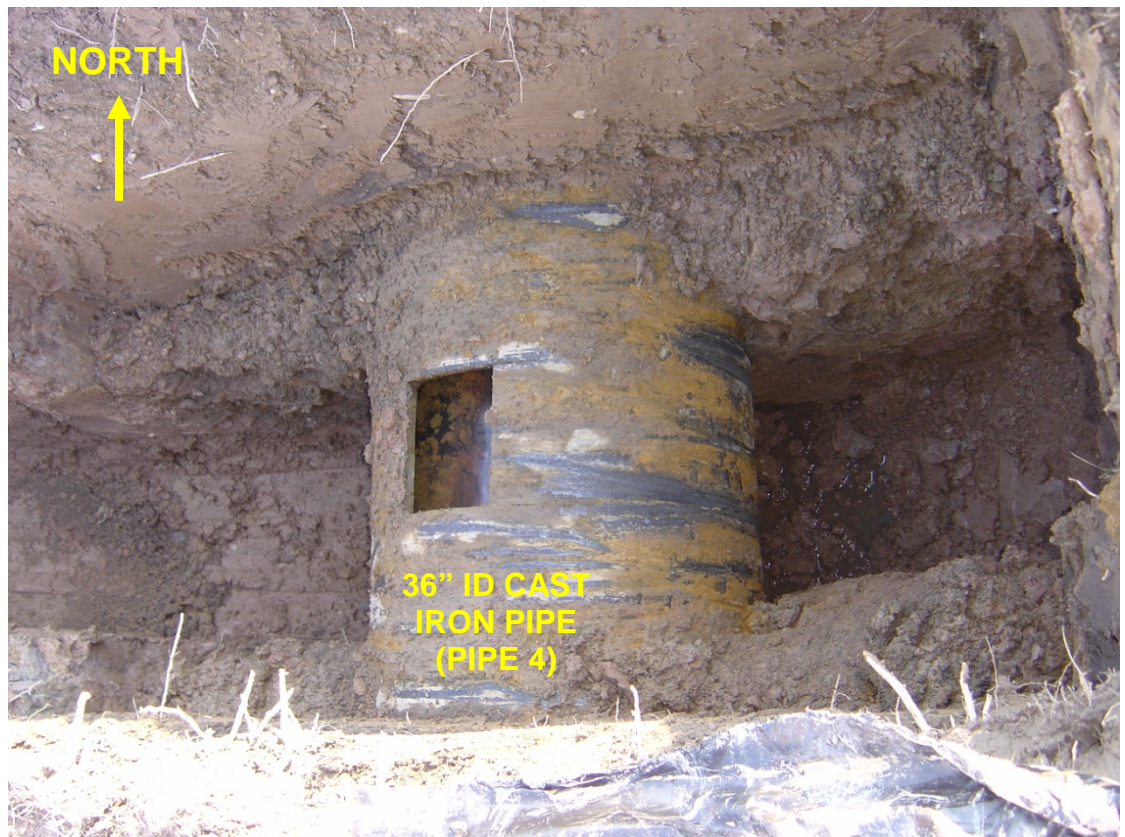
**Photo No.**  
PE4-7

A northward view of the east end of trench PE4 showing the excavated 36" ID pipe (PIPE 4). The top of the pipe was encountered at ~3.8' bgs. The contents of the pipe were not under pressure and no pumping was necessary at this location. Pipe cutting and sampling activities were performed with soils excavated to ~4' bgs. Soils were subsequently excavated to ~8.3 bgs (this view) to permit sealing around and under the pipe with concrete-bentonite mixture.

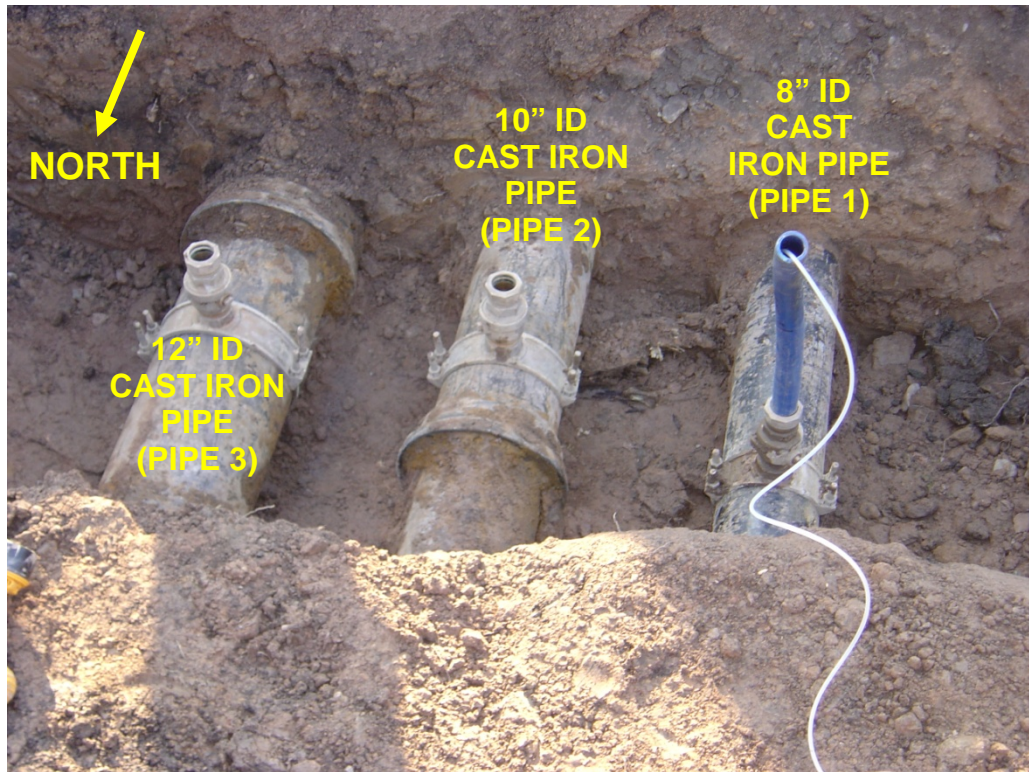
- PIPE 1 was under gravity pressure. ~500 gallons of water were pumped from PIPE 1 to lower the head below the top of the pipe.
- PIPE 2 was not under pressure.
- PIPE 3 was under gravity pressure. ~400 gallons of water were pumped from PIPE 3 to lower the head below the top of the pipe. No sediment was present in PIPE 3.
- PIPE 4 was under gravity pressure. With USACE approval, a 15" square window was scored into the top of the pipe with a chop saw, the window was broken with the excavator bucket, and the inside of the pipe and area around the pipe was filled with 7.5 yds<sup>3</sup> of concrete to prevent liquid migration within and along the outside of the pipe.

A view of the bottom of the west end of test pit PE-5 showing the 3 pipes encountered. Tops of pipes were at ~5.0-5.5' below ground surface (bgs). Brass saddle clamps with valves were installed on the pipes to evaluate if the contents were under pressure: contents of PIPE 1 were under pressure (~500 gallons of water were pumped from PIPE 1 to lower the head enough to permit sealing of the pipe); contents of PIPE 2 were not under pressure; and contents of PIPE 3 were under pressure (~400 gallons of water were pumped from PIPE 3 to lower the head enough to permit sealing of the pipe).

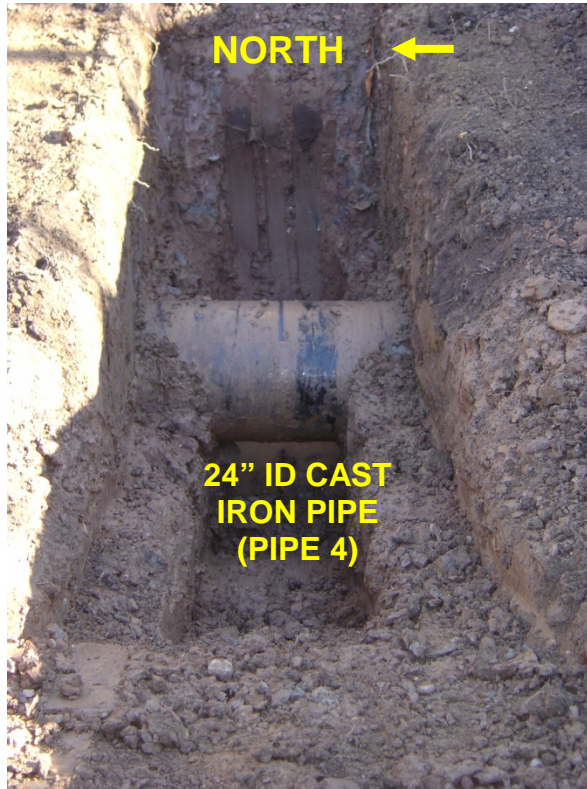
An eastward view of the east end of trench PE-5 showing the excavated 24" ID pipe (PIPE 4). The top of the pipe was encountered at ~5.0' bgs. The contents of the pipe were under pressure. Pipe sampling and scoring activities were performed with soils excavated to ~4' bgs. Soils were subsequently excavated to ~8.5 bgs (this view) to permit sealing around and under the pipe with concrete-bentonite mixture.

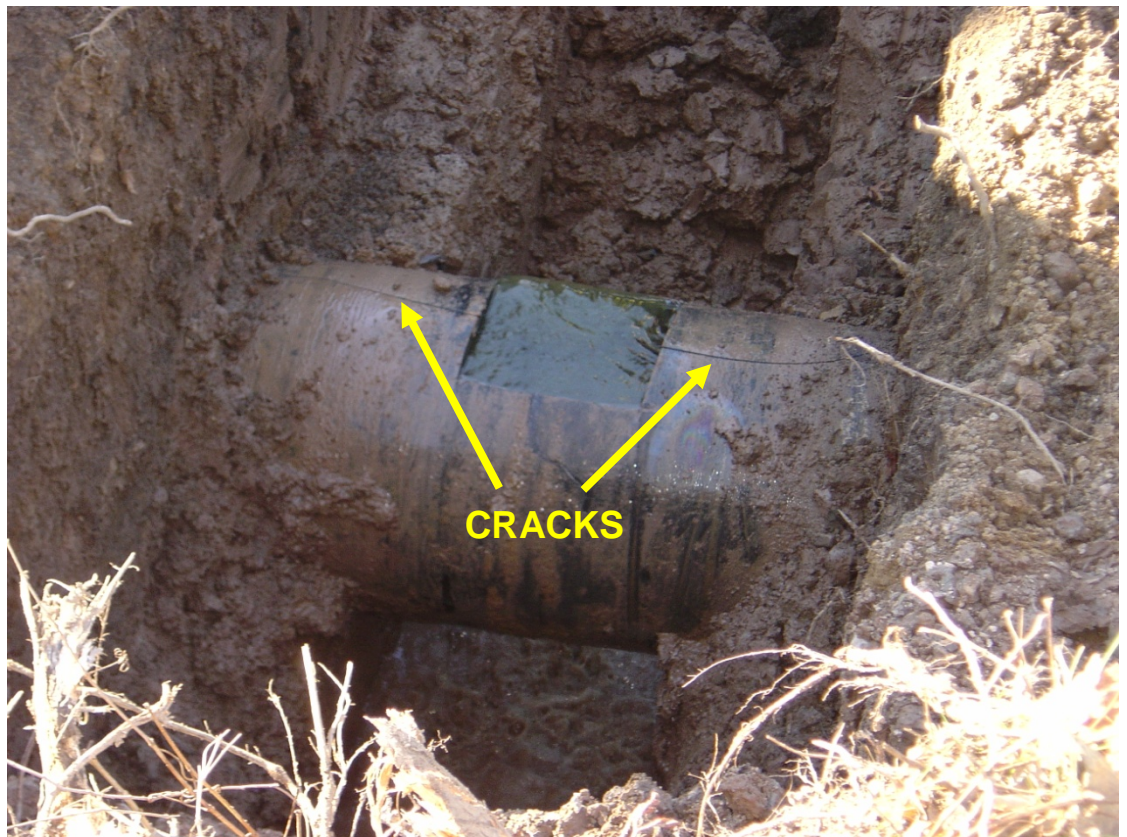
**Photo No.**  
PE5-6

A westward view of the east end of test pit PE4 showing the top of PIPE 4. Since the contents of the pipe were under pressure, a window was scored into the top of the pipe in preparation for filling the interior and areas surrounding the pipe with concrete. However, when the excavator broke the ~15" square window to permit filling the pipe with concrete, cracks developed in the top of the pipe that extended ~18" to the north and south of the window.

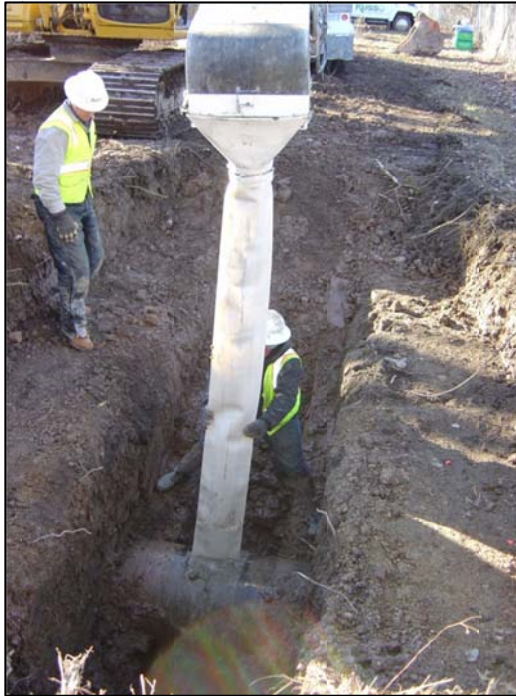
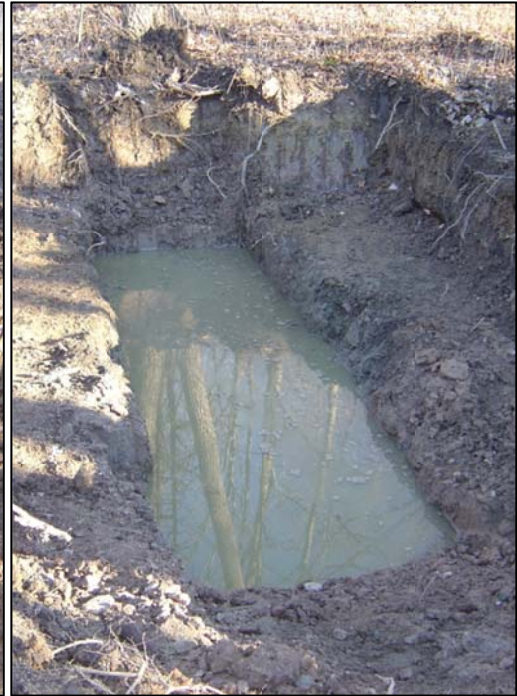
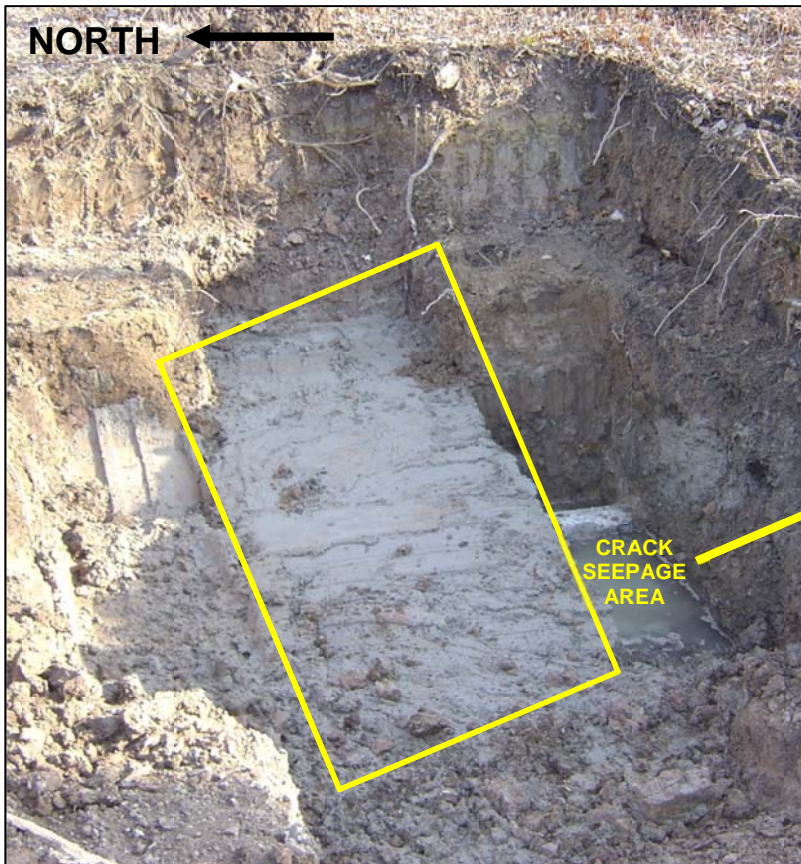
**Photo No.**  
PE5-9 &  
PE5-10

An eastward view of the east end of test pit PE-5; PIPE4 was filled and surrounded with a concrete-bentonite mixture on 12/13/2012 (yellow boxes). The areas to the north and south of this pour were excavated on 12/14/2012 to see if the cracks in the top of the pipe extended beyond the pour or were seeping; seepage was noted from a small portion of exposed crack on the south side of the pour (right side of photo). This area was excavated beyond the crack and completely around the pipe and sealed with another 1.5 yd<sup>3</sup> of concrete-bentonite mixture on 12/14/2012 (smaller right photo).

**SOUTH CRACK  
SURROUNDED  
WITH  
CONCRETE ON  
12/14/2012**

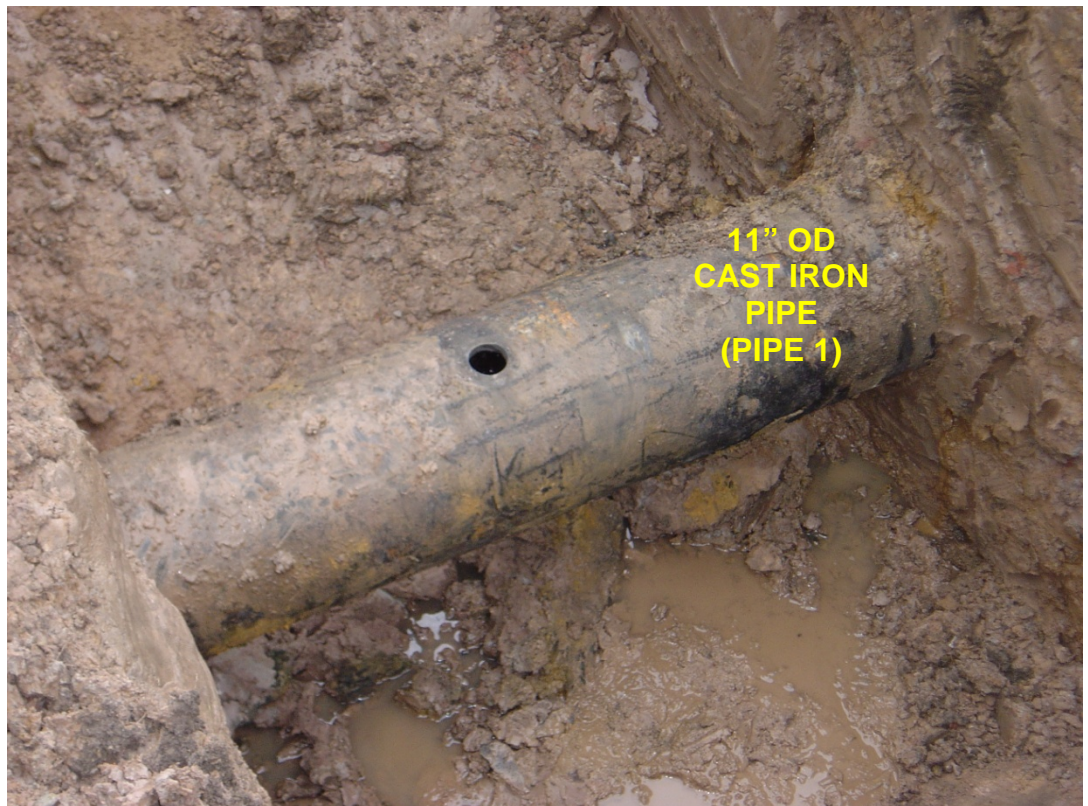
**Photo No.**  
PE6-2

A north-northwestward view of the inside of trench PE-6 showing PIPE 1, which was encountered at ~4' below ground surface. A brass saddle clamp with valve was installed on the pipe to evaluate if the contents were under pressure; the contents of PIPE 1 were not under pressure and the pipe was only about half- full with water. This photo shows the pipe after the saddle clamp/valve assembly was removed. Although no bedding material was observed (the pipe appeared to be backfilled with native silty clay), some water seeped into the excavation from beneath the pipe.
