APPENDIX P

Compaction Testing Results

Field Density Test Report

Project: TONAWANDA LANDFILL
TONAWANDA, NY

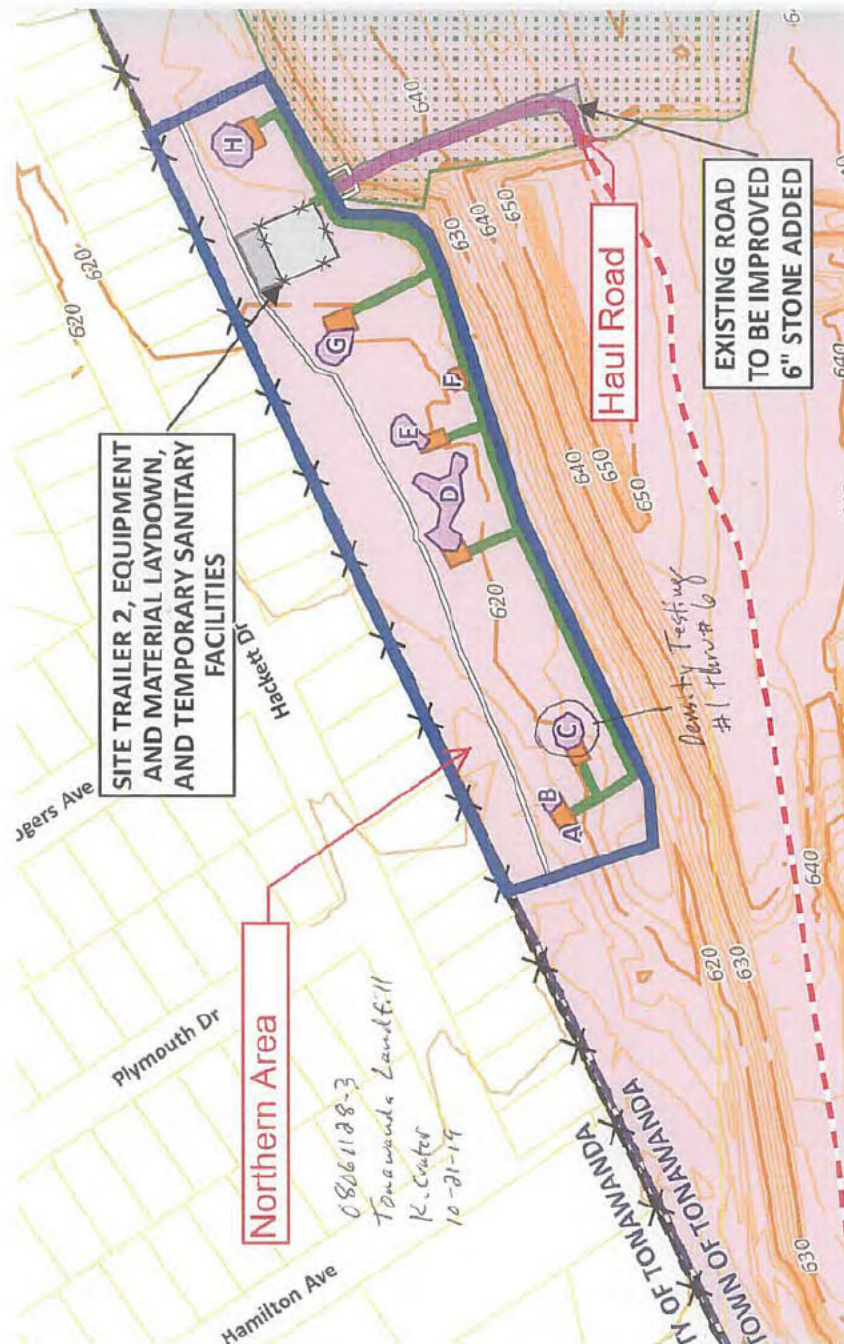
General Location: Excavation "C" Soil Remediation Backfill

Test No.	Field Sample ID	Location	Test Elev/Depth	Material/Layer
1	S1	See Attached Sketch - Test Location #1, North side of the Excavation	1st Lift	Subgrade Fill
2	S2	See Attached Sketch - Test Location #2, South side of Excavation	2nd Lift	Subgrade Fill
3	S3	See Attached Sketch - Test Location #3, Center of Excavation	3rd Lift	Subgrade Fill
4	S4	See Attached Sketch - Test Location #4, South side of Excavation	4th Lift	Subgrade Fill
5	S5	See Attached Sketch - Test Location #5, Center of Excavation	5th Lift	Subgrade Fill
6	S6	See Attached Sketch - Test Location #6, Southeast Area of Excavation	6th Lift	Subgrade Fill

(SO) = Sampled By Others
(TO) = Tested By Others
Elevation referenced from bottom of Excavation "C" (Top of Stone Placement)
18" of aggregate material was previously placed in the excavation and compacted

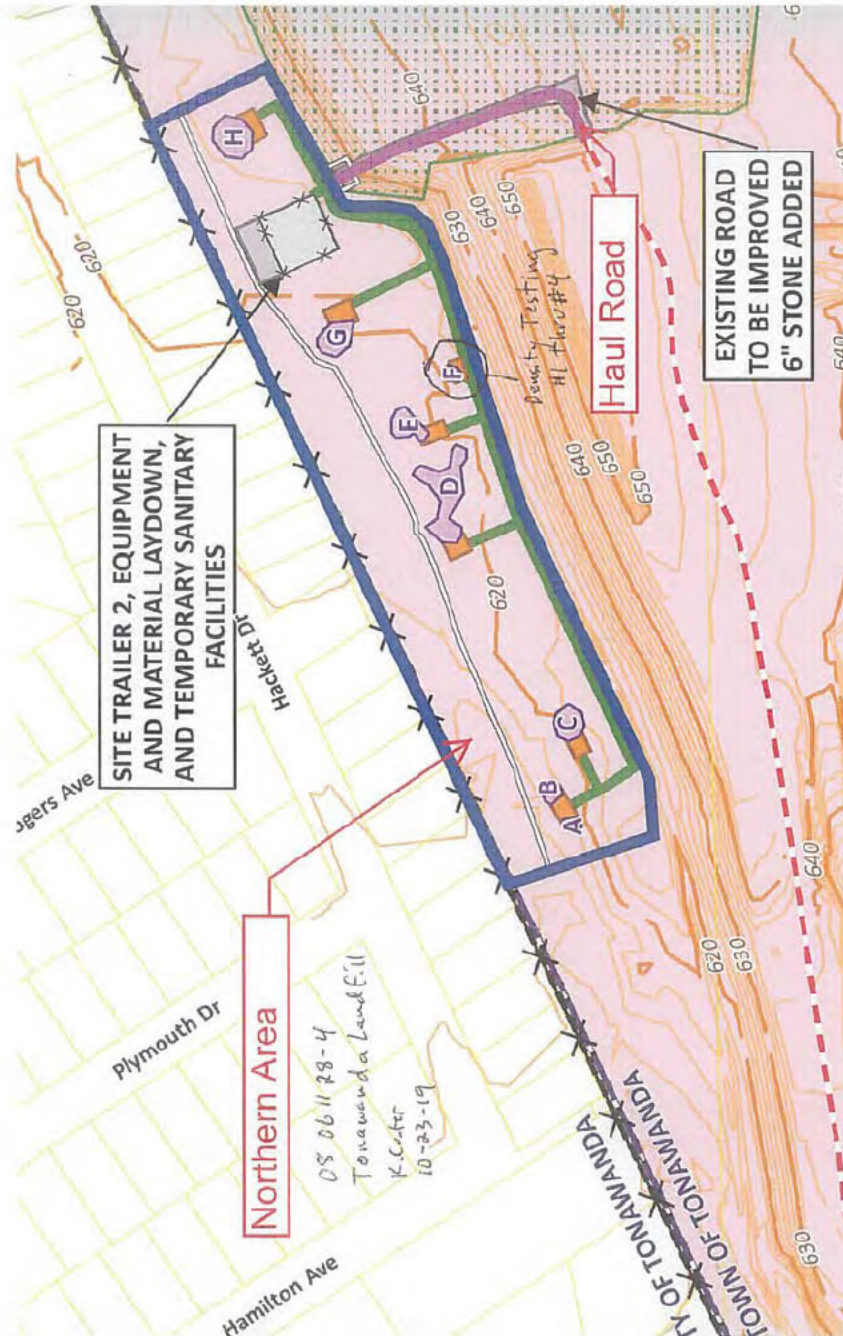
General Location: Excavation "F" Soil Remediation Backfill

Test No.	Field Sample ID	Location	Test Elev/Depth	Material/Layer
1	S1	See Attached Sketch - Test Location #1, South side of the Excavation	1st Lift	Subgrade Fill
2	S2	See Attached Sketch - Test Location #2, Center of the Excavation	2nd Lift	Subgrade Fill
3	S3	See Attached Sketch - Test Location #3, North side of the Excavation	3rd Lift	Subgrade Fill
4	S4	See Attached Sketch - Test Location #4, Center of the Excavation	4th Lift	Subgrade Fill

(SO) = Sampled By Others
(TO) = Tested By Others
Elevation referenced from bottom of Excavation "F" (Top of Stone placement)
24" of Aggregate material was placed in the excavation and compacted prior to the Subgrade Fill placement

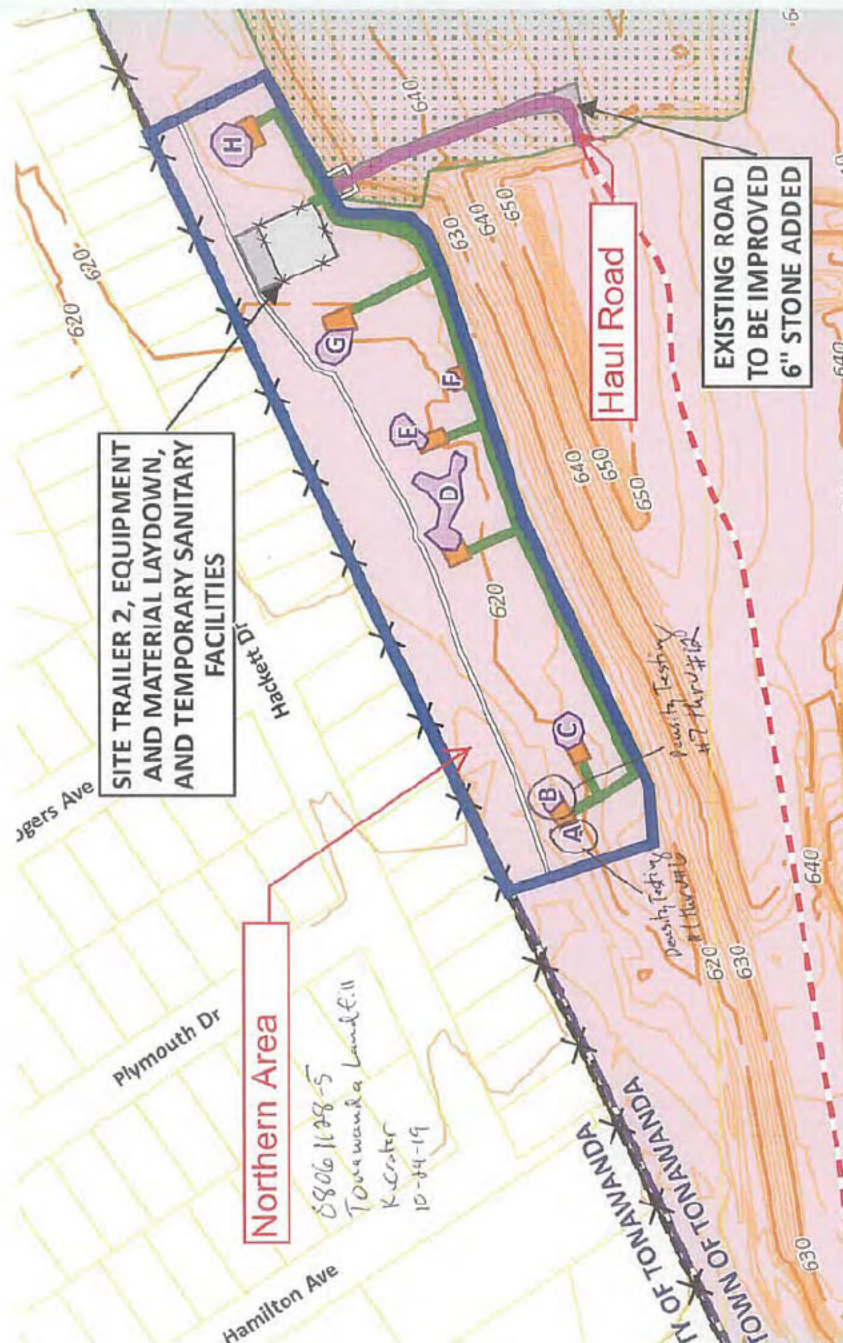
General Location: Excavation "A" - Soil Remediation Backfill

Test No.	Field Sample ID	Location	Test Elev/Depth	Material/Layer
1	S1	See Attached Sketch - Test Location #1, East side of the Excavation	1st Lift	Subgrade Fill
2	S2	See Attached Sketch - Test Location #2, West side of the Excavation	2nd Lift	Subgrade Fill
3	S3	See Attached Sketch - Test Location #3, Center of the Excavation	3rd Lift	Subgrade Fill
4	S4	See Attached Sketch - Test Location #4, North side of the Excavation	4th Lift	Subgrade Fill
5	S5	See Attached Sketch - Test Location #5, Center of the Excavation	5th Lift	Subgrade Fill
6	S6	See Attached Sketch - Test Location #6, Southside of the Excavation	6th Lift	Subgrade Fill

General Location: Excavation "B" - Soil Remediation Backfill

Test No.	Field Sample ID	Location	Test Elev/Depth	Material/Layer
7	S7	See Attached Sketch - Test Location #7, Center of the Excavation	1st Lift	Subgrade Fill
8	S8	See Attached Sketch - Test Location #8, South side of the Excavation	2nd Lift	Subgrade Fill
9	S9	See Attached Sketch - Test Location #9, Northside of the Excavation	3rd Lift	Subgrade Fill
10	S10	See Attached Sketch - Test Location #10, South side of the Excavation	4th Lift	Subgrade Fill
11	S11	See Attached Sketch - Test Location #11, Center of the Excavation	5th Lift	Subgrade Fill
12	S12	See Attached Sketch - Test Location #12, North side of the Excavation	6th Lift	Subgrade Fill

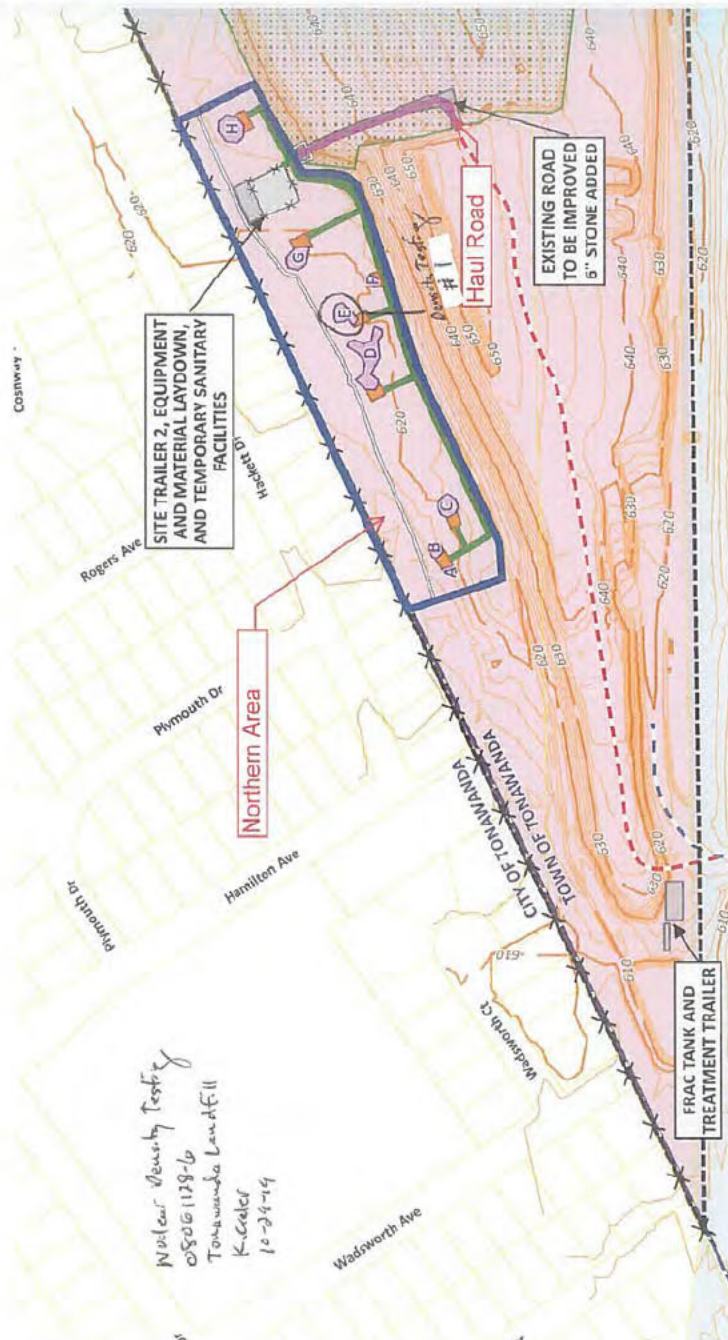
General Location: Excavation "E"- Soil Remediation Backfill

Test No.	Field Sample ID	Location	Test Elev/Depth	Material/Layer
1	S1	See Attached Sketch - Test Location #1	1st Lift	Subgrade Fill

(SO) = Sampled By Others
(TO) = Tested By Others
Elevation referenced from bottom of Excavation (Top of Stone Placement)
Prior to subgrade fill placement (18") of Aggregate material was placed on the North side of the Excavation and compacted. The Southside of the Excavation only has approximately (1") of Aggregate material placed.

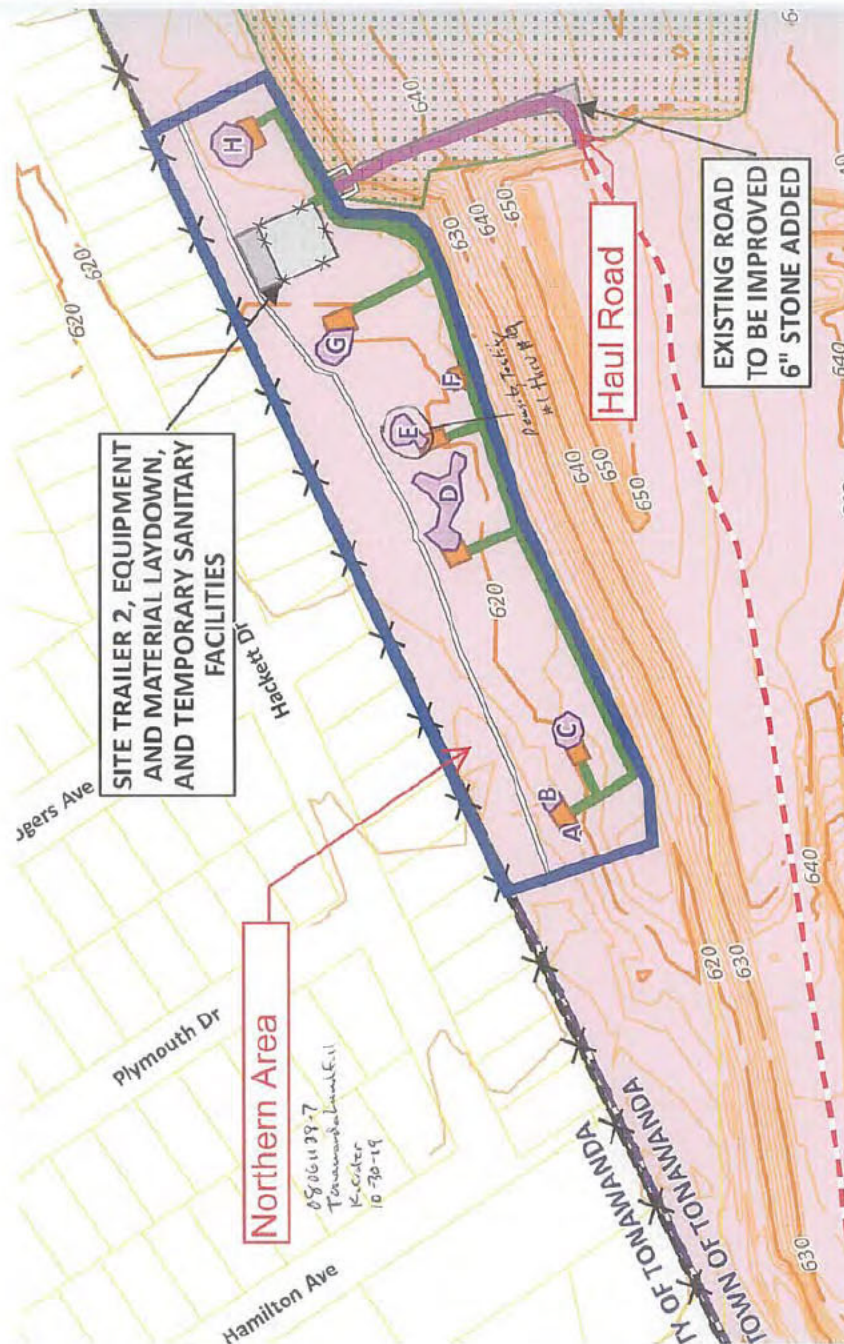
General Location: Excavation "E" - Soil Remediation Backfill

Test No.	Field Sample ID	Location	Test Elev/Depth	Material/Layer
1	S1	See Attached Sketch - Test Location #1, Southwest Area of the Excavation	2nd Lift	Subgrade Fill
2	S2	See Attached Sketch - Test Location #2, Northwest Area of the Excavation	2nd Lift	Subgrade Fill
3	S3	See Attached Sketch - Test Location #3, Southeast Area of the Excavation	2nd Lift	Subgrade Fill
4	S4	See Attached Sketch - Test Location #4, West side of the Excavation	3rd Lift	Subgrade Fill
5	S5	See Attached Sketch - Test Location #5, East side of the Excavation	3rd Lift	Subgrade Fill
6	S6	See Attached Sketch - Test Location #6, North side of the Excavation	4th Lift	Subgrade Fill
7	S7	See Attached Sketch - Test Location #7, South side of the Excavation	4th Lift	Subgrade Fill
8	S8	See Attached Sketch - Test Location #8, Center of the Excavation	5th Lift	Subgrade Fill
9	S9	See Attached Sketch - Test Location #9, Southwest Area of the Excavation	5th Lift	Subgrade Fill

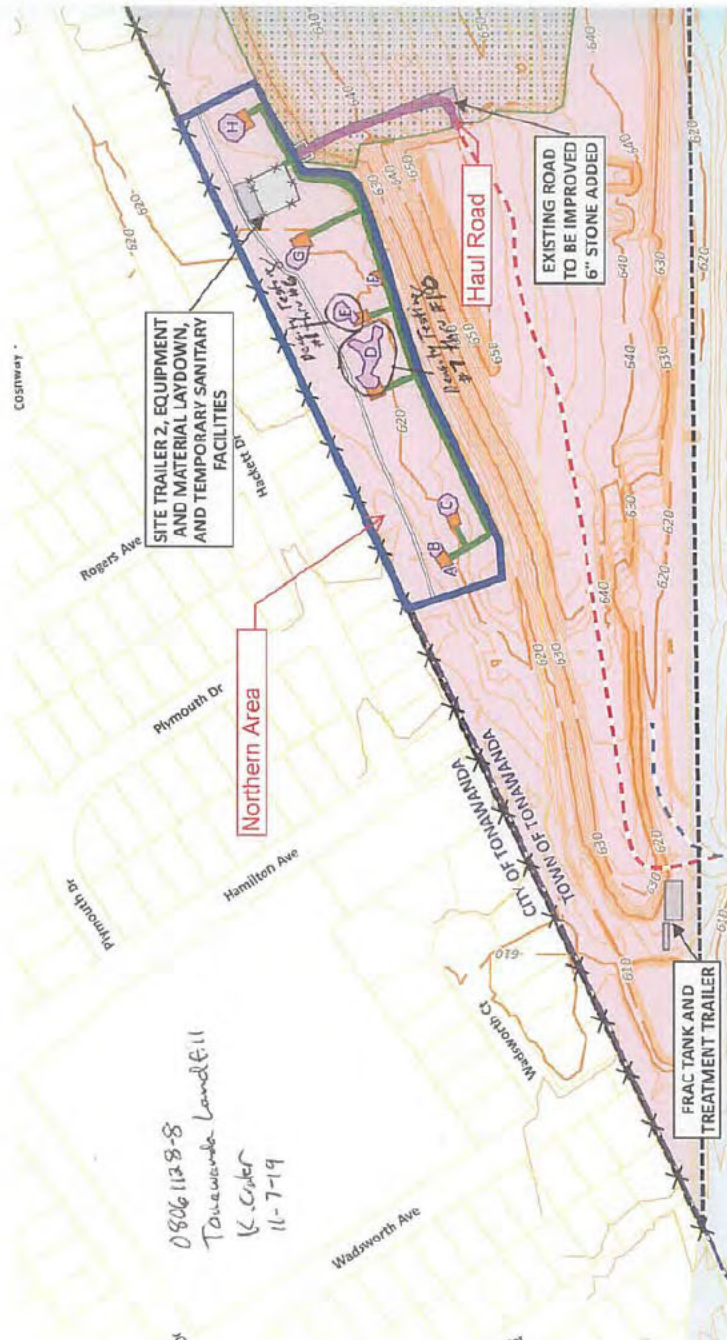
General Location: Excavation "E"- Soil Remediation Backfill

Test No.	Field Sample ID	Location	Test Elev/Depth	Material/Layer
1	S1	See Attached Sketch - Test Location #1, Center of the Excavation	5th Lift	Subgrade Fill
2	S2	See Attached Sketch - Test Location #2, Southwest Area of the Excavation	5th Lift	Subgrade Fill
3	S3	See Attached Sketch - Test Location #3, East side of the Excavation	6th Lift	Subgrade Fill
4	S4	See Attached Sketch - Test Location #4, Southwest Area of the Excavation	6th Lift	Subgrade Fill
5	S5	See Attached Sketch - Test Location #5, Southwest Area of the Excavation	7th Lift	Subgrade Fill
6	S6	See Attached Sketch - Test Location #6, Southwest Area of the Excavation	8th Lift	Subgrade Fill

General Location: Excavation "D"- Soil Remediation Backfill

Test No.	Field Sample ID	Location	Test Elev/Depth	Material/Layer
7	S7	See Attached Sketch - Test Location #7, West side of the Excavation	1st Lift	Subgrade Fill
8	S8	See Attached Sketch - Test Location #8, West side of the Excavation	1st Lift	Subgrade Fill
9	S9	See Attached Sketch - Test Location #9, Center of the West side of the Excavation	1st Lift	Subgrade Fill
10	S10	See Attached Sketch - Test Location #10, Center of the Excavation	1st Lift	Subgrade Fill
11	S11	See Attached Sketch - Test Location #11, Center of the East side of the Excavation	1st Lift	Subgrade Fill

(SO) = Sampled By Others
(TO) = Tested By Others
Excavation "D"- Elevation referenced from bottom of the Excavation and Top of Aggregate material placed at the West side of the Excavation only. The West side of the Excavation has (1') of Aggregate material placed and compacted throughout the area except for a channel area used during Dewatering activities which has (2') of Aggregate material placed and compacted.
