# Notice to Navigation Interests

L19-18	June 21, 2019
Notice No.	Date
Waterway

## Condition of Federal Navigation Channel Dunkirk Harbor, Dunkirk, New York

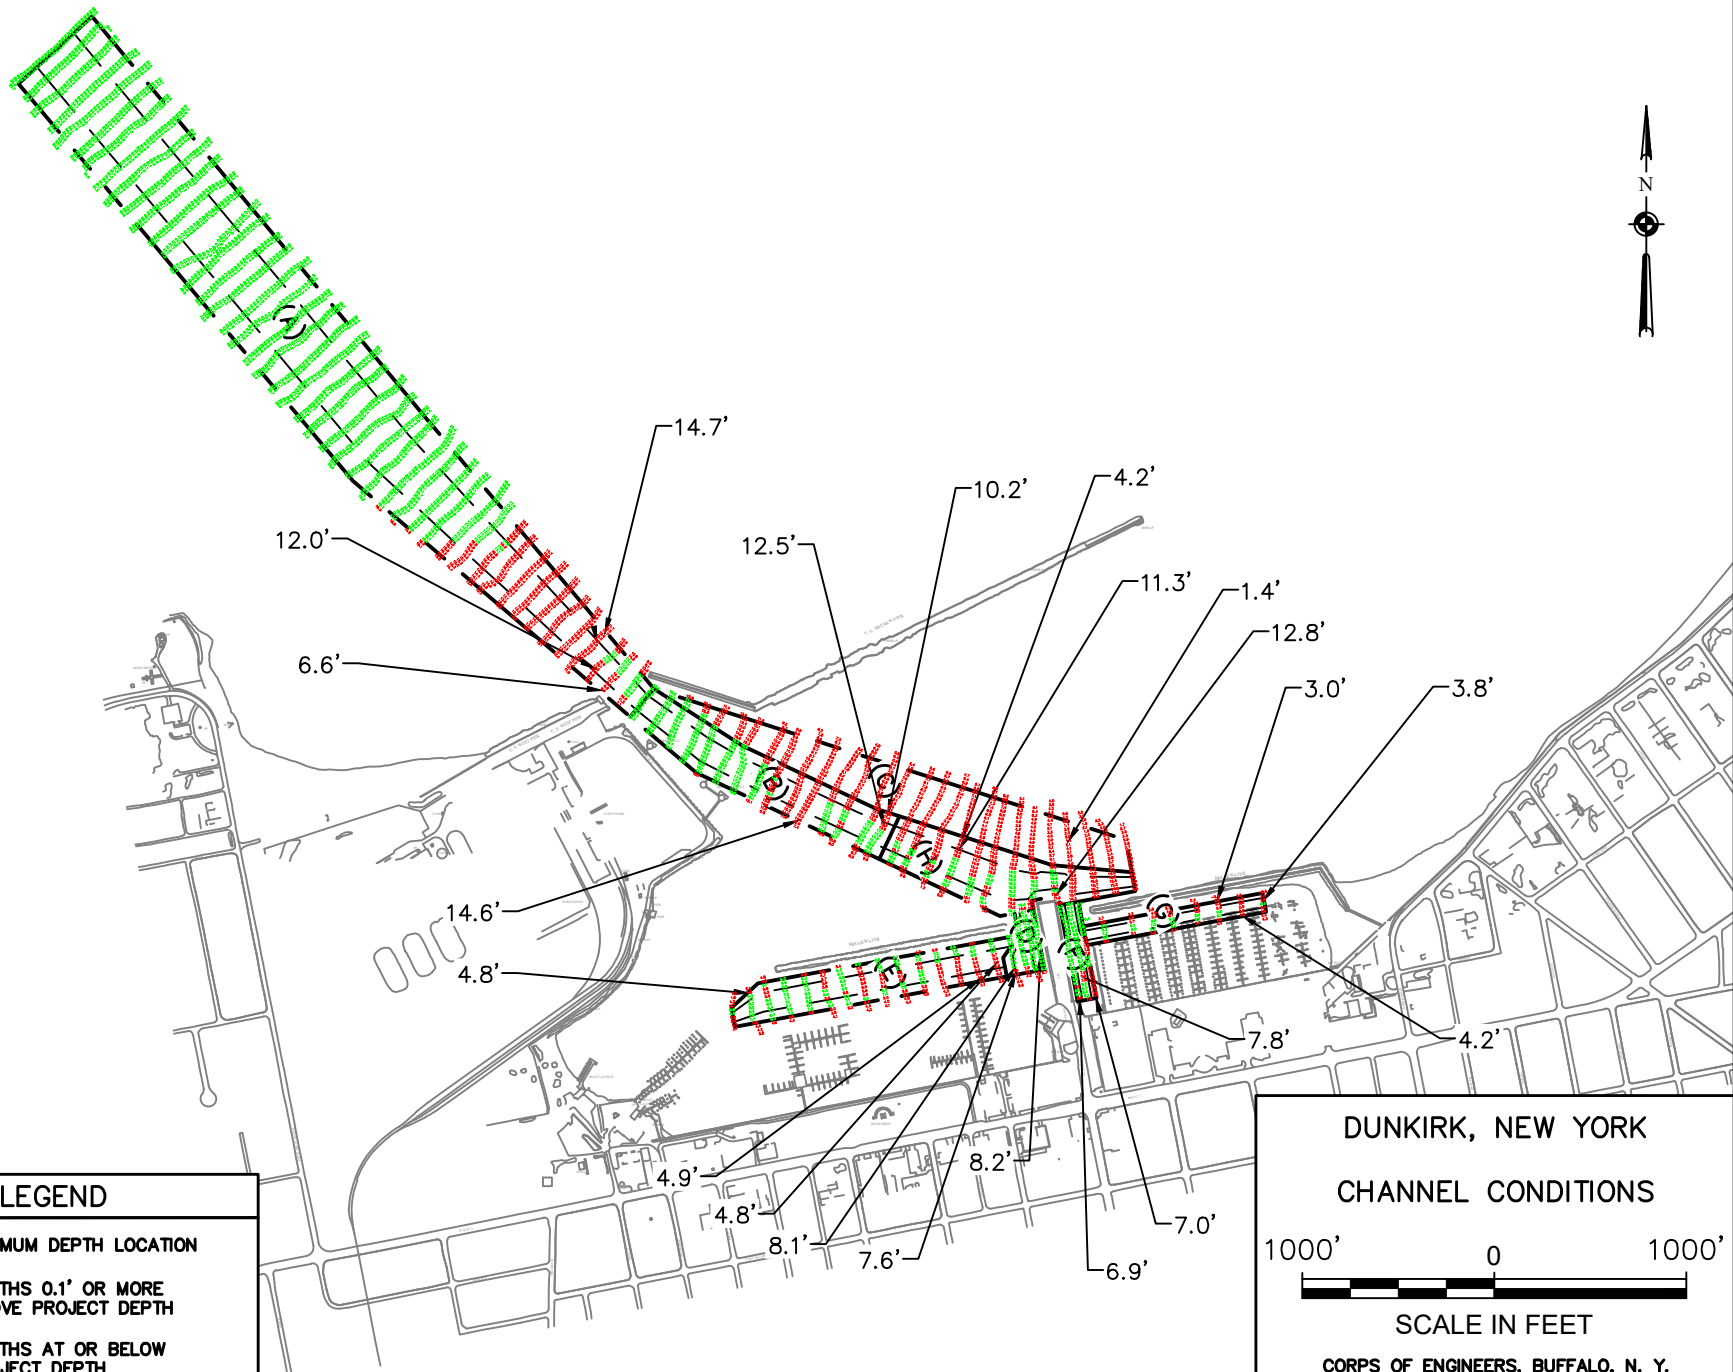
DUNKIRK, NEW YORK  
CHANNEL CONDITIONS

1. Condition surveys performed within the Federal Navigation Channel at Dunkirk Harbor, Dunkirk, New York during the month of June 2019 indicate shoaling has reduced depths to those shown on the attached standard tabular form and channel condition drawings.

3. Vessel operators are advised to use caution when navigating in this area.
4. Copies of the sounding print for Dunkirk Harbor, New York consisting of (2) sheets, Duk19VH101-2, at a cost of \$2.50 per sheet will be furnished upon receipt of a check in the full amount made payable to: USACE Finance and Accounting. Requests should be addressed to: District Commander, U.S. Army Engineer District, Buffalo, ATTN: NY/PA O&M Office, 1776 Niagara Street, Buffalo, New York 14207, requesting exact number or copies of sheets by file number. A point of contact and phone number must be indicated to facilitate response to the request. To download the same information and other related materials at no cost, simply point your web browser to <http://www.lrb.usace.army.mil/Library/MapsandCharts.aspx> then locate the harbor on the table of harbors and click on the file icon to see or download the file.
