# Notice to Navigation Interests

L 19-27	August 7, 2019
Notice No.	Date
<hr/>	
Waterway

Condition of Federal Navigation Channel  
Rocky River Harbor, Rocky River, Ohio

ROCKY RIVER HARBOR, OHIO  
CHANNEL CONDITIONS

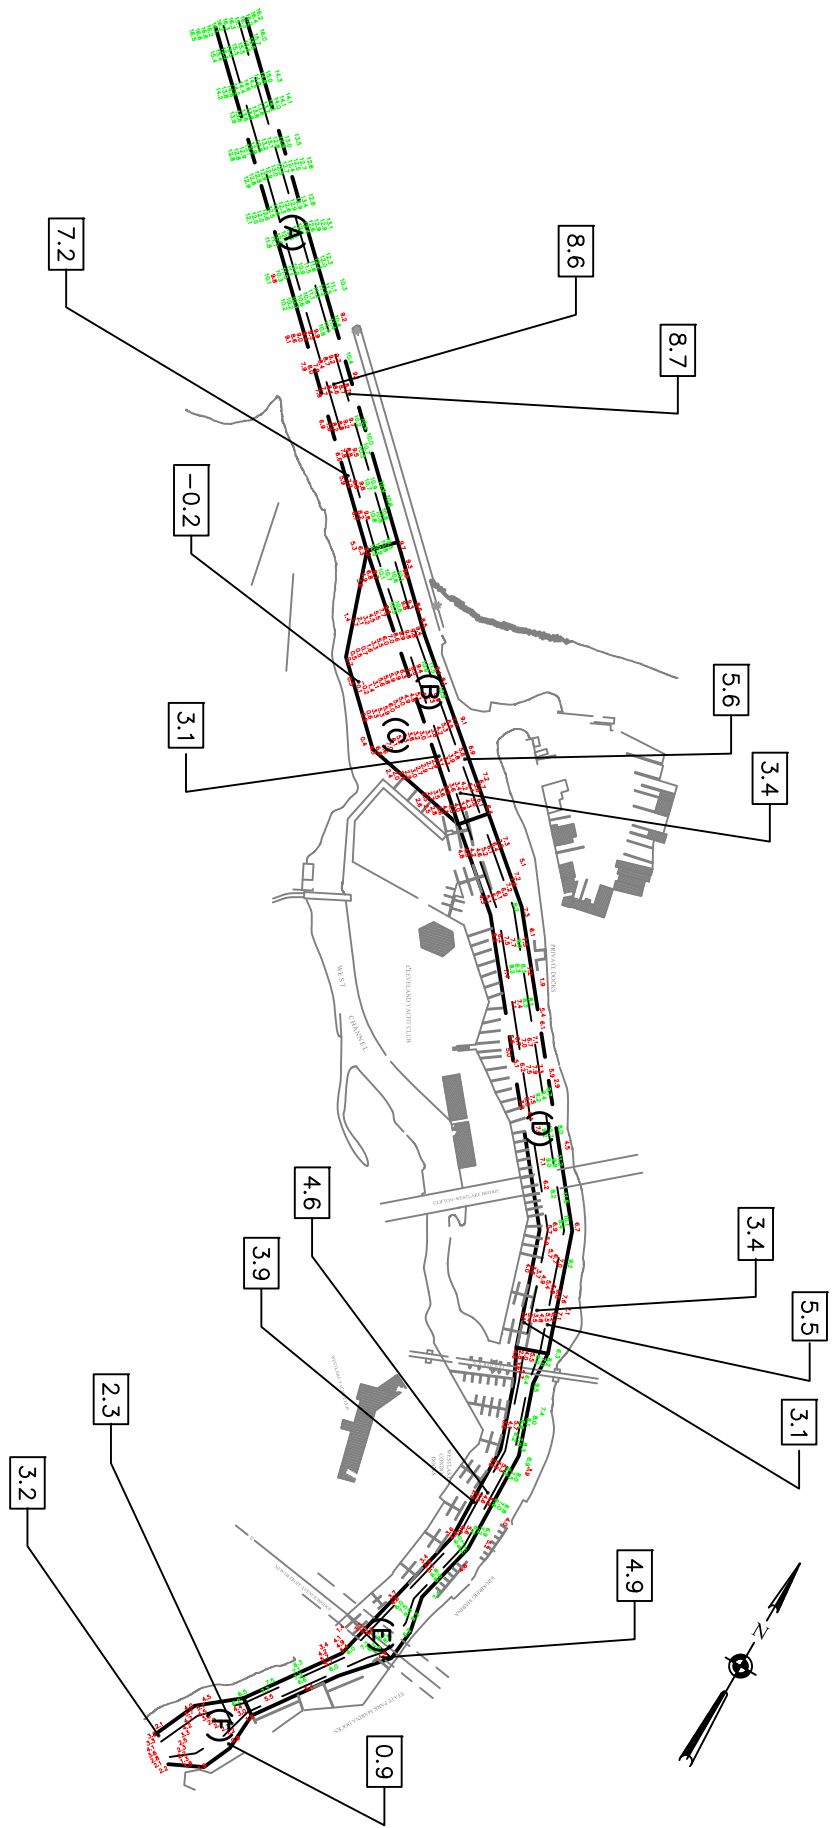
1. Condition surveys performed within the Federal Navigation Channel at Rocky River Harbor, Rocky River, Ohio during the month of August 2019 indicate shoaling has reduced depths to those shown on the attached standard tabular form and channel condition drawings.

NAME OF CHANNEL	DATE OF SURVEY	AUTHORIZED PROJECT			LEFT OUTSIDE QUARTER (feet)	MIDDLE HALF (feet)	RIGHT OUTSIDE QUARTER (feet)
		WIDTH (feet)	LENGTH (feet)	DEPTH (feet)			
SHALLOWEST DEPTHS AS PER DRAWING					1	2	3
(A) ENTRANCE CHANNEL.	August 2019	100	1400 (a)	10	8.7	8.6	7.2
(B) ROCKY RIVER CHANNEL FROM LOWER END OF THE ANCHORAGE AREA TO THE UPPER END OF THE ANCHORAGE AREA.	August 2019	100	900	10	5.6	3.4	3.1
(C) ANCHORAGE AREA.	August 2019	175	900 (b)	10		-0.2	
(D) ROCKY RIVER CHANNEL FROM THE UPPER END OF THE ANCHORAGE AREA TO JUST DOWNSTREAM OF THE N.&W. RAILROAD BRIDGE.	August 2019	100	1300	8	5.5	3.4	3.1
(E) ROCKY RIVER CHANNEL FROM JUST DOWNSTREAM OF THE N.&W. RAIL ROAD BRIDGE.	August 2019	60-120	1550	6	4.9	4.6	3.9
(F) UPPER TURNING BASIN	August 2019	180	300 (b)	6	0.9	2.3	3.2

3. Vessel operators are advised to use caution when navigating in this area.
4. Copies of the sounding print for Rocky River Harbor, Rocky River, Ohio consisting of (1) sheet, Rrh19VH 101-1, at a cost of \$2.50 per sheet will be furnished upon receipt of a check in the full amount made payable to: USACE Finance and Accounting. Requests should be addressed to: District Commander, U.S. Army Engineer District, Buffalo, ATTN: NY/PA O&M Office, 1776 Niagara Street, Buffalo, New York 14207, requesting exact number or copies of sheets by file number. A point of contact and phone number must be indicated to facilitate response to the request. To download the same information and other related materials at no cost, simply point your web browser to <http://www.lrb.usace.army.mil/Library/MapsandCharts.aspx> click on the year and then locate the harbor on the table of harbors.
