# Braddock Bay Restoration

## 2017 Monitoring and Adaptive Management Report

U.S. Army Corps of Engineers

4/20/2018

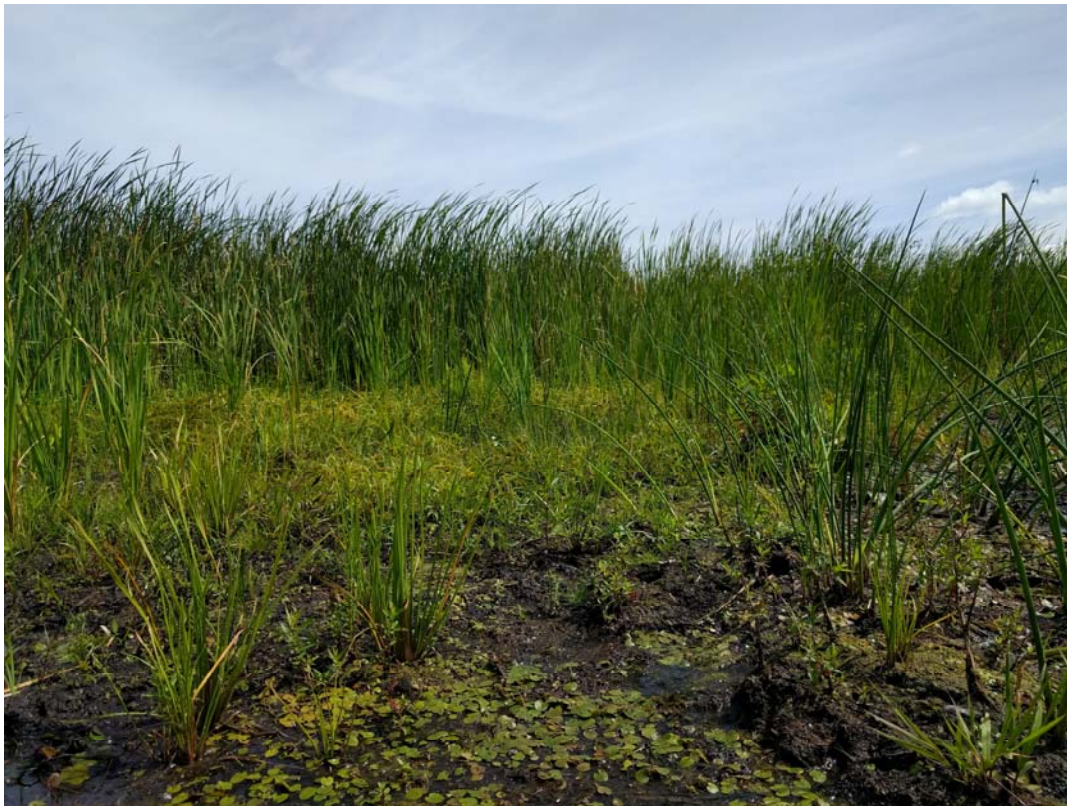
Figure 5. Pothole fringe showing emergent marsh species. Photo taken September 1, 2017.

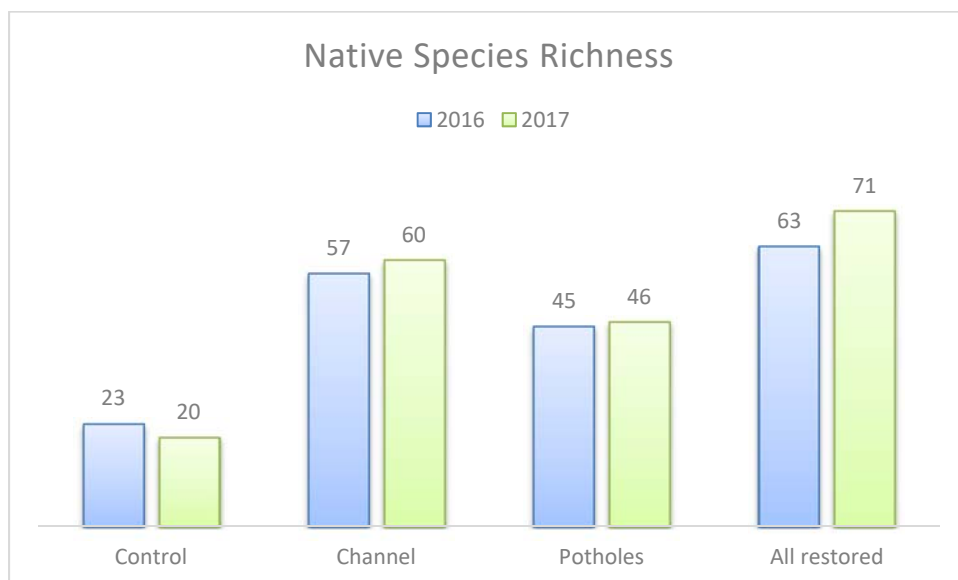
**Figure 7. Native Species Richness by Restoration Area.**
