FINAL SITE INSPECTION REPORT

Ground Disturbances at the Former Lake Ontario Ordnance Works Niagara County, New York

November 2014

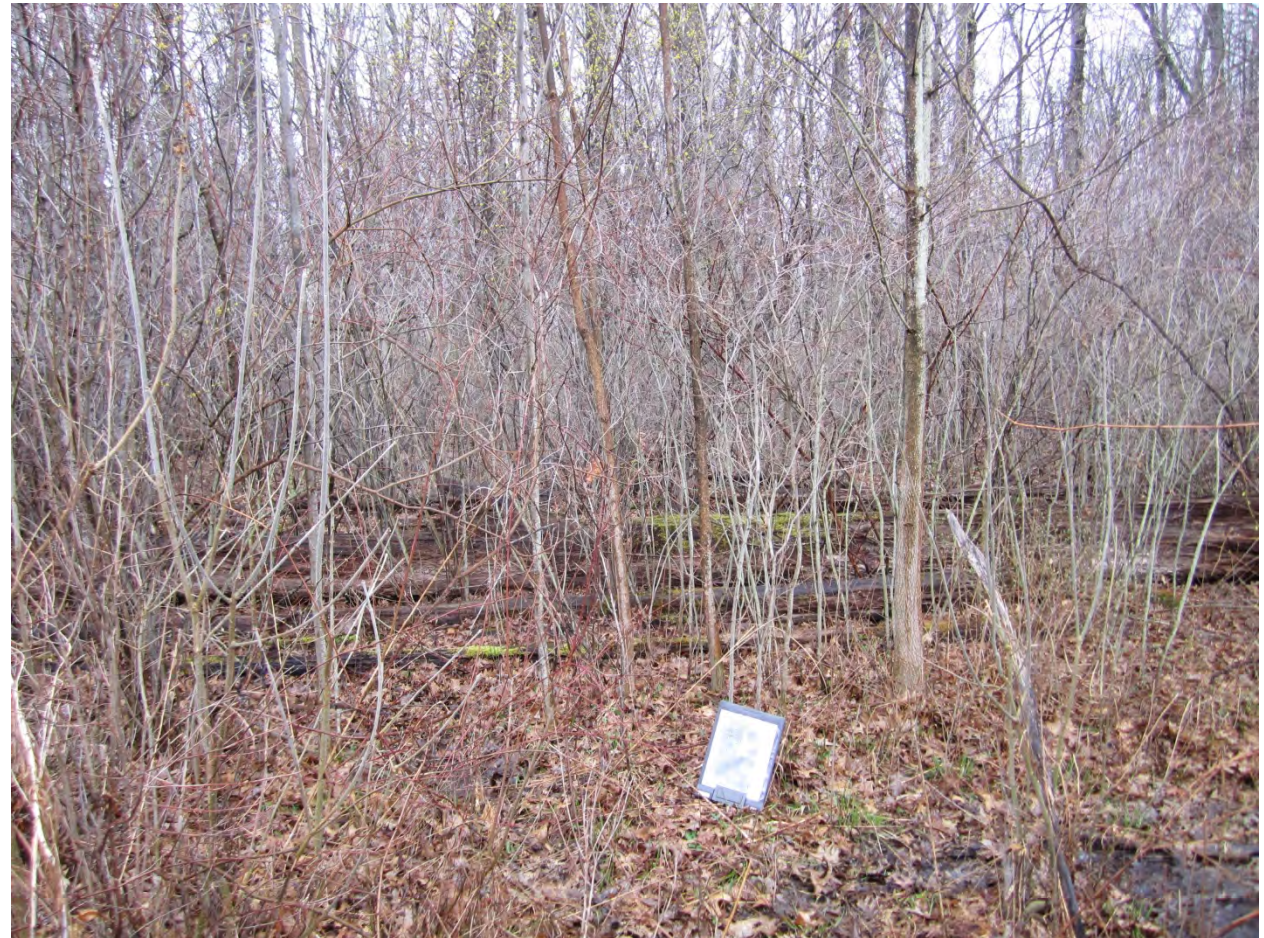
Parcel Group:	Tax Parcel ID:
Support Facility Administration Offices	88.00-1-41
Feature:	Property Owner:
1944-47 (Mound Material)	National Grid
Notes:	Date:
view west; nothing observed	23 April 2014

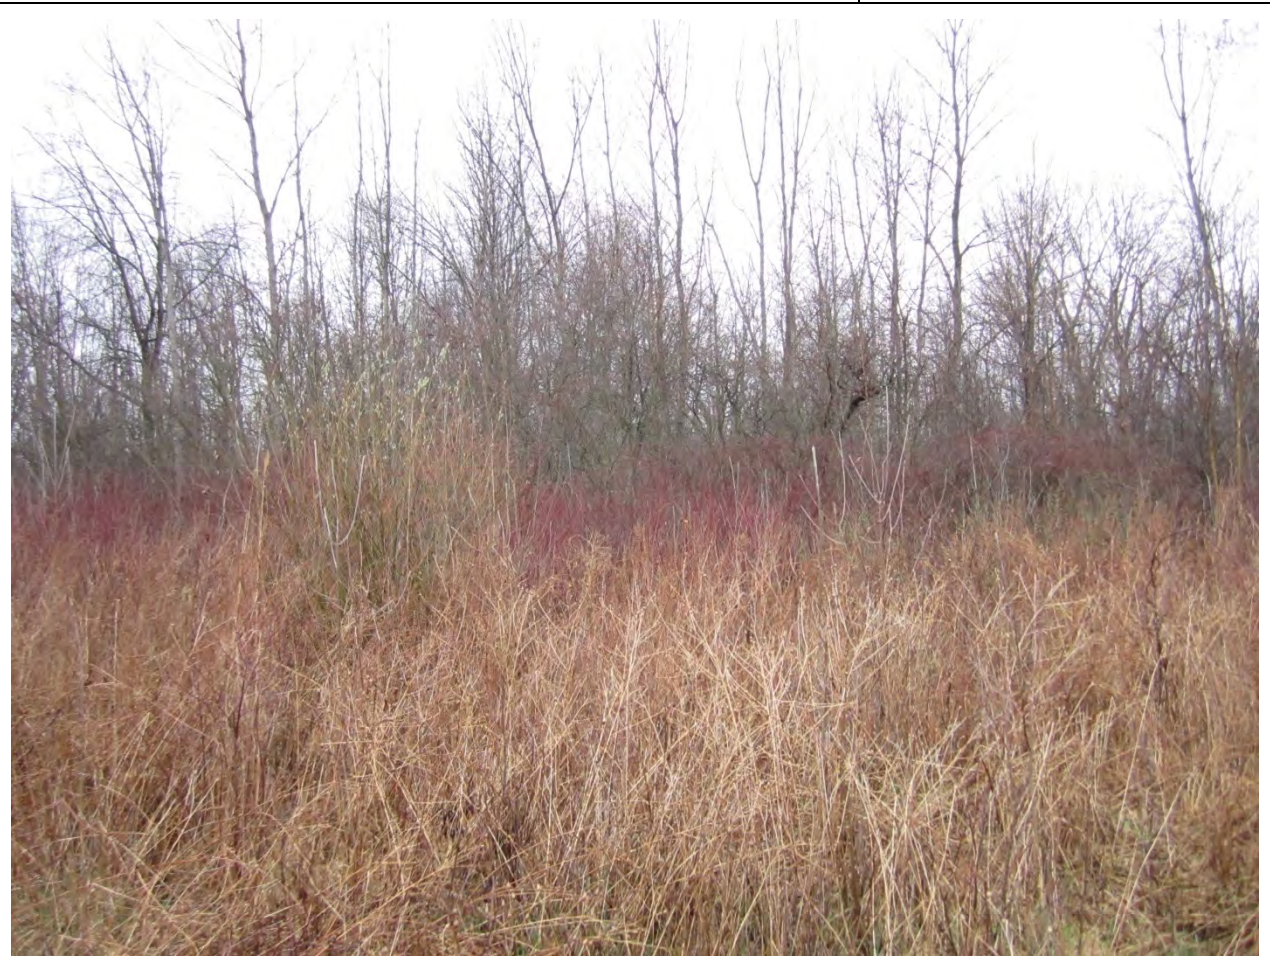
Parcel Group:	Tax Parcel ID:
Support Facility Administration Offices	88.00-1-41
Feature:	Property Owner:
1944-121 (Disturbed Ground) & 1944-153 (Disturbed Ground/Scar)	National Grid
Notes:	Date:
view west from N Grid ROW; nothing observed	23 April 2014

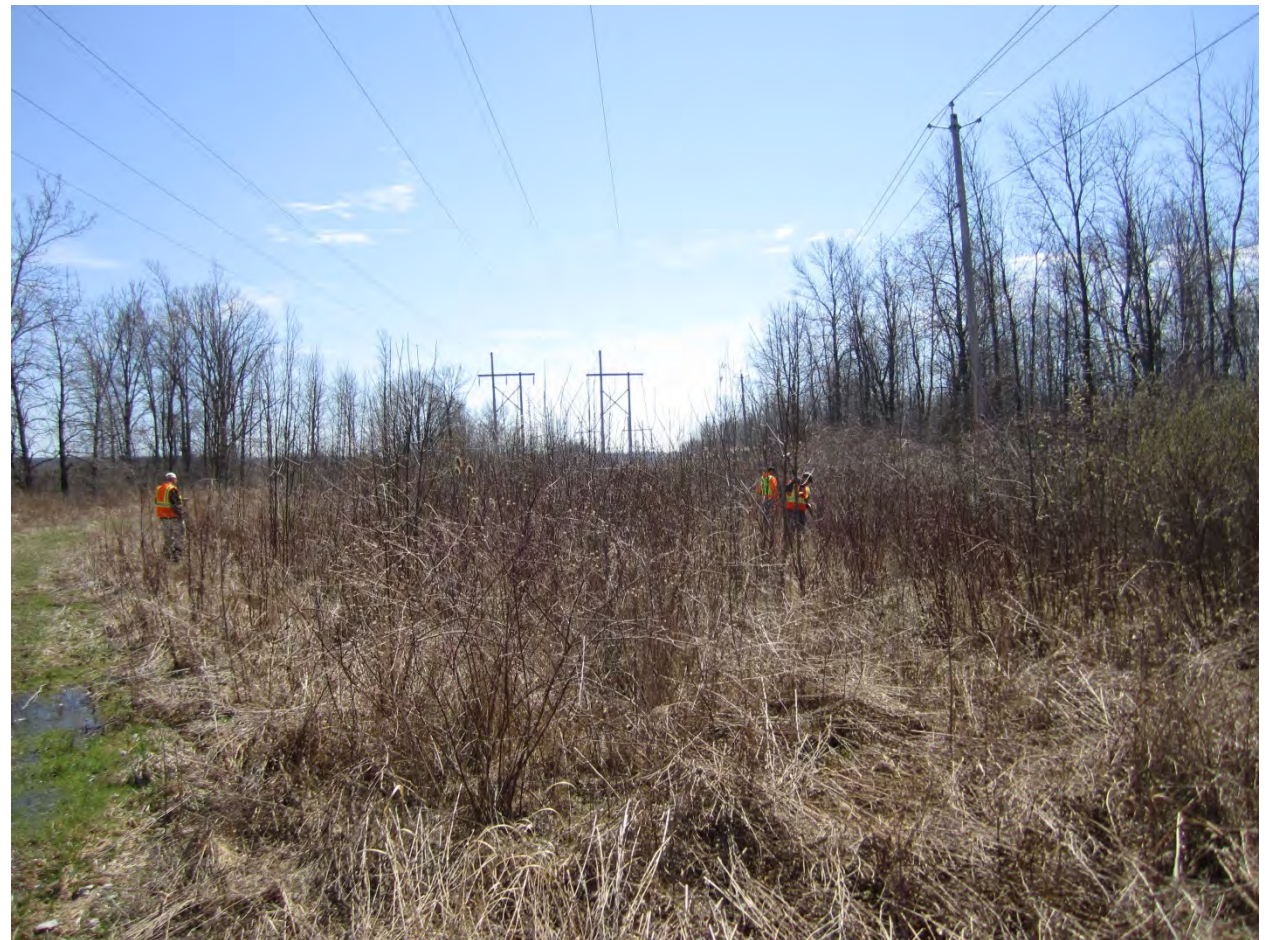
Parcel Group:	Tax Parcel ID:
Support Facility Administration Offices	88.00-1-41
Feature:	Property Owner:
1944-138 (Disturbed Ground/Scar)	National Grid
Notes:	Date:
view south; nothing observed	23 April 2014

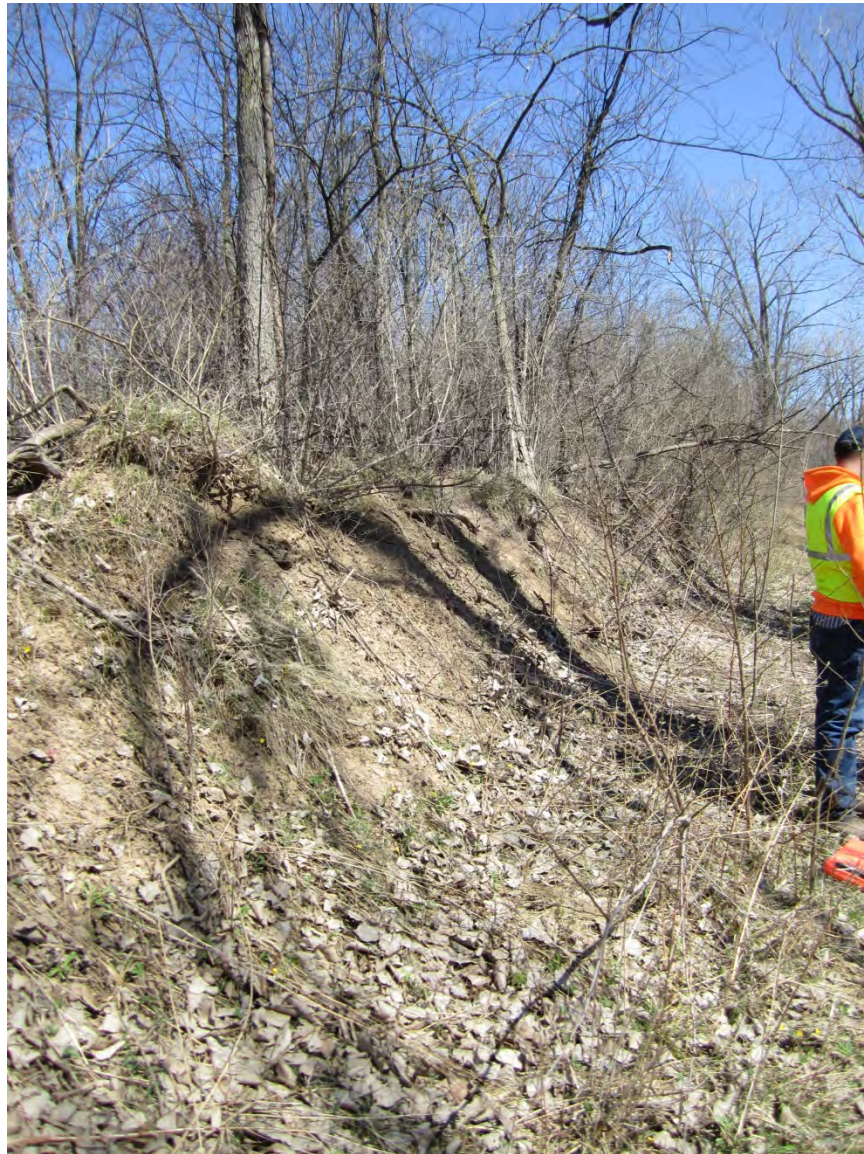
Parcel Group:	Tax Parcel ID:
Support Facility Slurry Pond	74.00-1-4
Feature:	Property Owner:
1944-45 (Berm)	Guardian Corporation
Notes:	Date:
view southeast of former sedimentation pond berm	24 April 2014

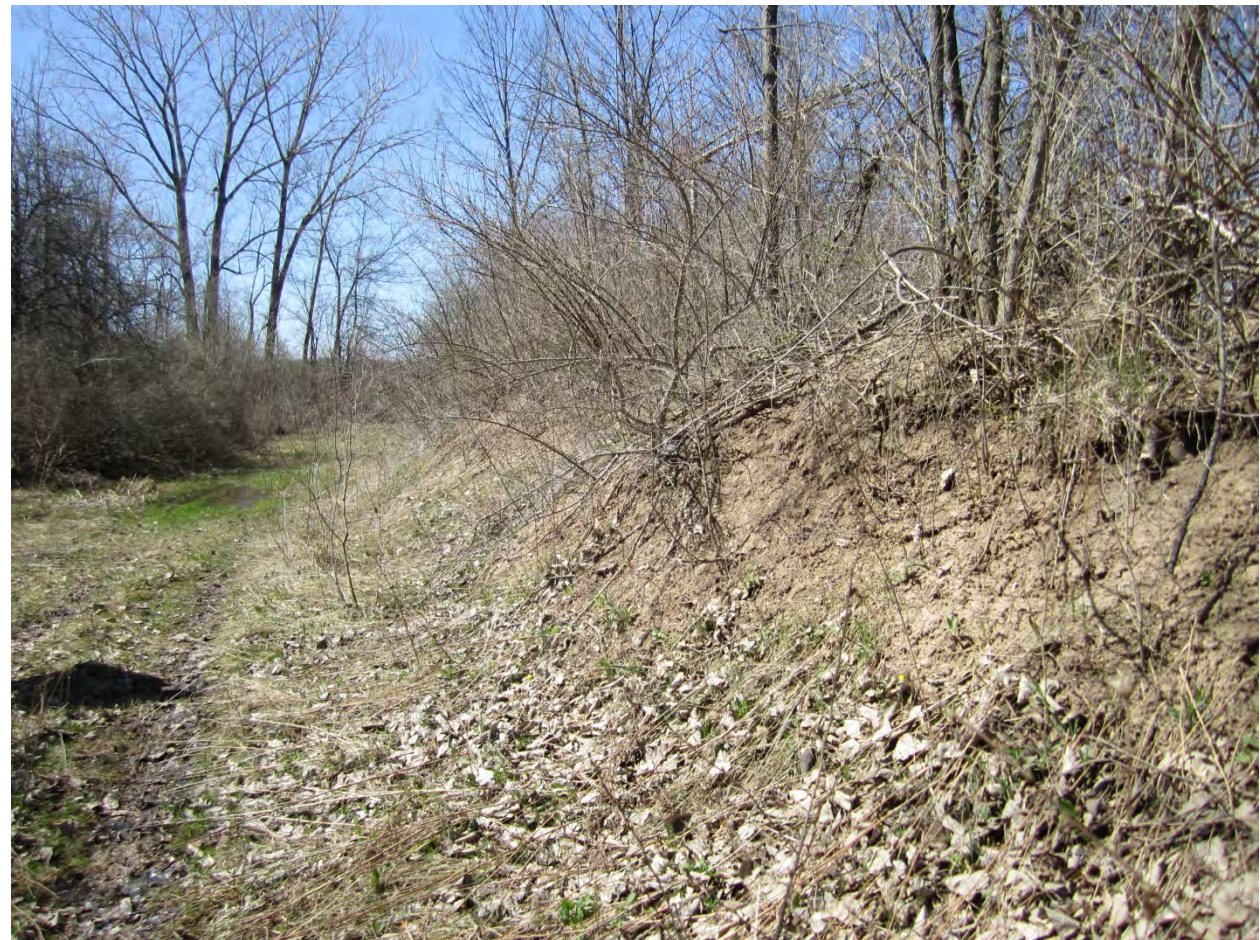
Parcel Group:	Tax Parcel ID:
Support Facility Slurry Pond	74.00-1-4
Feature:	Property Owner:
1944-45 (Berm)	Guardian Corporation
Notes:	Date:
view west of former sedimentation pond berm	24 April 2014

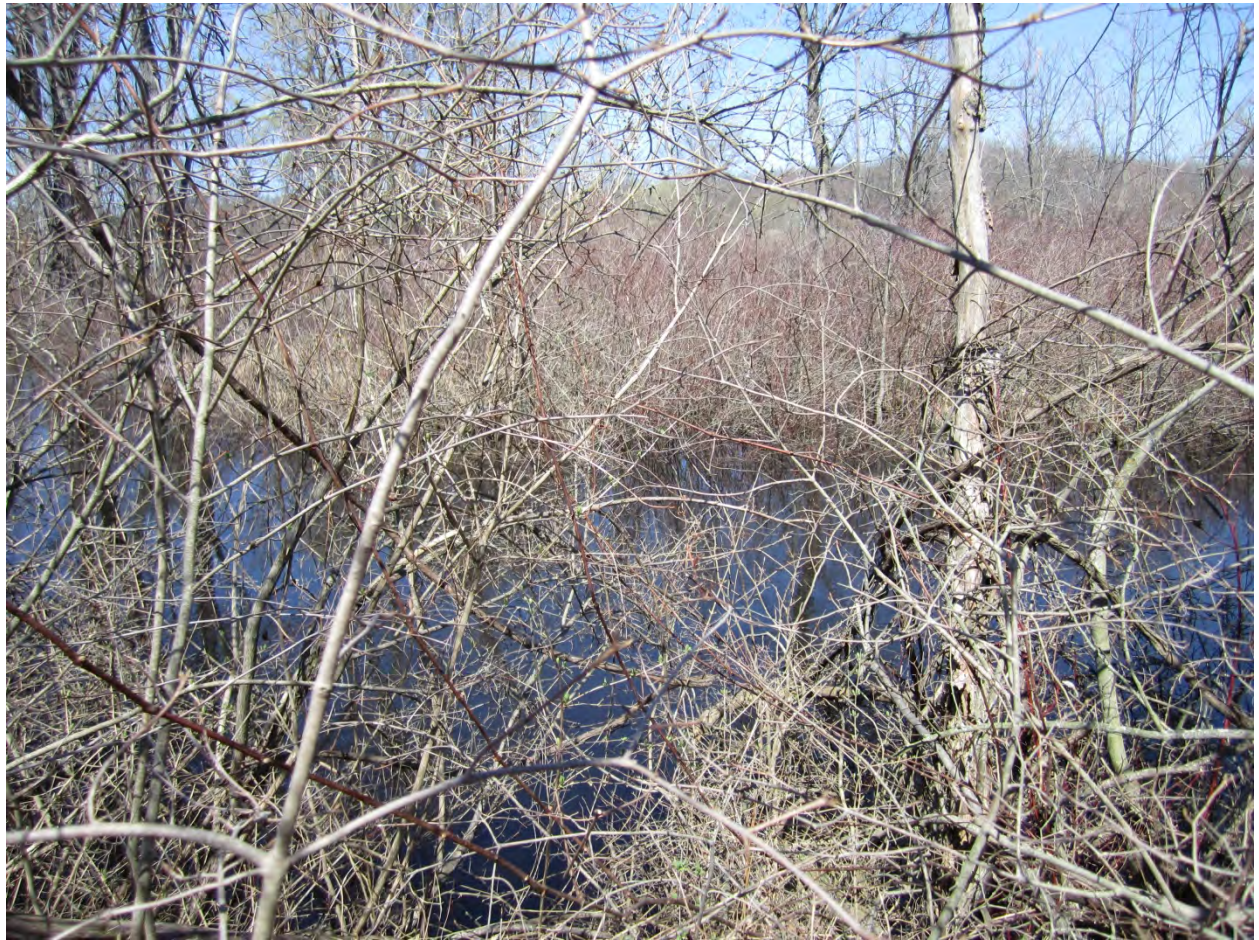
Parcel Group:	Tax Parcel ID:
Support Facility Slurry Pond	74.00-1-4
Feature:	Property Owner:
1944-46 (Trench)	Guardian Corporation
Notes:	Date:
view north from former sedimentation pond berm	24 April 2014

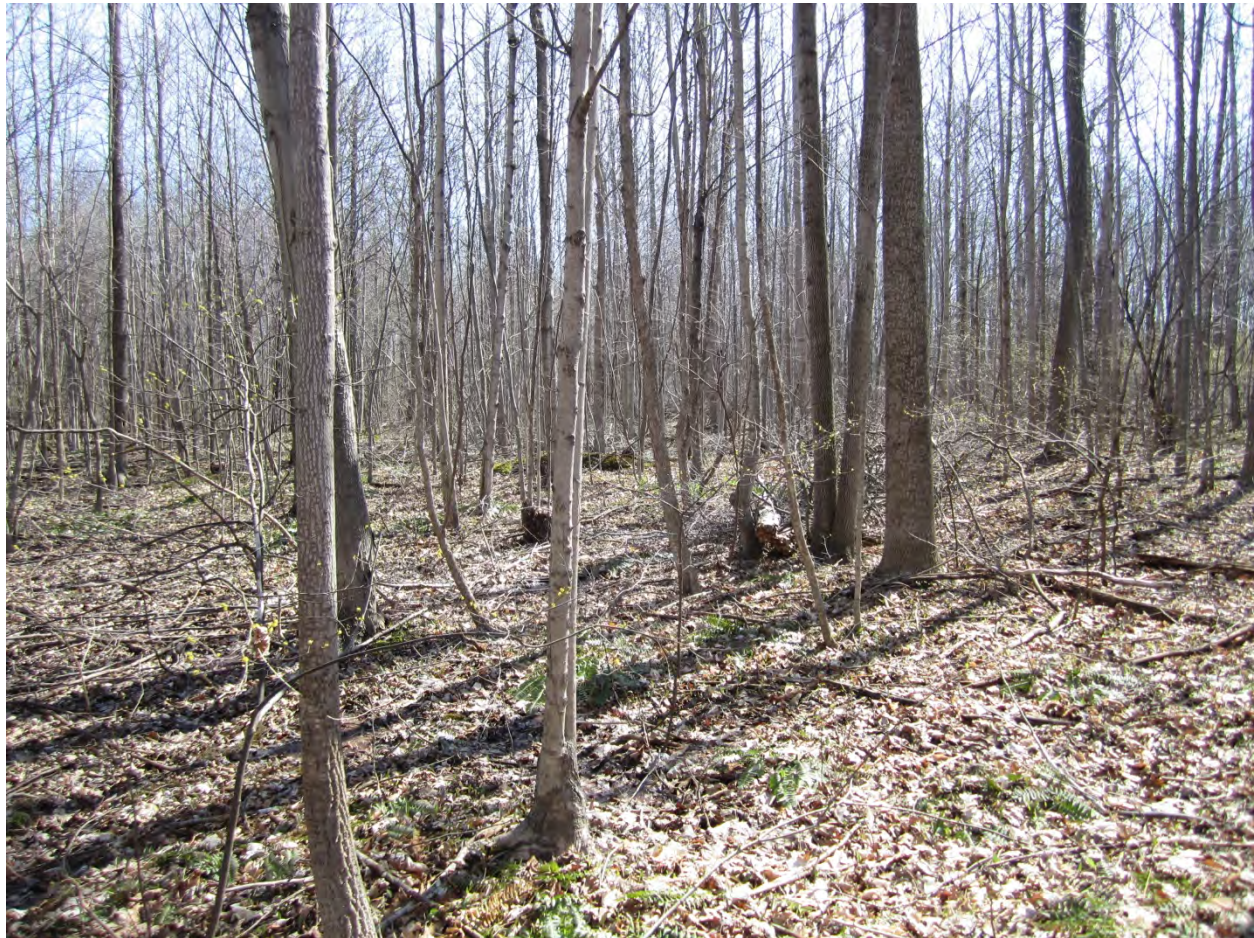
Parcel Group:	Tax Parcel ID:
Support Facility Slurry Pond	74.00-1-4
Feature:	Property Owner:
1944-163 (Other)	Guardian Corporation
Notes:	Date:
view south; nothing observed	24 April 2014

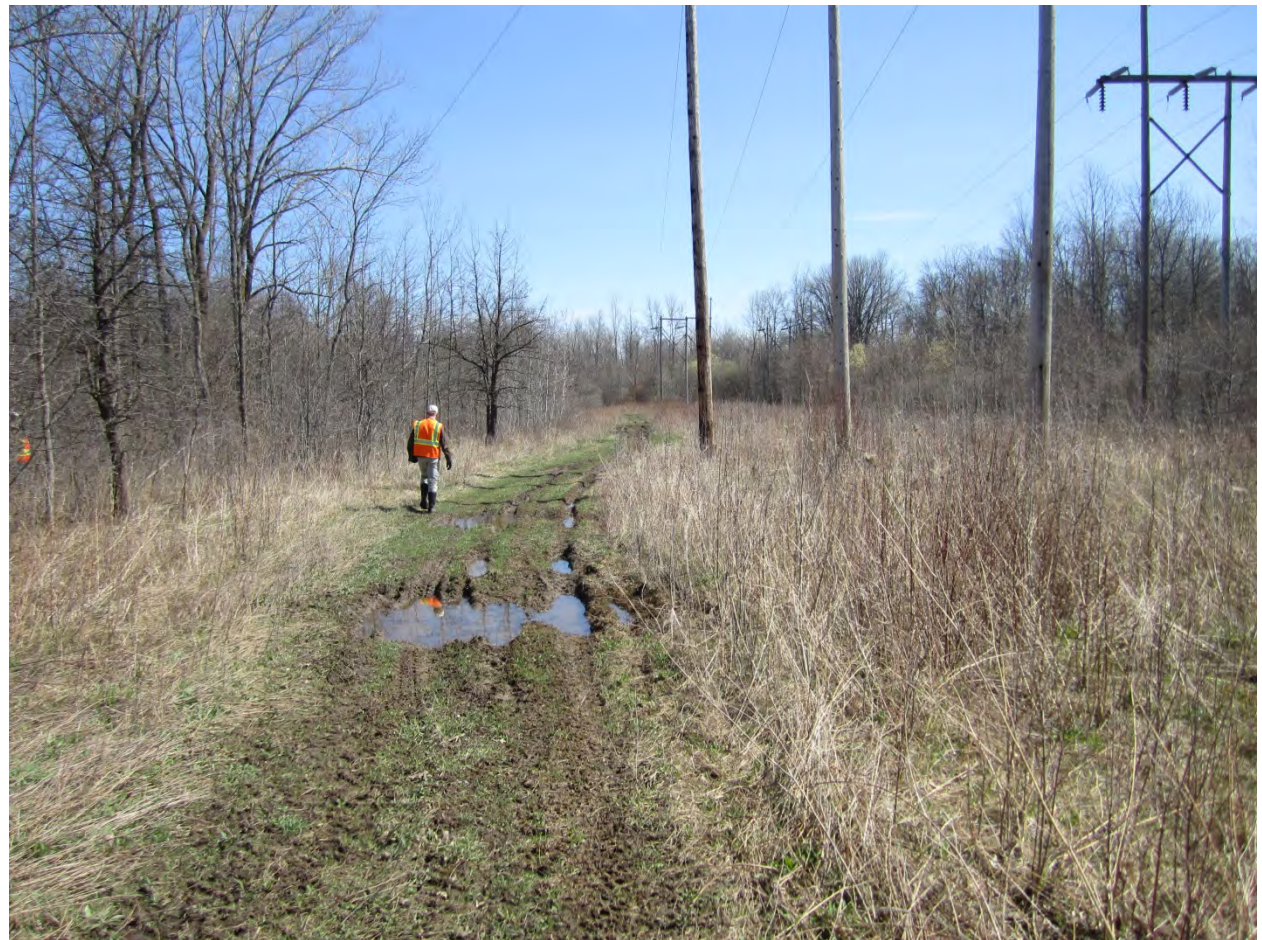
Parcel Group:	Tax Parcel ID:
Group R	60.00-3-6
Feature:	Property Owner:
1944-173 (Disturbed Ground)	National Grid
Notes:	Date:
view north; nothing observed	24 April 2014

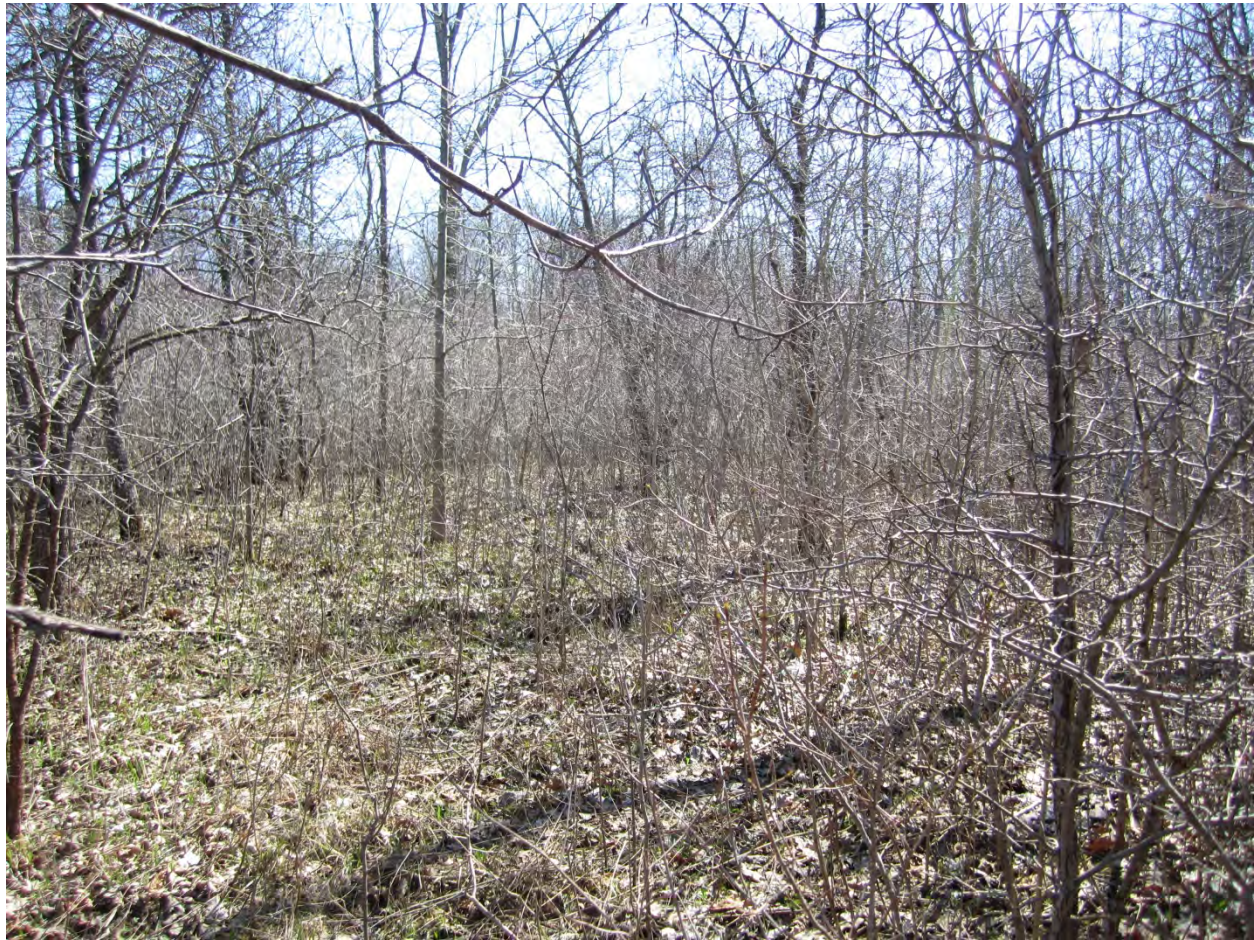
Parcel Group:	Tax Parcel ID:
Group R	60.00-3-6
Feature:	Property Owner:
1944-173 (Disturbed Ground)	National Grid
Notes:	Date:
view of feature northwest corner; nothing observed	24 April 2014

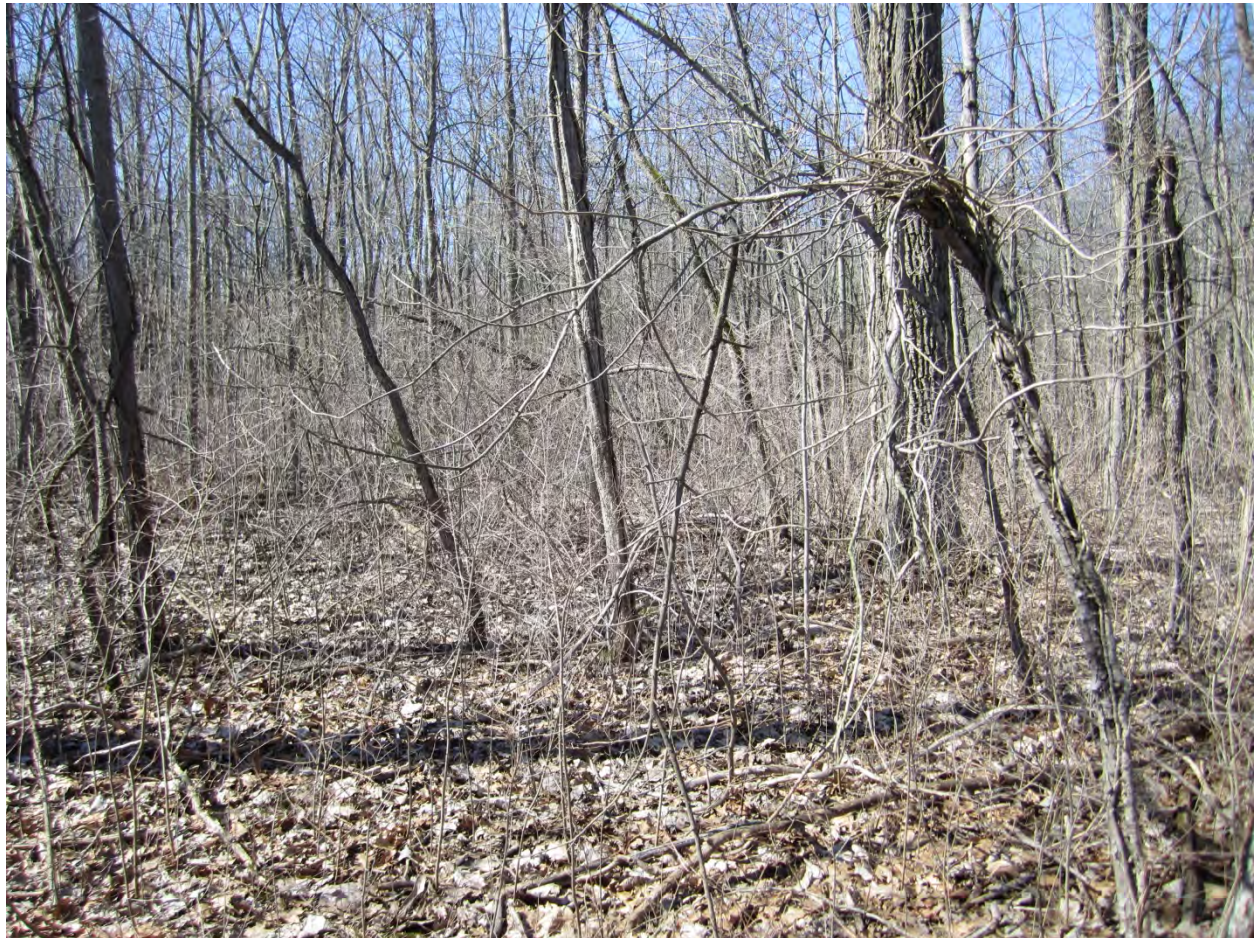
Parcel Group:	Tax Parcel ID:
Group R	60.00-3-6
Feature:	Property Owner:
1944-174 (Pond)	National Grid
Notes:	Date:
view east; nothing observed	24 April 2014

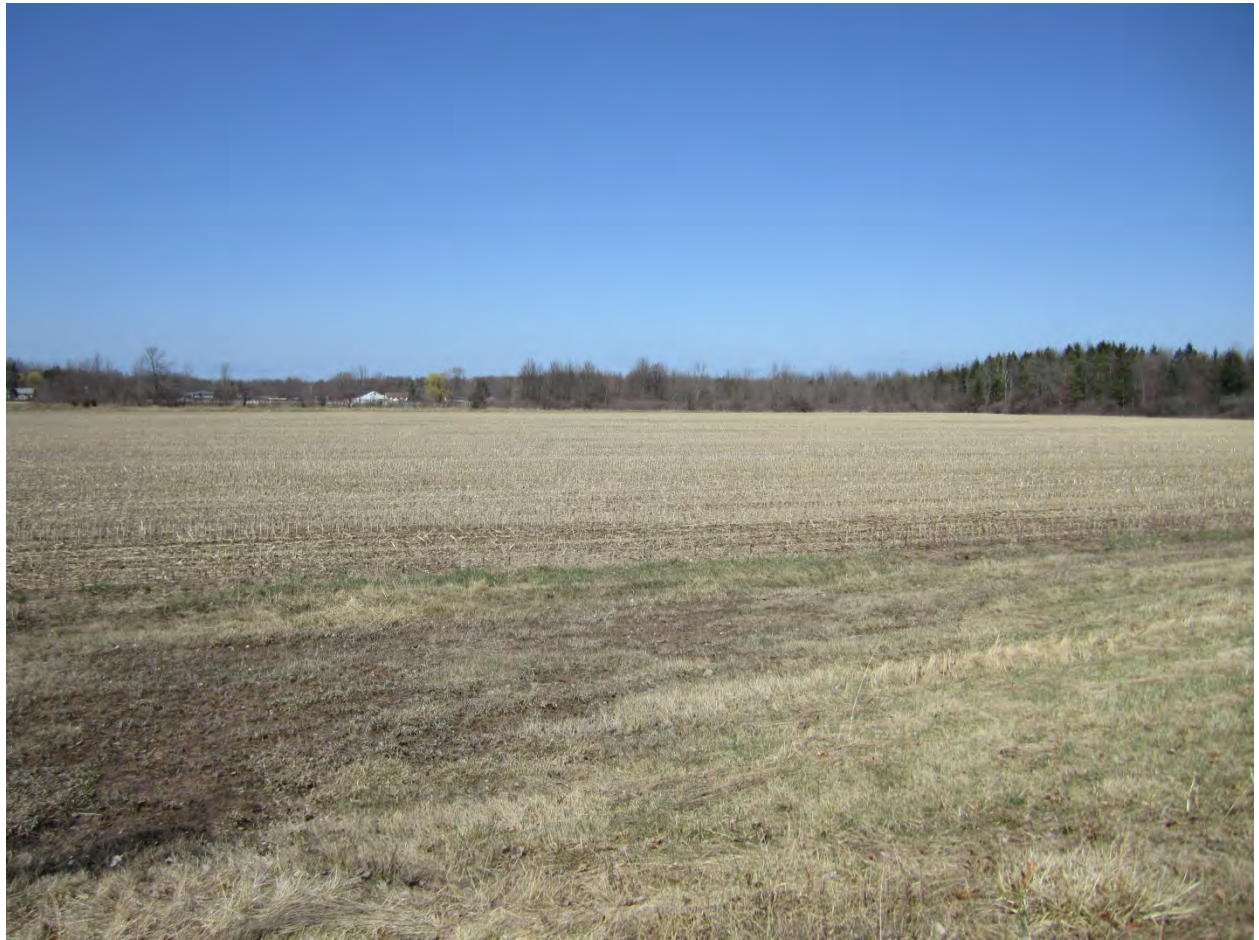
Parcel Group:	Tax Parcel ID:
Group N	60.00-2-9
Feature:	Property Owner:
1944-192 (Other)	Property
Notes:	Date:
view north; nothing observed	23 April 2014

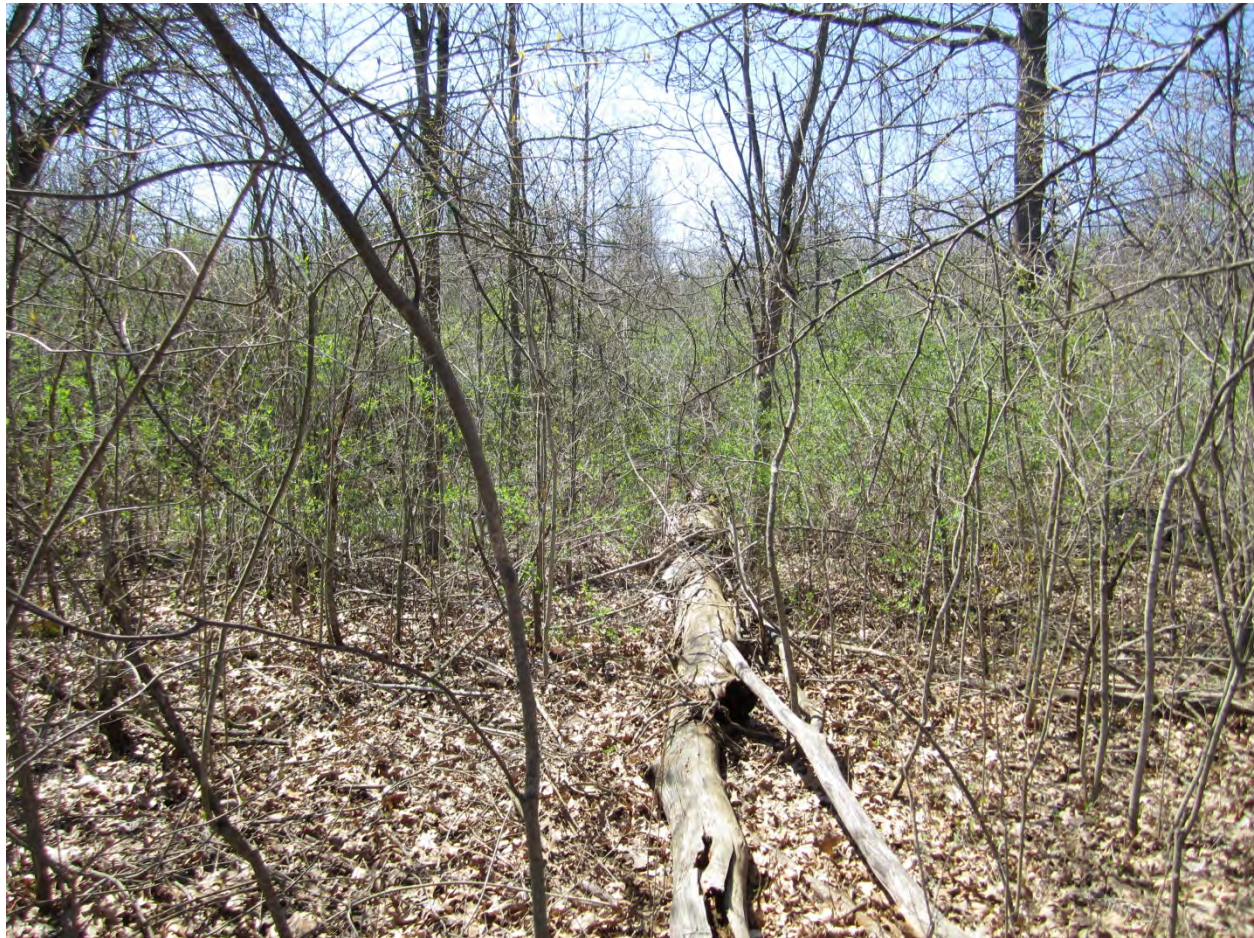
Parcel Group:	Tax Parcel ID:
Group K	74.00-1-15.1
Feature:	Property Owner:
1944-147 (Other)	Modern Landfill Inc.
Notes:	Date:
view west from NE corner of mapped feature; nothing observed	6 May 2014

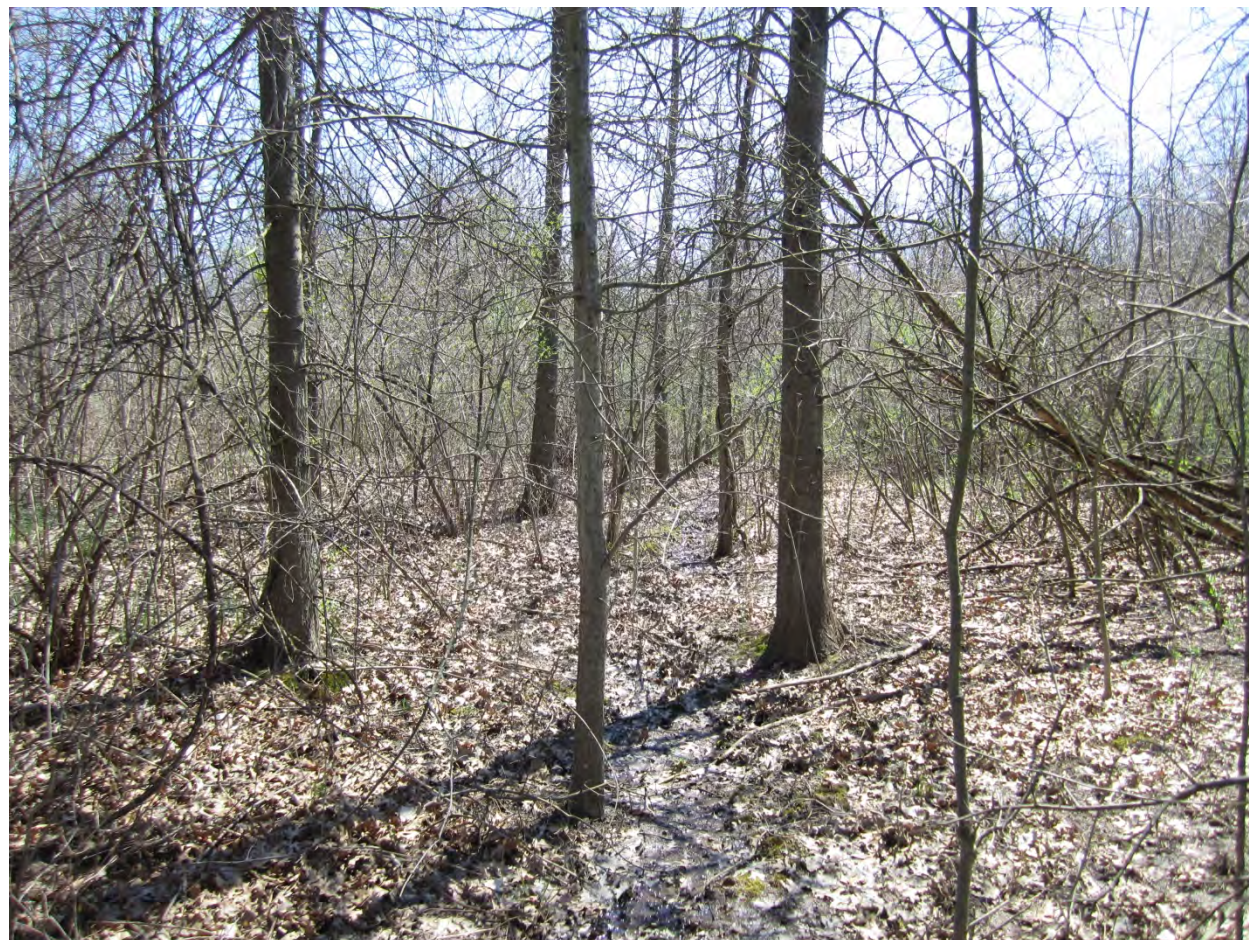
Parcel Group:	Tax Parcel ID:
Group K	74.00-1-15.1
Feature:	Property Owner:
1944-147 (Other)	Modern Landfill Inc.
Notes:	Date:
view south from NE corner of mapped feature; nothing observed	6 May 2014

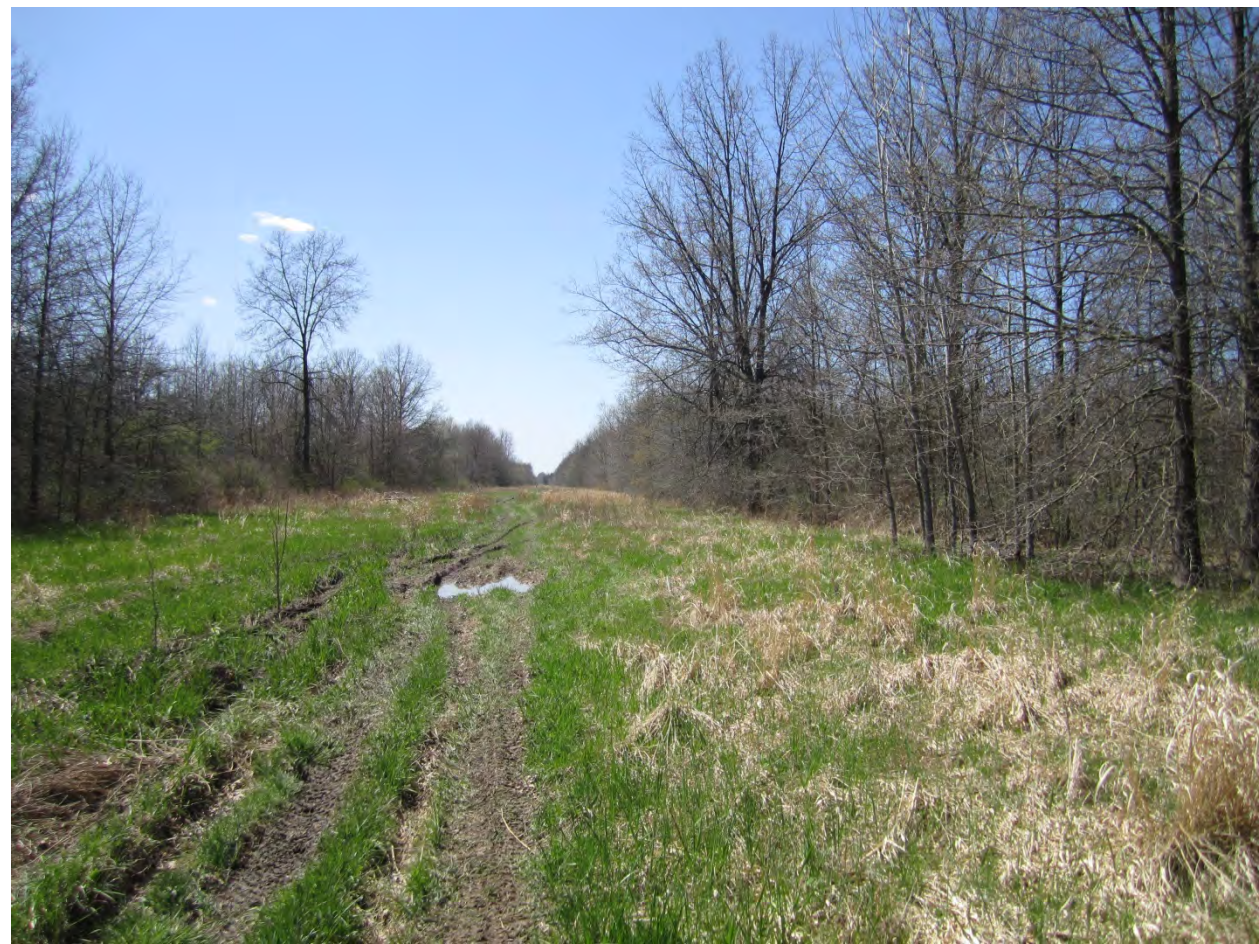
Parcel Group:	Tax Parcel ID:
Group K	74.00-1-15.1
Feature:	Property Owner:
1944-147 (Other)	Modern Landfill Inc.
Notes:	Date:
view west from southern end of mapped feature (on gas pipeline ROW); nothing observed	6 May 2014

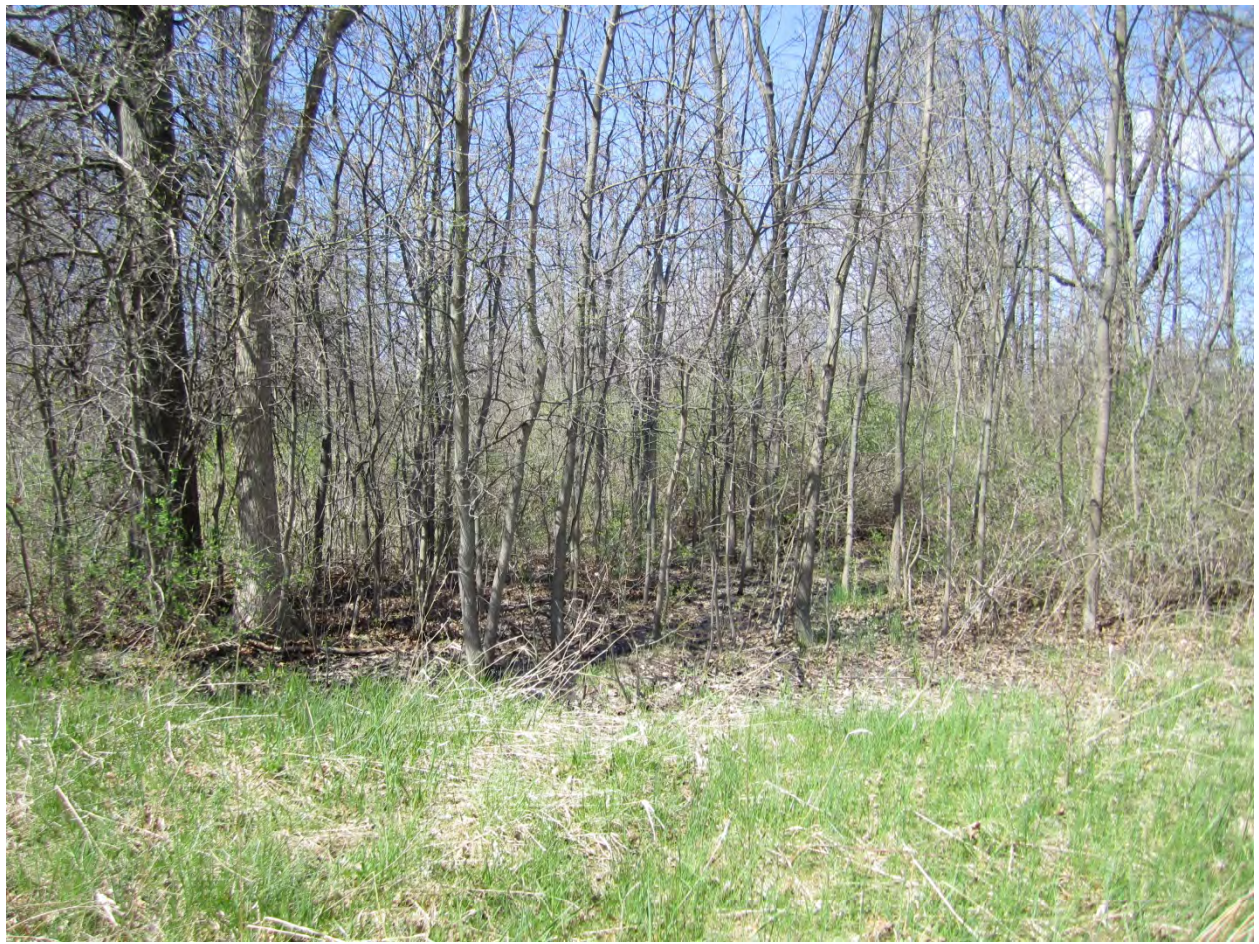
Parcel Group:	Tax Parcel ID:
Group K	74.00-1-15.1
Feature:	Property Owner:
1944-147 (Other)	Modern Landfill Inc.
Notes:	Date:
view north from southern end of mapped feature (on gas pipeline ROW); nothing observed	6 May 2014

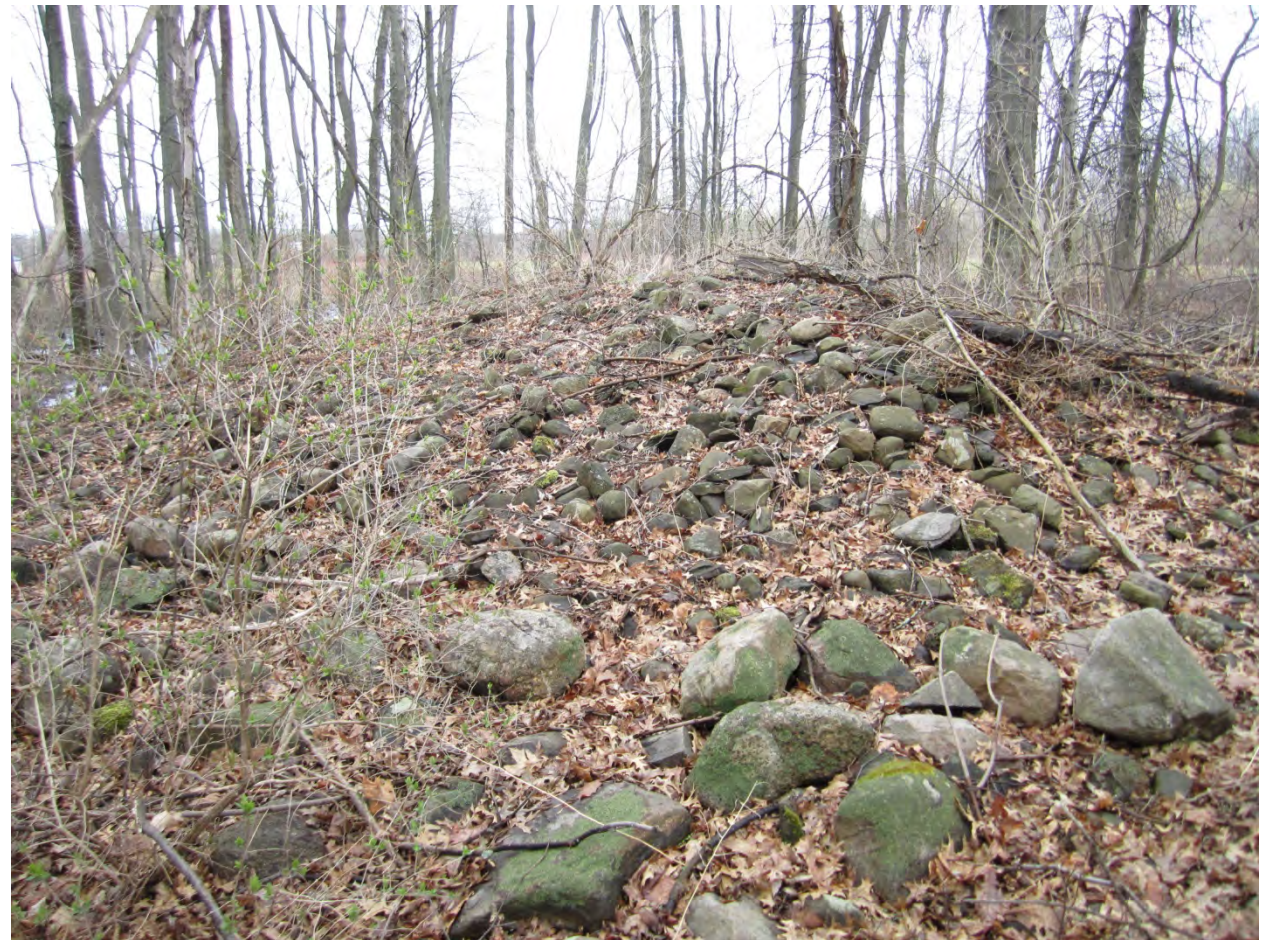
Parcel Group:	Tax Parcel ID:
TEC Group B	88.00-1-46.1
Feature:	Property Owner:
1944-161 (Disturbed Ground/Scar)	Three F Club
Notes:	Date:
small mound of rocks	23 April 2014

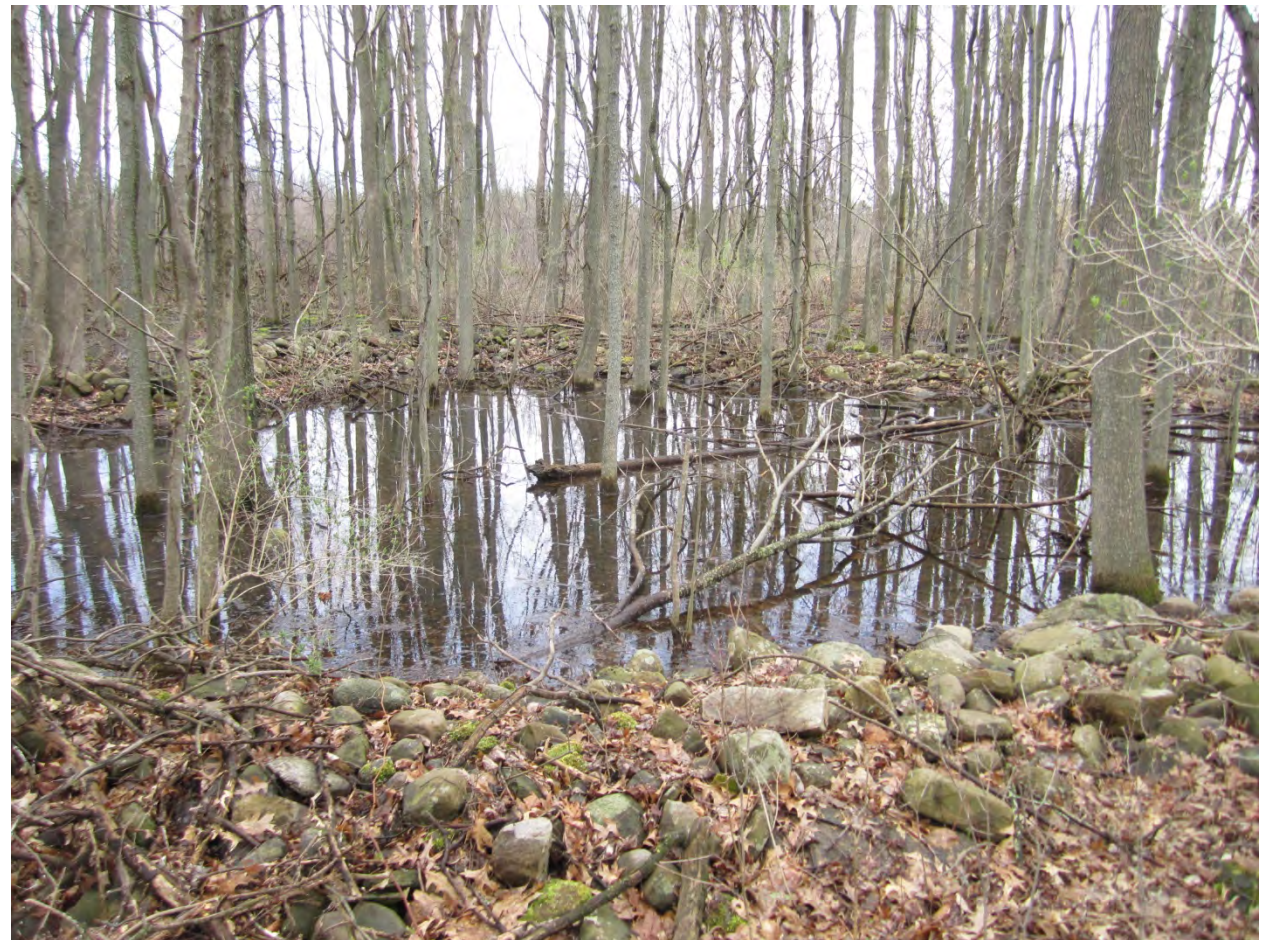
Parcel Group:	Tax Parcel ID:
TEC Group B	88.00-1-46.1
Feature:	Property Owner:
1944-161 (Disturbed Ground/Scar)	Three F Club
Notes:	Date:
view west; ponded area	23 April 2014

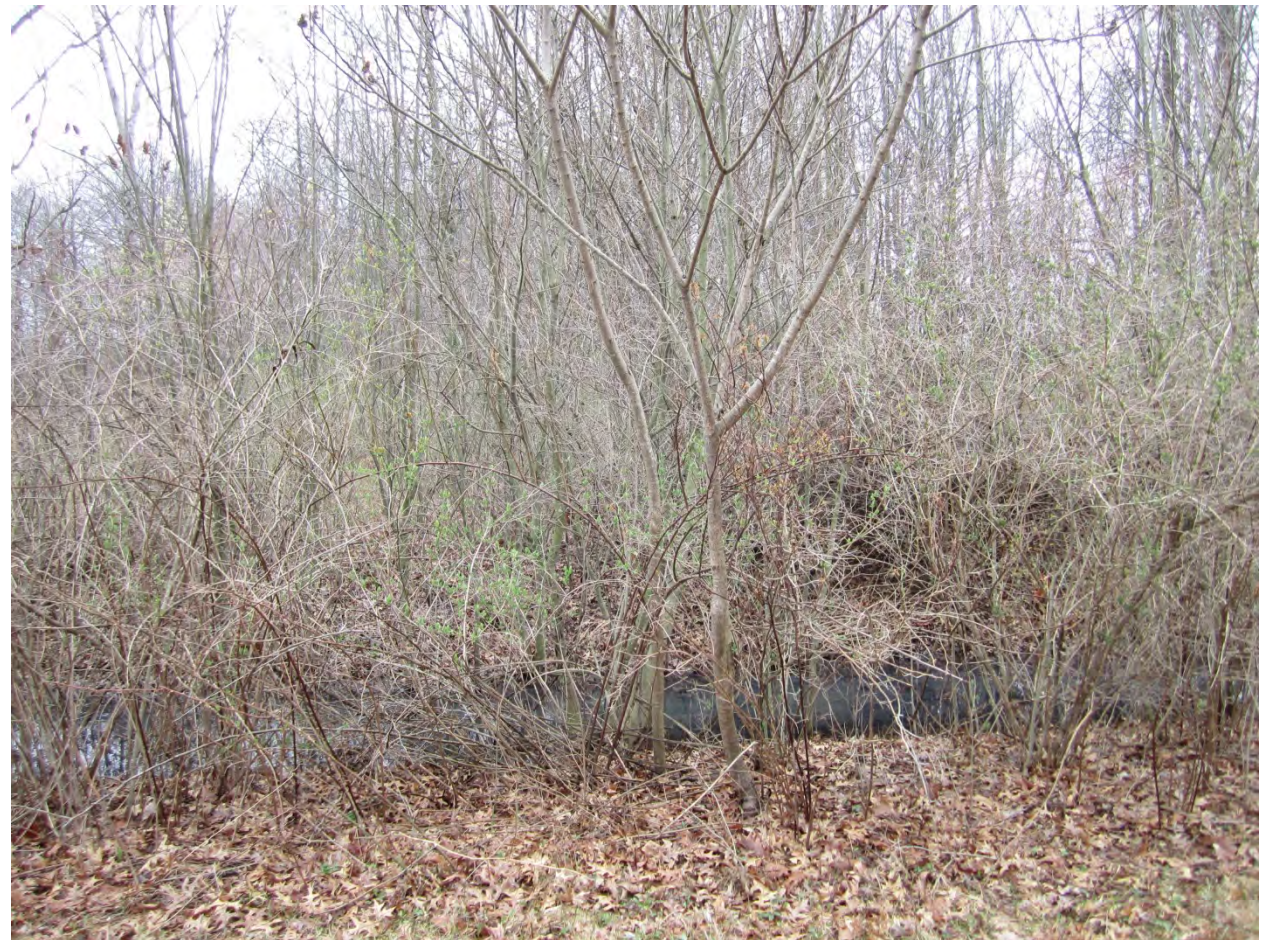
Parcel Group:	Tax Parcel ID:
TEC Group B	88.00-1-46.1
Feature:	Property Owner:
1944-161 (Disturbed Ground/Scar)	Three F Club
Notes:	Date:
view east, drainage channel	23 April 2014
