FINAL SITE INSPECTION REPORT

Ground Disturbances at the Former Lake Ontario Ordnance Works Niagara County, New York

November 2014

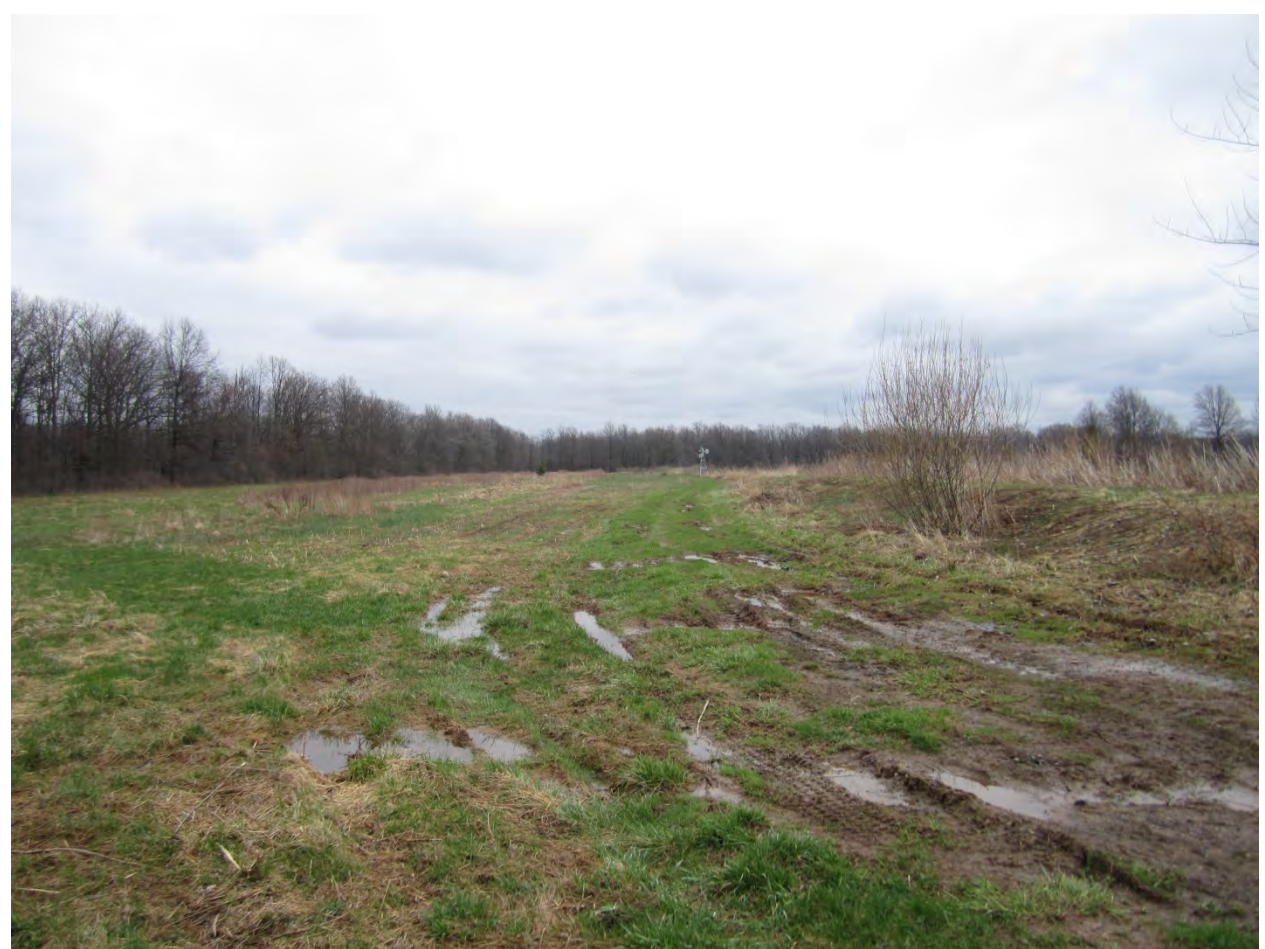
Parcel Group:	Tax Parcel ID:
TEC Group B	88.00-1-46.1
Feature:	Property Owner:
1944-162 (Tracks/Trail)	Three F Club
Notes:	Date:
view east; tracks are recent features on Three F Property	23 April 2014

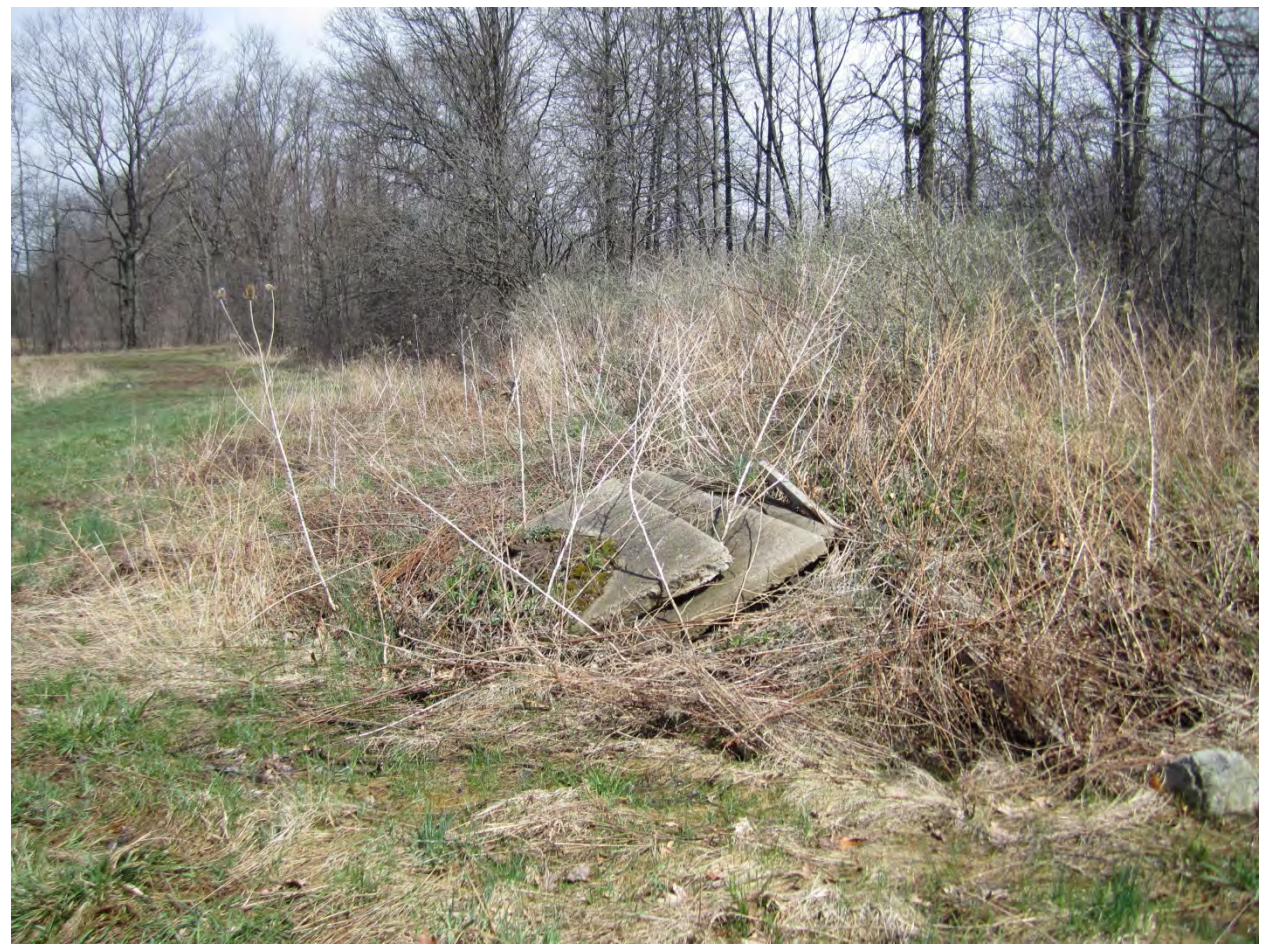
Parcel Group:	Tax Parcel ID:
TEC Group B	88.00-1-46.1
Feature:	Property Owner:
1944-162 (Tracks/Trail)	Three F Club
Notes:	Date:
view northeast (Three F Property) C&D debris from recent property improvement	23 April 2014

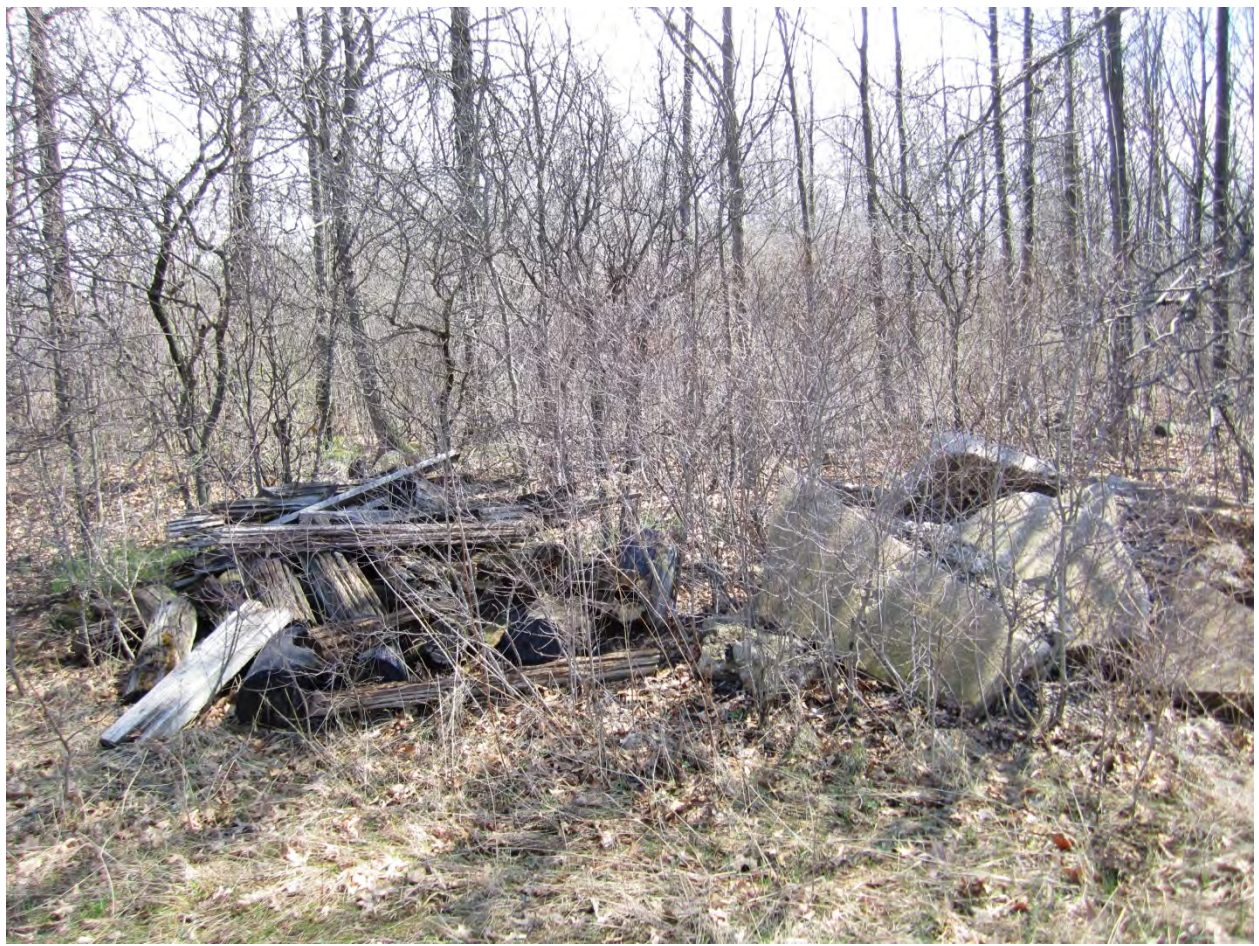
Parcel Group:	Tax Parcel ID:
TEC Group B	88.00-1-46.1
Feature:	Property Owner:
1944-162 (Tracks/Trail)	Three F Club
Notes:	Date:
view northeast (Three F Property) C&D debris from recent property improvement	23 April 2014

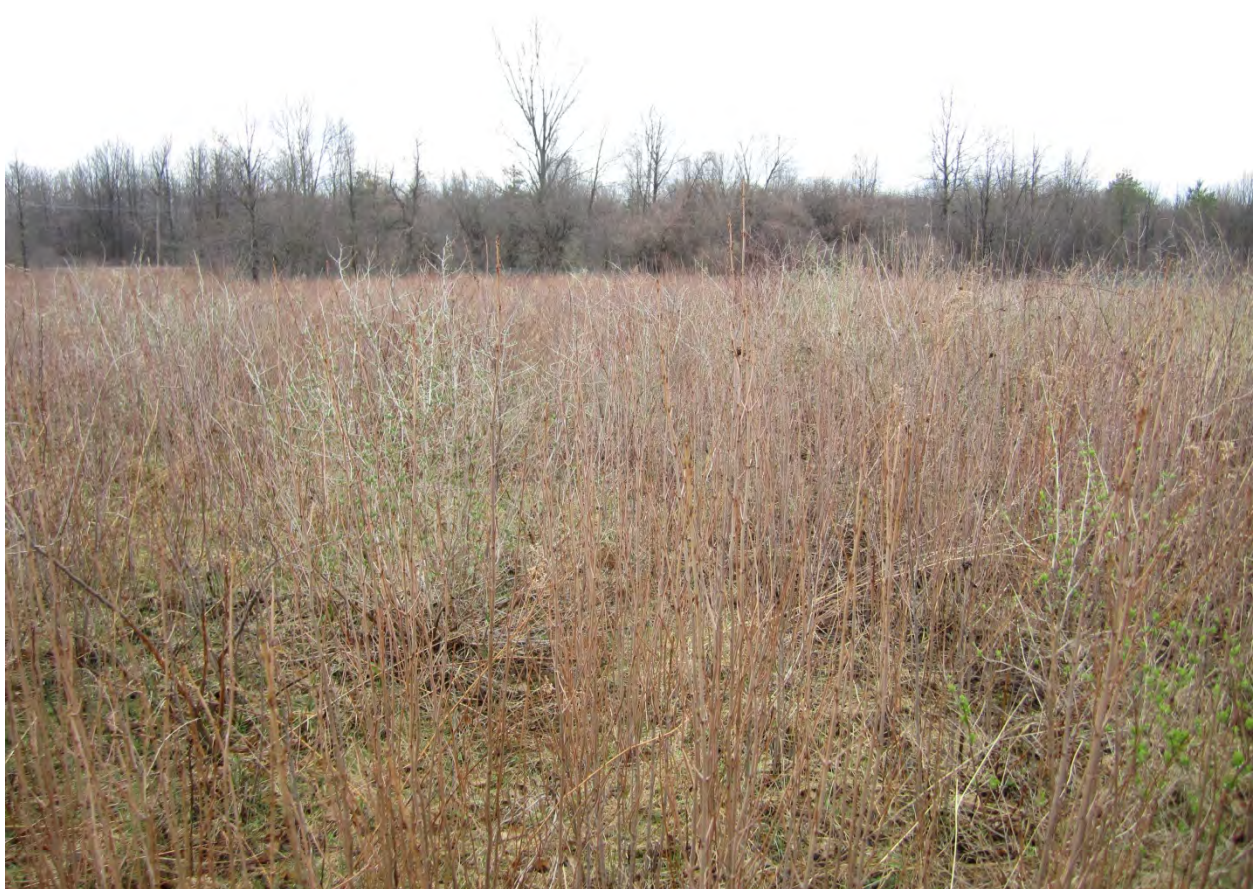
Parcel Group:	Tax Parcel ID:
TEC Group B	88.00-1-46.1
Feature:	Property Owner:
1944-177 (Material/Mounded Material)	Three F Club
Notes:	Date:
view north (on Three F Property); nothing observed	23 April 2014

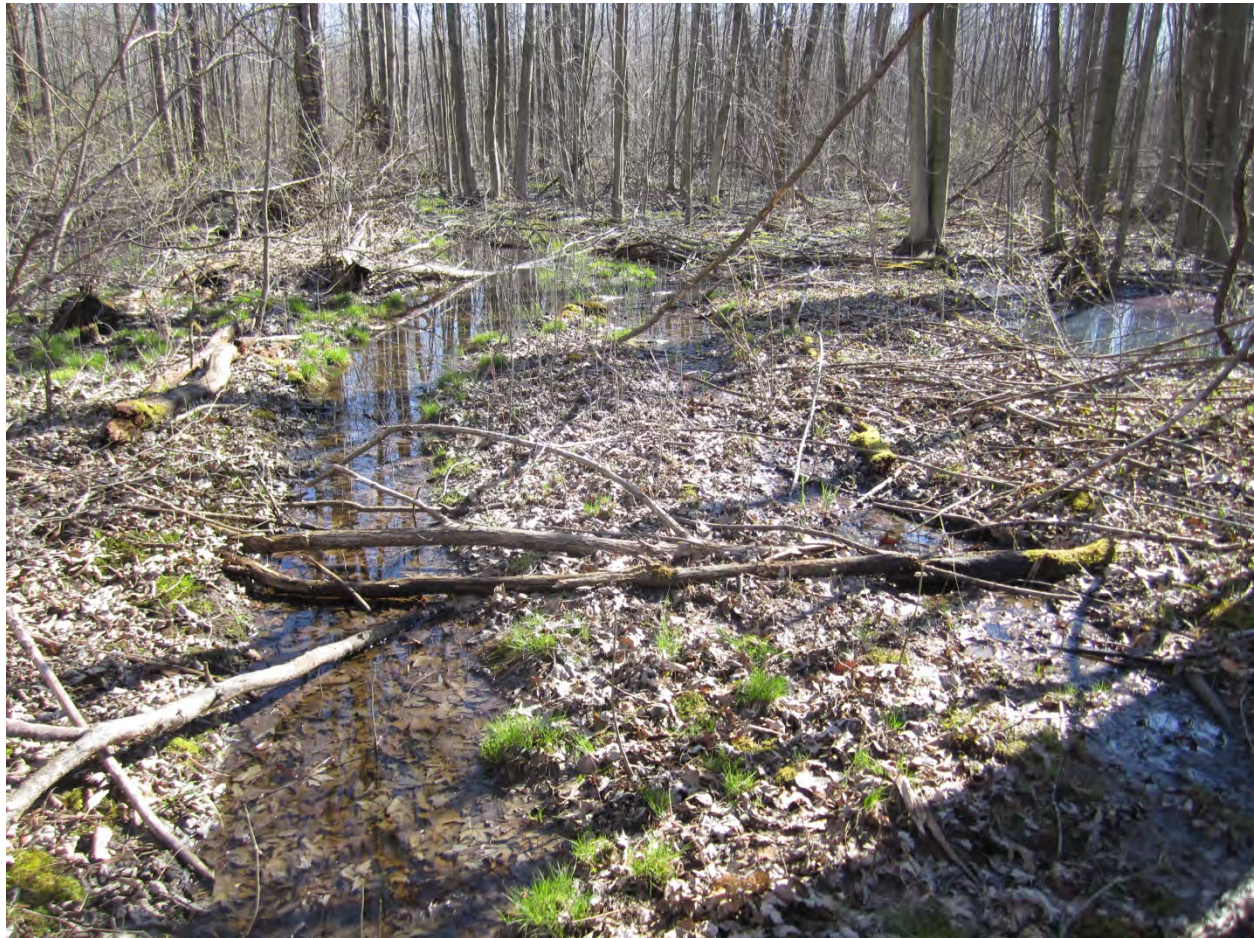
Parcel Group:	Tax Parcel ID:
TEC Group C	74.00-1-3
Feature:	Property Owner:
1944-170 (Other)	
Notes:	Date:
view east; vehicle track scars on property	24 April 2014

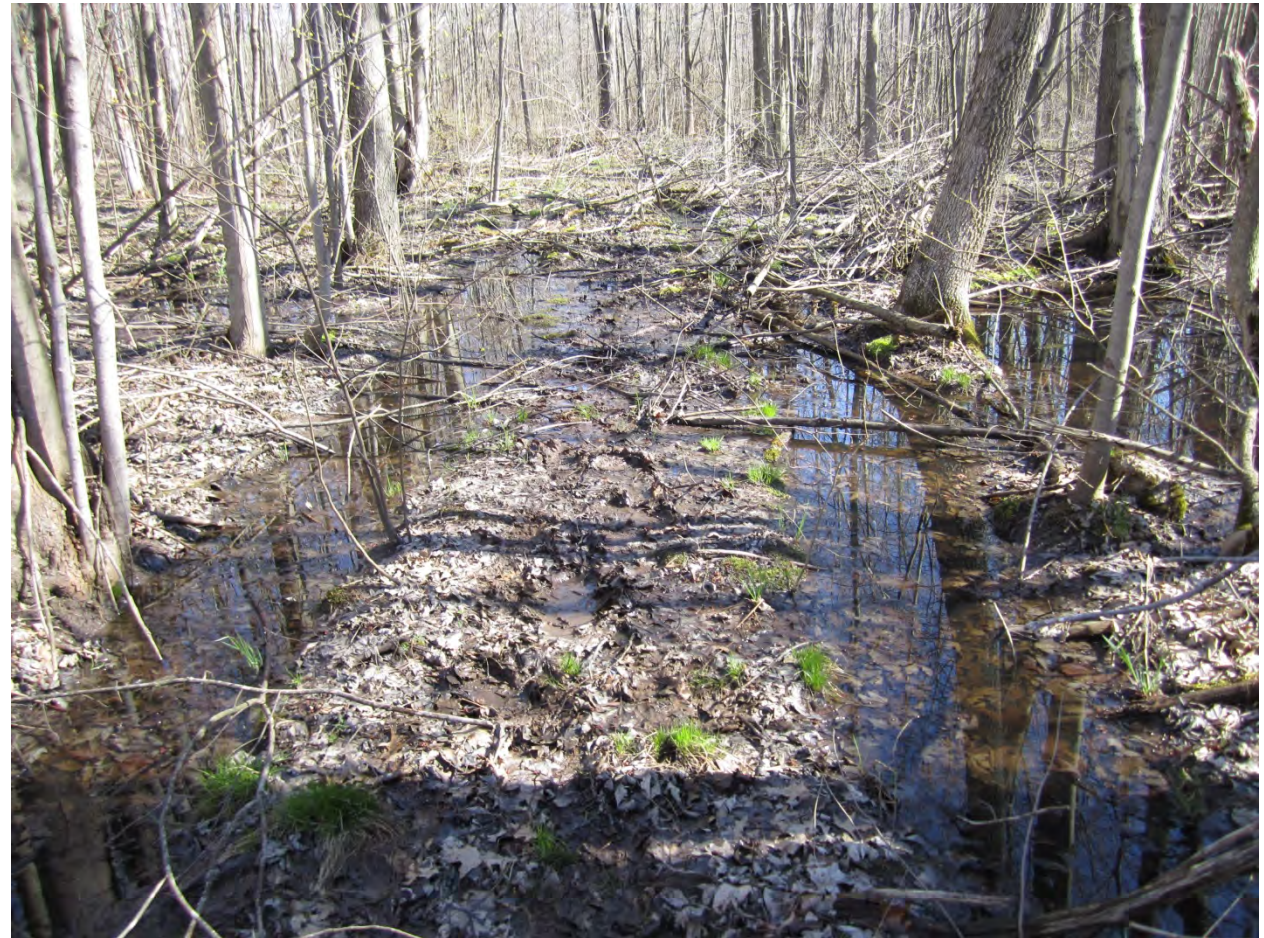
Parcel Group:	Tax Parcel ID:
TEC Group C	74.00-1-3
Feature:	Property Owner:
1944-170 (Other)	
Notes:	Date:
view northeast; vehicle track scars on property	24 April 2014

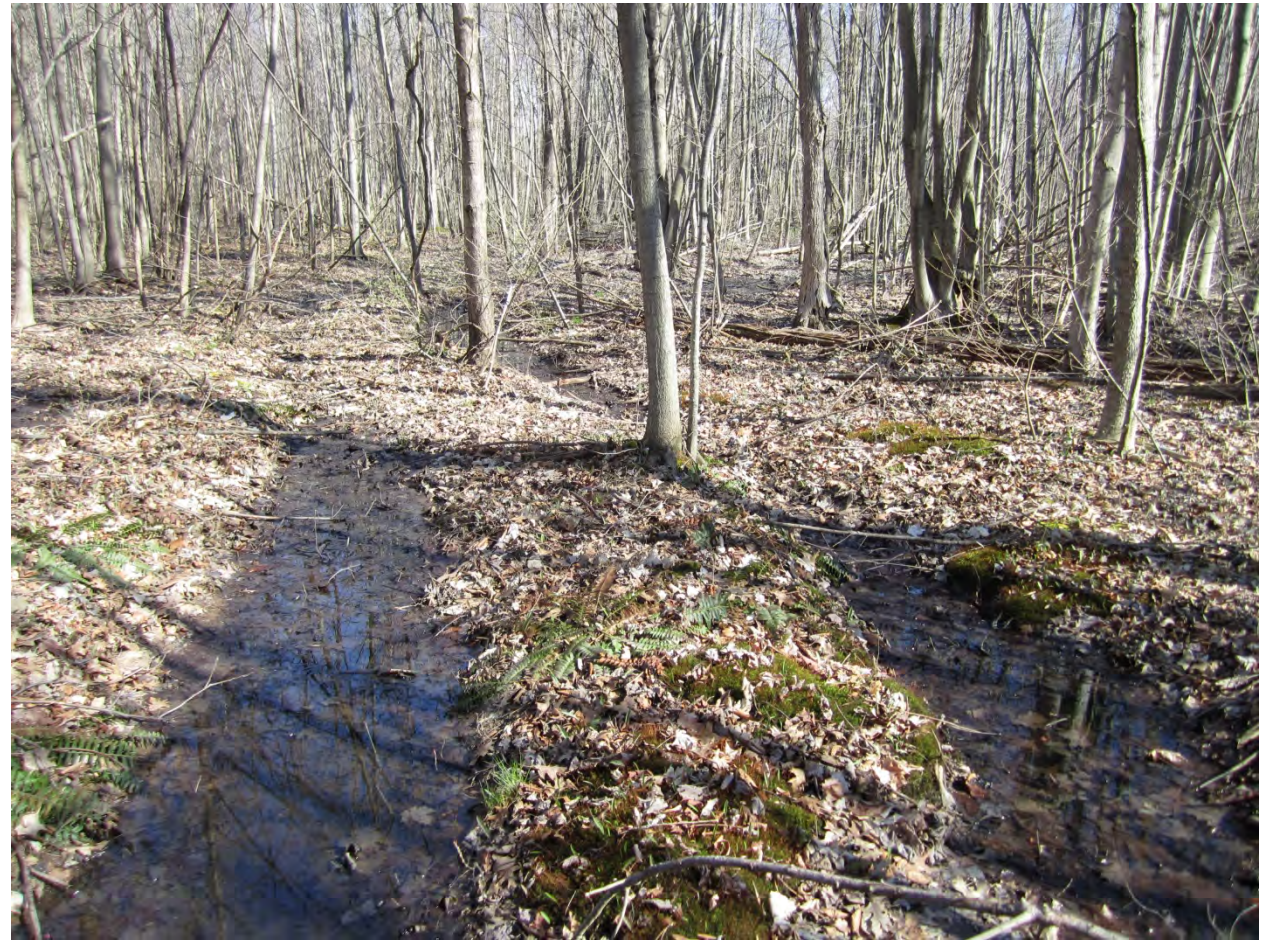
Parcel Group:	Tax Parcel ID:
TEC Group C	74.00-1-3
Feature:	Property Owner:
1944-170 (Other)	
Notes:	Date:
view north; vehicle track scars on property	24 April 2014

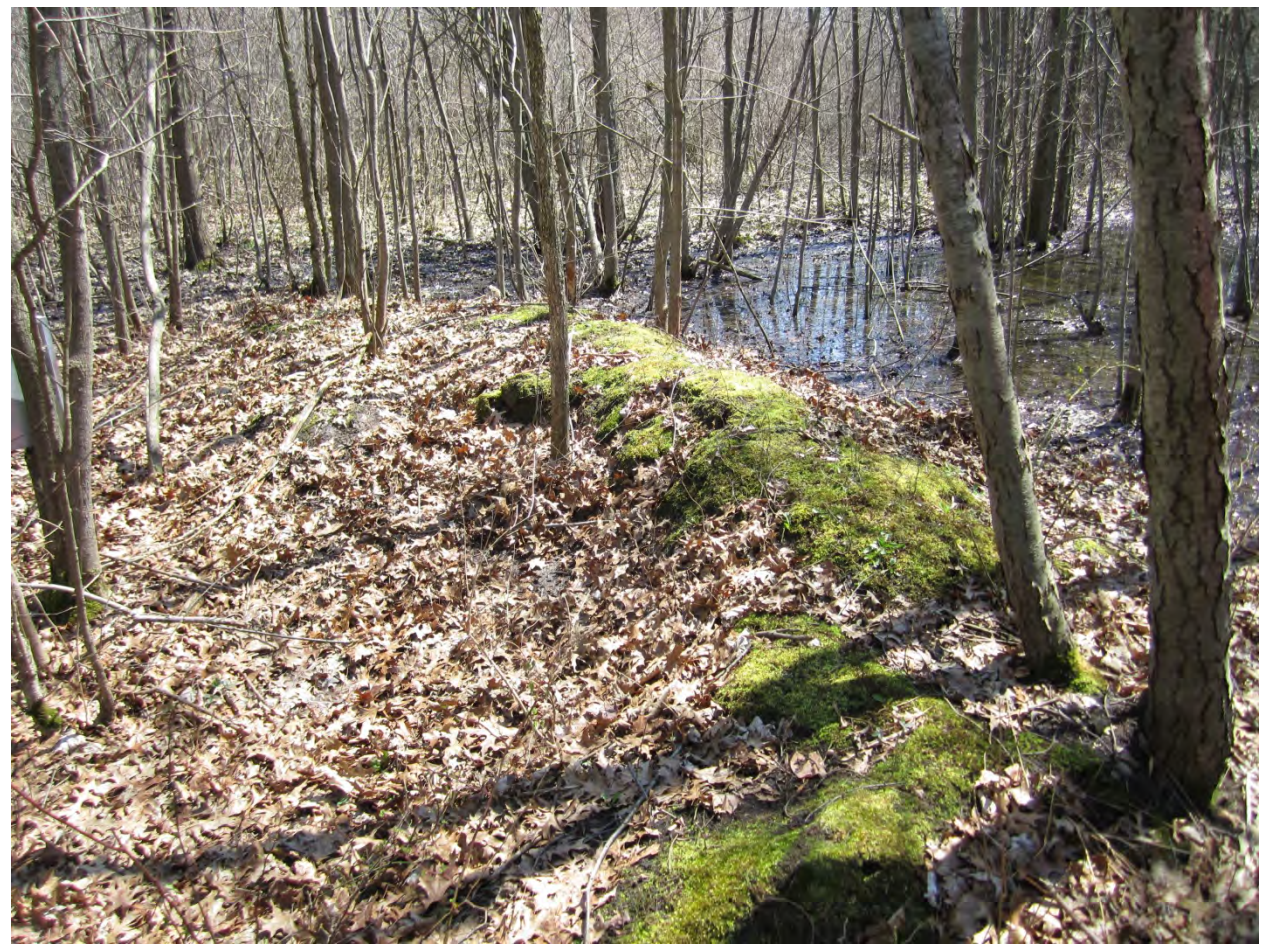
Parcel Group:	Tax Parcel ID:
TEC Group D	60.00-2-17
Feature:	Property Owner:
1944-180 (Material/Mounded Material)	Guardian Corporation
Notes:	Date:
small mound of native soil; appears to be related to excavations for drainage	23 April 2014
