Former Harshaw Chemical Company FUSRAP Site

Investigative Area (IA) 06 Soil Characterization

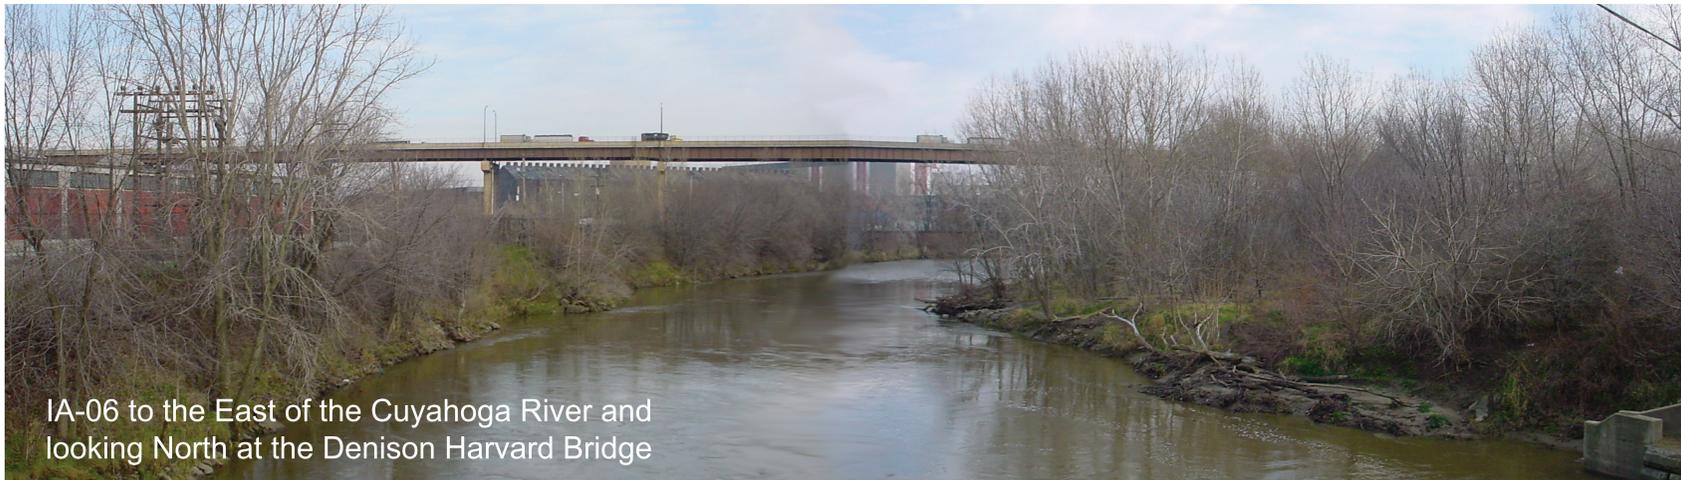
IA-06 to the East of the Cuyahoga River and looking North at the Denison Harvard Bridge

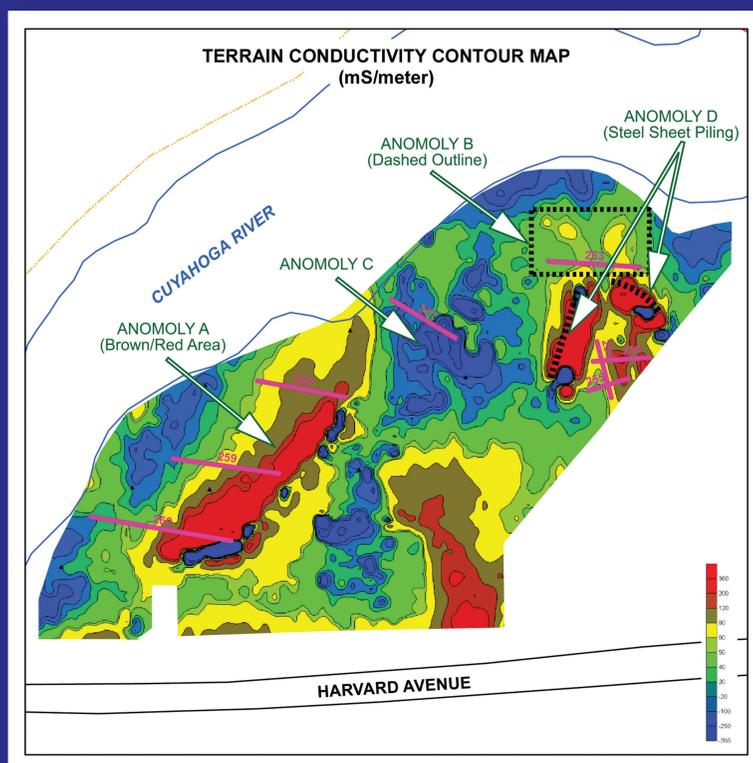
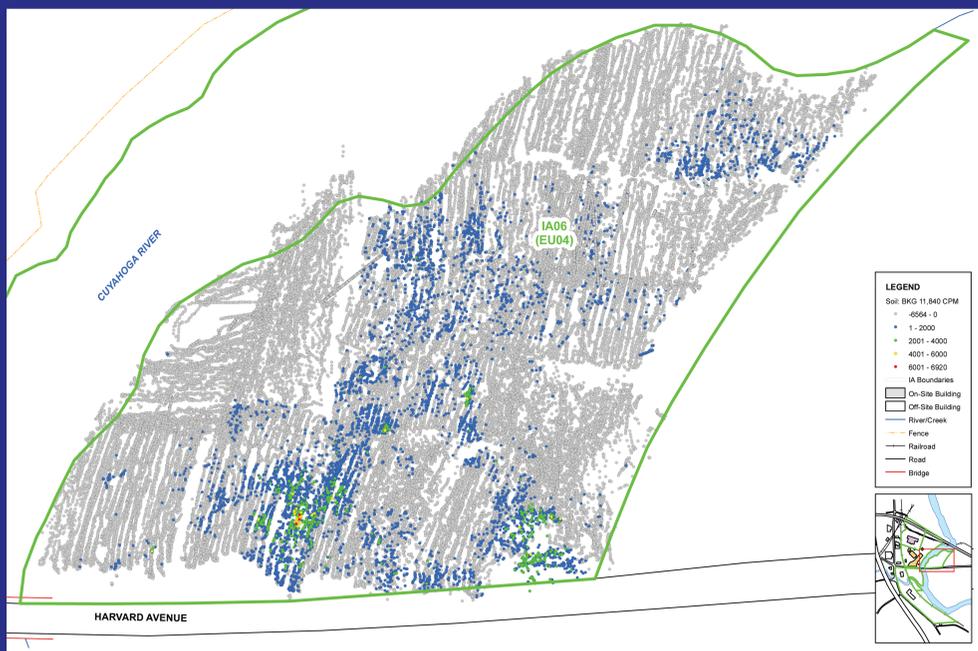
To begin the investigation in IA-06, the Corps performed geophysical surveys using electromagnetic terrain conductivity scans and ground penetrating radar. The geophysical surveys did not indicate the presence of underground utilities, tanks or other storage containers, or building foundations. Four anomalies were detected as shown on the figure to the right. Anomalies depict changes in soil properties such as sand and clay. Soil borings taken in these areas had no Manhattan Engineer District/Atomic Energy Commission material in the results. Anomaly D was investigated and verified to be a steel sheet pile wall.

The Corps performed a gamma walkover survey using a field instrument for the detection of low energy radiation to characterize gamma radiation levels across IA-06 and identify any elevated locations for collection of soil borings. The yellow and red dots near the south-central portion of IA-06 shown in the figure to the left indicate gamma readings above normal levels for the area.

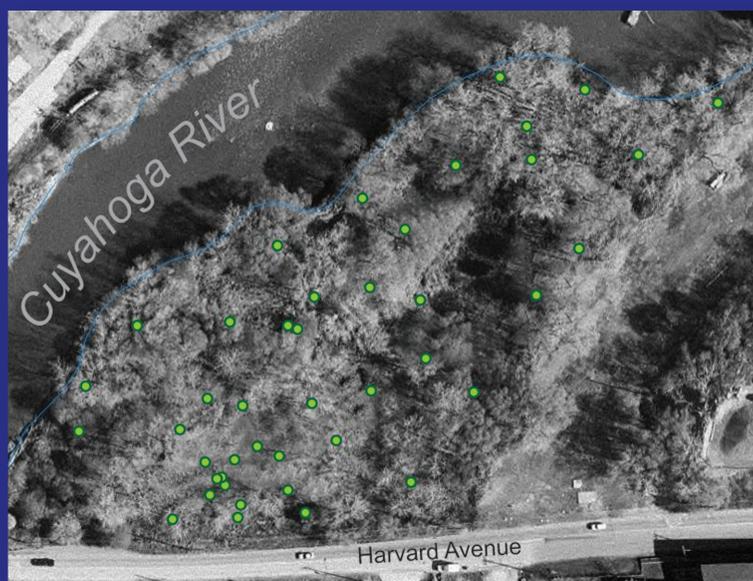
The green dots in this photograph demonstrate the locations of soil samples taken based on the results of the previous surveys pictured above. Localized soil impacts are thought to be the result of fill material and debris. The highest sampling detection results are well below acceptable levels for recreational land use, the reasonably anticipated future land use for IA-06.
