FORMER HARSHAW CHEMICAL SITE PROJECT UPDATE

Formerly Utilized Sites
Remedial Action Program

Cleveland, Ohio

January 20, 2010

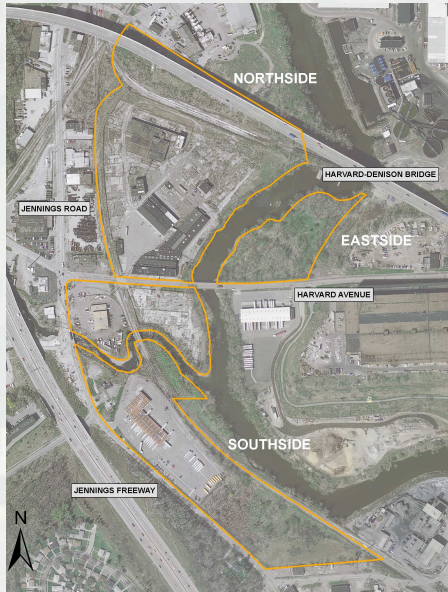
- Located at 1000 Harvard Avenue in Cleveland, Ohio; approximately 3 miles south of downtown Cleveland
- Total size is approximately 55 acres
- Located within an industrialized area adjacent to the Cuyahoga River and Big Creek

- Consists of several developed and undeveloped land parcels with multiple property owners
- Current site use is limited to storage and warehousing operations

- To support implementation of the CERCLA process, the site has been divided into three distinct areas:
 - o Northside – includes soil, buildings, sanitary/storm sewers, and groundwater north of Big Creek/west of Cuyahoga River (also includes sediment/surface water)

- o Southside – includes soil and groundwater south of Big Creek/west of Cuyahoga River
 - o Eastside – includes soil and groundwater east of Cuyahoga River

- Existing buildings remaining from the government operational period are located within the Northside area and include:
 - o Building G-1
 - o Boiler House

- o Foundry
 - o Warehouse
 - o Garage
 - o Scale House

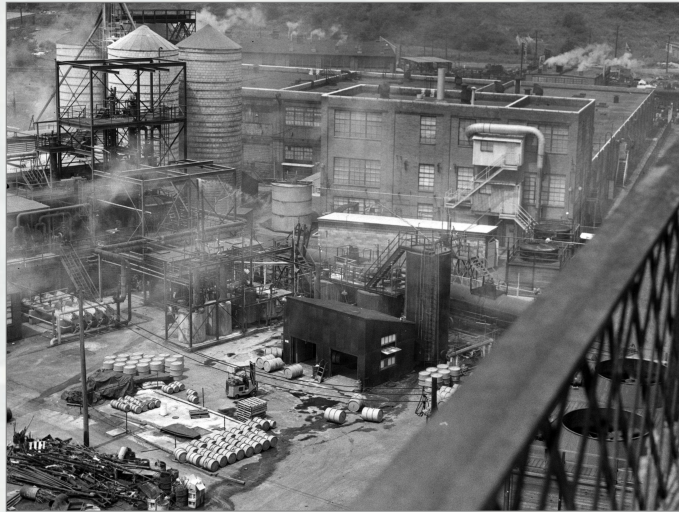
- o Harshaw uranium products produced for the government included uranium tetrafluoride (UF₄), uranium hexafluoride (UF₆) and uranium trioxide (UO₃)
 - o 1955 Photo – view of Building G-1 from original Harvard-Denison bridge looking west; ongoing production operations late in the period of government operations

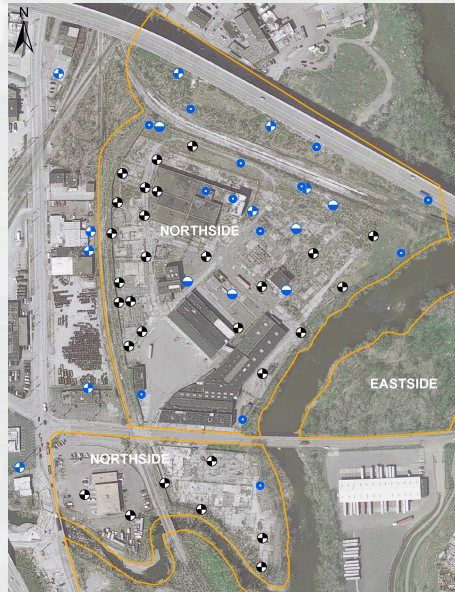
GROUNDWATER LOCATIONS

- Existing Well
- RI Well
- RI Temporary Piezometer
- RI Temporary Well Point

- Eastside area groundwater is physically isolated from Northside groundwater by the Cuyahoga River

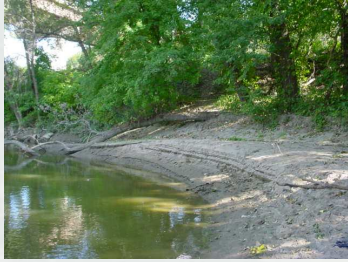
- Proposed Plan public release scheduled for 2010
- Recommended remedial alternative will be no further FUSRAP action based on recreational development

- The lack of significant FUSRAP contamination in the Eastside area formed the basis for the recommended FUSRAP remedial alternative of no further FUSRAP action in the Proposed Plan
- The Eastside area also was identified as Investigative Area 06 (IA06) during the Remedial Investigation
- The recommended remedial alternative will be no further FUSRAP action based on recreational development
- The conditions identified during the Remedial Investigation and the potential use of this property as part of the Ohio Canal Corridor – Towpath Trail also supported the acceleration of the Eastside area through the CERCLA process (relative to the remainder of the site)
