# CUYAHOGA RIVERBANK INSPECTION AND SOIL SAMPLING HARSHAW CHEMICAL COMPANY FUSRAP SITE

**U.S. Army Corps of Engineers  
Buffalo District**

April 2016

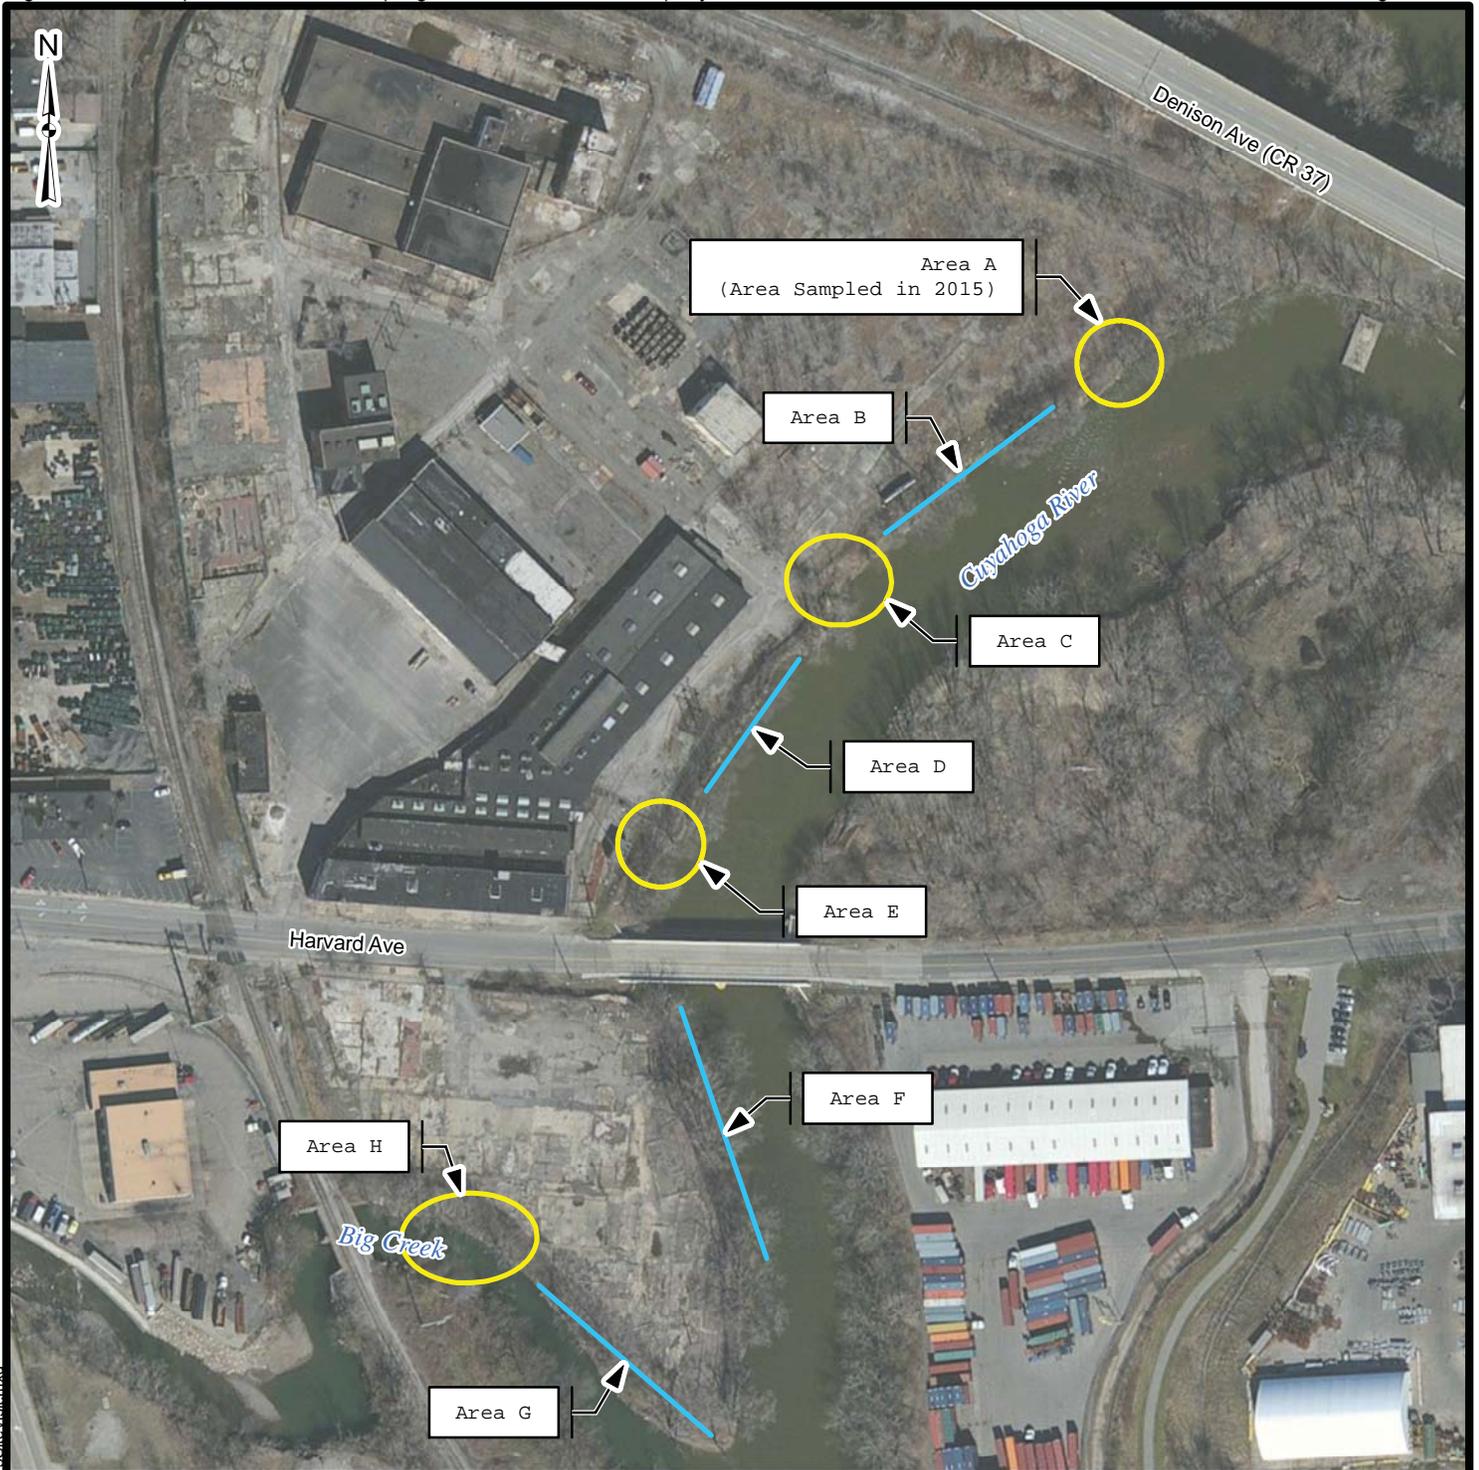
FIGURE 1

On November 13, 2014, the Corps of Engineers inspected bank stability of the Cuyahoga River and Big Creek. The inspection focused on eight areas, identified as A through H, shown on Figure 1. The inspection of Area A indicated a large, localized area of sloughing. There is a known area of FUSRAP-related contamination, identified in the RI, near Area A. In the spring of 2015, Corps of Engineers personnel visually inspected Area A and determined additional erosion had occurred and sampling was needed.

AREAS IDENTIFIED DURING THE 13 NOVEMBER 2014  
SITE VISIT

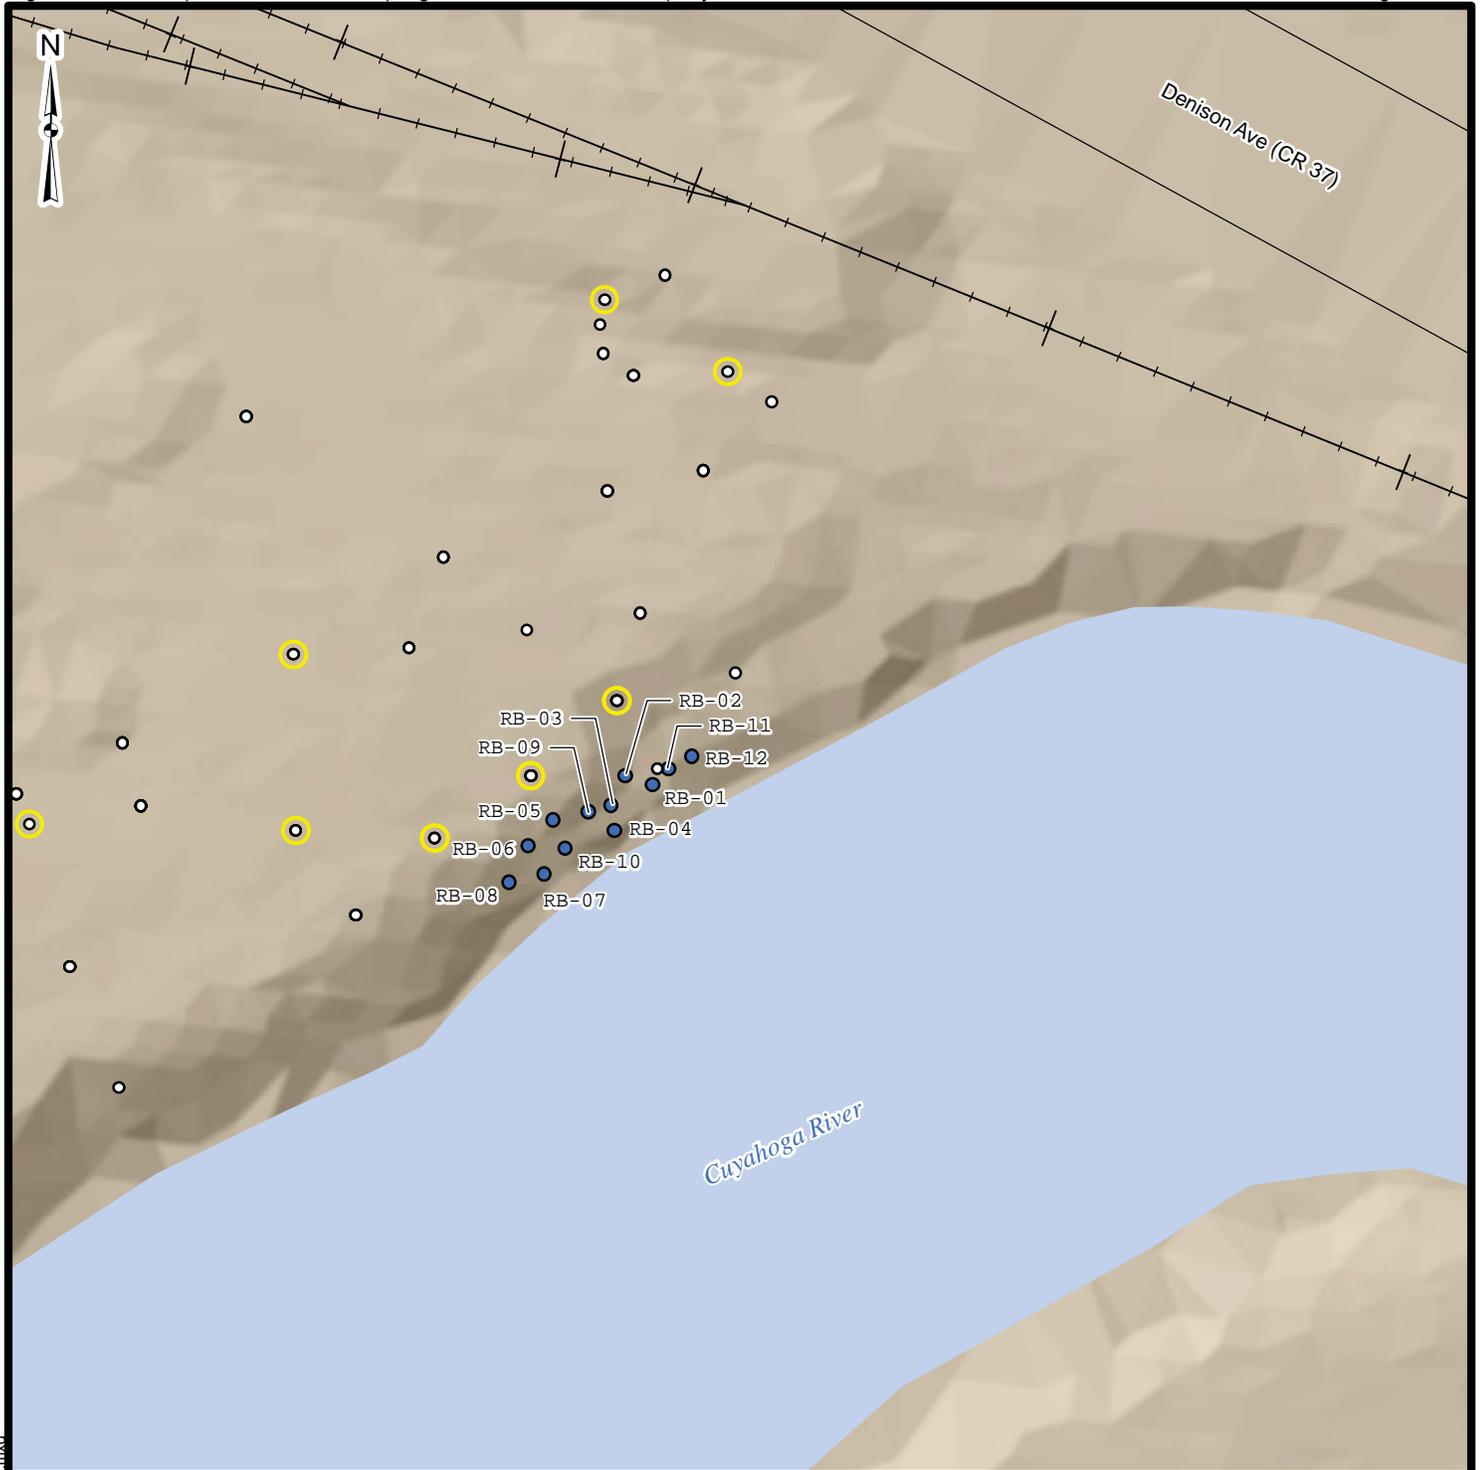
**FIGURE 2**

On August 24, 2015, Corps of Engineers personnel collected 12 riverbank soil samples from Area A, as shown in Figure 2 and Table 1. The Corps of Engineers obtained samples at different elevations, from river level to the top of the riverbank, with a range of approximately 11 feet. The Corps of Engineers analyzed the samples for FUSRAP-related contaminants: isotopic radium (Ra-226), isotopic thorium (Th-228, Th-230, Th-232), and isotopic uranium (U-234, U-235, U-238.) A representative of the Ohio Environmental Protection Agency was present to observe and assist with the sampling event.

**SOIL SAMPLES NEAR ERODED AREA**

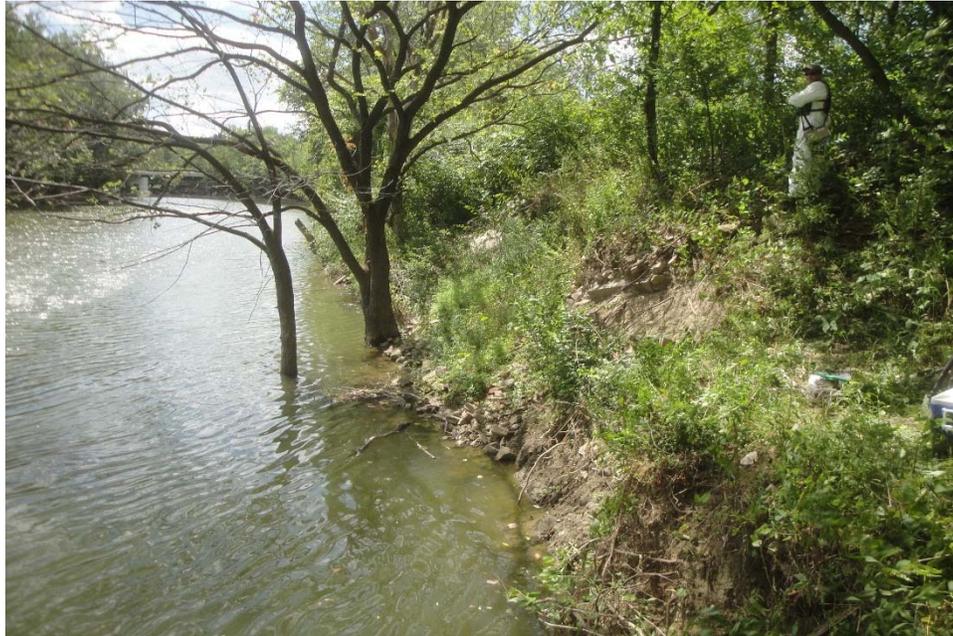
Photograph 1: Looking south at Area A of Cuyahoga Riverbank. Sloughing and erosion is seen in the middle portion of the photograph.

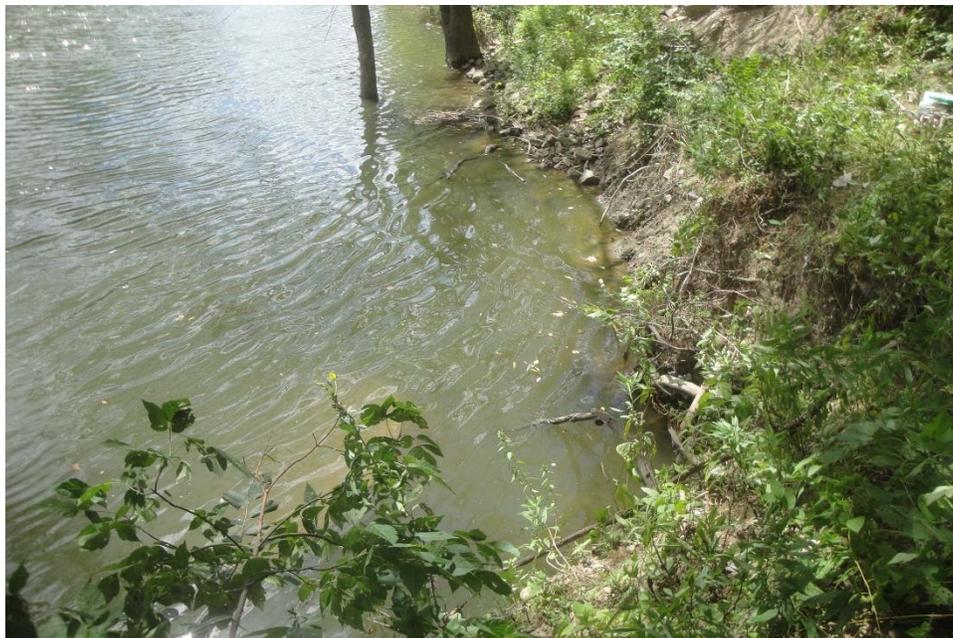
Photograph 2: Close-up of riverbank erosion. A large piece of debris that has sloughed from the bank is visible in the middle section of the photograph.

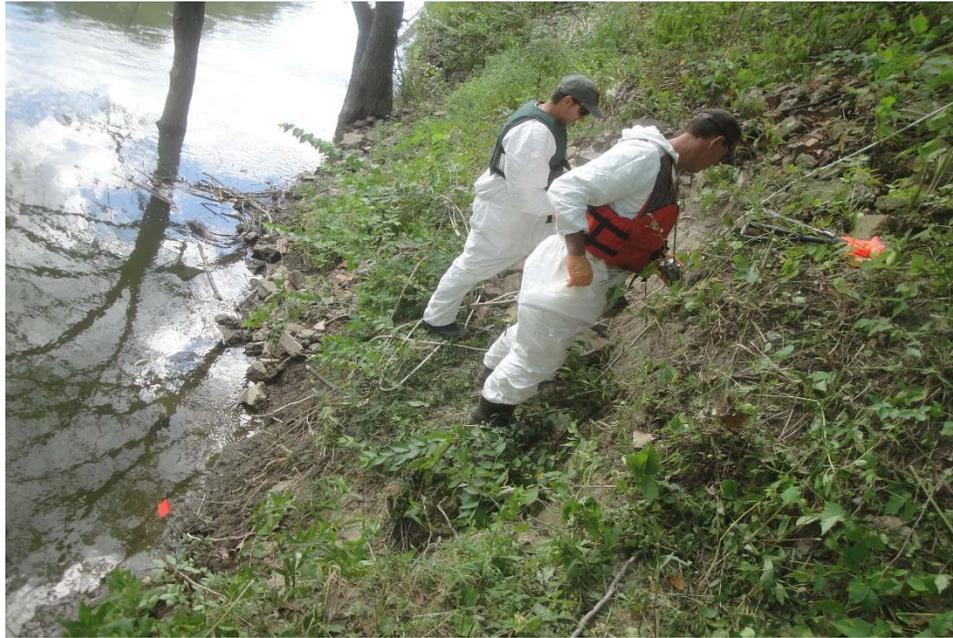
Corps of Engineers personnel scanned the eroded area with 2-inch x 2-inch sodium iodide gamma radiation detectors. The scans indicated no readings above background, so samples were spaced on an unbiased triangular sampling grid. The Corps of Engineers collected the soil samples using stainless steel spoons and bucket augers. Construction debris present in the soil sampling area had to be avoided. The result was an imperfect triangular grid. The Cuyahoga River water level was at its annual average, 3 feet, on the sampling date, based on U.S. Geological Survey's Cuyahoga River hydrographic estimates. Attachment 1 contains photographs of the field activities.

Photograph 3: Survey of riverbank area with 2-inch x 2-inch sodium iodide gamma radiation detectors.

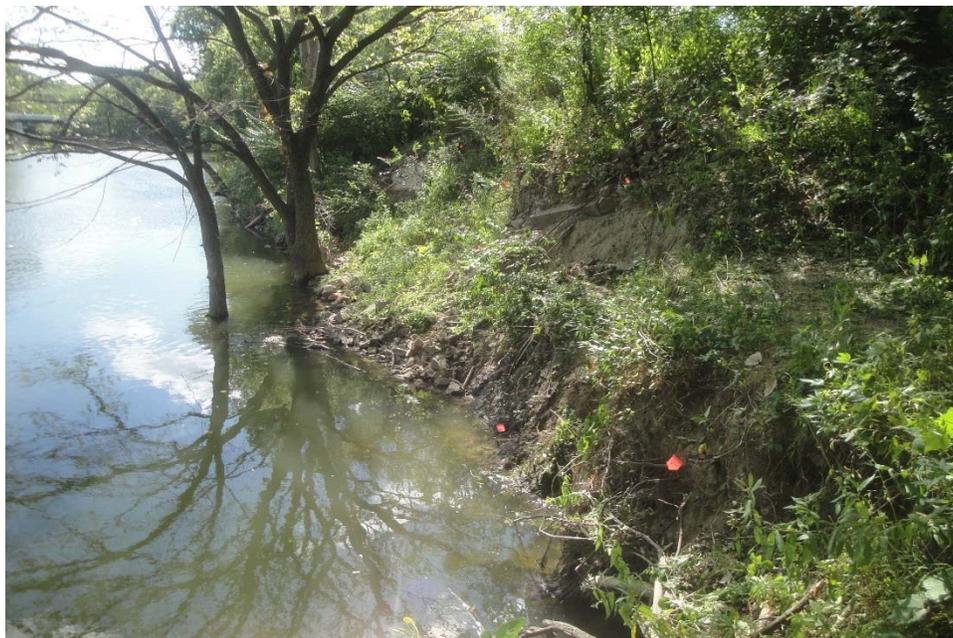
Photograph 4: Looking south at completed sample locations marked with pin flags.
