AFTER ACTION REPORT

UXO ACTIVITIES AT THE WASTE WATER TREATMENT PLANT (WWTP) AT THE FORMER LAKE ONTARIO ORDNANCE WORKS (LOOW) SITE 2003

USACE CONTRACT NUMBER DACW49-00-D-0002-0008

JUNE 2004

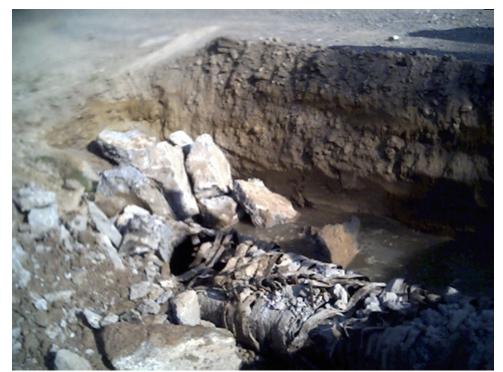
Test	Location/Site	Remarks	Results: TNT % in sample
1.	Composite 1	38" Terra Cotta Outfall to river	Sediment in pipe	1.05%
2.	Composite 2	Excavation #2	Soil Sample	1.5%
3.	Composite 3	Acid Neutralization Bldg. Vault	Sediment sample	5.0%
4.	Composite 4	24" Wooden Pipe	4" of Sludge in pipe 2-3" of water above sludge, black with visible crystalline TNT	29.0%

TNT 24" Wooden Transfer Pipe Entry No. 1

While the test results of the Terra Cotta outfall pipe to the river, Excavation #2, and the vault in the Acid Neutralization building are below explosive reaction levels of 10%, these areas should undergo further testing in a more comprehensive manner to insure the entire areas are safe. TNT contamination exists in the 24" Wooden Pipe and this needs to be addressed.

ISSI UXO recommends action be taken to remediate the 24" wooden pipe, and that the other areas be comprehensively investigated.

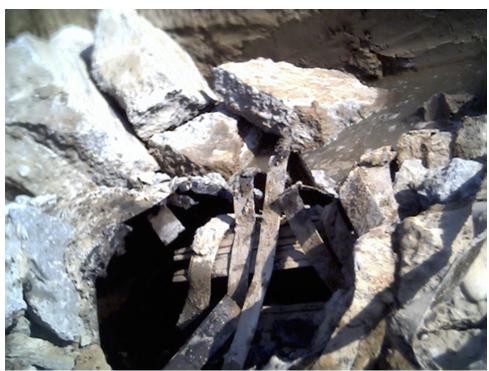
TNT 24" Wooden Transfer pipe Entry No. 2

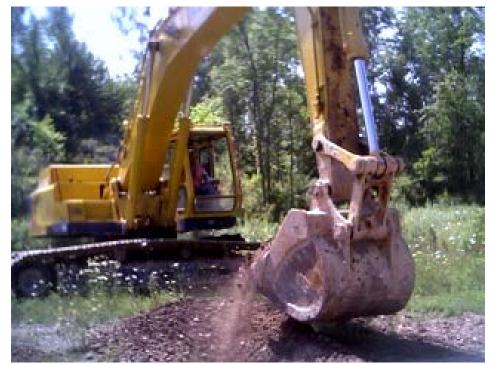
Excavation #2 was suspended by the Radiation Safety Officer; gamma exposure rates exceeded the established action level. Information on the radiological status of Excavation #2 can be found in the Health and Safety Monitoring Report for TNT Investigation at the LOOW WWTP, Sevenson Environmental Services, Inc., June 2004.

Excavation No. 2

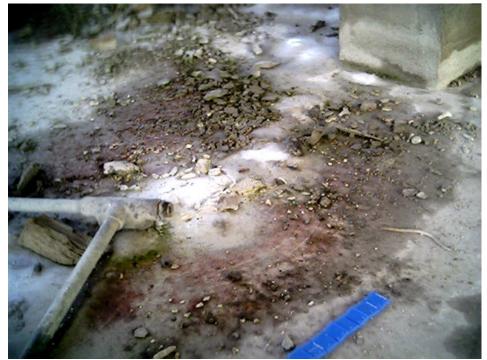
As a result of the Expray Test in the vault area of the Acid Neutralization Building, TNT Surface Crystalline Contamination was noted on the floor. Due to the kit's limited scope, it only indicates a presence of TNT, not a quantitative amount. The sediment samples from all locations were allowed to dry over the weekend and an EnSys Test for TNT was conducted, the results are listed in Paragraph 4.0 Tests.

Included as Appendix D is the Expray Test sheet showing the results from the vault area. Crystalline TNT contamination was found on the floor surface of the Vault area in the Acid Neutralization Building.

TNT Stains on Acid Neutralization Floor

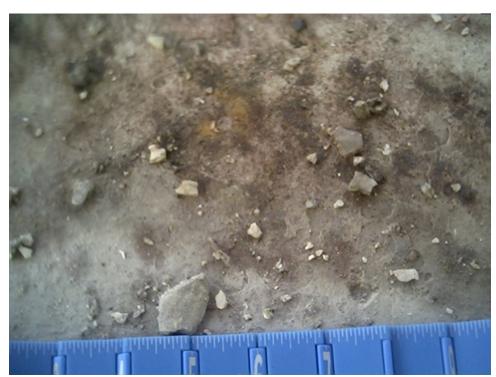
TNT Stains on Acid Neutralization Floor
