Luckey Site

Formerly Utilized Sites Remedial Action Program (FUSRAP) Site Features

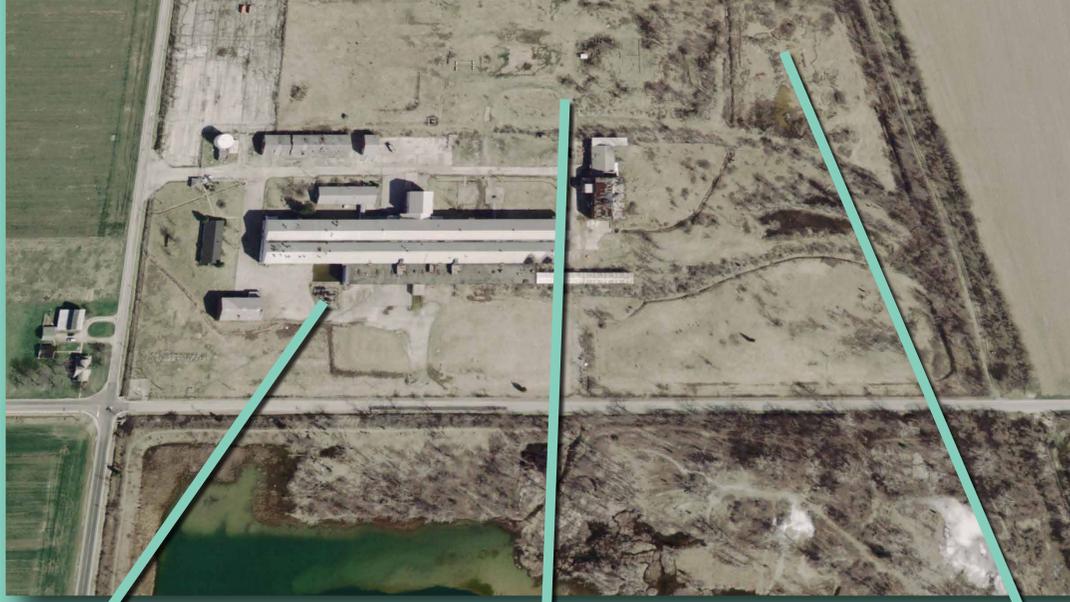
Aerial Photograph of the Luckey Site showing quarry (south of site), roads, buildings, and disposal areas.

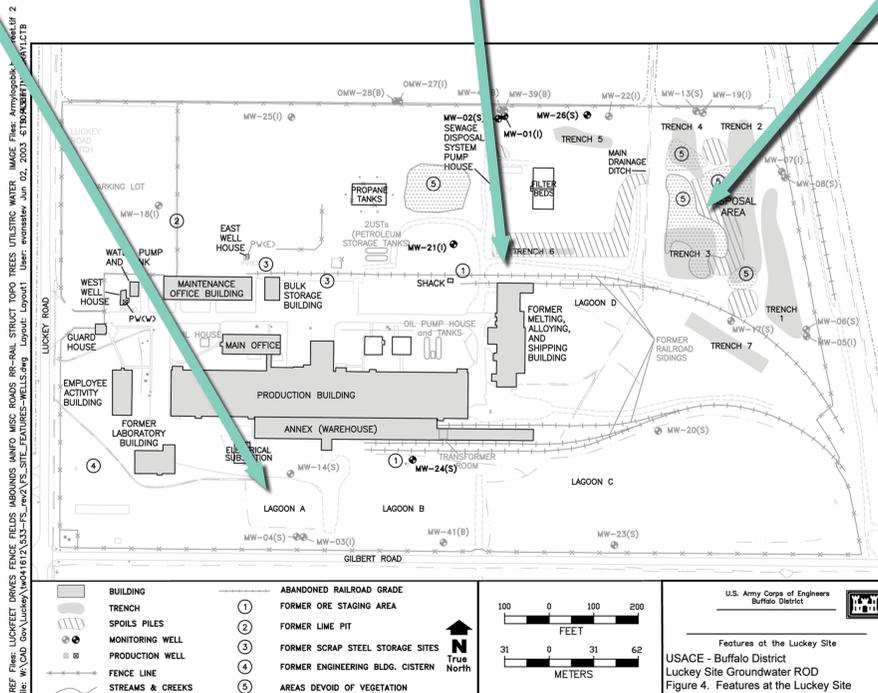
Features Map - Showing all features on site (buildings, trenches, lagoons, former rail lines, disposal areas, and storage facilities)

During the production of beryllium, process waste was discharged into lagoons on site (Lagoons A, B, and C on the figure). The lagoons were periodically dredged and the sludge transferred to trenches in the northeastern landfill area. These trenches were also used for the disposal of scrap steel. The landfill area is known to have received decontamination residues and building debris at the time of site closure.
