PROJECT: Niagara Falls Storage Site (Lewiston, NY) Delineation Investigation		EXCAVATION ID: IETES-01
CLIENT/OWNER: USACE	JOB NUMBER: 11176991.00007	
DATE STARTED: 11/27/2013	URS GEOLOGIST:	
DATE COMPLETED: 11/27/2013	URS HEALTH PHYSICIST:	
CONTRACTOR: Russo Development	RUSSO OPERATOR & LABORER:	
EQUIPMENT: Komatsu 200 LC excavator		
LOCATION: Adjacent to west access road, south of the South 31 ditch		
PURPOSE: Investigate the presence (or absence) of the concrete encased sanitary sewer		
CORNER COORDINATES: (NW Cor) N-1171060.940, E-1041218.197; (SW Cor) N-1171052.501, E-1041215.483		
(NE Cor) N-1171058.371, E-1041224.042; (SE Cor) N-1171049.842, E-1041221.105		
FINAL EXCAVATION DIMENSIONS: ~6' wide x 9' long x 13' deep

**Project: Niagara Falls Storage Site
(Lewiston, NY) BOP Field Investigation**

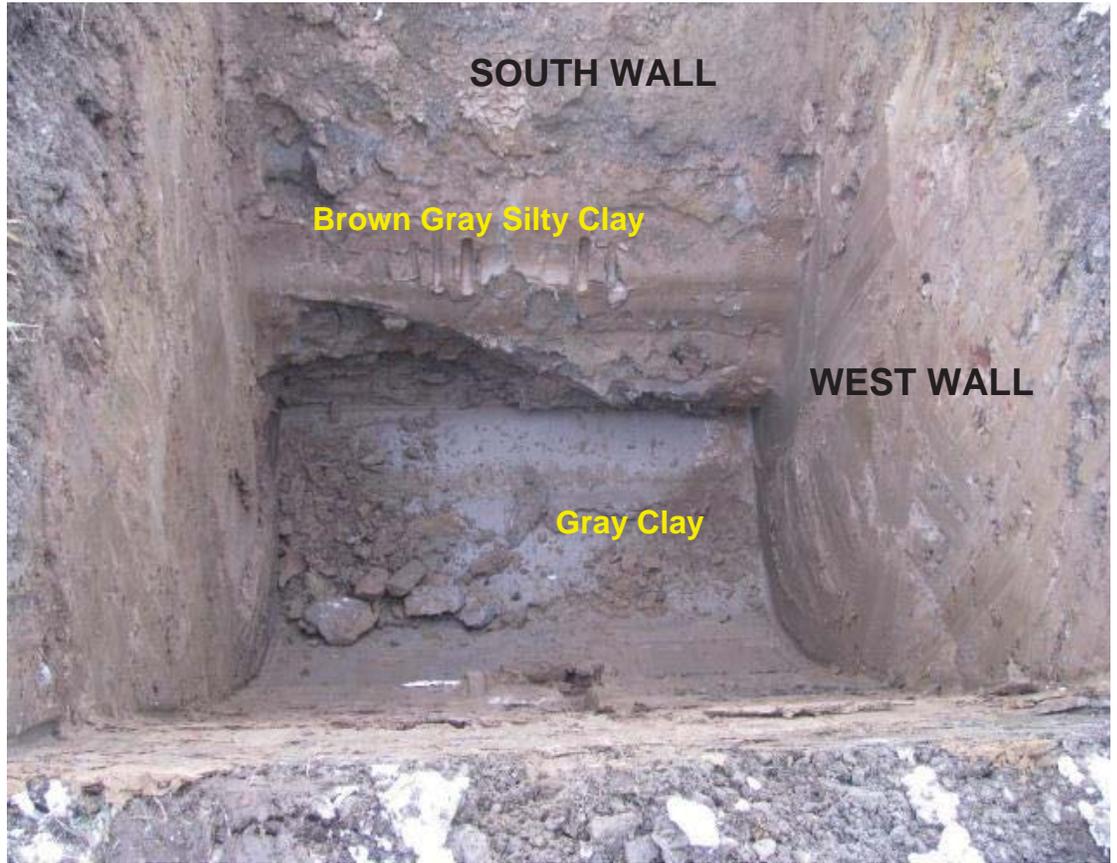
Photo No.
IETES-1

Photo taken looking south. Brown gray silty clay and gray clay strata that characterized soil Units # 2 and #3 respectively are shown.

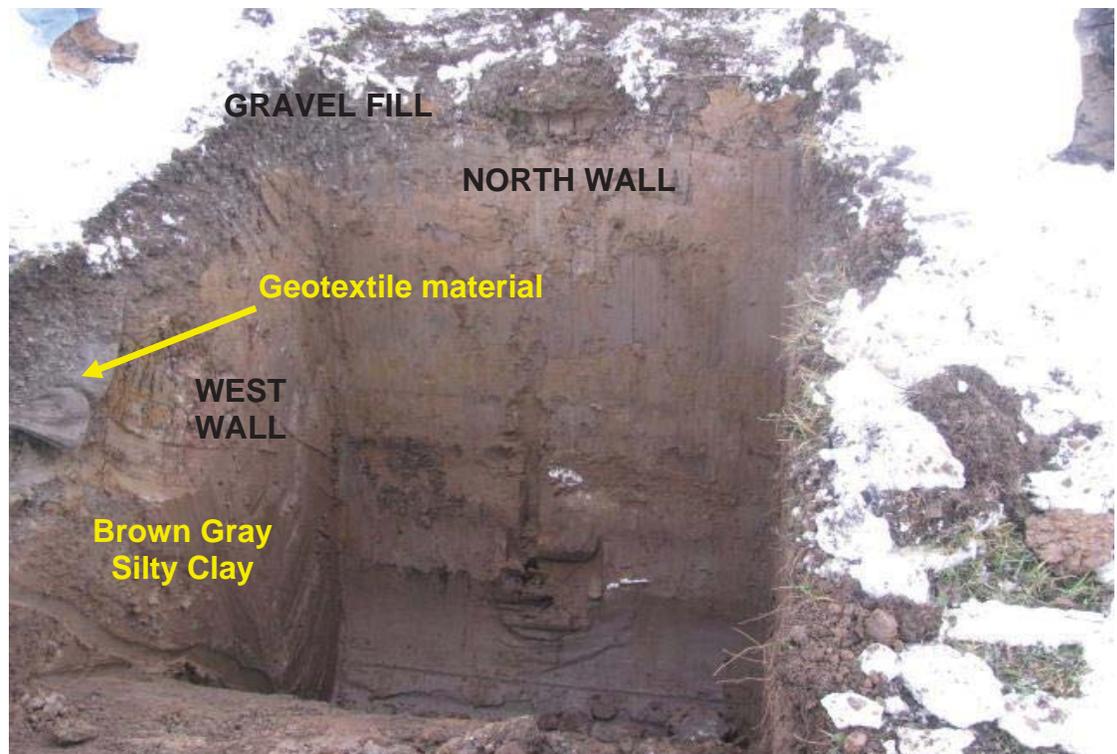
Photo No.
IETES-2

A northward looking view of the soil section along the north and west walls of trench IETES-1. The gravel fill unit and Geotextile material associated with the west access road are depicted in the photo.

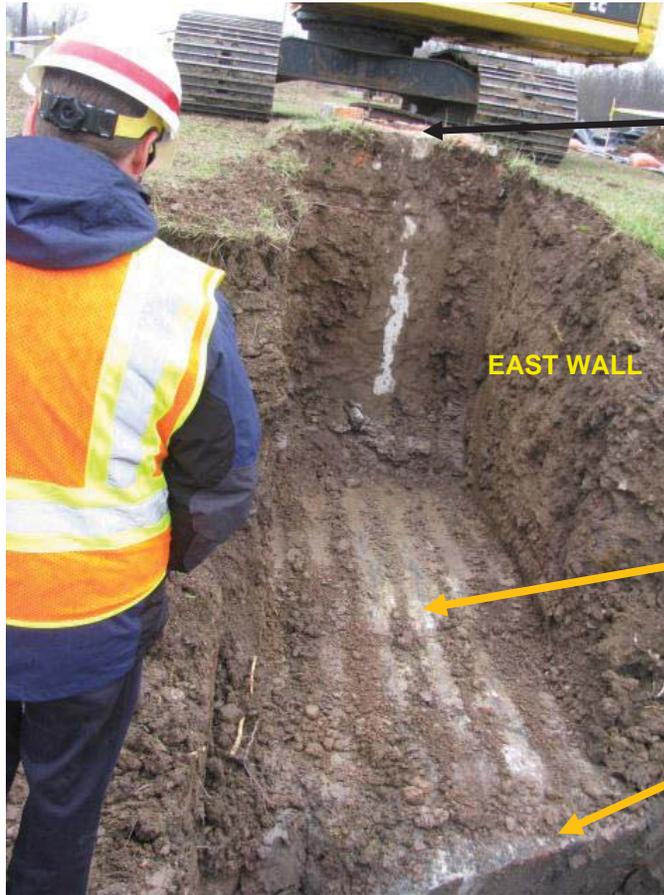
Photo No.
IEMH-06-1

A concrete encased sewer measuring approximately 4' wide was exposed on the south side of the manhole at a depth of approximately 6' to 9' bgs. This southernmost terminus of the NE - SW trending sewer had been previously plugged and extended approximately 14' south of MH-06. The sewer was plugged with concrete inside the manhole structure.

Photo taken looking north to show the southern terminus of the sanitary sewer.

Access to concrete encased manhole

Top of concrete encased sewer

Plugged sewer endpoint

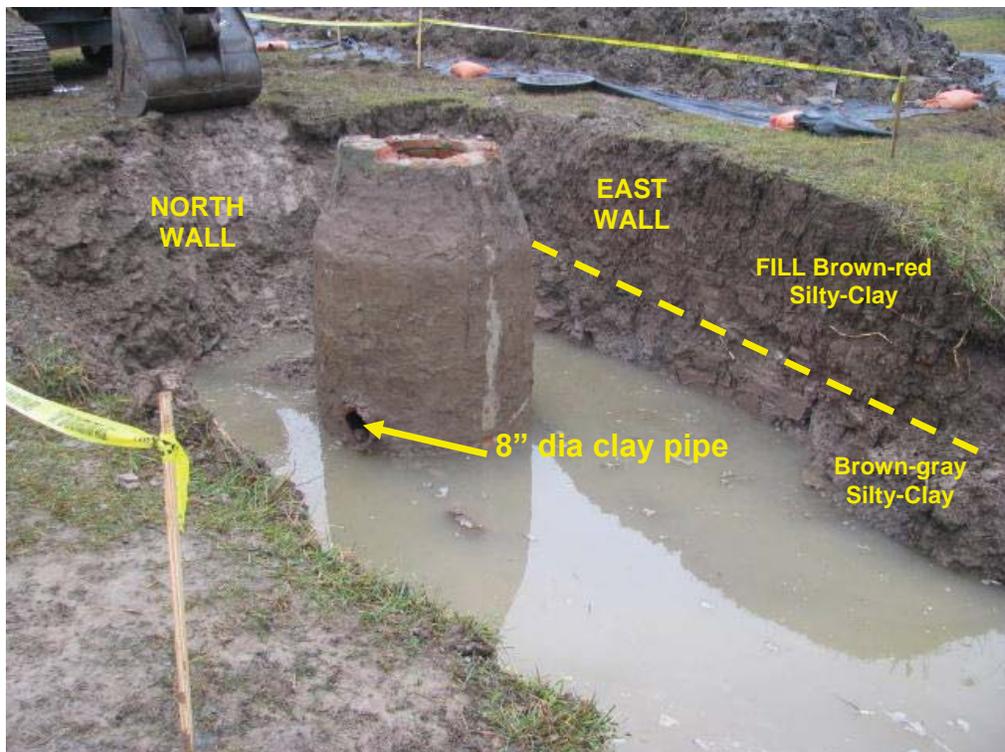
Photo No.
IEMH06-2

The excavation exposed the manhole structure designated MH-06. Examination of MH-06 determined that it was constructed of red clay brick enclosed in a protective concrete housing that measured approximately 5' in diameter. The structural integrity was intact as no cracks or fractures were observed.

An 8" diameter clay tile opening was identified approximately 3' above the base of the manhole on the west side. The opening was partially filled with loose red brick. There was no sign of a lateral leading from the opening.

Photo was taken looking northeast to show the exposed freestanding manhole structure. A truncated 8-inch dia. clay tile pipe was identified on the west side of the manhole.

8" dia clay pipe

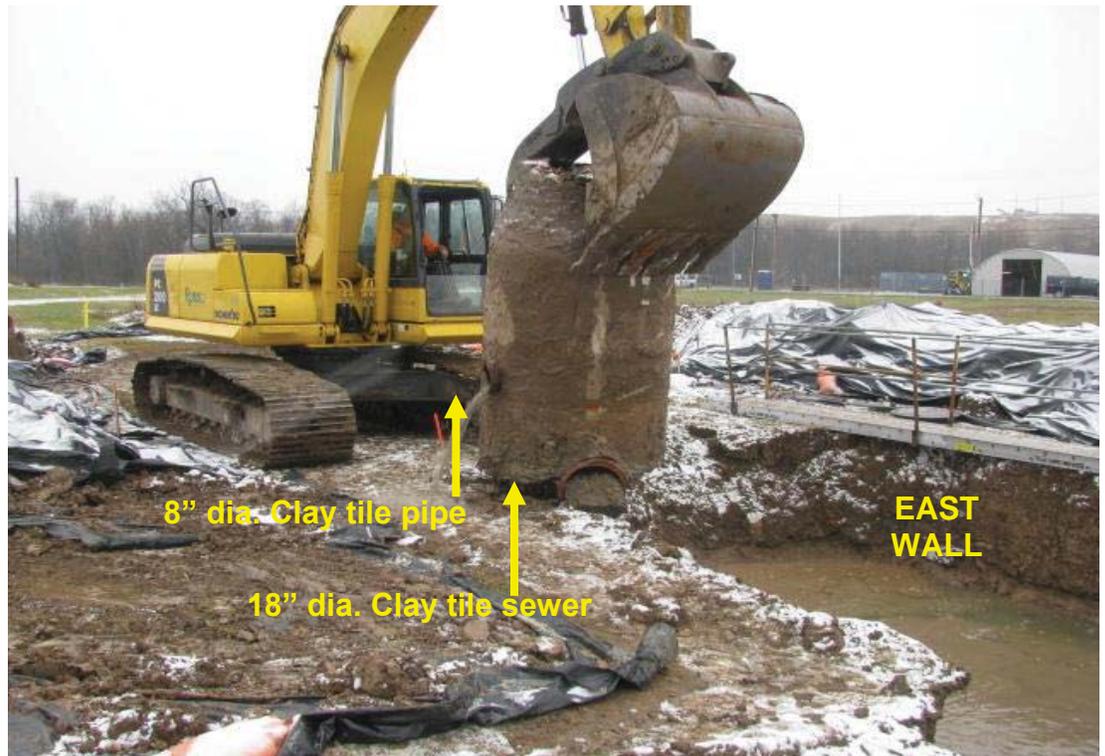
Photo No.
IEMH06-3

A northeast view of IEMH-06 trench location taken during removal of the manhole structure. The aluminum catwalk shown parallel with the east wall was used to perform the requisite RAD survey.

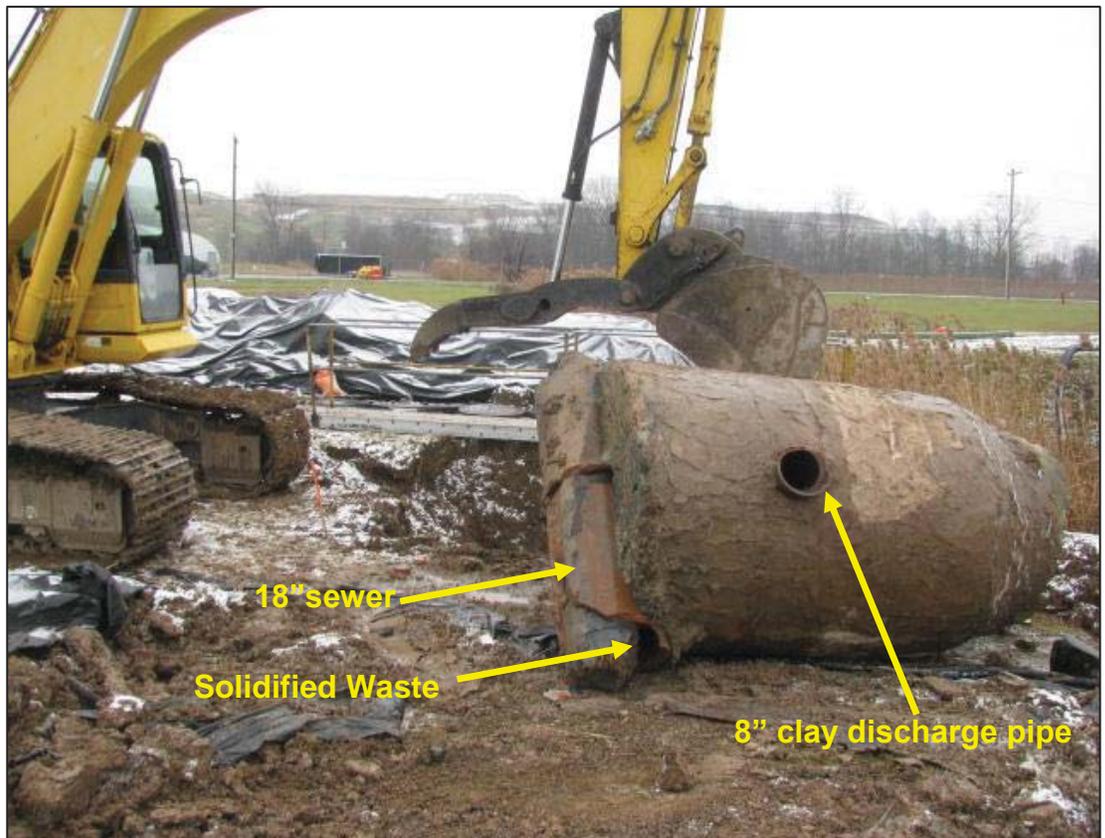
Photo No.
IEMH06-4

An east facing view of IEMH-06 trench subsequent to manhole removal. The 18" clay tile sewer was partially filled with solidified waste residue and concrete.

The manhole access structure was removed in its entirety. The excavation was dewatered and the northern 18" sewer extension plugged with concrete (4,000 psi). The MH-06 excavation was backfilled with concrete to an elevation 2' above the top of the sewer. Approximately 8 yds³ of concrete were poured to effectively seal the sewer.

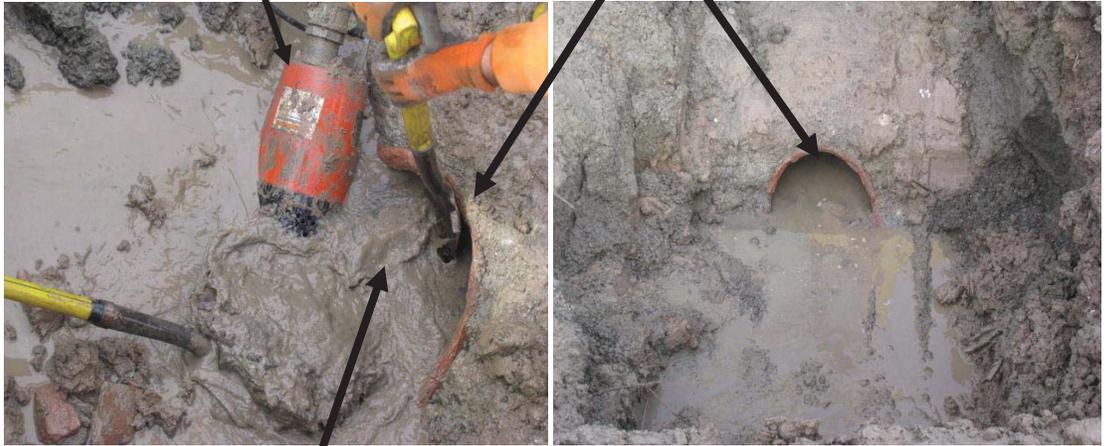
Photo No.
IEMH06-5,6

Photos taken to document condition of the sewer prior to abandonment. Due to the presence of solidified waste within the sewer, the reduced annular space was drained prior to plugging and encapsulating the sewer with concrete.

Submersible pump

18" dia. sewer

Removing soil and concrete aggregate from sewer to re-attempt plugging.

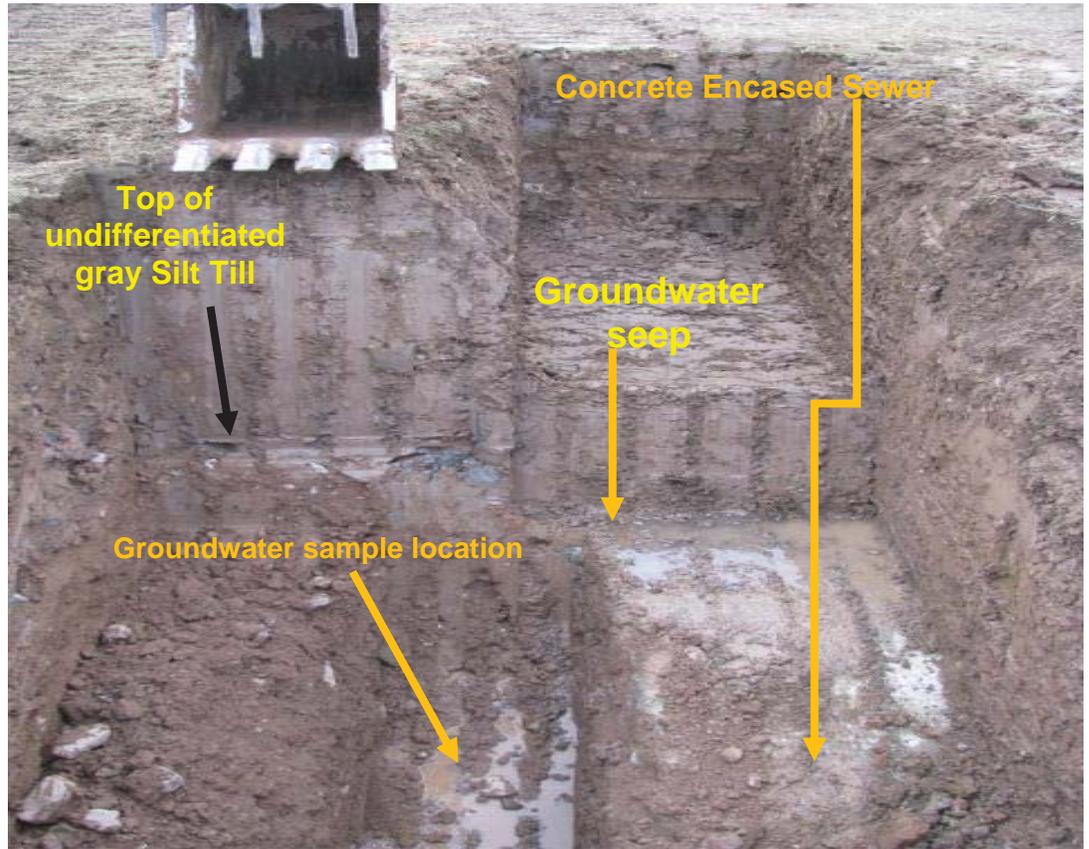
Photo No.
IE9-1

Photo taken looking south. Trench was benched to facilitate collection of a requisite groundwater sample and radiation survey.

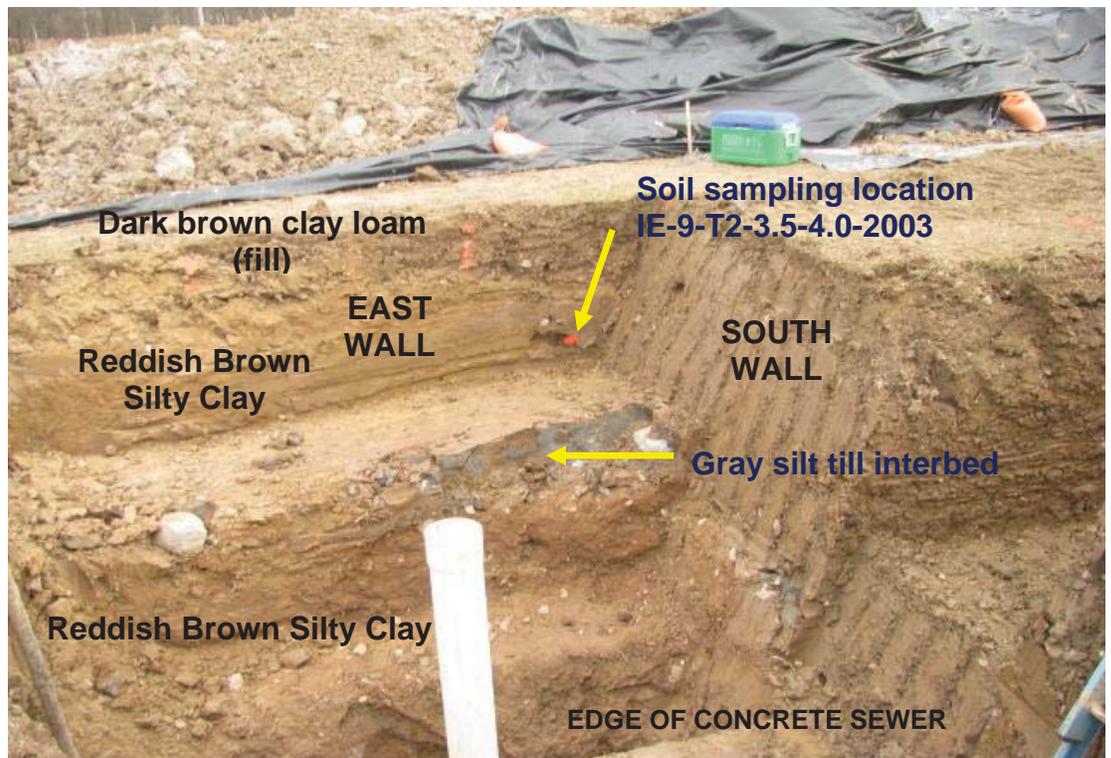
Photo No.
IE9-2

An eastward looking view of the soil section along the east and south walls of trench IE-9. The top of the interbedded (~3.2 – 4.0") gray silt till and east wall soil sampling location are depicted in the photo.

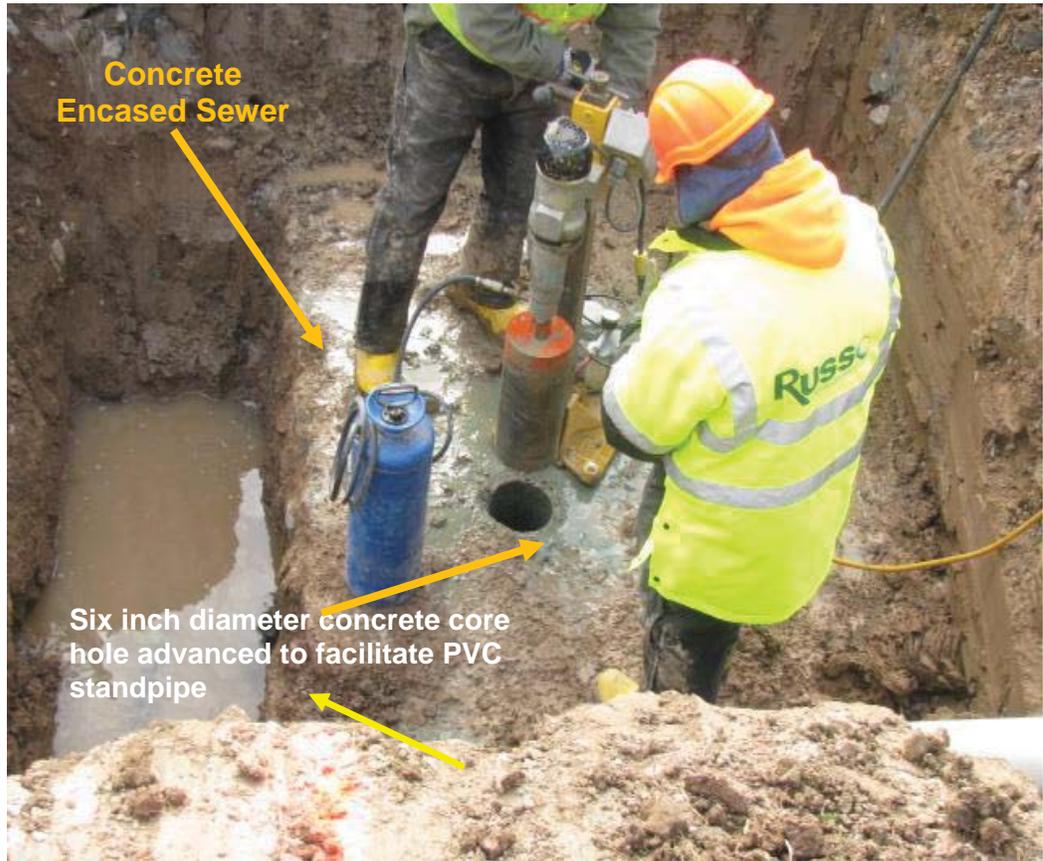
Photo taken looking southward into trench IE-9. Photo documents coring activity required to breach sanitary sewer. Maximum trench depth in photo is ~10.5' bgs.

To facilitate sewer abandonment, a nominal 6-inch diameter core drill was advanced through the top of the concrete encased sewer. And while most of the concrete core was recovered, approximately 4 - 6 inches of the remaining core section dropped into the sewer annulus. A 6-inch diameter PCV standpipe fitted with a rubber gasket was then placed into the corehole to mitigate the flow of gravity fed sewer water into the excavation. Subsequent to placement of the PVC standpipe, attempts to push the unrecovered section of concrete core into the sewer were unsuccessful due to the presence of solidified sediment filling the bottom of the sewer. Approximately 4 yd³ of concrete was initially poured into the sewer via the standpipe in an attempt to plug the 18" dia. sanitary sewer. However, due to the position of the concrete core obstruction within the sewer annulus, it was estimated that less than 1 yd³ of concrete actually made it into the sewer.

An second concrete pour of approximately 2 yd³ was used to successfully encapsulate the sewer in the excavation IE-09. The concrete was poured to an elevation approximately 2' above the top of the sewer.

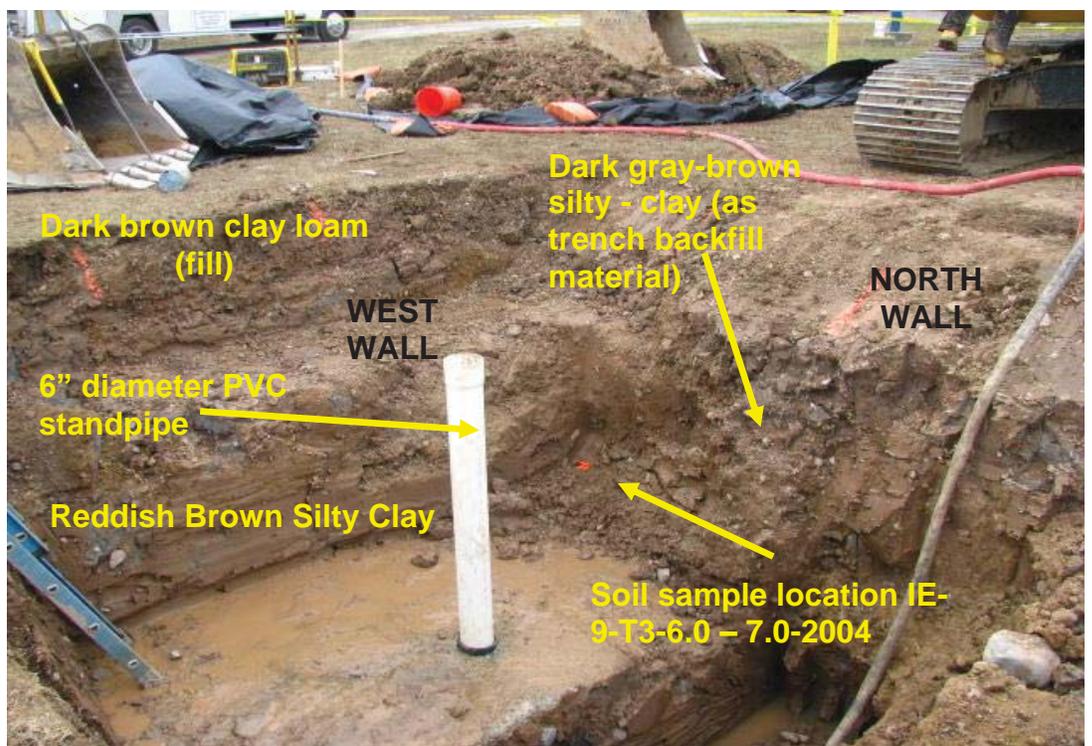
Photo No.
IE9-4

Photo taken looking northwest into trench. The west wall soil sampling location, backfill placed subsequent to sewer installation and PVC standpipe are shown.

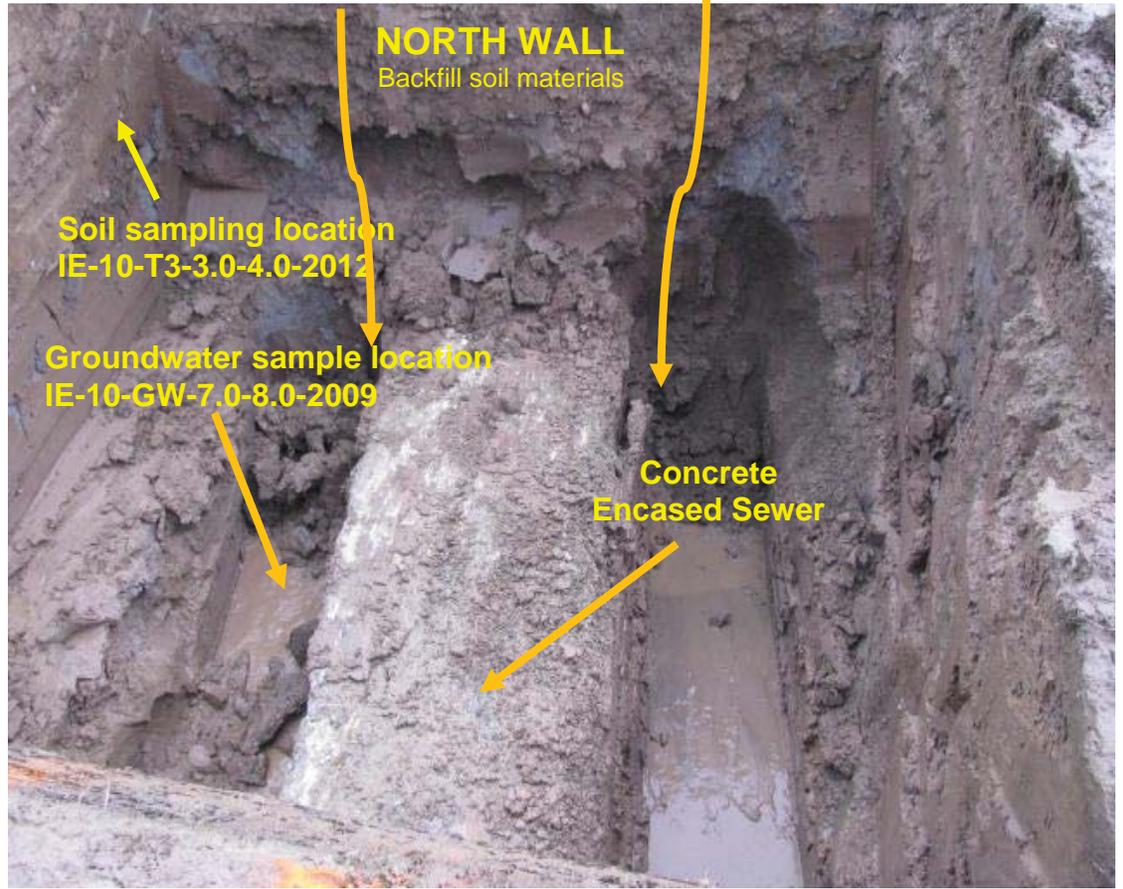
Photo taken looking north. Groundwater sample collected from a sump positioned in northwest corner of the excavation. Note: gray silt deposits were observed on surfaces of preferentially broken desiccation fractures.

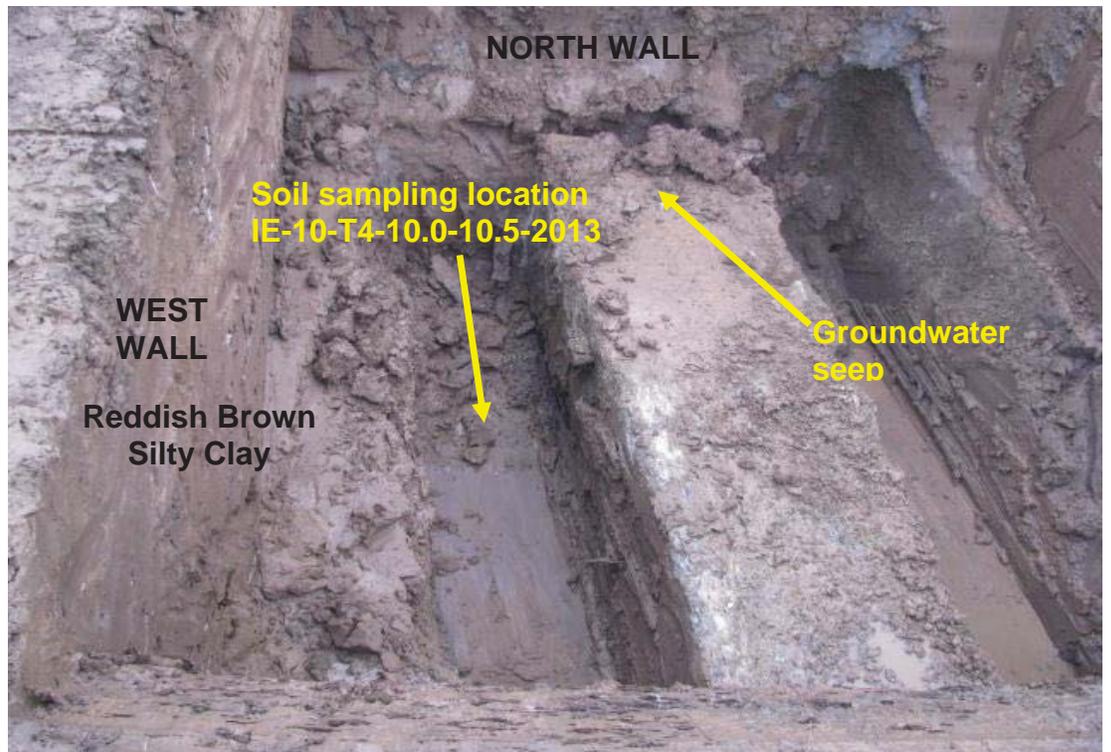
Photo No.
IE10-2

The concrete encased sewer was exposed at a depth of approximately 7.0' to 10.5' bgs and a groundwater seep identified emanating from a fractured clay and interbedded sand layer on top of the concrete sewer.

A northward looking view of trench IE-10. The red-brown coloration of the silty clay soil is depicted in the photo. Additionally, the groundwater seep and bottom soil sampling locations are shown.

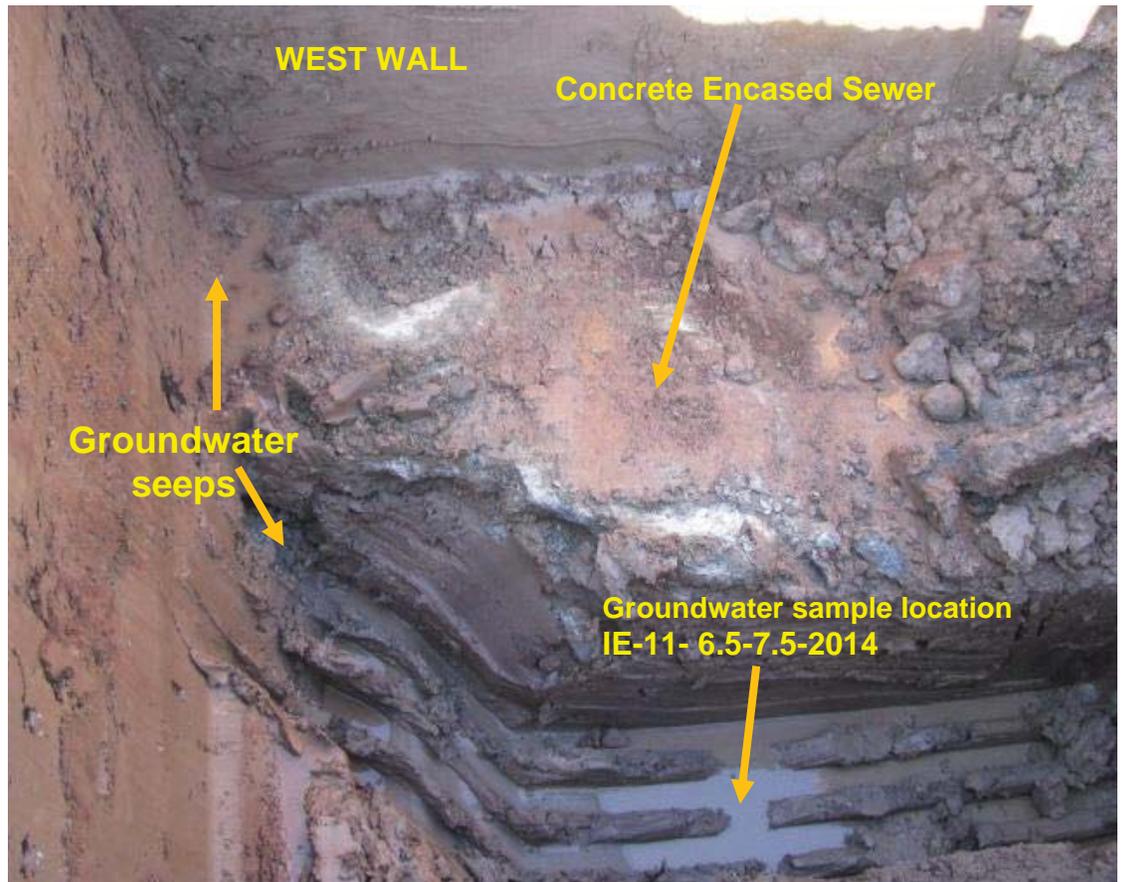
Photo taken looking westward into trench. Widened top of concrete sewer attributed to slight westward deviation in sewer alignment.

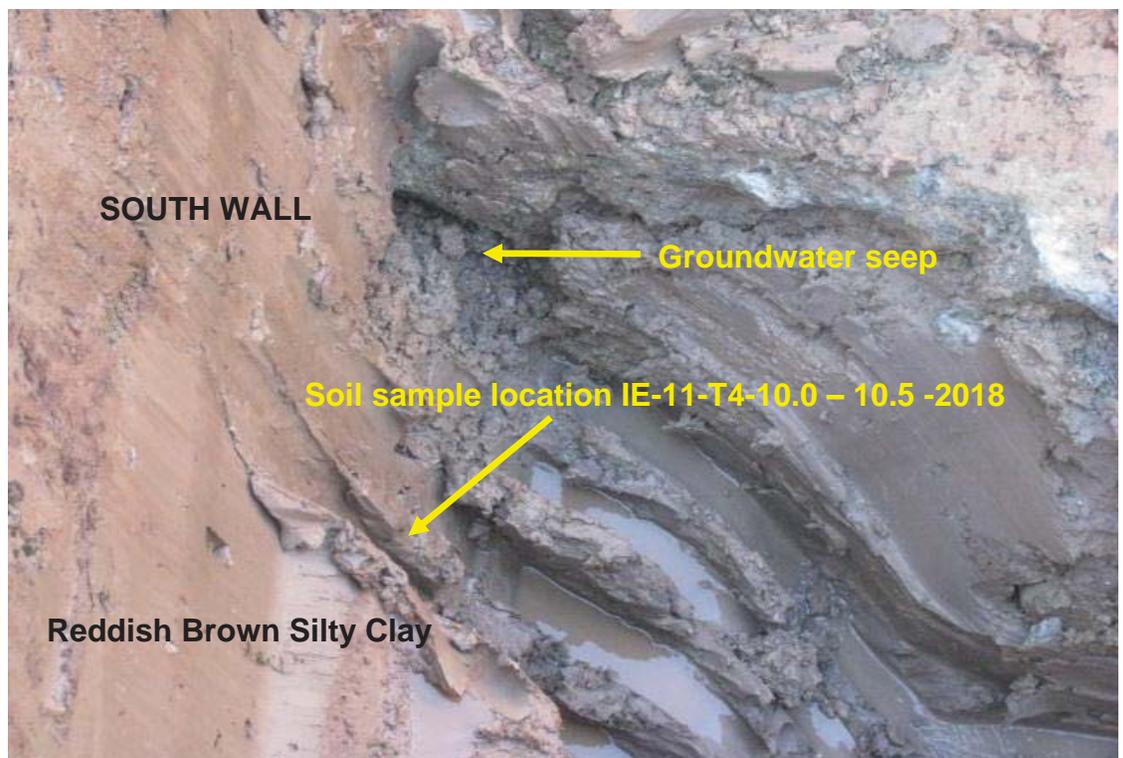
Photo No.
IE11-2

Photo depicts the groundwater seep emanating beneath the sewer through loose gravel bedding material, the trench bottom soil sampling location and the dense clayey nature of the overburden soil material.

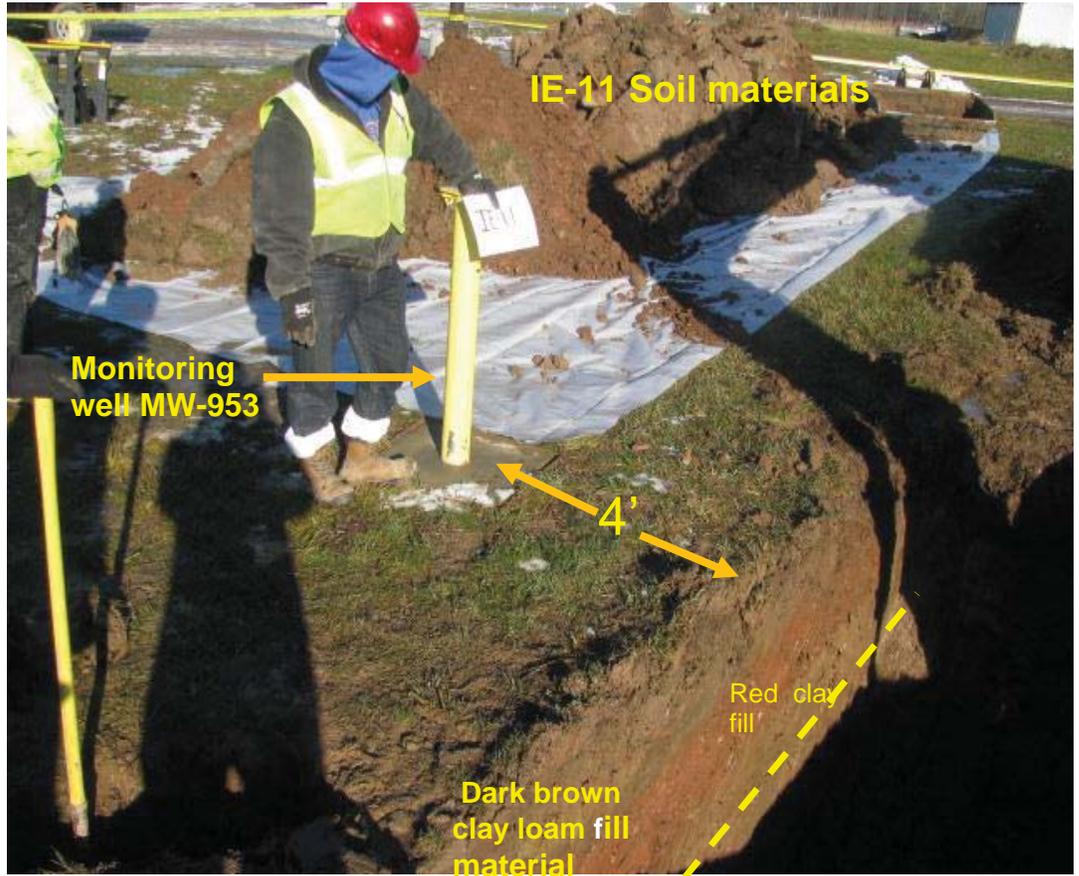
Photo taken looking north to show sewer proximity and associated potential impacts to adjacent monitoring well MW-953.

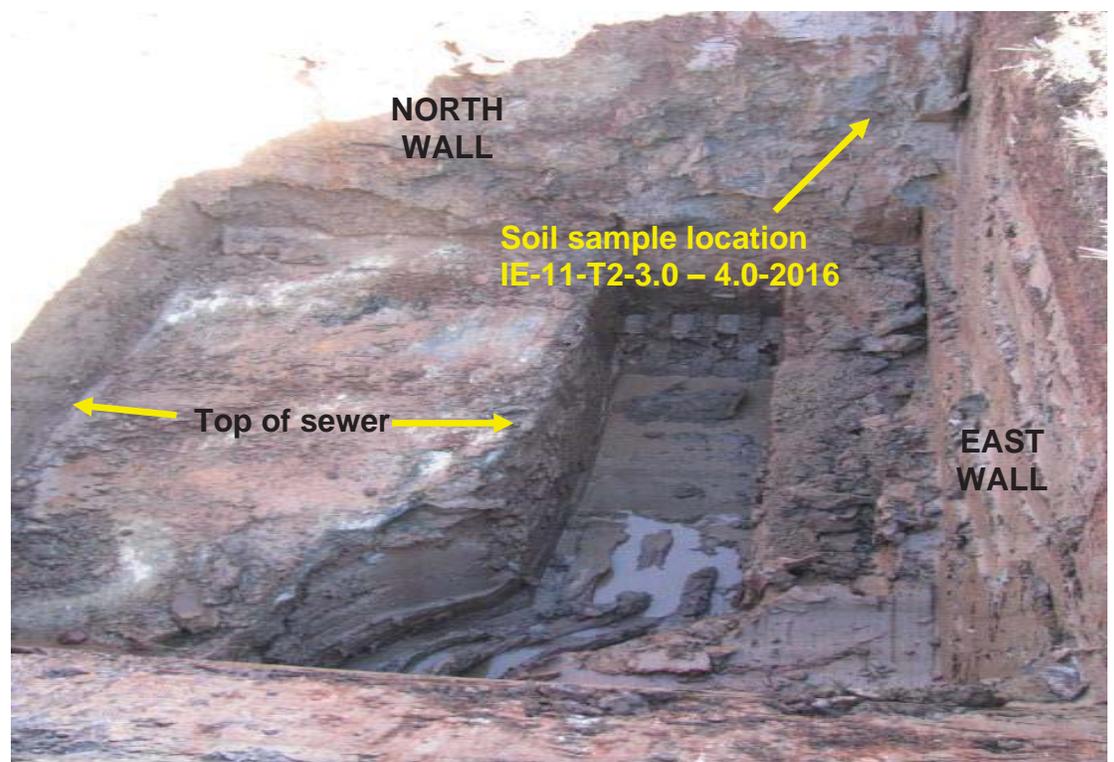
Photo No.
IE11-4

Photo taken looking north into trench to indicate the north wall soil sampling location, and to show the top of the sewer extending into the west wall toward monitoring well MW-953. Maximum trench depth in photo is ~10.5' bgs.

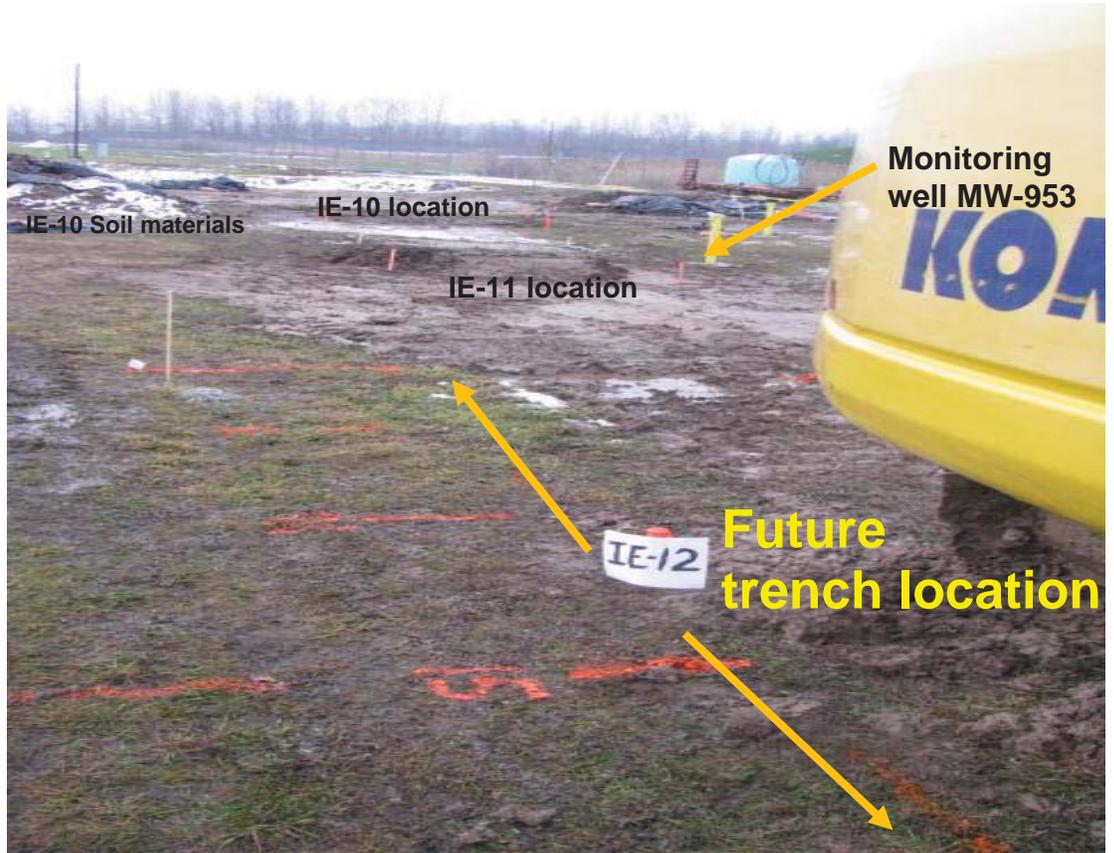
Photo taken looking south- southwest to show the trench/sewer orientation, monitoring wells MW-953/954 and proposed IE-12 location.

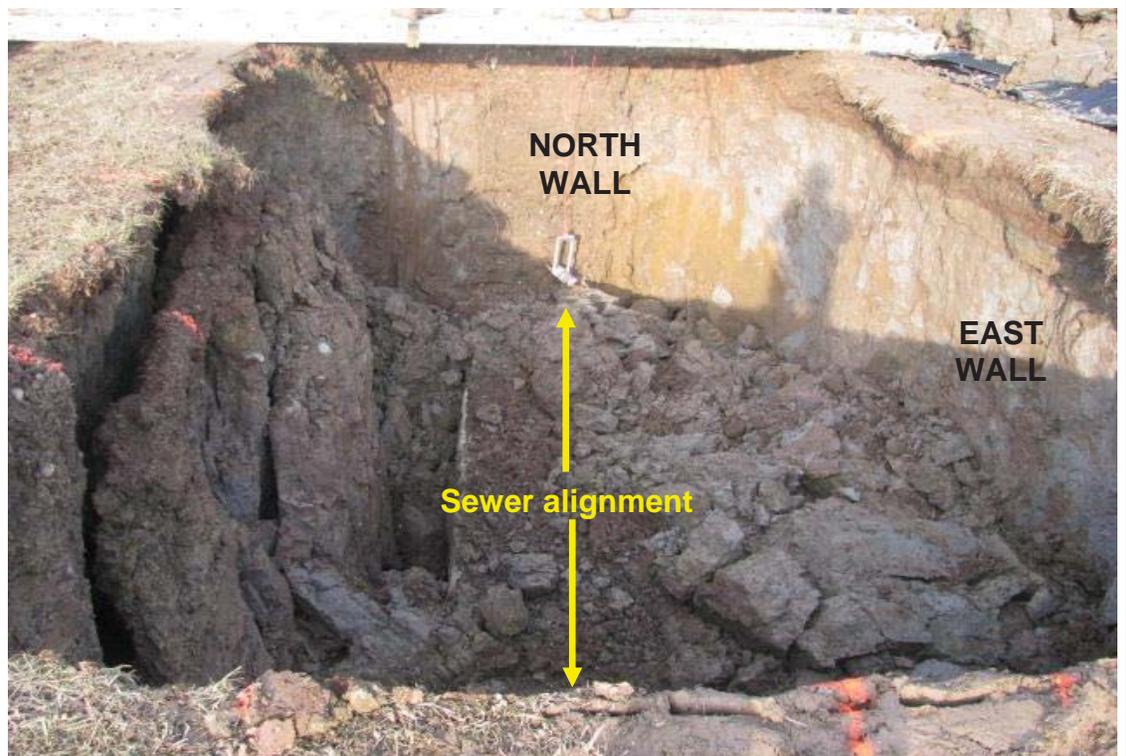
Photo No.
IE12-2

Due to the slightly larger dimensions of the excavation and physical properties of the overburden, the competency of the excavation sidewalls was susceptible to sloughing and wall collapse. Preferential sloughing was observed along north south aligned desiccation fractures.

Subsequent to completing IE-12, this photo was taken looking north into the trench. The photo documents the catastrophic slope failure of the overburden soil materials exposed along the excavation sidewalls. The soil materials broke along silt filled desiccation fractures.

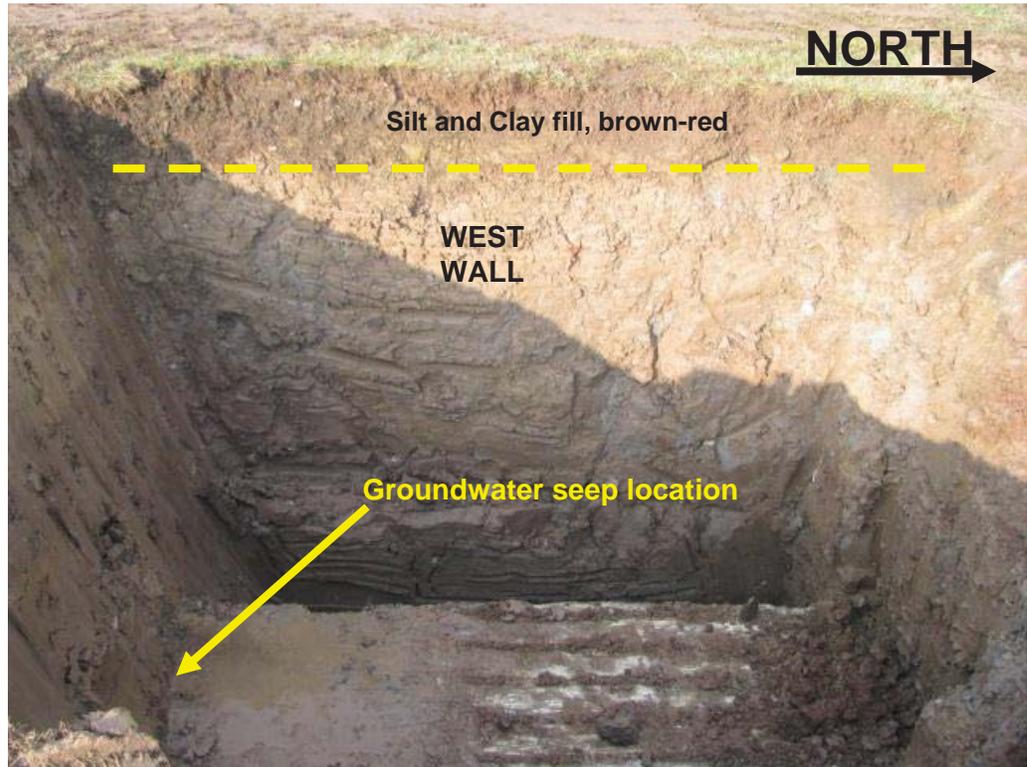
Prior to lengthening the excavation, the photo documents a westward view of IE-12 showing the interior of the excavation and groundwater seeping from the top of the sewer. .

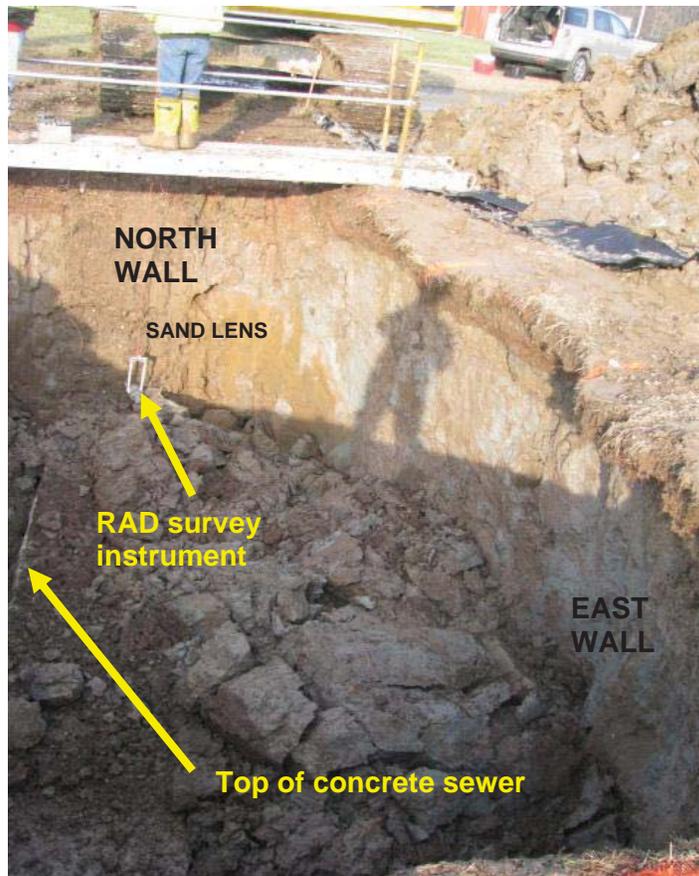
Photo No.
IE12-4

A northward view of the excavation IE-12 subsequent to collapse of the east sidewall. A discontinuous orange-brown sand lens can be seen along the north wall of the excavation where the RAD survey was being performed. A soil sample (IE12-T4-6.0-7.0-2022) was collected from this sand lens.

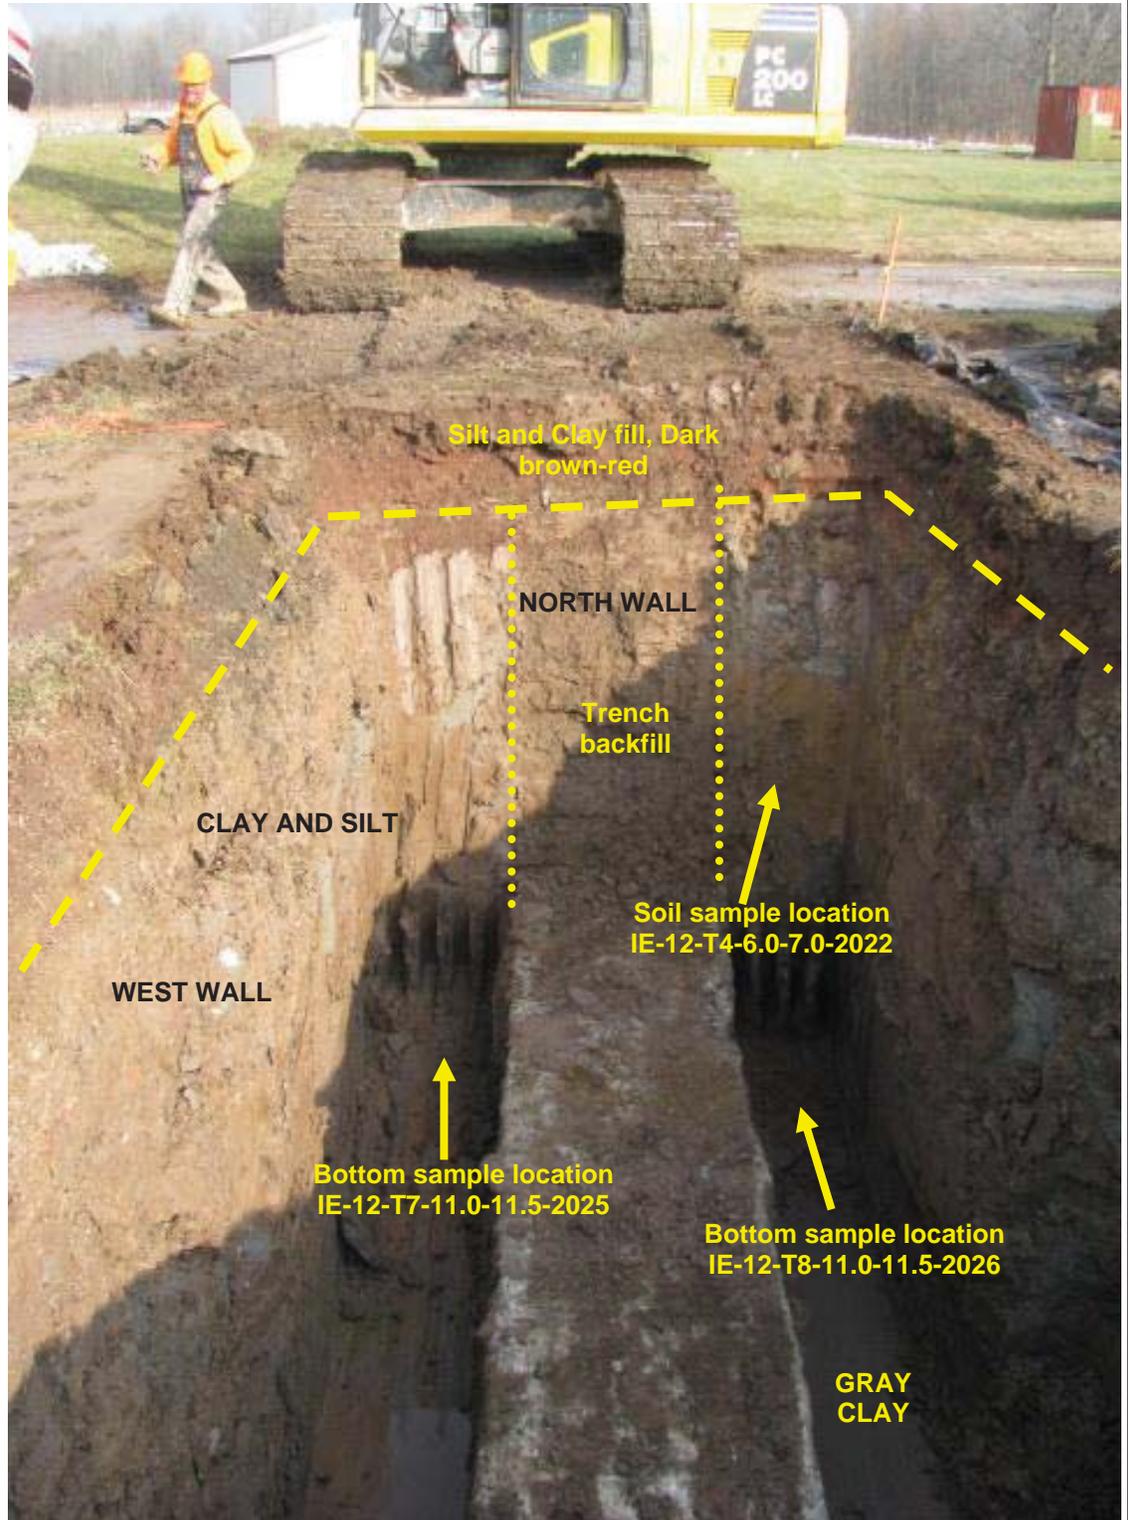
A view looking north into trench location IE-12 prior to the collapse of the east west sidewalls. The photo identifies the backfill material placed subsequent to the sewer installation in addition to the orange-brown sand lens located ~5.5'-7' bgs along the north wall just above the top of the sewer. Maximum depth of the excavation was 11.5' bgs.
