Appendix K

Investigative Excavation and Manhole Logs

PROJECT: Niagara Falls Storage Site (Lewiston, NY) BOP Field Investigation		EXCAVATION ID: IE-1
CLIENT/OWNER: USACE	JOB NUMBER: 11176781.00005	
DATE STARTED: 12/5/2012	URS GEOLOGIST: [REDACTED]	
DATE COMPLETED: 12/5/2012	URS HEALTH PHYSICIST: [REDACTED]	
CONTRACTOR: Russo Development	RUSSO OPERATOR & LABORER: [REDACTED]	
EQUIPMENT: John Deere 200 LC excavator, support truck and trailer, aluminum catwalk		
LOCATION: North side of former grit chamber, west-central portion of EU 11		
PURPOSE: Investigate possible contamination near grit chamber		
CORNER COORDINATES: (NE Cor.) N - 1171358.146, E - 1041306.307, Elev. 321.50; (SW Cor.) N - 1171354.757, E - 1041294.880, Elev. 320.83; (NW Cor.) N - 1171357.319, E - 1041294.792, Elev. 321.14; (SE Cor.) N - 1171355.683, E - 1041306.216, Elev. 321.11		
FINAL EXCAVATION DIMENSIONS: ~11' long x 2.2' wide x 10' deep

**Project: Niagara Falls Storage Site
(Lewiston, NY) BOP Field Investigation**

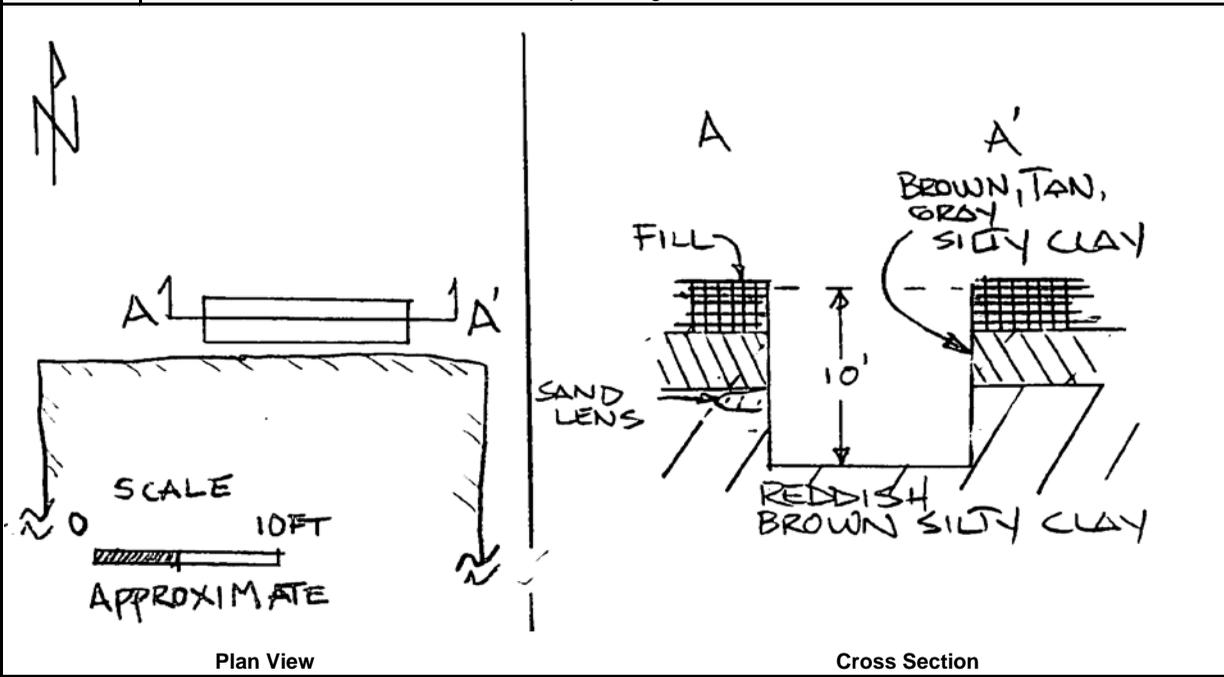
DEPTH (FT)	VERTICAL PROFILE DESCRIPTION
1	0 - 1.3' below ground surface (bgs): FILL/REWORKED MATERIAL (ML/CL) - Dark brown loamy clay top soil, moist, many fine roots with trace gravel; 7" concrete lip of grit chamber on south side of excavation

1.3' - 3.0' bgs: FILL - Red silty clay with trace to some angular to subangular F-C sand and gravel, granular texture (GC)
	3.0' - 3.5' bgs: Dark brown loamy clay (ML/CL) (buried top soil layer).
5	3.5'-6.0' bgs: Brown, yellowish brown, gray SILTY CLAY (CL), trace rounded gravel and cobbles, silty fine sand thin partings and lenses, moist, stiff, slightly plastic

6.0'-8.0' bgs: Reddish brown SILTY CLAY (CL), 3 sand lenses (fine sand, trace medium-coarse sand and fine gravel) on west wall at 6.0'-7.5' bgs that seeped water

8.0'-10.0' bgs: Reddish brown FINE SAND (SM), some silt & clay, trace coarse sand, gravel, & cobbles
10	moist Maximum depth 10' bgs

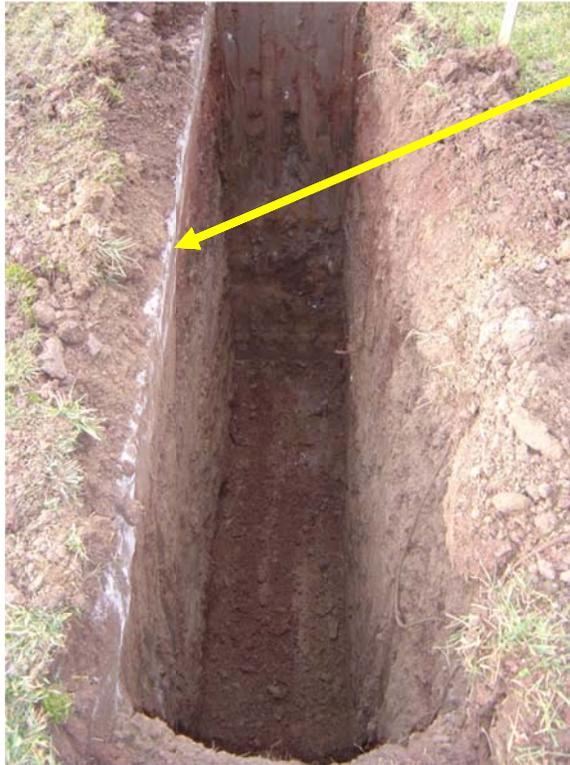
Photo No.
IE1-1

A westward view from the east end of excavation IE-1 showing the interior of the excavation.

**EDGE OF CONCRETE RIM
AT NORTH END OF GRIT
CHAMBER**

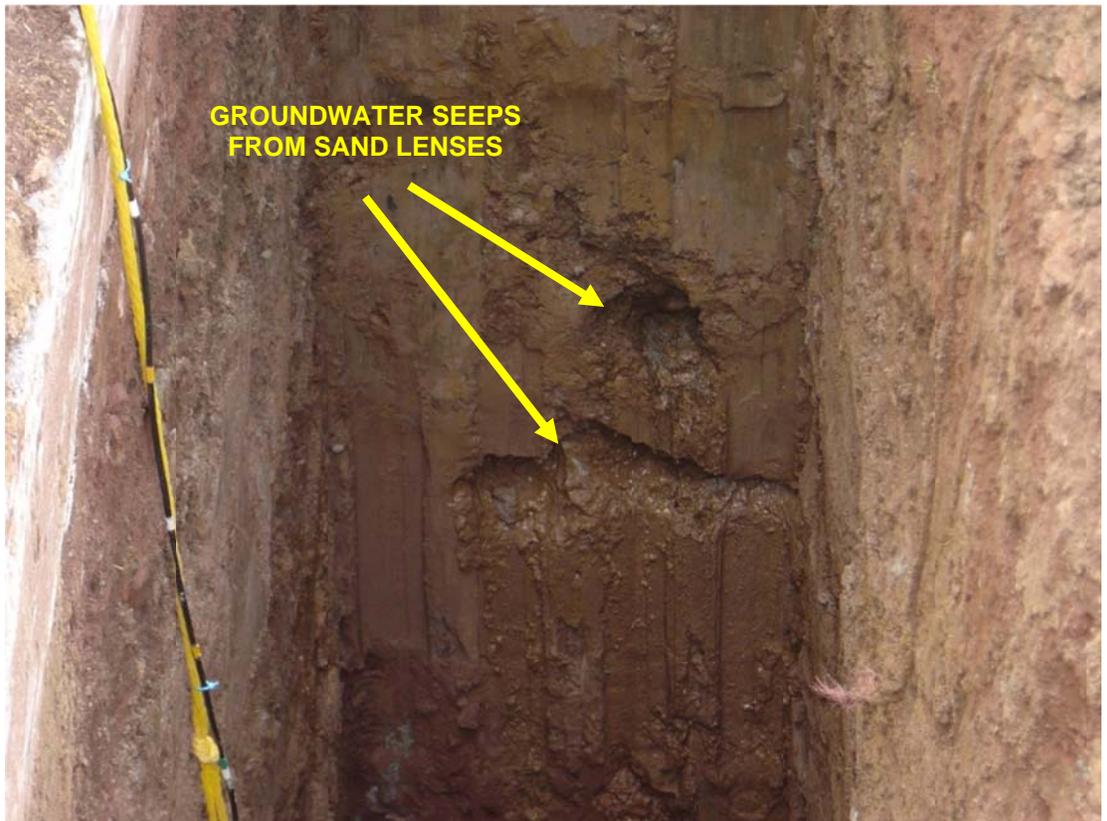
Photo No.
IE1-2

A westward view of the west wall of excavation IE-1 showing perched groundwater seeping from sand lenses located from ~ 6.0'-7.5' bgs; a soil sample (IE1TB26.0-7.5-0146) was collected from these sand lenses.

**GROUNDWATER SEEPS
FROM SAND LENSES**

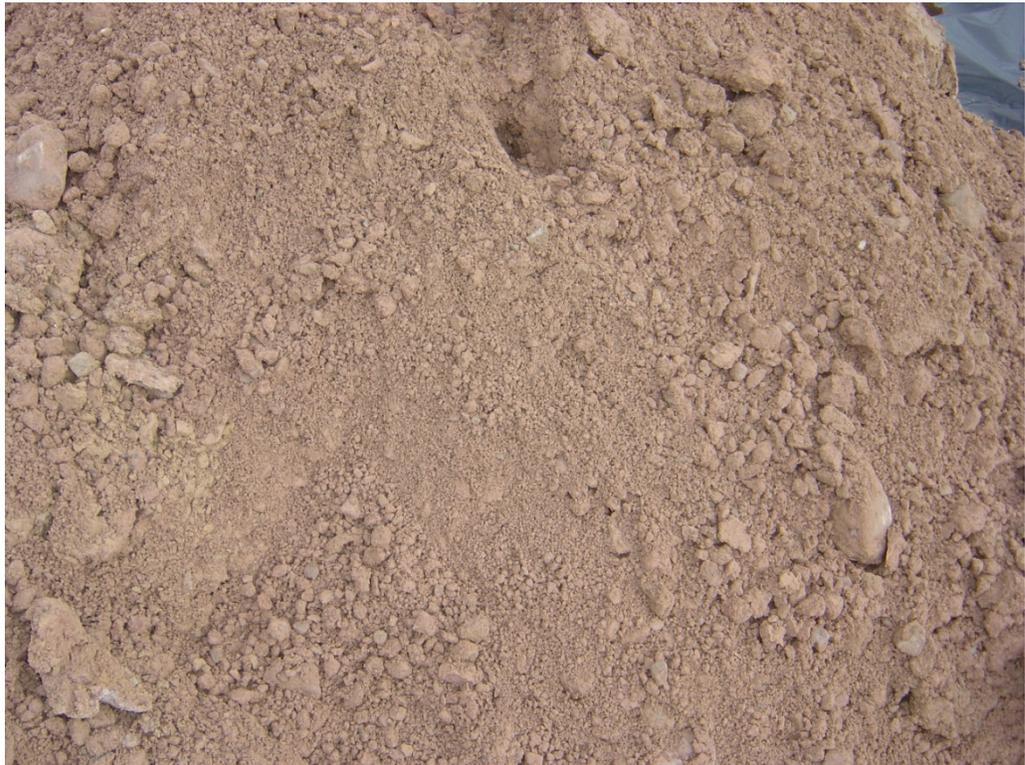
Photo No.
IE1-3

A view of stockpiled reddish brown sandier soil encountered from ~8'-10' bgs at location IE-1. The soil was moist, but not saturated with groundwater.

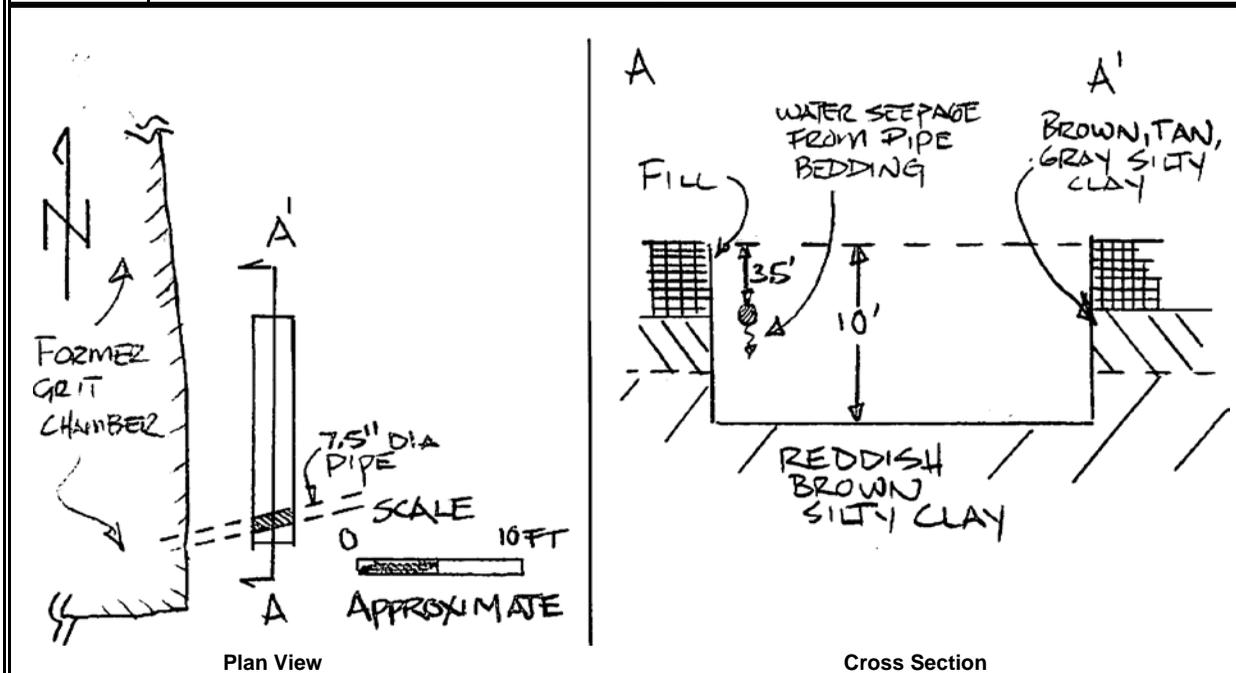
DEPTH (FT)	VERTICAL PROFILE DESCRIPTION
1	0 - 1.5' below ground surface (bgs): FILL/REWORKED MATERIAL (ML/CL) - Dark brown loamy clay top soil, moist, many fine roots with trace gravel; 8" concrete lip of grit chamber on west side of excavation

1.5'-3.5' bgs: FILL - Red silty clay with trace to some angular to subangular F-C sand and gravel, granular texture, moist (GC)
	3.5'- 4.0' bgs: Dark brown loamy clay (ML/CL) (buried top soil layer). Found 7.5" OD pipe at 3.5' bgs in fine to coarse sand bedding; water flowed from bedding.
5	4.0'-7.0' bgs: Brown, yellowish brown, gray SILTY CLAY (CL), trace rounded gravel and cobbles, orange and gray mottles, trace yellowish brown silty fine sand partings, moist, stiff, slightly plastic

7.0'-10.0' bgs: from 7.0'-8.0' bgs gradually grades to reddish brown SILTY CLAY (CL), trace rounded gravel, trace orange mottles and gray silty partings, moist, plastic, slightly sticky
10	Maximum depth 10' bgs.

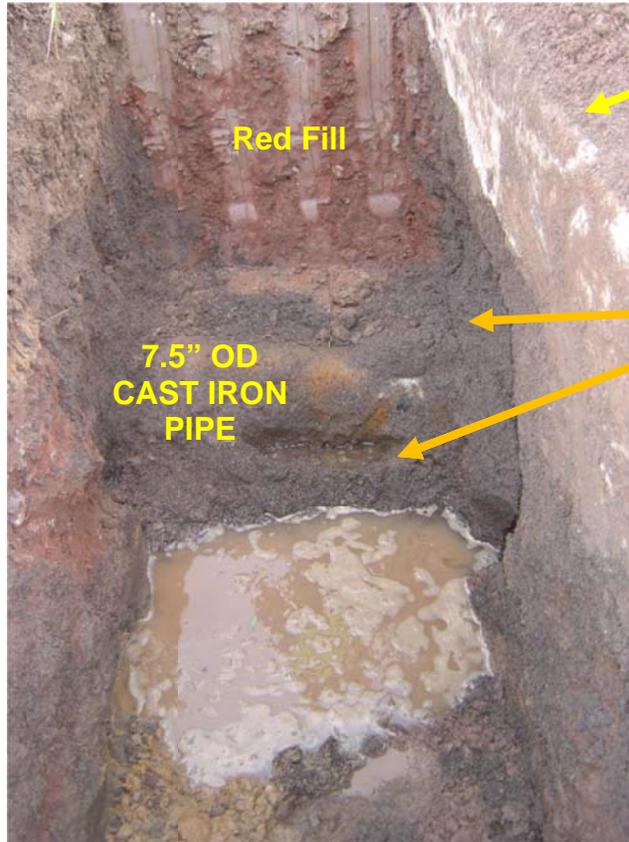
A southward view of the south end of excavation IE-2 (excavation depth is ~5' bgs at time of photo) showing the pipe connecting the concrete decontamination pad (to the east) to the grit chamber. The angular gray bedding around pipe was saturated and samples were collected from the pipe bedding (IE2TB24.0-4.5-0149) beneath the north side of the pipe and from the puddling water (IE2GW4.5-5.0-0150 and IE2GW4.5-5.0F-0150) that seeped out of the pipe bedding.

**EDGE OF CONCRETE RIM
AT EAST END OF GRIT
CHAMBER**

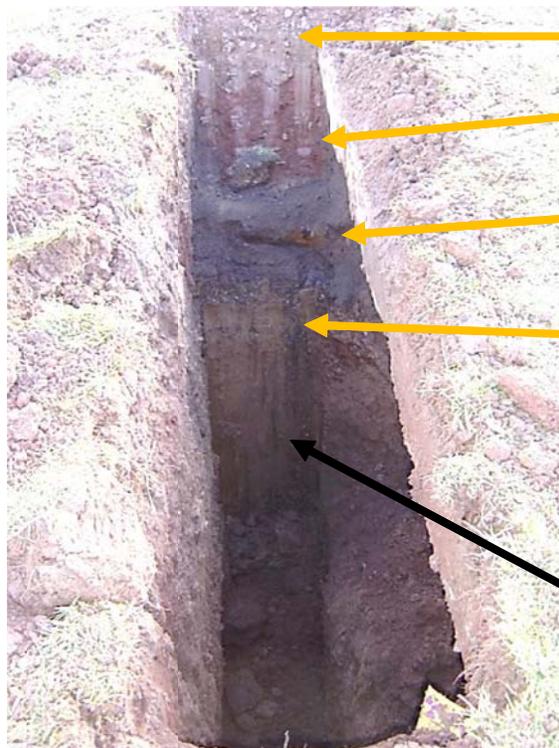
A southward view from the north end of excavation IE-2 showing the interior of the excavation.

Dark brown clay loam (fill)

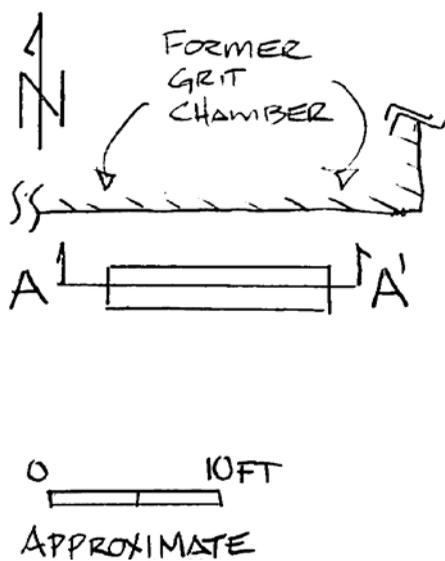
Plan View

DEPTH (FT)	VERTICAL PROFILE DESCRIPTION
1	0 - 1.8' below ground surface (bgs): FILL/REWORKED MATERIAL (SM/SW) - Angular fine to coarse SAND & angular fine gravel in a brown loamy clay matrix, moist, many fine roots, granular texture

1.8' - 3.4' bgs: FILL - Red silty clay with trace to some angular to subangular F-C sand and gravel, granular texture, moist (GC)
	3.4' - 4.0' bgs: Dark brown loamy clay (ML/CL) (buried top soil layer)
5	4.0' - 8.0' bgs: Brown, yellowish brown, gray SILTY CLAY (CL), trace rounded gravel and orange and pink mottles, slightly moist, very stiff, slightly plastic from 7'-10' bgs: trace to some gray silty partings & yellowish brown F-M sandy partings or seams, moist but not wet

8.0'-10.0' bgs: Reddish brown SILTY CLAY (CL), trace rounded gravel and cobbles, increase in moisture and plasticity, stiff. Some water seeps at bottom of excavation.
10	Maximum depth 10' bgs.

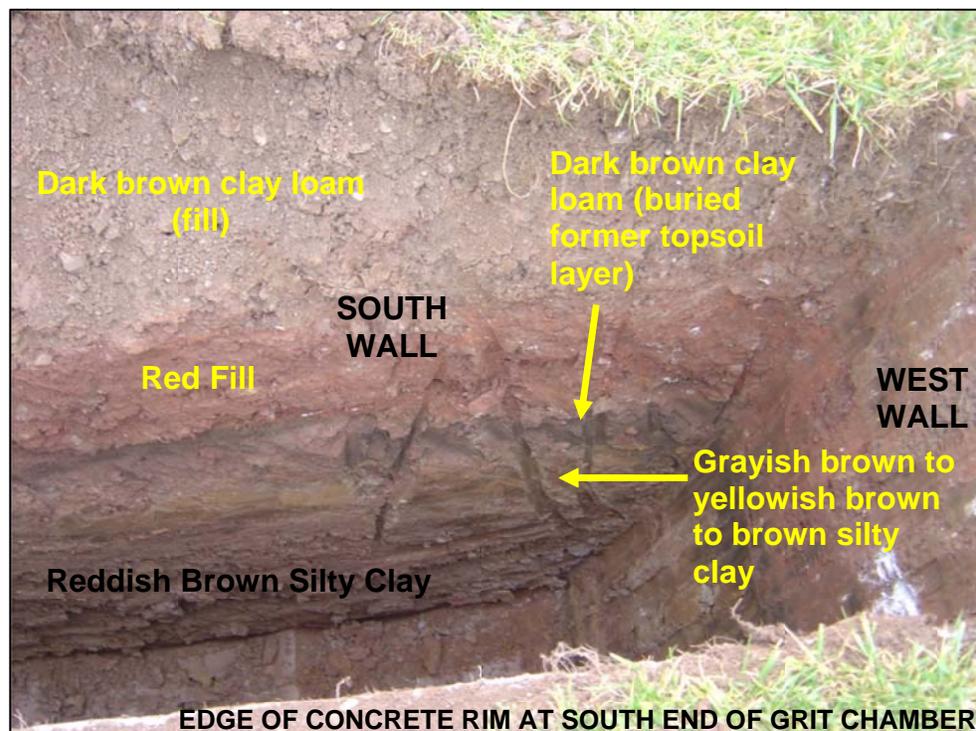
Photo No.
IE3-2

A southward view of the soil section on the south and west walls of trench IE-1; maximum trench depth in photo is ~10' bgs.

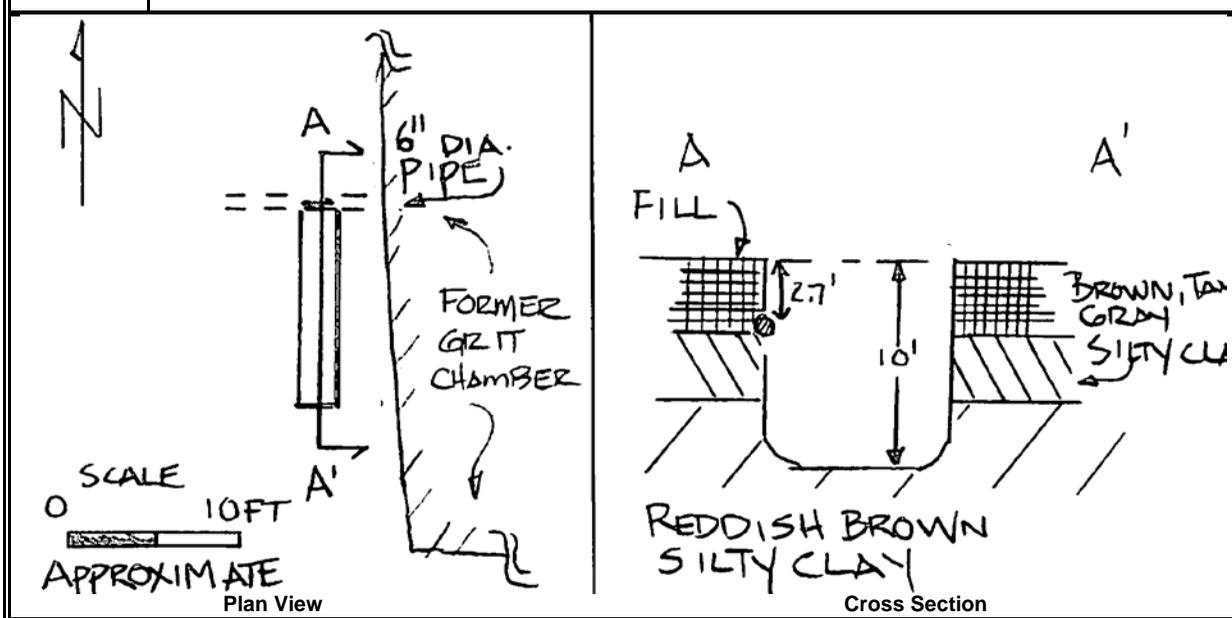
DEPTH (FT)	VERTICAL PROFILE DESCRIPTION
1	0 - 1.5' below ground surface (bgs): FILL/REGRADED MATERIAL (ML/CL) - Dark brown loamy clay topsoil, moist, many fine roots, trace rounded gravel

1.5' - 2.8' bgs: FILL - Red silty clay with trace to some angular to subangular F-C sand and gravel, granular texture, moist (GC)
	2' bgs: Found black crushed 55 gallon drum. No elevated Rad or PID readings.

2.7' bgs: 6" OD pipe found in north end of excaaction. Water seeped from sandy backfill around pipe
	2.8' - 3.2' bgs: Dark brown loamy clay (ML/CL) (buried top soil layer)
5	3.2'-7.0' bgs: Brown, yellowish brown, gray, SILTY CLAY (CL), trace rounded gravel and cobbles, some orange and gray mottles, some gray to yellowish brown silty-fine sandy partings, slightly moist

7.0'-10.5' bgs: Reddish brown SILTY CLAY (CL), trace rounded gravel, increase in moisture and plasticity, stiff. Some moist yellowish brown silty-fine sandy partings and seams up to 4" thick.
10	Maximum depth 10.5' bgs.

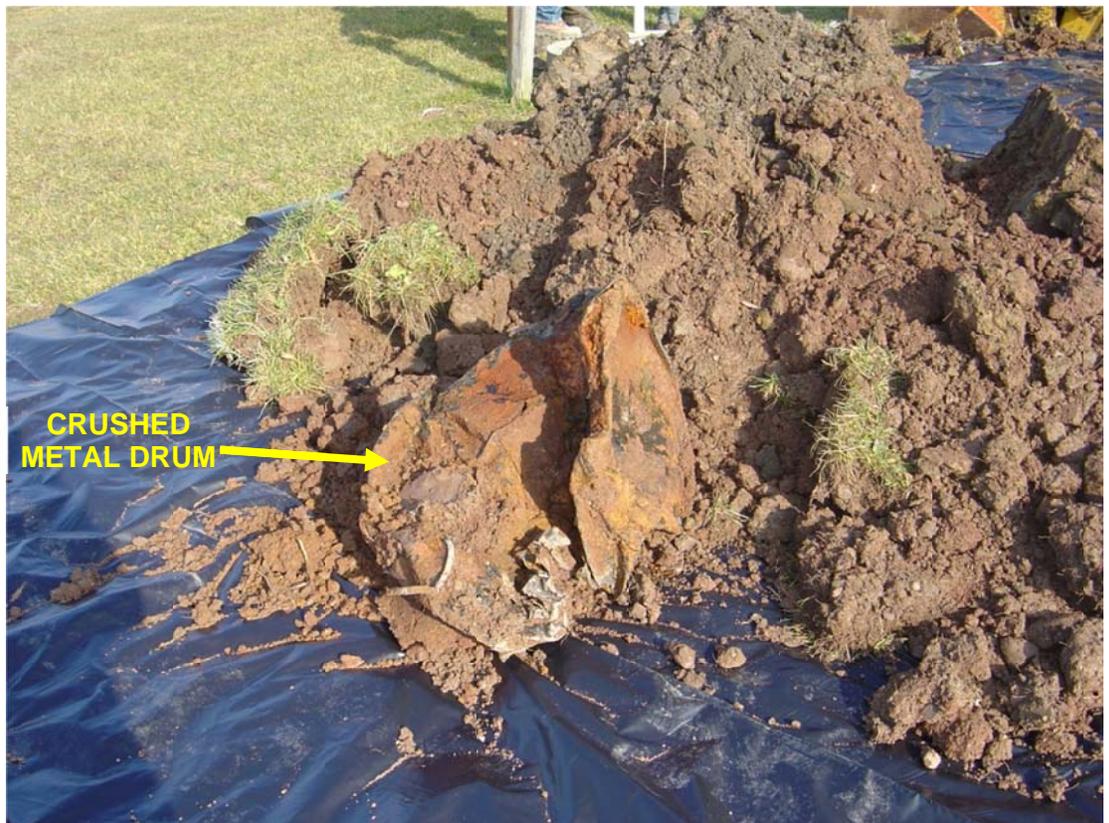
Photo No.
IE4-2

A northwestward view of a crushed metal drum found at ~2' bgs while excavating trench IE-4. The drum appeared to be empty, soils surrounding the drums did not show any impacts (i.e., staining or odors), and radiation monitor and photoionization detector readings from the drum and surrounding soils were at background levels.

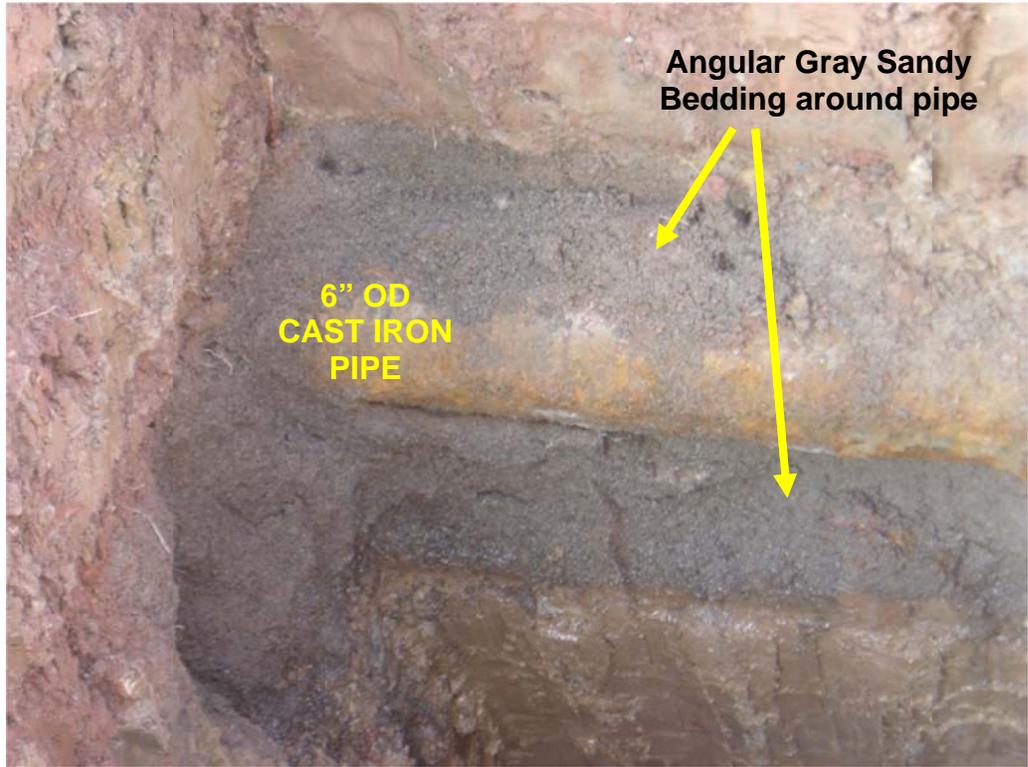
Sandy bedding material was present around the pipe. Water in bedding sand leaked into the excavation. No drop in water level observed in grit chamber lift station manhole.

A northward view of the north end of excavation IE-4 (excavation depth is ~5' bgs at time of photo) showing the pipe connecting the grit pad lift station (to the west) to the grit chamber. The angular gray bedding around pipe was saturated and samples were collected from the pipe bedding (IE4TB23.5-4.0-0132) beneath the south side of the pipe and from the puddling water (IE4GW4.0-4.5-0133 and IE4GW4.0-4.5F-0133) that seeped out of the pipe bedding.

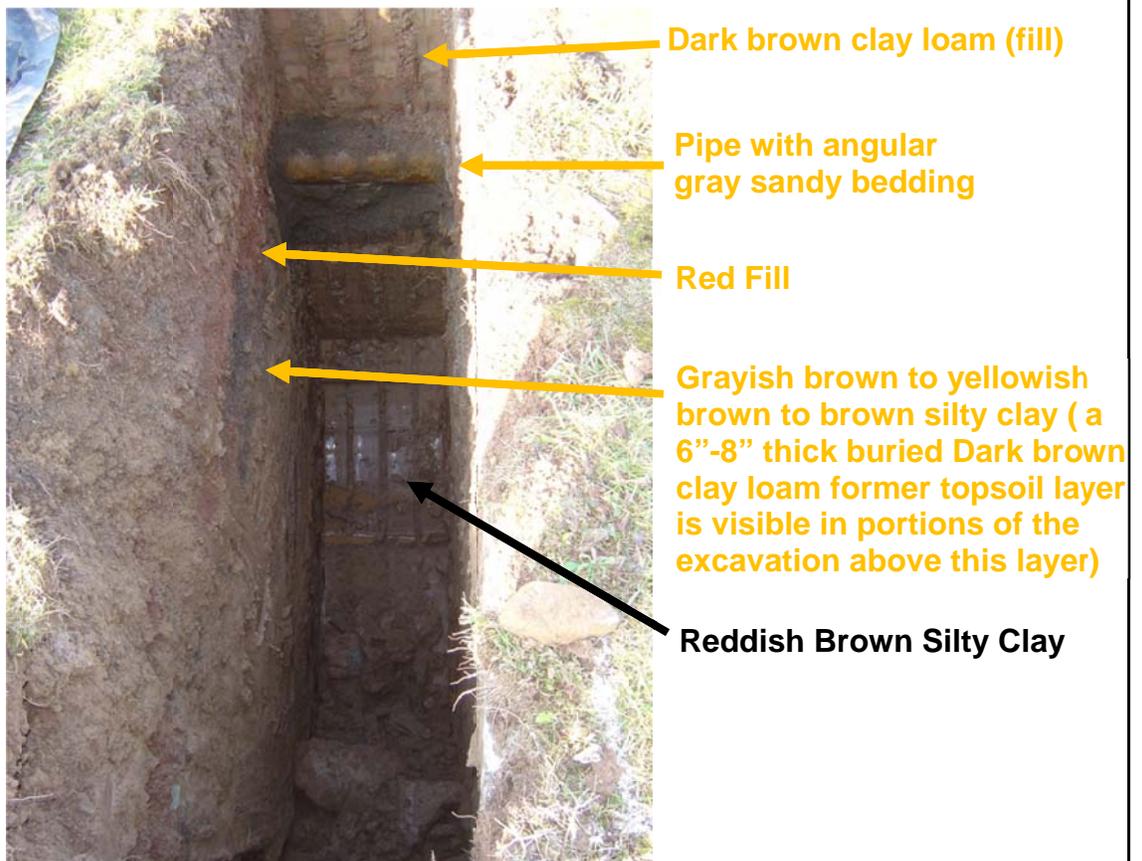
Photo No.
IE4-4

A northward view from the south end of excavation IE-4 showing the interior of the excavation.

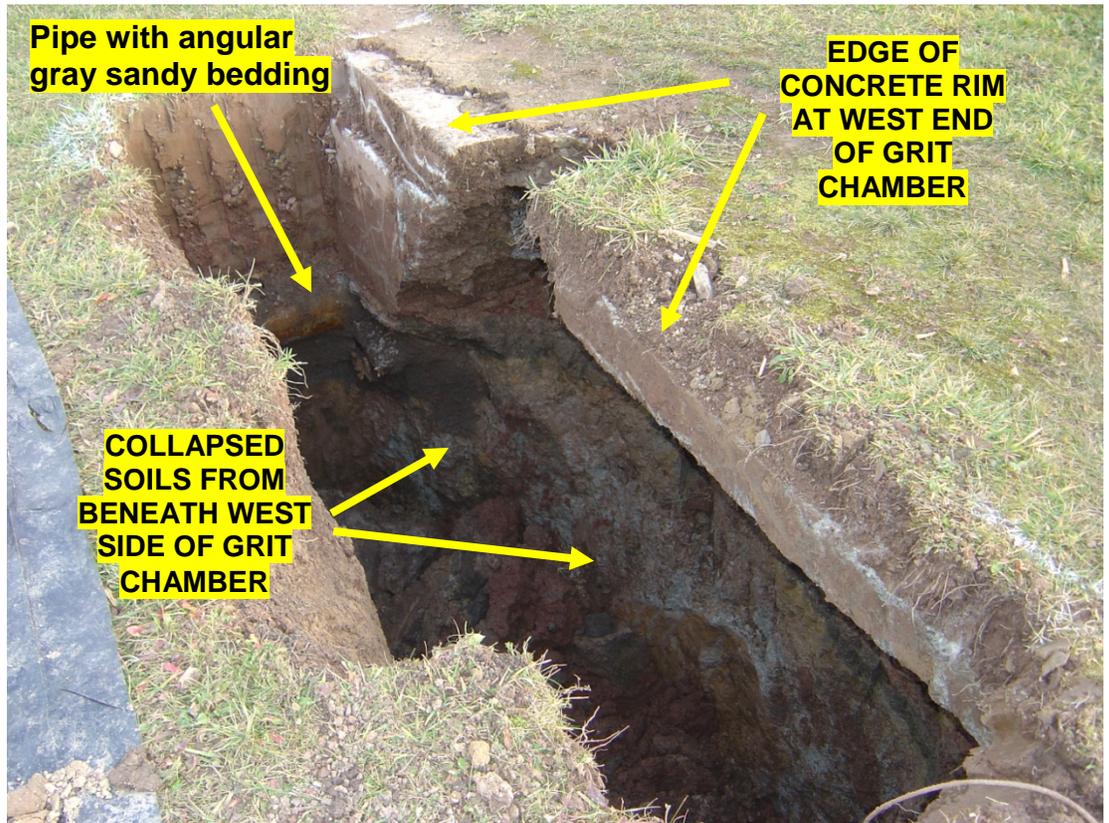
A north-northeastward view of the interior of excavation IE-4 after the east sidewall collapsed.

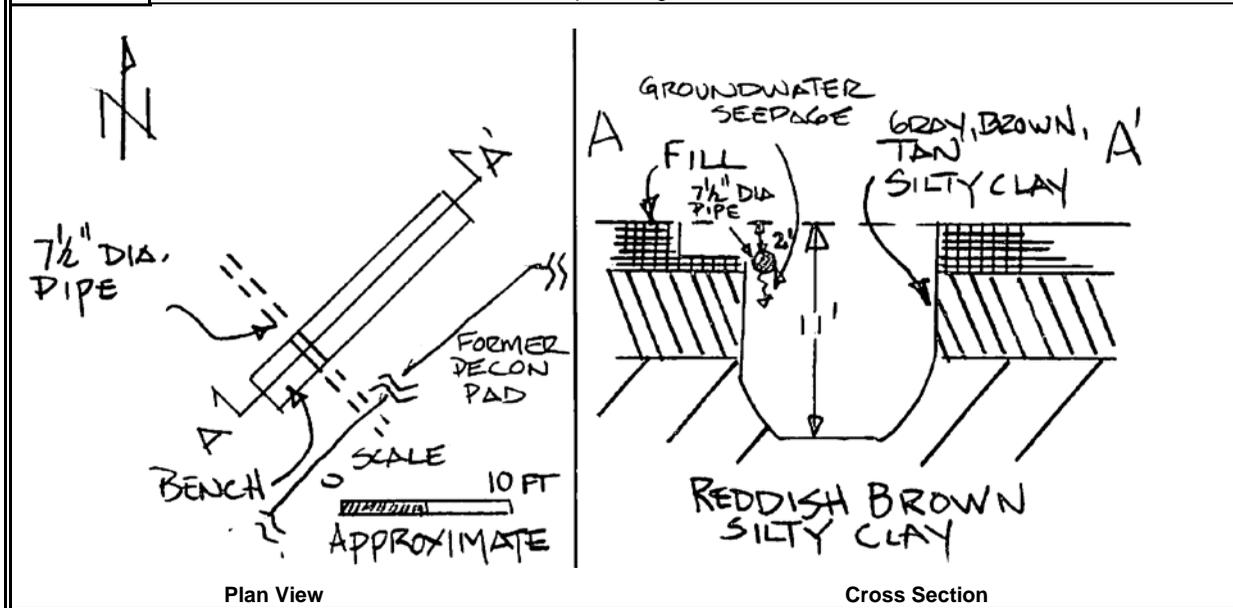
DEPTH (FT)	VERTICAL PROFILE DESCRIPTION
1	0 - 0.6' below ground surface (bgs): FILL/REWORKED MATERIAL (ML/CL) - Dark brown loamy clay topsoil, moist, many fine roots, trace rounded gravel

0.6' - 2.2' bgs: FILL - Red silty clay with some angular to subangular F-C sand and gravel, granular texture, moist (GC) 2.0' bgs: 7.5" OD pipe found in south end of excavation. Water seeped from sandy backfill around pipe

2.2' - 3.0' bgs: FILL/REWORKED MATERIAL - Brown SILTY CLAY (CL) and discontinuous Dark brown loamy clay (ML/CL) (buried top soil layer - up to 6" thick)
5	3.0'-7.0' bgs: Brown, yellowish brown, gray, SILTY CLAY (CL), trace rounded gravel and cobbles, some orange and gray mottles, some yellowish brown silty-fine sandy partings, slightly moist
10	7.0'-11.0' bgs: Reddish brown SILTY CLAY (CL), moist, plastic, firm, trace rounded gravel and cobbles, gray silty partings.
	Maximum depth 11' bgs.

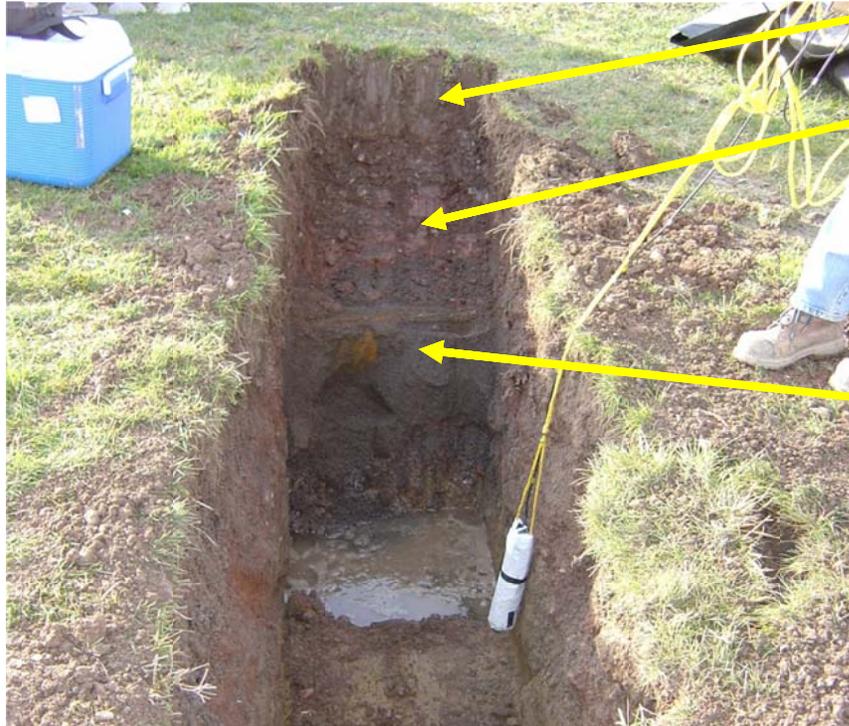
A south-southwestward view of the south end of excavation IE-5 (excavation depth is ~4.5' bgs at time of photo) showing the pipe connecting the former concrete decontamination pad (to the east) to the grit chamber. The angular gray bedding around pipe was saturated and samples were collected from the pipe bedding (IE5TB22.7-3.2-0154) beneath the north side of the pipe and from the puddled water (IE5GW2.7-3.4-0155 and IE5GW2.7-3.4F-0155) that seeped out of the pipe bedding (bottom center of photo).

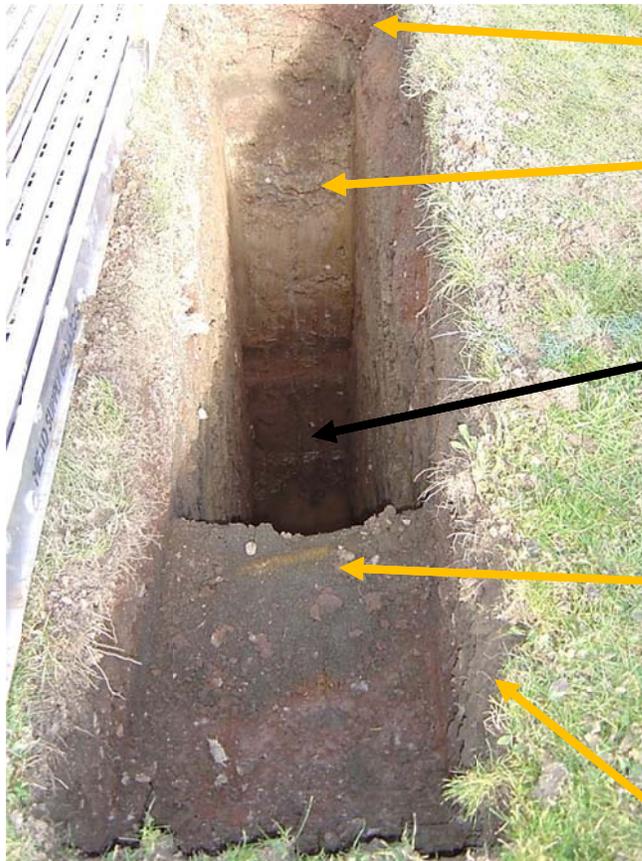
A northward view from the south end of excavation IE-4 showing the interior of the excavation.

Red Fill

**Grayish brown to yellowish
brown to brown silty clay (a
6"-8" thick buried Dark brown
clay loam former topsoil layer
is visible in portions of the
excavation above this layer)**

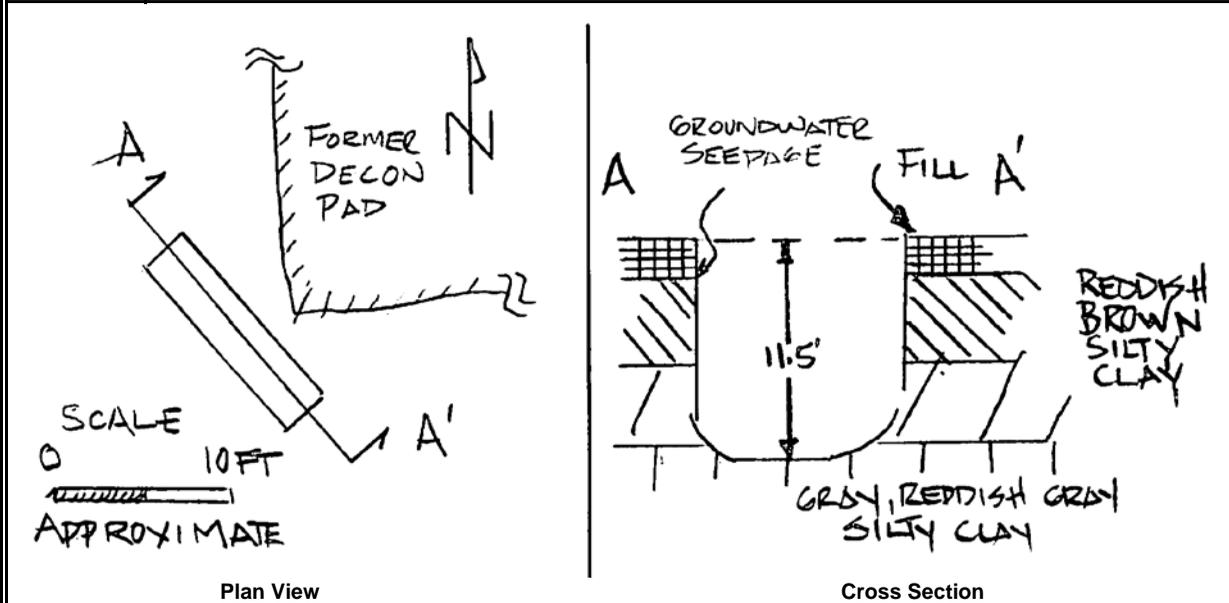
DEPTH (FT)	VERTICAL PROFILE DESCRIPTION
1	0 - 1.0' below ground surface (bgs): FILL - Gray fine sand to coarse gravel (#3 crusher run) (underlain by geotextile fabric in NW end of excavation), moist to wet

1.0' - 2.0' bgs: FILL - Red silty clay with some angular to subangular F-C sand and gravel, granular texture, moist to wet (GC)
	2.0'-2.7' bgs: Dark brown loamy clay (ML/CL) (buried top soil layer), moist; some lenses of dry, compact black silt, trace clay (ML)
5	2.7'-6.5' bgs: Brown, yellowish brown, gray SILTY CLAY (CL), trace rounded gravel and cobbles, some orange and gray mottles, some yellowish brown silty-fine sandy partings and lenses to 3" thick, slightly moist.

6.5'-11.0' bgs: Reddish brown SILTY CLAY (CL), slightly moist, very stiff, trace rounded gravel and cobbles, gray silty partings.
10	
	11.0'-11.5' bgs: Brownish gray to pinkish gray SILTY CLAY (CH), moist, very plastic, sticky.

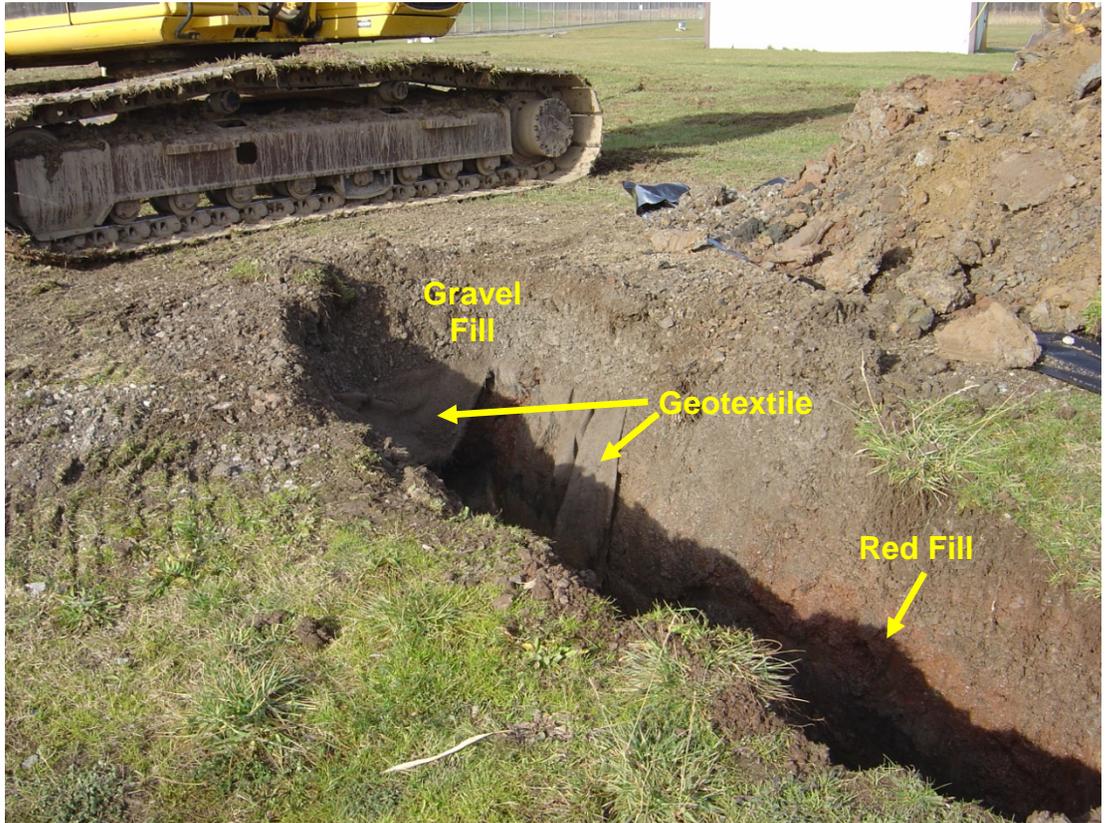
A northward view of the IE-6 trench excavation showing a section across the former gravel access ramp to southwest end of decontamination pad.

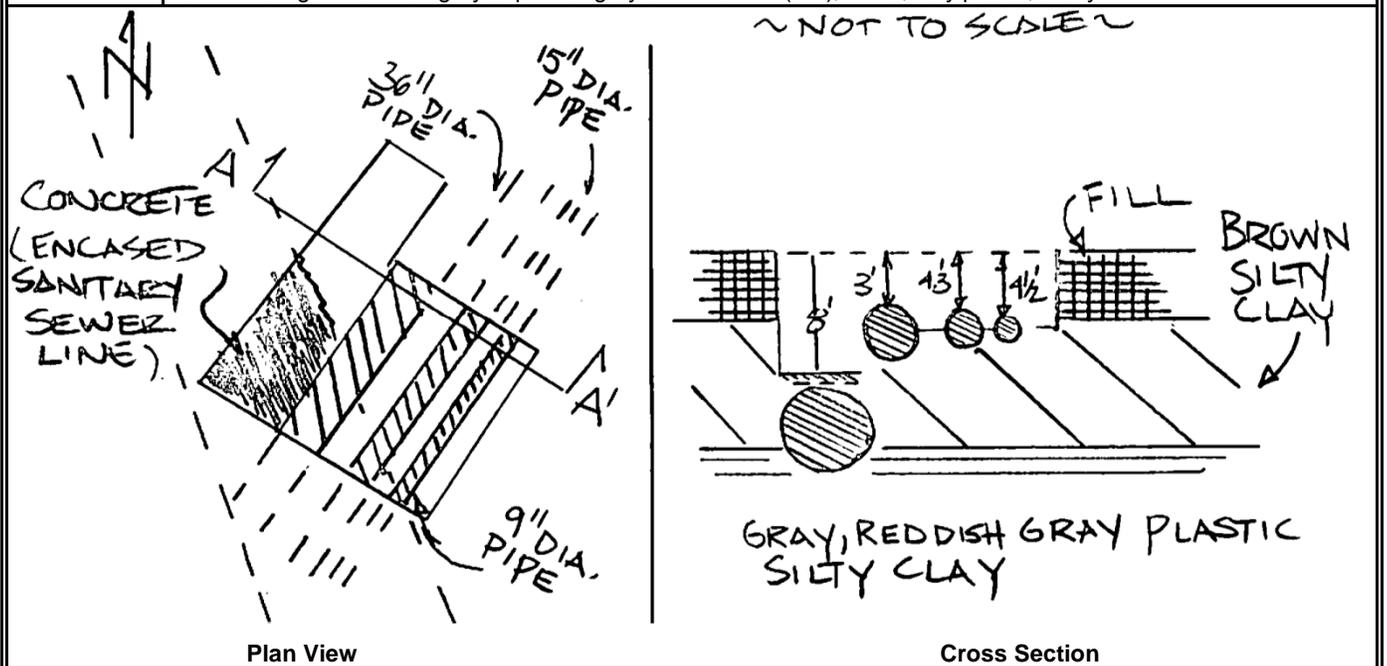
DEPTH (FT)	VERTICAL PROFILE DESCRIPTION
1	0 - 1.5' below ground surface (bgs): FILL/REWORKED MATERIAL (ML/CL) - Dark brown loamy clay topsoil, moist, many fine roots, trace rounded gravel

1.5'-3.0' bgs: FILL - Red silty clay with some angular to subangular F-C sand and gravel, granular texture, moist to wet (GC), mainly at the south and east ends of IE7

3.0'-10.5' bgs: Brown to reddish brown SILTY CLAY (CL), moist, firm, plastic, some orange and gray mottles, some yellowish brown silty-fine sandy partings.
5	Three pipelines running NE-SW found between 3' to 4.5' bgs.
	Concrete-encased sanitary sewer running NNE-SSW found at 8' bgs on north end of excavation. Groundwater seeped in from surrounding soils along top of concrete-encased sewer pipeline.
10	
	10.5'-11.0' bgs: Brownish gray to pinkish gray SILTY CLAY (CH), moist, very plastic, sticky.

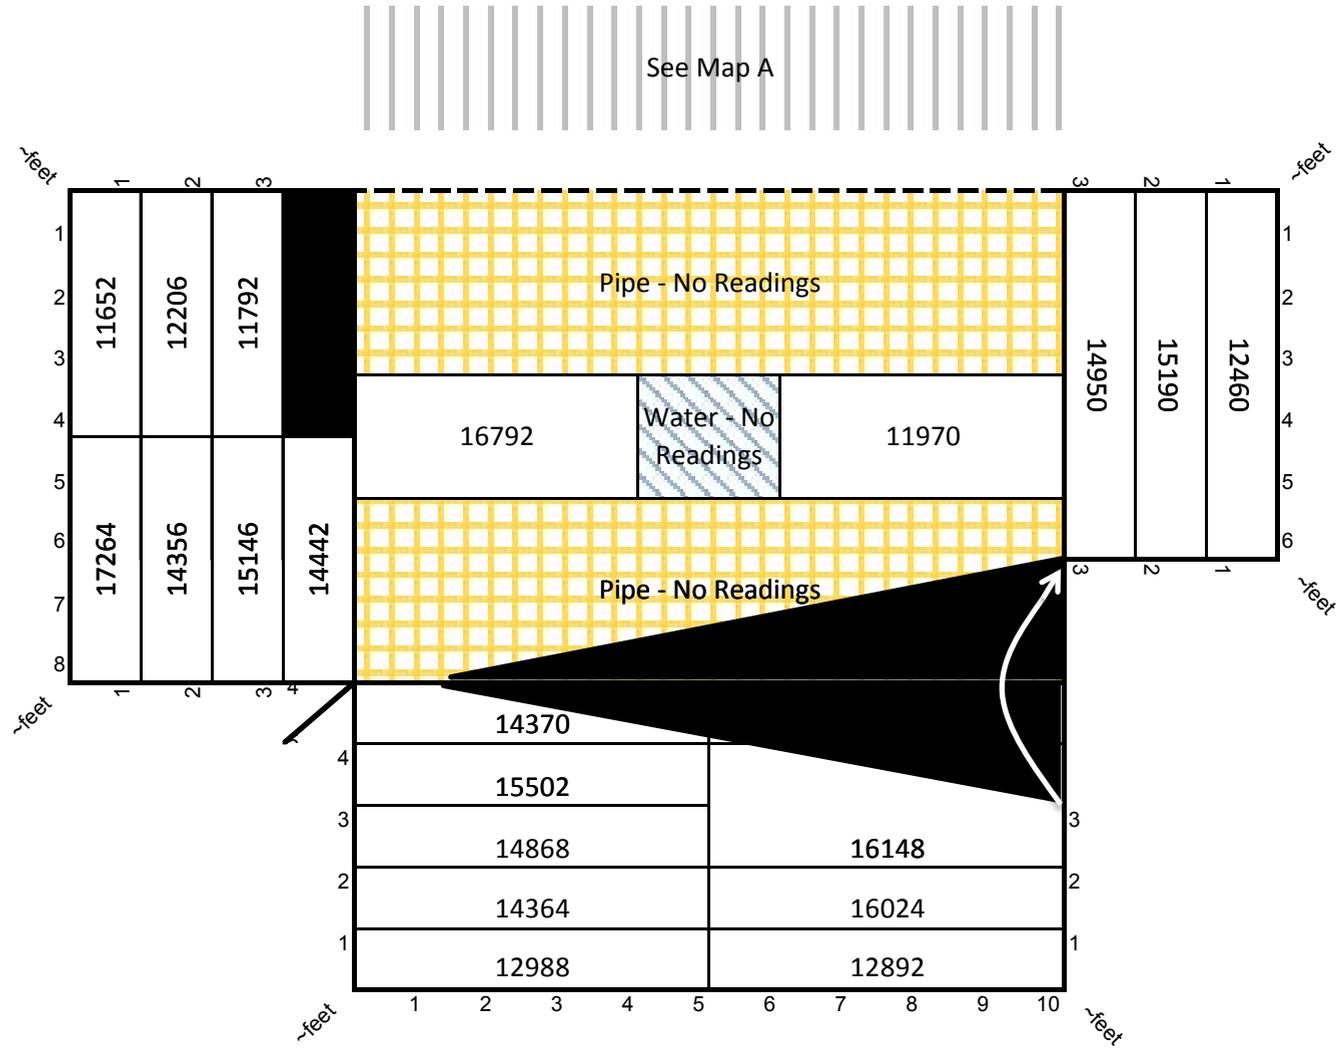
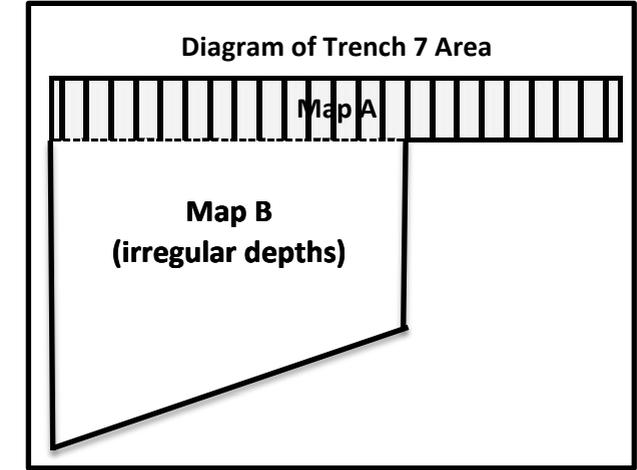
Gamma survey of IE 7 - Map B
Using 2-inch NaI (Ludlum 2221 w/44-10)
Results in CPM

NOTE: Excavated soils were routinely scanned during excavation. Gamma results ranged from 9,000-15,000 cpm, with the majority between 10,000-12,000 cpm.

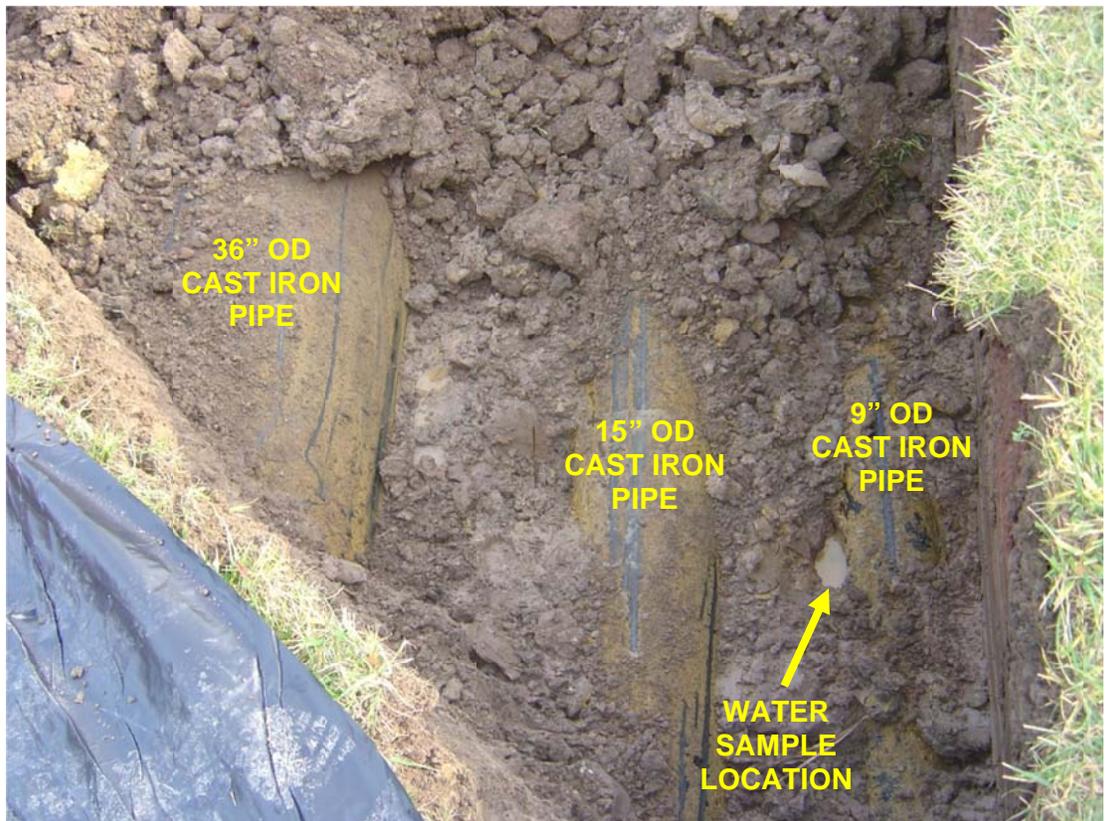
**Photo No.
IE7-2**

An northeastward view of the cast iron pipes encountered in excavation IE-7. A water sample (IE7GW5.0-6.0-0137 and IE7GW5.0-6.0F-0137) was collected from an area of groundwater seepage between the 9\" and 15\" OD cast iron pipes.

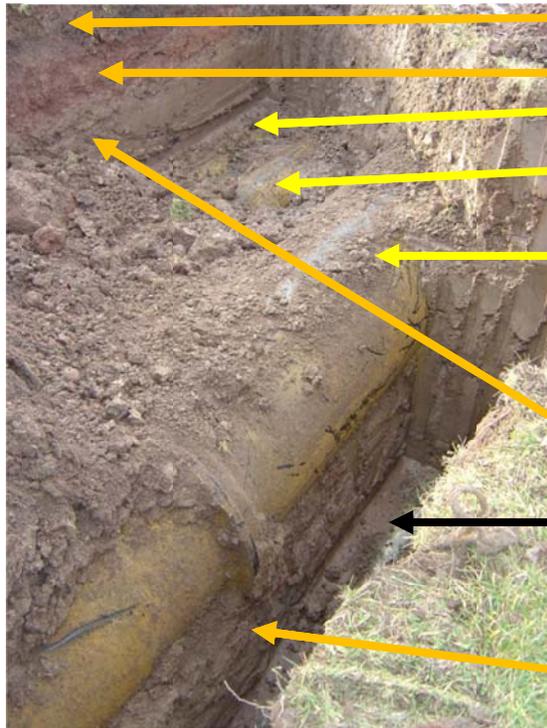
A south-southwestward view from the northeast corner of excavation IE-7 (top of concrete-encased sewer pipe is ~8' bgs) showing the relationship of the 3 cast iron water pipes (southwest-northeast orientation) and the underlying concrete-encased sanitary sewer line (north-south orientation). The soil section encountered in the excavation is also labeled.

Dark brown clay loam (fill)

Red Fill

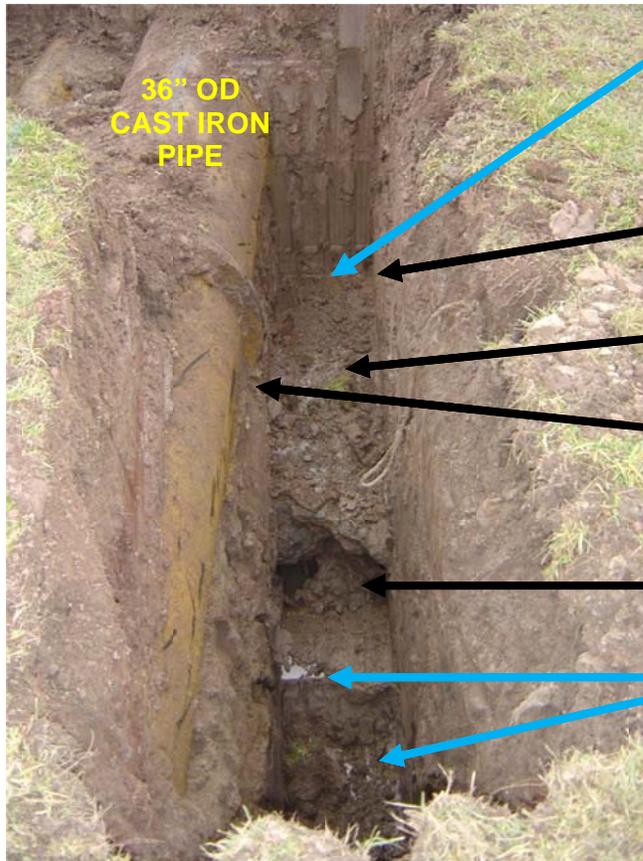
A southwestward view from the northeast corner of excavation IE-7 showing the subsurface soil sample locations and groundwater seep locations around the concrete-encased sanitary sewer line. The groundwater seeps in the vicinity of the concrete-encased sanitary sewer line did not produce enough volume to sample.

36" OD
CAST IRON
PIPE

Groundwater seep

A north-northeast/south-southwest trending concrete encased sewer line was encountered at a depth of 8' bgs in the north end of the excavation running beneath three pipelines. A small amount of water seepage was observed coming from the top of the concrete encasement (not enough to sample). Utility maps show this sewer line.

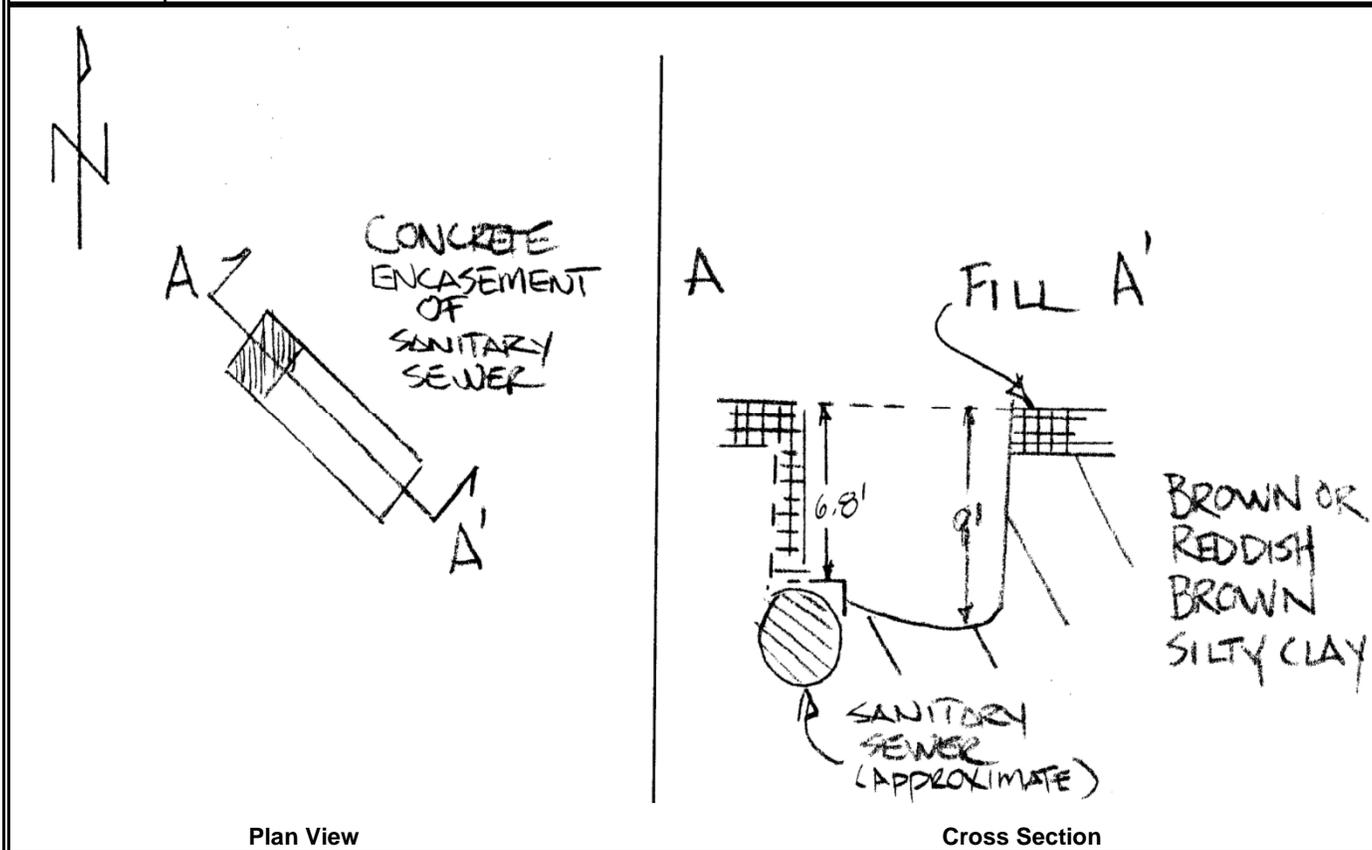
DEPTH (FT)	VERTICAL PROFILE DESCRIPTION
1	0 - 1.5' below ground surface (bgs): FILL/REWORKED MATERIAL (ML/CL) - Dark brown, loamy clay topsoil, trace rounded gravel and cobbles, moist, many fine roots, granular texture
	1.5'-9.0' bgs: Brown or reddish brown SILTY CLAY (CL), trace rounded gravel and cobbles, moist, firm, plastic, some orange and gray mottles, some yellowish brown silty-fine sandy partings
5	
	6.8' bgs: Concrete-encased sanitary sewer line encountered at north end of excavation. Some groundwater seeped into excavation from surrounding soils along the top of concrete-encased sewer pipeline.
9	Maximum depth 9.0' bgs
