Appendix K

Investigative Excavation and Manhole Logs

PROJECT: Niagara Falls Storage Site (Lewiston, NY) BOP Field Investigation		EXCAVATION ID: IE-1
CLIENT/OWNER: USACE	JOB NUMBER: 11176781.00005	
DATE STARTED: 12/5/2012	URS GEOLOGIST: [REDACTED]	
DATE COMPLETED: 12/5/2012	URS HEALTH PHYSICIST: [REDACTED]	
CONTRACTOR: Russo Development	RUSSO OPERATOR & LABORER: [REDACTED]	
EQUIPMENT: John Deere 200 LC excavator, support truck and trailer, aluminum catwalk		
LOCATION: North side of former grit chamber, west-central portion of EU 11		
PURPOSE: Investigate possible contamination near grit chamber		
CORNER COORDINATES: (NE Cor.) N - 1171358.146, E - 1041306.307, Elev. 321.50; (SW Cor.) N - 1171354.757, E - 1041294.880, Elev. 320.83; (NW Cor.) N - 1171357.319, E - 1041294.792, Elev. 321.14; (SE Cor.) N - 1171355.683, E - 1041306.216, Elev. 321.11		
FINAL EXCAVATION DIMENSIONS: ~11' long x 2.2' wide x 10' deep

**Project: Niagara Falls Storage Site
(Lewiston, NY) BOP Field Investigation**

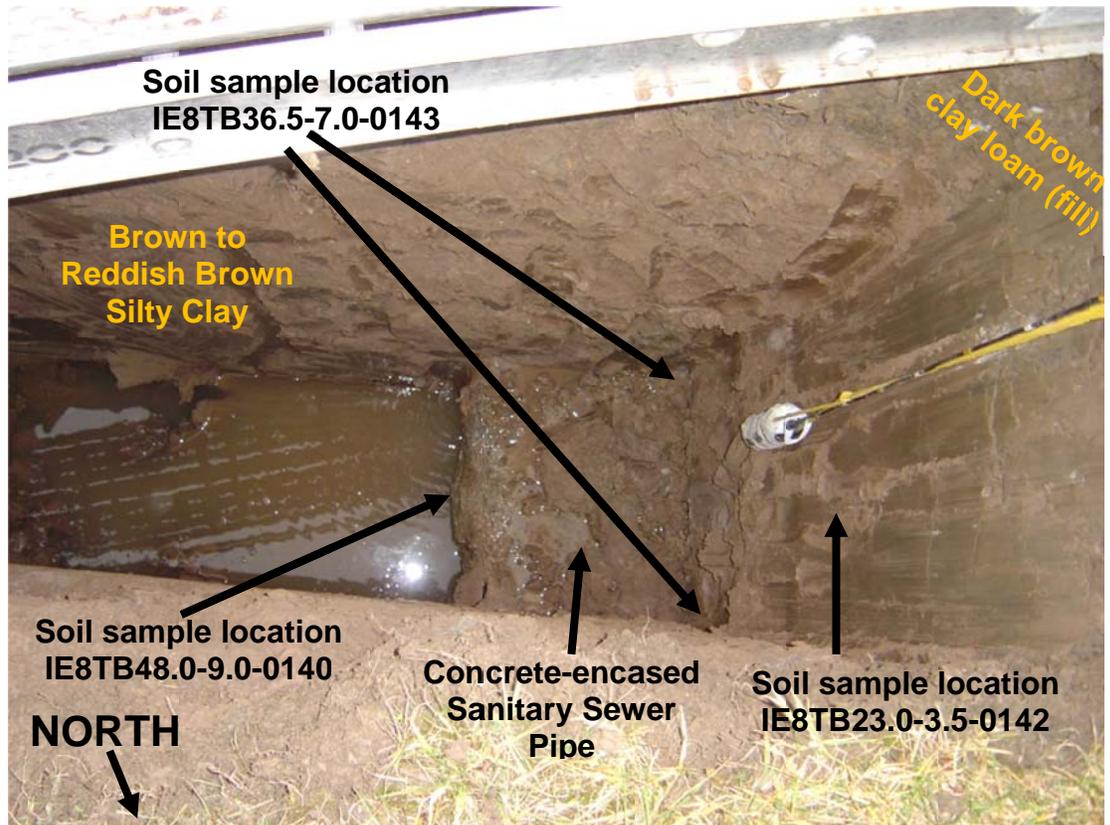
A north-northeast/south-southwest trending concrete encased sewer line was encountered at a depth of 7' bgs in the northwest end of the excavation. Water seepage was observed coming from the top of the concrete encasement. Utility maps show this sewer line.

A southwestward view of the bottom of excavation IE-8 showing the concrete-encased sanitary sewer line (north-south orientation) and water that seeped into the excavation from around the sewer line (water sample IE8GW8.0-9.0-0141).

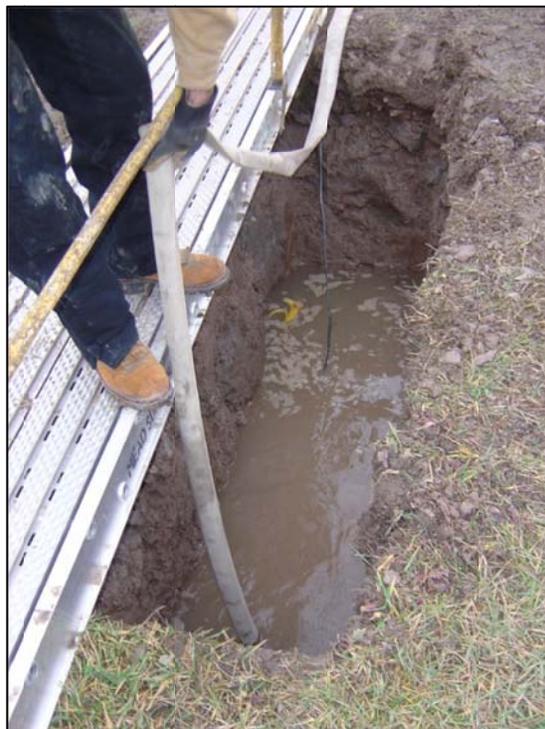
A southeastward view from the west end of excavation IE-8. The excavation had filled with water to ~3' bgs overnight and required pumping prior to backfilling.

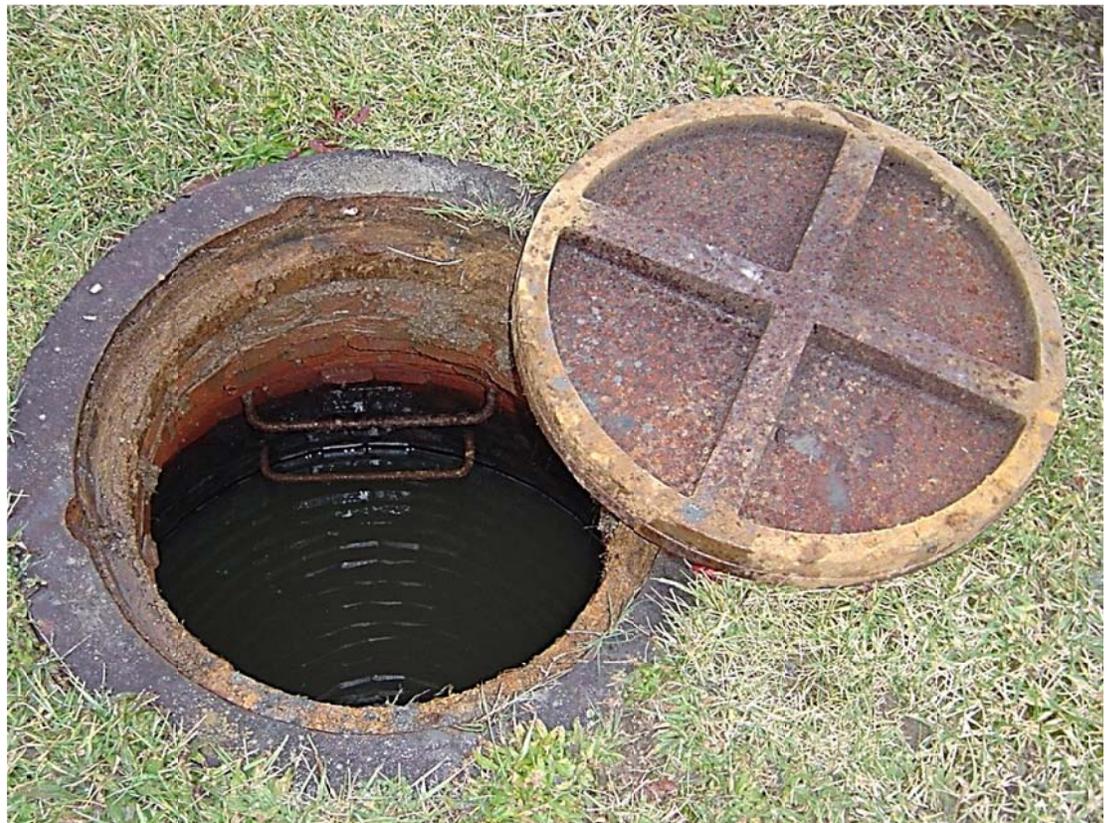
Photo No.
MH08-2

A view of the interior of Manhole 08 prior to decommissioning.

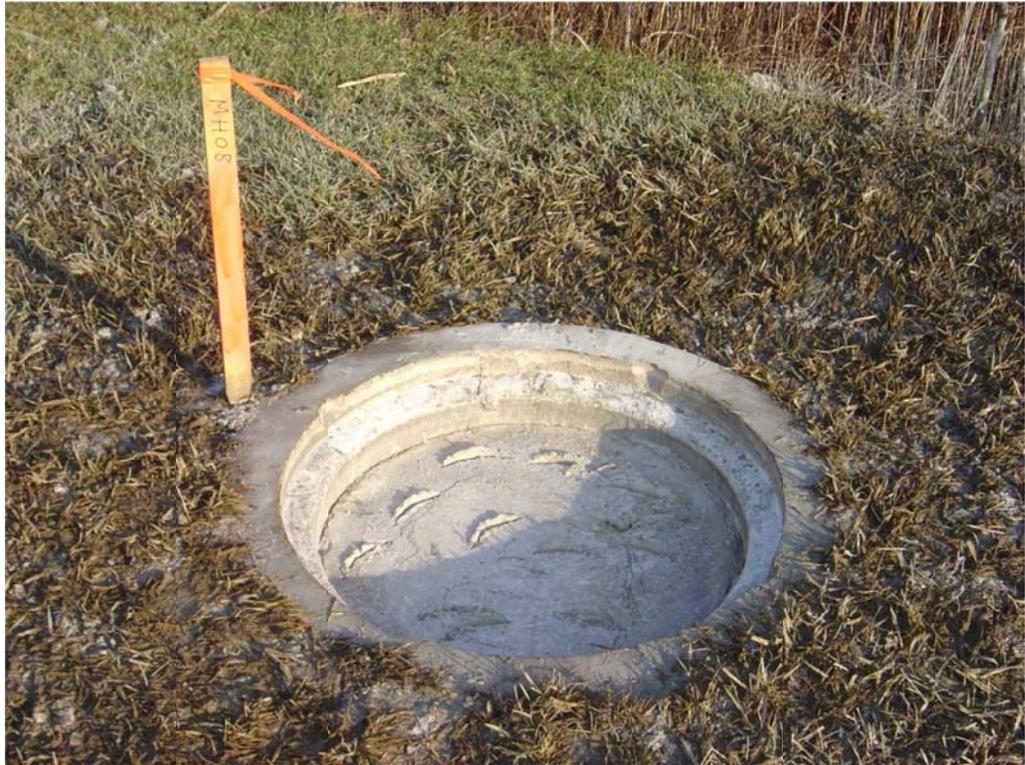
A northeastward view of Manhole 08 after being filled with concrete/bentonite mixture (decommissioning completed). Manhole lid was replaced after photo.

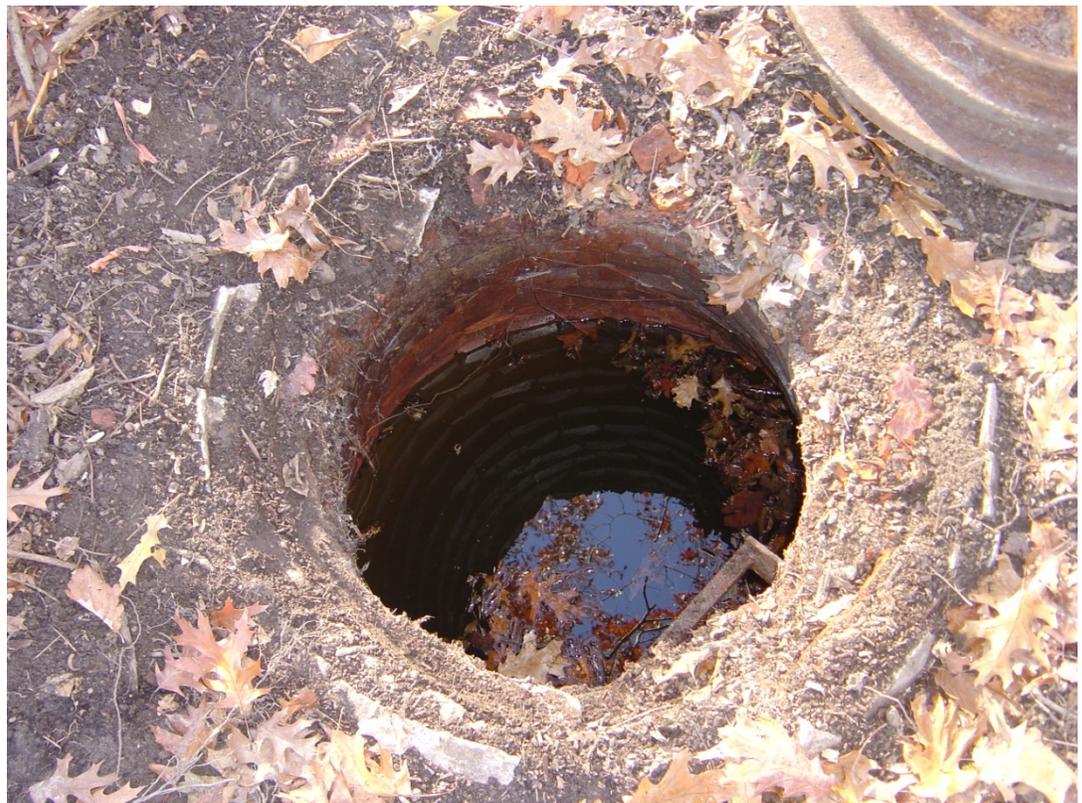
Photo No.
MH41-2

A view of the interior of Manhole 41 prior to decommissioning.

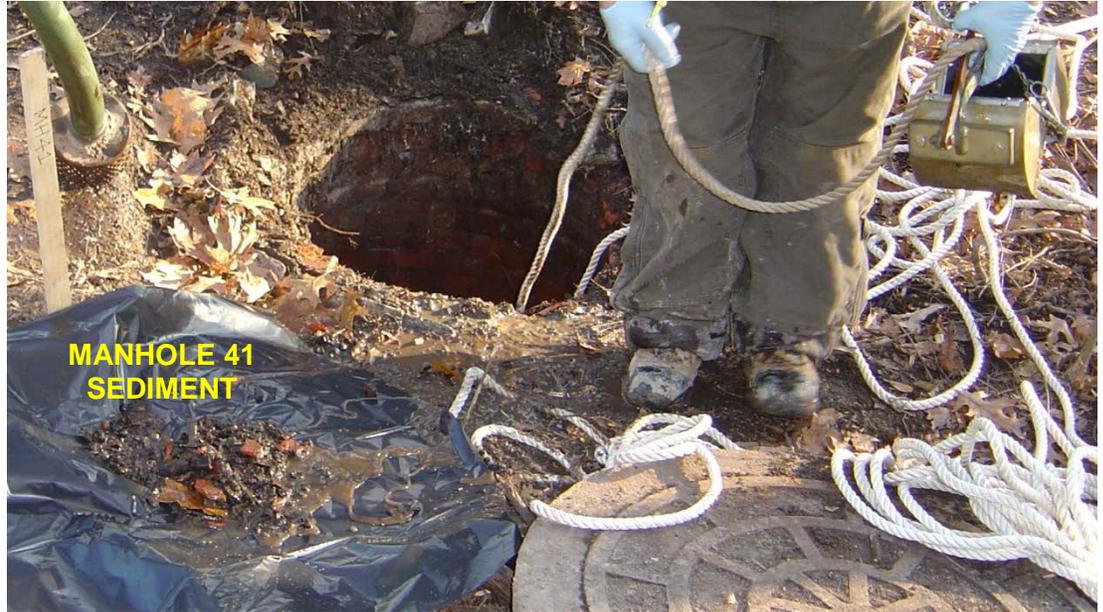
A view of sediment recovered from the bottom of Manhole 41 (on black plastic in bottom left corner of photo).

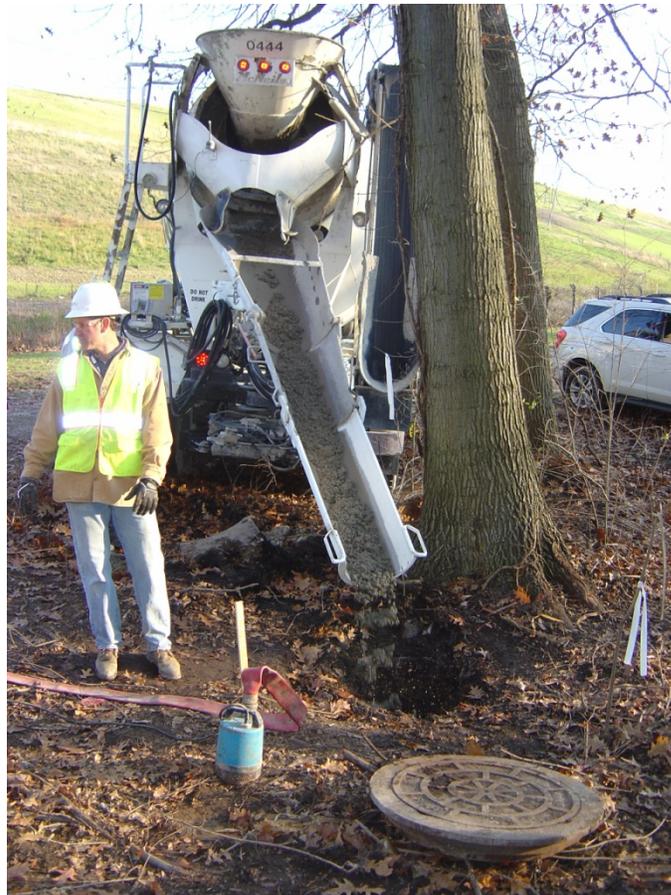
Photo No.
PE6-4

A southeastward view of the initial filling of Manhole 41 with ~1.5 cubic yards of concrete/bentonite mixture to prevent liquid migration through the manhole. An electric vibrator was used to distribute the concrete/bentonite mixture into the pipes entering the base of the manhole. Top of concrete was brought up to ~3.3' bgs.

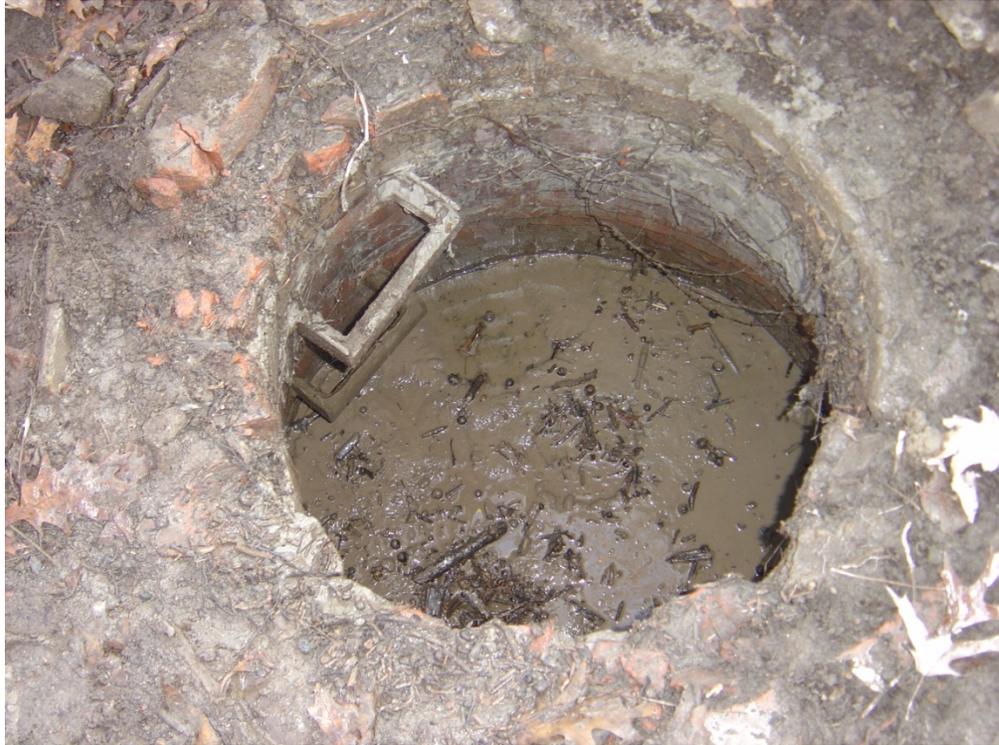
A view of the interior of Manhole 41 after the initial concrete/bentonite mixture filling had settled and partially cured.

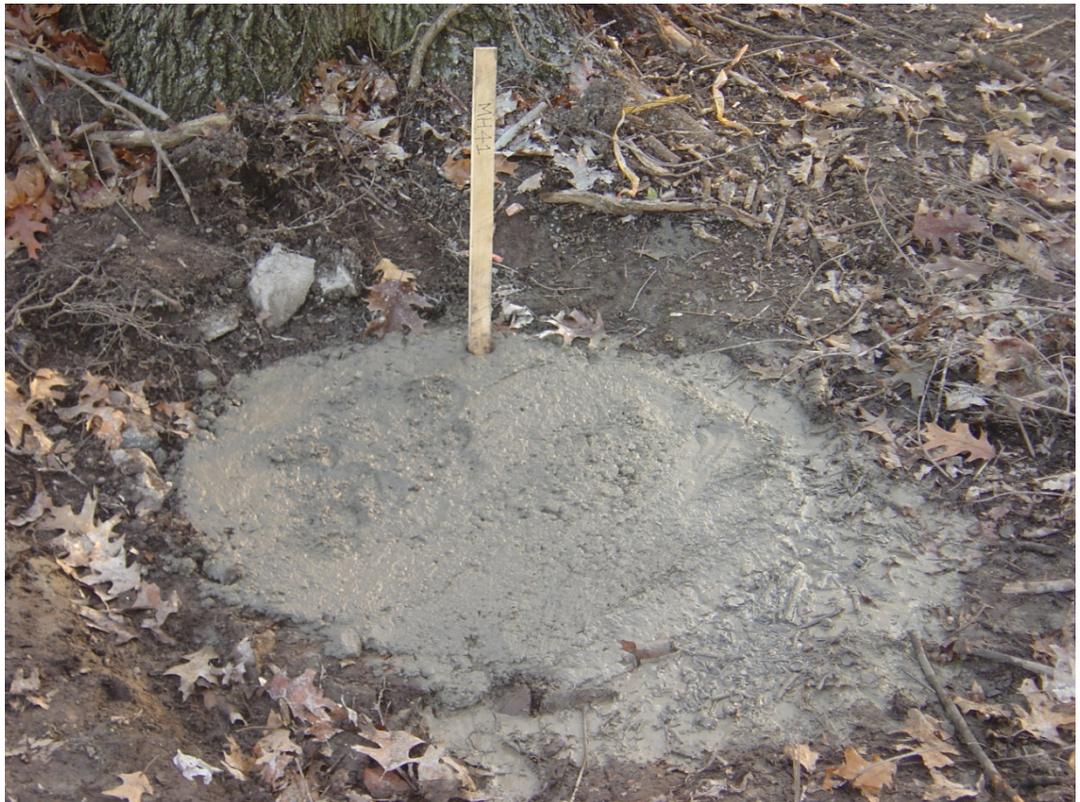
Photo No.
MH41-6

A southwestward view of Manhole 41 after being filled to the surface with additional concrete/bentonite mixture (decommissioning completed).
