## SUMMARY REPORT

AERIAL RADIOLOGICAL SURVEY

LAKE ONTARIO ORDNANCE WORKS

DATE OF SURVEY: OCTOBER 1978

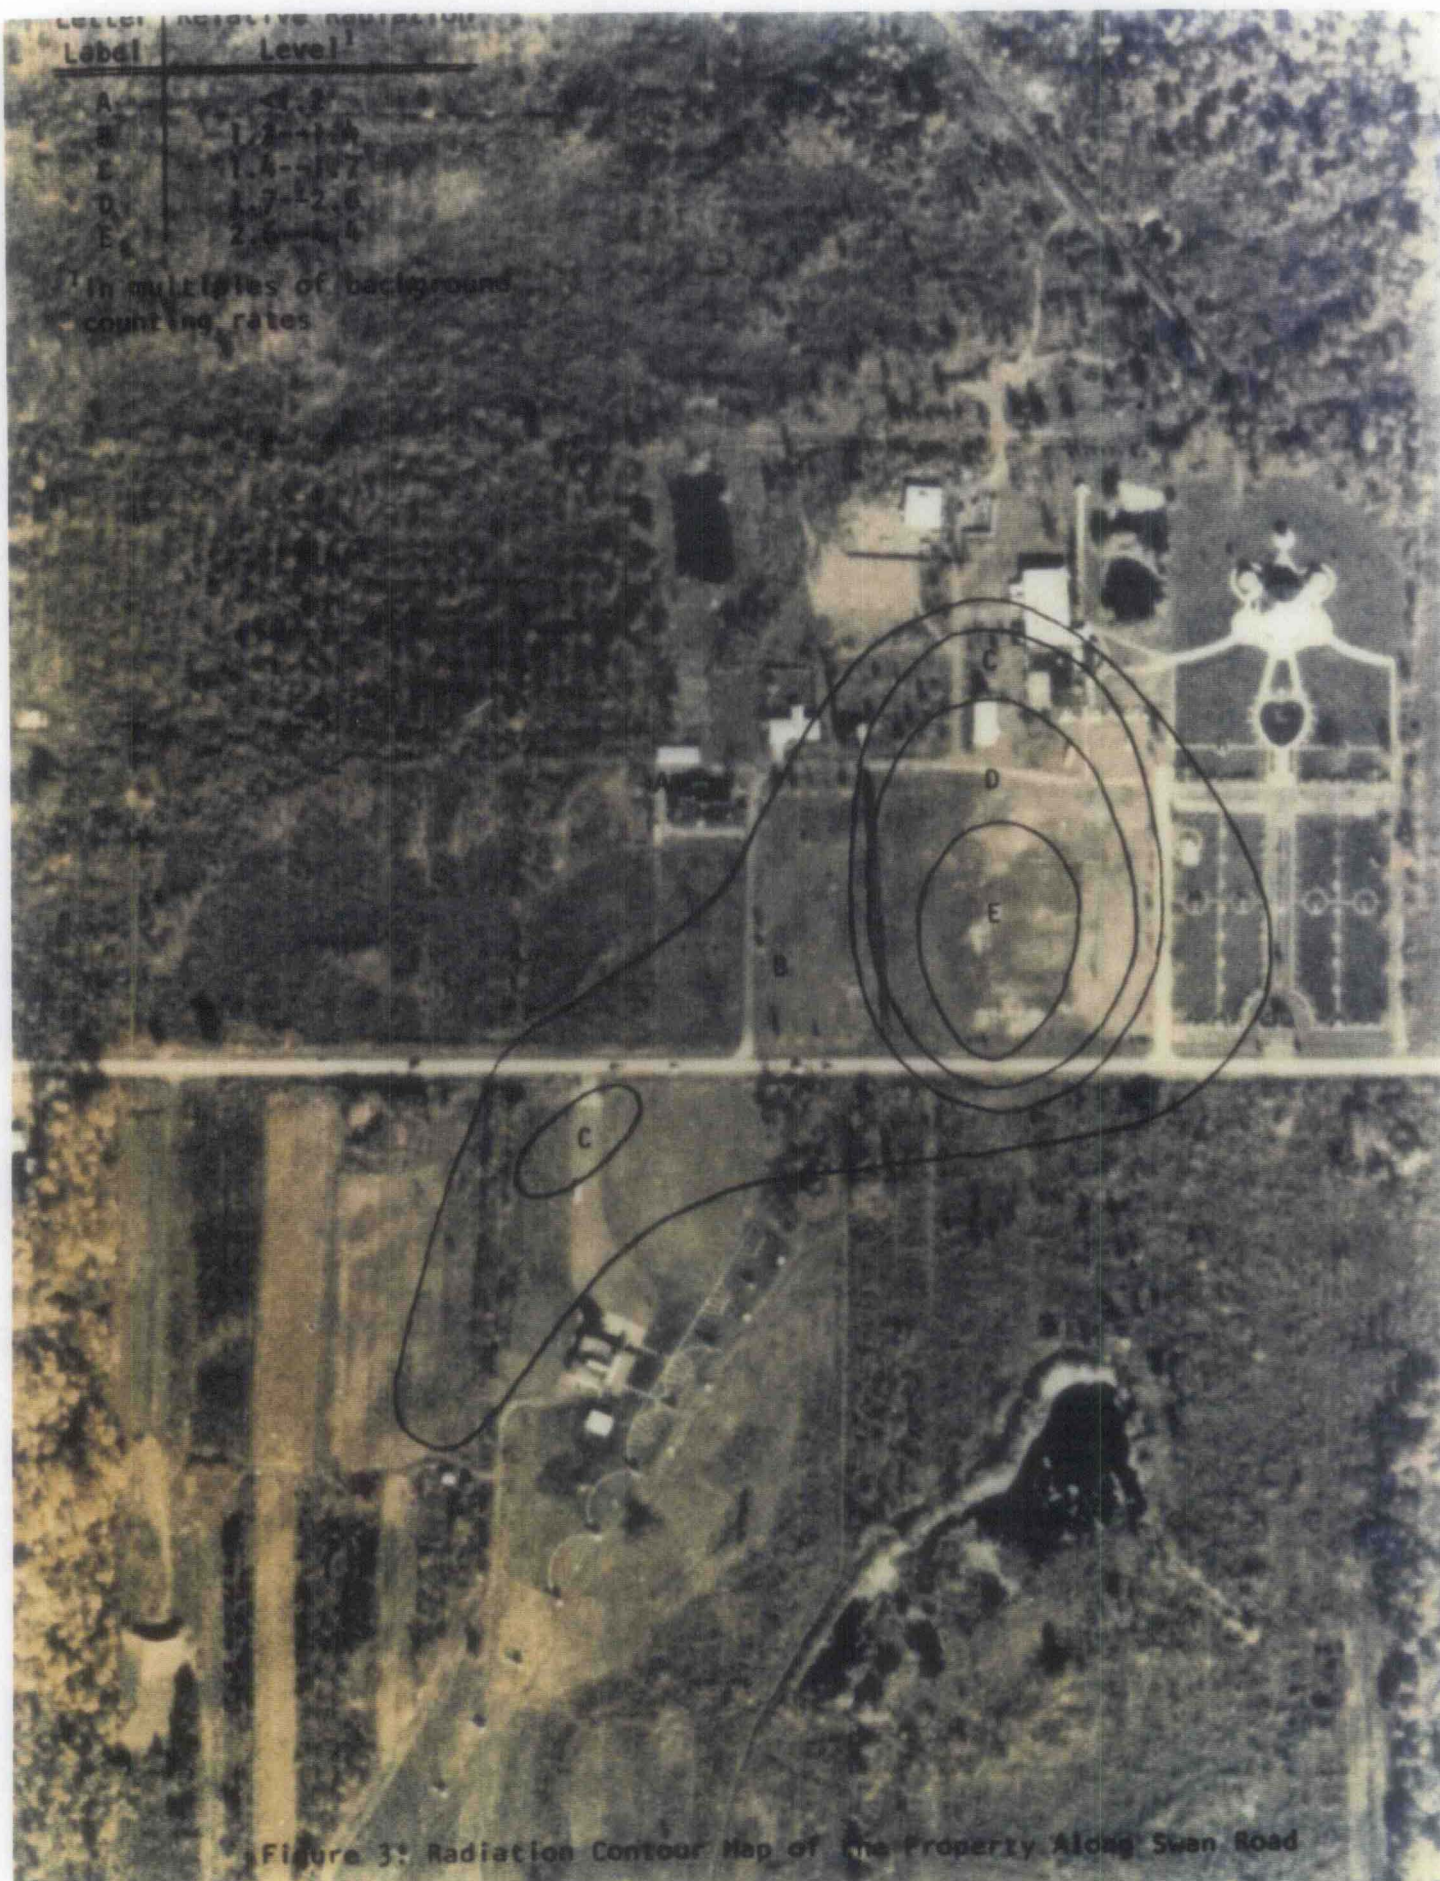
Figure 3: Radiation Contour Map of the Property Along Swan Road

levels due to radium were found in an area along Swann Road, approximately 1.5 miles southwest of the L00W. The radiation distribution in this area is shown in Figure 3. The contour lines show regions of elevated radiation ranging from 1.2 to 4.4 times the intensity of natural background.

A	< 1.2
B	1.2-1.4
C	1.4-1.7
D	1.7-2.0
E	2.0-4.0

<sup>1</sup>In multiples of background counting rates
