PERFORMANCE MONITORING REPORT FOR THE NIAGARA FALLS STORAGE SITE WASTE CONTAINMENT STRUCTURE FOR CALENDAR YEAR 1990

**PERFORMANCE MONITORING REPORT
FOR THE NIAGARA FALLS STORAGE SITE
WASTE CONTAINMENT STRUCTURE**

Lewiston, New York

Calendar Year 1990

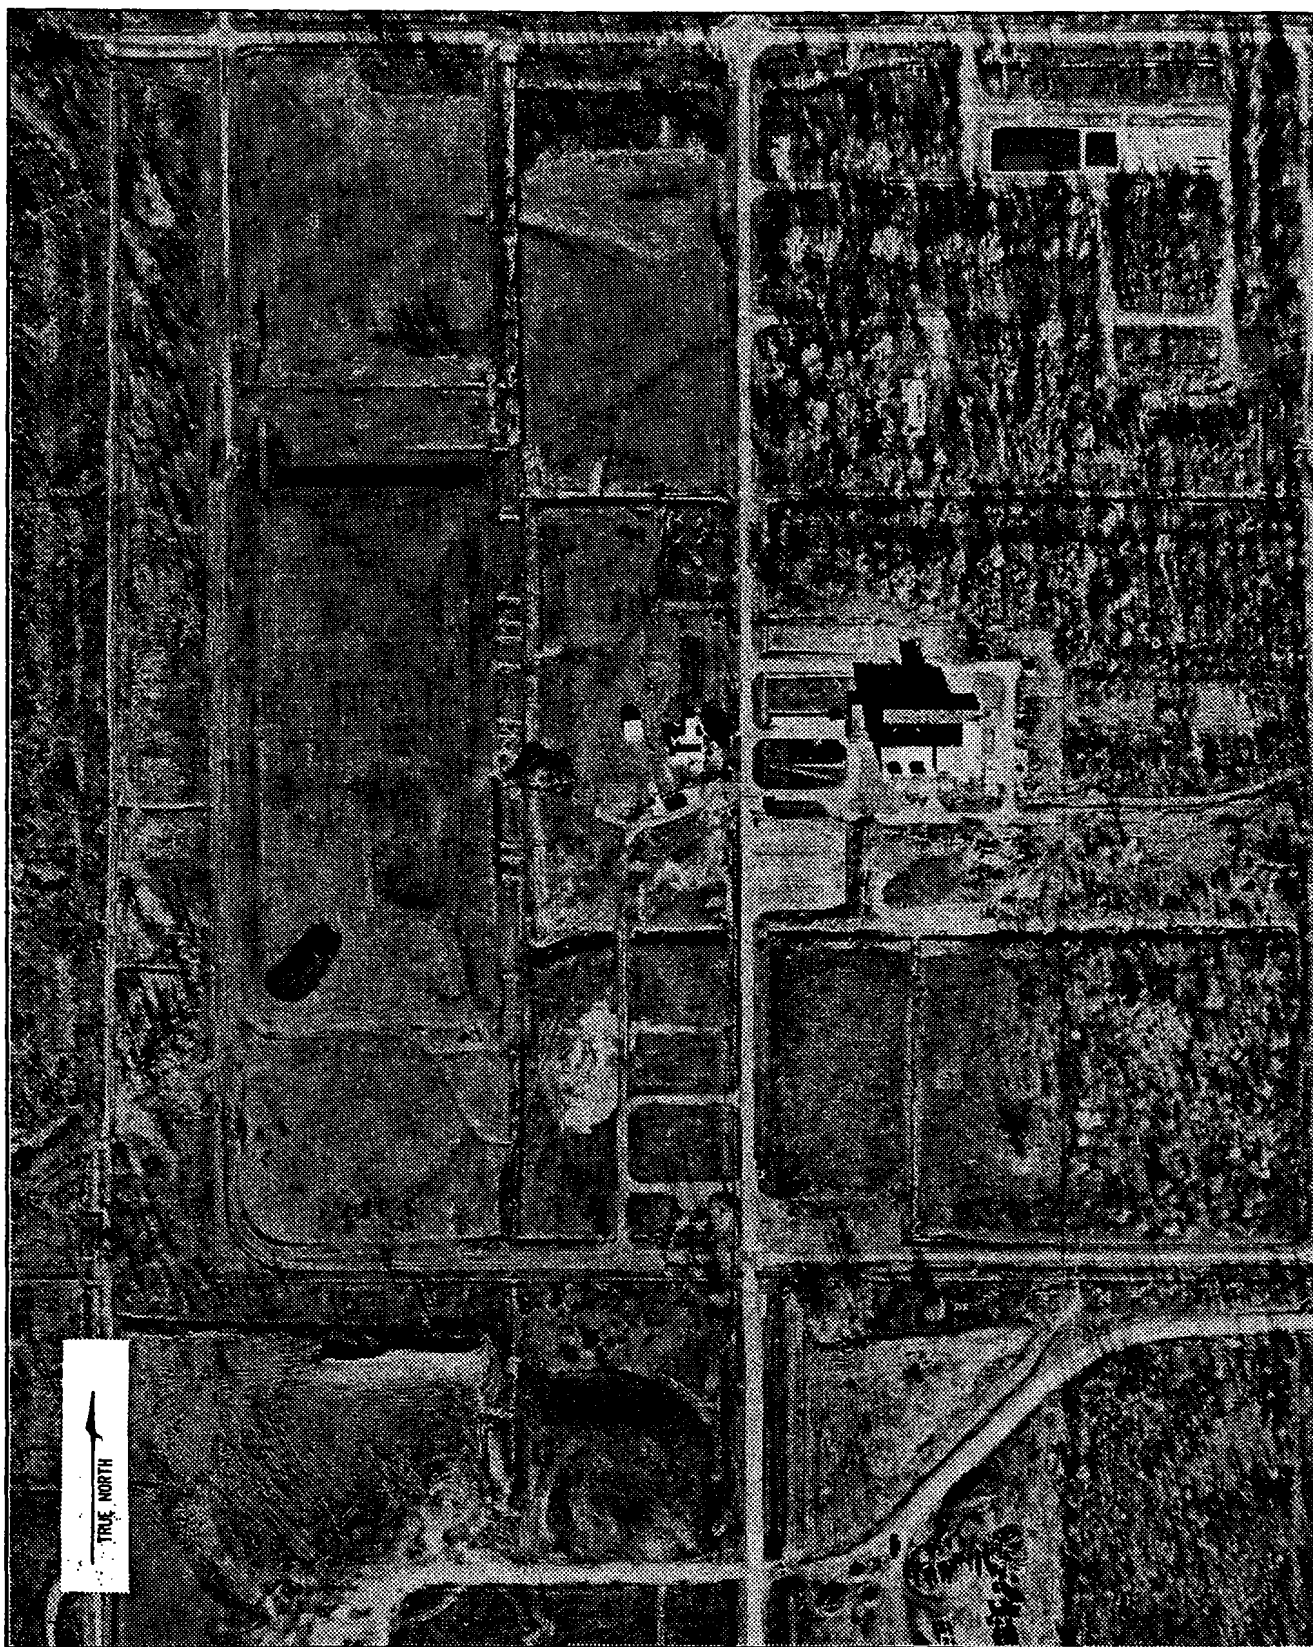
Figure 3-2
Aerial View of the NFSS WCS, November 1990

The most recent aerial contour mapping of the WCS surface was performed in November 1990 (see Figure 3-1). The latest aerial photograph of the WCS was taken in November 1990 (see Figure 3-2). When compared with the October 1986 aerial photograph (Figure 3-3), the 1990 photograph clearly shows that formerly bare areas in the middle and at the south end of the WCS now have well-established turf. The water-holding ponds shown in the 1986 photograph have been filled and, therefore, are not in the 1990 view. The 1990 photograph documents the improved condition of the WCS as a result of maintenance performed under the performance monitoring program.

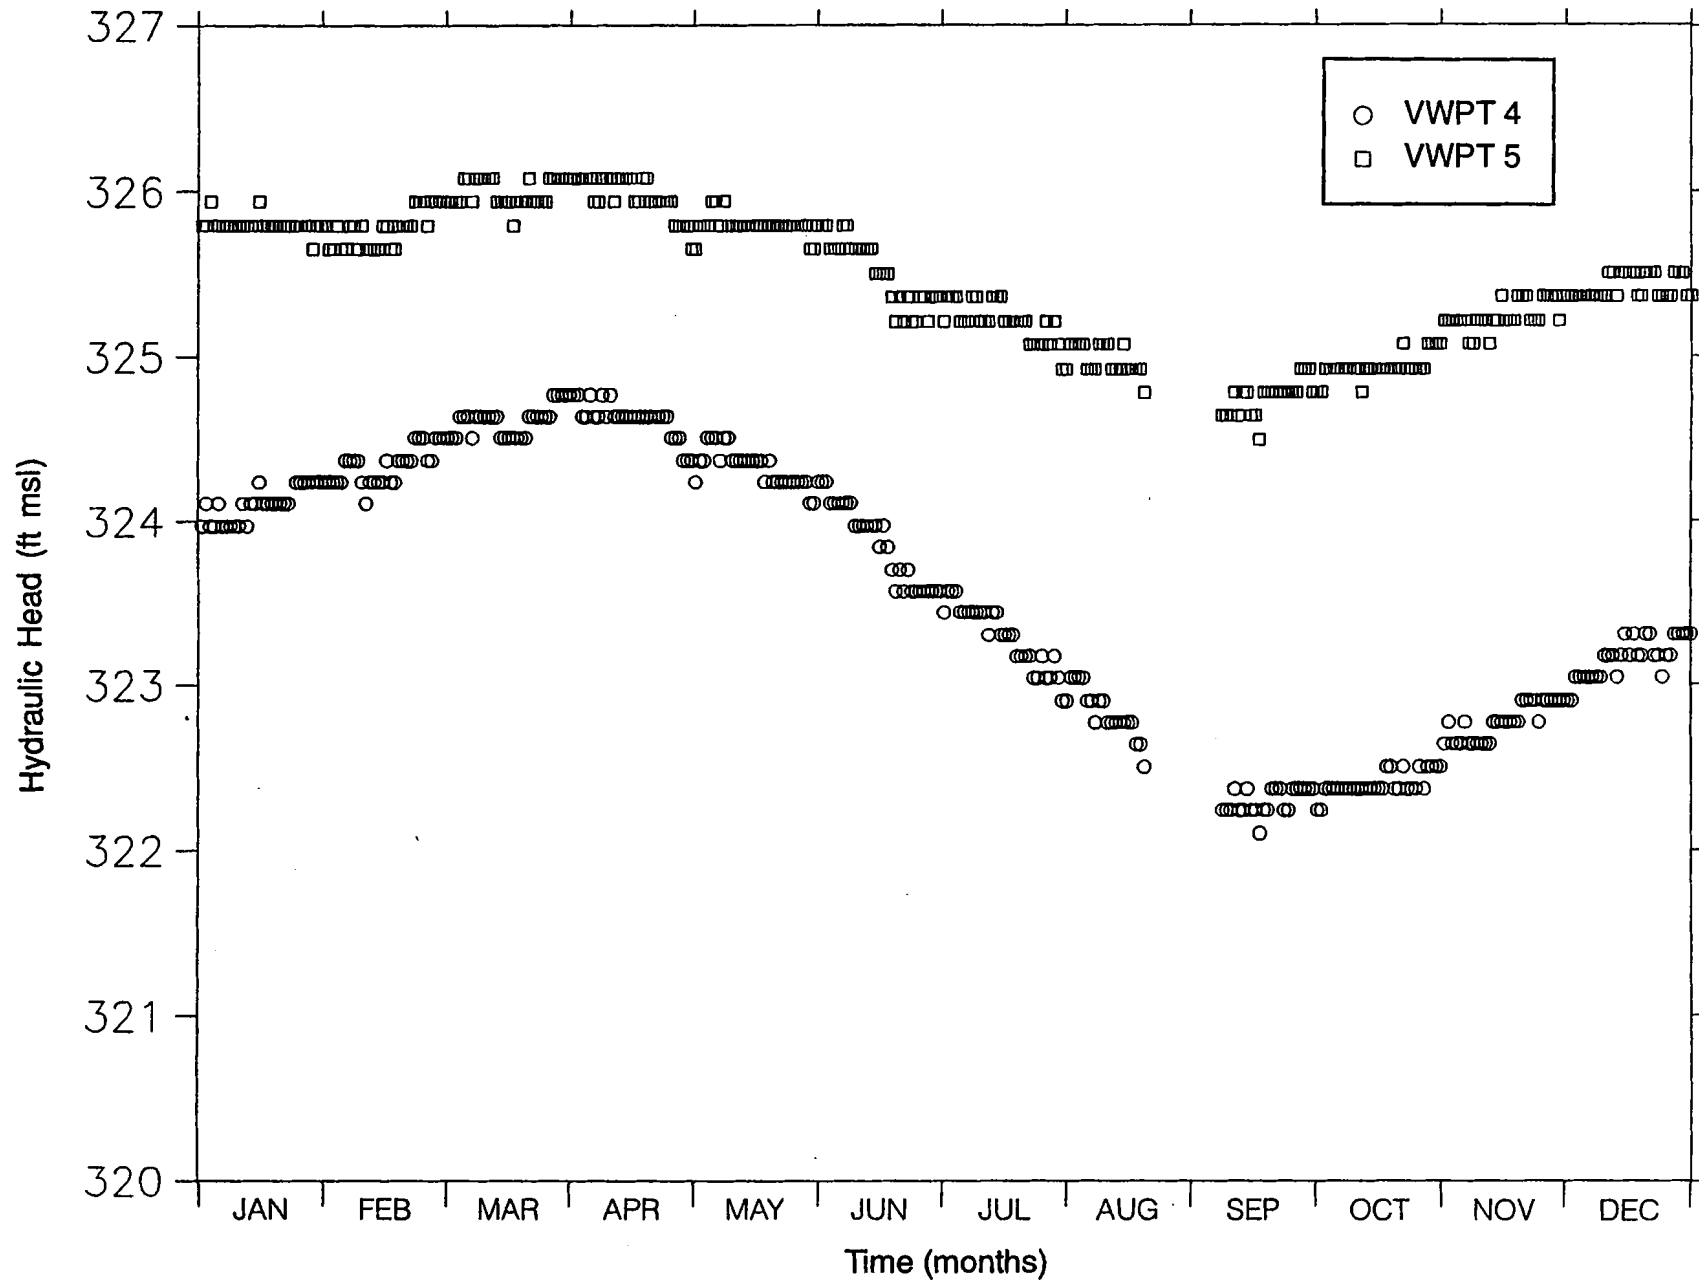
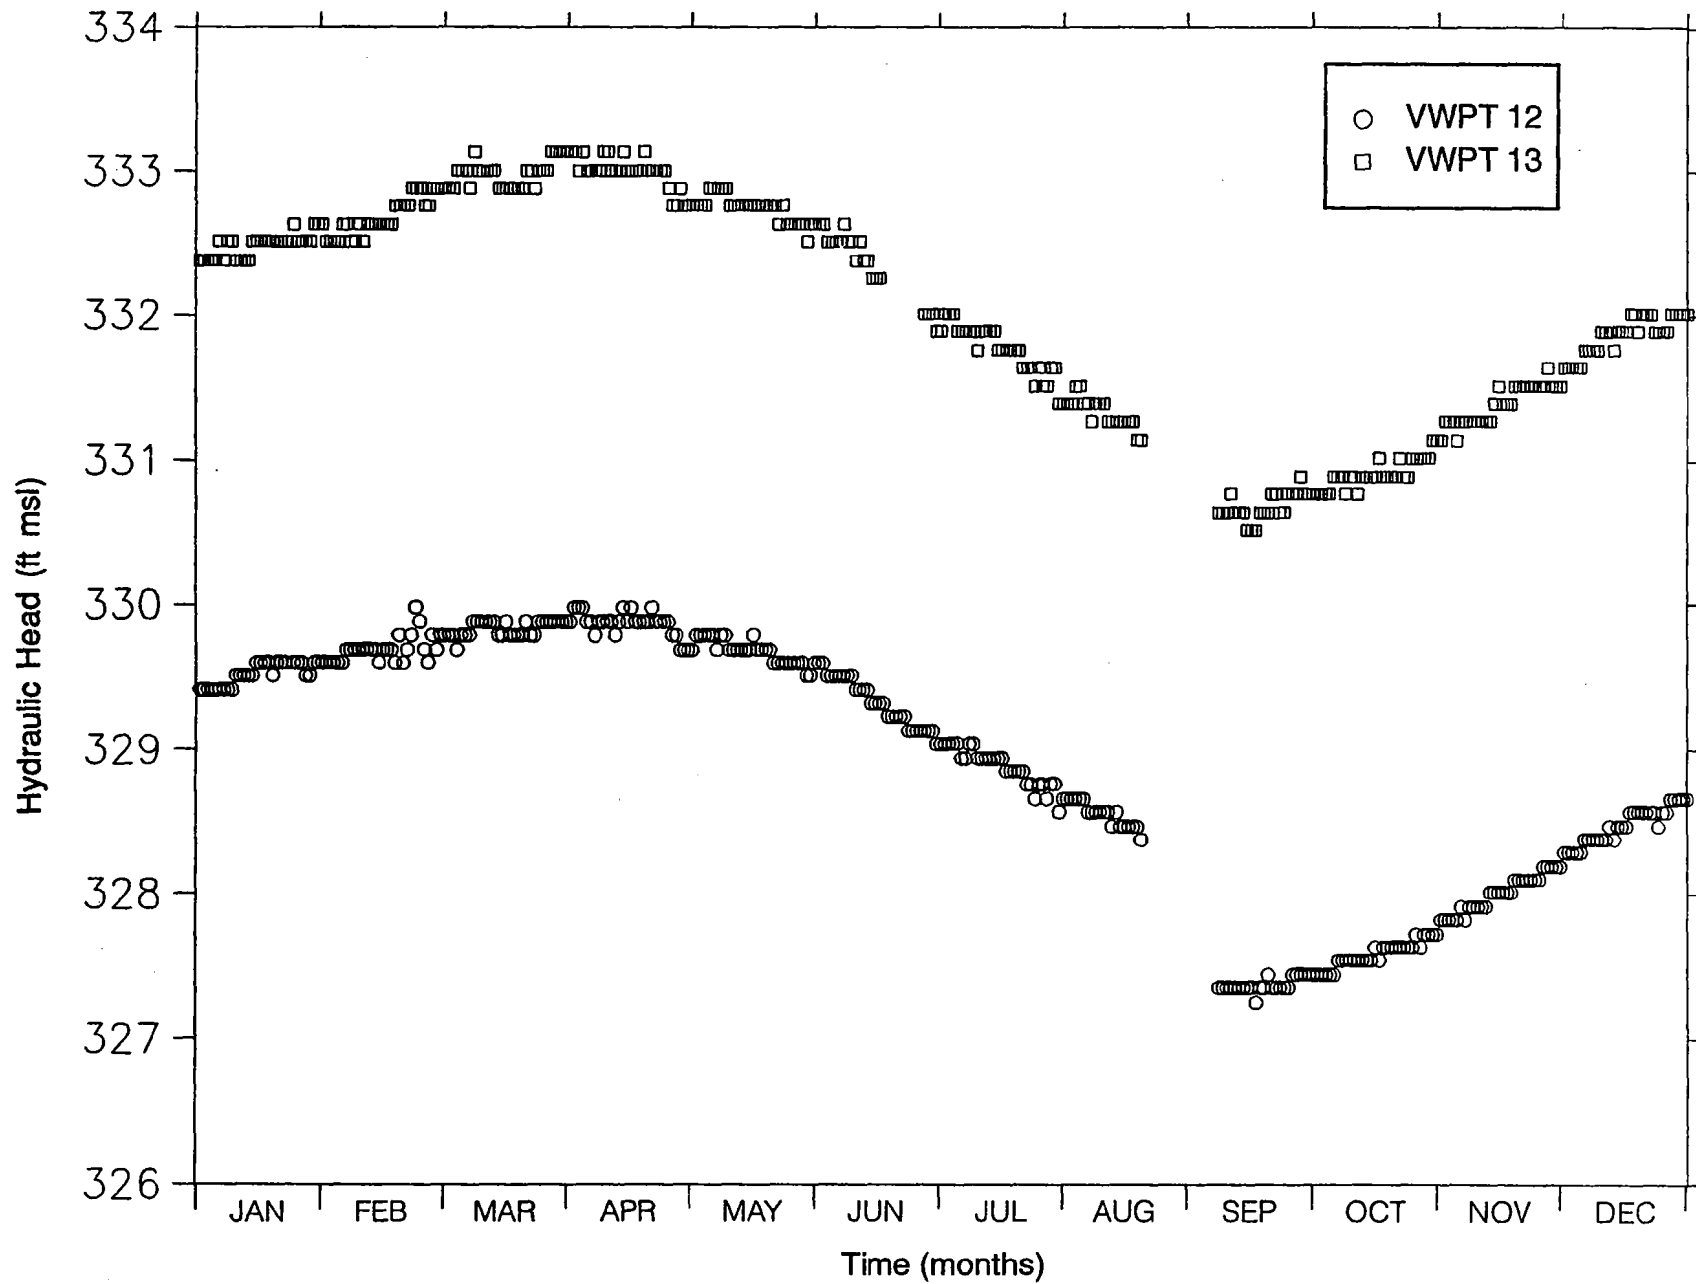
VWPT DATA FOR NFSS — 1990

The VWPT data for this report include readings from January 1990 through December 1990. VWPT data are not available for late August and early September 1990 because of diagnostic testing that was performed on the automatic reader box during that period. The data from the VWPTs have been converted to hydraulic head and are plotted in Appendix A. In general, the plots exhibit a continuation of the seasonal trends observed in previous years. These trends are characterized by a maximum head elevation in early spring (March or April) and a minimum head elevation in the fall (September or October).

Exceptions to these trends were observed at VWPT-3, VWPT-11, and VWPT-12. Instrument 11 failed to operate for the entire calendar year. Instruments 3 and 12 had complex operating histories of several reading and nonreading cycles. Currently, it is uncertain whether the irregular readings of instruments 3 and 12 are the result of changes in pore pressure within the WCS or whether they result from electrical problems. Diagnostic testing to identify and correct the problems associated with these instruments is continuing.
