Niagara Falls Storage Site Geophysical Survey Results

Science Applications International Corporation

Niagara Falls Storage Site Lewiston, NY

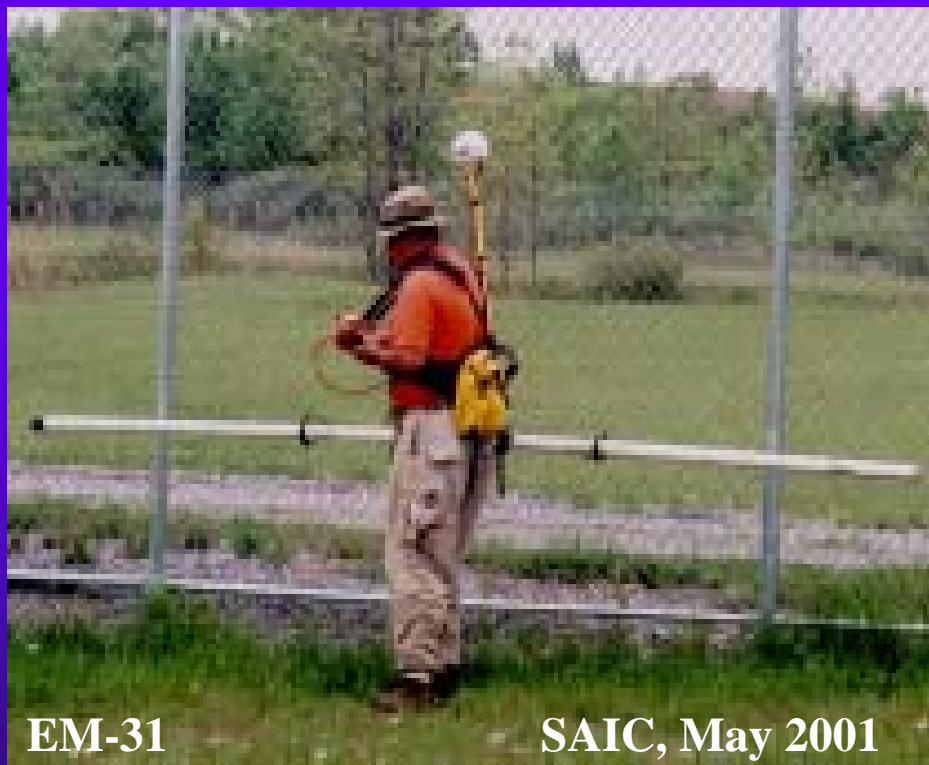
Electromagnetics (EM-31)

EM-31 with Data Logger and GPS

Conductivity

- ◆ Water Saturation
- ◆ Voids/Sinkholes
- ◆ Metallic Signature
- ◆ Changes in Soil Properties
- ◆ Contaminant Plumes

Magnetic Susceptibility

- ◆ Metallic Signature

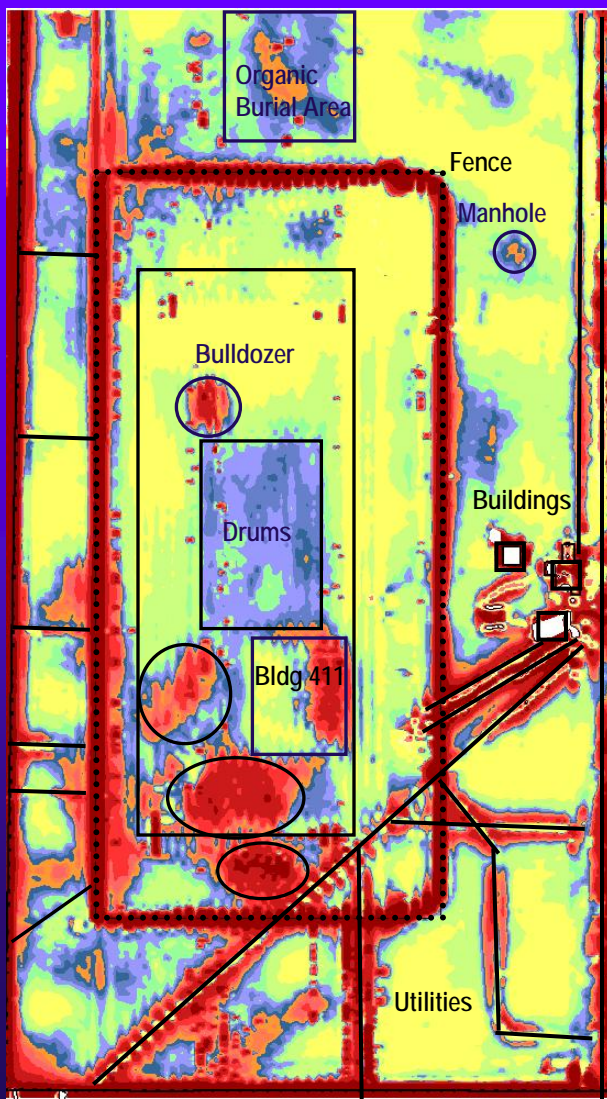
EM Results of the NFSS IWCS

Conductivity (mM/m)

Quadrature Phase

Magnetic Susceptibility (ppt)

Inphase

Drain Pipes

- ◆ Delineated lateral extent of landfill contents and metallic debris (buildings, bulldozer, etc.)
- ◆ Geospatially located Building Foundations within IWCS
- ◆ Identified metallic debris in Bays B and C of Building 411
- ◆ Identified metallic debris outside building footprints
- ◆ Confirmed rebar-reinforced walls and floor in Building 411
- ◆ Confirmed lateral extent of 1991 drum addition to IWCS
- ◆ Confirmed no voids or areas of increased water saturation within IWCS

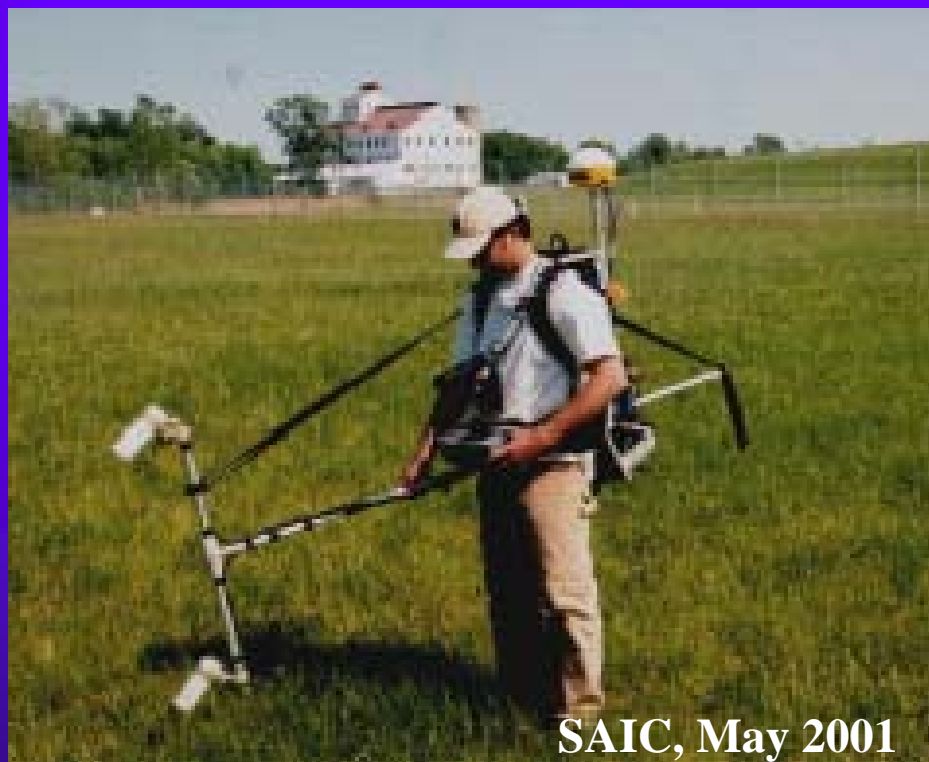
Magnetometer

♦ Ferrous
Metallic
Signature

Magnetic Gradiometer with GPS and Data
Logger

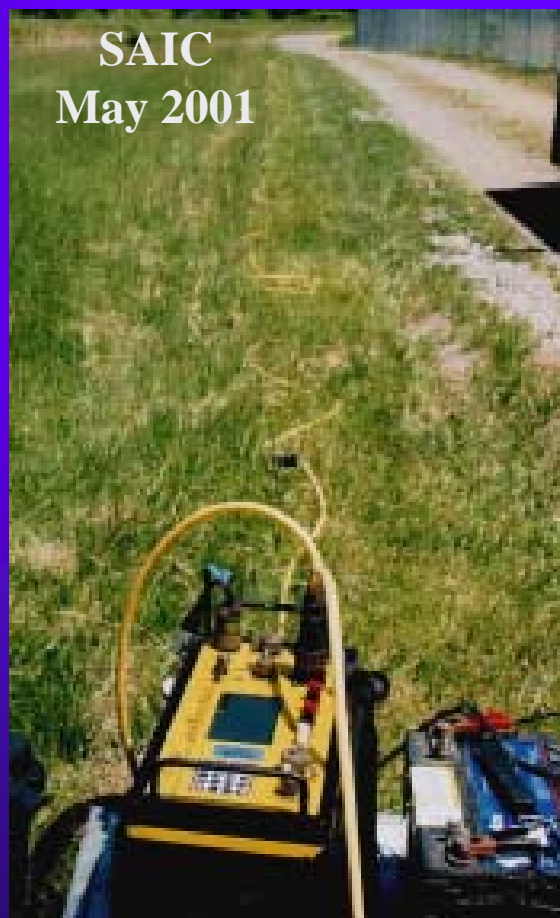
Electrical Imaging Setup

Measures Electrical Resistivity

- ◆ Water Saturation
- ◆ Voids/Sinkholes
- ◆ Fractures
- ◆ Stratigraphy
- ◆ Soil/Bedrock Interface
- ◆ Contaminant Plumes
- ◆ Metallic Signature

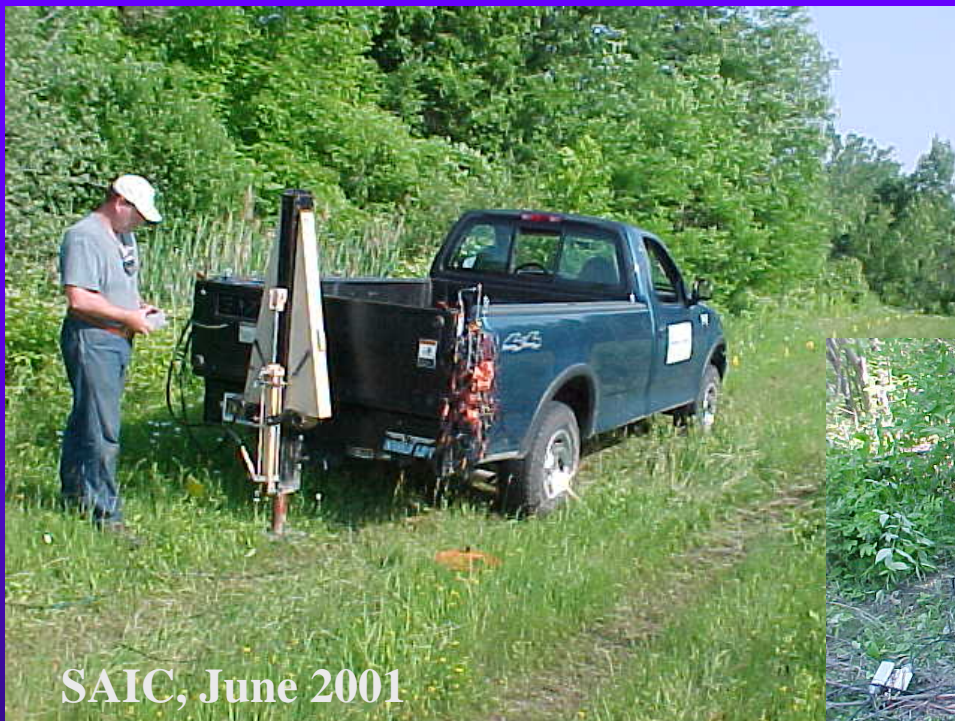
Elastic Wave Generator and
Geophone String

- ◆ Measure DEEP bedrock features

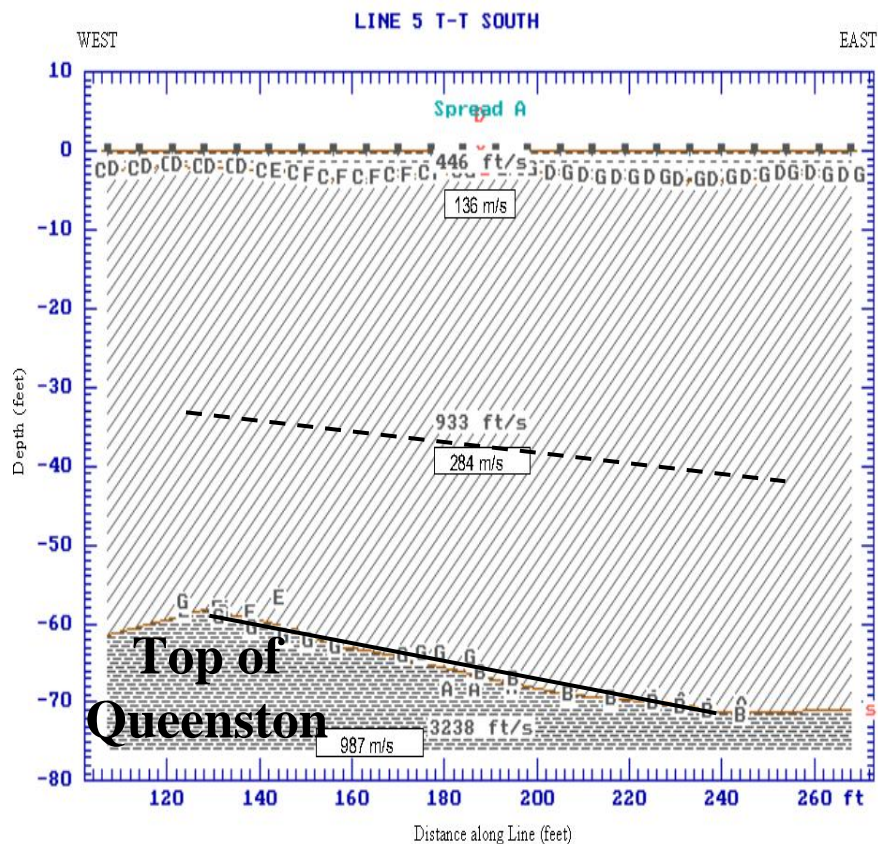
Shear Wave Data

- ◆ Key Technology Shear Wave Seismic Refraction
 - Shear waves do not refract at water surface
 - Compressional waves refract at water surface
- ◆ Performed Assessment in “Quiet” Area

Water Below Landfill is 3 feet below the foundation of Building 411

Top of Queenston Velocities suggest weathering/fracturing

- ◆ No significant lateral geologic discontinuities
- ◆ No faults/fractures/seismic pressure points near IWCS
- ◆ Confirmed stagnant water table beneath IWCS (3 feet below Building 411)
- ◆ Confirmed no areas of increased saturation within IWCS
- ◆ Delineated weathered and un-weathered bedrock topography
- ◆ Identified a bedrock “sag” outside IWCS boundaries
