SEAWAY LANDFILL TONAWANDA, NEW YORK

*Formerly Utilized Sites Remedial
Action Program (FUSRAP)*

August 2006 Final Report

Prepared for the US Army Corps of Engineers,
Buffalo District, Buffalo, New York

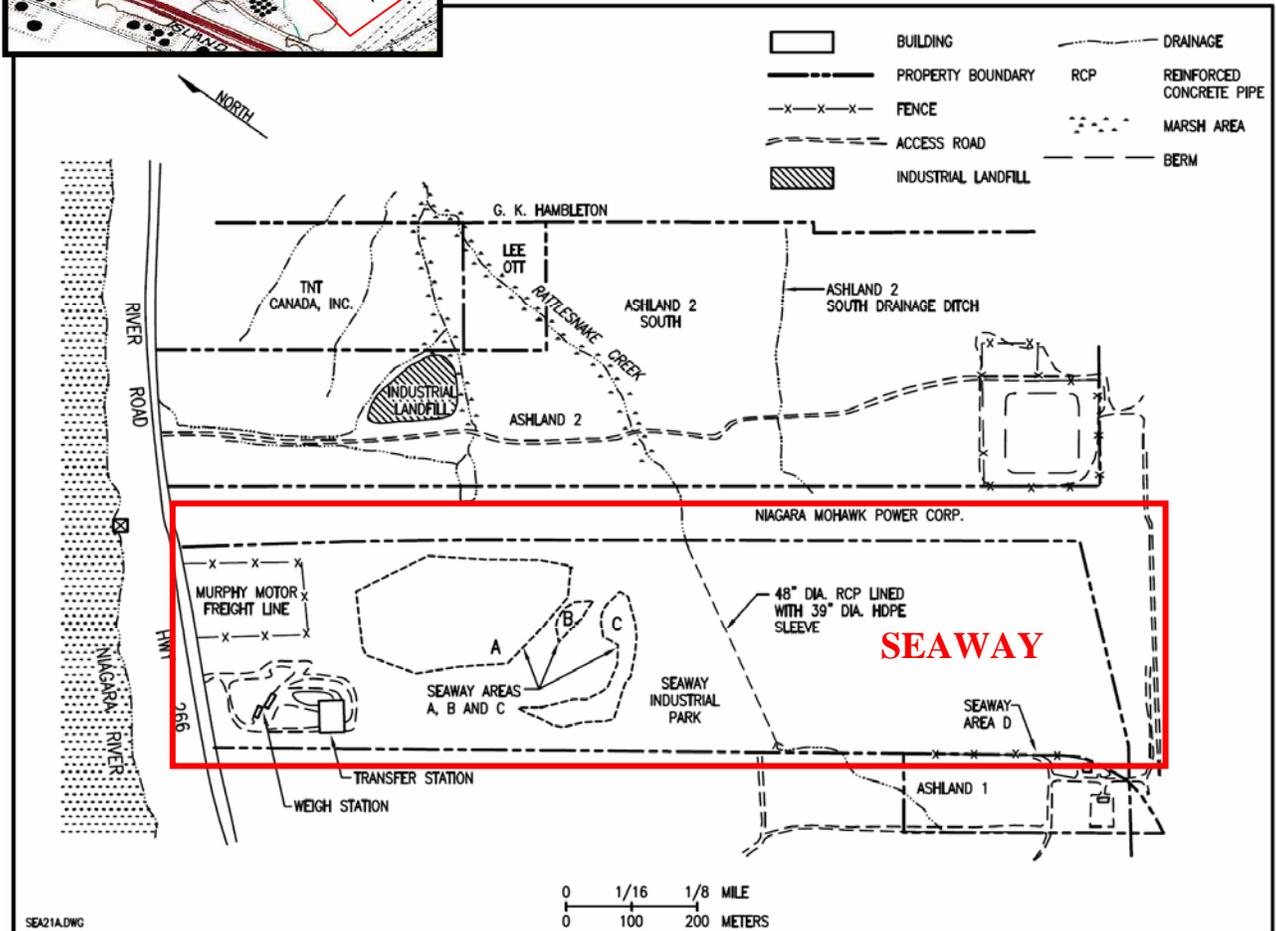
FIGURE A

The location of sites A, B, & C from this sketch are superimposed on the overview map graphic used throughout the report and on select photos.

Location Details Of The Seaway Property As Presented By Bechtel National, Inc., Courtesy US Army Corps Of Engineers, Buffalo District.

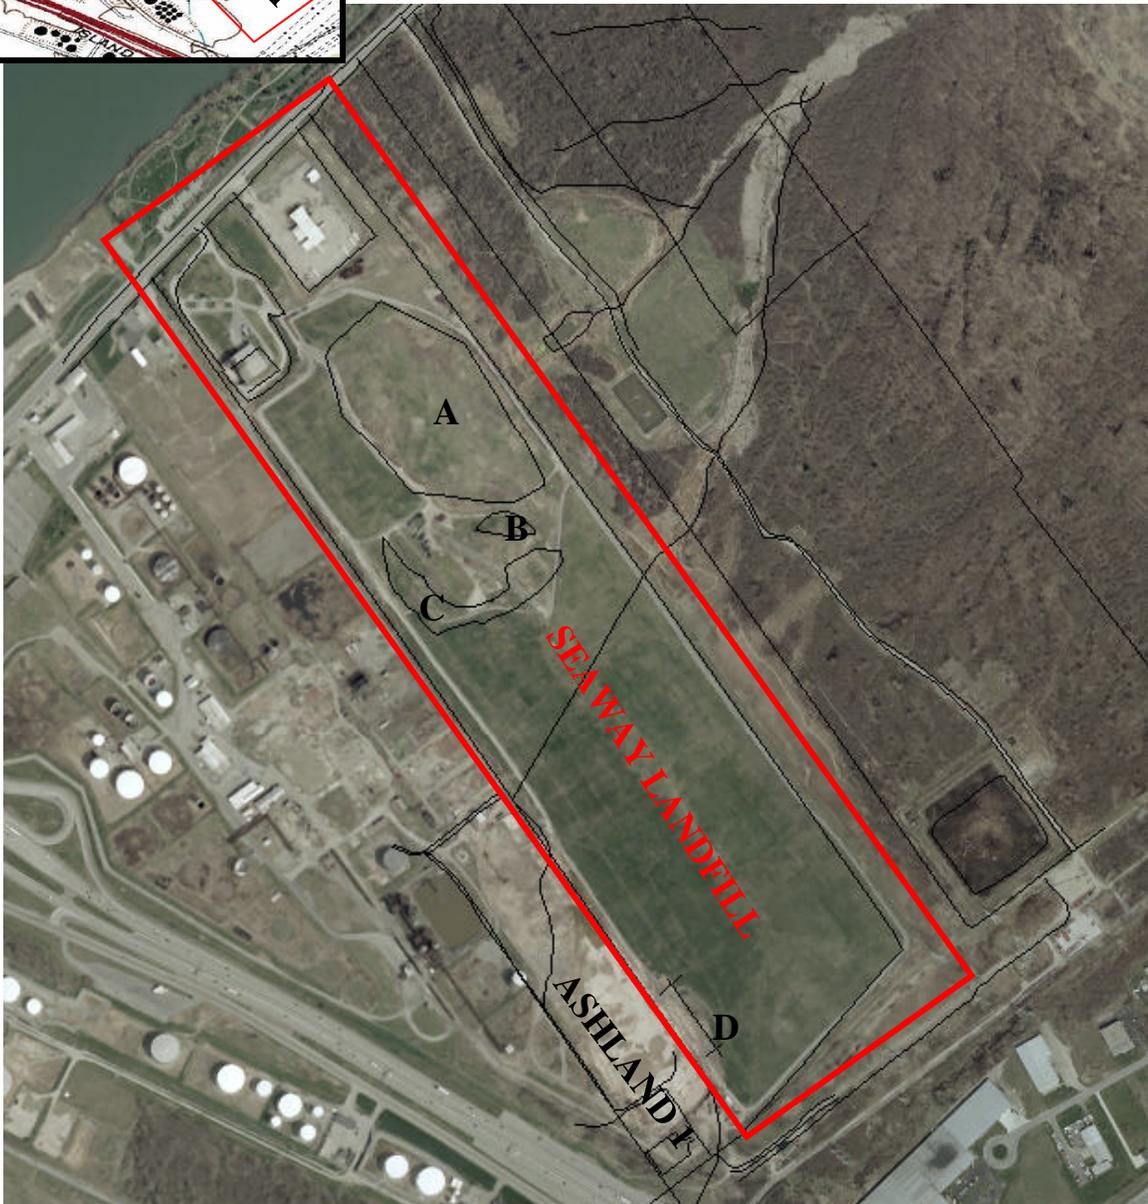
AREAS A, B, & C - ATOP 2002 PHOTO

Locations Based on Figure A Sketch

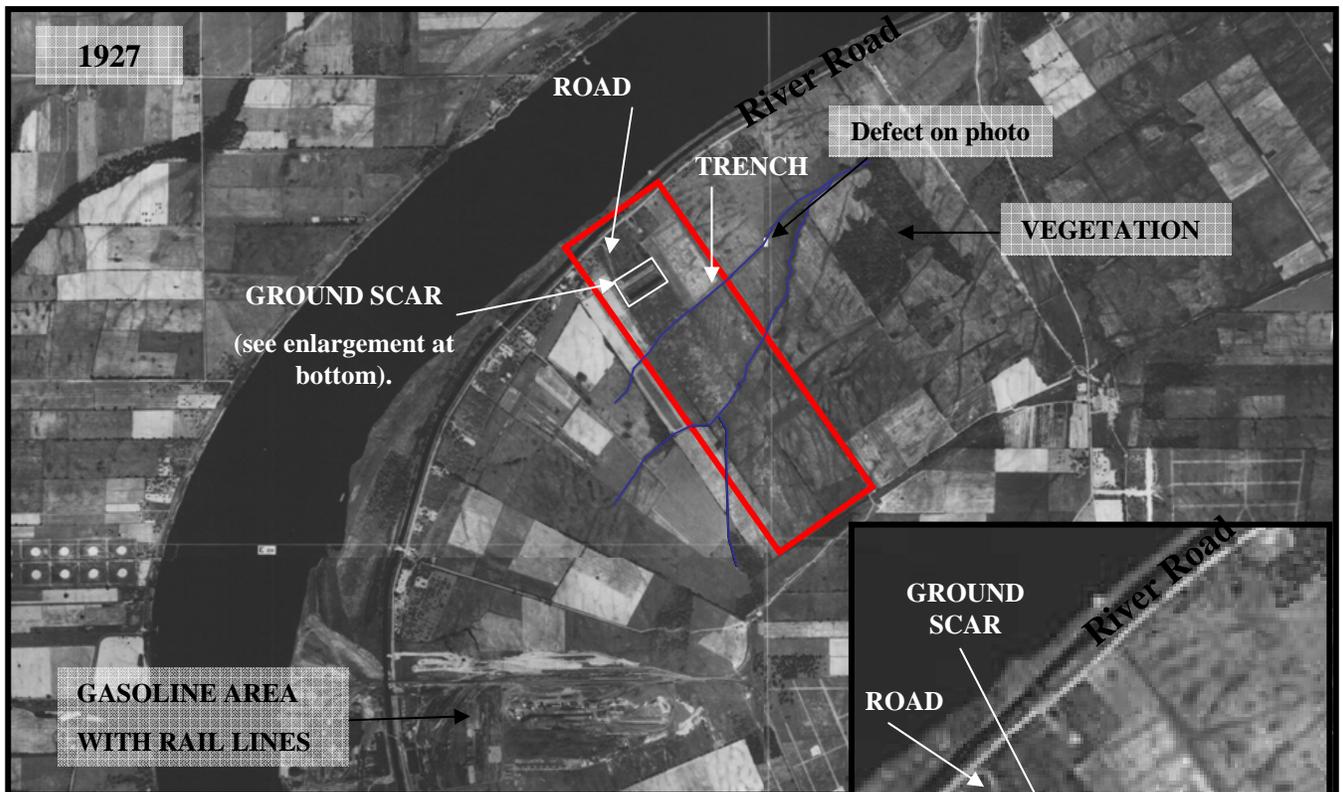
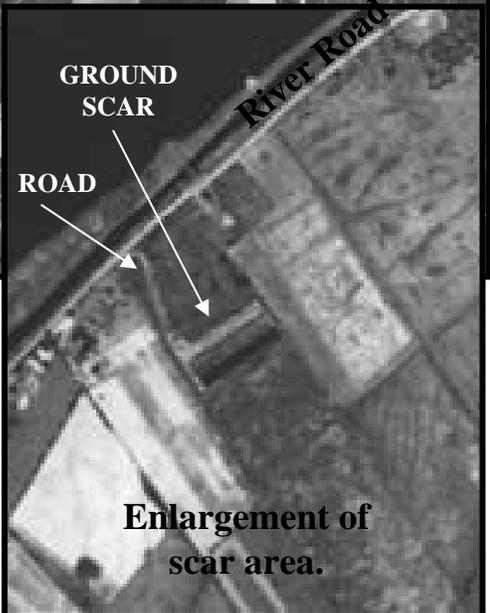
A 1927 image was the earliest aerial photo obtained for this report, but no stereo pair was available. Evident in the area (present day Seaway) is a road leading to a ground scar—indicating the site was disturbed at this time (but it is not known if it was a landfill during this time). FUSRAP Fact Sheet, February 2001, indicates Browning Ferris Industries operated a landfill here between 1930 and 1995.¹

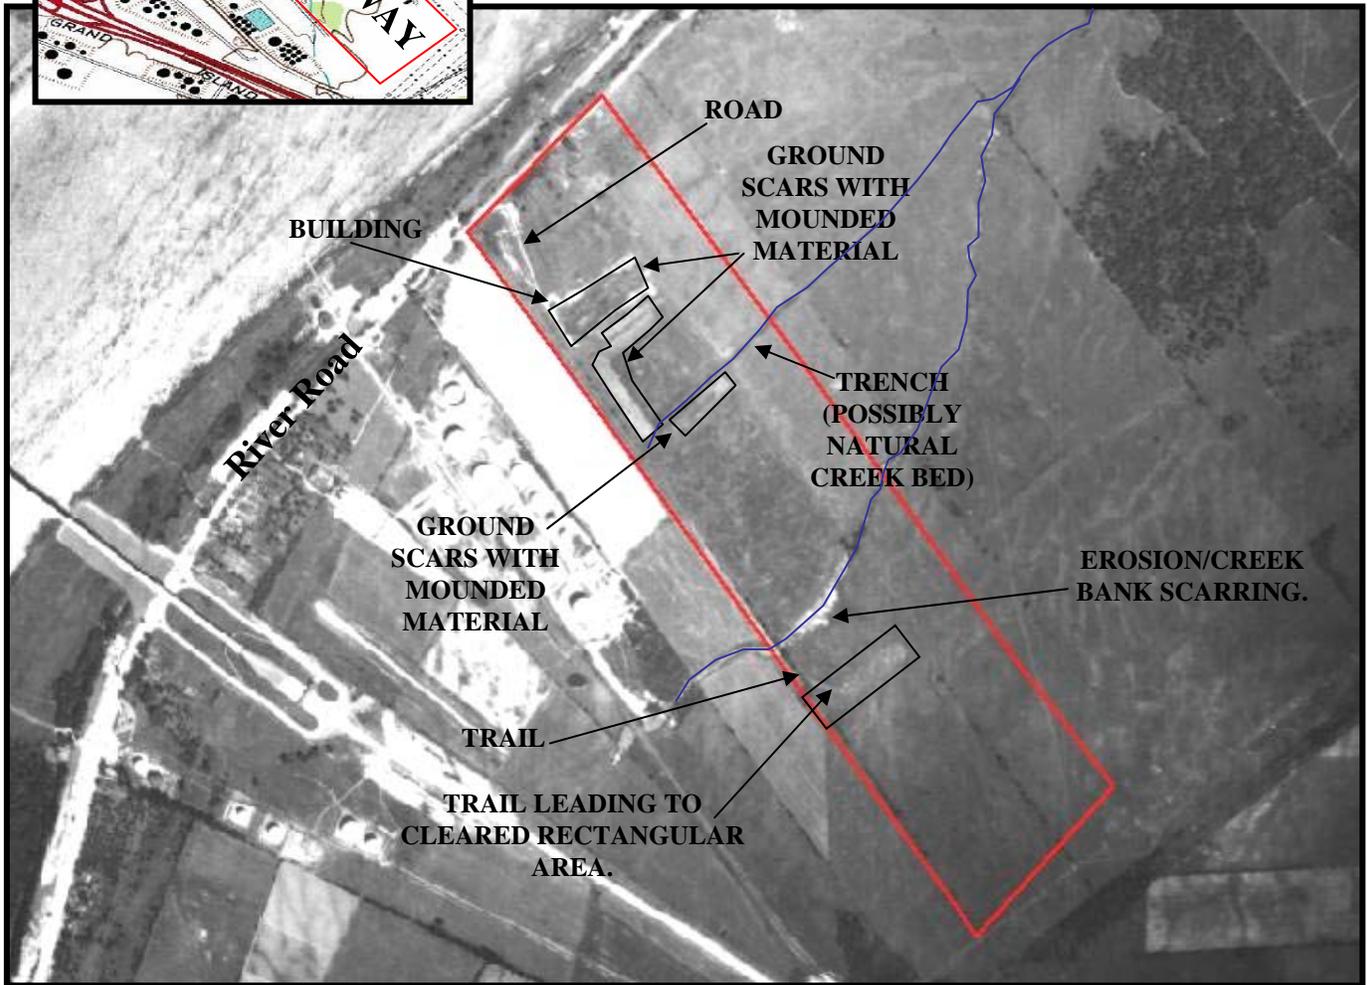
Ground scars are seen on the 1938 images. FUSRAP Fact Sheet, February 2001, indicates Browning Ferris Industries operated a landfill here between 1930 and 1995.¹

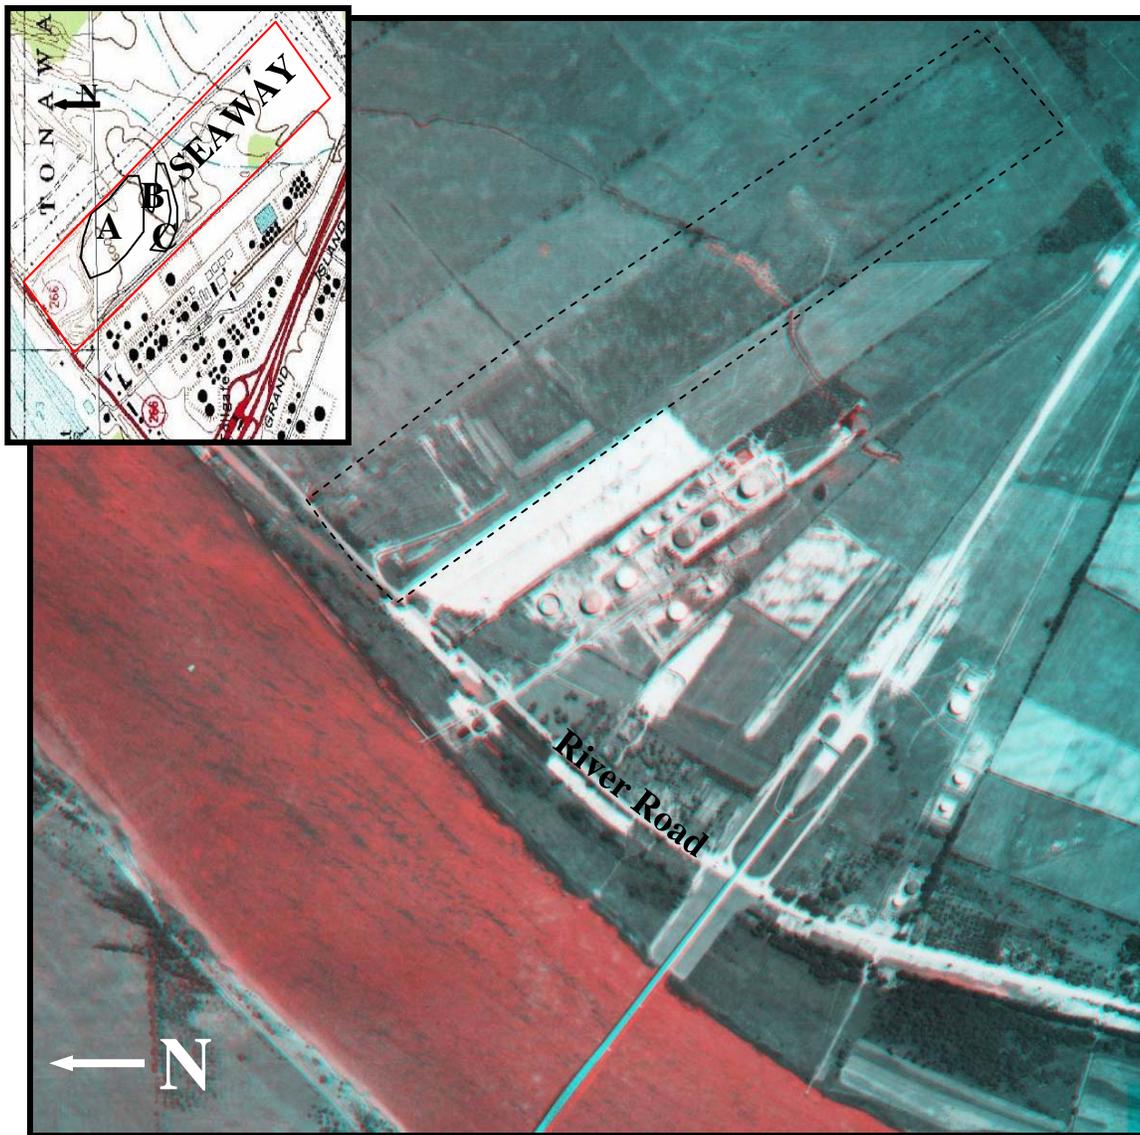
HISTORICAL PHOTOGRAPHIC ANALYSIS 1938 ANAGLYPH

In order to make the 1938 anaglyph, the direction of the photos had to be oriented to their stereo viewing position. North is to the left.

Dashed line defines the approximate Seaway site area.

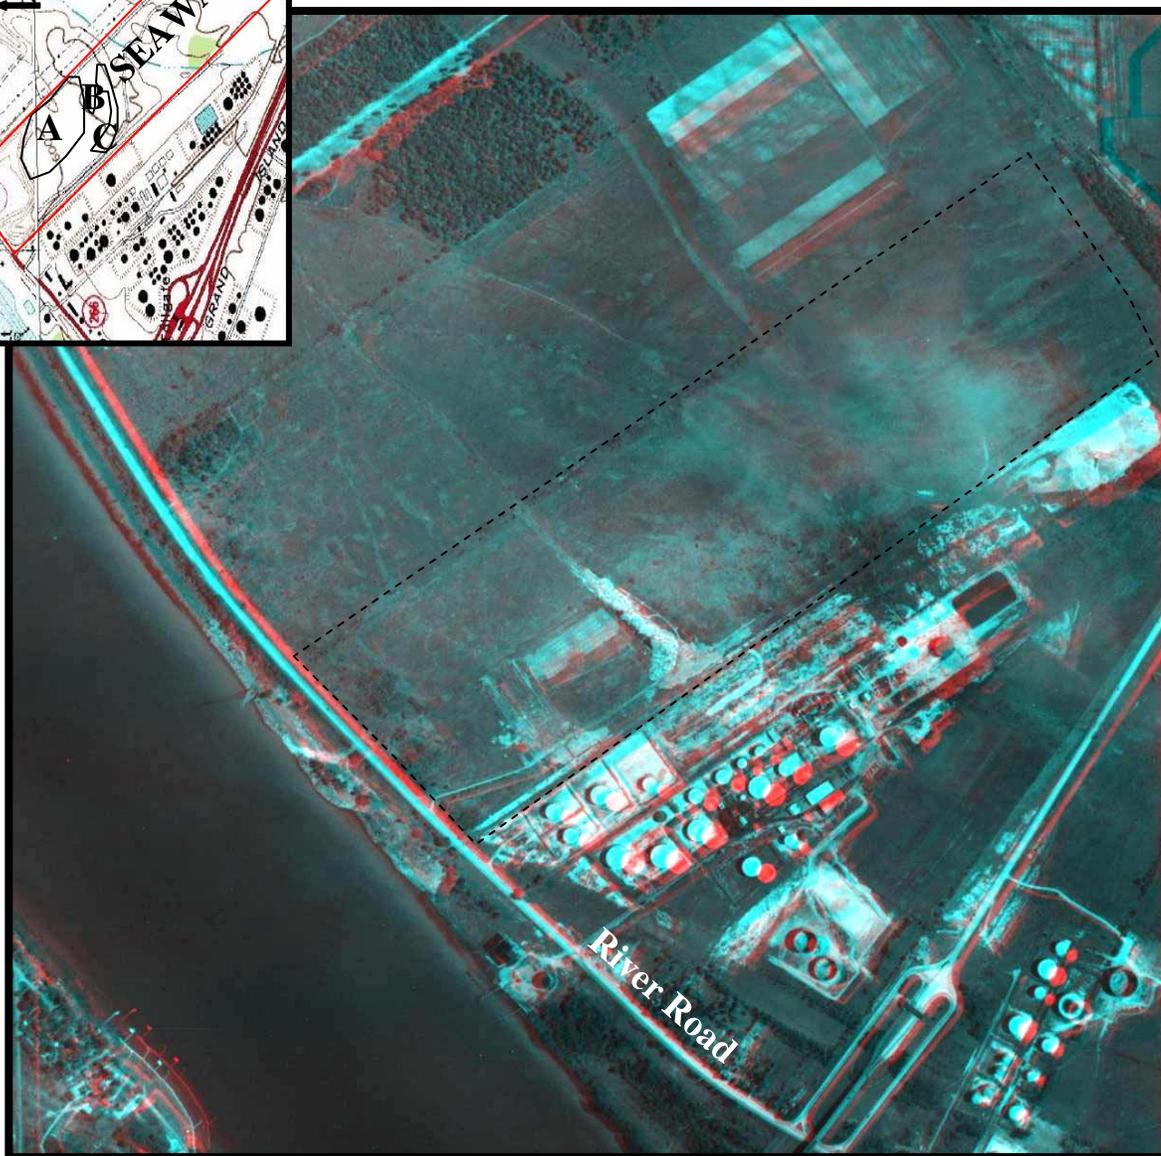
HISTORICAL PHOTOGRAPHIC ANALYSIS 1951 ANAGLYPH

In order to make the 1951 anaglyph, the direction of the photos had to be oriented to their stereo viewing position. North is to the left.

Dashed line defines the approximate Seaway site area.

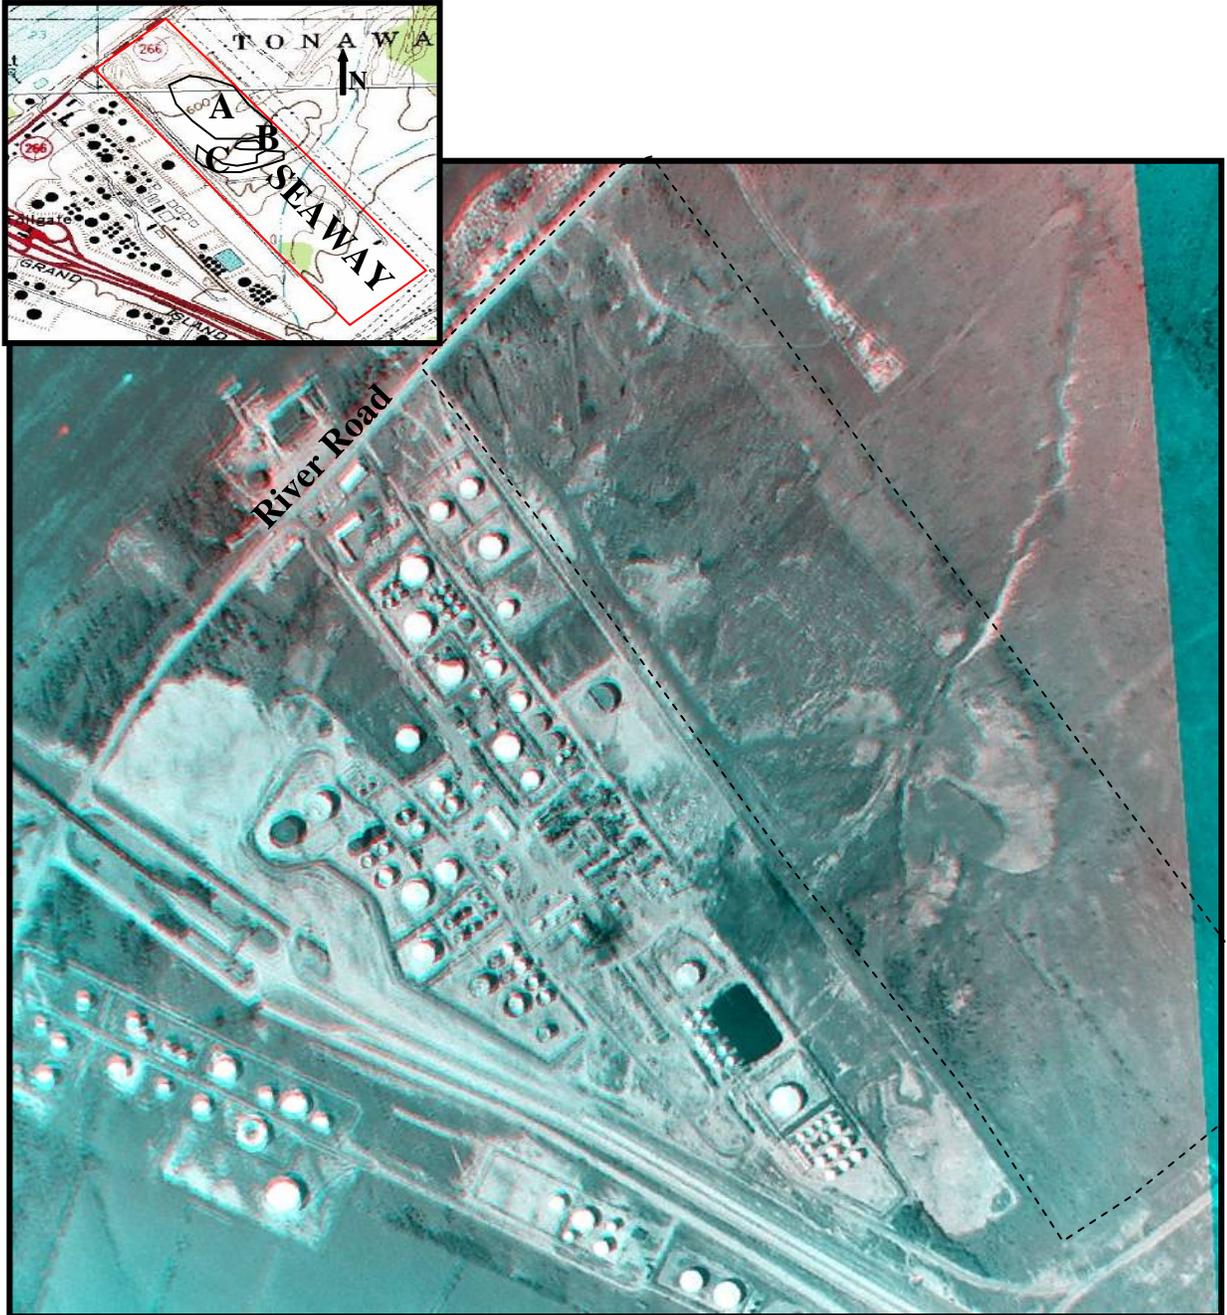
HISTORICAL PHOTOGRAPHIC ANALYSIS 1960 ANAGLYPH

Dashed line defines the approximate Seaway site area. Line may also distort image giving the appearance of a deep trench around the site where none exist.

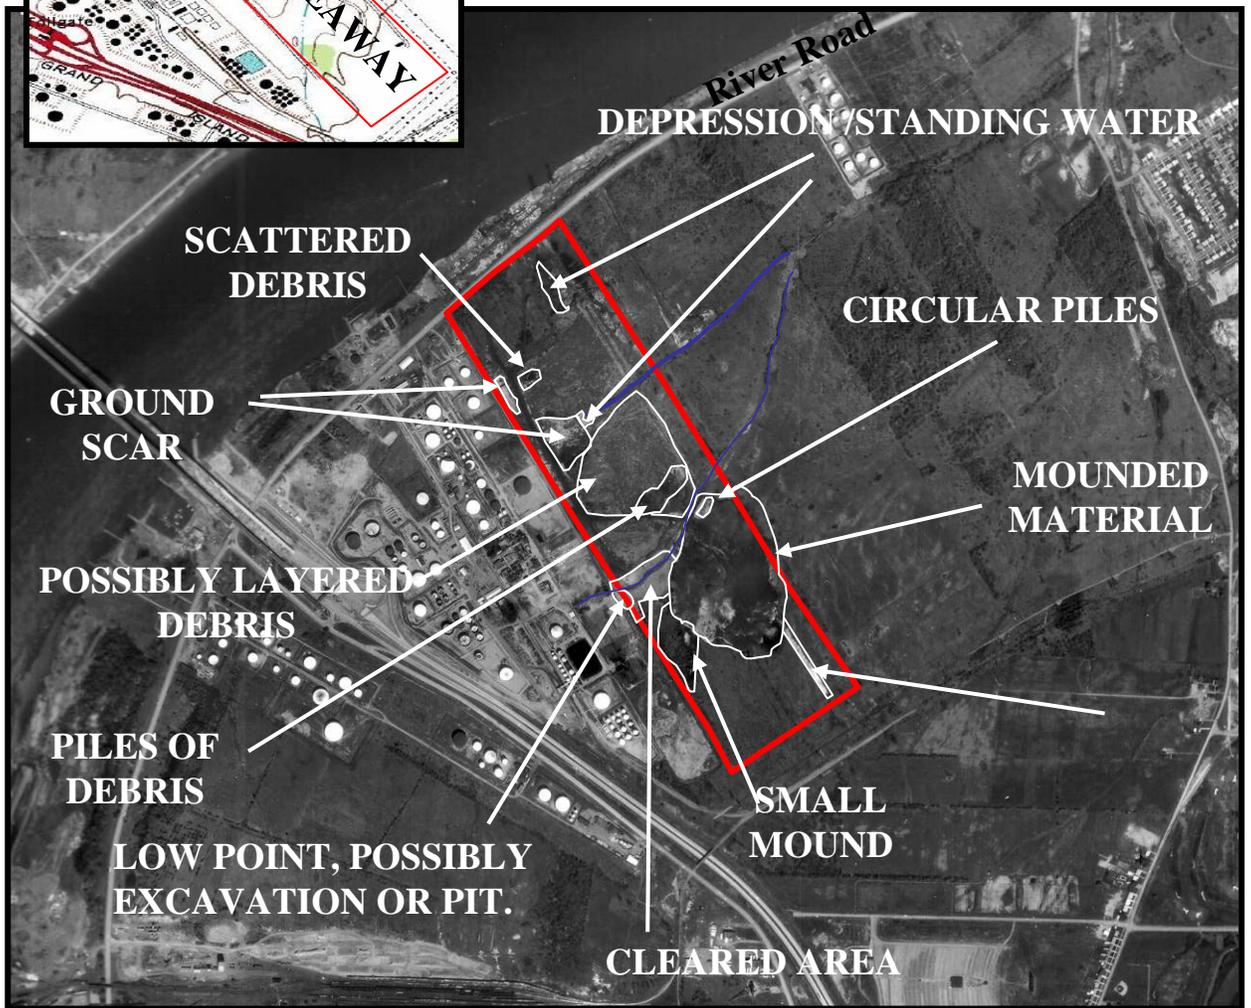
1962

The Seaway site is higher in elevation than the adjacent Ashland site. Varying hill heights are apparent on the Seaway property.

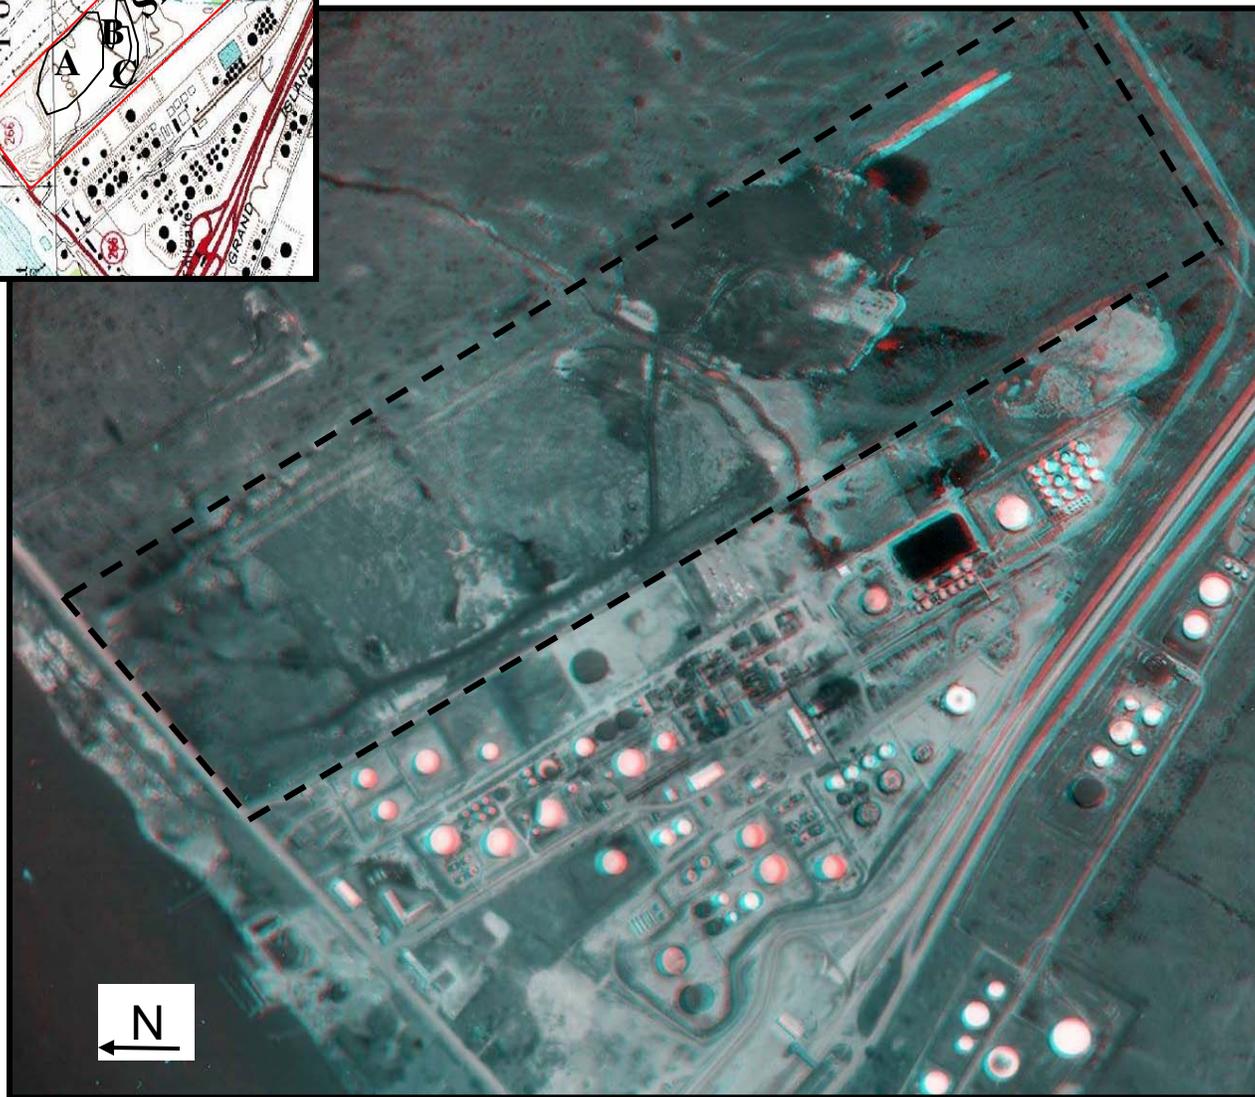
HISTORICAL PHOTOGRAPHIC ANALYSIS 1962 ANAGLYPH

In order to make the 1962 anaglyph, the direction of the photos had to be oriented to their stereo viewing position. North is to the left.

Dashed line defines the approximate Seaway site area. Line may also distort image giving the appearance of a deep trench around the site where none exist.

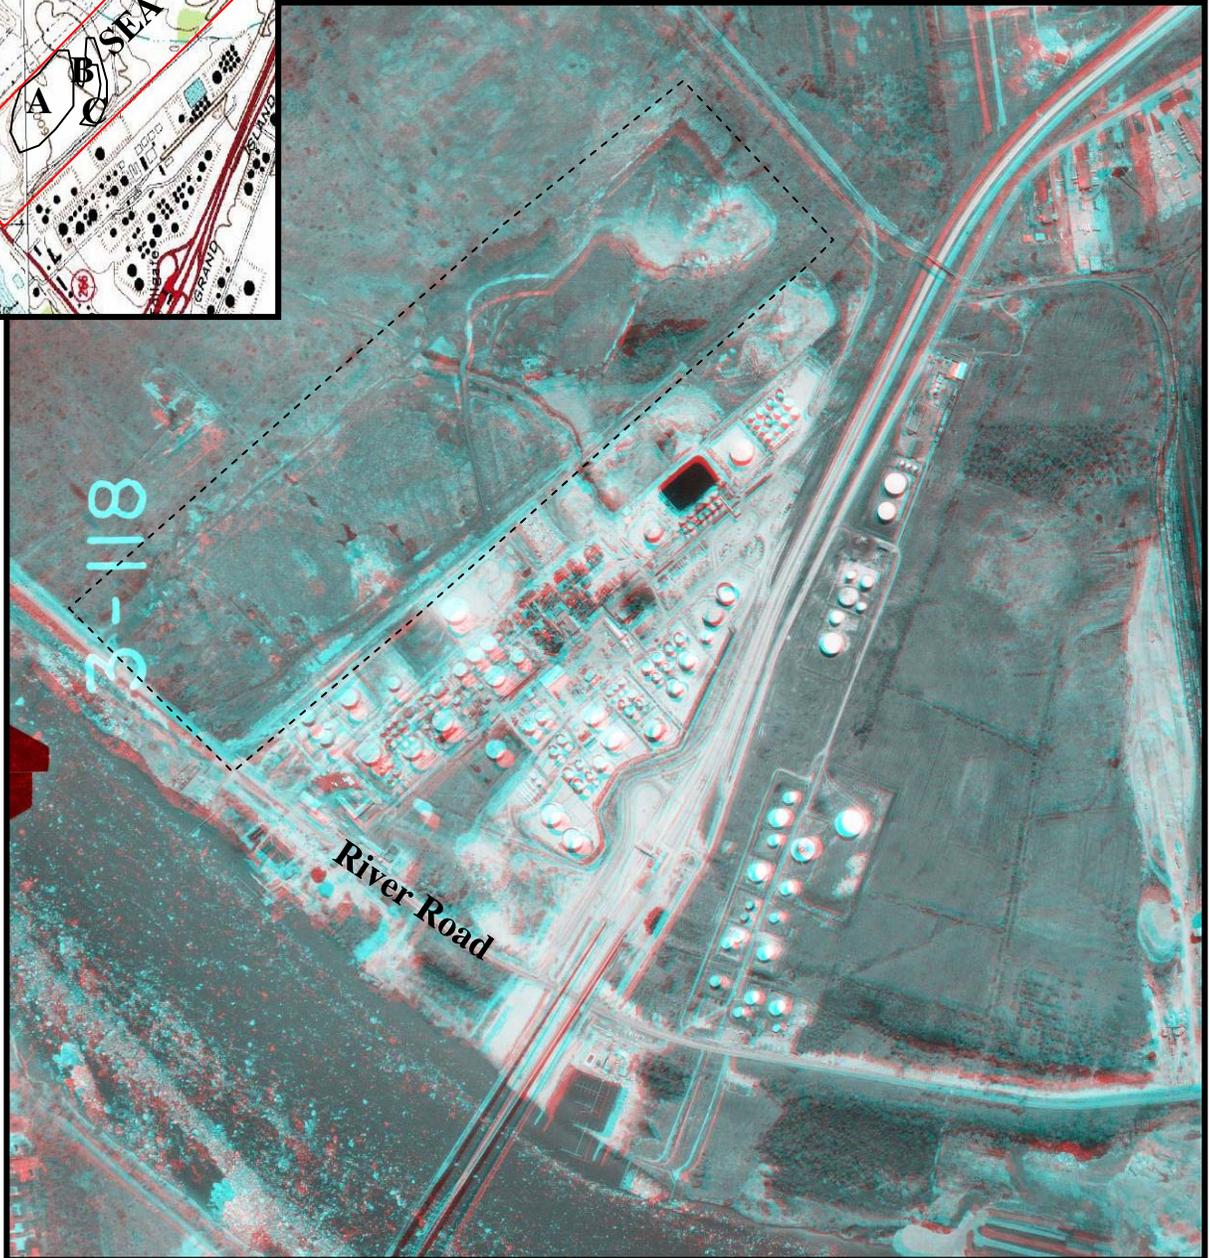
1963 ANAGLYPH

In order to make the 1963 anaglyph, the direction of the photos had to be oriented to their stereo viewing position. North is to the left. Dashed line defines the approximate Seaway site area.

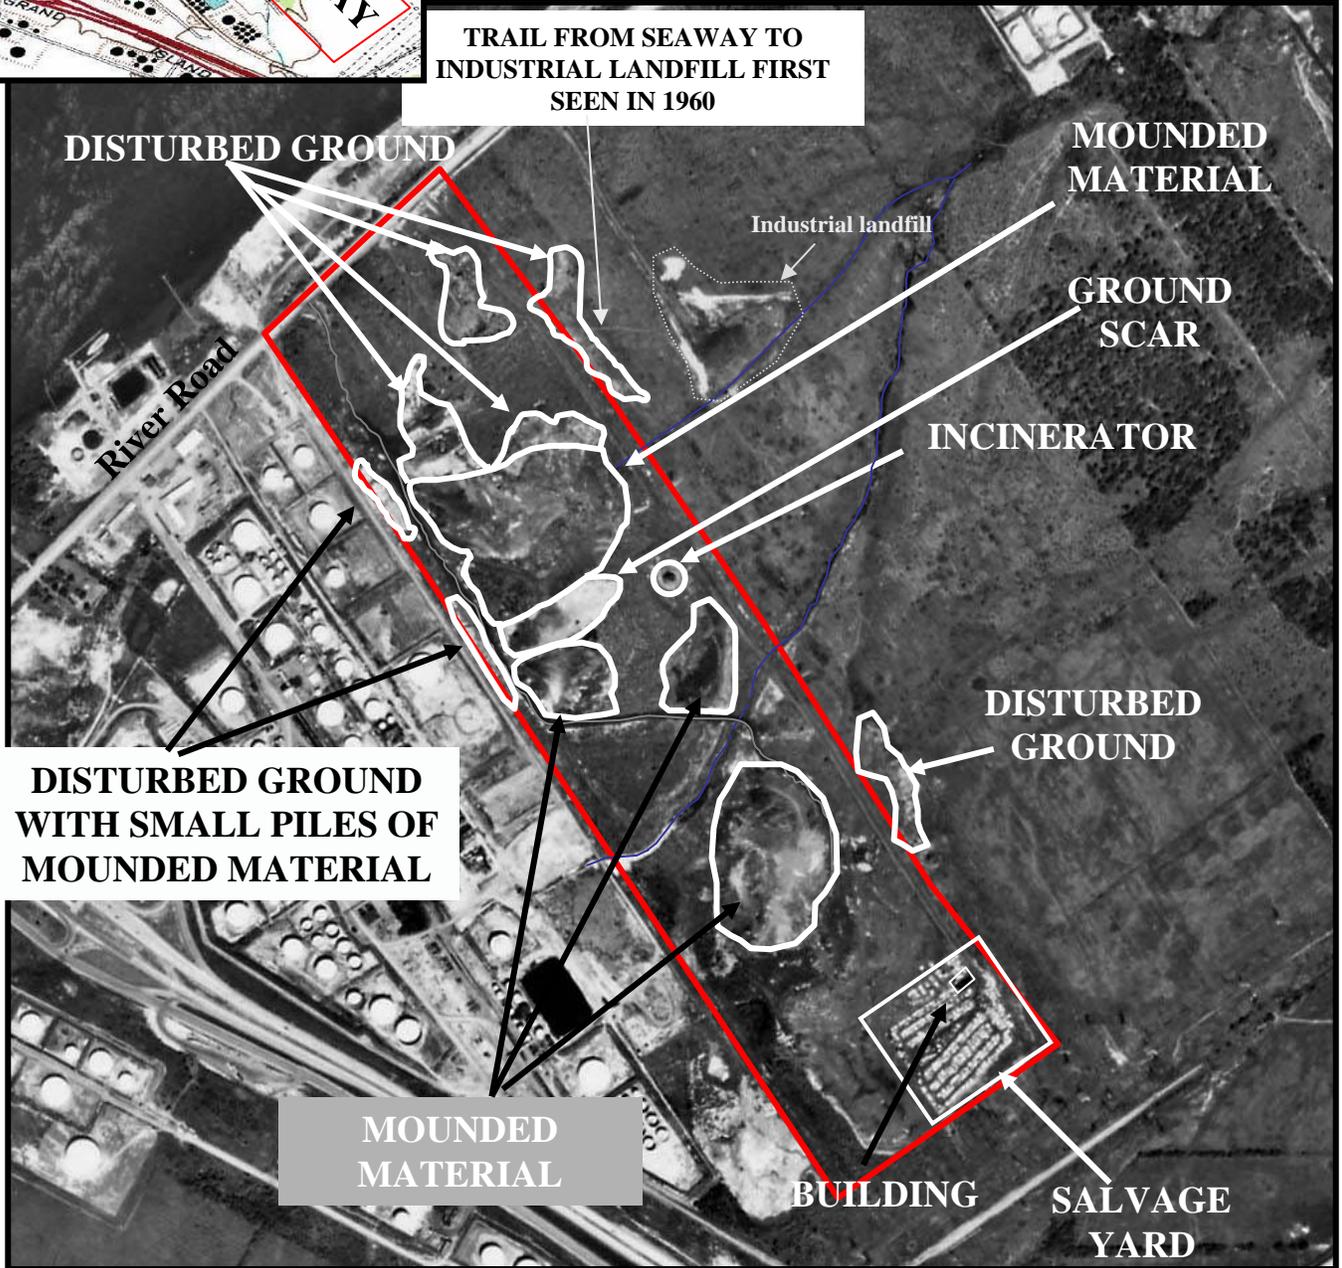
HISTORICAL PHOTOGRAPHIC ANALYSIS 1966

INCINERATOR LOCATION IS: 4762708.1 E; 669544.2 N UTM
LAT: 42 59 53.3 N; LON: 78 55 12.0 W

TRAIL FROM SEAWAY TO INDUSTRIAL LANDFILL FIRST SEEN IN 1960

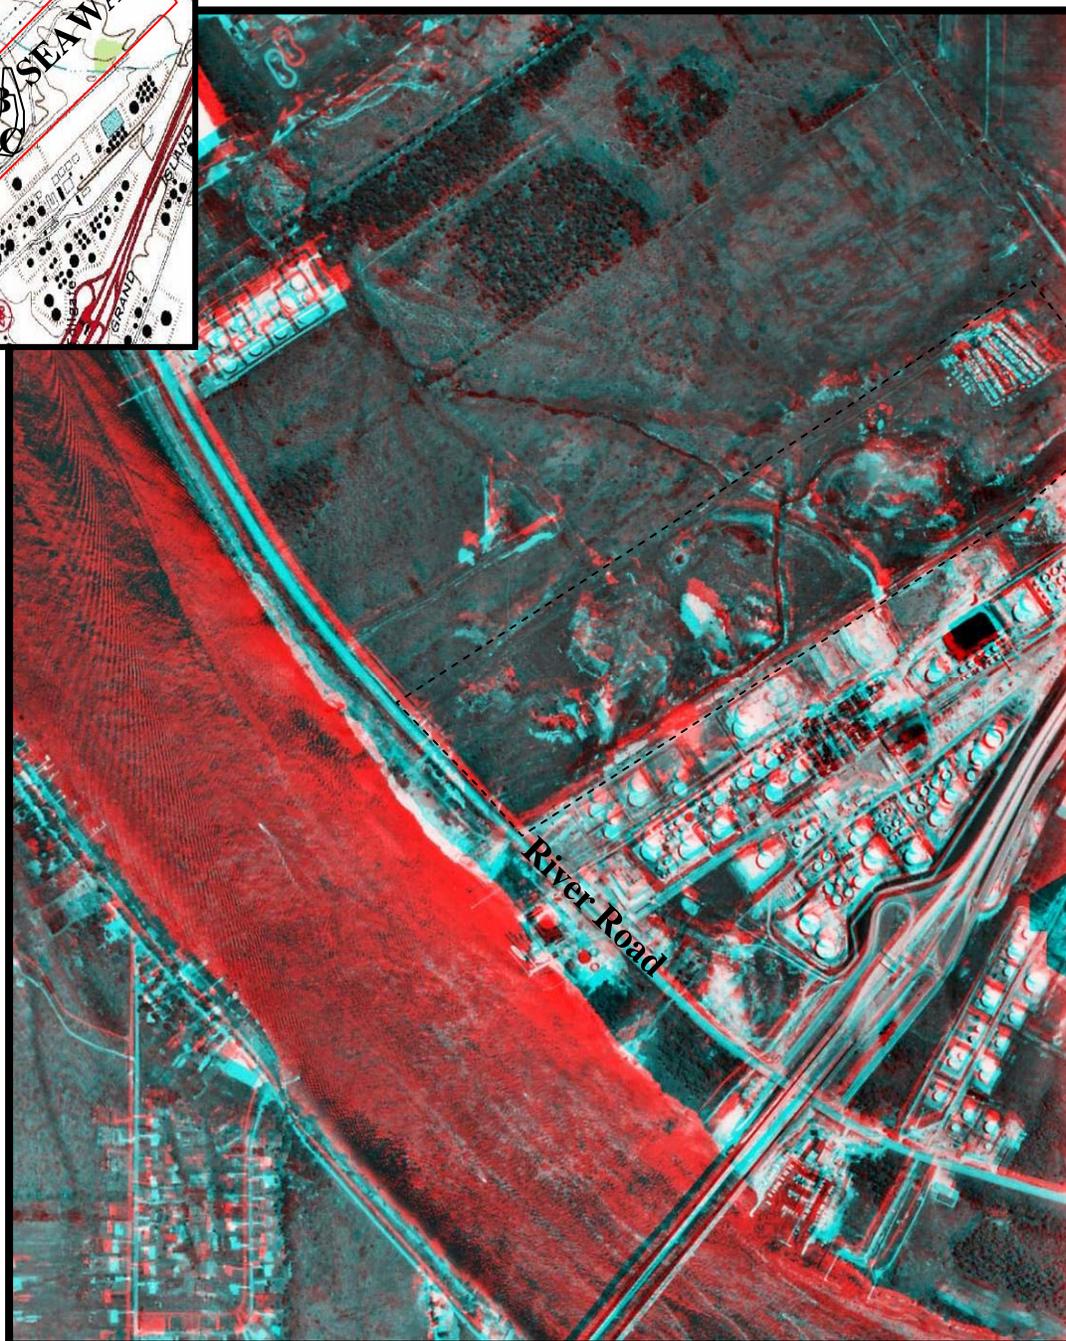
HISTORICAL PHOTOGRAPHIC ANALYSIS 1966 ANAGLYPH

In order to make the 1966 anaglyph, the direction of the photos had to be oriented to their stereo viewing position. North is to the left.

Dashed line defines the approximate Seaway site area.

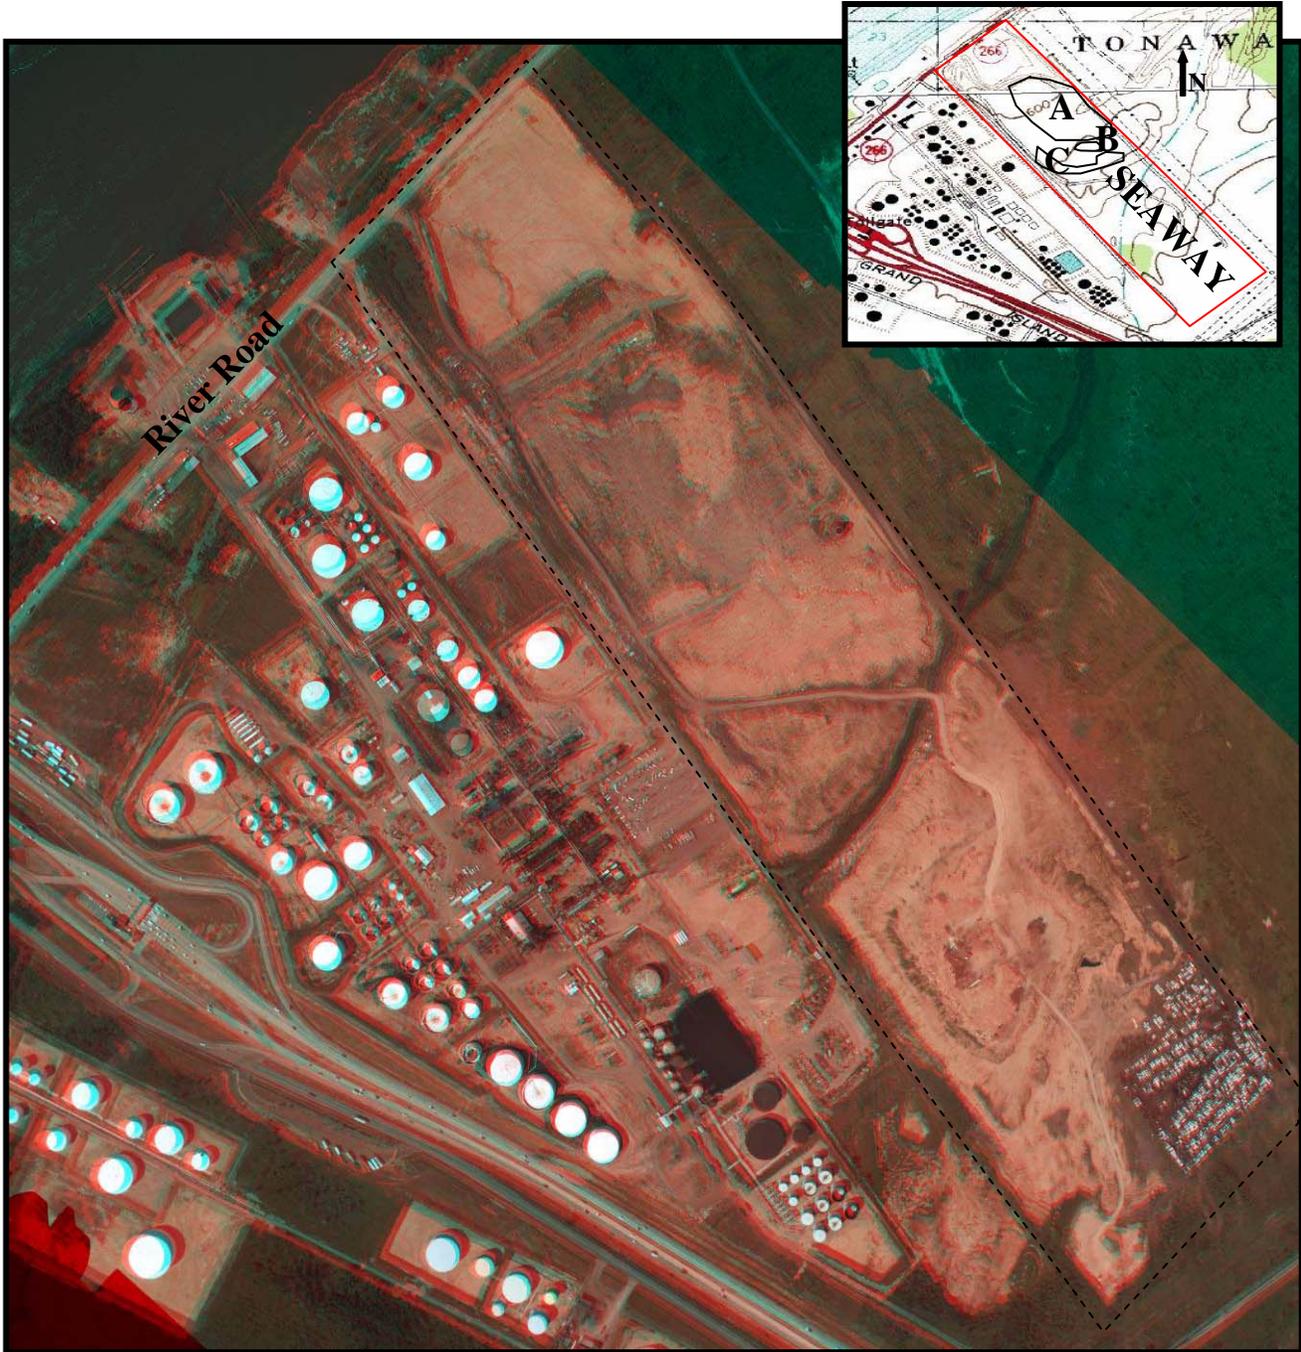
HISTORICAL PHOTOGRAPHIC ANALYSIS 1970 ANAGLYPH

TRAIL FROM SEAWAY TO DISTURBED GROUND (INDUSTRIAL LANDFILL) IS FIRST SEEN IN 1960 PHOTO.

MOUNDED MATERIAL
EACH AREA SLIGHTLY HIGHER THAN THE BASE, WITH VEHICLES OR TRUCKS SEEN ATOP THE HIGHEST MOUND.

(IN 1966 THIS AREA WAS ABOUT 600' ABOVE SEA LEVEL. IN 1970 IT IS ABOUT 575' ABOVE SEA LEVEL, AS PER U. S. G. S. TOPOGRAPHIC MAPS)

POSSIBLE TANK IN EXCAVATED AREA AT CREEK HEAD

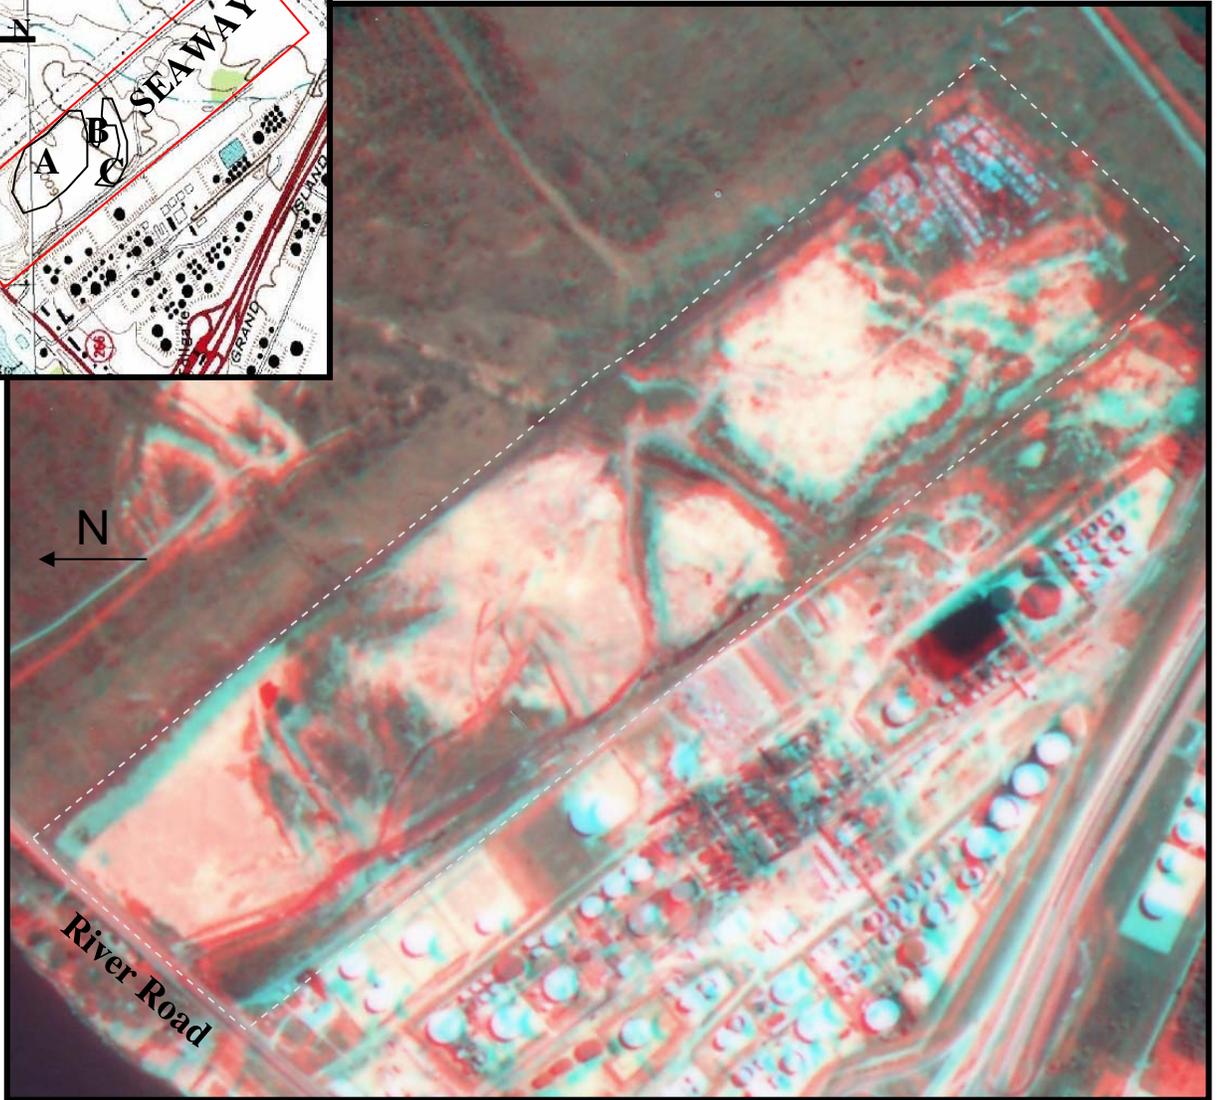
HISTORICAL PHOTOGRAPHIC ANALYSIS 1972 ANAGLYPH

In order to make the 1972 anaglyph, the direction of the photos had to be oriented to their stereo viewing position. North is to the left. Dashed line defines the approximate Seaway site area. Line may also distort image giving the appearance of a deep trench around the site where none exist.

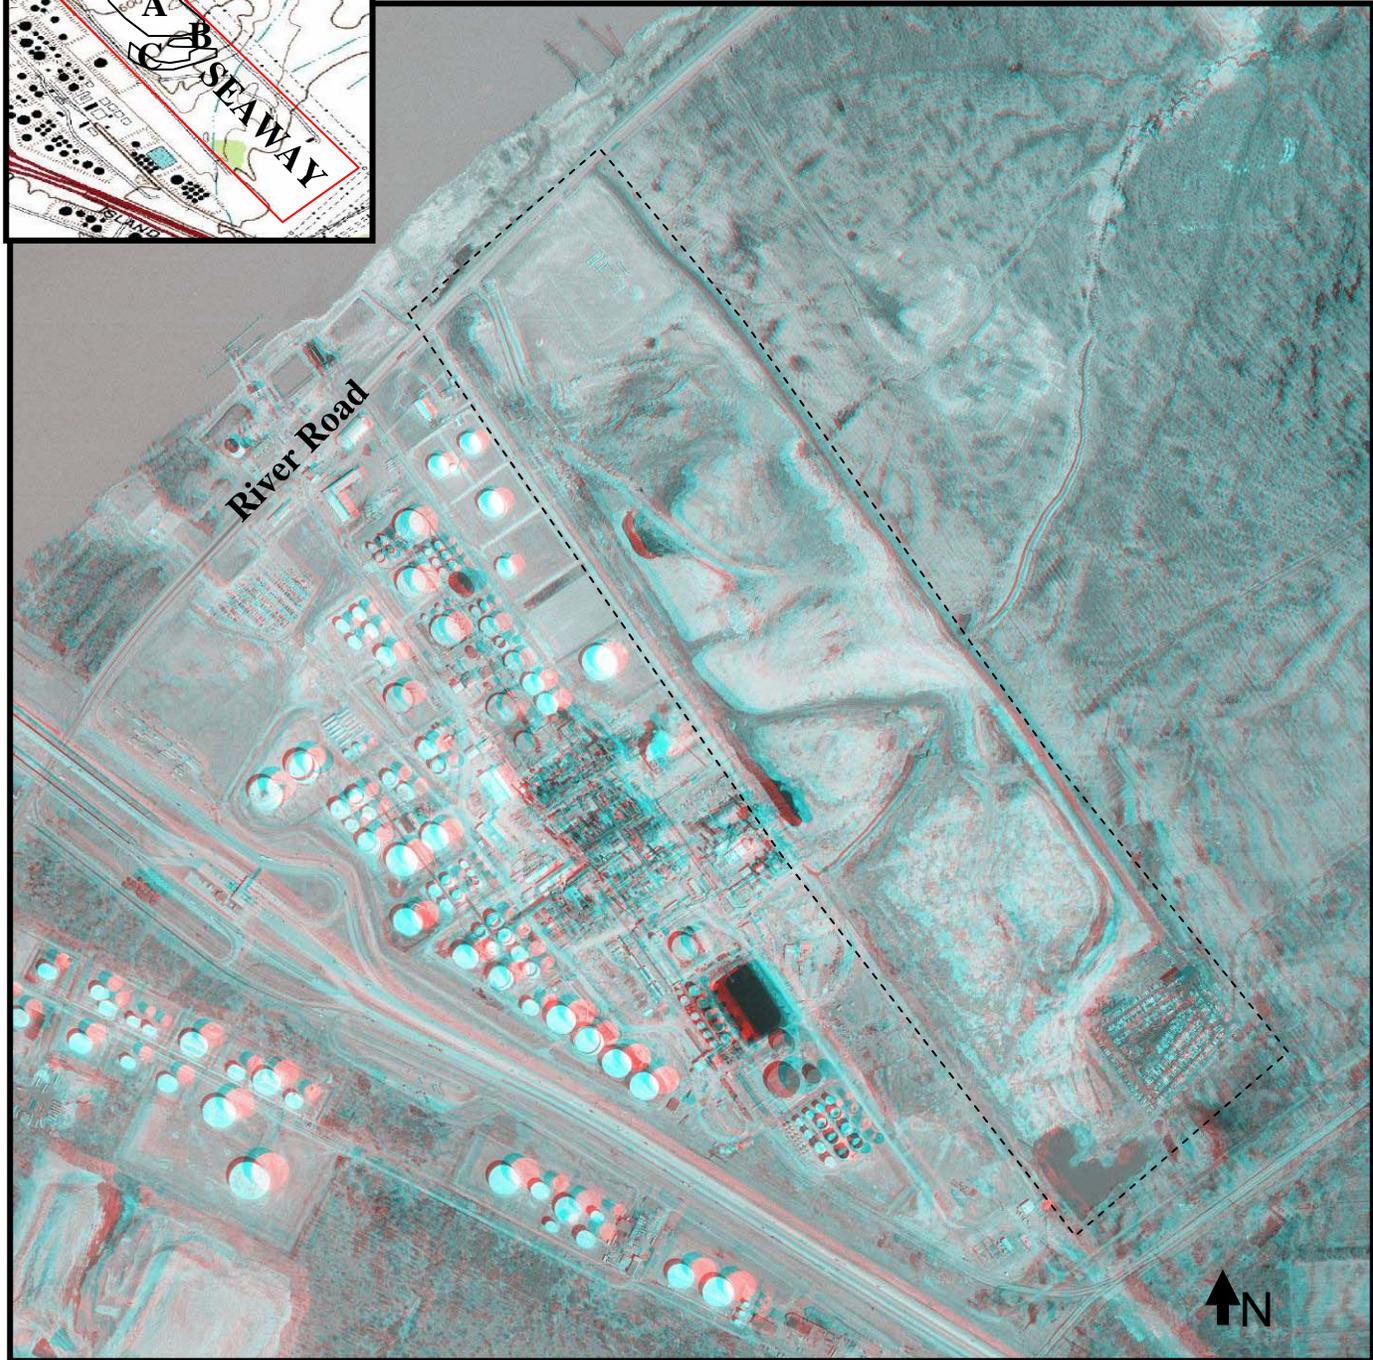
1974 ANAGLYPH

Dashed line defines the approximate Seaway site area. Note – on this image the dashed line may distort your view of the image giving the appearance of a deep trench around the site where none exist.
