SEAWAY LANDFILL TONAWANDA, NEW YORK

*Formerly Utilized Sites Remedial
Action Program (FUSRAP)*

August 2006 Final Report

Prepared for the US Army Corps of Engineers,
Buffalo District, Buffalo, New York

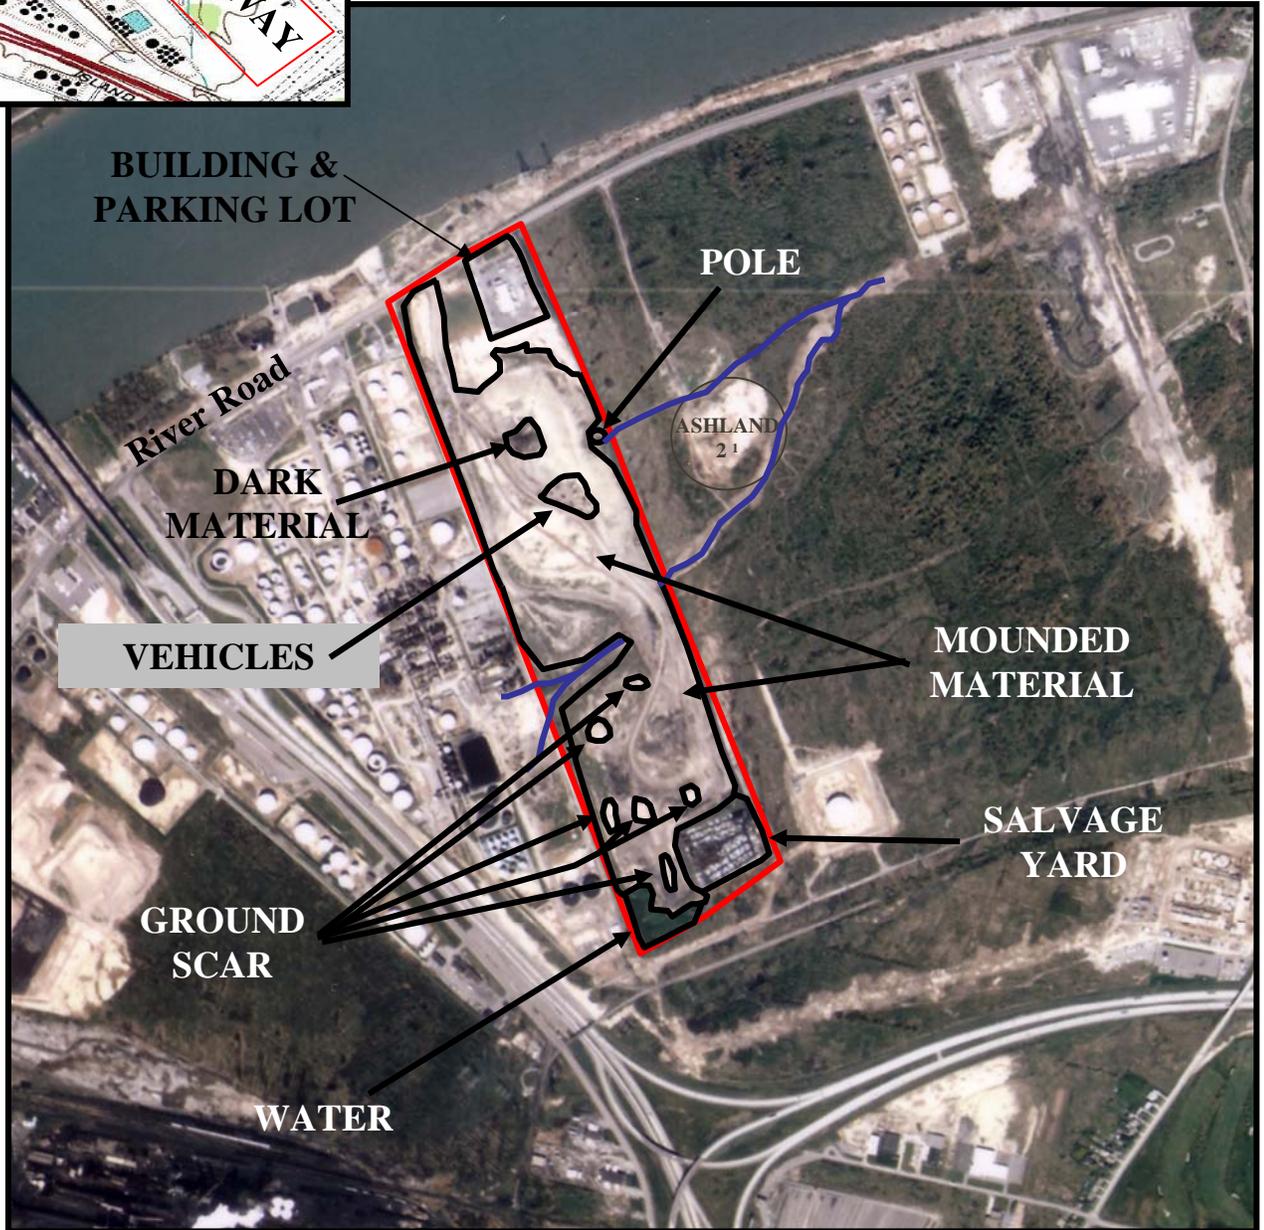
1976

POLE POSSIBLY AIR SAMPLING LOCATION. ¹
LOCATION OF POLE: UTM X: 669485; Y: 4762840 METERS
LAT 42 59 57 N; LON 78 55 14 W

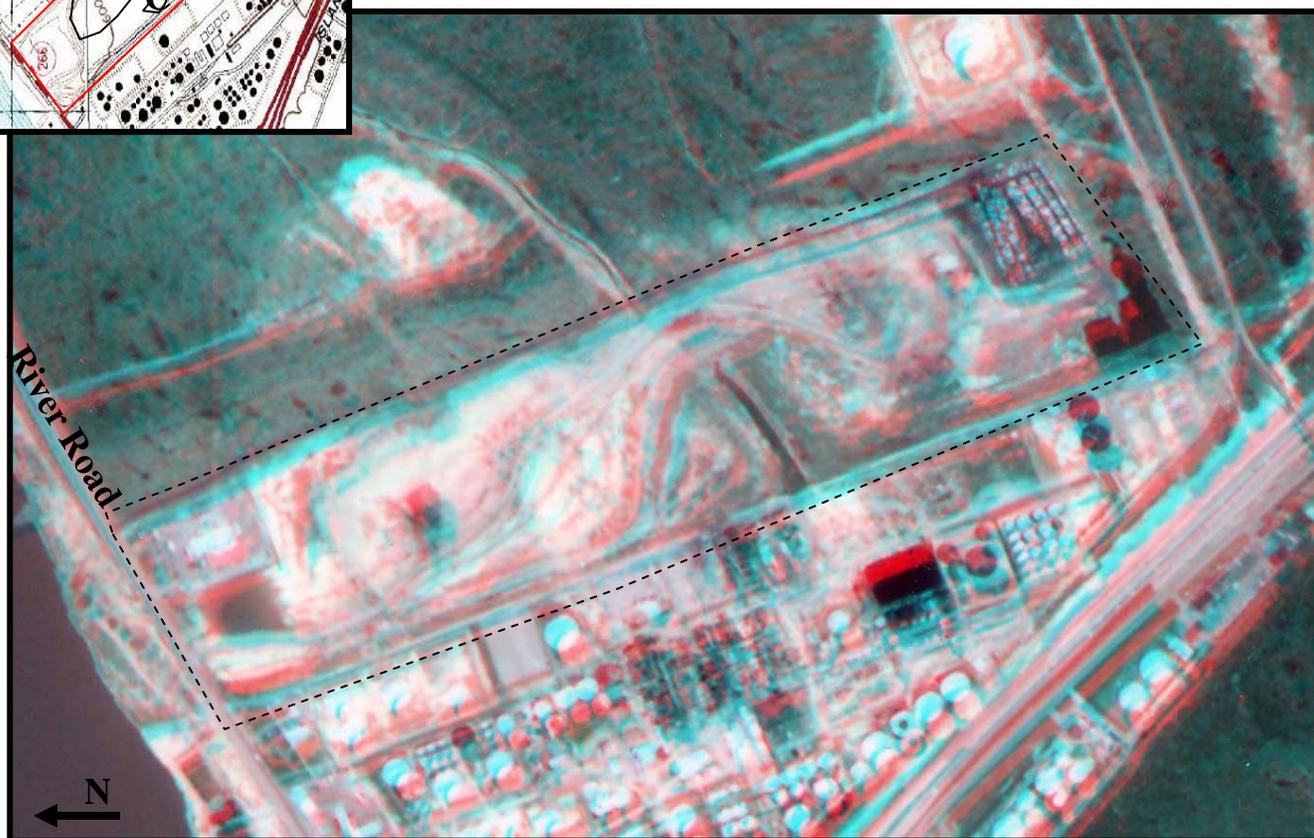
HISTORICAL PHOTOGRAPHIC ANALYSIS 1976 ANAGLYPH

In order to make the 1976 anaglyph, the direction of the photos had to be oriented to their stereo viewing position. North is to the left.

Dashed line defines the approximate Seaway site area.

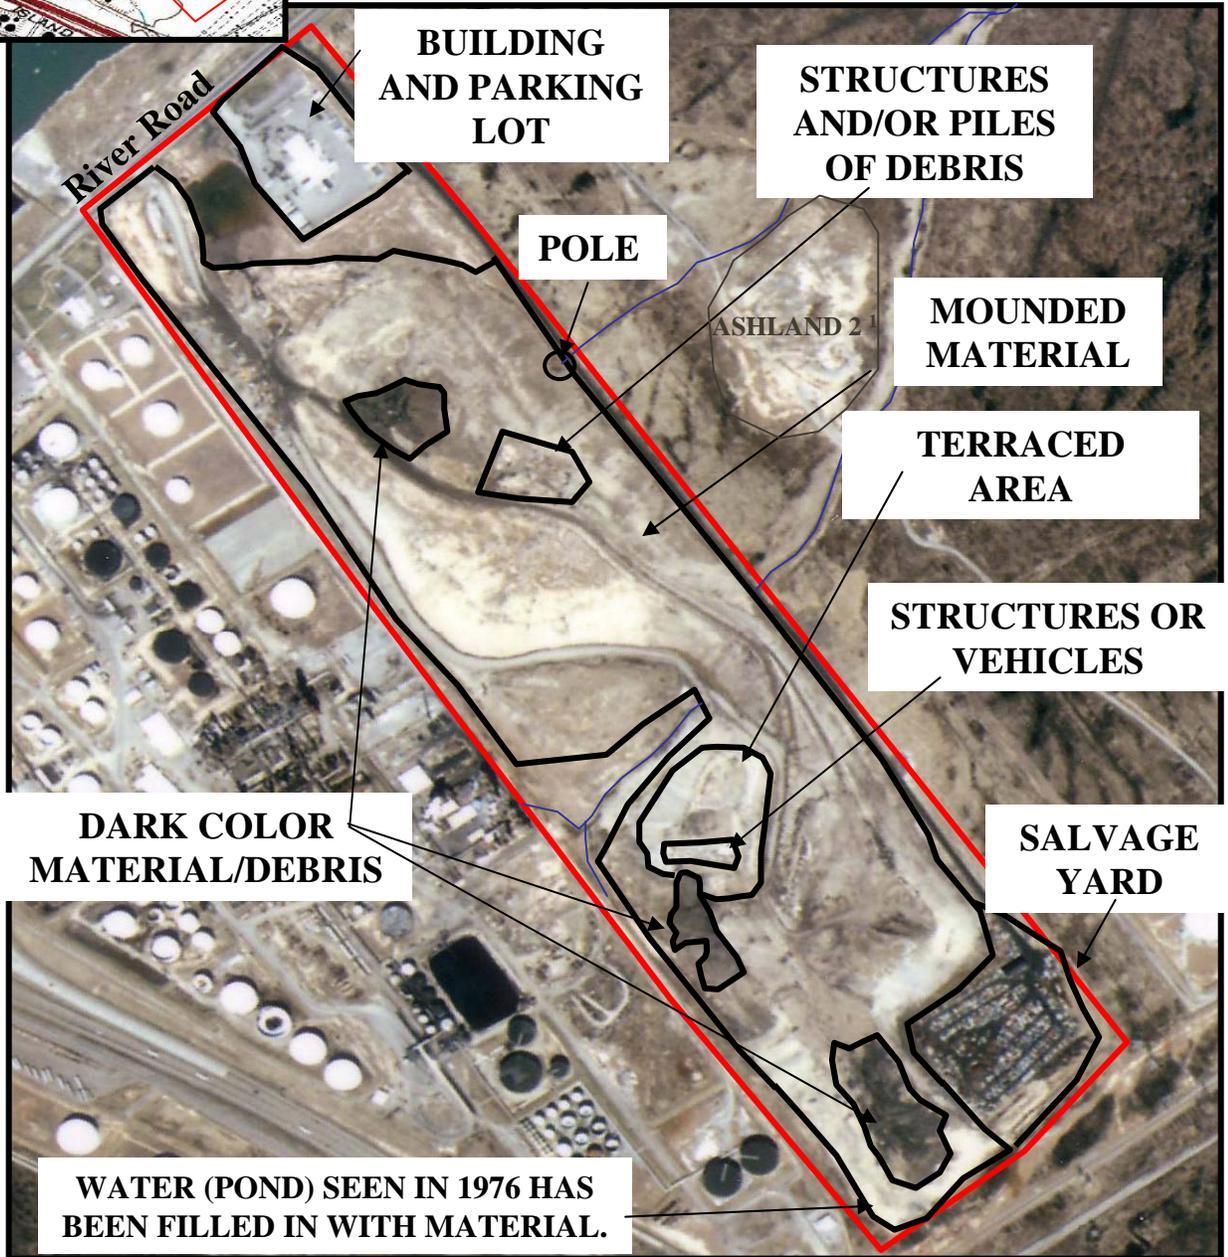
1978

POLE POSSIBLE AIR QUALITY SAMPLING LOCATION.¹
LOCATION OF POLE: UTM X: 669485; Y: 4762840 METERS
LAT 42 59 57 N; LON 78 55 14 W

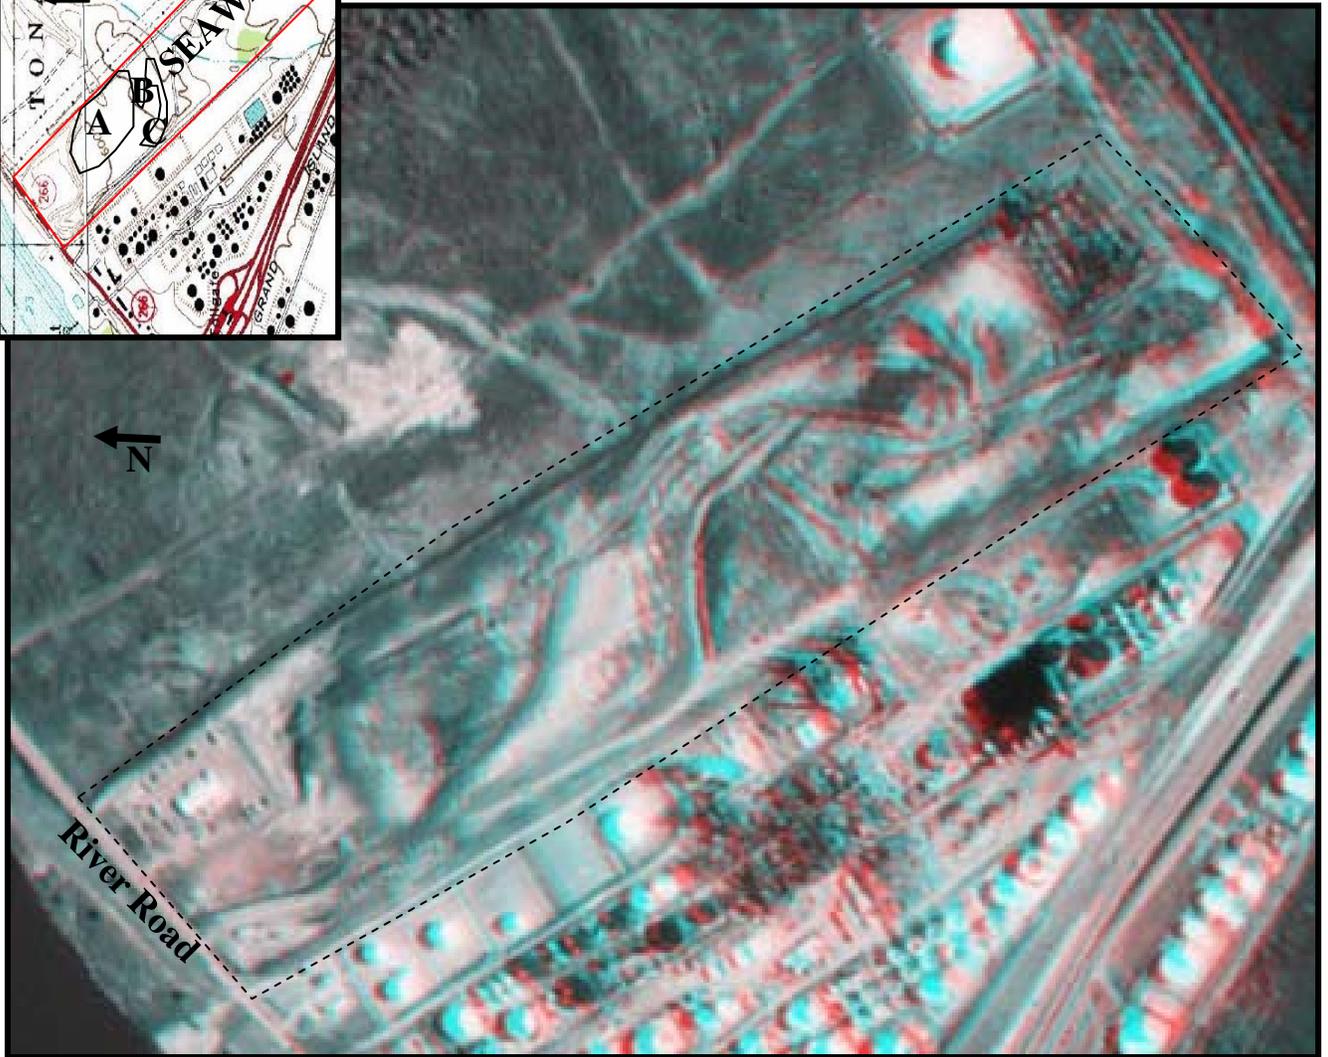
HISTORICAL PHOTOGRAPHIC ANALYSIS 1978 ANAGLYPH

In order to make the 1978 anaglyph, the direction of the photos had to be oriented to their stereo viewing position. North is to the left.

Dashed line defines the approximate Seaway site area. Line may also distort image giving the appearance of a deep trench around the site where none exist.

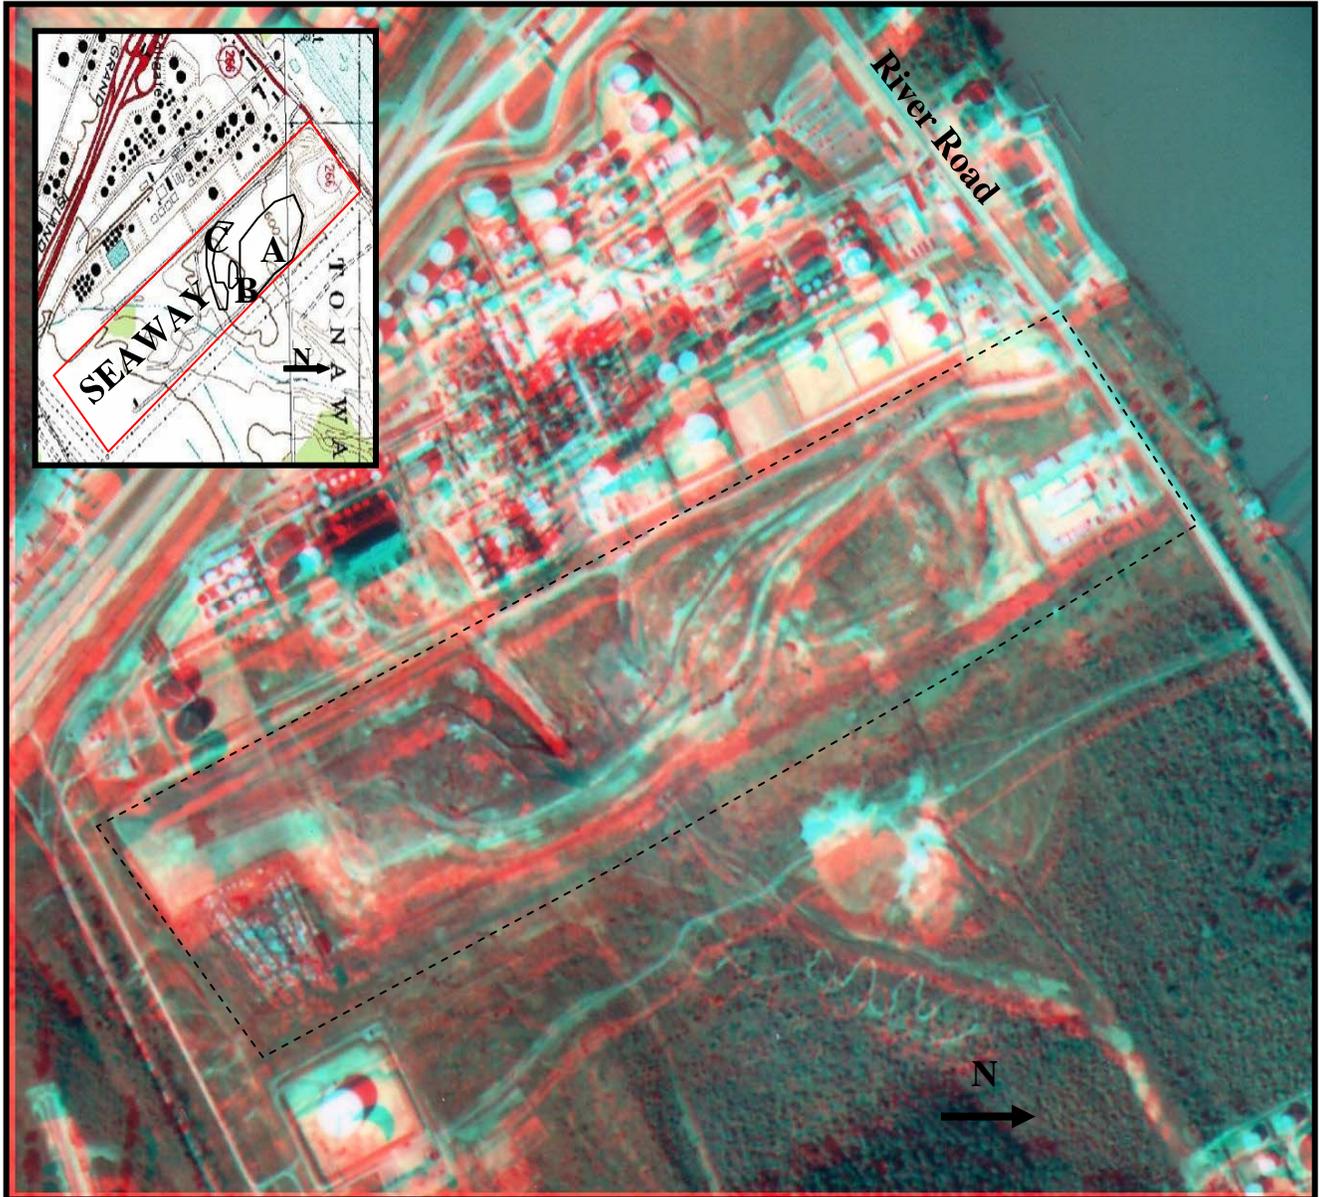
HISTORICAL PHOTOGRAPHIC ANALYSIS 1980 ANAGLYPH

**In order to make the 1980 anaglyph, the direction of the photos had to be oriented to their stereo viewing position. North is to the right.
Dashed line defines the approximate Seaway site area.**

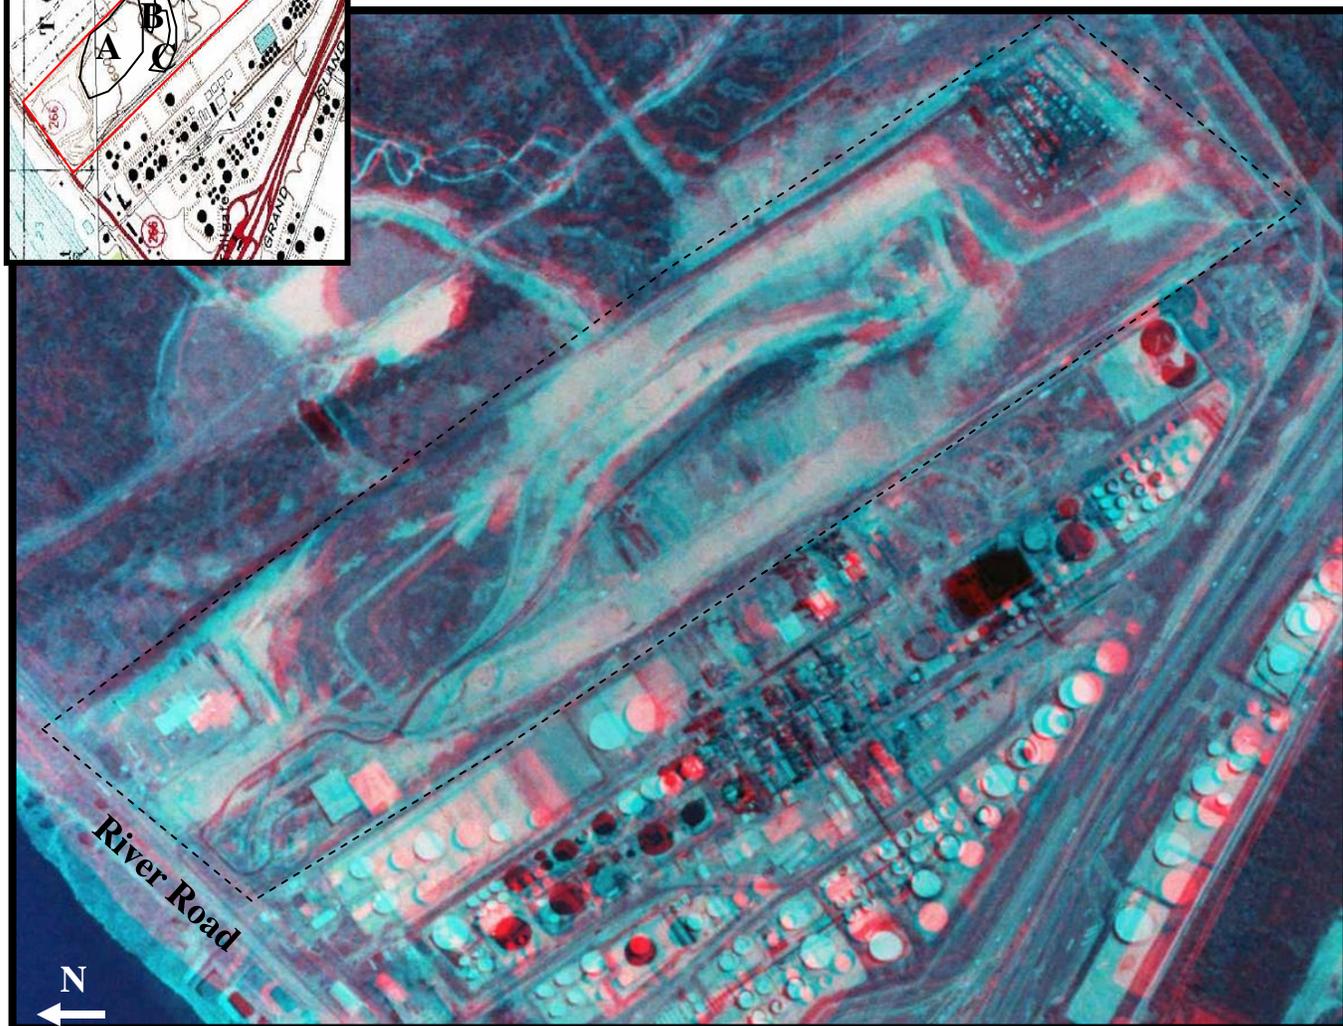
HISTORICAL PHOTOGRAPHIC ANALYSIS 1985 ANAGLYPH

**In order to make the 1985 anaglyph, the direction of the photos had to be oriented to their stereo viewing position. North is to the left.
Dashed line defines the approximate Seaway site area.**

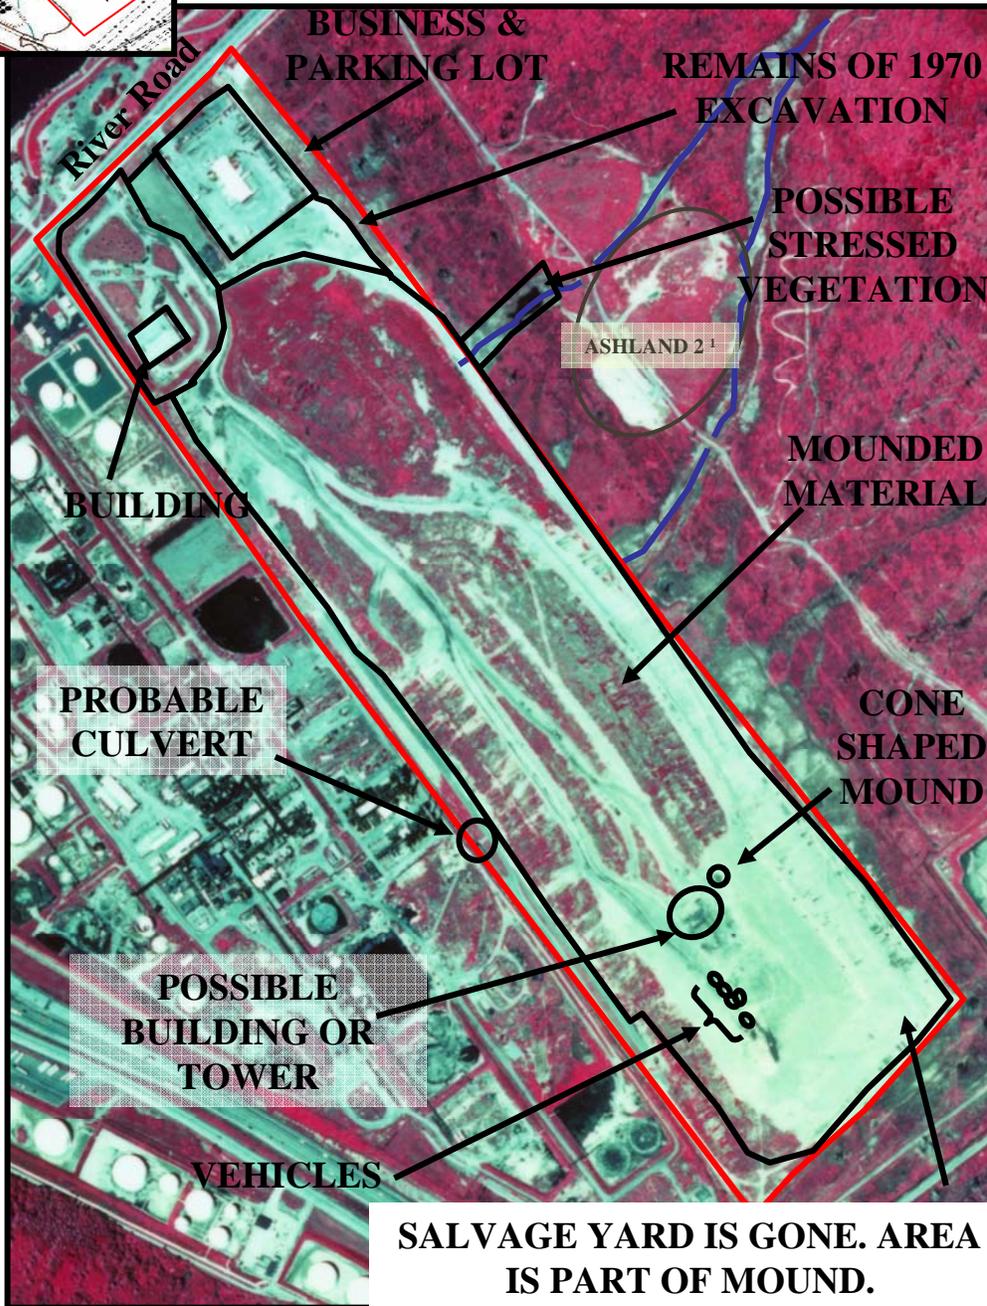
HISTORICAL PHOTOGRAPHIC ANALYSIS 1990

SALVAGE YARD IS GONE. AREA IS PART OF MOUND.

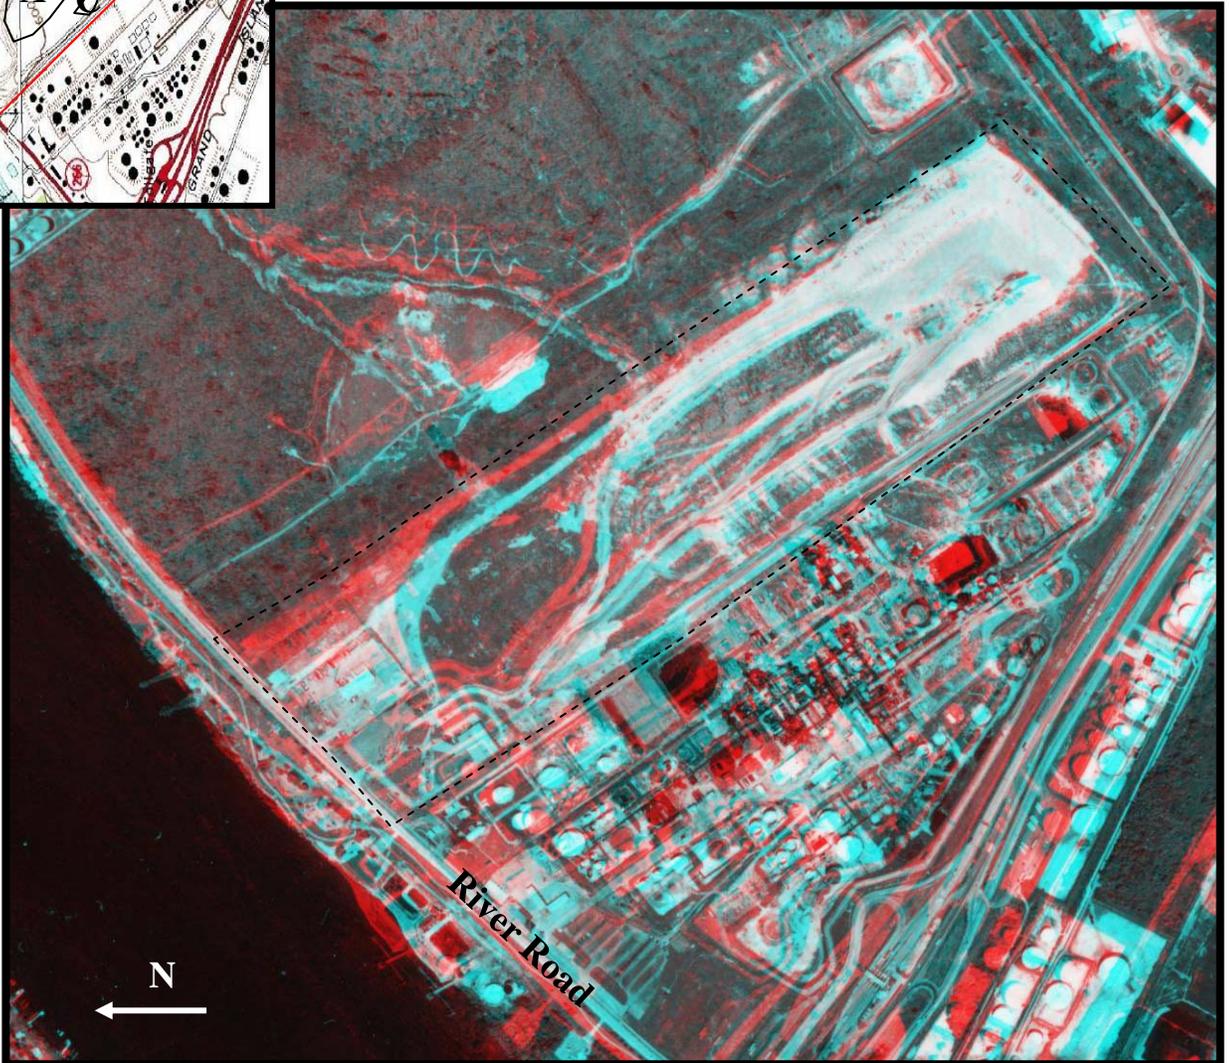
HISTORICAL PHOTOGRAPHIC ANALYSIS 1990 ANAGLYPH

**In order to make the 1990 anaglyph, the direction of the photos had to be oriented to their stereo viewing position. North is to the left.
Dashed line defines the approximate Seaway site area.**

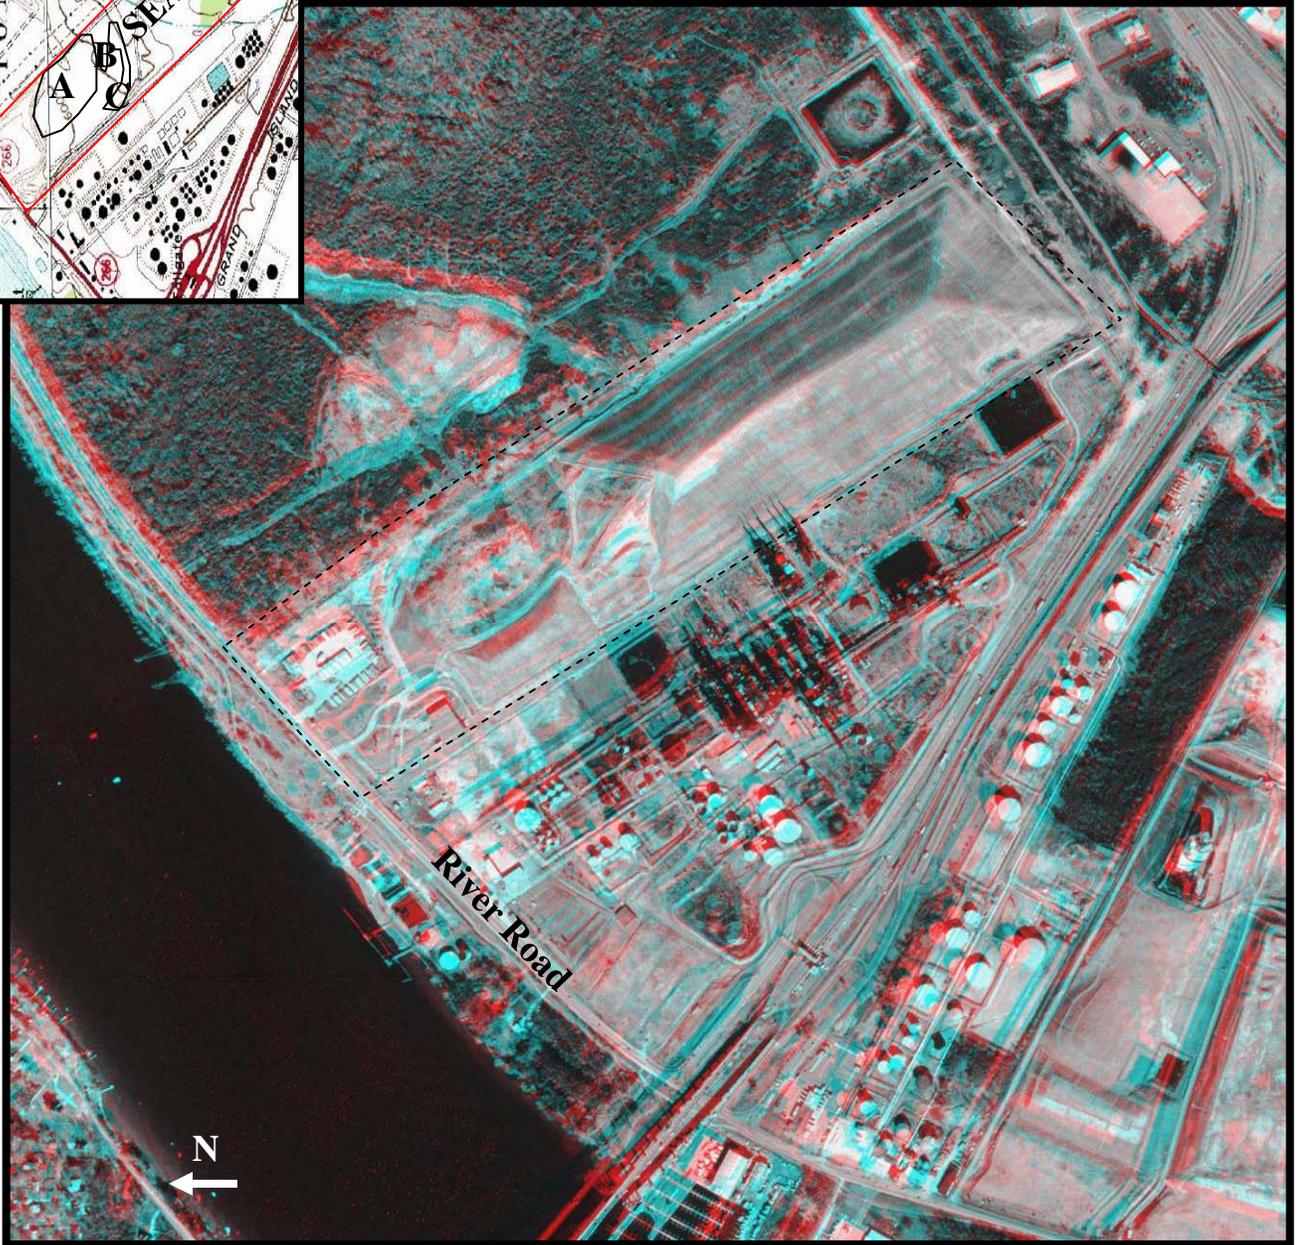
HISTORICAL PHOTOGRAPHIC ANALYSIS 1995 ANAGLYPH

In order to make the 1995 anaglyph, the direction of the photos had to be oriented to their stereo viewing position. North is to the left. Dashed line defines the approximate Seaway site area.

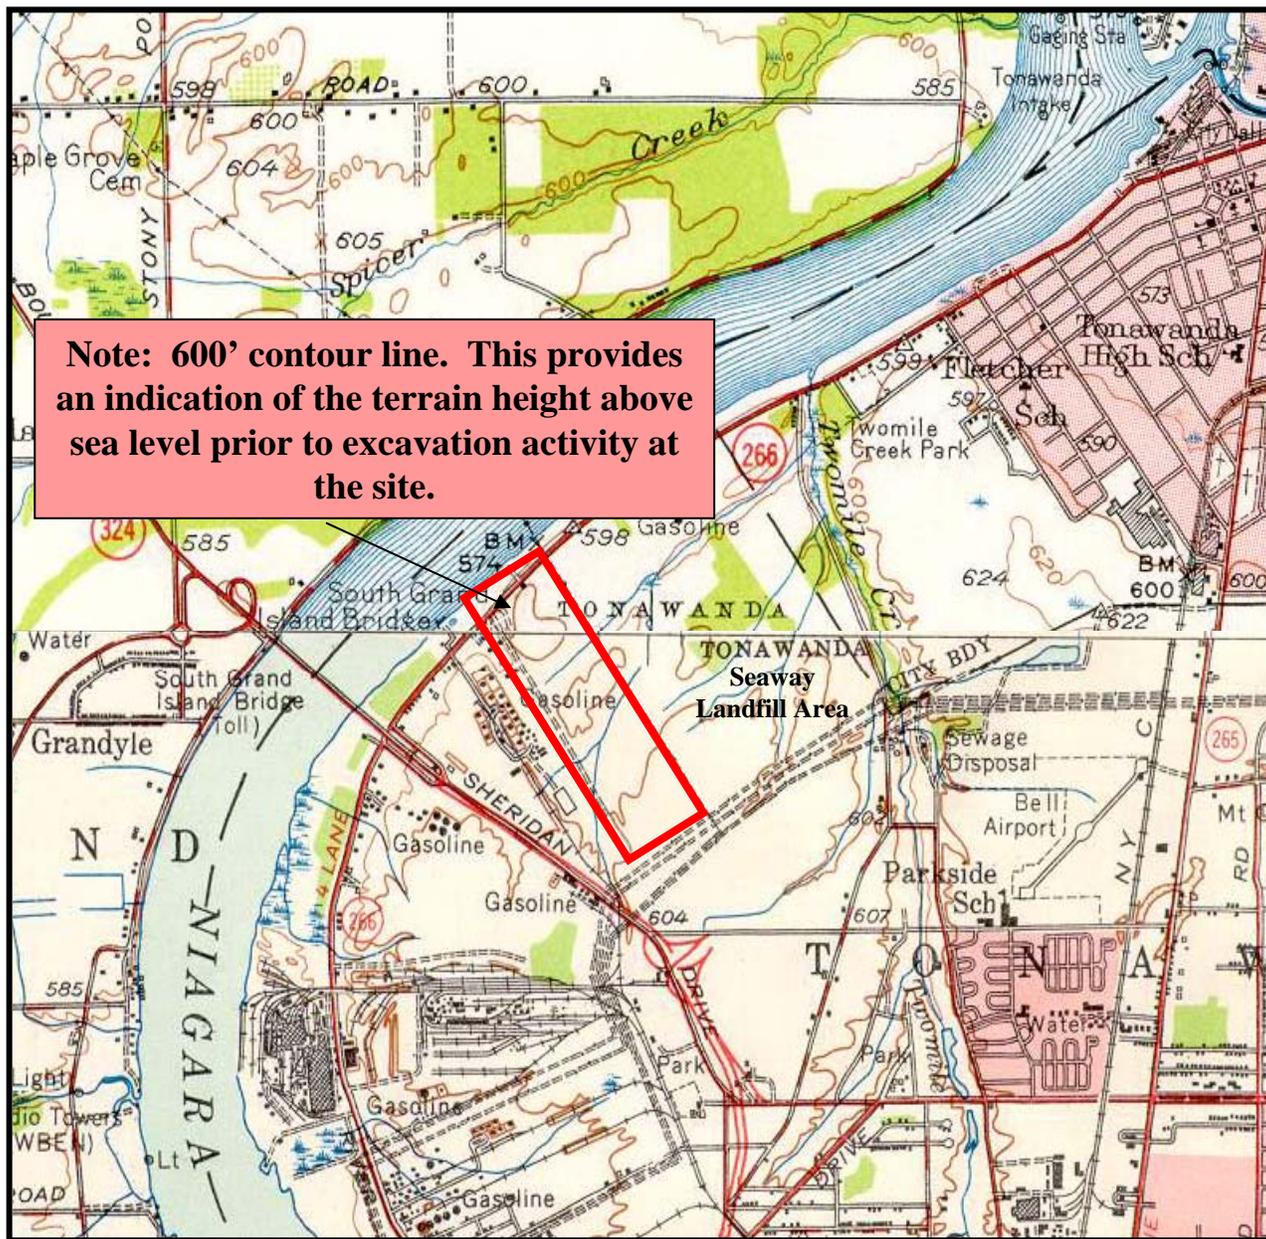
1948 USGS Topographic Maps of the Area

1948 Edition **Tonawanda, NY**, 15 min quad: contour interval 20 feet; Culture and drainage in part compiled by Corps of Eng, Dept of the Army, from aerial photographs taken 1942. Topography by plane-table methods 1948.

1948 Edition **Buffalo, NY**, 15 min quad: contour interval 20 feet; Culture and drainage in part compiled by Corps of Eng, Dept of the Army, from aerial photographs taken 1942. Topography by plane-table methods 1948.

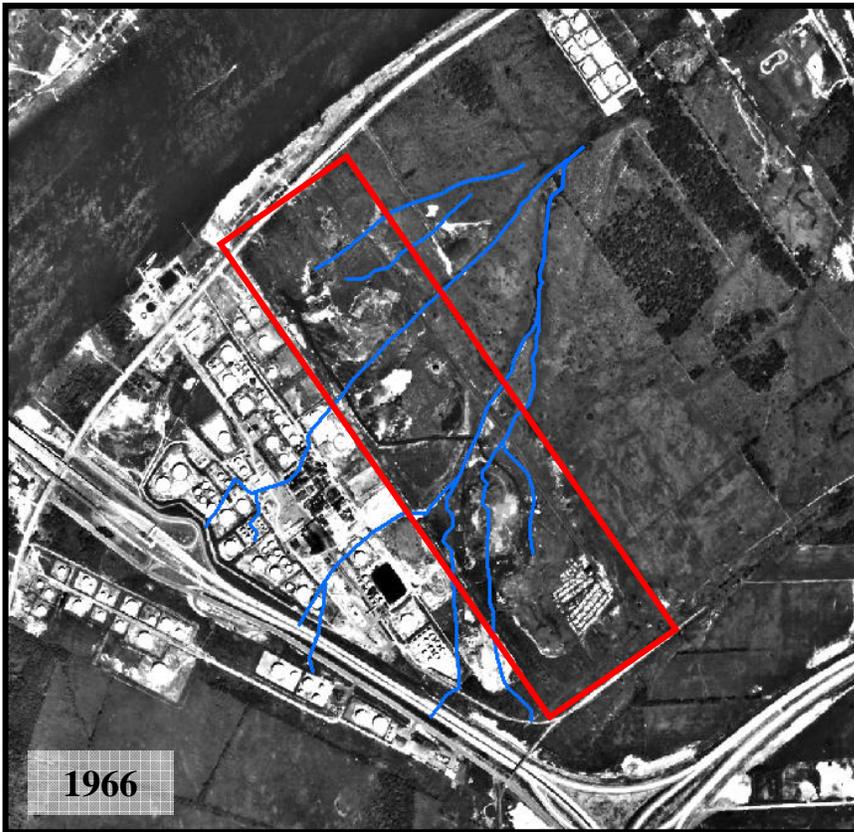
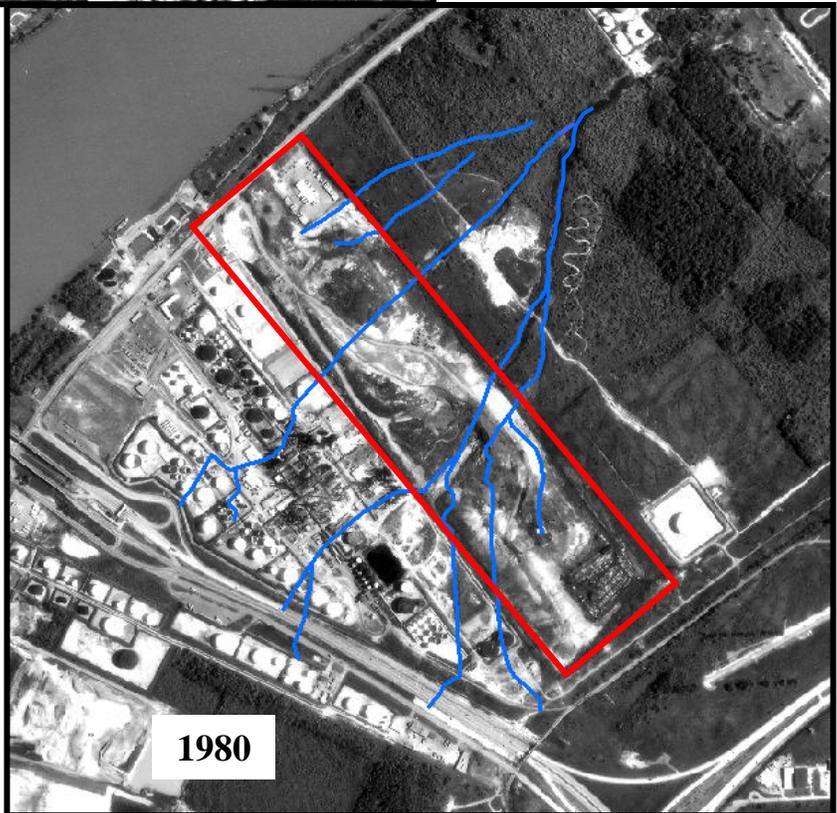
SUMMARY – SURFACE DRAINAGE

From 1927 to 1980 the drainage in the area changed. In 1985 photos it is evident the creek is channelized and travels under the mound on Seaway property through a concrete conduit.¹ Historical drainage is important because creeks often represent fracture traces, important when addressing aquifer contamination. Creeks may represent conduits for groundwater flows and may provide possible subsurface contaminant pathways.

1966 photo (above) and 1980 photo (right) are used as bases for the 1927 drainage network shown atop the photos.

NOTE: Vegetation signatures were used to map drainage for the 1927 photos. Stereo pairs were not available for 1927.

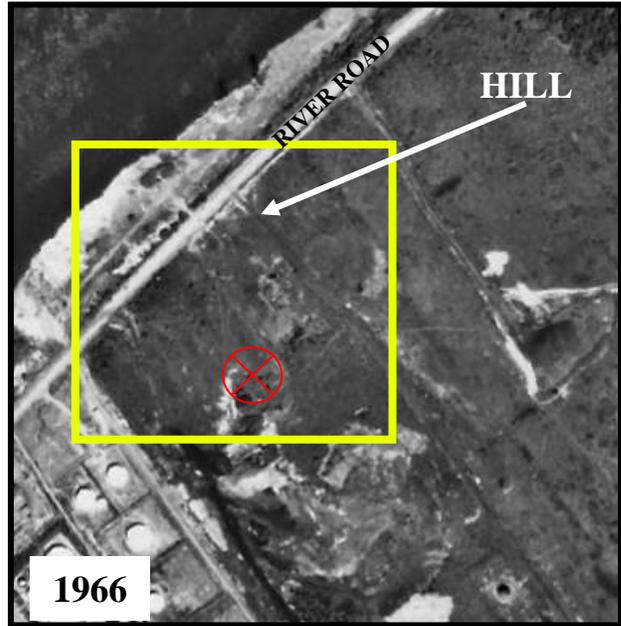
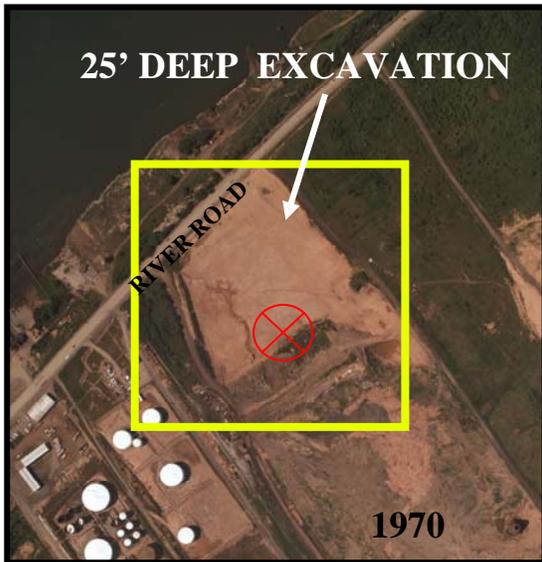
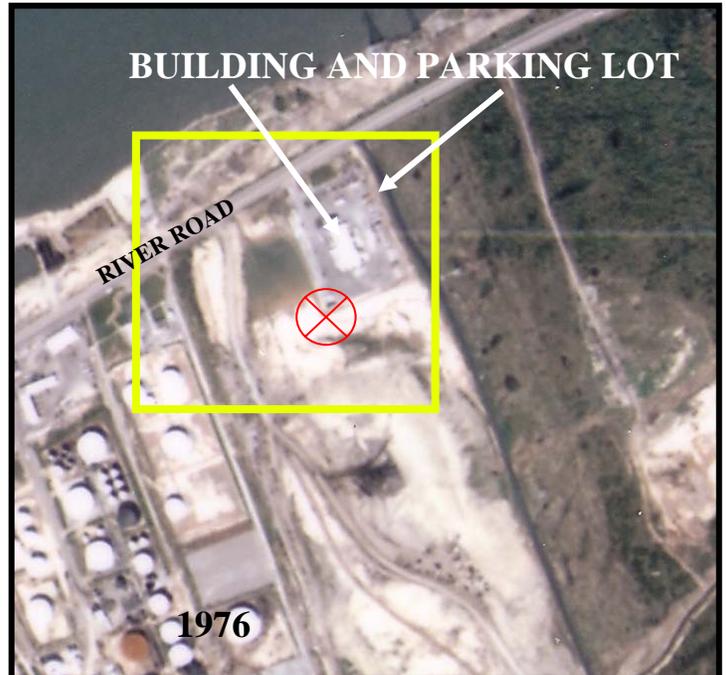
SUMMARY – HILL BESIDE ROAD

In 1966 and earlier photos, the land along River Road is a hill, with an elevation of about 600' above sea level. In the 1970 photo an excavation about 25 feet deep (575' elevation) is evident. In 1976 a building and parking lot is seen in the Northeast side of the excavation.

Topographic measurements are taken from the U.S.G.S. 15 Minute and 7.5 Minute Topographic maps.

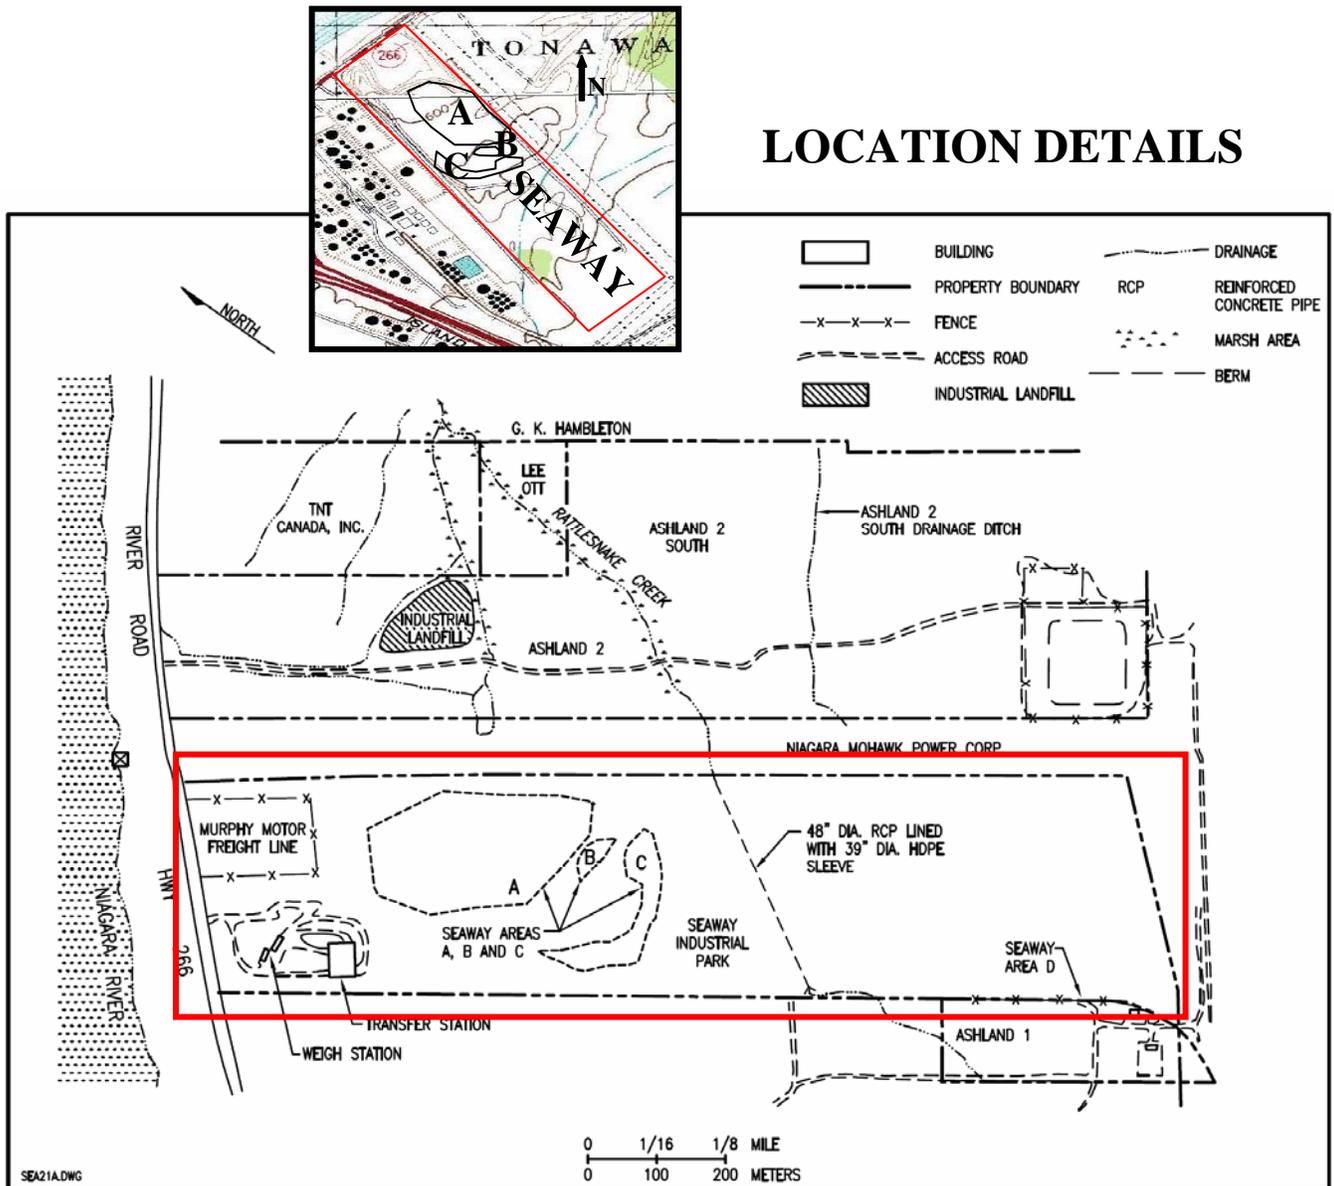
FIGURE A

The location of sites A, B, & C from this sketch are superimposed on the overview map graphic used throughout the report and on select photos.

Location Details Of The Seaway Property As Presented By Bechtel National, Inc., Courtesy US Army Corps Of Engineers, Buffalo District.

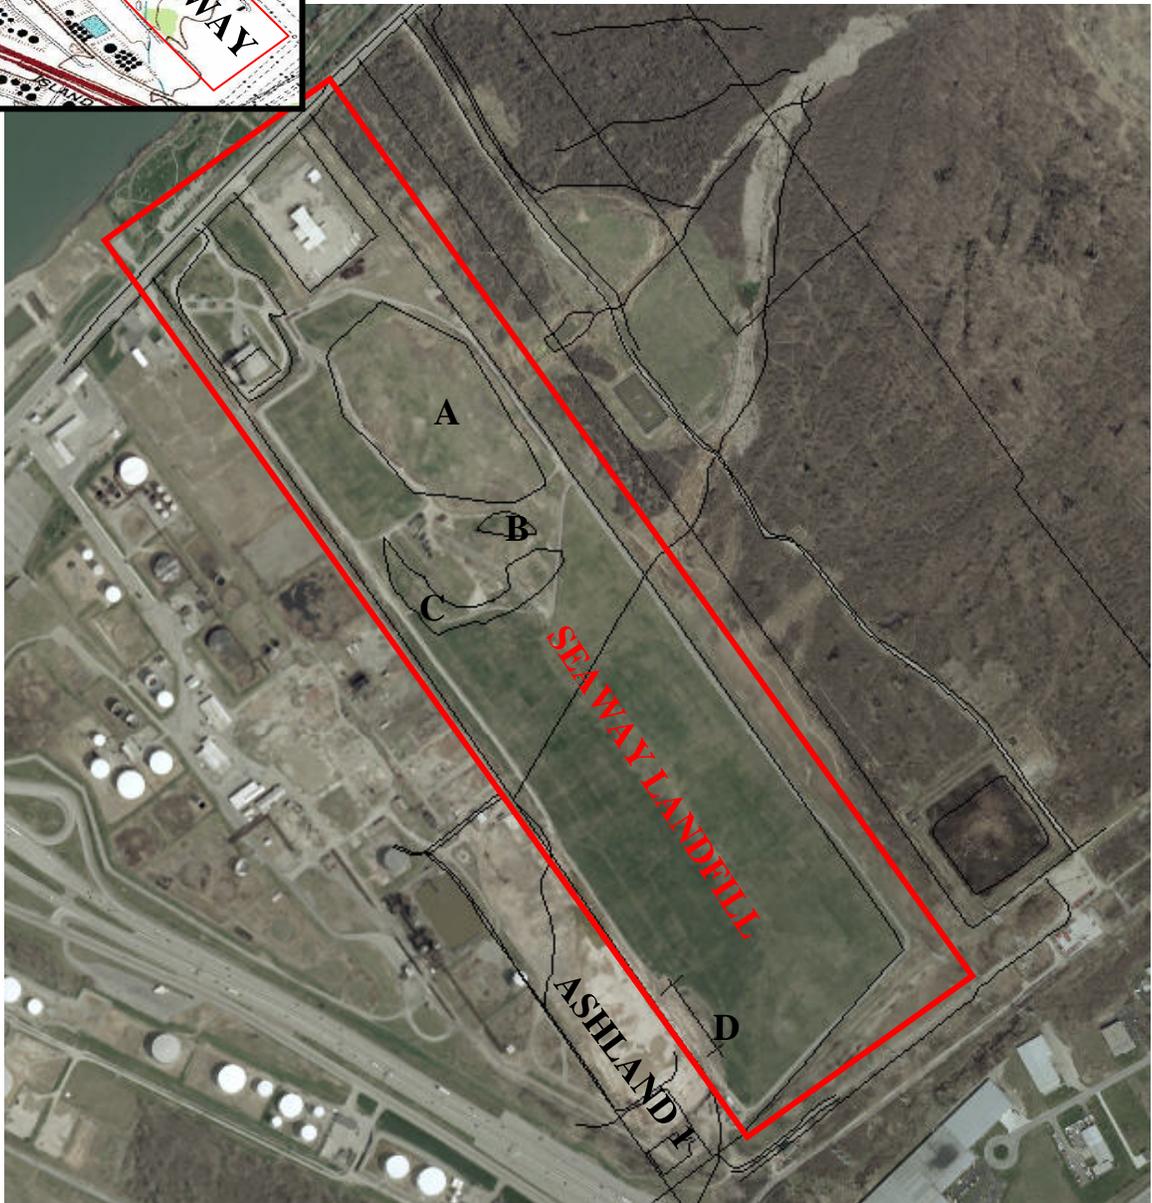
AREAS A, B, & C ATOP 2002 PHOTO

Locations Based on Figure A Sketch

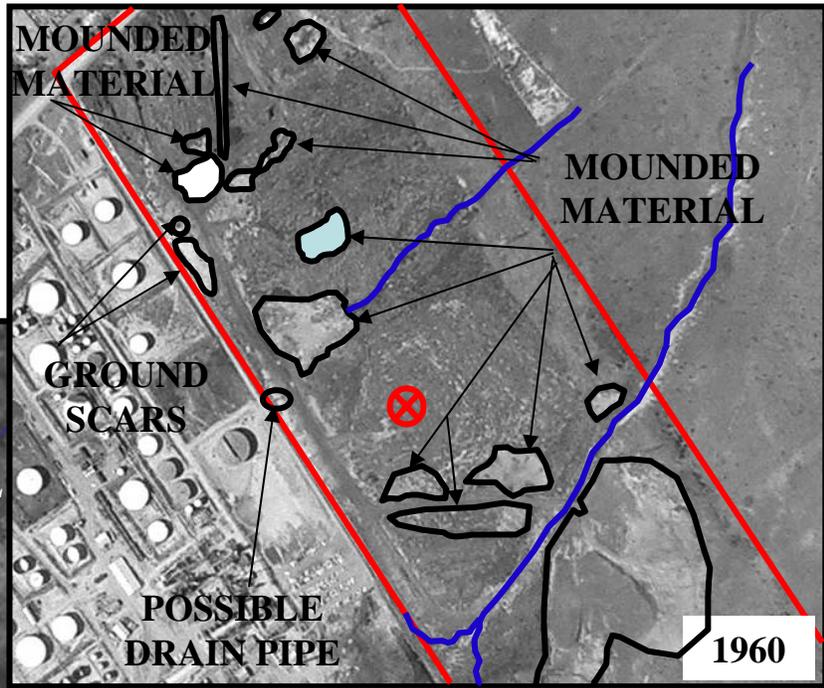
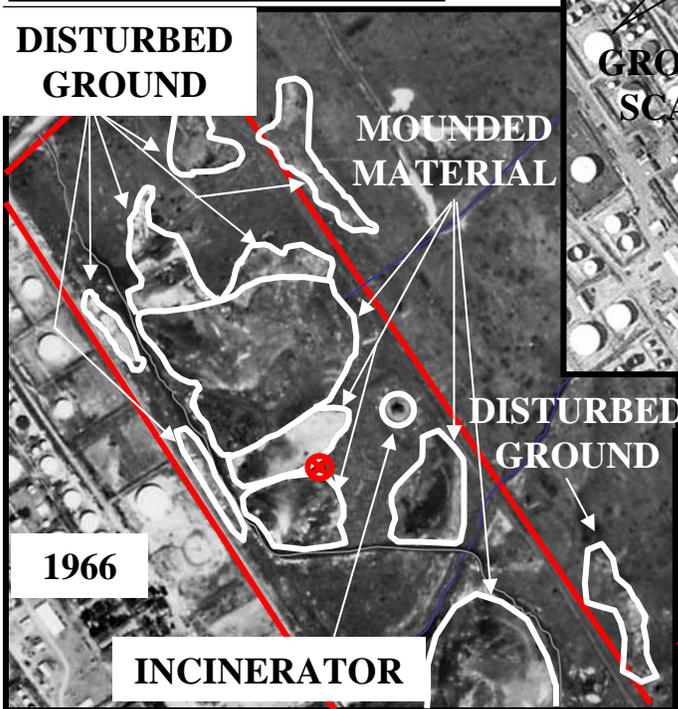
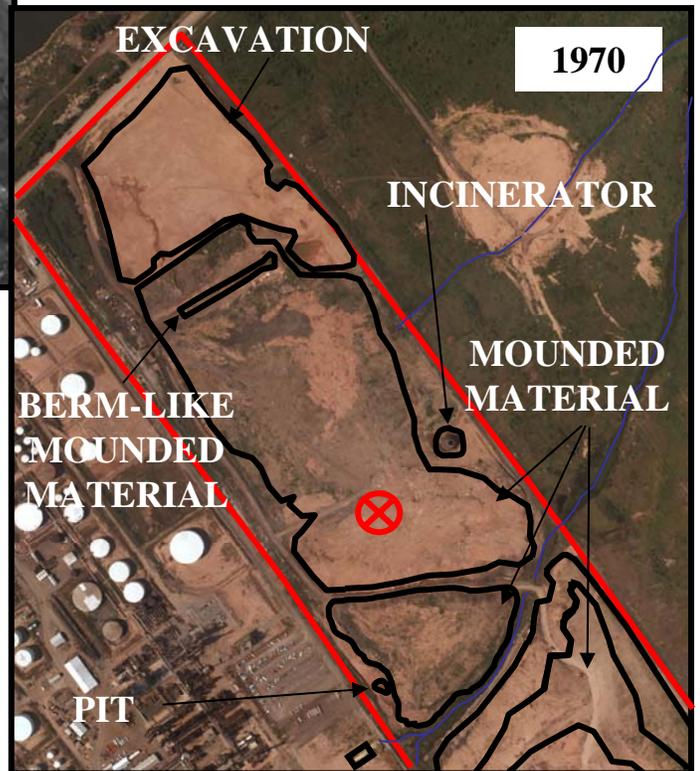
Features seen in the area of sites A, B, & C, 1960-1970

These photos show the increase in activity at the landfill between 1960 and 1970. The depth of deposits seen in these photos are from a few feet deep in the 1960 photos to tens of feet deep in the 1970 photos.
