SEAWAY LANDFILL TONAWANDA, NEW YORK

*Formerly Utilized Sites Remedial
Action Program (FUSRAP)*

August 2006 Final Report

Prepared for the US Army Corps of Engineers,
Buffalo District, Buffalo, New York

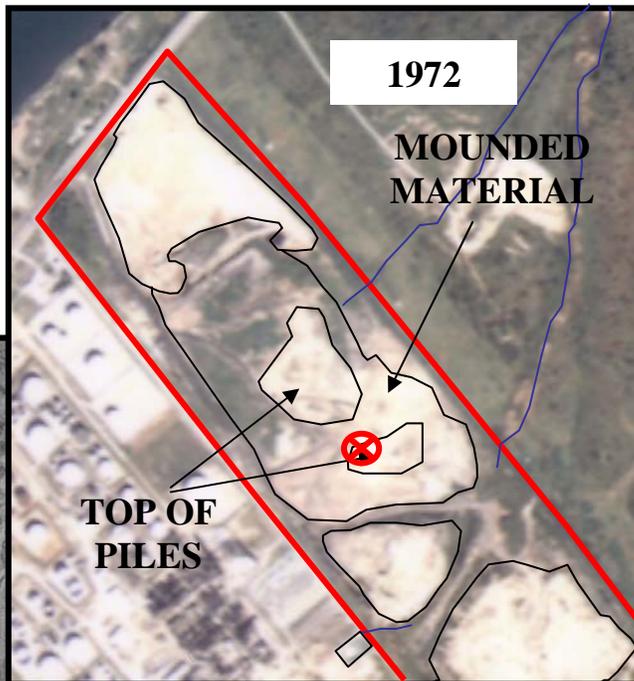
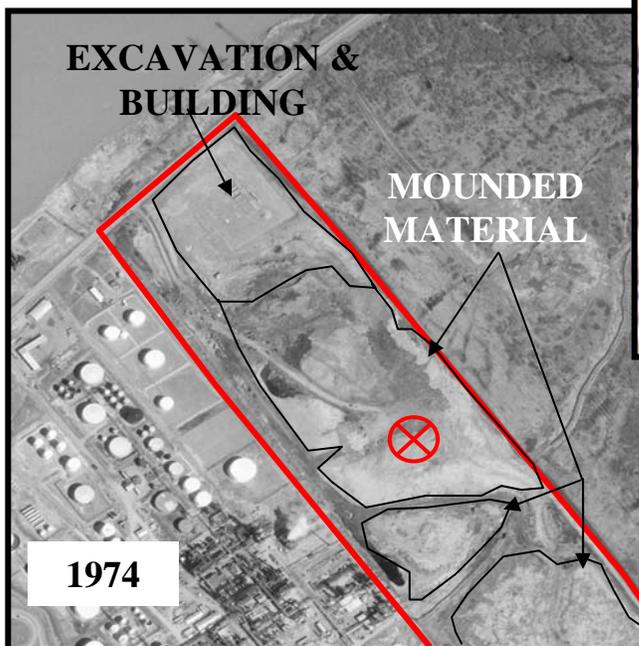
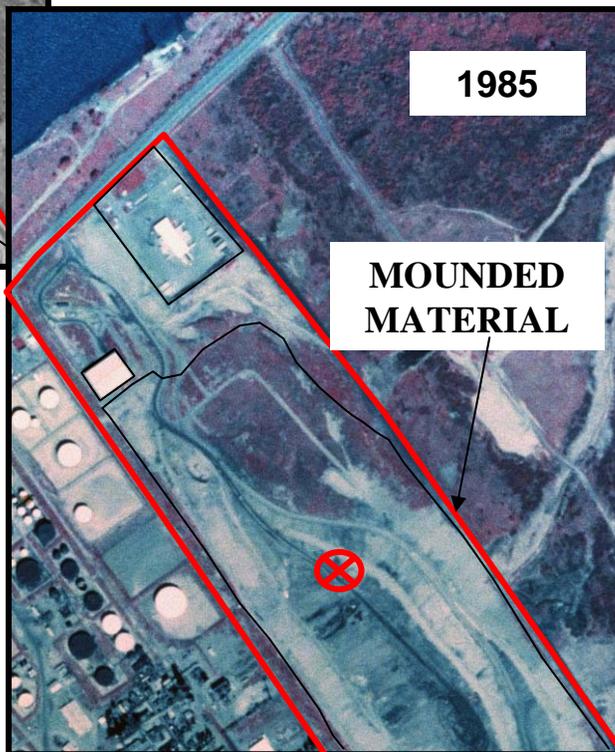
Features seen in the area of sites A, B, & C, 1972-1985

1972 to 1985 shows continued changes in mounds, activity and site topography. Material is deposited in tens of feet in these photos. In 1972 there were separate piles. In 1985 the debris covered most of the area as one pile.

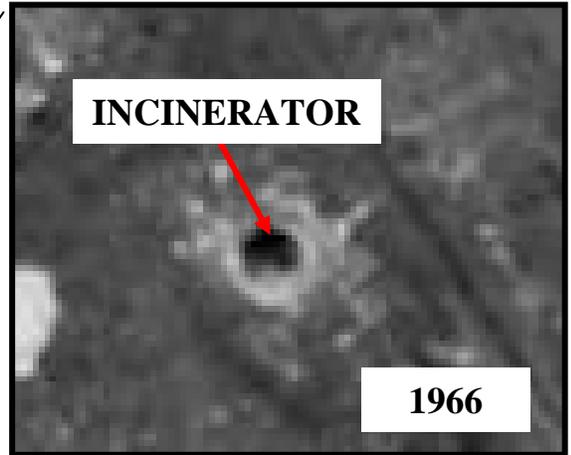
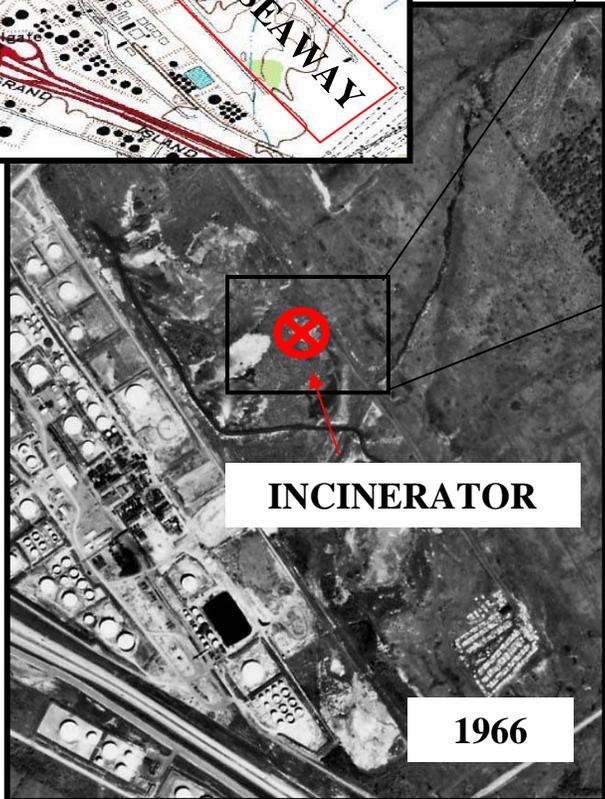
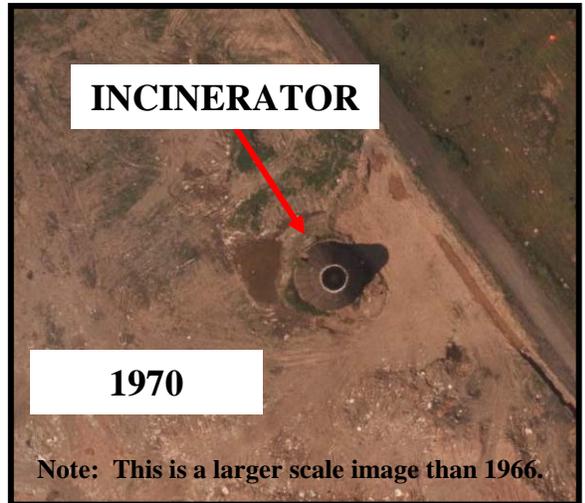
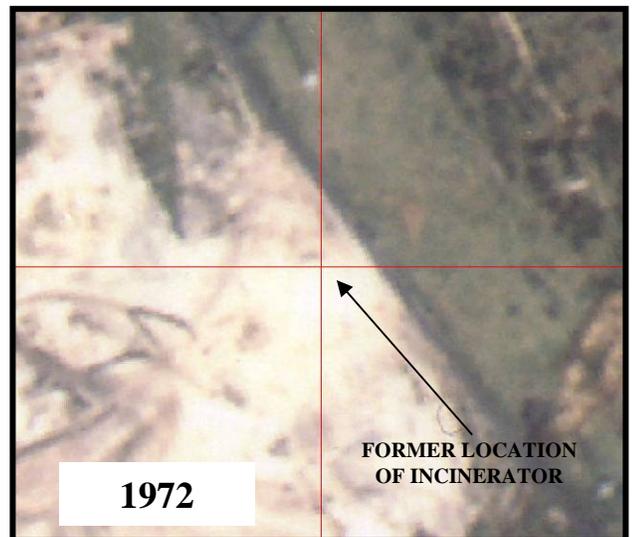
SUMMARY – INCINERATOR IN AREA A, B, & C

The incinerator is seen in the 1966 and 1970 photos. It is not evident in earlier years (such as 1963) nor is it evident after 1970.

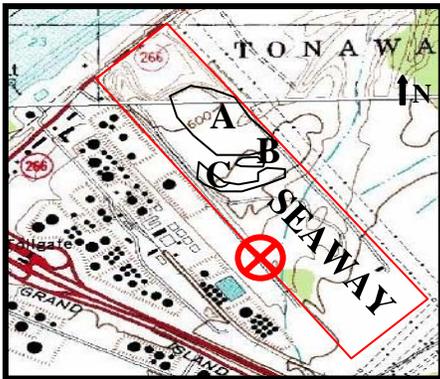
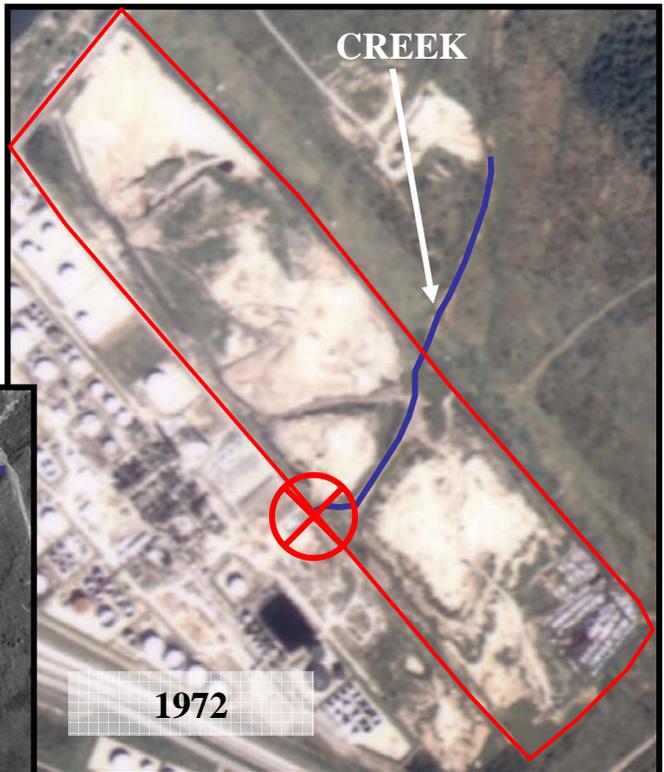
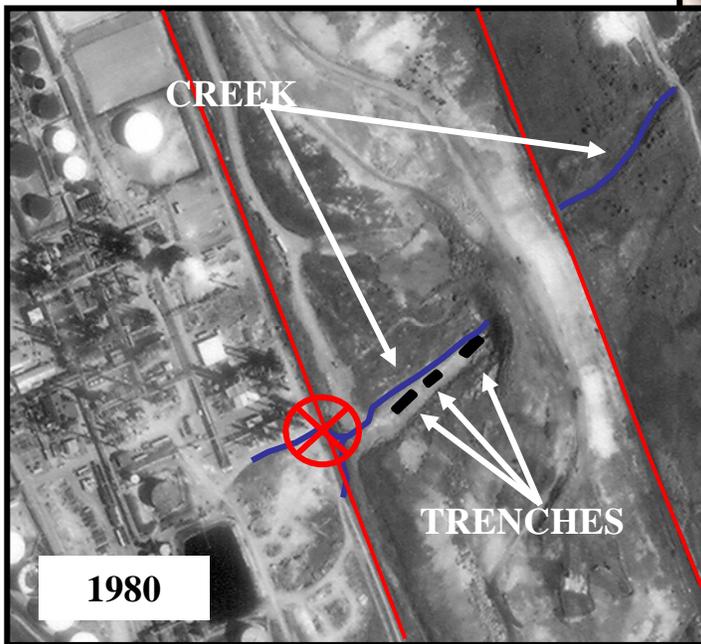
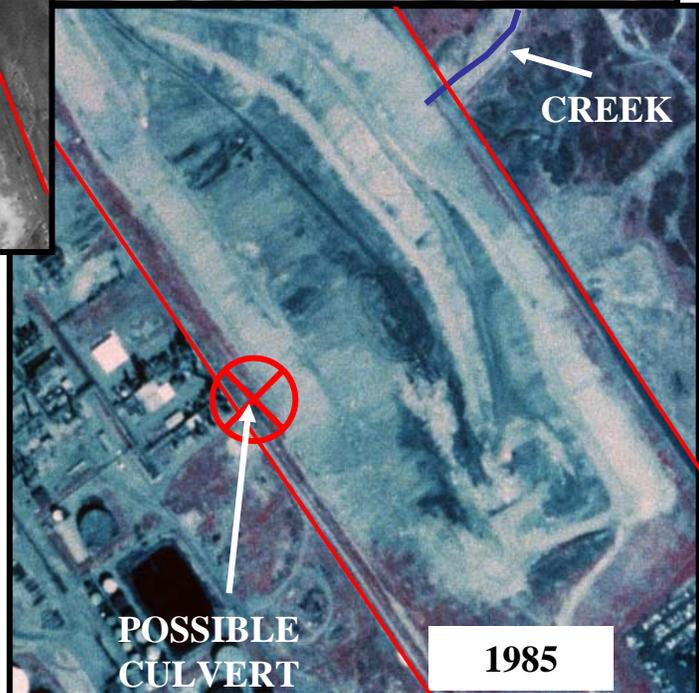
SUMMARY – DRAINAGE THROUGH CULVERT

In 1980 photo, creek or ditch leads to point at which it goes under the road leading to the southern section of the land fill. In 1985 photo the creek is no longer visible. An underground conduit for drainage may exist in this area. ¹

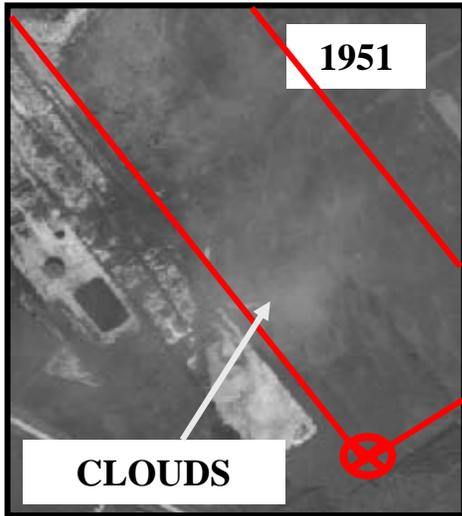
No activity in the southern half of the landfill is noted on the 1951 photos.

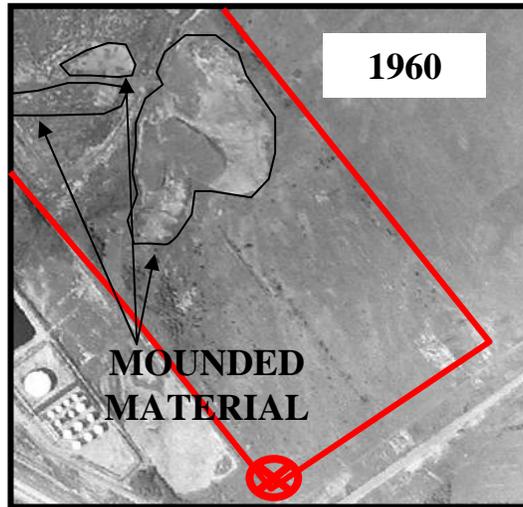
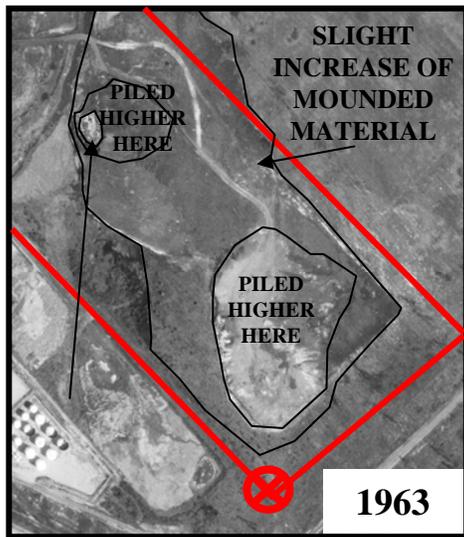
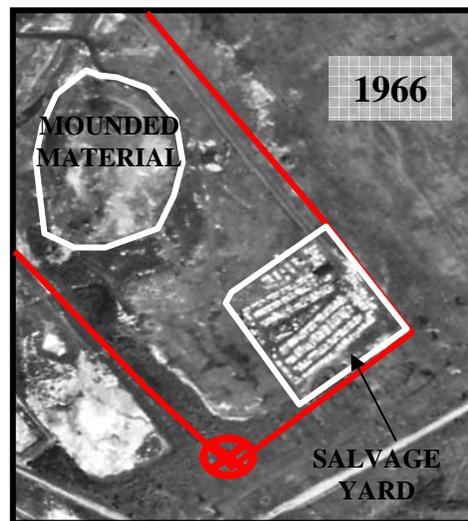
Debris in this area is first seen in 1960 photos. The amount of debris is seen to increase slightly through the year 1966.

THE SALVAGE YARD IS FIRST SEEN IN 1966 PHOTOS

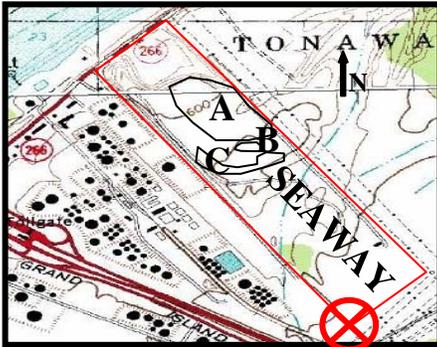
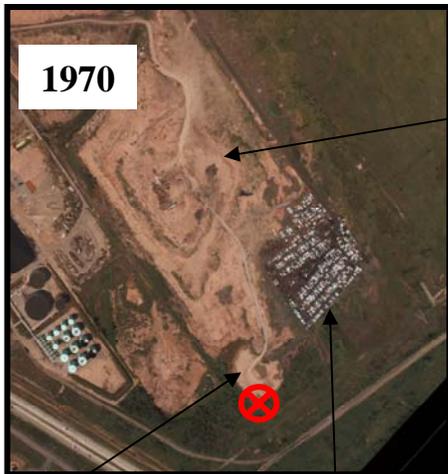
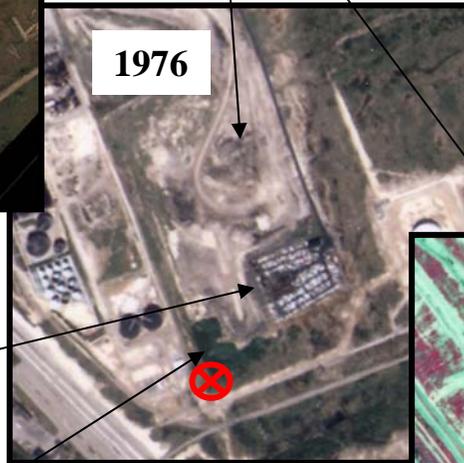
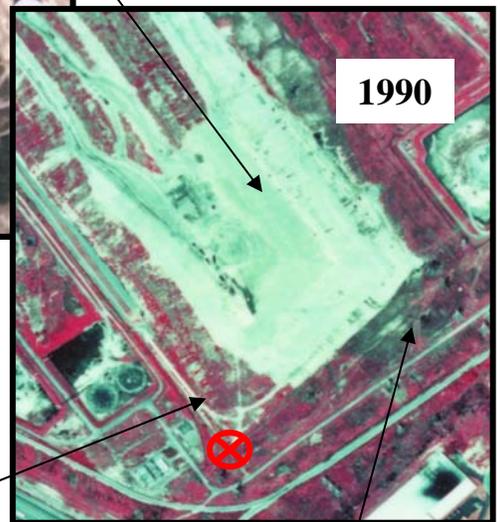
SUMMARY - SOUTHERN SECTION: PART II

Excavation is seen in 1970 and water has filled the excavation site in 1976 – an artificial lake.

The excavation, water, and salvage yard are gone in 1990 photos, replaced by large pile of mounded material or debris.
