TONAWANDA LANDFILL AND MUDFLATS AREA

TONAWANDA, NEW YORK

GIS-Based Historical Photographic Analysis

July 2009 Final Report

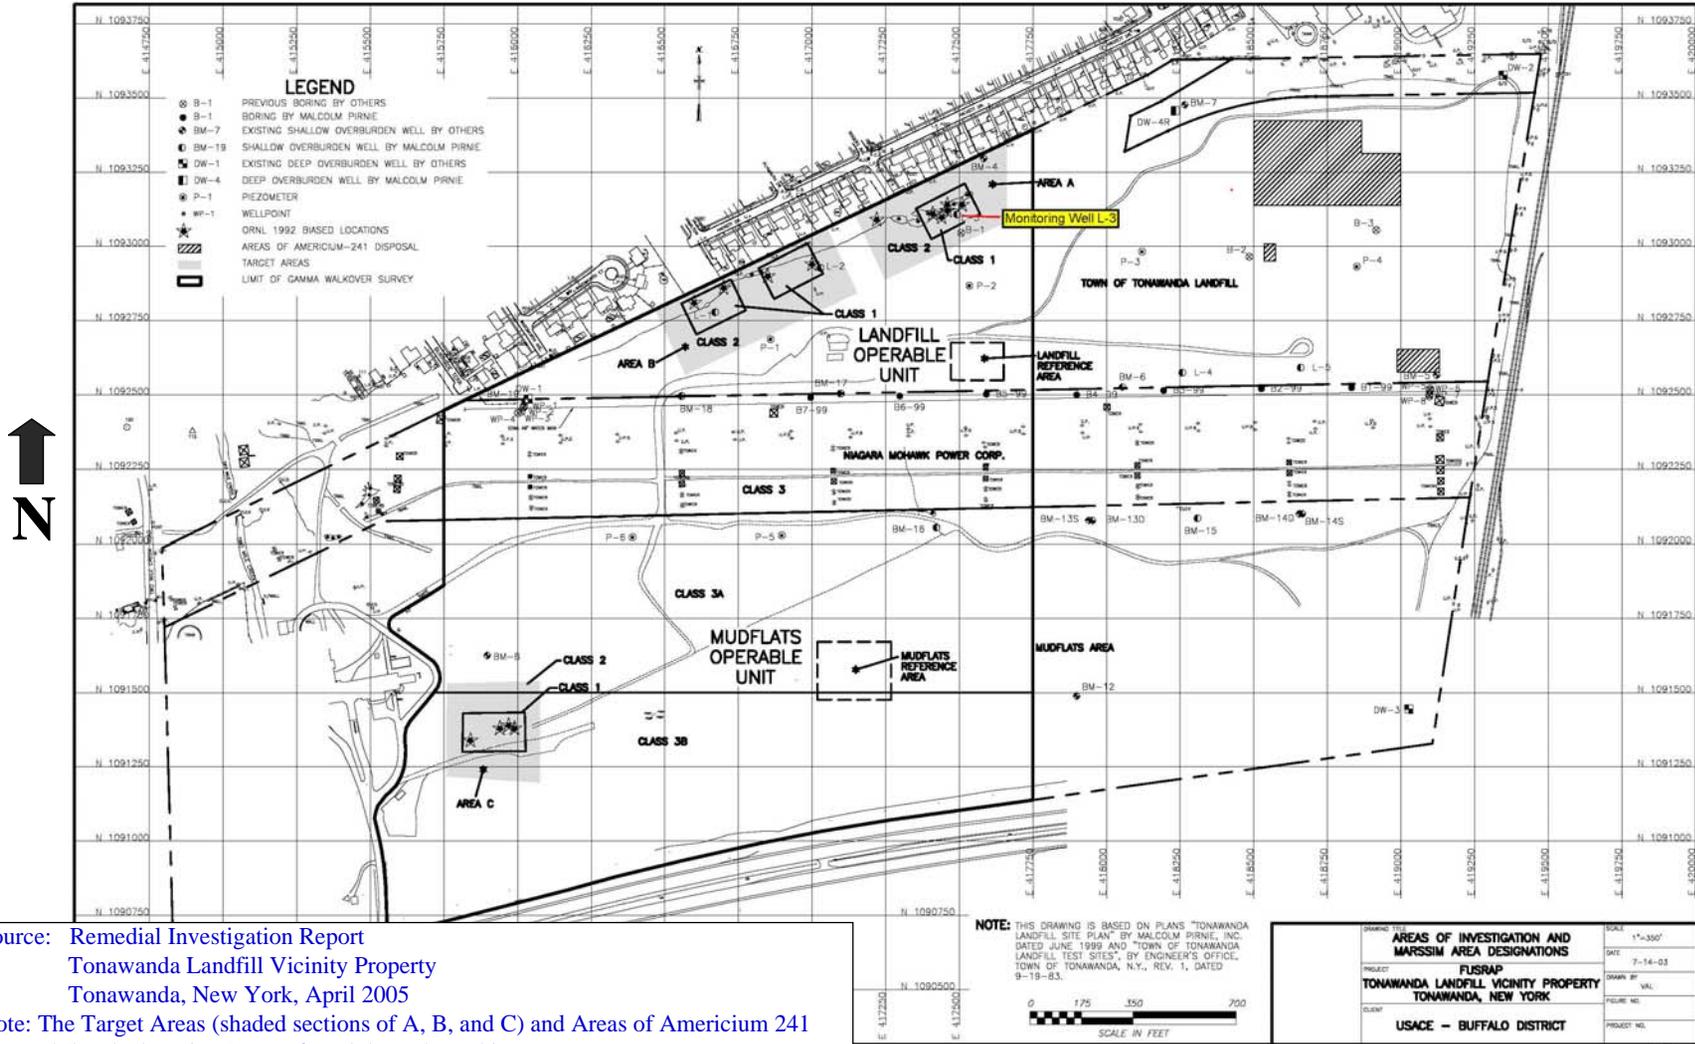
AREAS OF INVESTIGATION MAP REMEDIAL INVESTIGATION REPORT

Note: The Target Areas (shaded sections of A, B, and C) and Areas of Americium 241 disposal (hatched sections) are referred throughout this report.

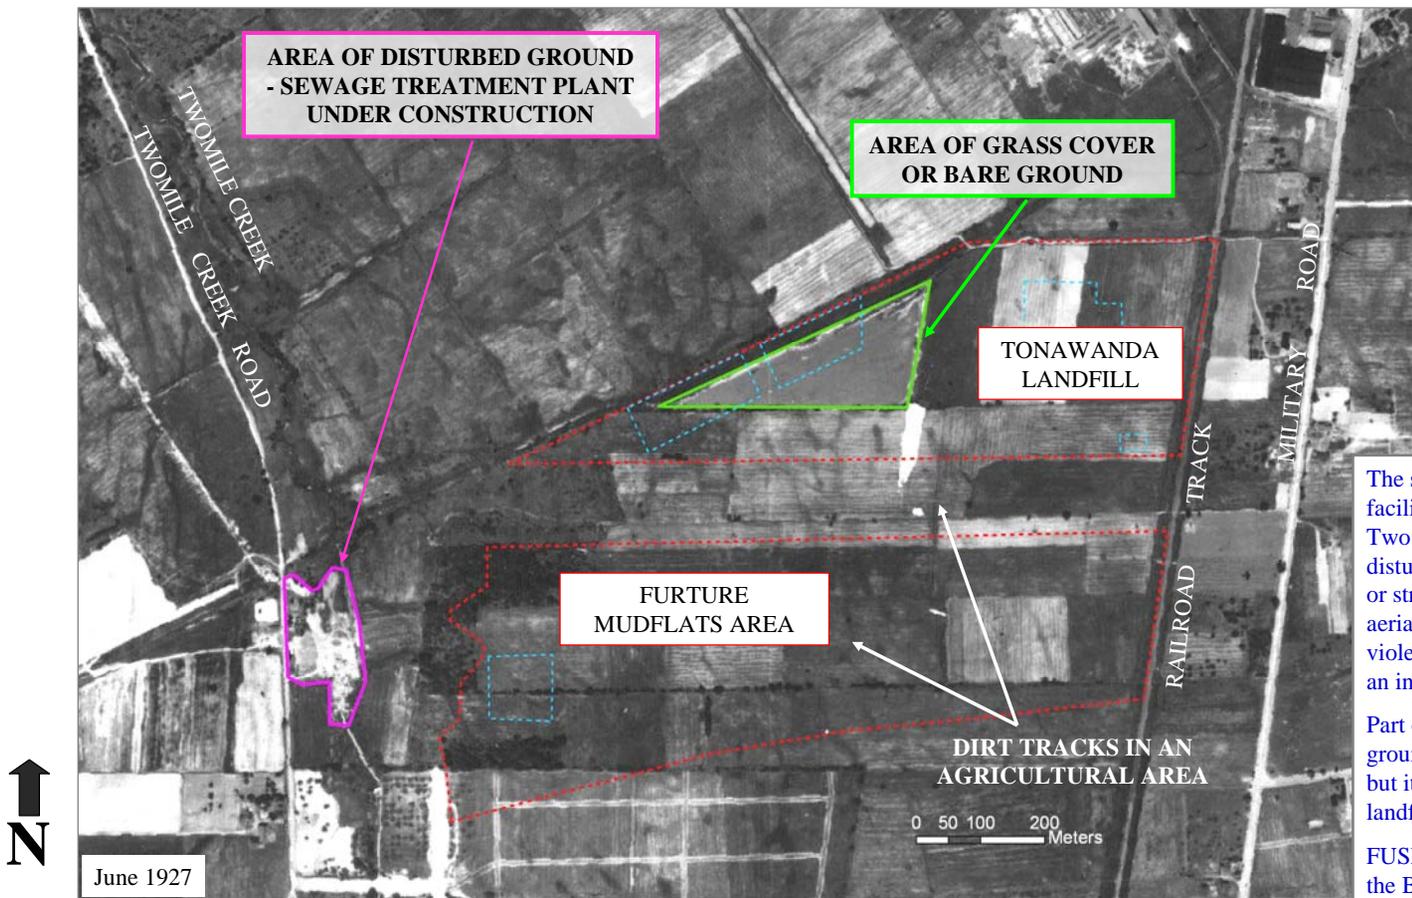
1927 OVERVIEW

A 1927 image was the earliest aerial photo obtained for this report. In the general, the 1927 photo depicts the area as an agricultural site.

The site for a sewage treatment facility is being developed along Two Mile Creek Road. An area of disturbed ground, lacking buildings or structures, is observed on the aerial photography (shown in violet). There is no evidence yet of an incinerator.

Part of the landfill area is a bare ground/field area (shown in green), but it is not known if it was used as a landfill during this time.

FUSRAP Fact Sheets (produced by the Buffalo District COE in April 2007) indicate that a quarry operated in the western portion of the landfill area from the 1900s to the 1920s. This 1927 photo shows no evidence of such activity.

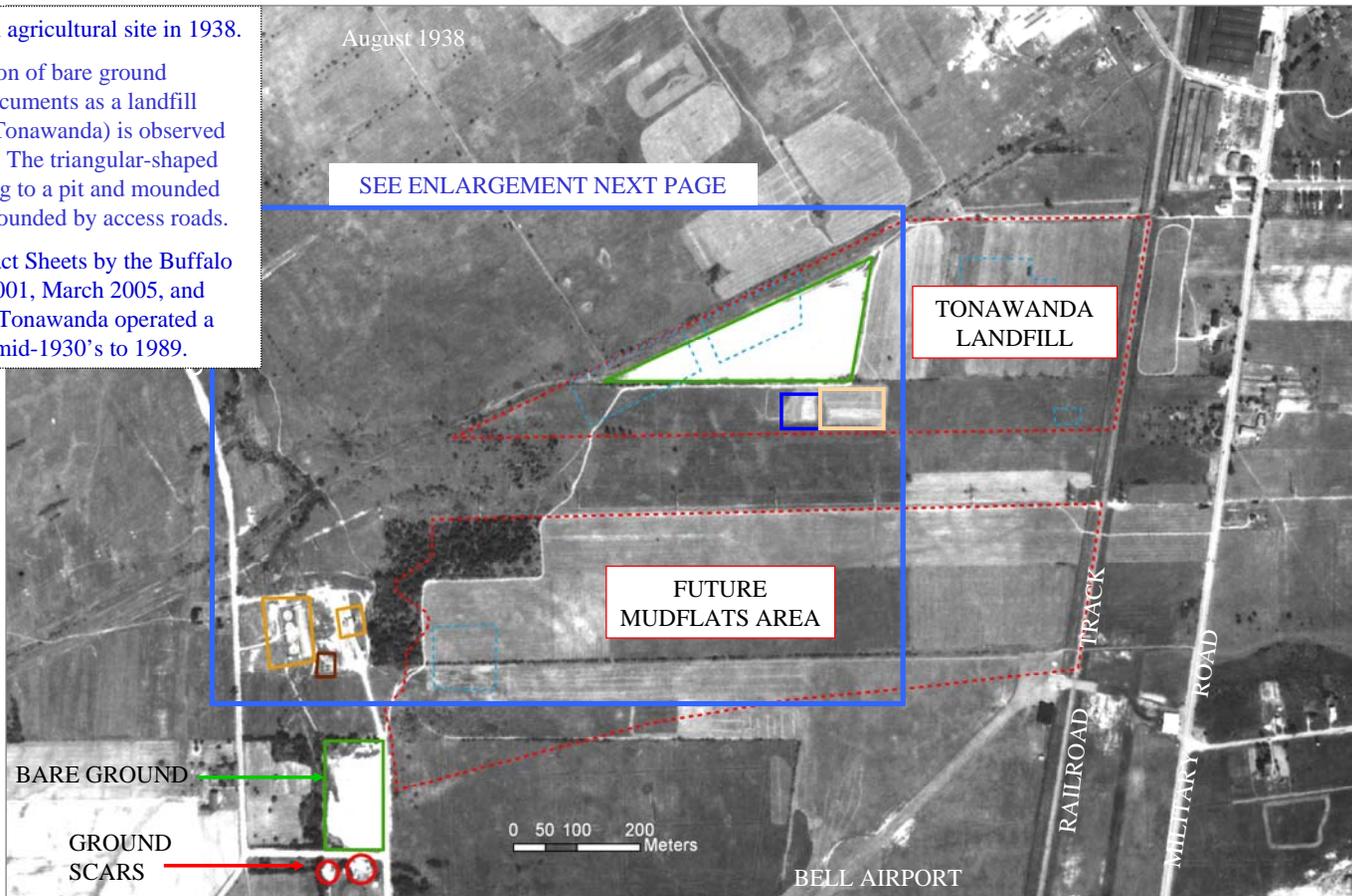
1938 OVERVIEW

Overall, the area is still an agricultural site in 1938.

A slightly depressed section of bare ground (described in historical documents as a landfill operated by the Town of Tonawanda) is observed on the aerial photography. The triangular-shaped area also shows connecting to a pit and mounded materials. This site is surrounded by access roads.

According to FUSRAP Fact Sheets by the Buffalo District COE (February 2001, March 2005, and April 2007), the Town of Tonawanda operated a landfill here between the mid-1930's to 1989.

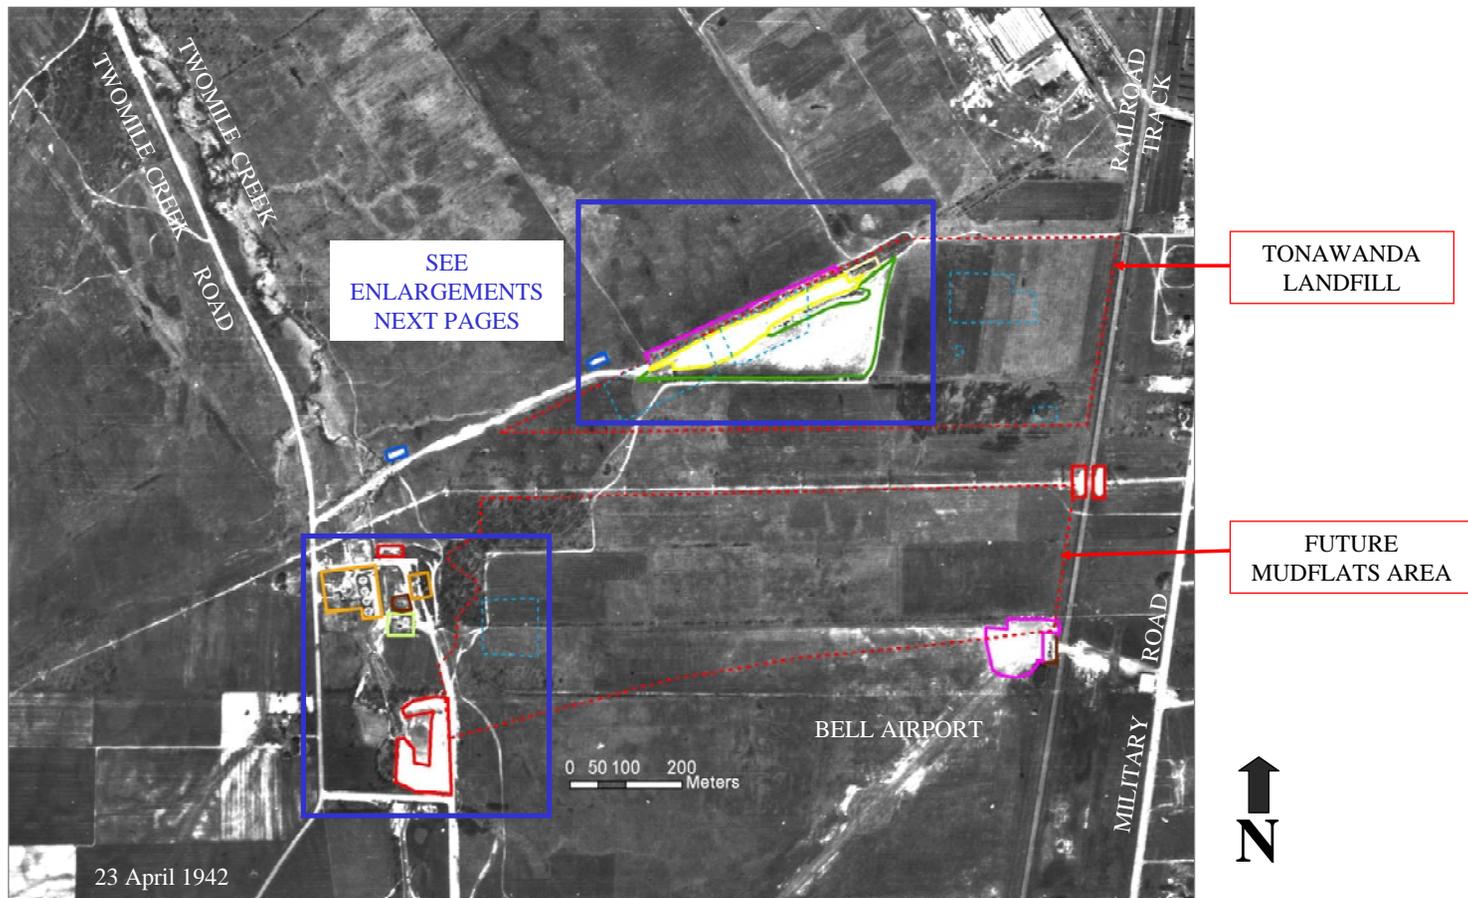
1942 OVERVIEW

In 1942, the landfill area shows some changes. Along the access road in the north side is a disturbed ground area which is adjacent to a long shallow excavation. Some mounded materials appear between the excavation and the slightly depressed bare ground, possible a mudflats area, on the southern side. Some new roads were observed in the area. According to FUSRAP Fact Sheets by the Buffalo District COE (February 2001, March 2005, and April 2007), the Town of Tonawanda operated a landfill here between the mid-1930's to 1989. The Sewage Treatment Facility and Incinerator are well developed. The Mudflats Area still appears as agricultural land. Bell Airport is under construction. (See following pages for details)

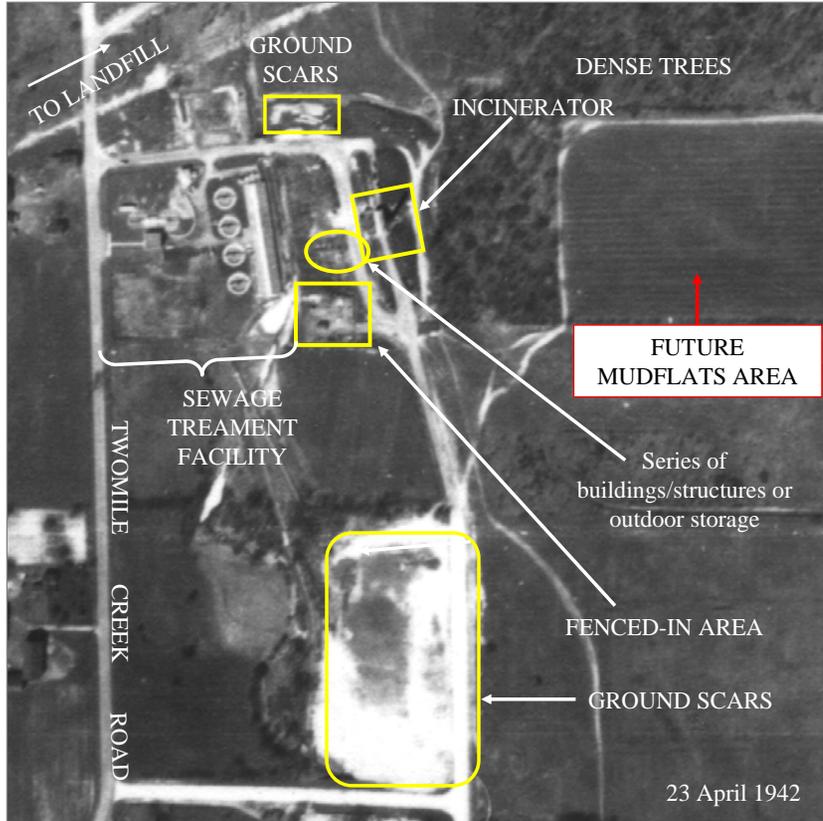
SEWAGE TREATMENT FACILITY AND INCINERATOR, 1942

The Landfill Area contains an elongate disturbed ground, a long and shallow excavation site along the northern side, and a slightly depressed bare ground in the south. This triangular shape area could serve as a mudflats area. According to FUSRAP Fact Sheets by the Buffalo District COE (February 2001, March 2005, and April 2007), the Town of Tonawanda operated a landfill here between the mid-1930's to 1989. The pit and mounded materials adjacent to the southern edge of Tonawanda landfill observed in 1938 aerial photos are not evidence any more. Buildings and small structures are observed in the Sewage Treatment Facility and Incinerator. The Mudflats Area still appears as agricultural land.

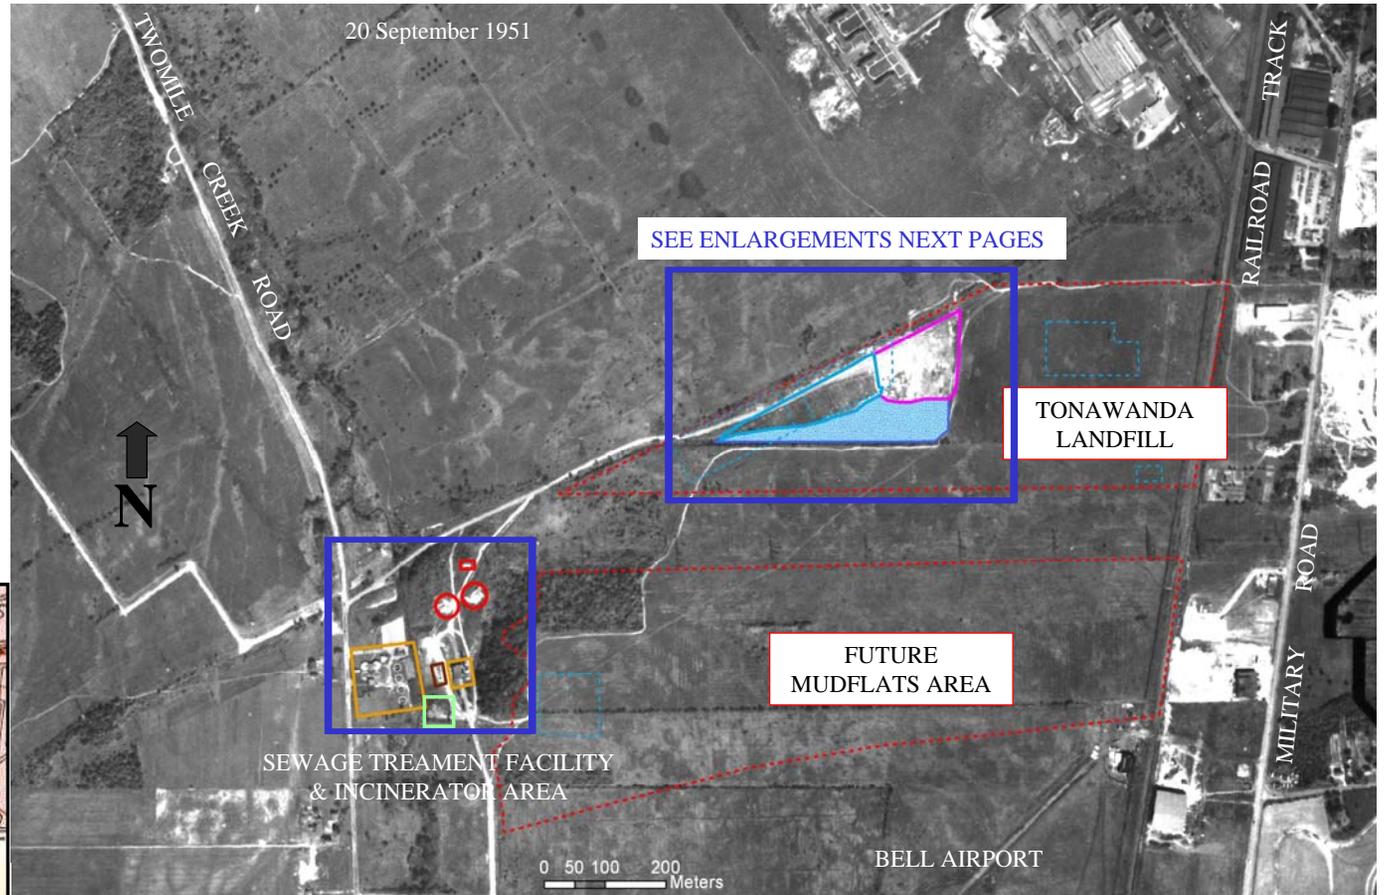
1951 OVERVIEW

In 1951, the landfill area shows significant changes. A pond and an area of disturbed ground are observed for the first time on available aerial photography.

The Sewage Treatment Facility and Incinerator are expanded.

The Mudflats Area still appears as agricultural land.

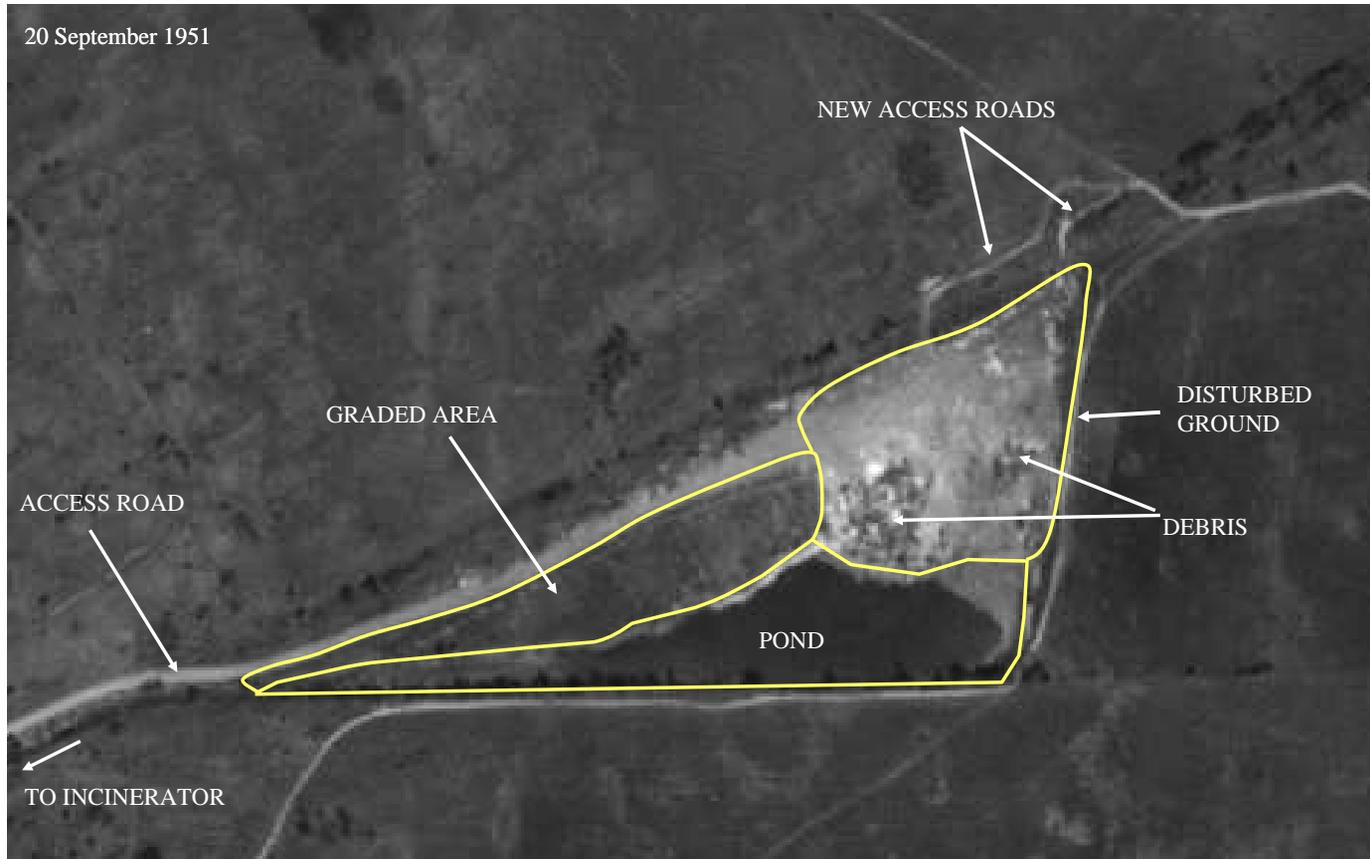
TONAWANDA LANDFILL 1951

In 1951, the landfill area contained a graded area, a pond, and disturbed ground with scattered debris.

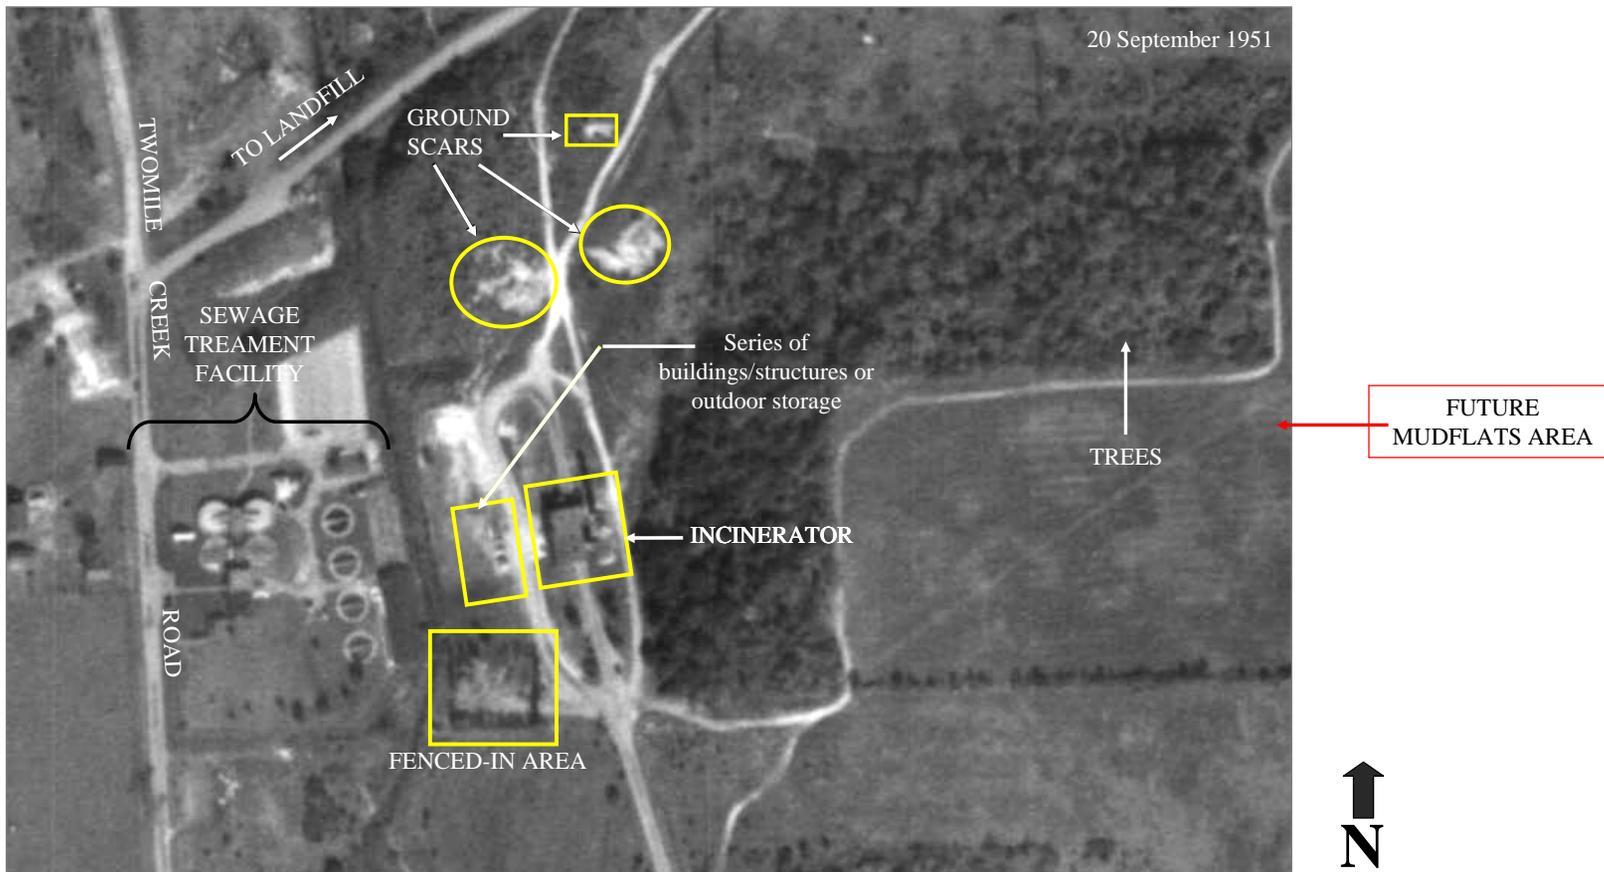
SEWAGE TREATMENT FACILITY AND INCINERATOR, 1951

Scattered ground scars, buildings and small structures, possible outdoor storage are observed in the Incinerator. The Mudflats Area still appears as agricultural land.

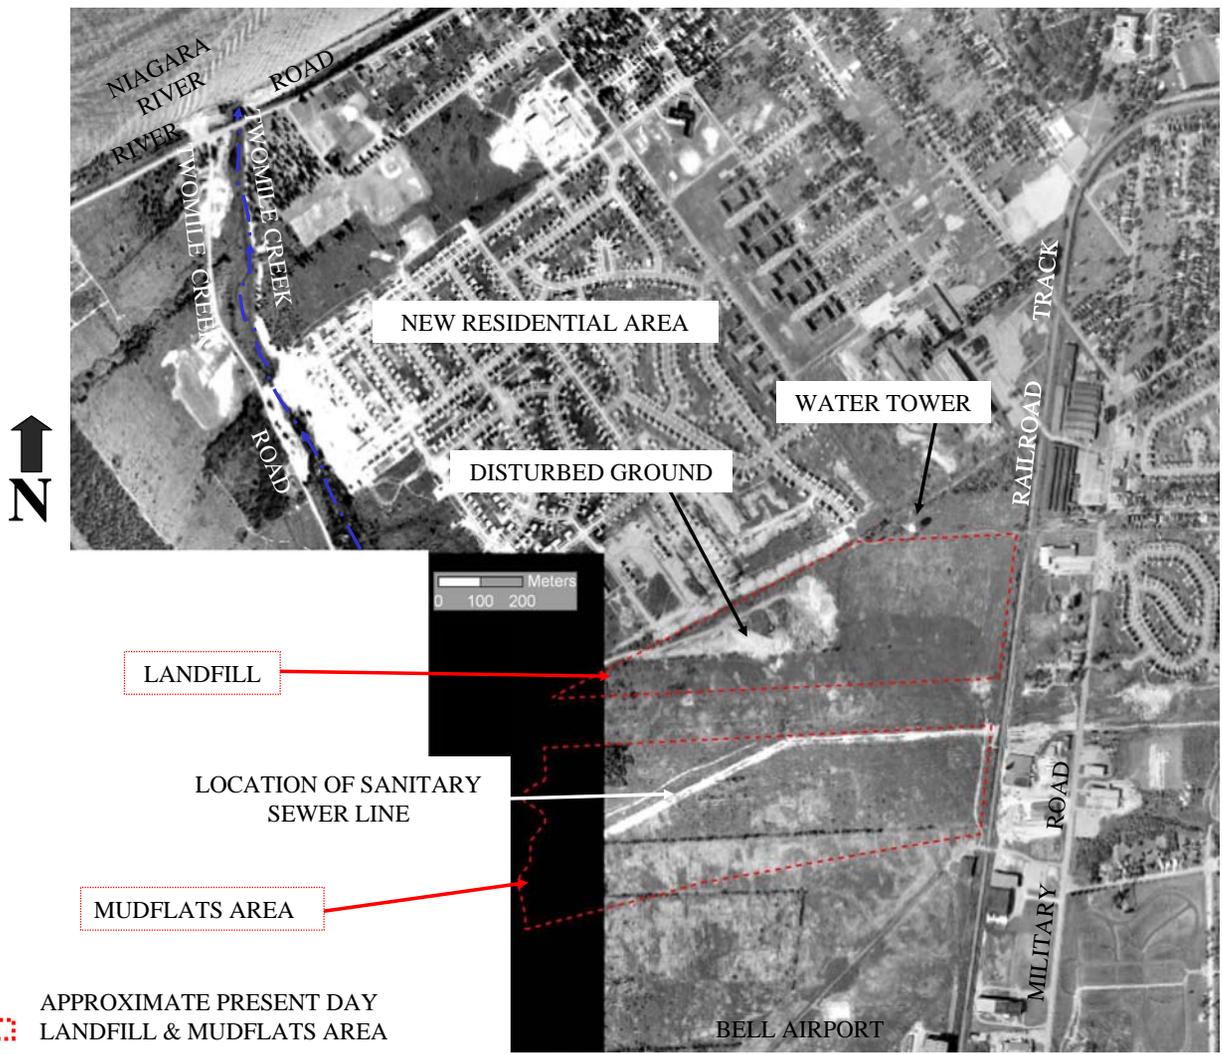
1958 OVERVIEW

A medium-resolution scanned image of 1958 was obtained for this report, but no stereo pair was available.

In 1958, a new residential area is observed just north of the landfill. A section of the new residential area, located adjacent to the landfill property, is still under construction.

The road leading into the landfill from the east is no longer present. Access to the landfill is available only from the west.

Within the area of the landfill, a previously-observed pond (in 1951) appears filled-in. The active portion of the landfill is identified on the photo as disturbed ground.

A linear ground scar clearly shows the alignment of a sanitary sewer that traverses through the future Mudflats Area.

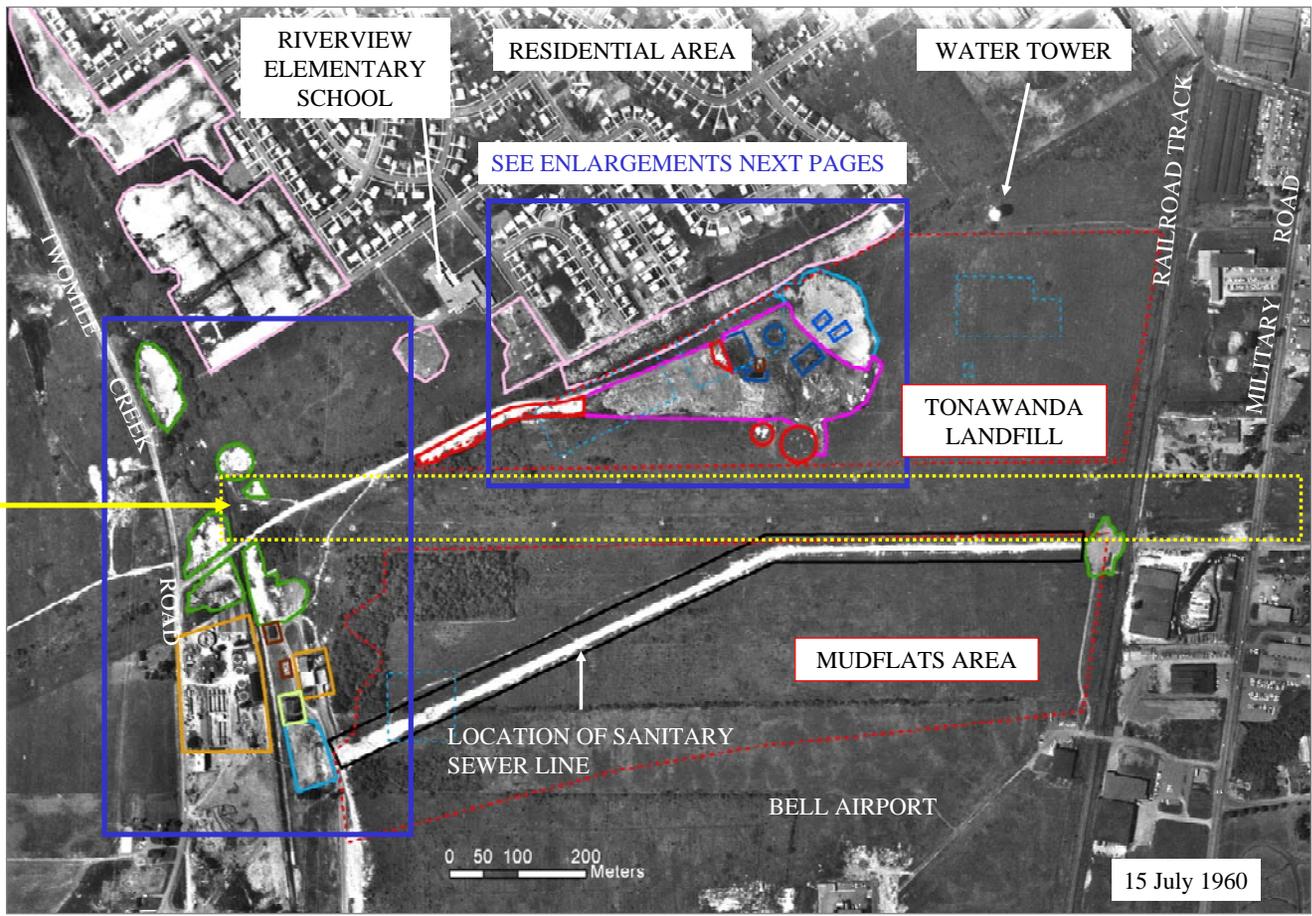
1960 OVERVIEW

In 1960, the Sewage Treatment Facility and Incinerator Area are well developed.

A section of the residential area (lying just adjacent to the landfill) is still under construction.

The landfill area contains disturbed ground, a graded area, pits, trenches, and ground scars.

A linear ground scar (observed for the first time on 1958 aerial photography) shows the alignment of a 42" sanitary sewer line across the future Mud Flats Area.

Towers of a new electric power line are identified within the study area.

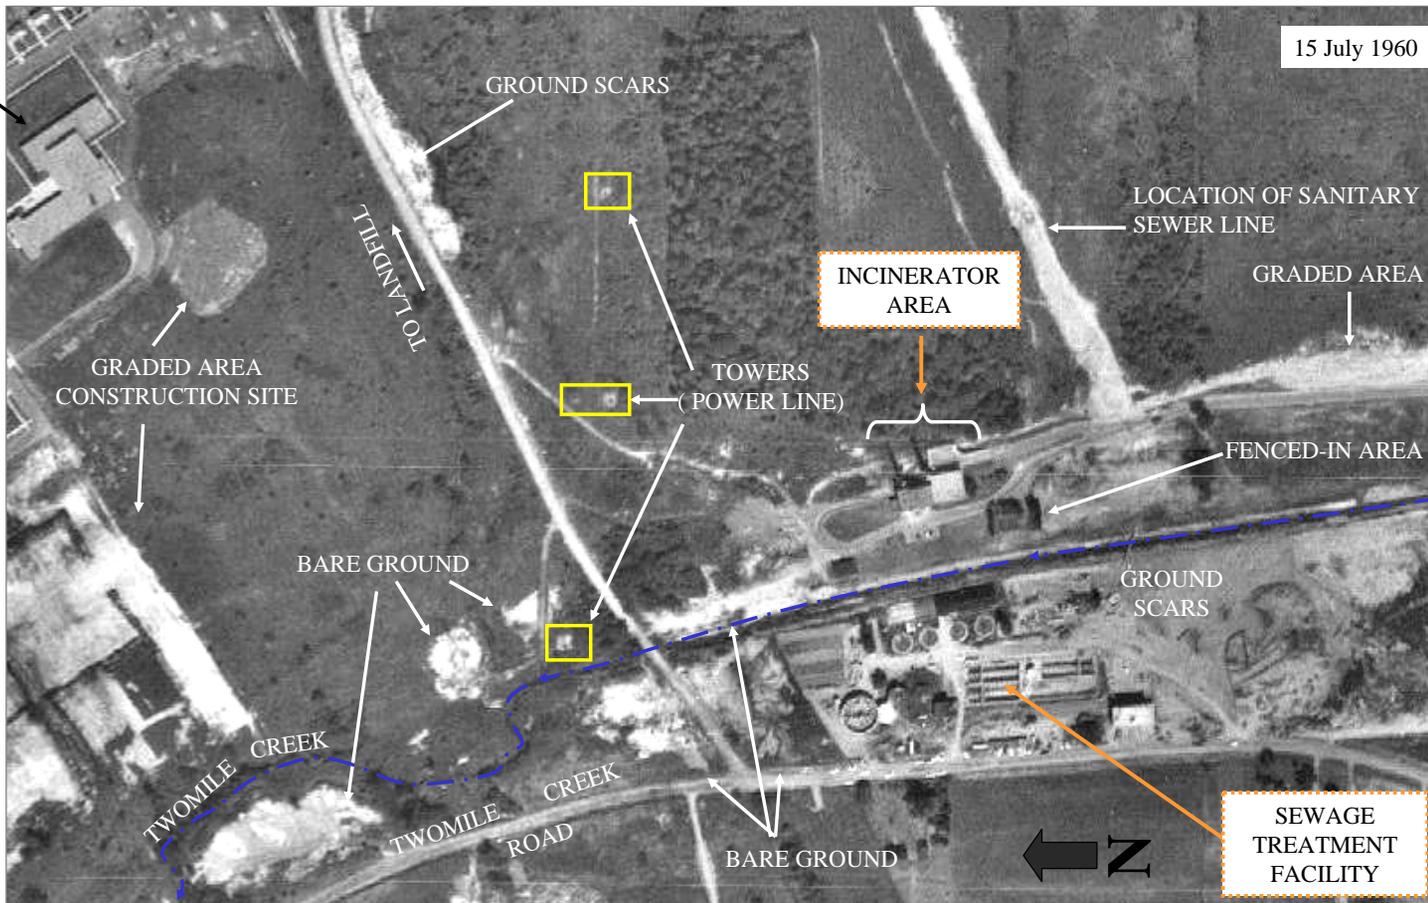
SEWAGE TREATMENT FACILITY AND INCINERATOR, 1960

The Sewage Treatment Facility and Incinerator Area show expansion since the 1950s. Two incinerators are now present on the Incinerator Area property. The road system appears well developed.

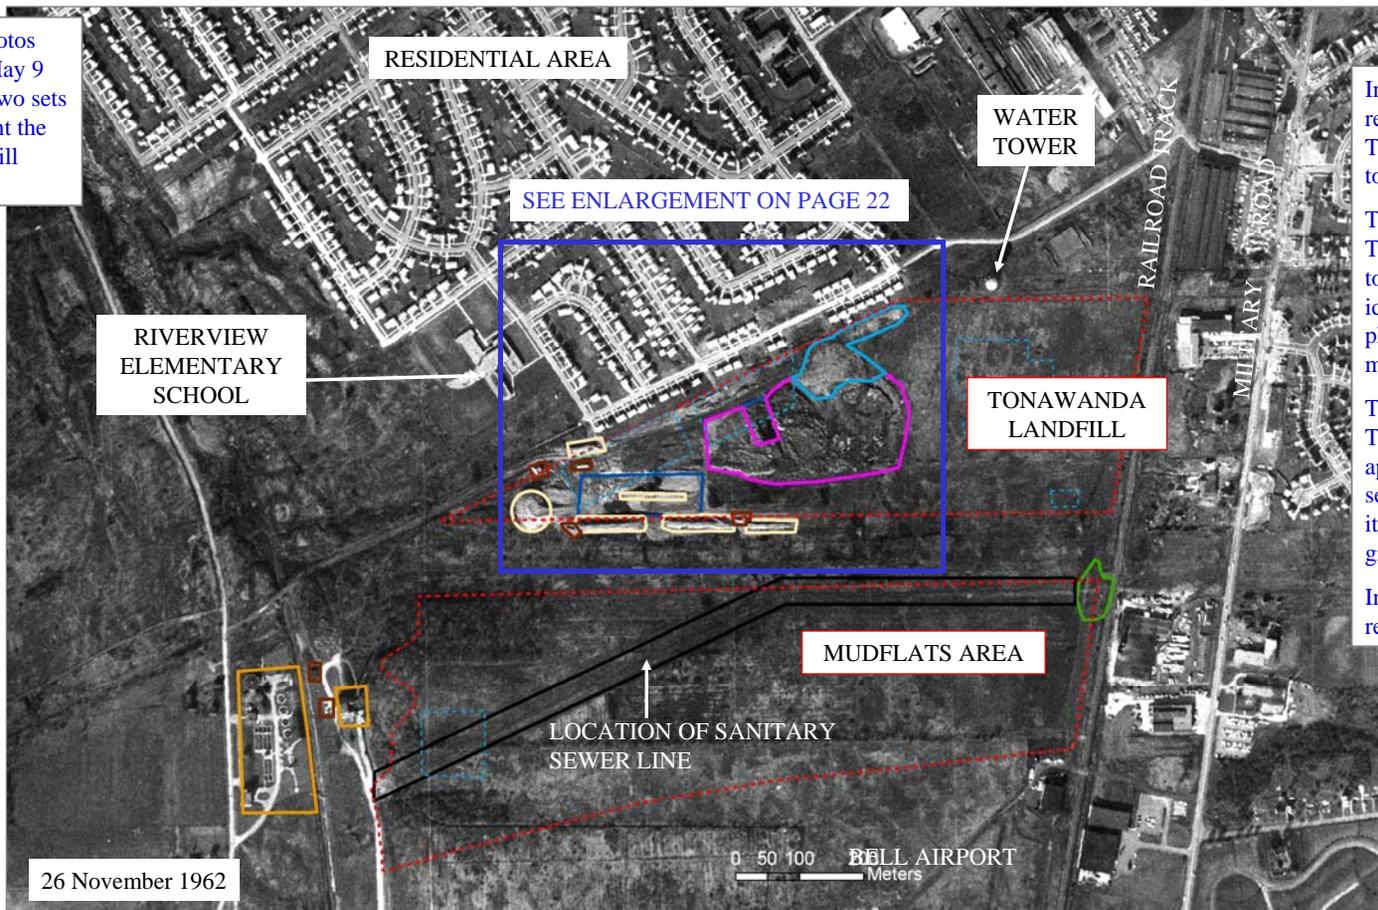
1962 OVERVIEW

In 1962, development of the residential area north of the Tonawanda Landfill Area appears to be complete.

The western section of the Tonawanda Landfill Area appears to be very active. Features identified from the aerial photography include large pits, mounded material, and structures.

The central section of the Tonawanda Landfill Area also appears active. Features in this section of the landfill include such items as: disturbed ground, a pit, ground scars, and piles of debris.

In 1962, the Mudflats Area remains undeveloped.

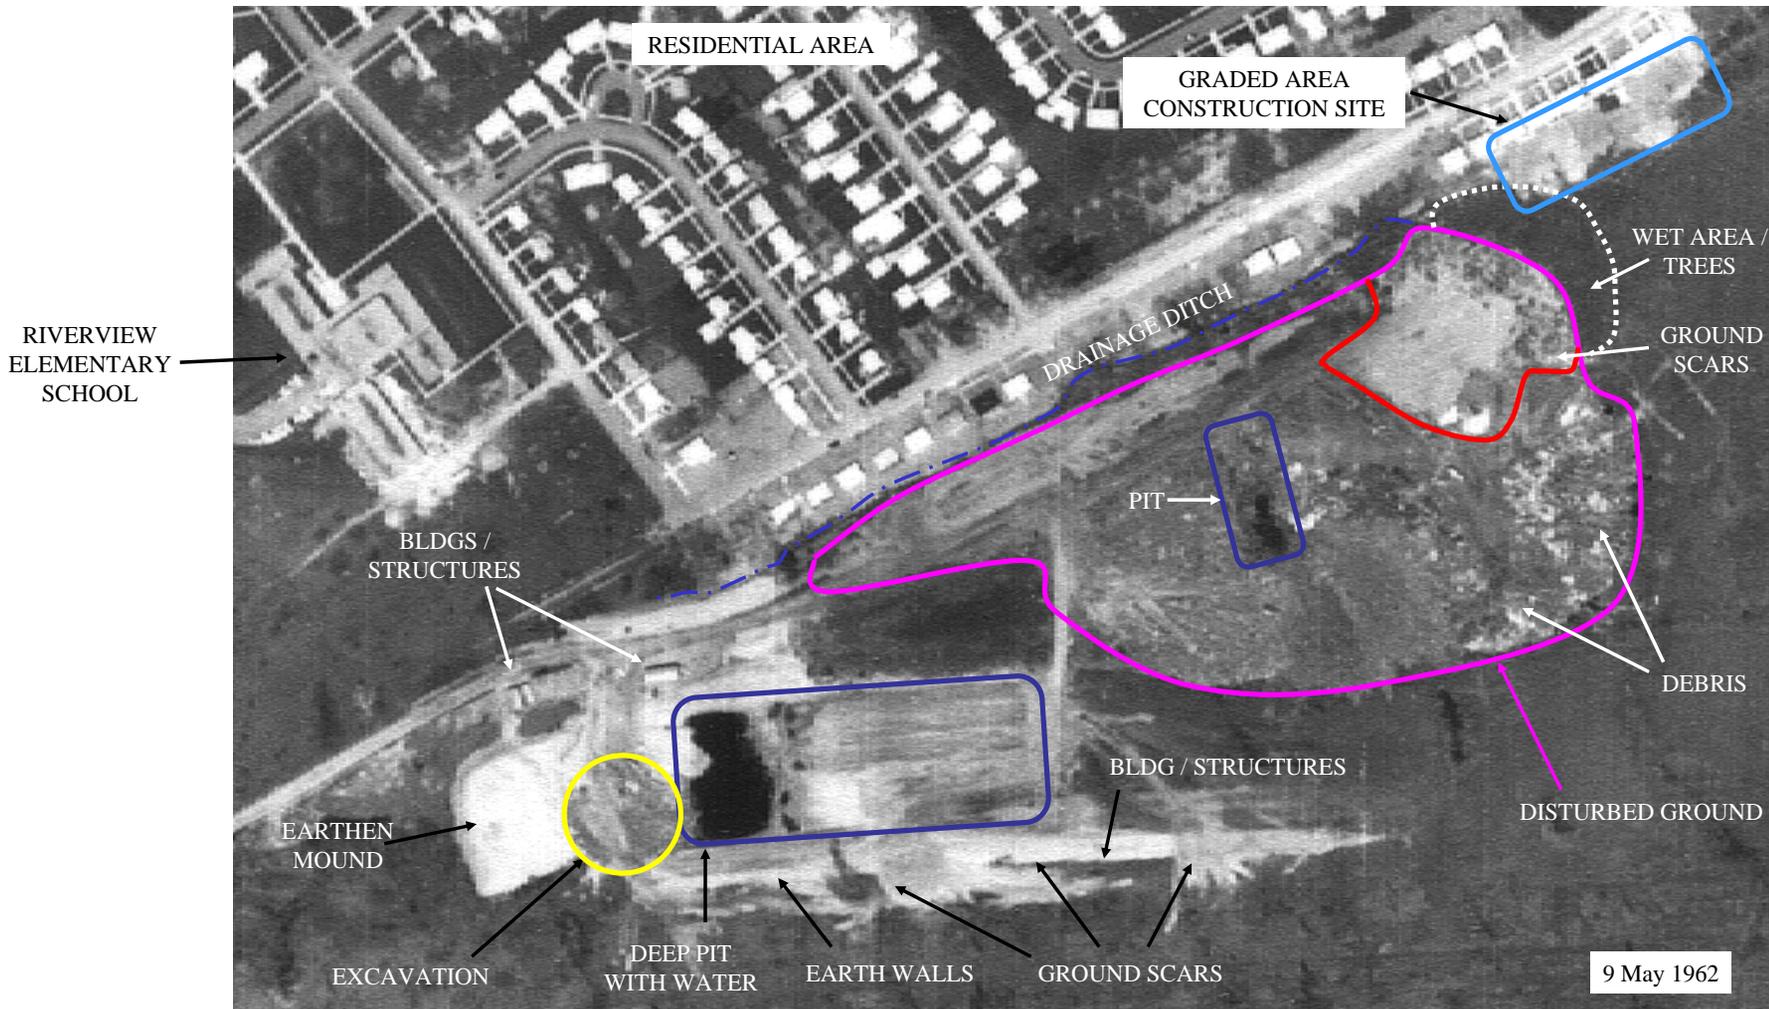
SIGNIFICANT FINDINGS IN THE TONAWANDA LANDFILL, MAY 1962

There are two photo collections for 1962, May 9 and November 26. In this May 9, 1962 photo, on the western side of the landfill, an earthen mound, and a large and deep pit were first observed. The landfill also contained an area of disturbed ground with pit, ground scars, and debris. A drainage ditch is seen between the landfill and the new houses. This ditch appears on May 62 photos only.

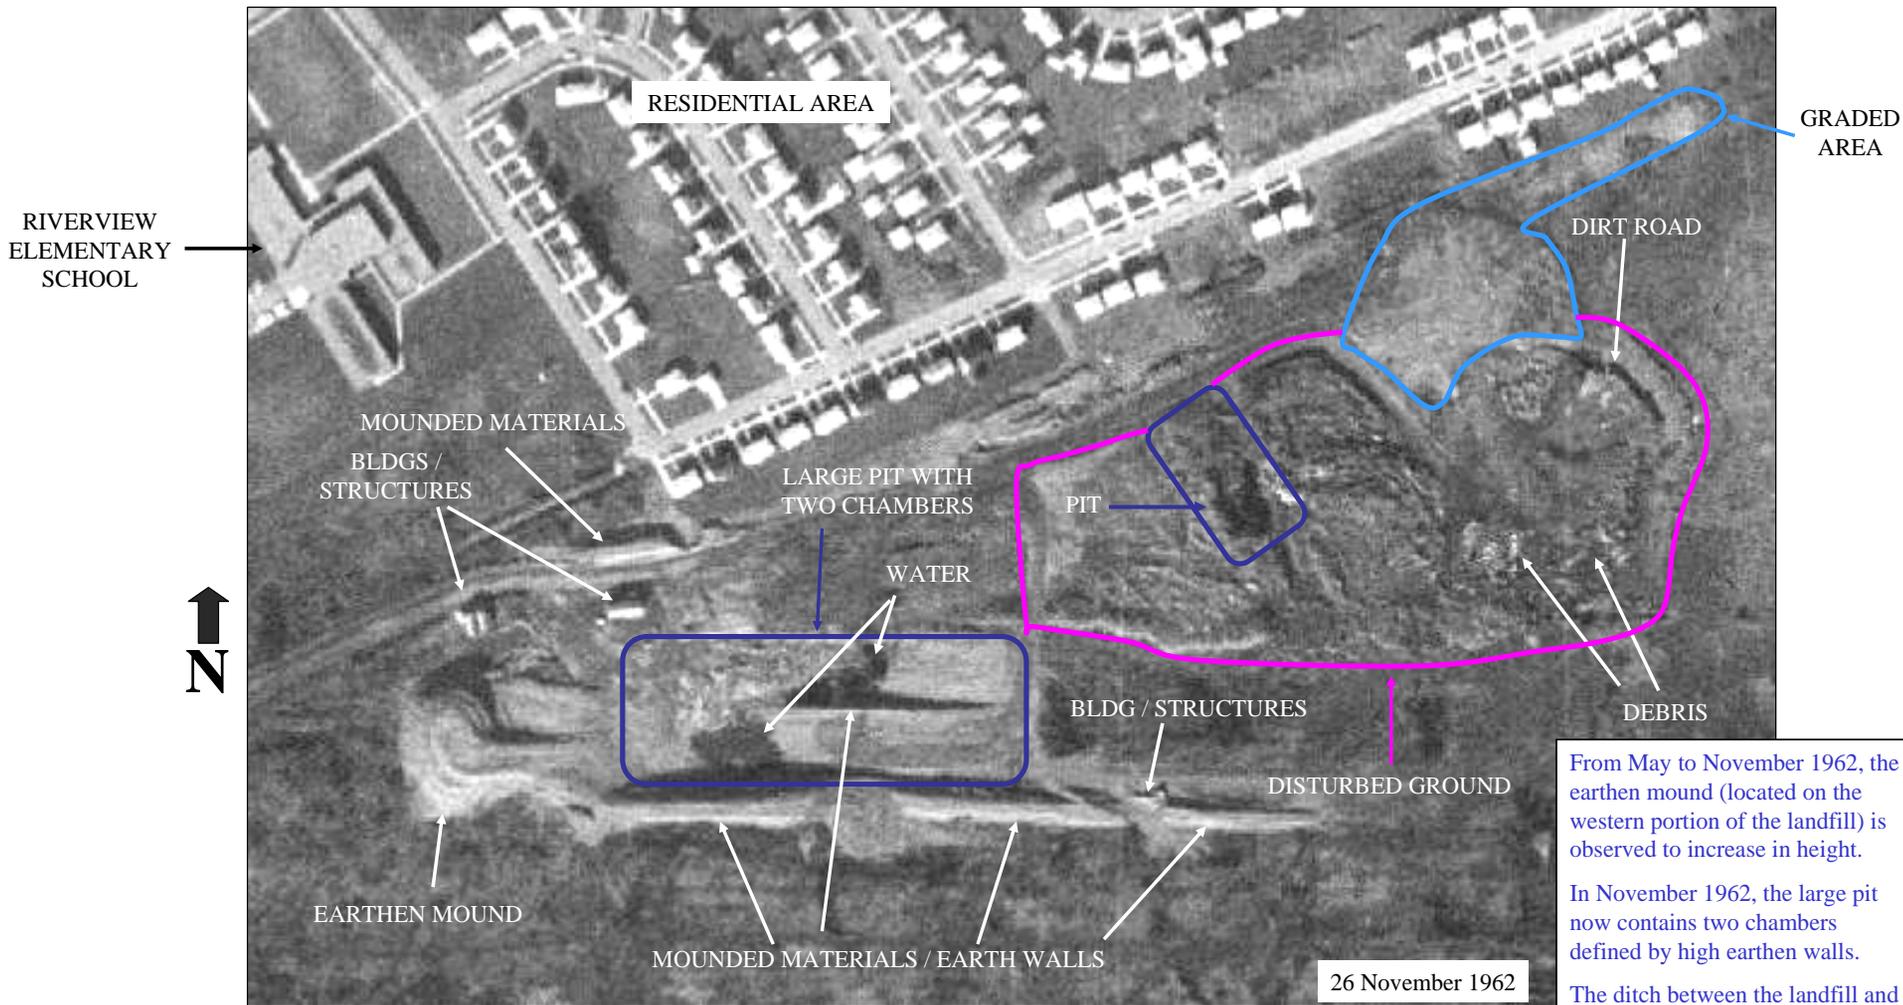
SIGNIFICANT FINDINGS IN THE TONAWANDA LANDFILL, NOVEMBER 1962

From May to November 1962, the earthen mound (located on the western portion of the landfill) is observed to increase in height.

In November 1962, the large pit now contains two chambers defined by high earthen walls.

The ditch between the landfill and the residential area (observed in May 1962) is no longer evident.

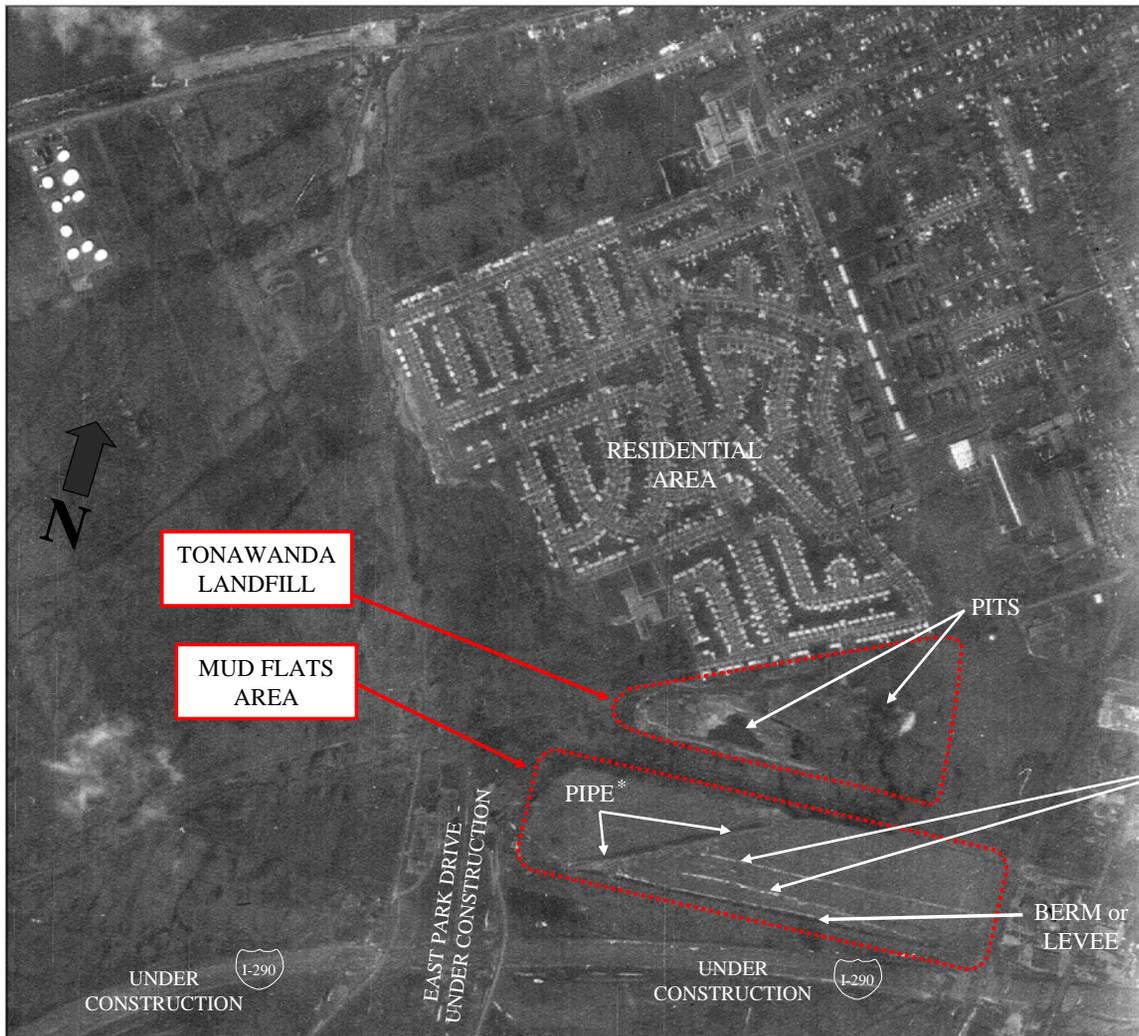
1964 OVERVIEW

The Mudflats Area is observed for the first time on 1964 aerial photography.

A limited photographic interpretation was made of the 1964 aerial photography due to the small-scale nature of the imagery.

In general, the landfill shows an area of disturbed ground containing pits – some filled with water.

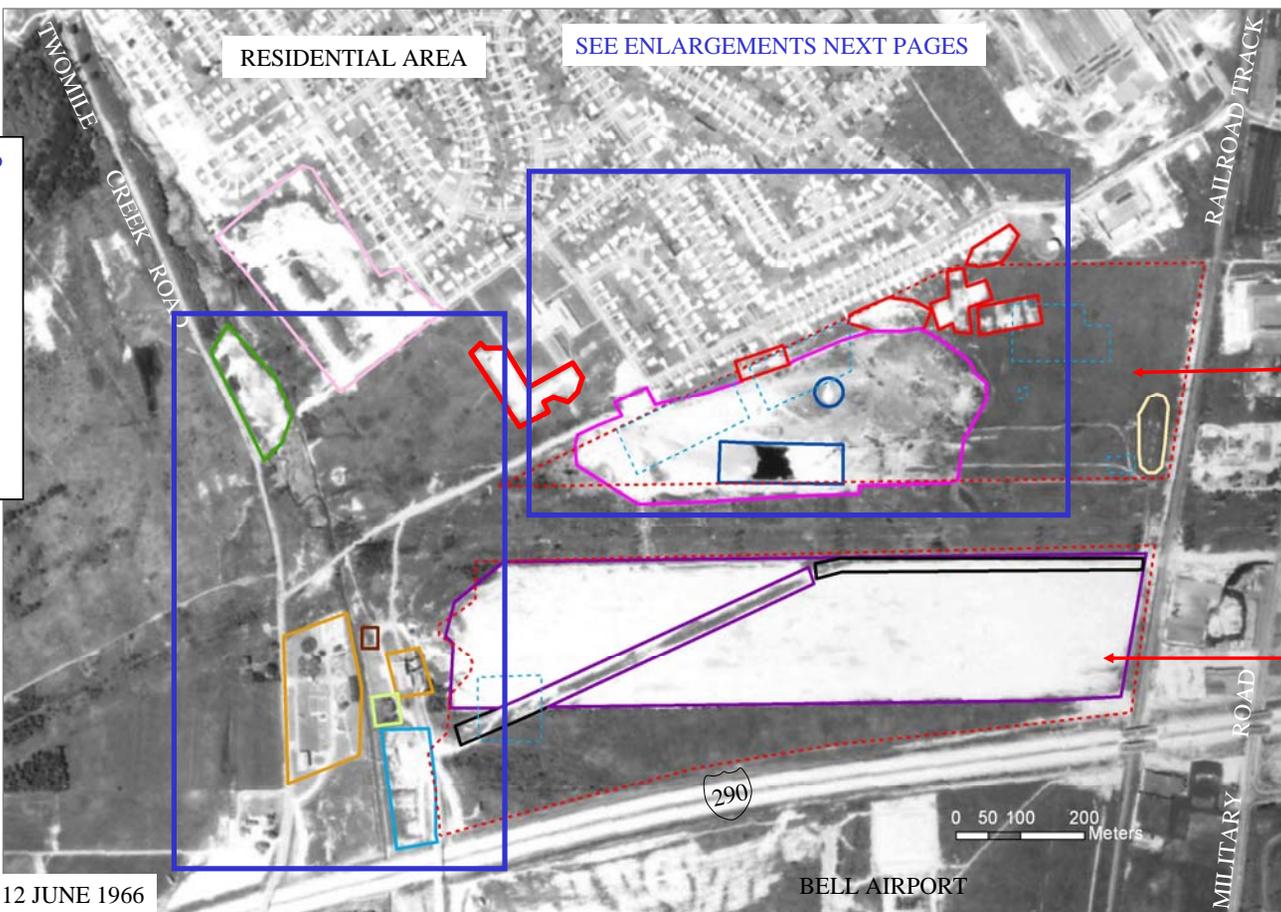
1966 OVERVIEW

The 1966 photo shows changes to the property since what was last observed with 1964 aerial photography.

New excavated areas and dirt roads are observed in the landfill area.

The Mudflats Area is observed clearly on the 1966 aerial photography (with a distinctive light-toned appearance).
