TONAWANDA LANDFILL AND MUDFLATS AREA

TONAWANDA, NEW YORK

GIS-Based Historical Photographic Analysis

July 2009 Final Report

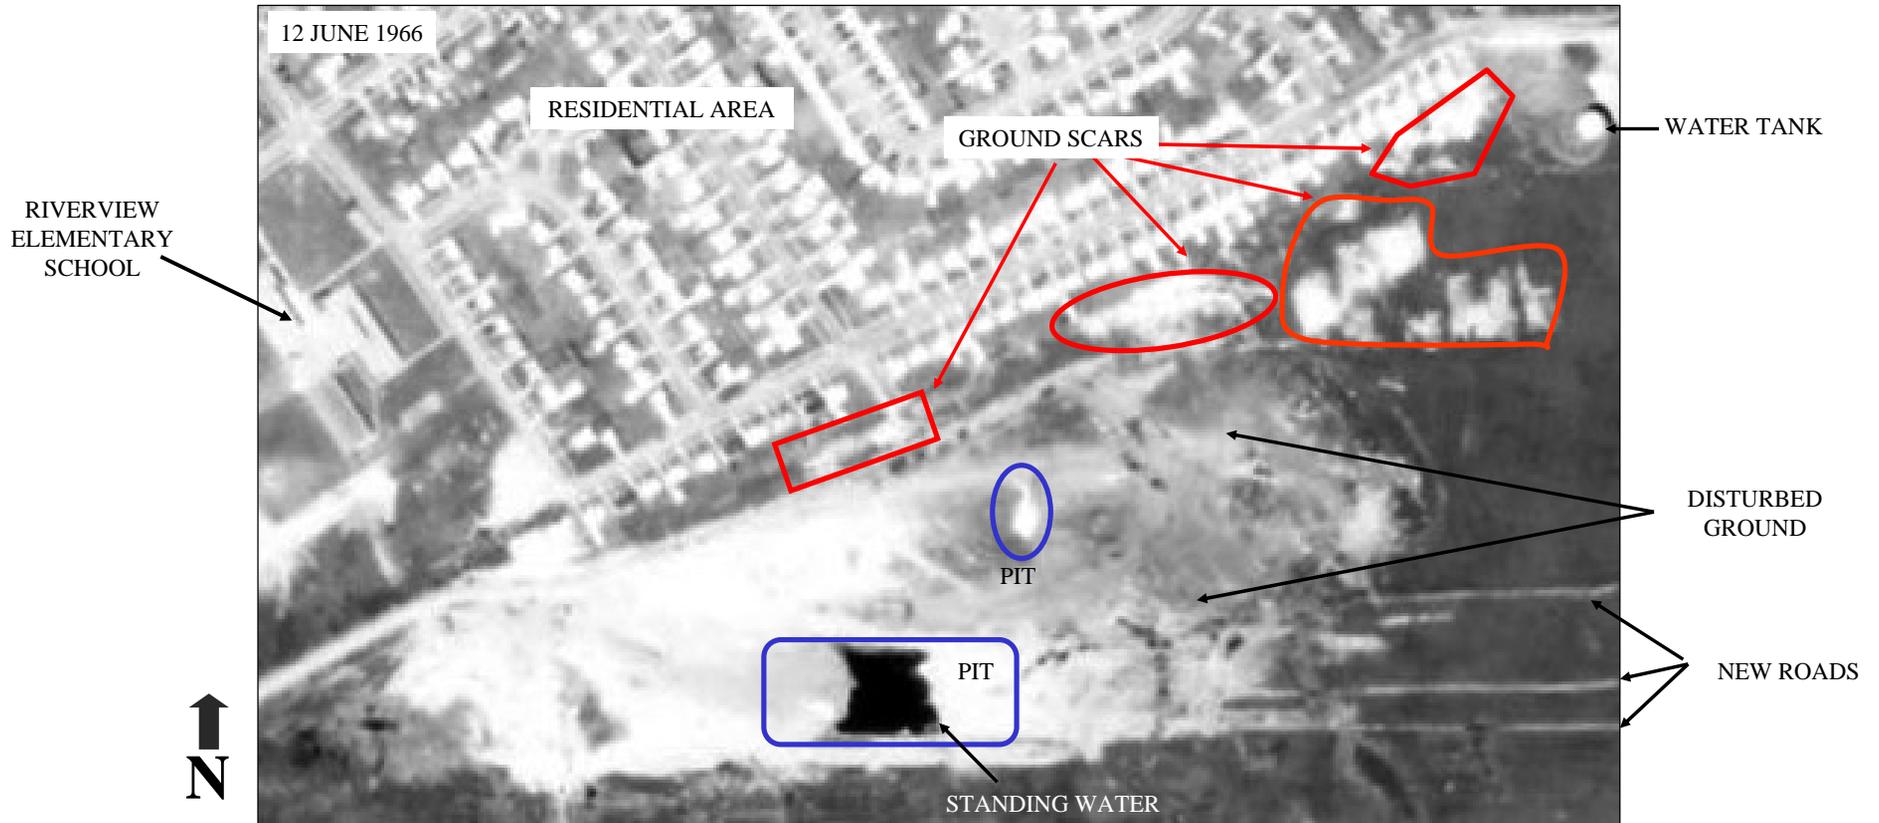
LANDFILL AREA, 1966

In 1966, the landfill remains active. Much of the area appears as disturbed ground. Mounded material which was previously located on the west side of the landfill is now leveled. The large pit, previously observed on both 1962 and 1964 aerial photography, shows standing water inside. Patches of ground scars are observed on landfill property adjacent to the residential area.

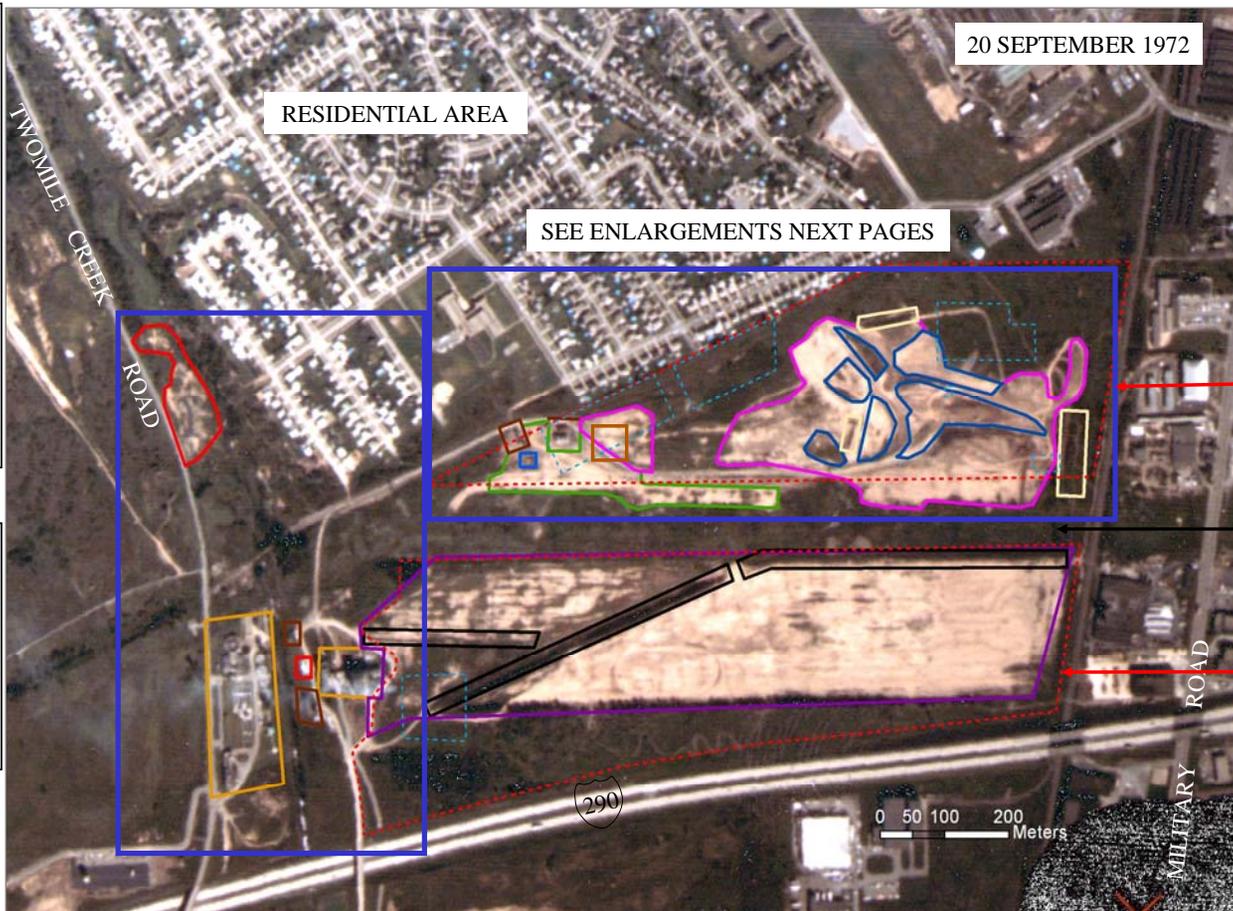
1972 OVERVIEW

In 1972, increased activity is observed in the Tonawanda Landfill.

The Mudflats Area continues to be observed south of the Niagara Mohawk power line right-of-way.

Note: Two set of aerial photos were collected for 1972: May 10 and September 20. These two sets of photos are used to present the detailed views of the Landfill Area in the next page.

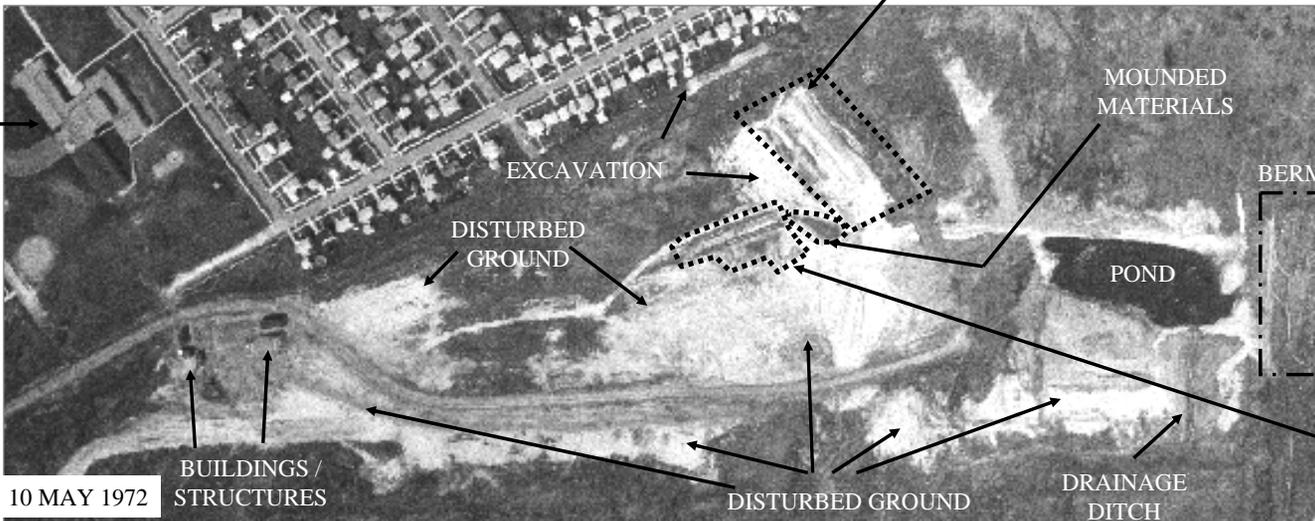
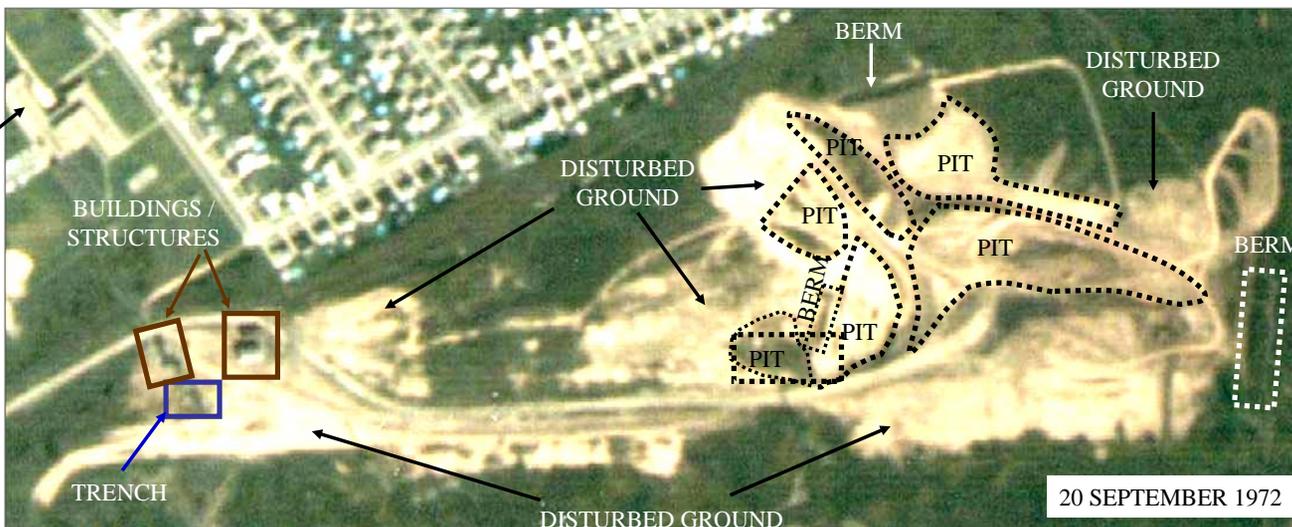
HISTORICAL PHOTO COMPARISON OF MAY AND SEPTEMBER 1972

Two (2) linear trenches filled with dark-toned material.

In May 1972, the landfill contains a pond and numerous excavation sites and trenches. By September, the pond was filled. The landfill was a large disturbed ground with many pits and berms.

Two (2) linear trenches and one (1) smaller 'Z-shaped' trench.

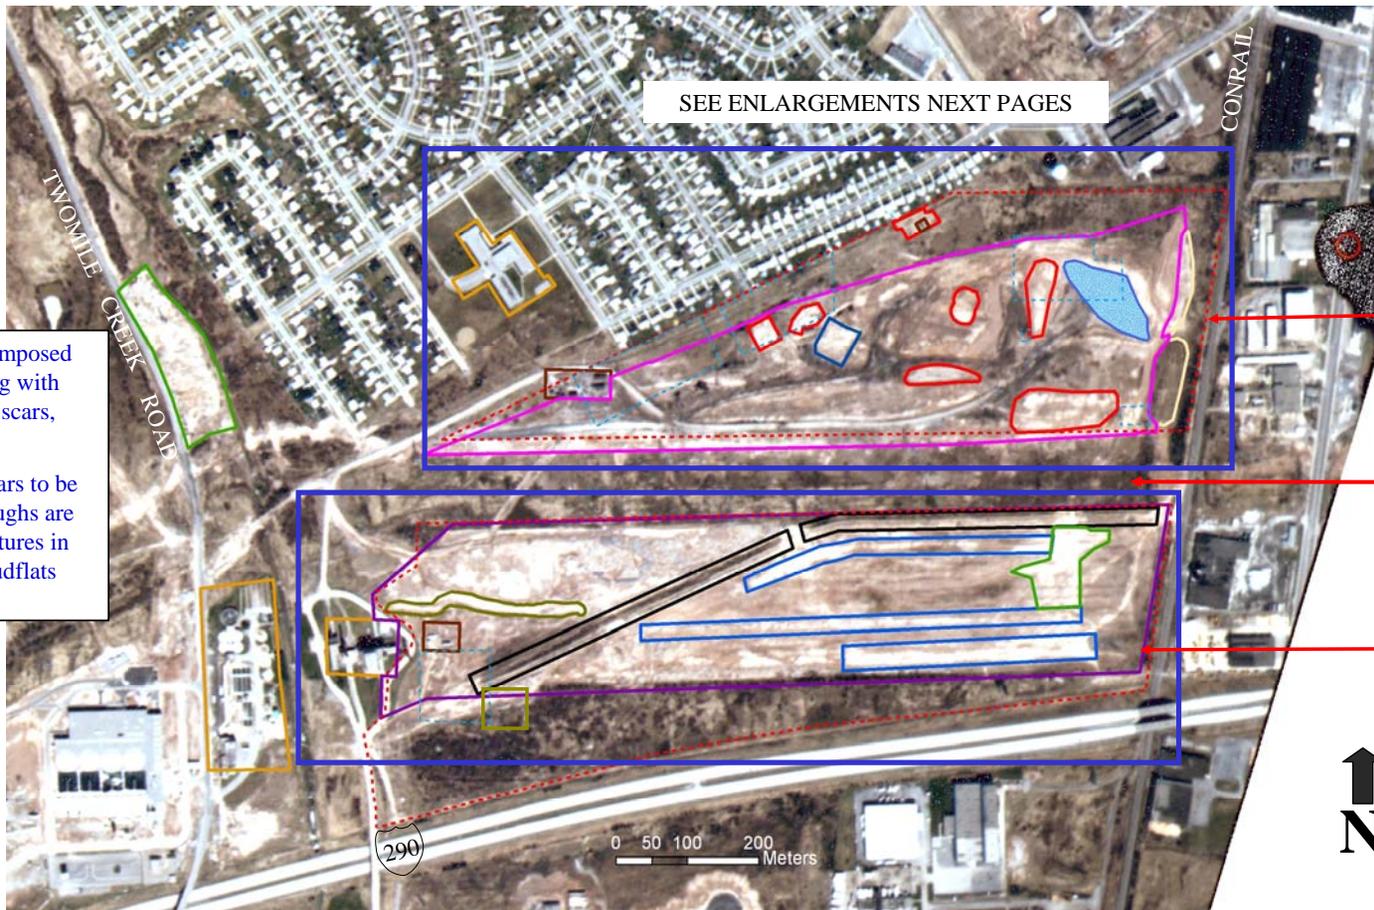
1978 OVERVIEW

In 1978 the landfill is composed of disturbed ground along with excavation sites, ground scars, and two ponds.

The Mudflats Area appears to be drained. Trench and troughs are identified as residual features in the somewhat vacant Mudflats Area.

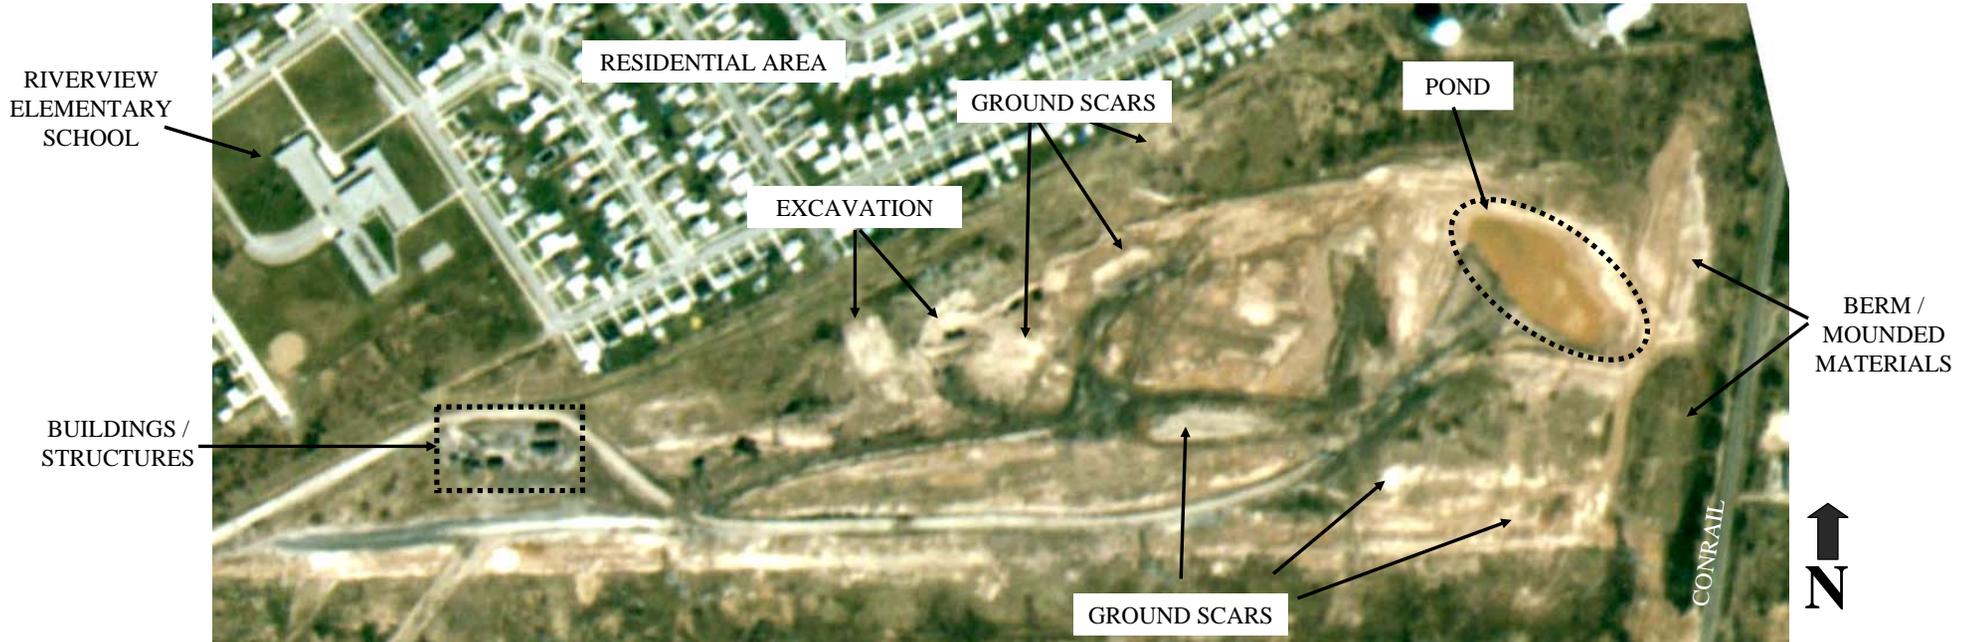
LANDFILL AREA, 1978

In 1978 the Tonawanda Landfill is a large area of disturbed ground. The landfill also contains excavation sites, scattered ground scars, and two ponds.

PLEASE SEE A 3D VIEW OF 1978 PHOTO ON PAGE 53

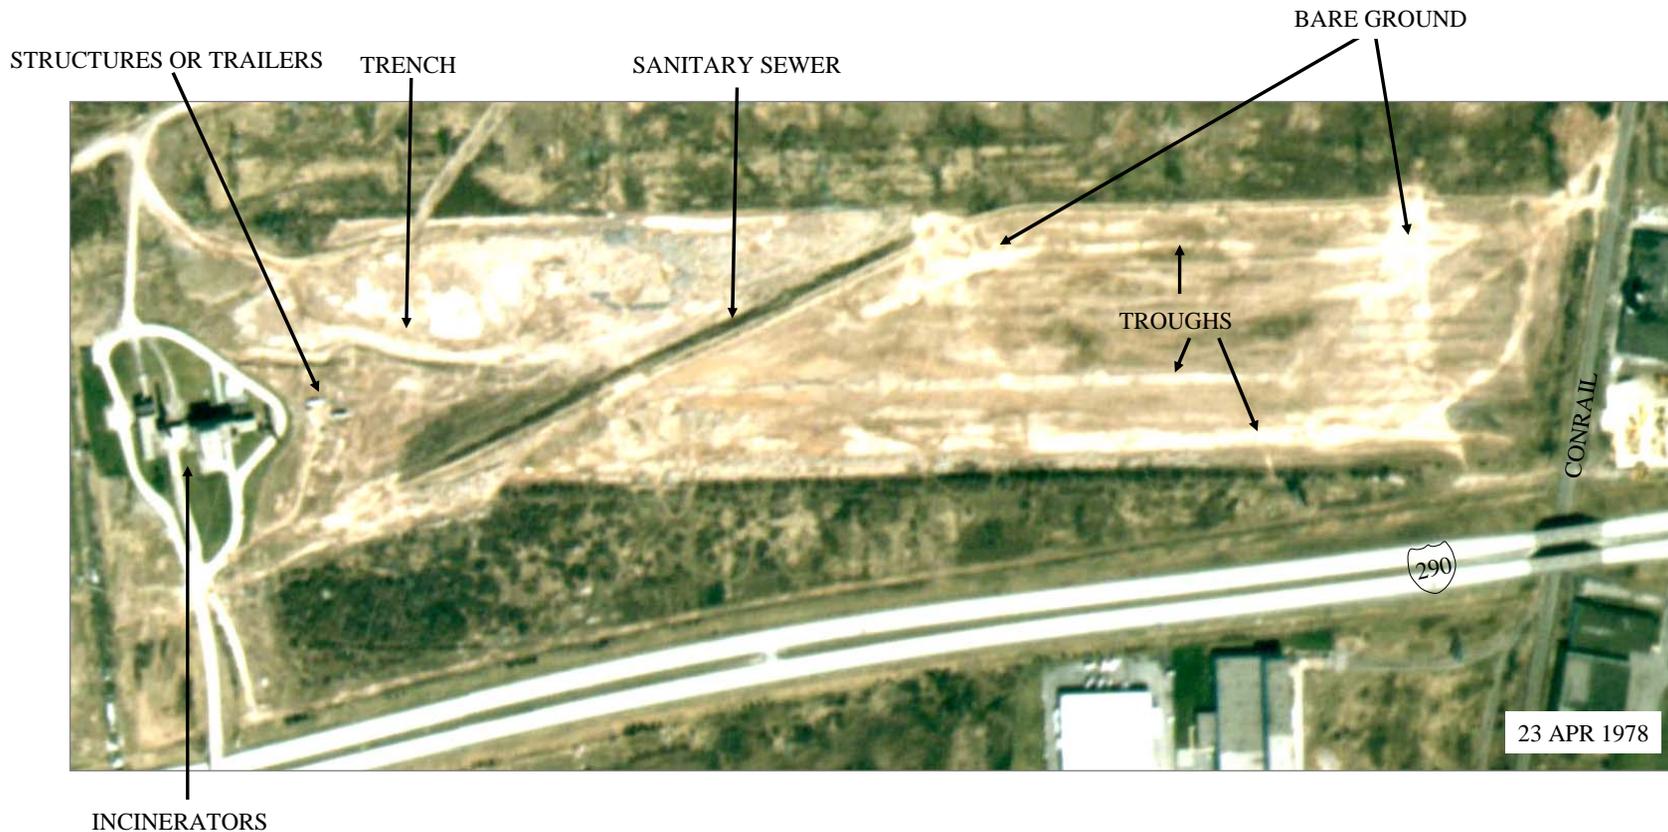
MUDFLATS AREA, 1978

In 1978 the Mudflats Area appears to be drained. Trench and troughs occur along the bottom.

PLEASE SEE A 3D VIEW OF 1978 PHOTO ON PAGE 53

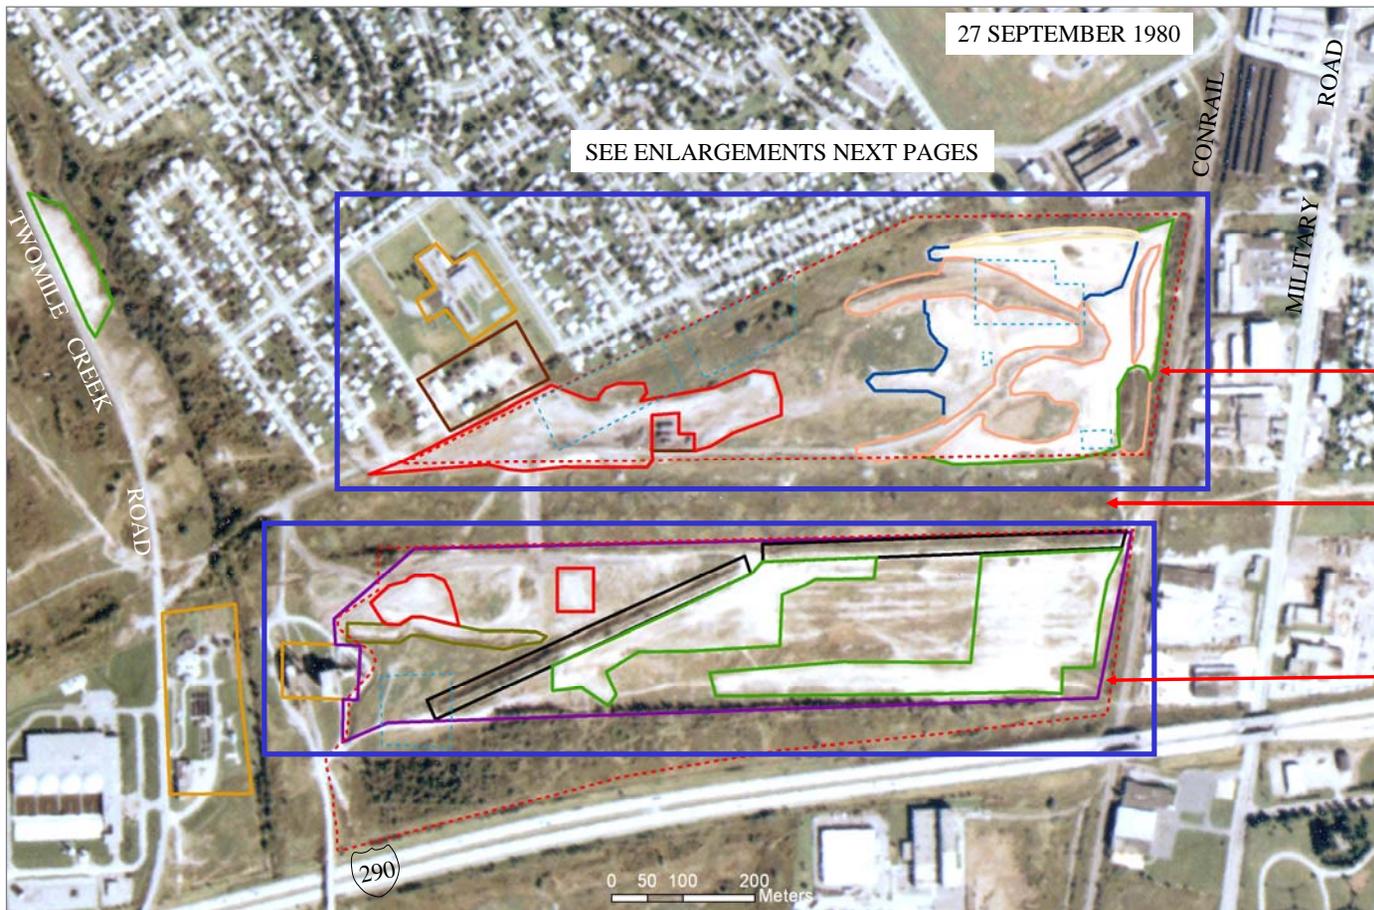
1980 OVERVIEW

In 1980, the Tonawanda Landfill contains shallow pits, a trench, a berm, and an area of ground scars.

Both the landfill and mudflats area appear to be less active (showing signs of revegetation).

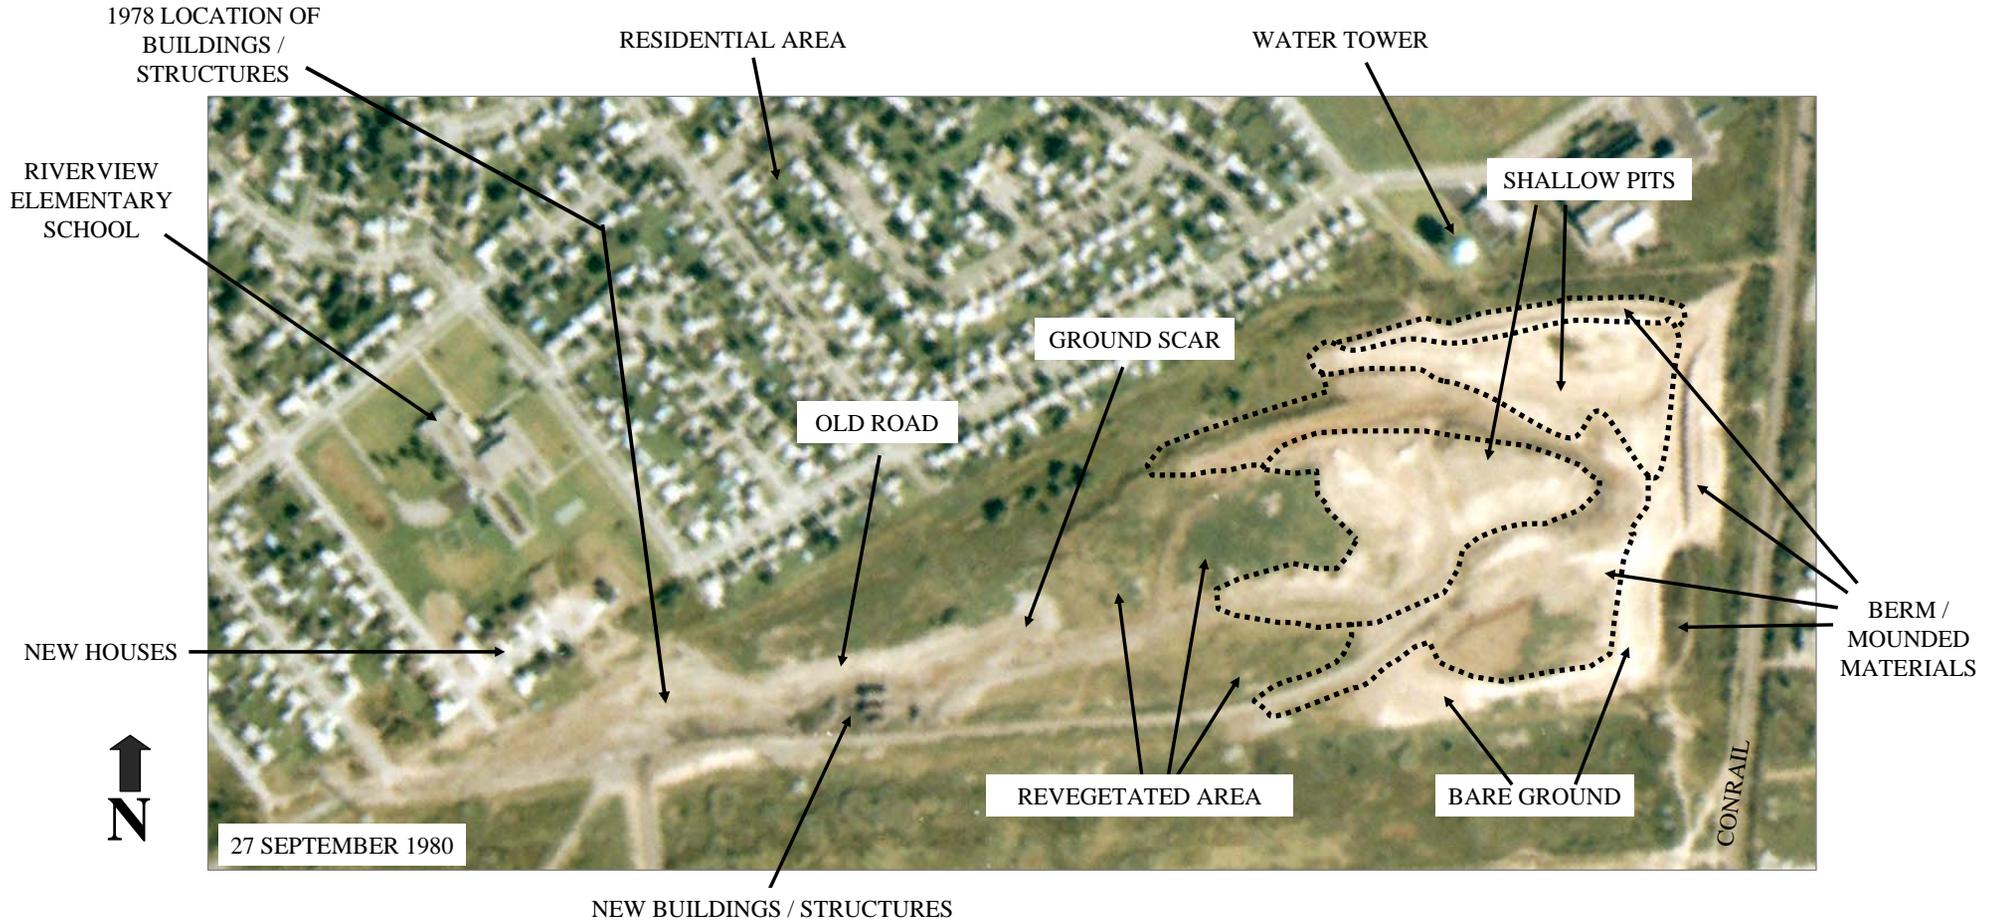
LANDFILL AREA, 1980

Portions of the landfill appear to be covered with patches of new vegetation.

PLEASE SEE A 3D VIEW OF 1980 PHOTO ON PAGE 54

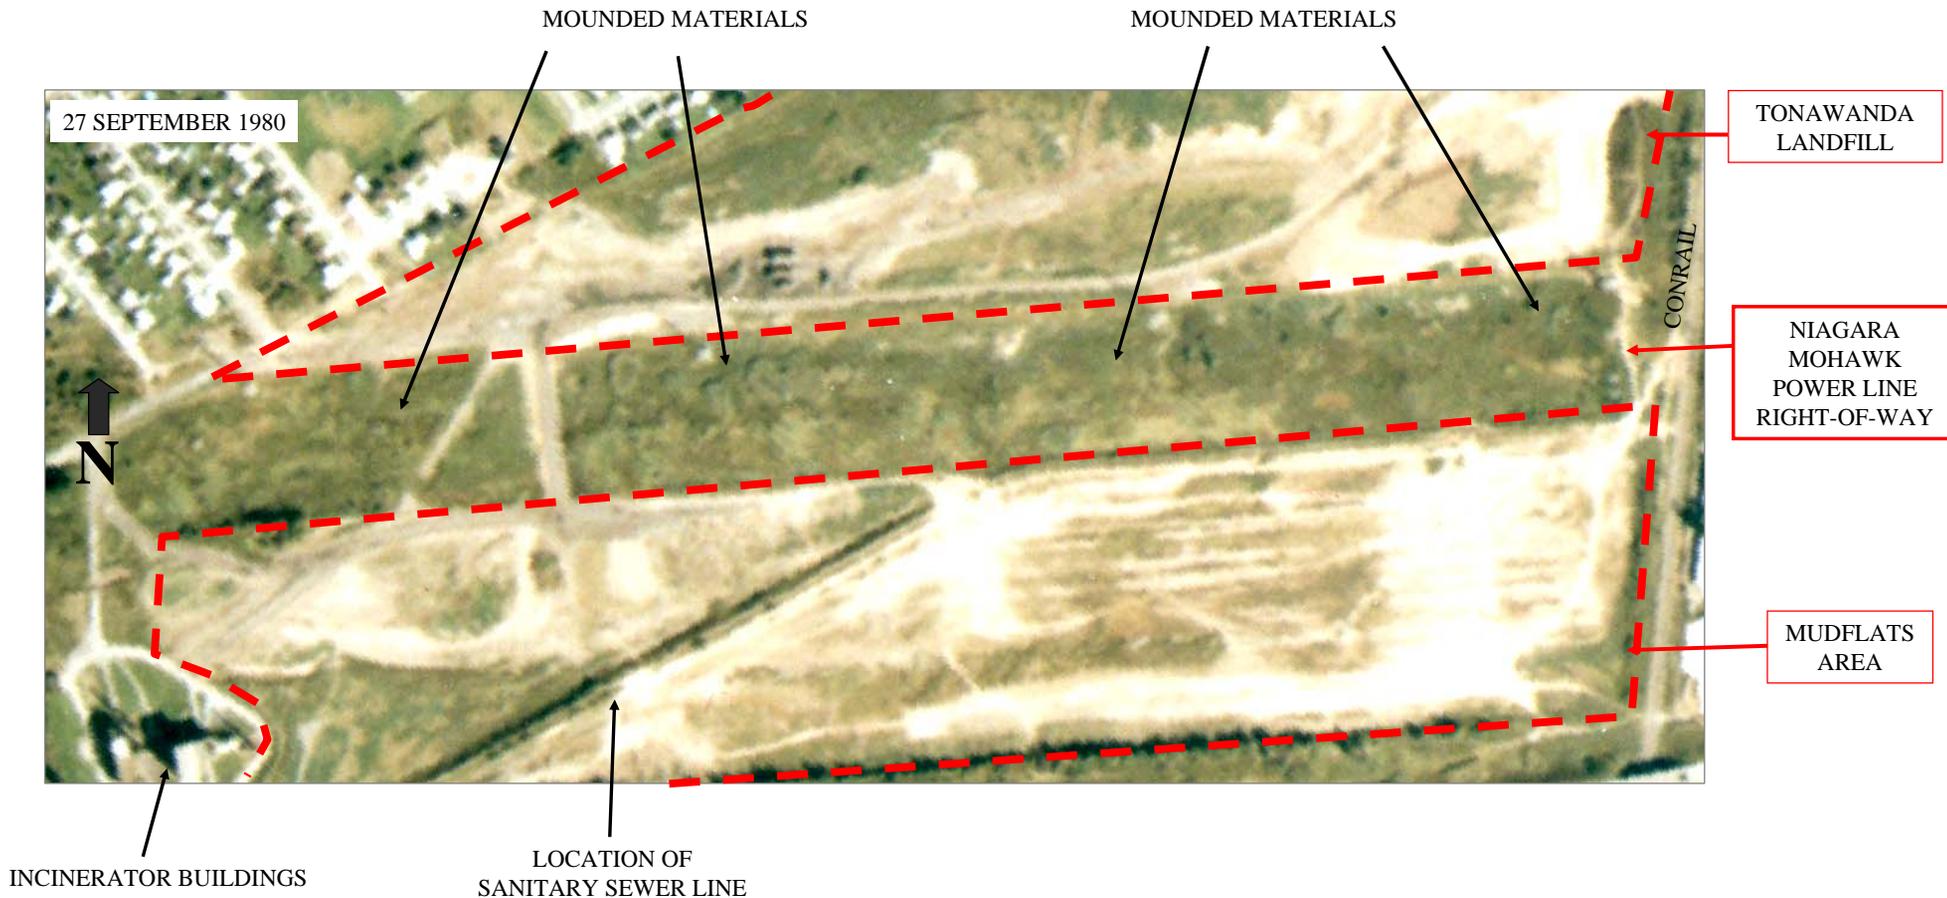
POWER LINE RIGHT-OF-WAY, 1980

In 1980, the power line right-of-way lying between the Tonawanda Landfill and the Mudflats Area contains scattered mounded materials.

PLEASE SEE A 3D VIEW OF 1980 PHOTO ON PAGE 54

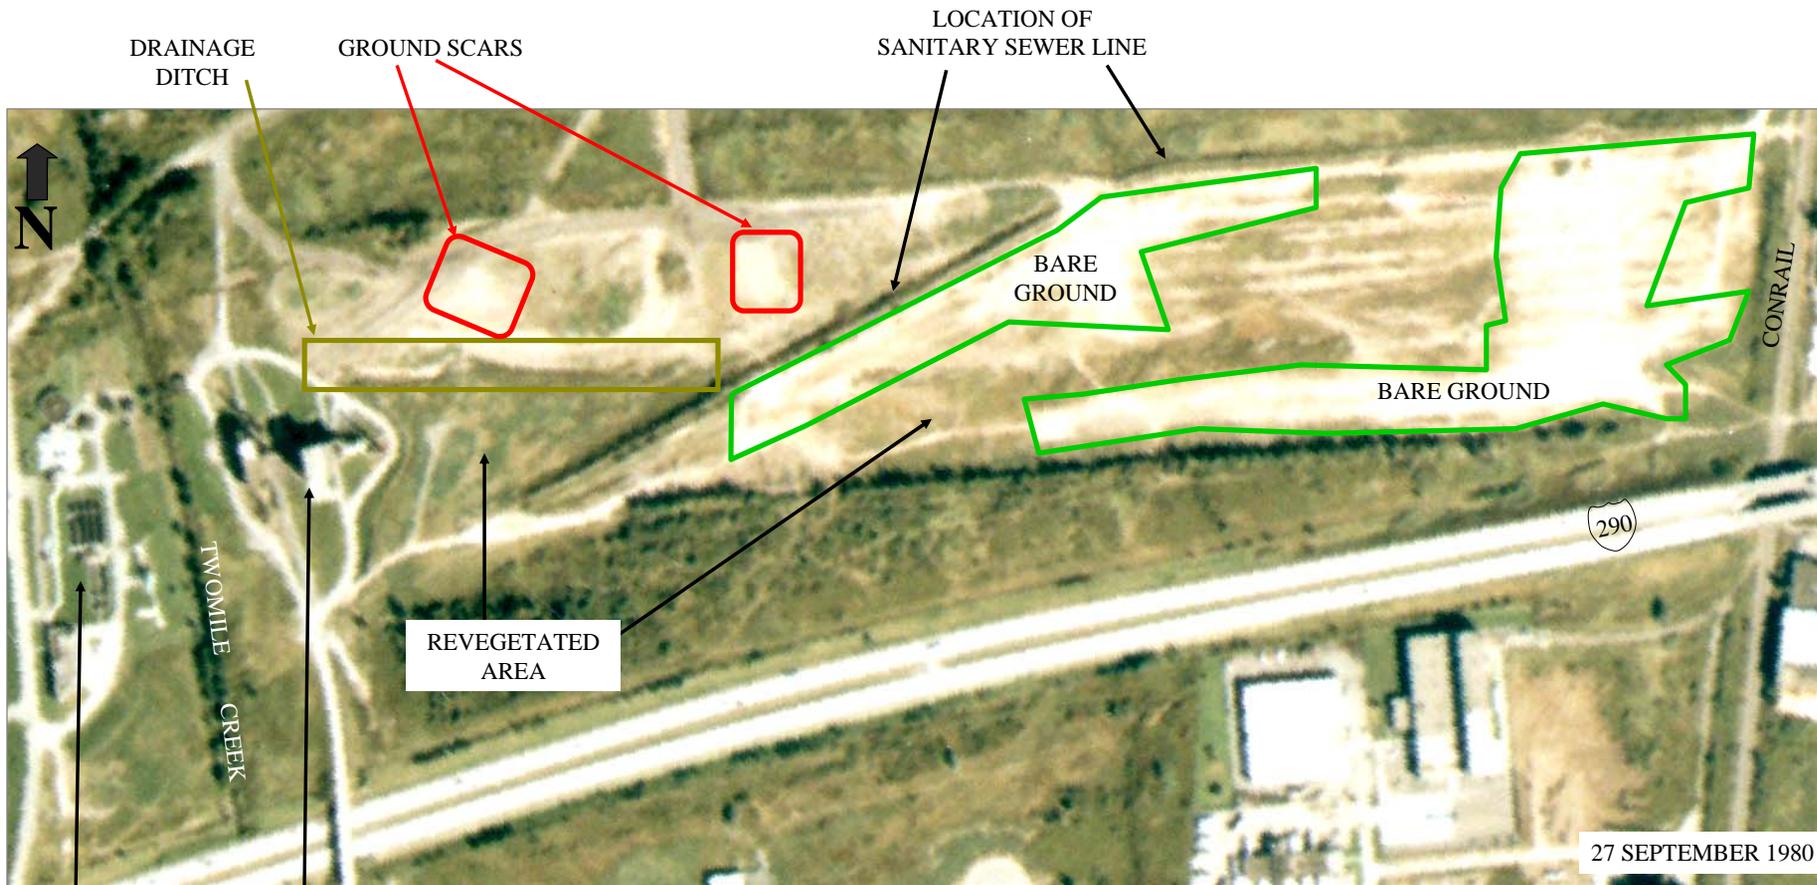
MUDFLATS AREA, 1980

SEWAGE TREATMENT FACILITY

INCINERATOR BUILDINGS

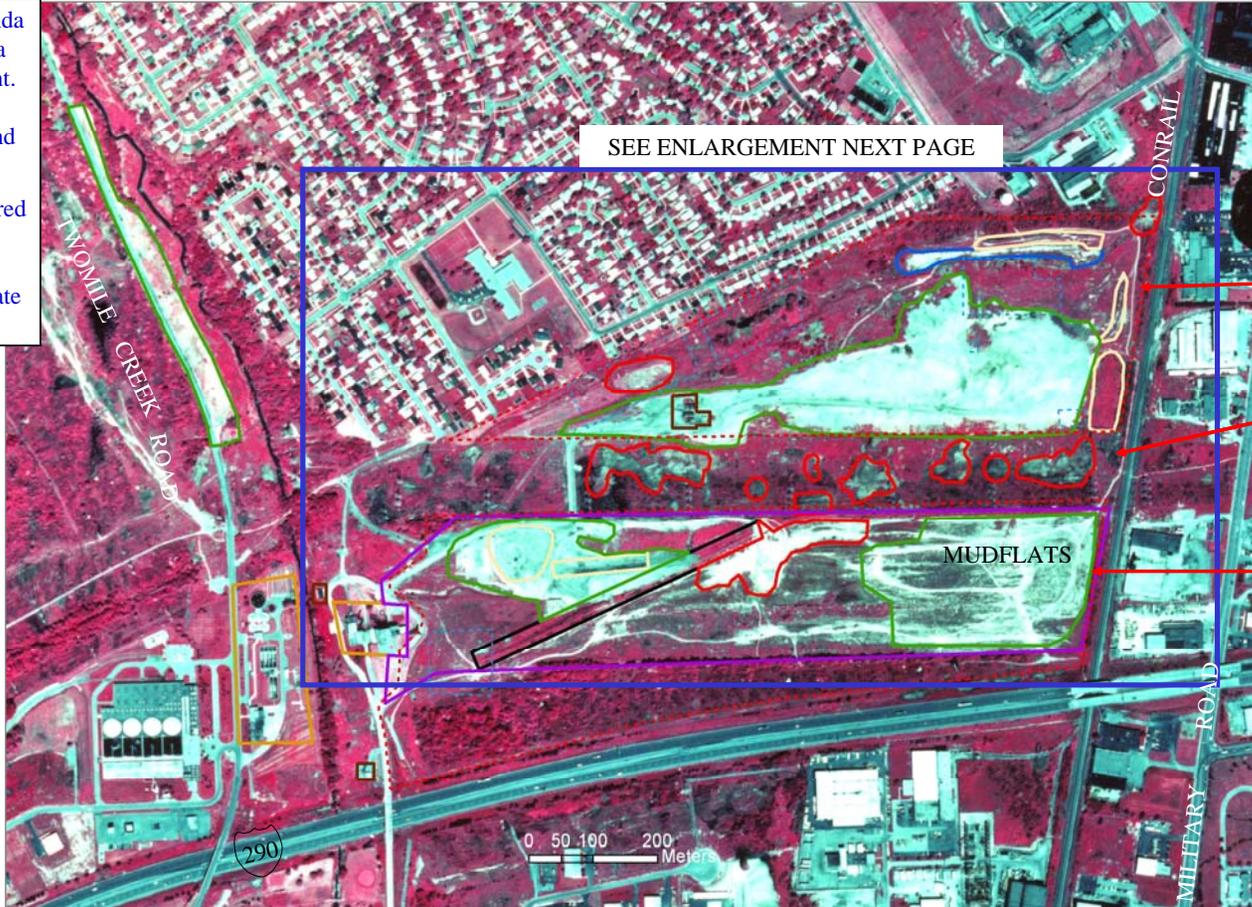
In 1990, both the Tonawanda Landfill and Mudflats Area show signs of abandonment. These two sites contain a large amount of bare ground (fill soil).

Note: This is a color infrared photograph. Red color indicates dense vegetation. White and light blue indicate bare ground.

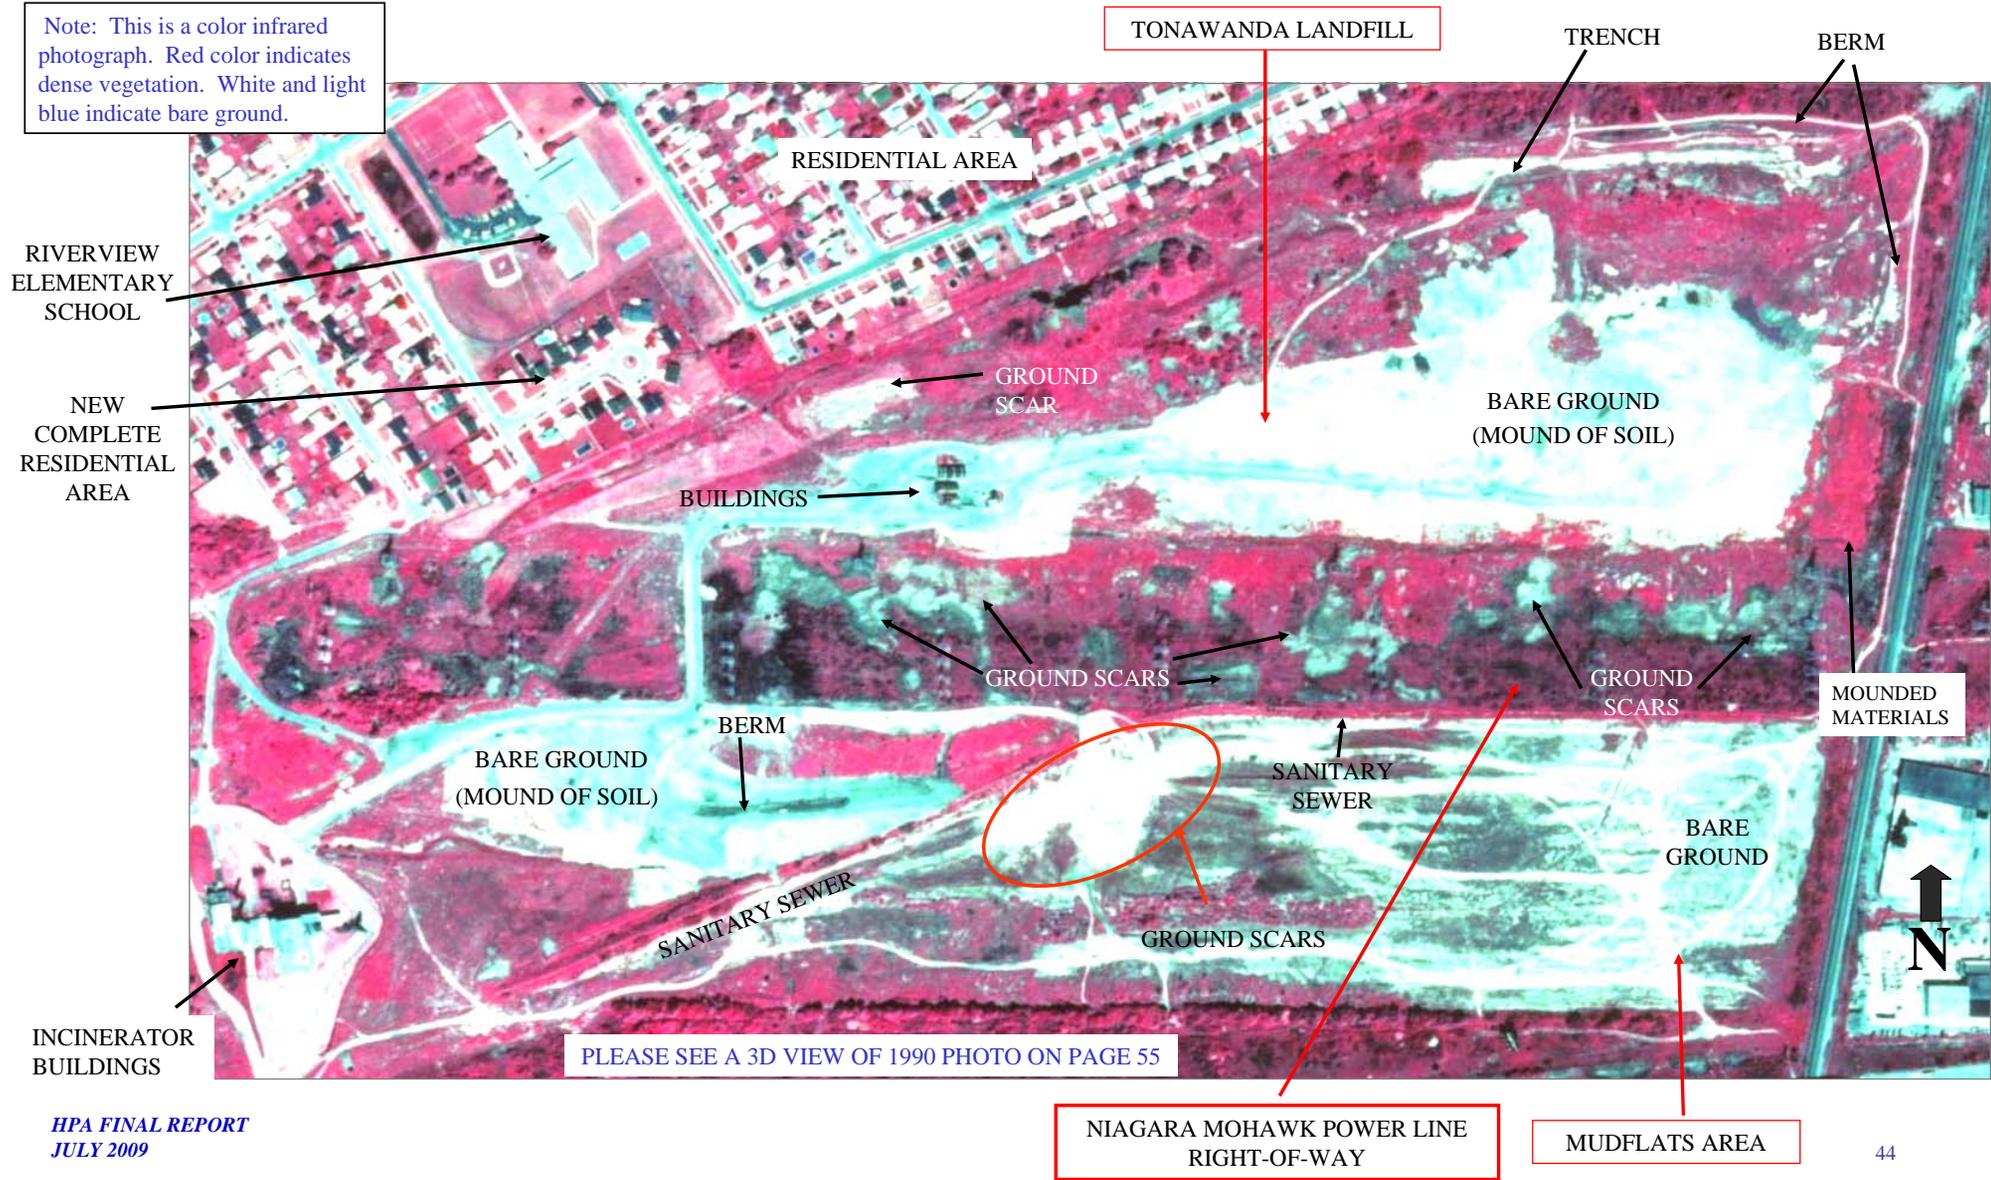
1995 OVERVIEW

Note: This is a color infrared photograph. Red color indicates dense vegetation. White and light blue indicate bare ground.

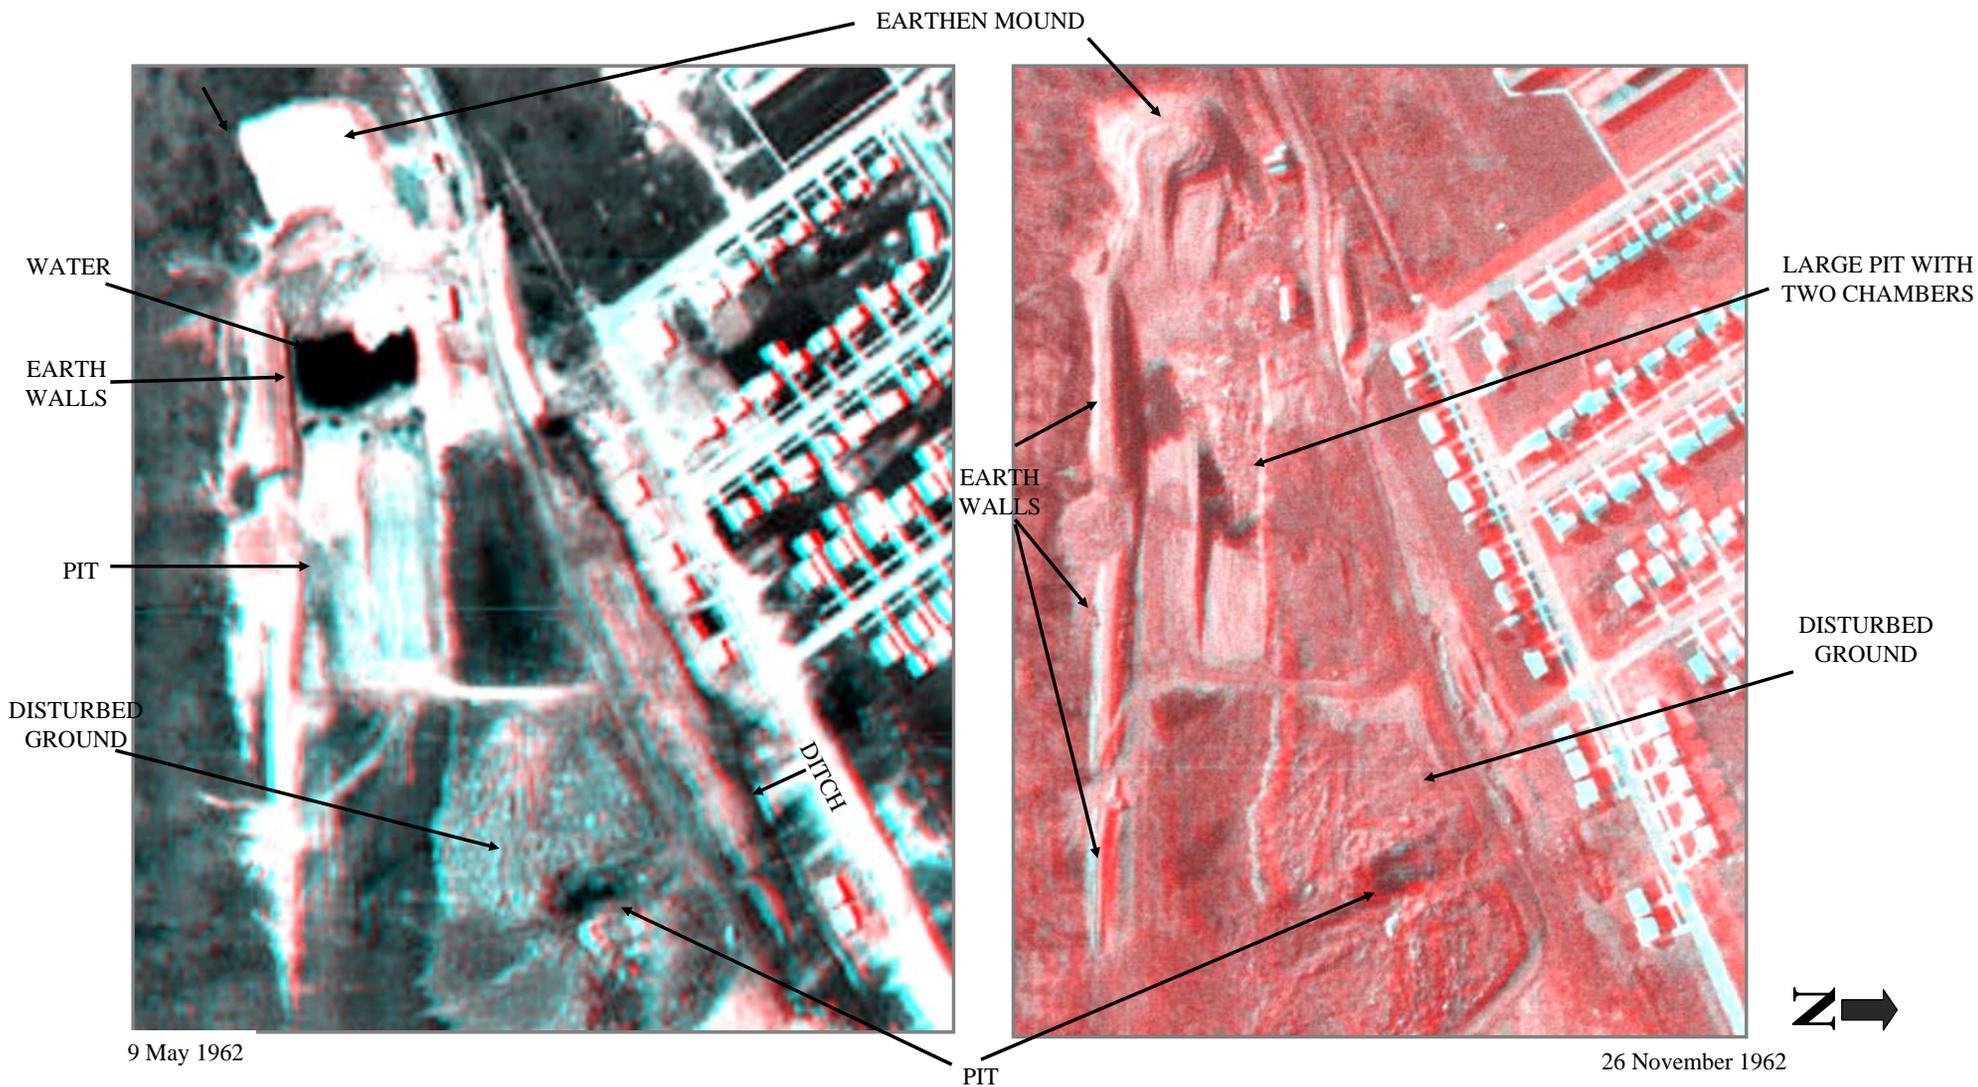
HISTORICAL PHOTO COMPARISON OF MAY AND NOVEMBER 1962

From May to November 1962, the earthen mound (located on the western portion of the landfill) is observed to increase in height.

The ditch between the landfill and the residential area (observed in May 1962) is no longer evident.

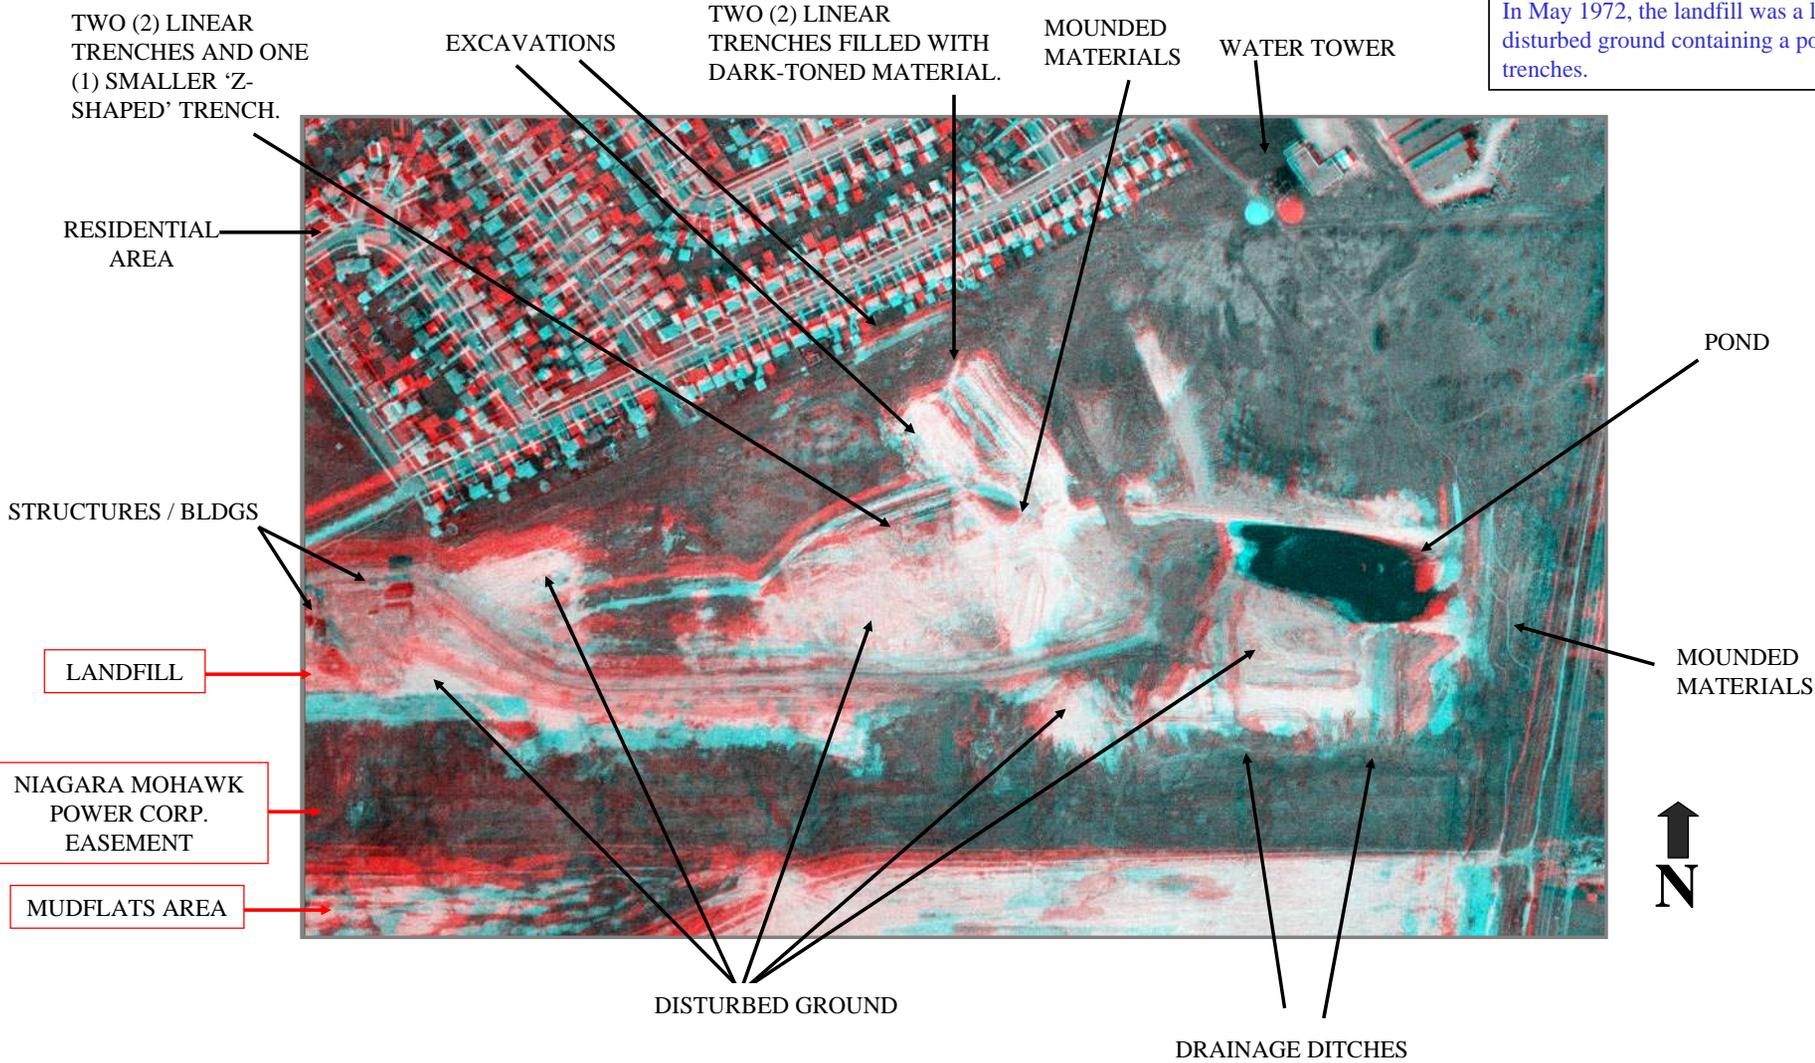
3D VIEW OF THE LANDFILL AREA, MAY 1972

In May 1972, the landfill was a large disturbed ground containing a pond and some trenches.
