TONAWANDA LANDFILL AND MUDFLATS AREA

TONAWANDA, NEW YORK

GIS-Based Historical Photographic Analysis

July 2009 Final Report

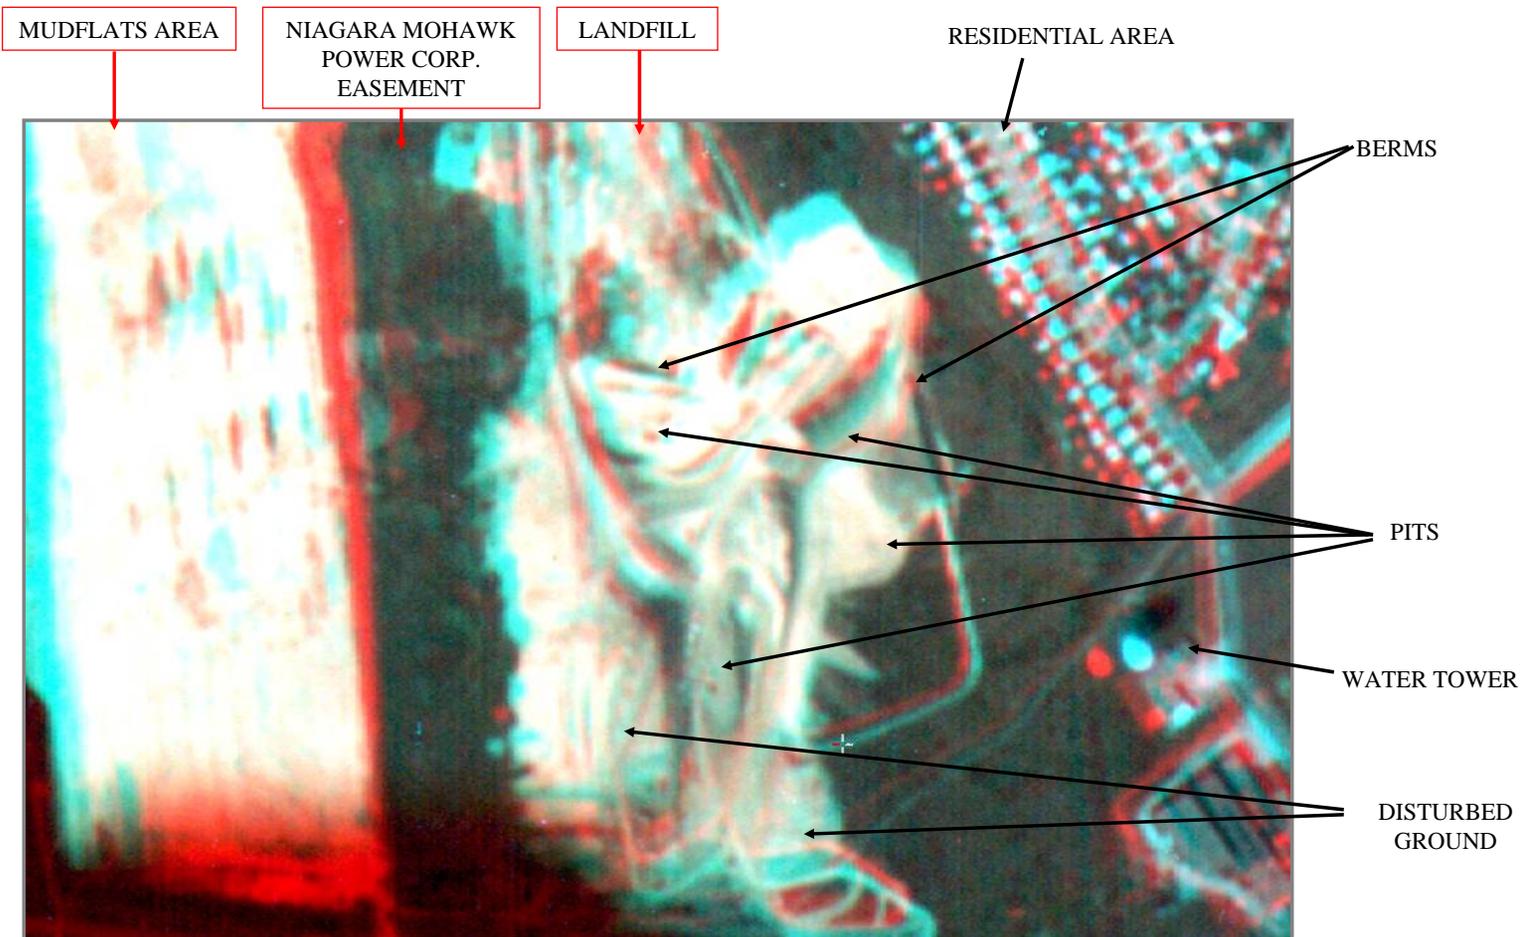
3D VIEW OF LANDFILL AREA, SEPTEMBER 1972

By September 1972, the pond was filled. The landfill was a large disturbed ground with many pits and berms.

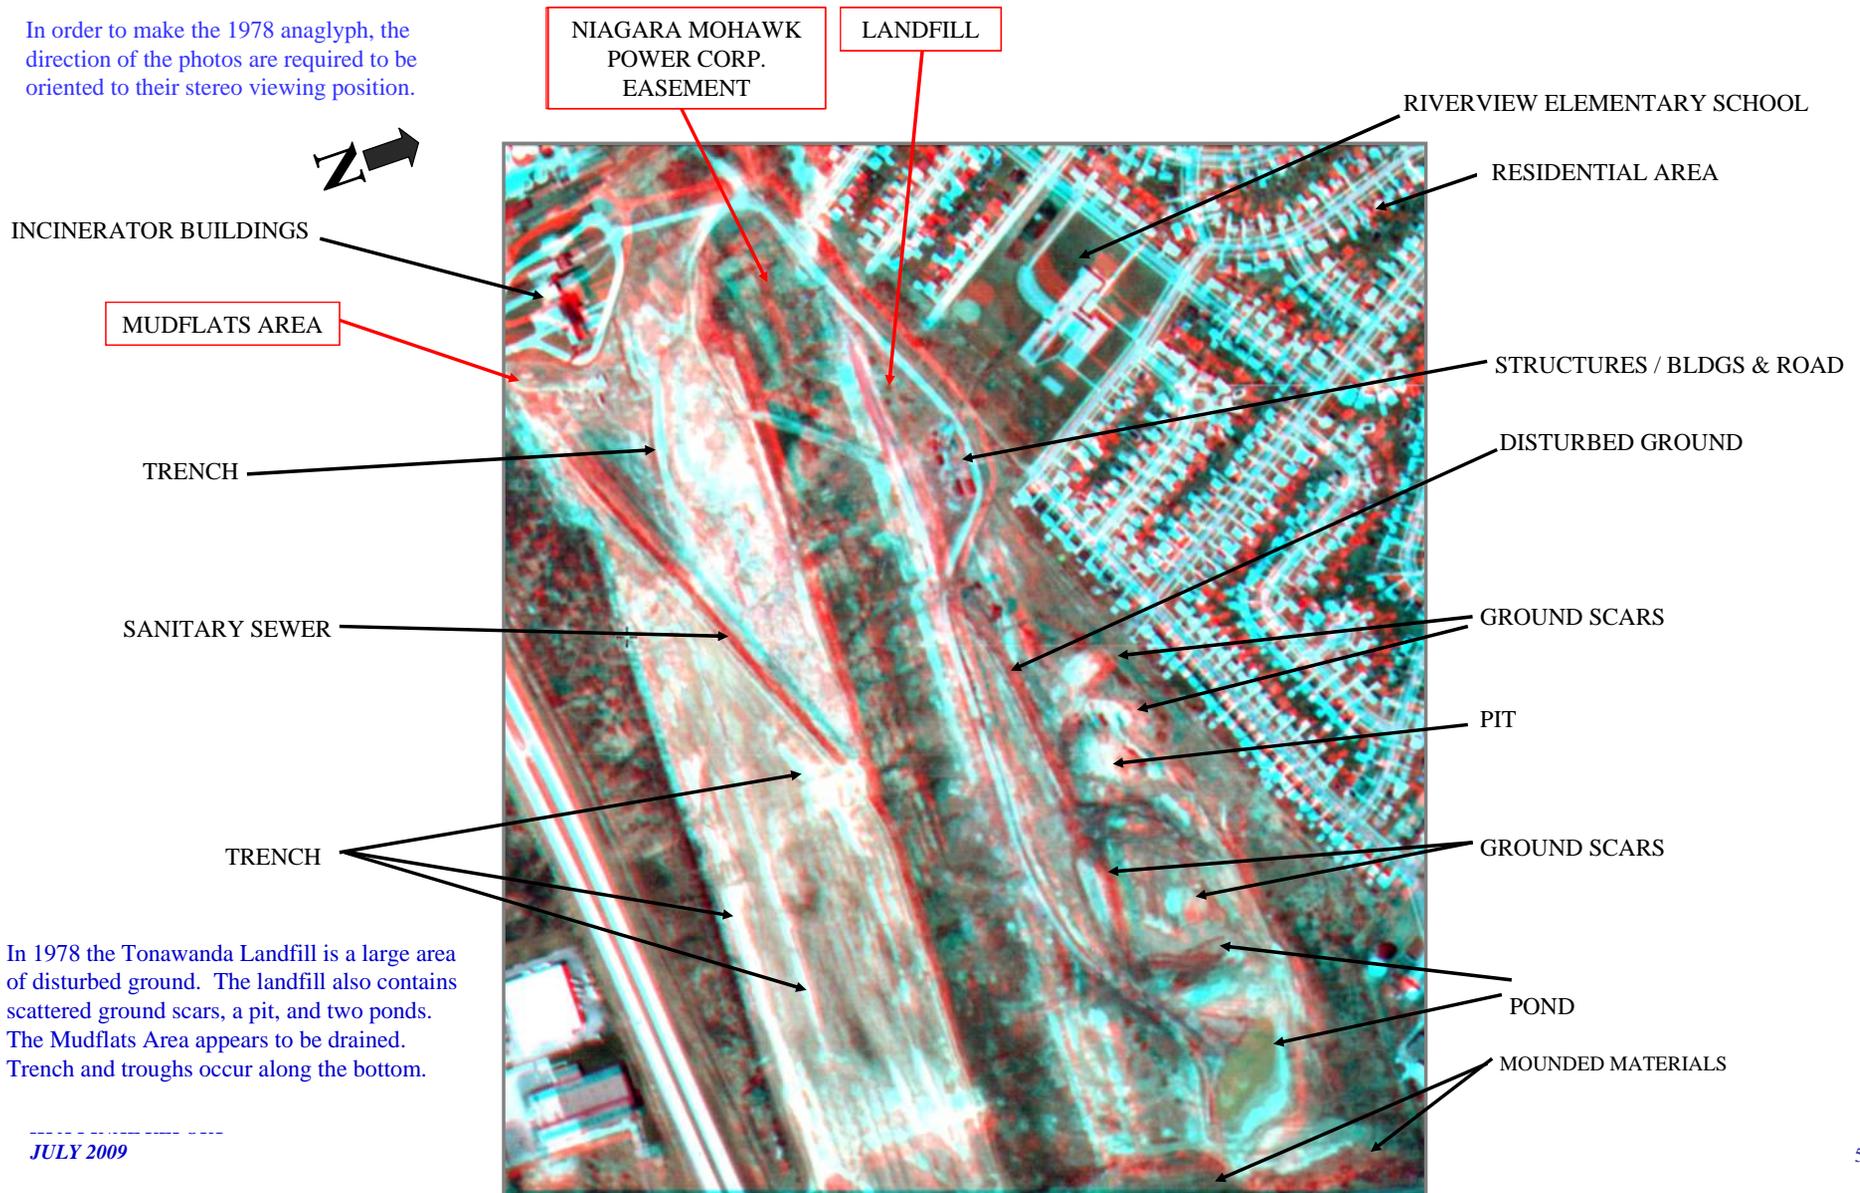
In 1978 the Tonawanda Landfill is a large area of disturbed ground. The landfill also contains scattered ground scars, a pit, and two ponds. The Mudflats Area appears to be drained. Trench and troughs occur along the bottom.

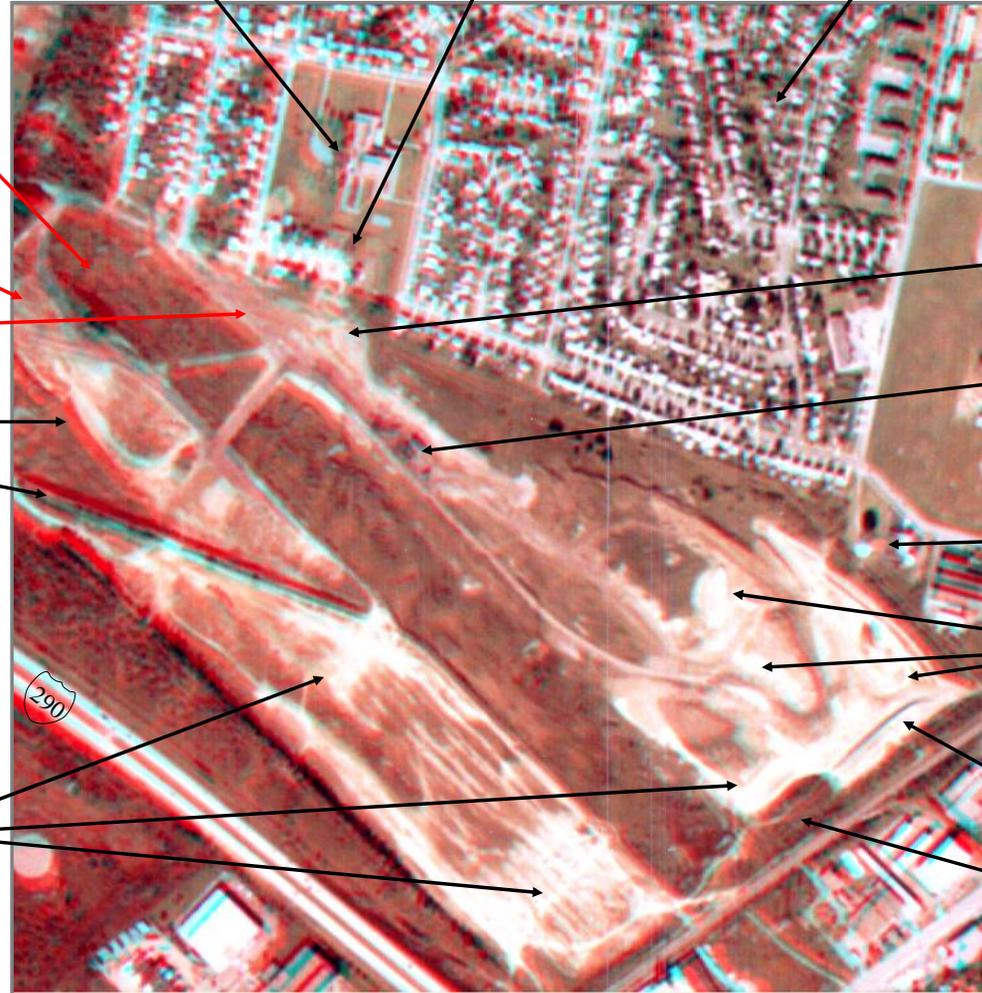
In 1980, the Tonawanda Landfill contains shallow pits, a trench, a berm, and an area of ground scars.

Both the landfill and mudflats area appear to be less active (showing signs of revegetation).

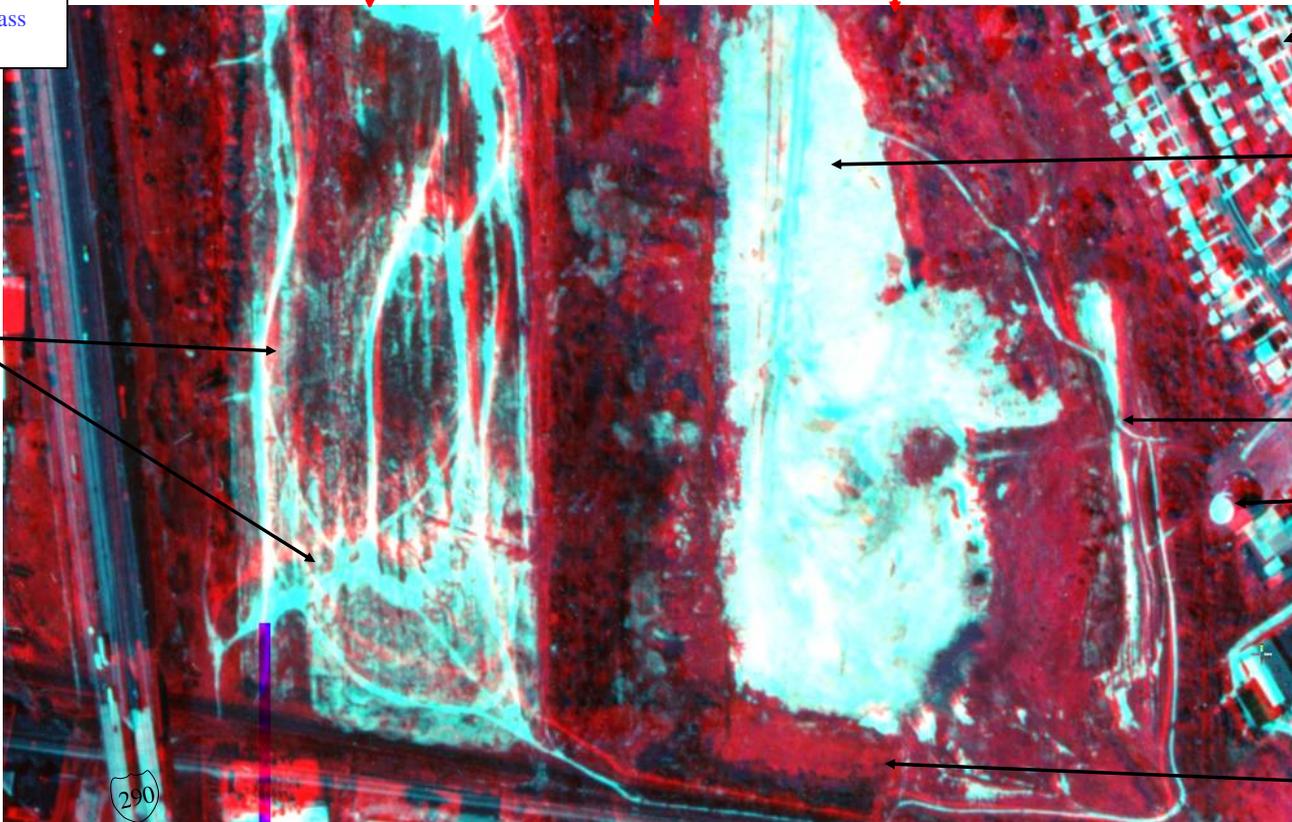
WATER TOWER

MOUNDED
MATERIALS

In order to make the 1990 anaglyph, the direction of the photos are required to be oriented to their stereo viewing position. North is to the right.

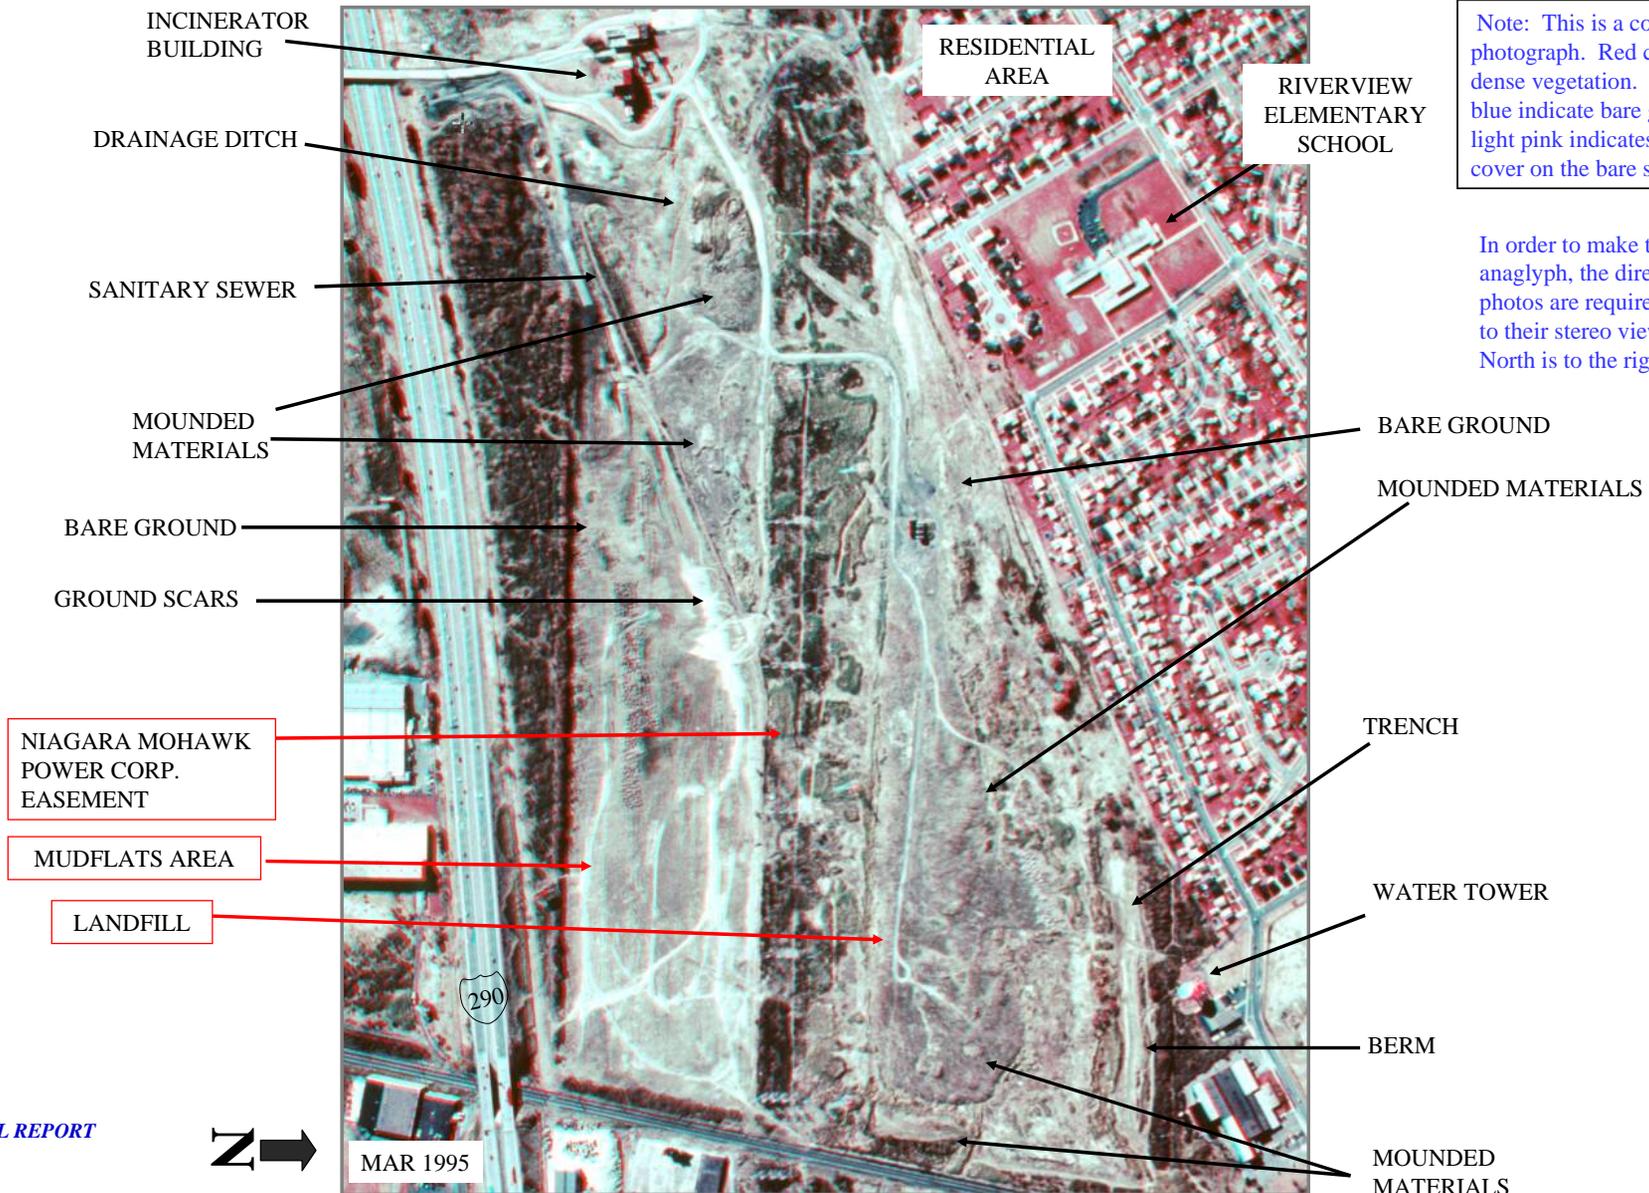
3D VIEW OF LANDFILL AND MUDFLATS AREA, 1995

Note: This is a color infrared photograph. Red color indicates dense vegetation. White and light blue indicate bare ground. Mottle light pink indicates sparse grass cover on the bare soil.

In order to make the 1995 anaglyph, the direction of the photos are required to be oriented to their stereo viewing position. North is to the right.
