BRADDOCK BAY ECOSYSTEM RESTORATION

Braddock Bay Ecosystem Restoration

UNDER CONSTRUCTION

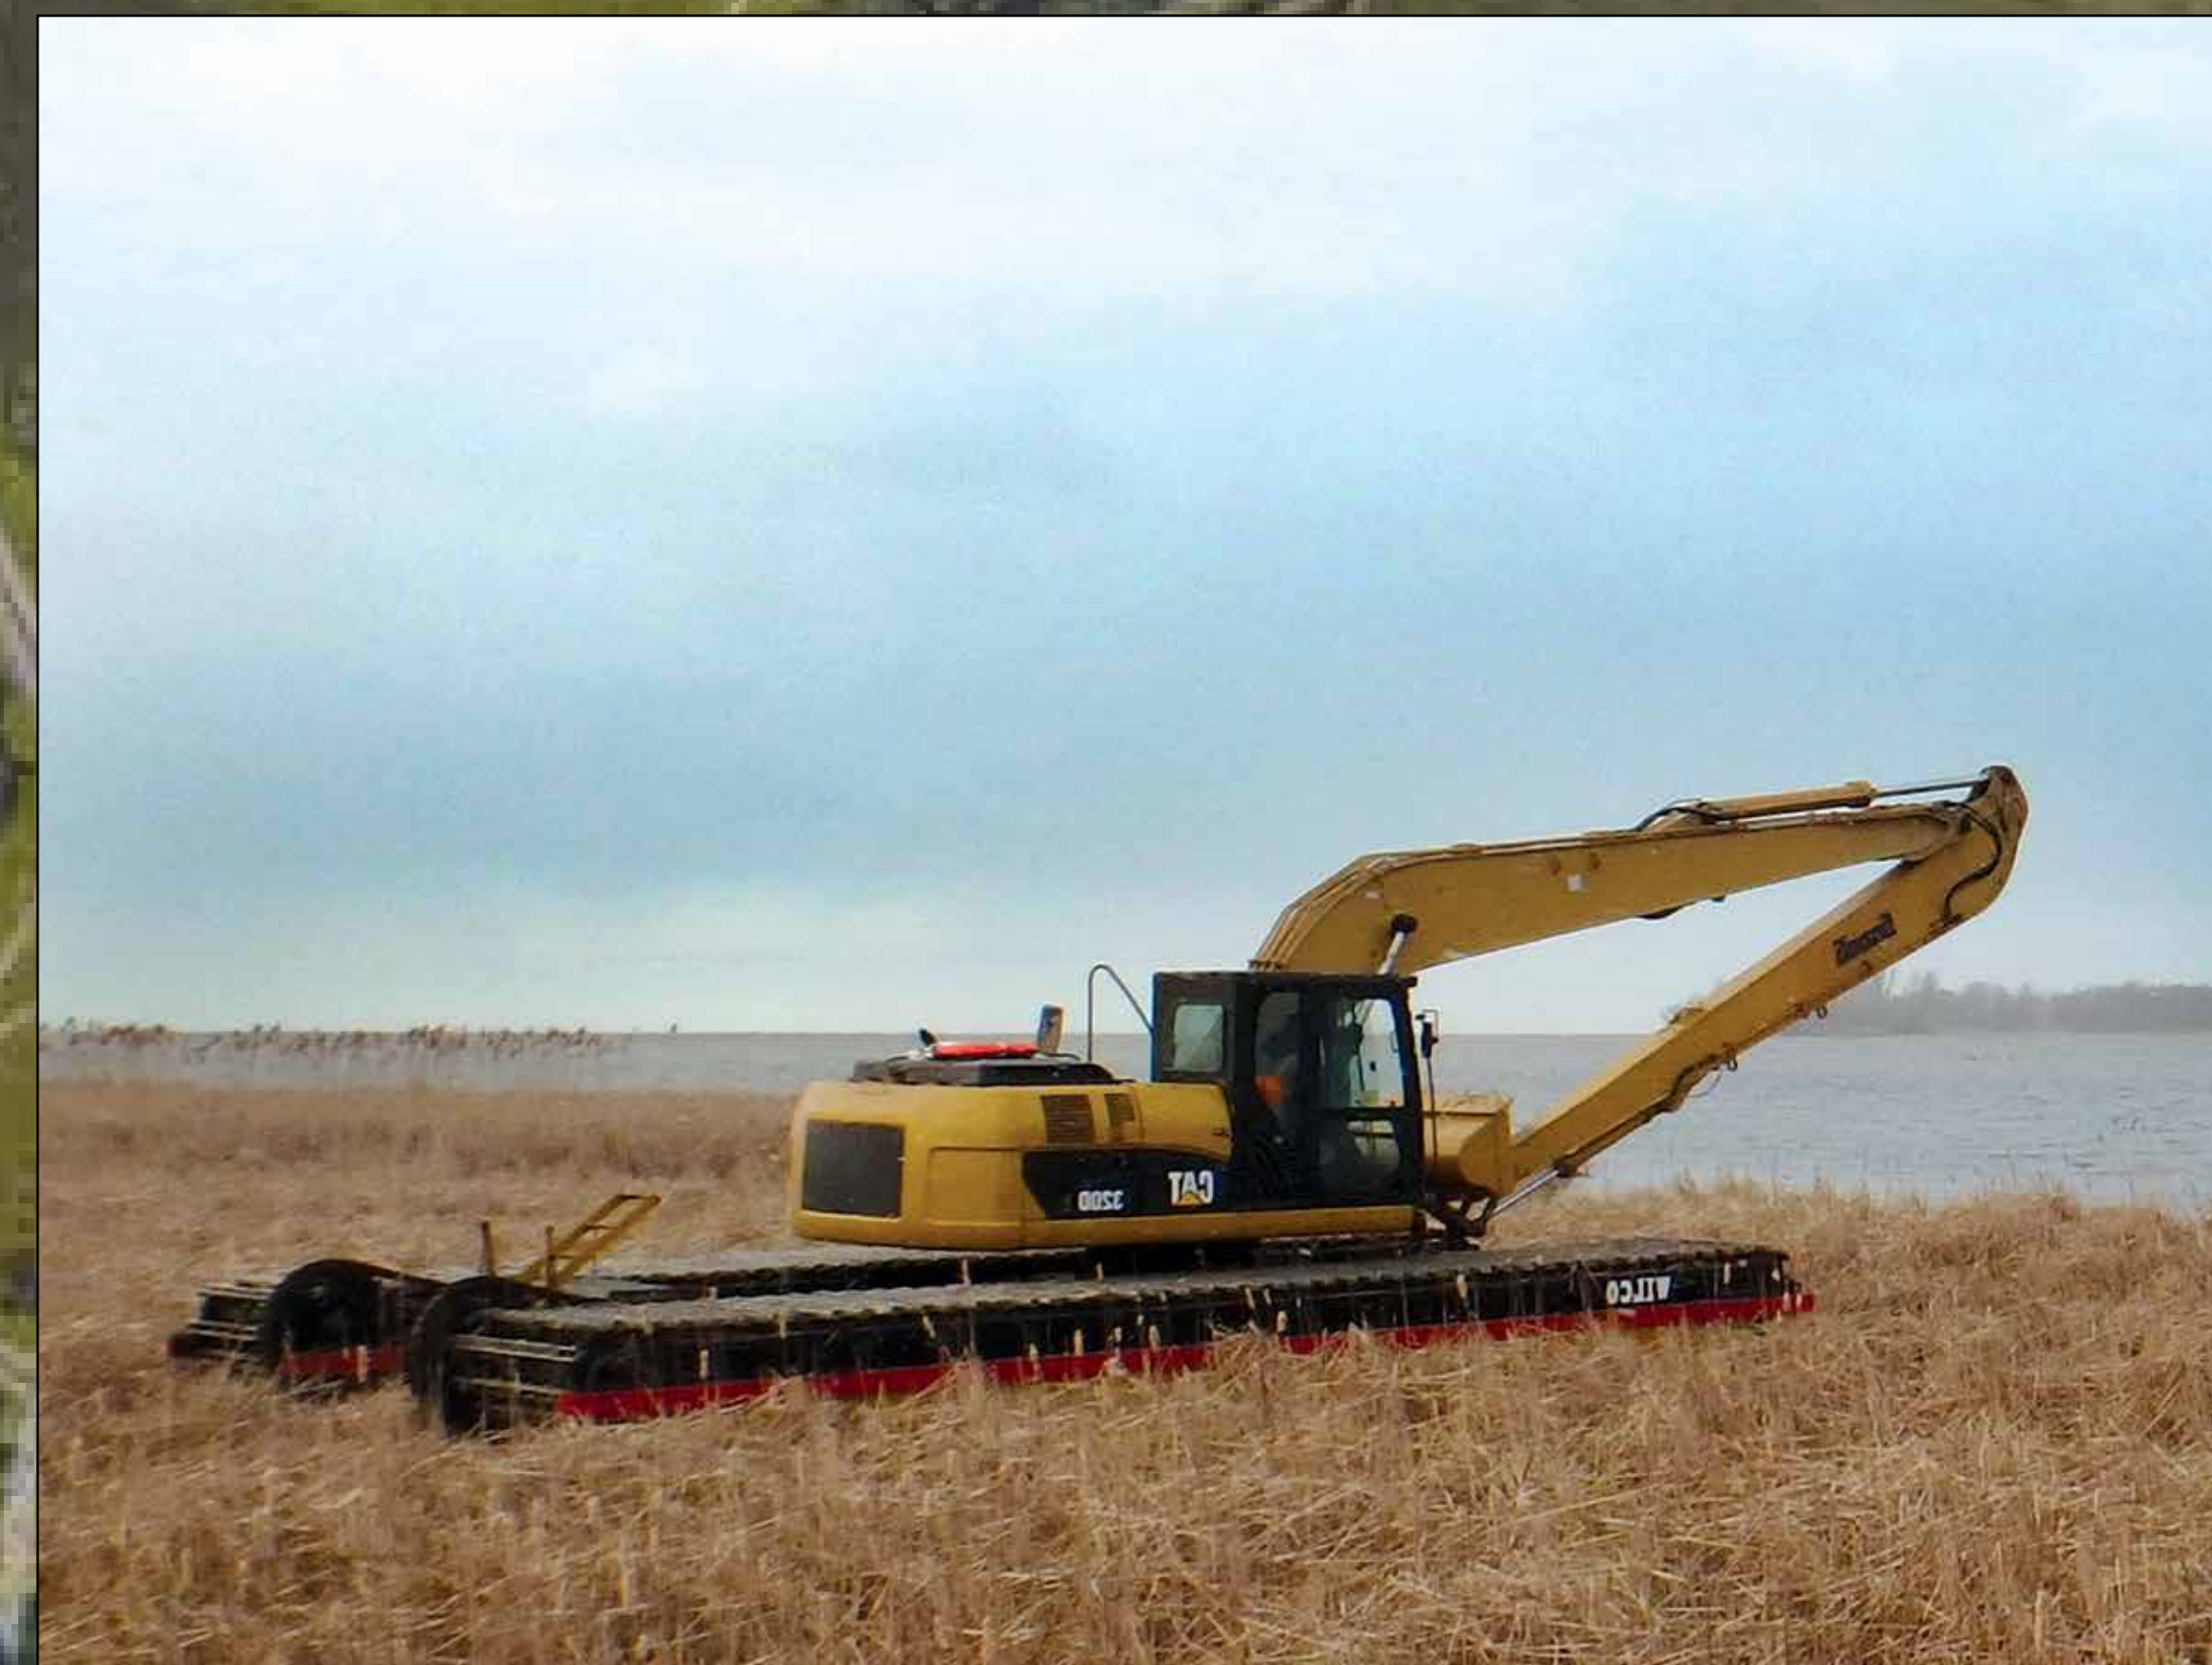
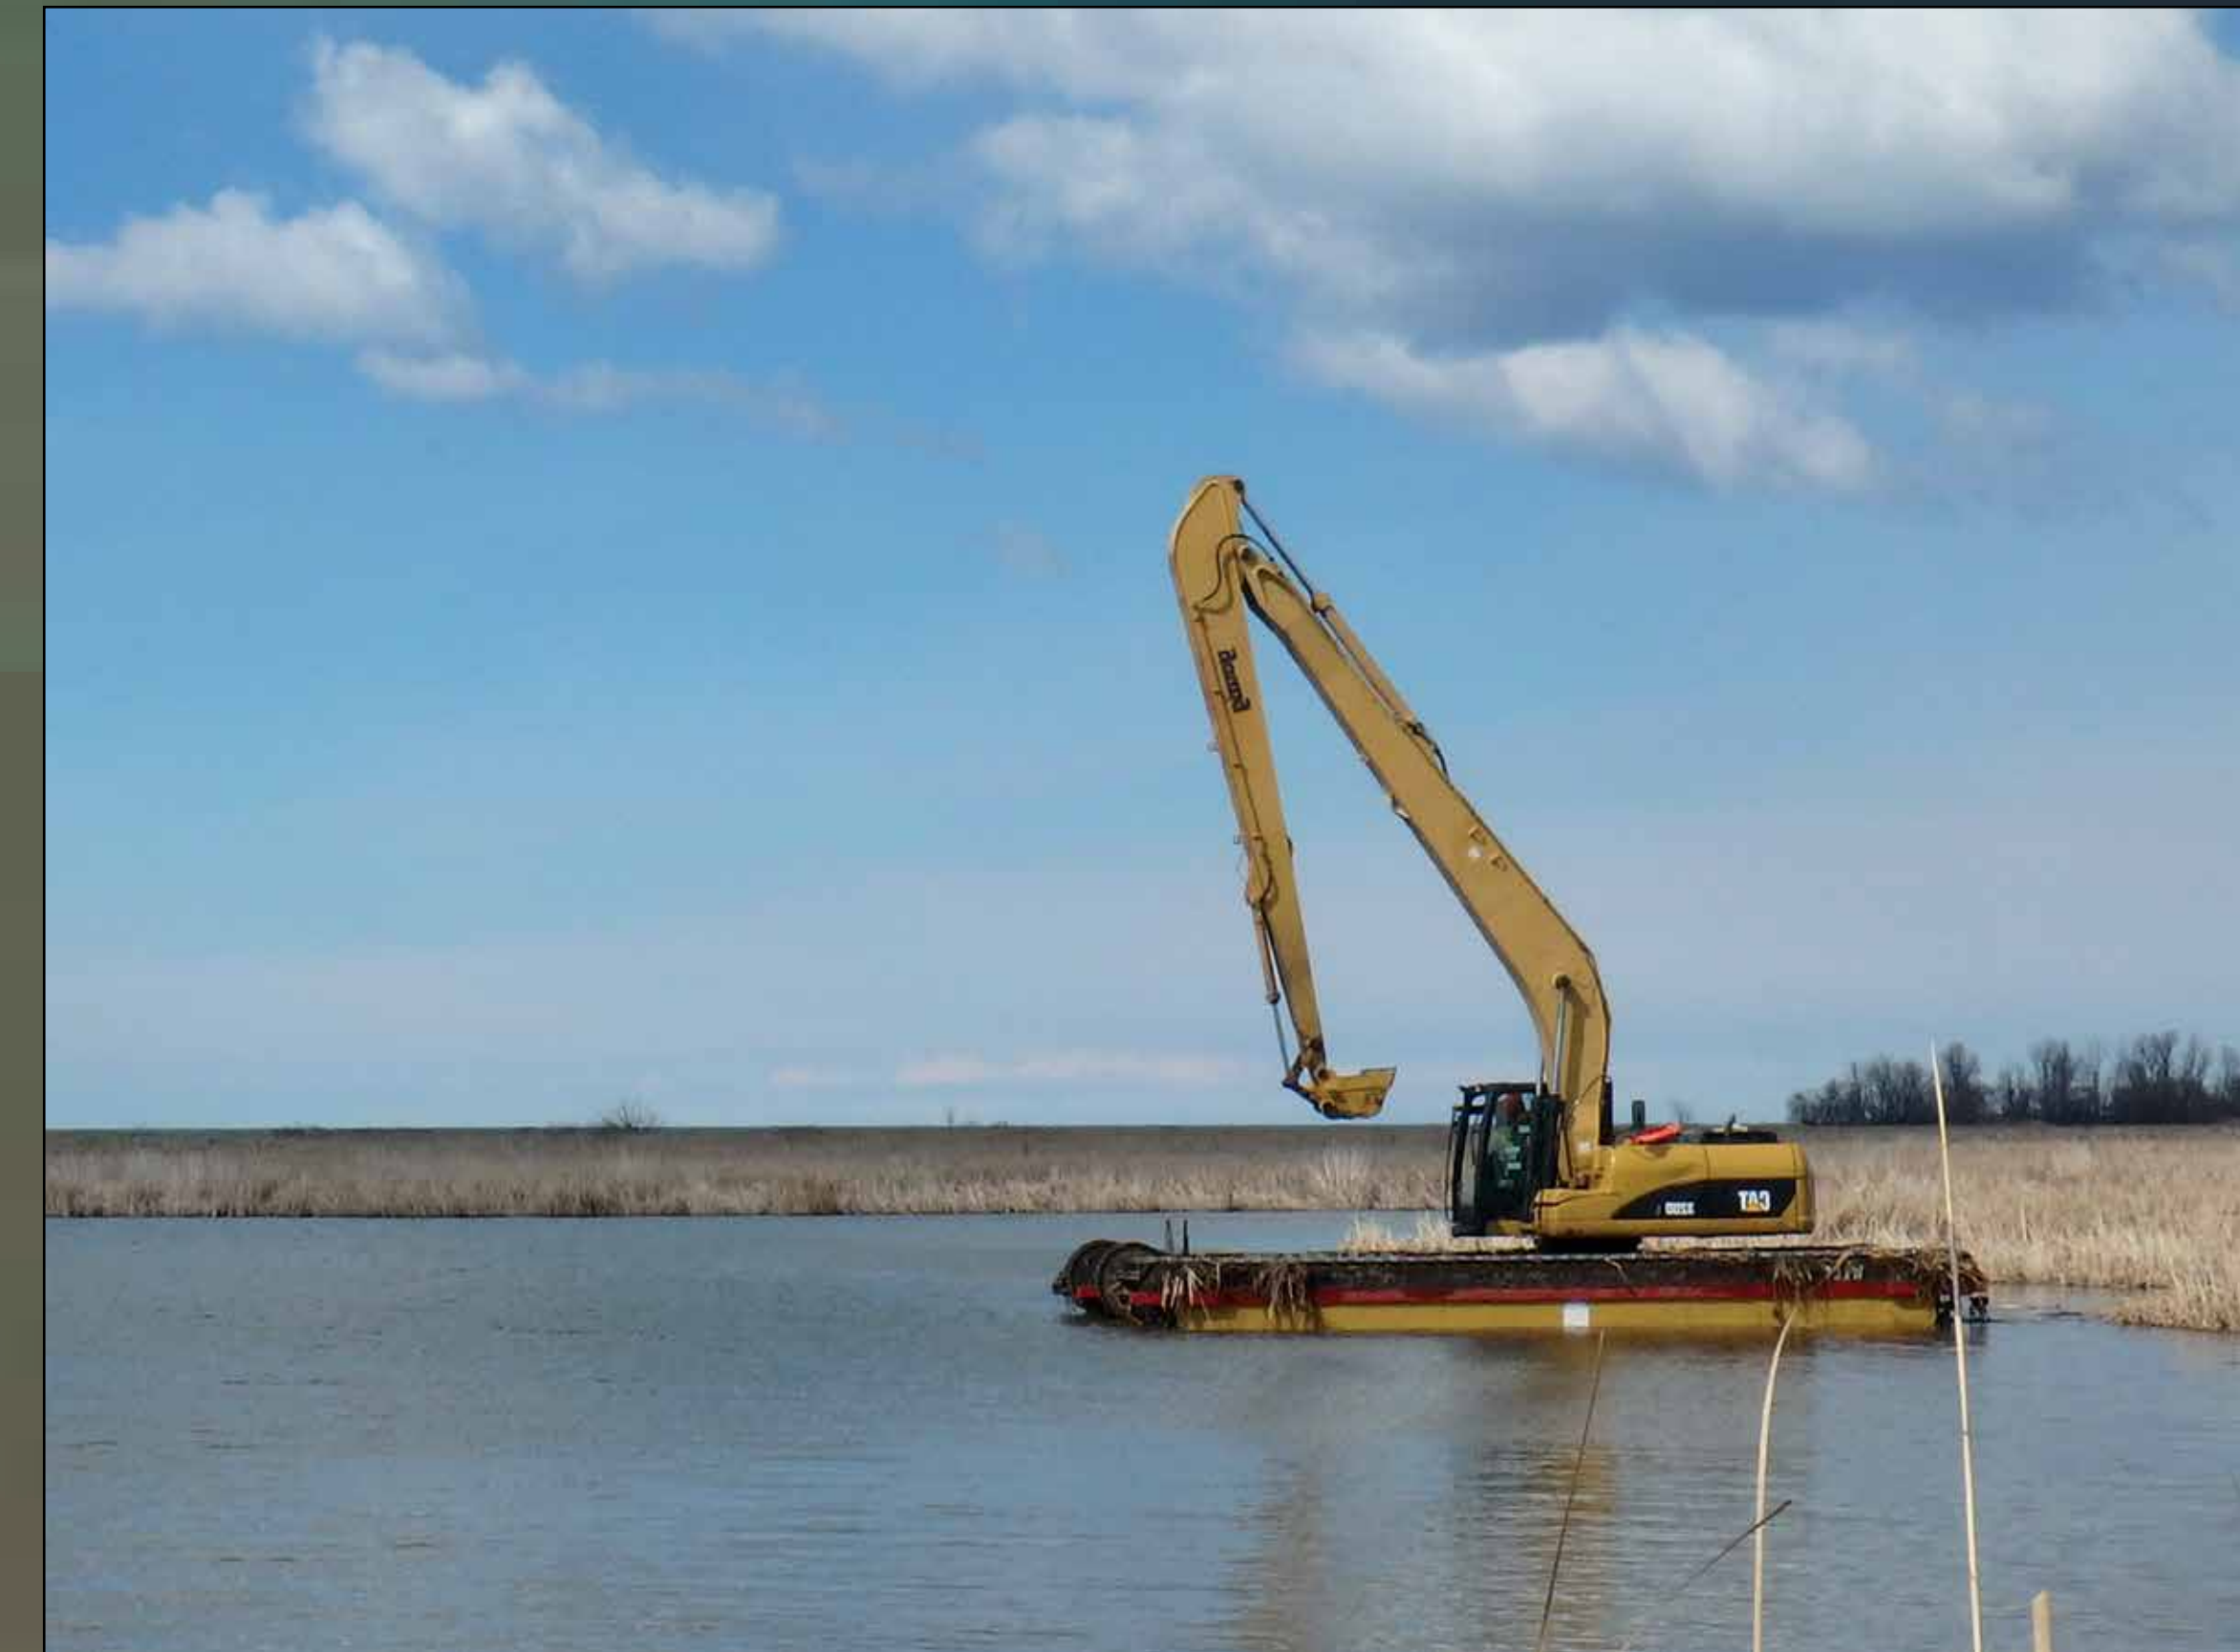
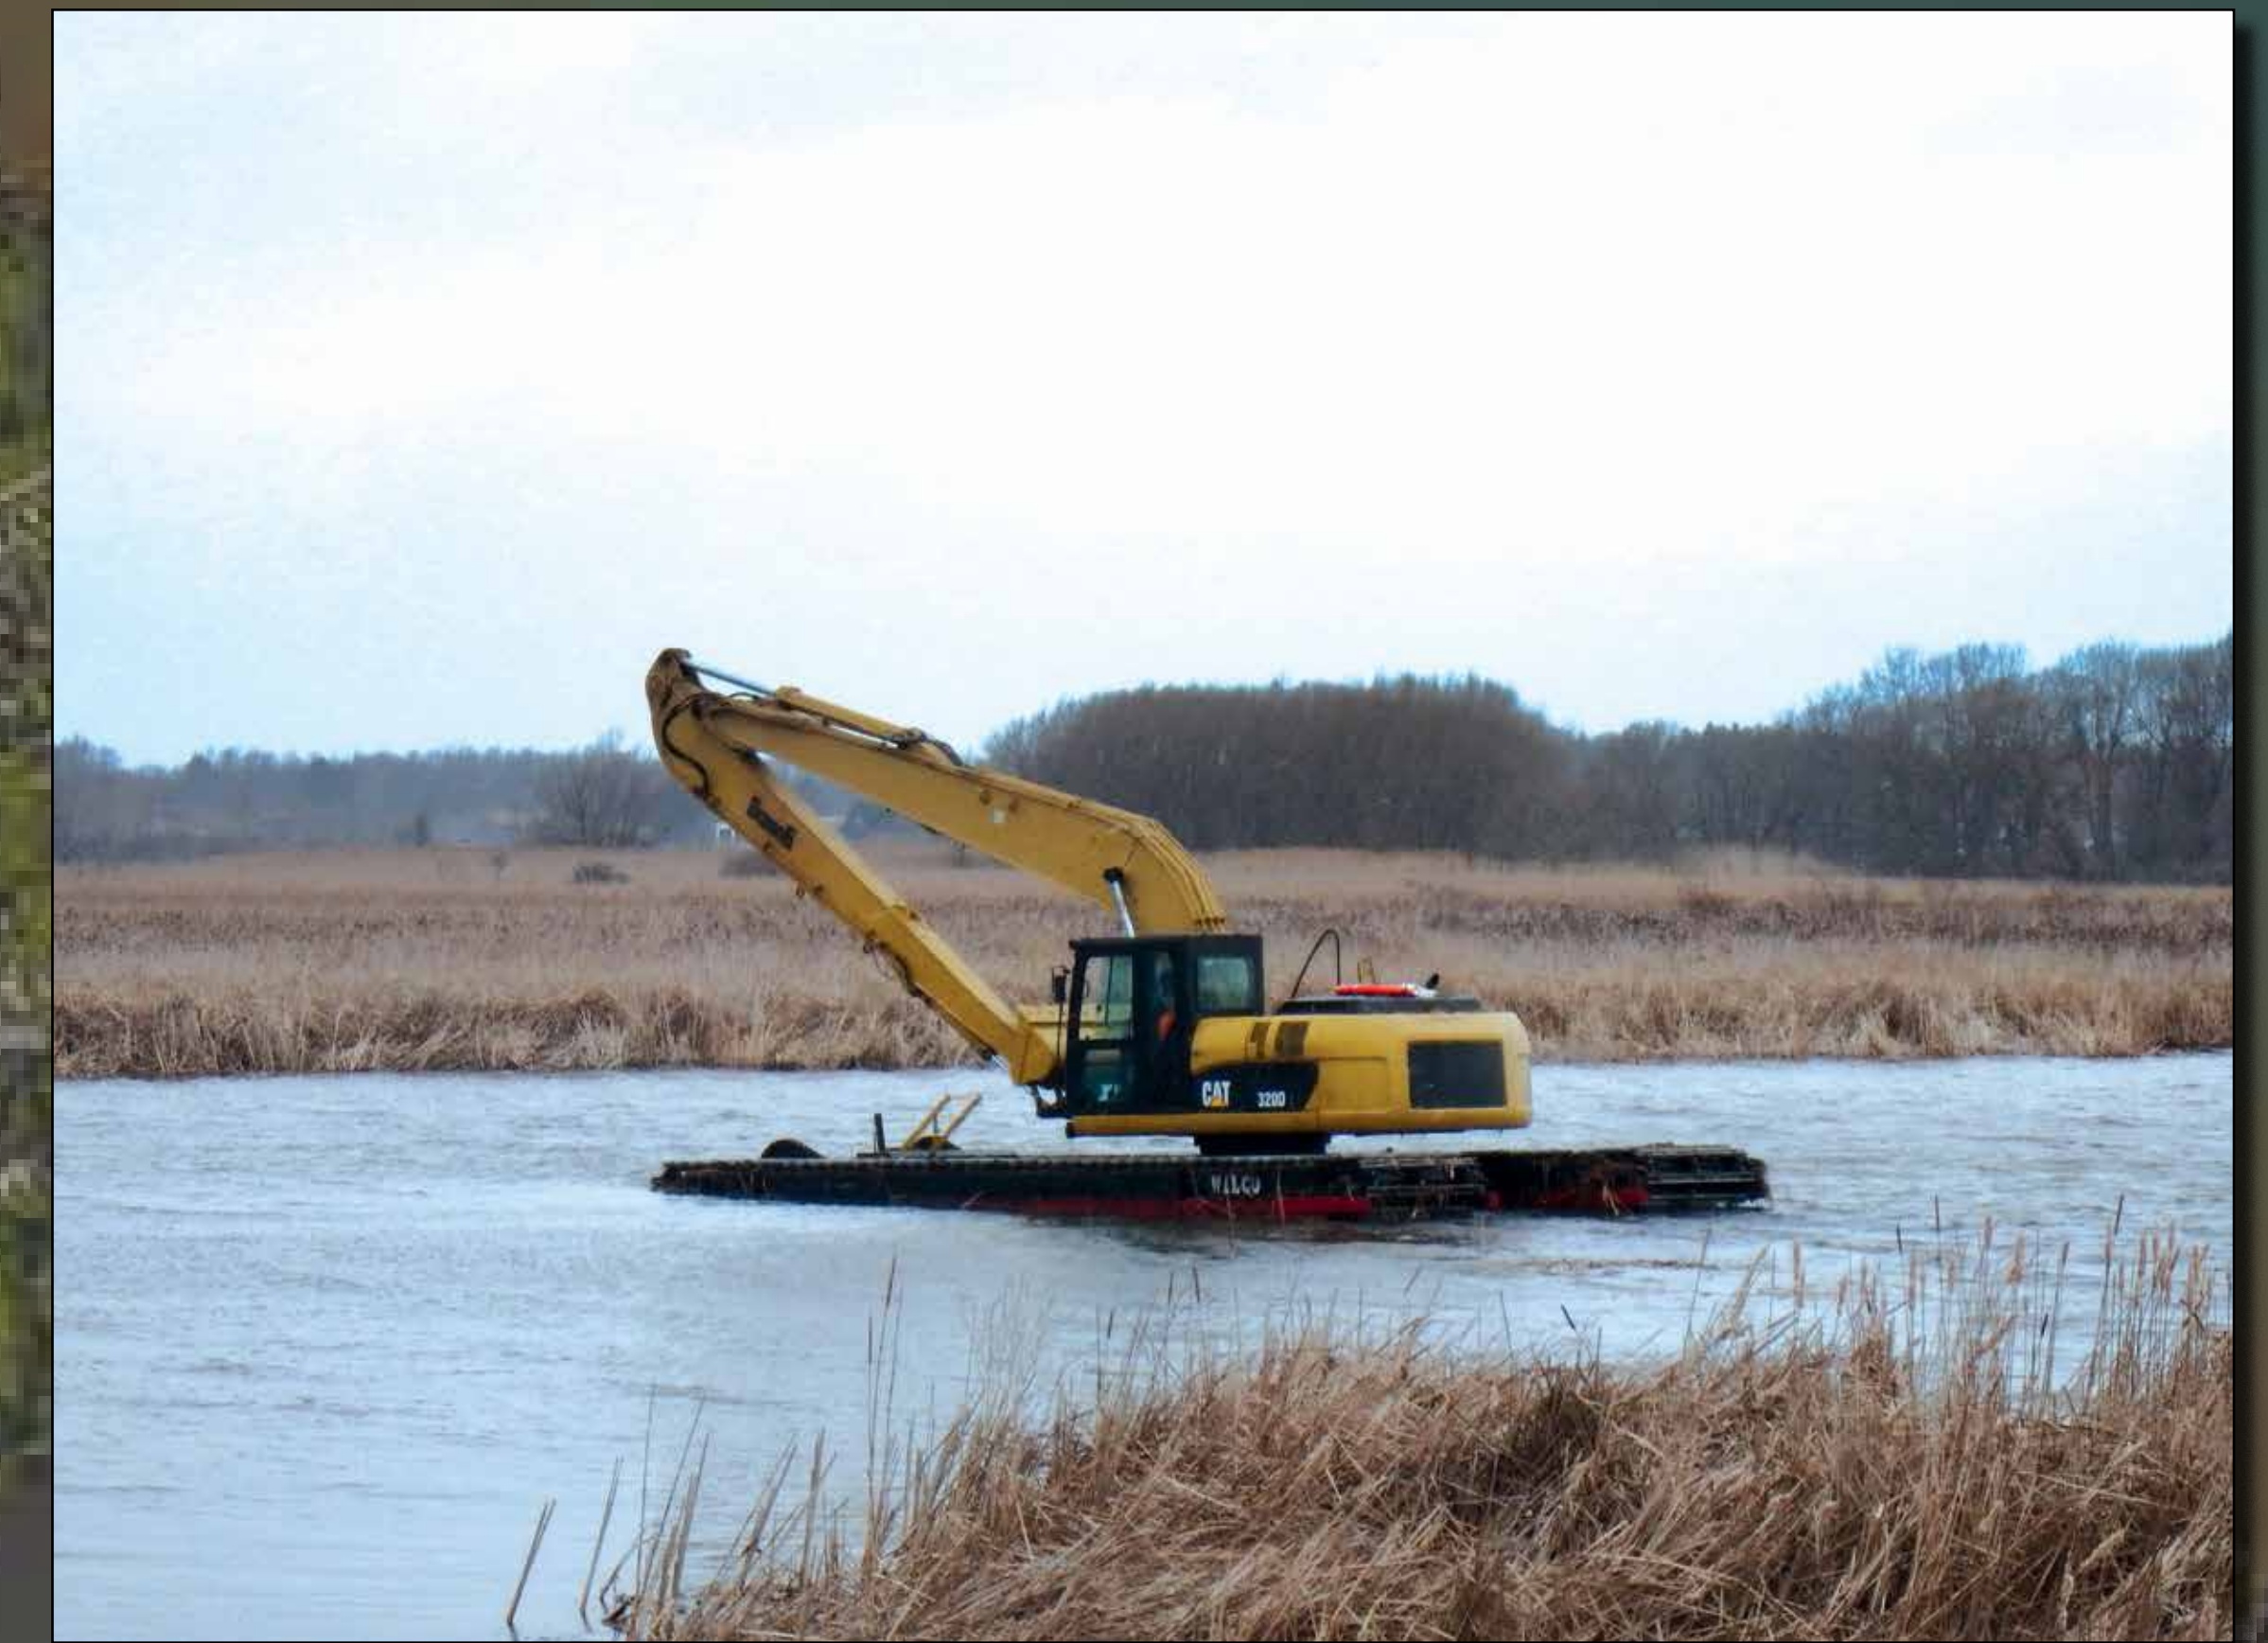
A 3-acre emergent wetland will be created by filling a shallow portion of the bay with sandy sediments to bring it up to an elevation that will support a diverse emergent marsh community. This new emergent marsh will replace emergent wetlands that historically occupied the same location, but have since eroded.

Approximately 6.7 acres of potholes and 11,723 linear feet of channels will be excavated in the cattail dominated emergent marsh to improve wetland habitat.

Mechanical and chemical methods will be implemented to reduce the density of invasive cattail species and increase native species richness between proposed channels and potholes and existing remnant sedge grass meadow.
