**Transmission Line Report Addendum No. 1, Rev.01**  
**Additional Investigation of Site Transmission Lines and Test Pit #4**  
**FINAL**

**Building G-1 Deconstruction and Groundwater Investigation**  
**Former Harshaw Chemical Company Site**  
**Cleveland, Ohio**  
**Formerly Utilized Sites Remedial Action Program**

March 2016

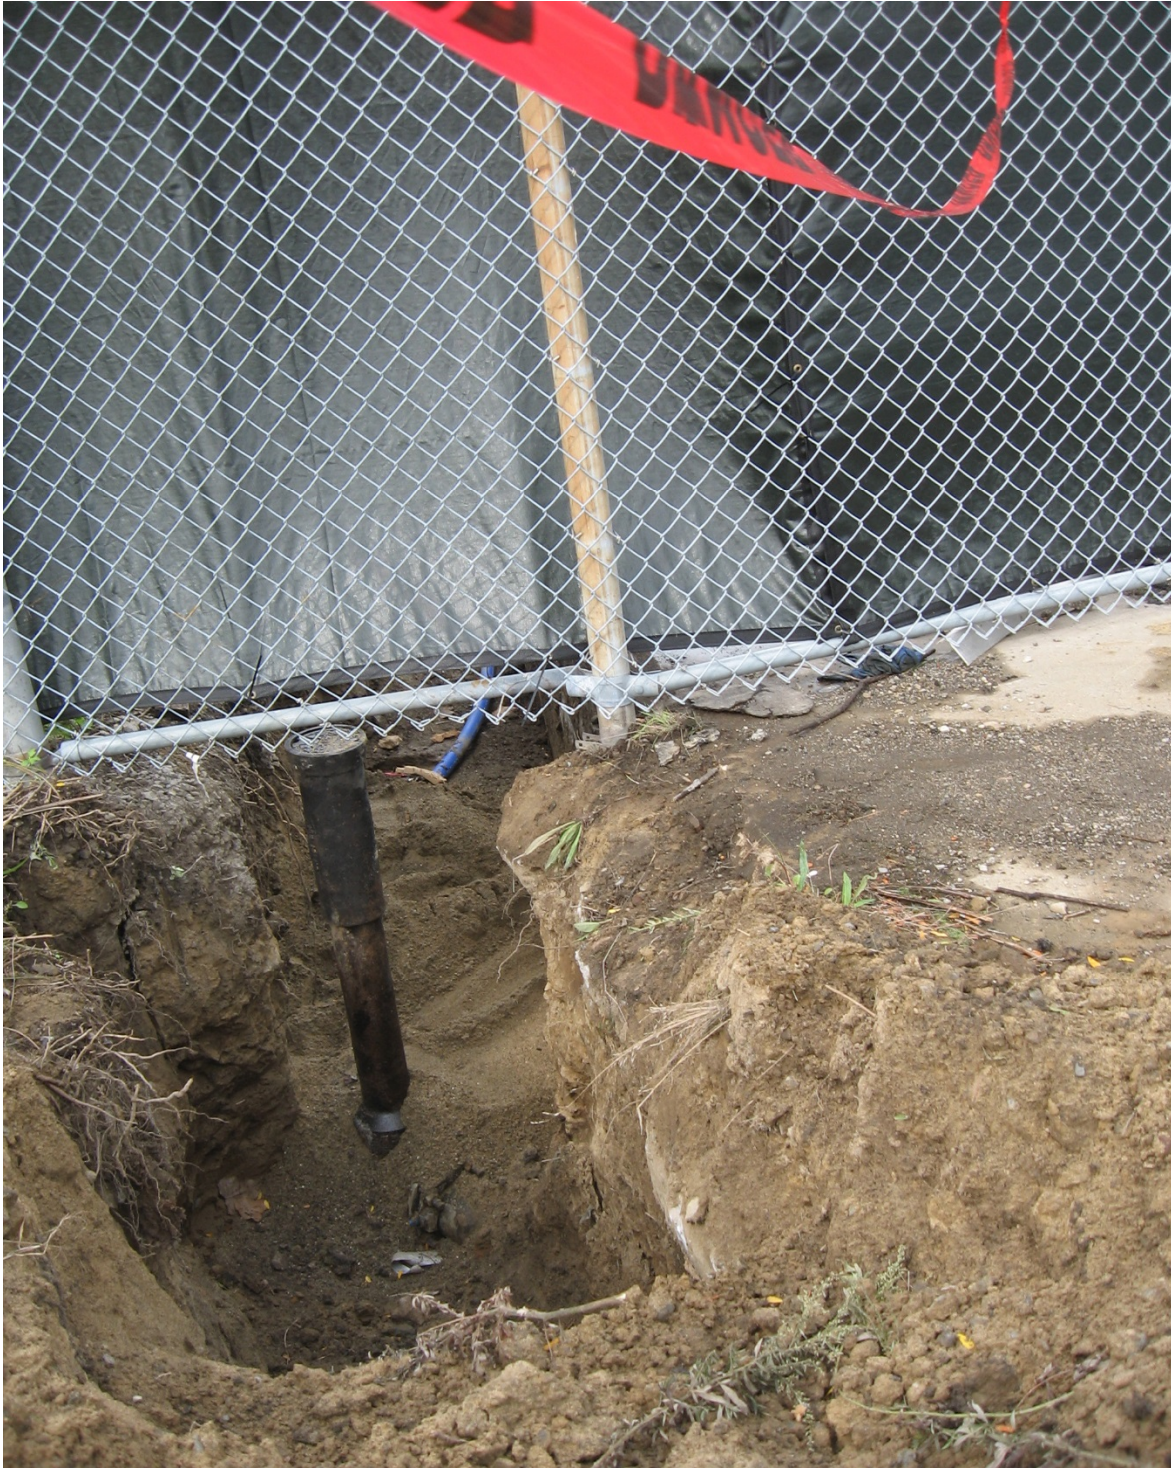
2014: View of water main connection (shut off valve) at Harvard Avenue where the water enters the Site from the municipal source. Photo shows the new water main connection made by BASF, after the old transmission line was removed.

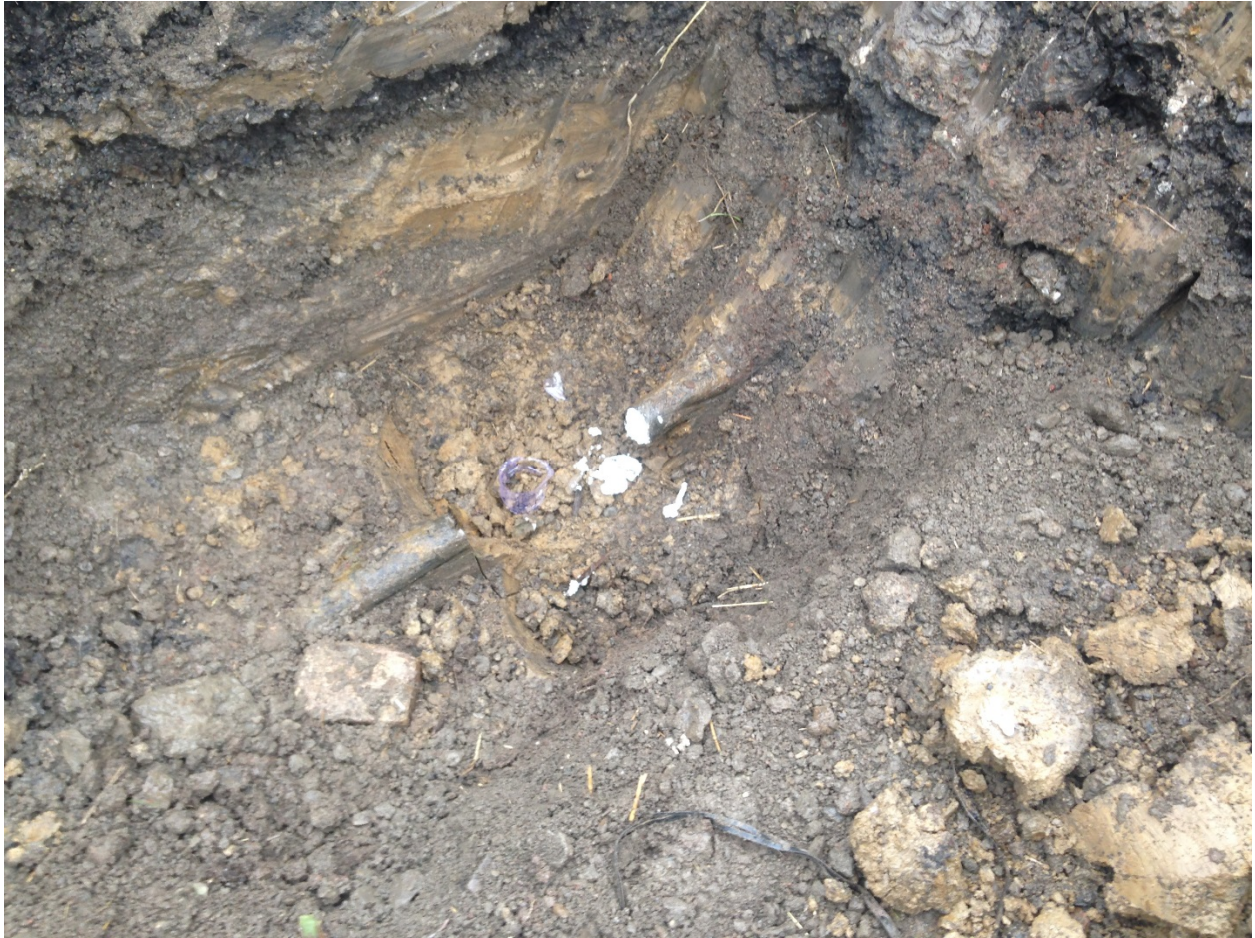
12/2/2014: This photo is of the 2" steel water line terminated on the north side of Building G-1. The line appeared to run northward towards Denison Avenue. The line was left in place after termination. This was terminated prior to the start of the Building G-1 deconstruction work.

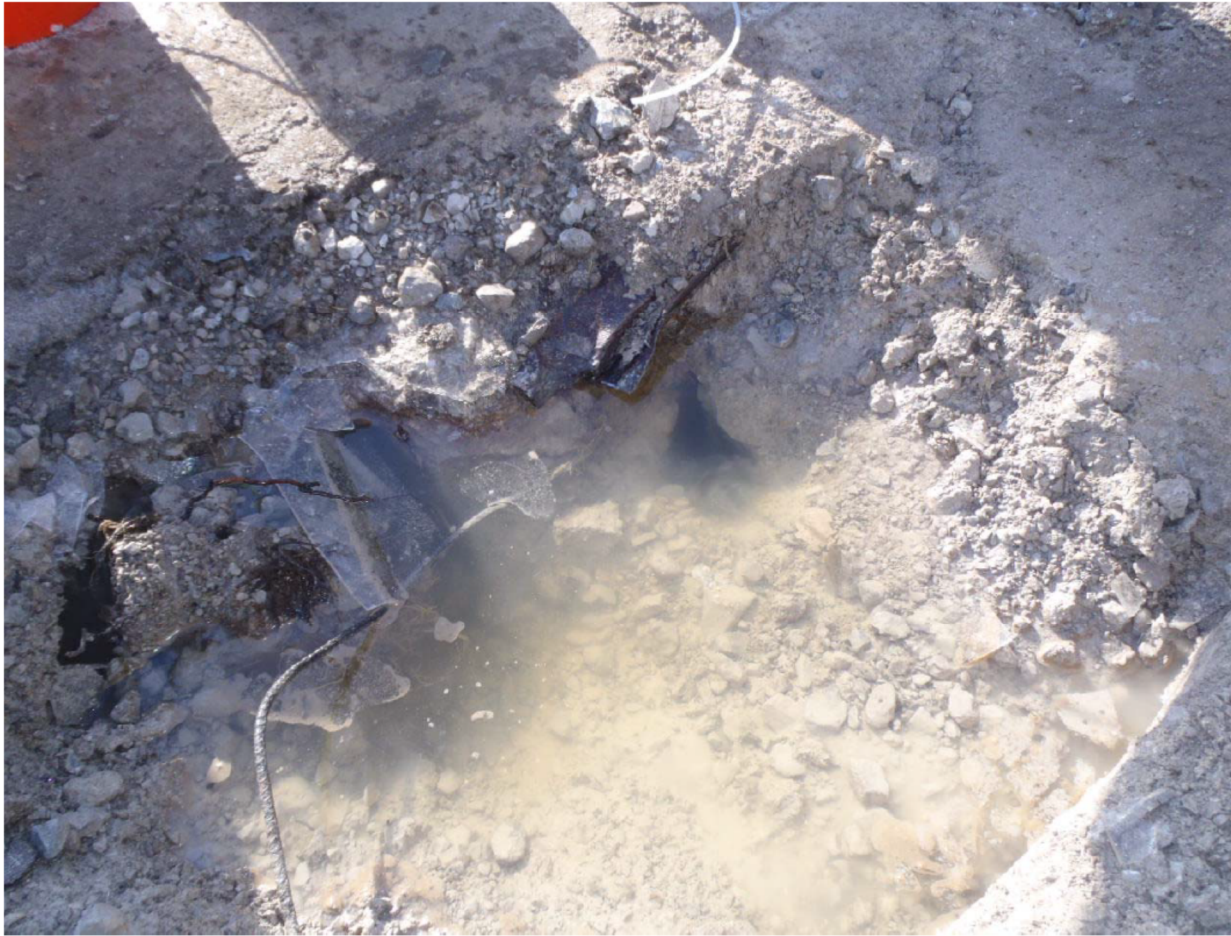
Representatives of ECC and the USACE observed water upwelling from the vicinity of Test Pit #4 in January 2015 and speculated that this water may be a contributing factor to the groundwater high located in this area of the site. In the spring of 2015, representatives of ECC and the USACE observed a void forming on the ground surface in the vicinity of Test Pit #4. The USACE determined that an additional investigation was required to verify if there are any previously unidentified/unknown lines along the west property that may feed to the Test Pit #4 area and the vault-like structure.

1/28/2015: Photo of the upwelling water above the Test Pit #4 area prior to excavation.

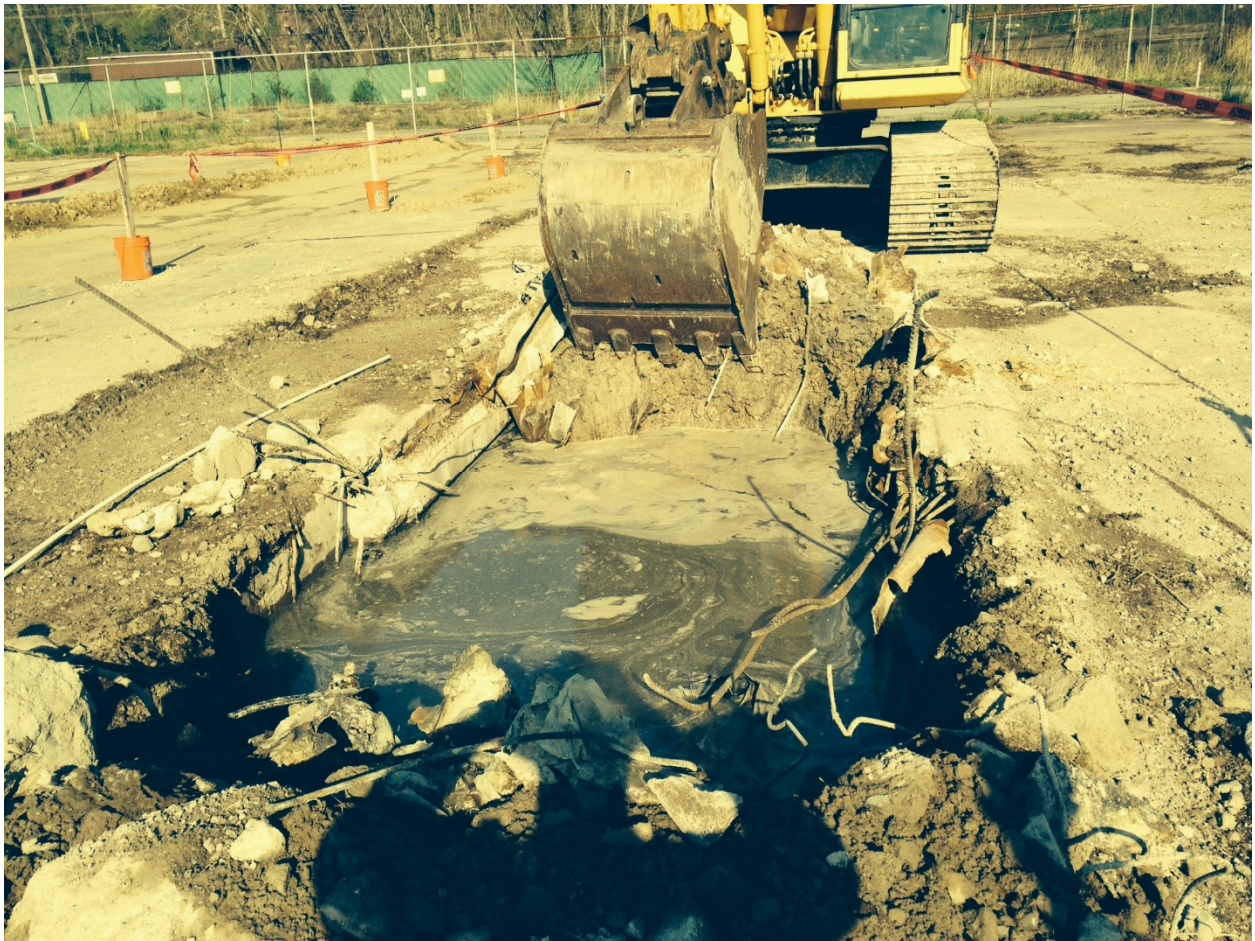
Further investigation of Test Pit #4 revealed a previously unidentified concrete vault at the location where the observed void and upwelling water was observed (see Photo 3 in Attachment 1). It was initially speculated that the vault may contain an unknown transmission line; however, no transmission lines were discovered.

05/07/2015: Excavation and dewatering of Test Pit #4.

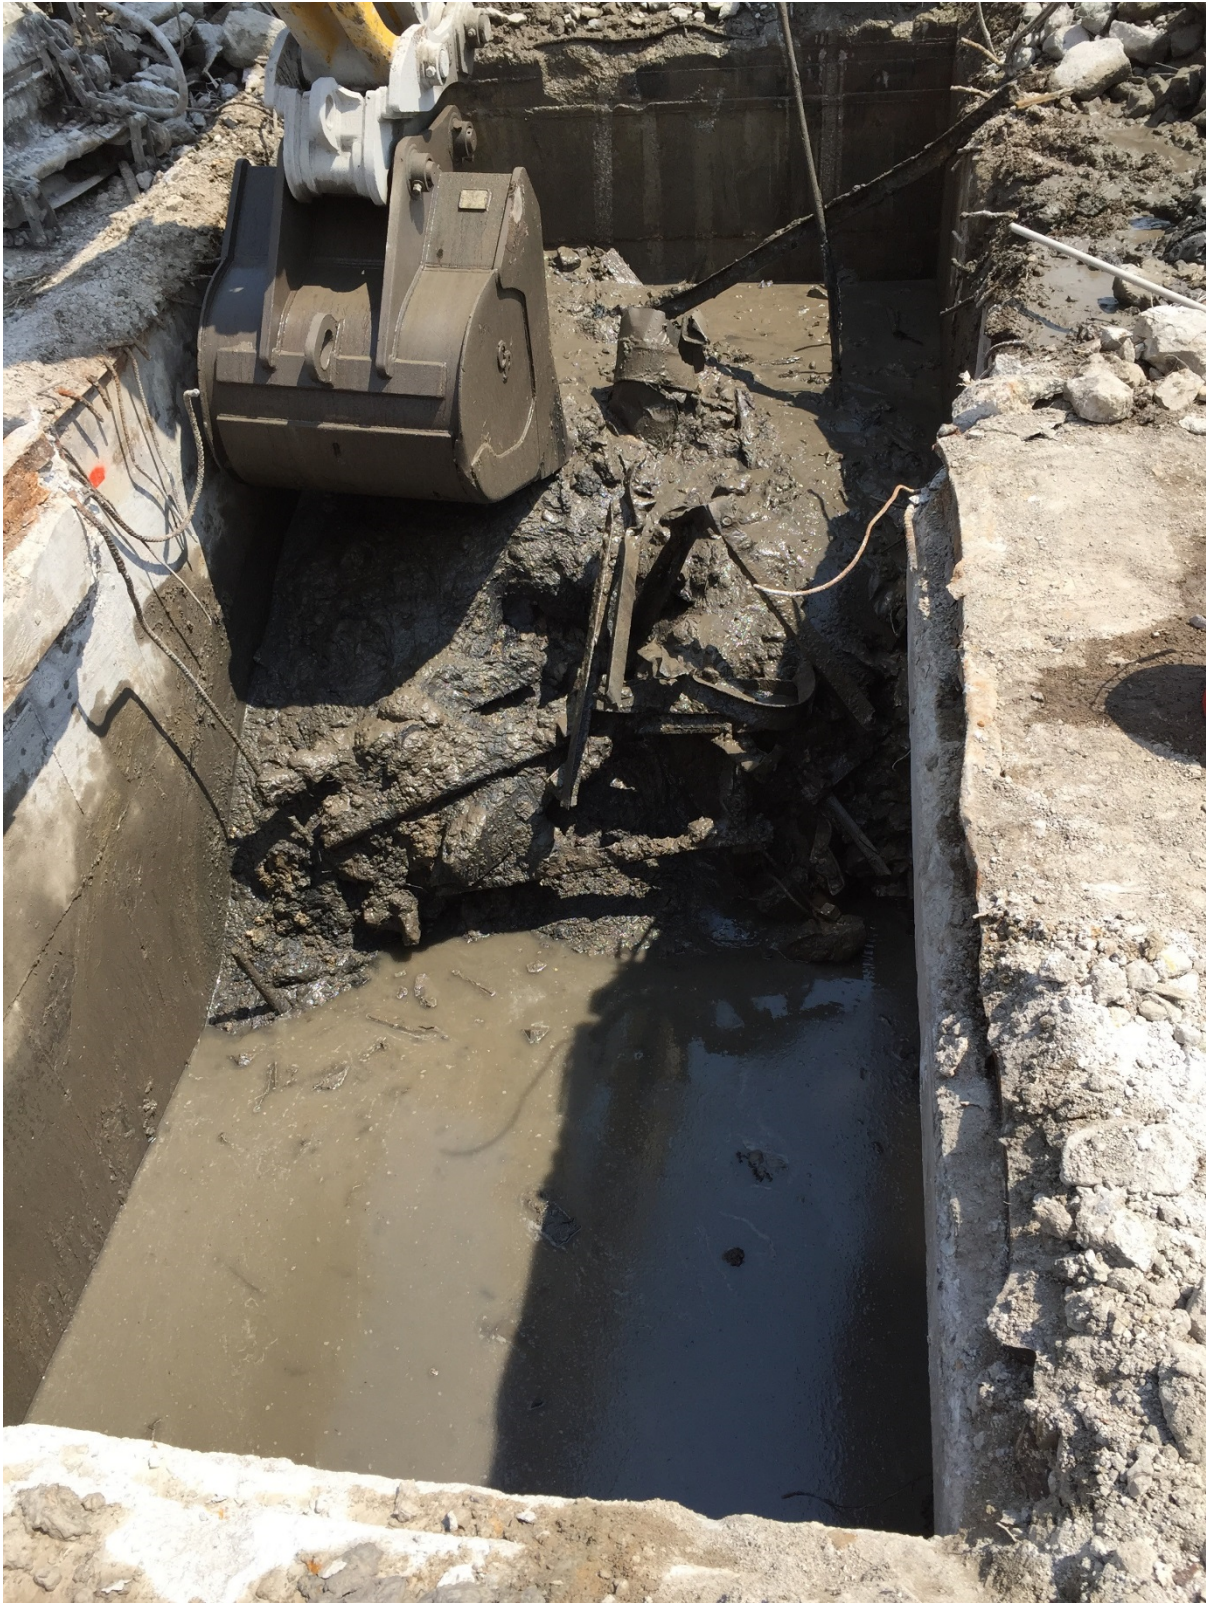
05/08/2015: Removal of debris from the vault structure found in Test Pit #4.

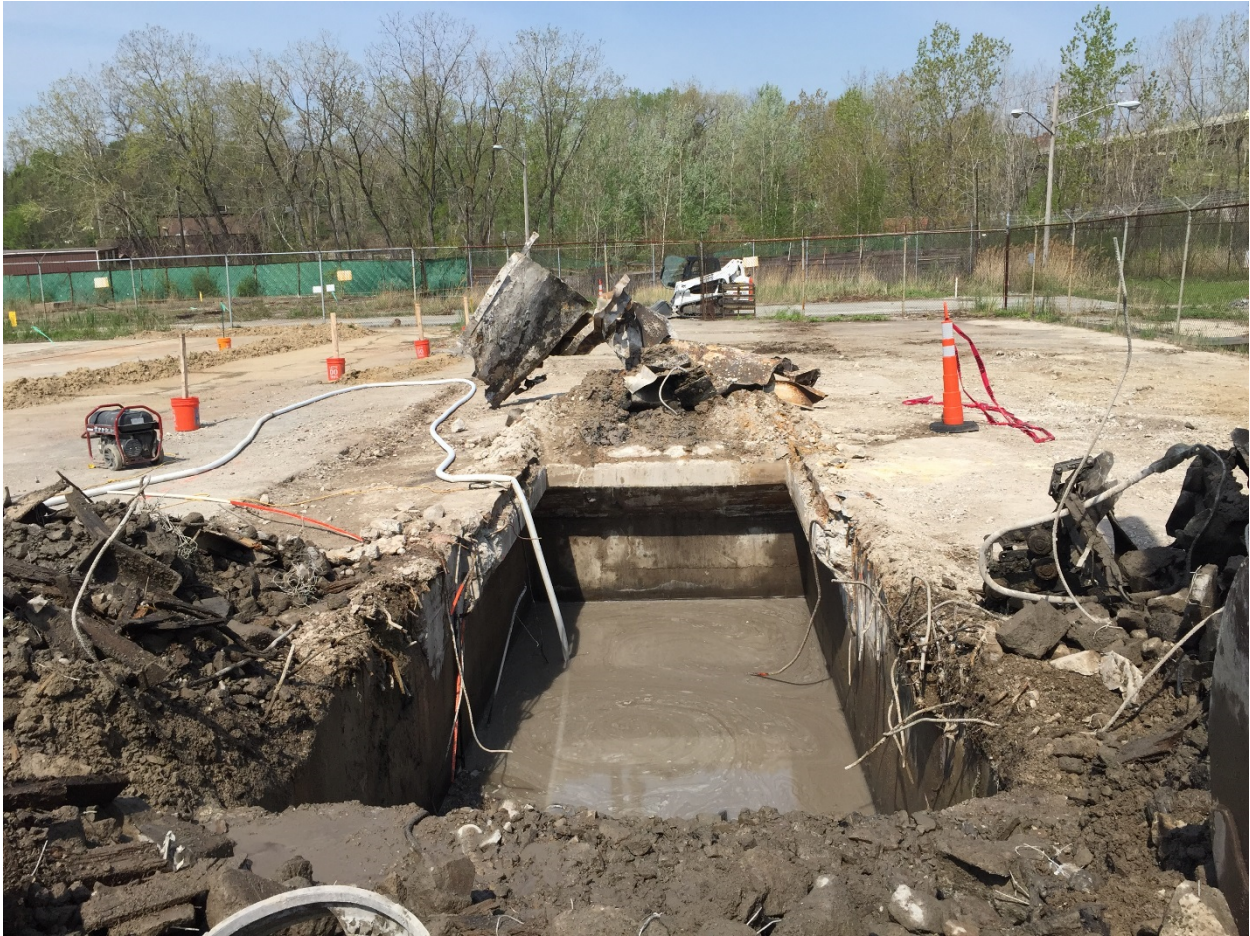
05/08/2015: Photo of accumulated debris removed from vault.

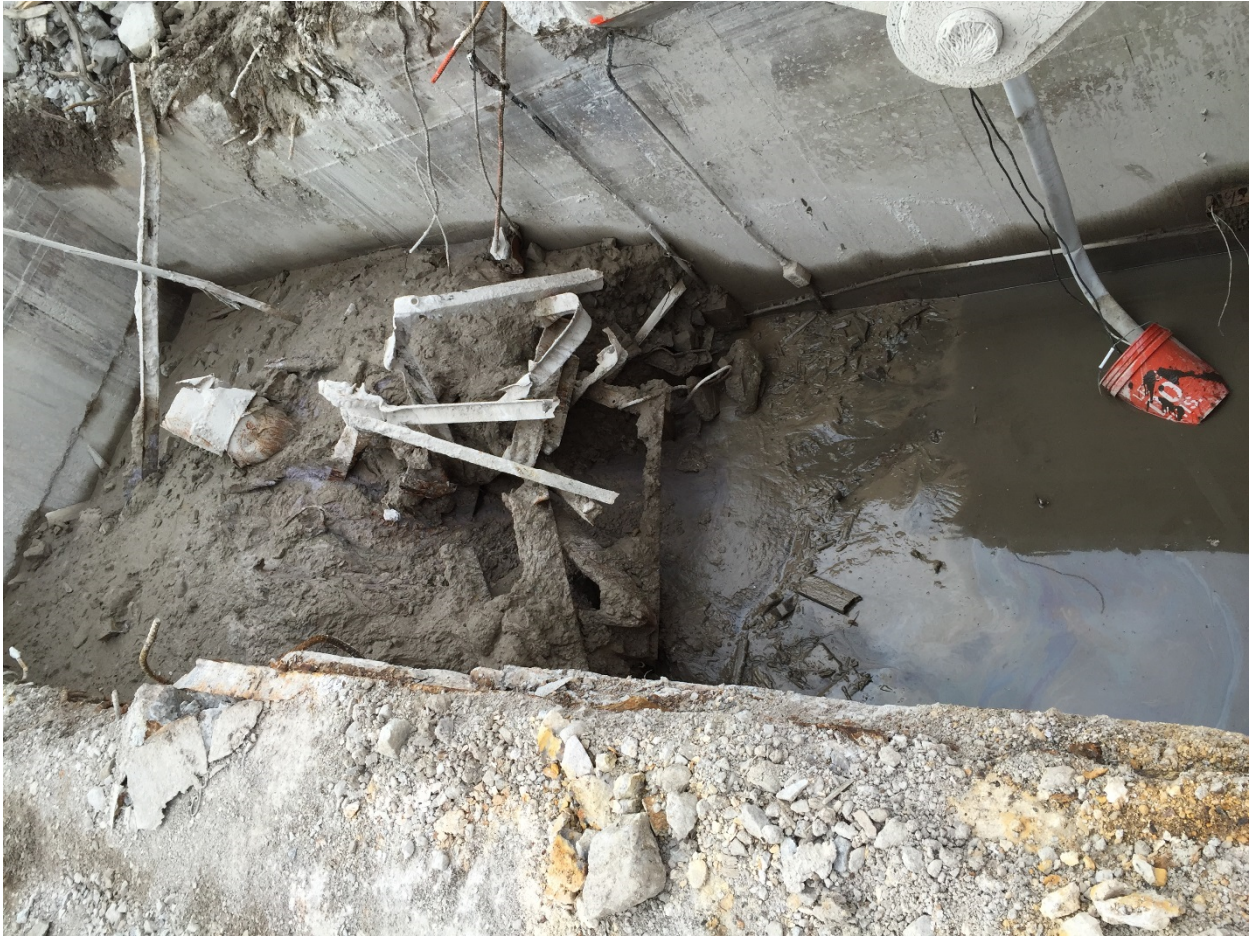
05/11/2015: Dewatering of vault and additional debris removal.

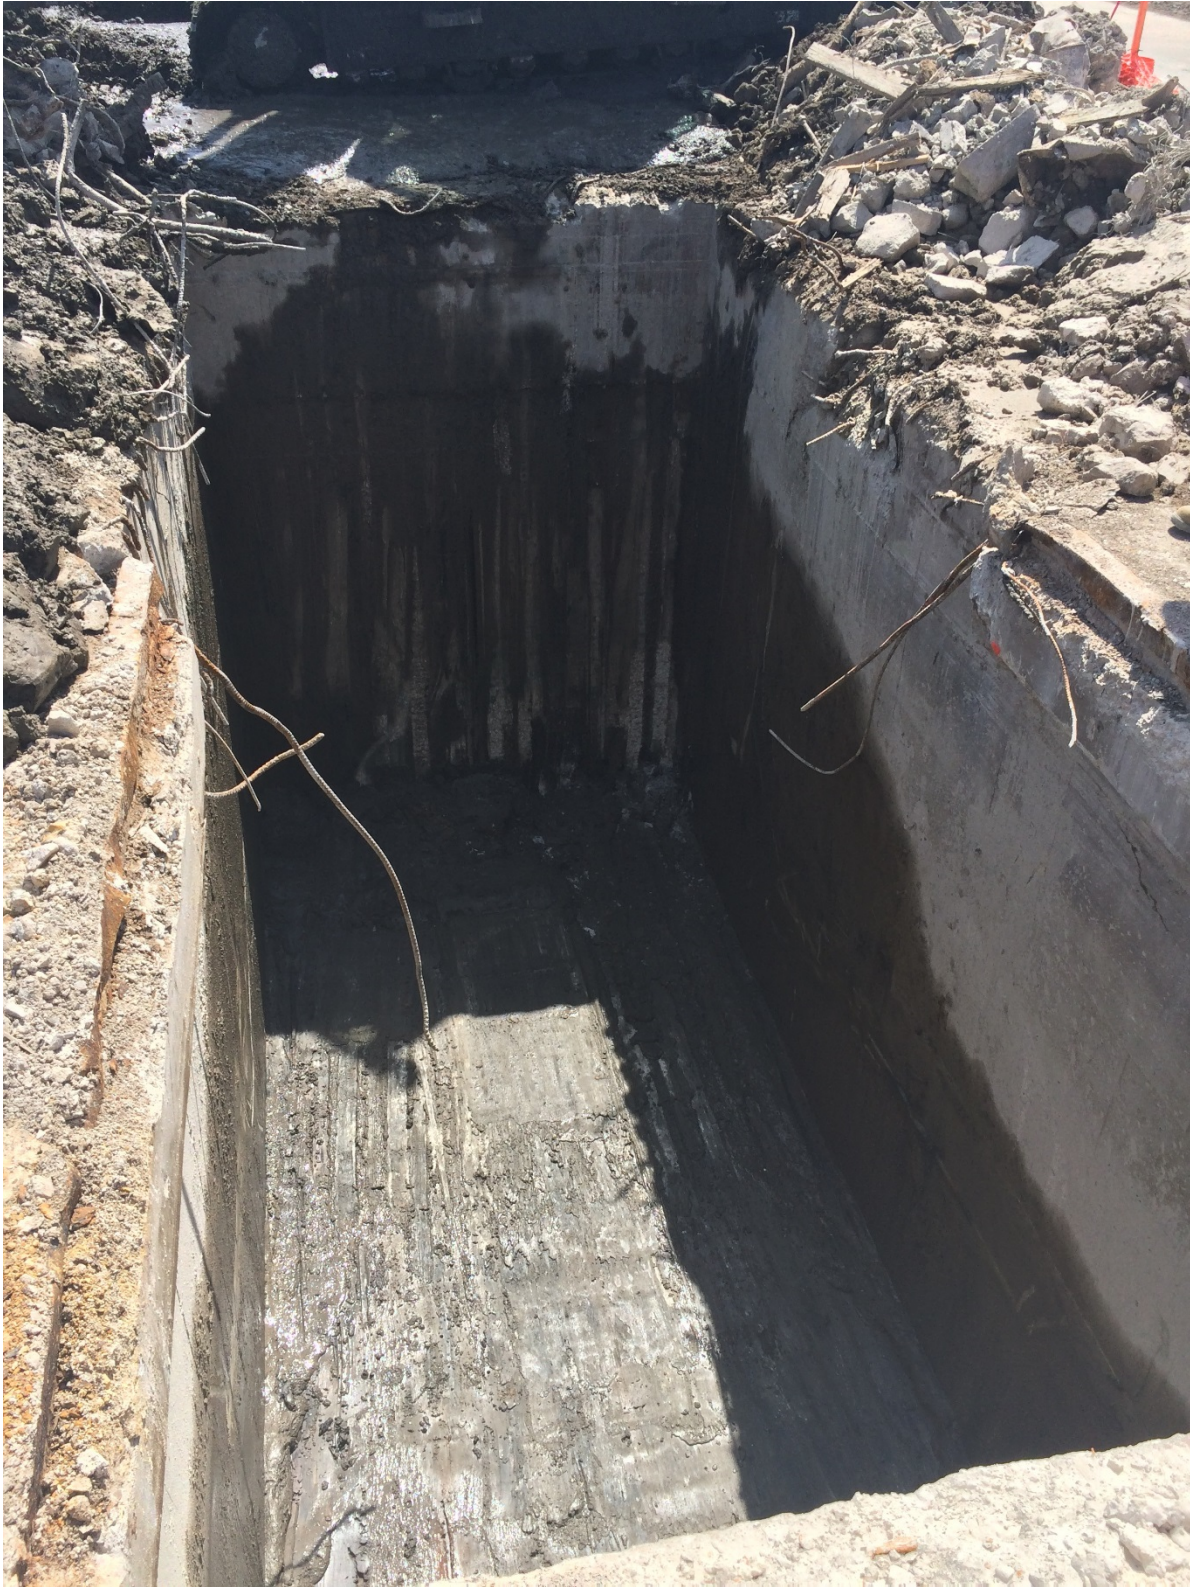
The inspection confirmed the vault was of concrete construction; its dimensions were 23 feet long by 9 feet wide by 12 feet deep. The concrete was in sound condition; there had been no significant deterioration of the walls or floor of the structure. ECC found no water transmission lines in the vault structure and didn't observe any water recharge.

05/11/2015: Photo of vault with contents removed.

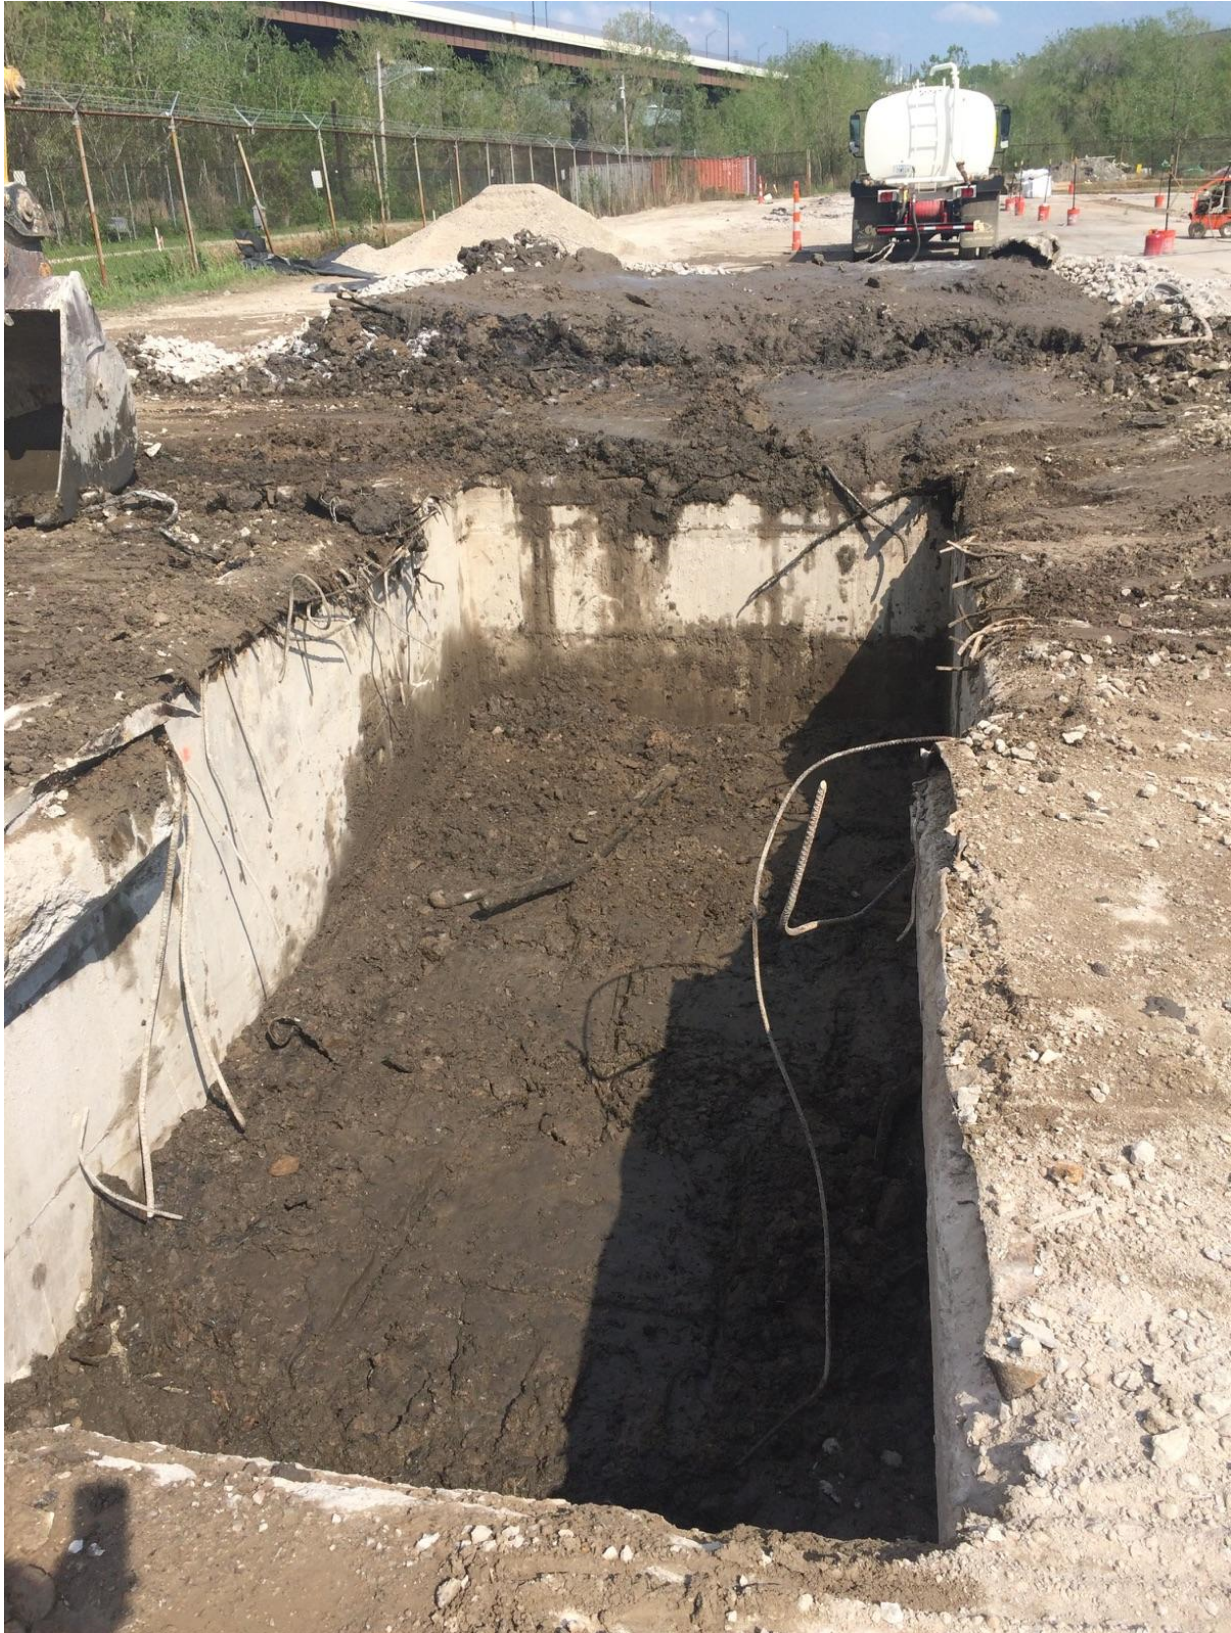
05/11/2015: Progress on the backfilling of the vault at Test Pit #4.

Per instruction from USACE (see e-mail correspondence in Attachment 4), following the inspection, ECC placed all excavated material and debris back into the vault. ECC personnel used crushed stone to backfill the remaining void; this brought the level of backfill in the vault up to 1.5 feet below subgrade. A layer of geotextile fabric was installed and a 1.5 foot layer of brown clay was placed to minimize surface water infiltration. ECC completed backfilling the vault on May 12, 2015.

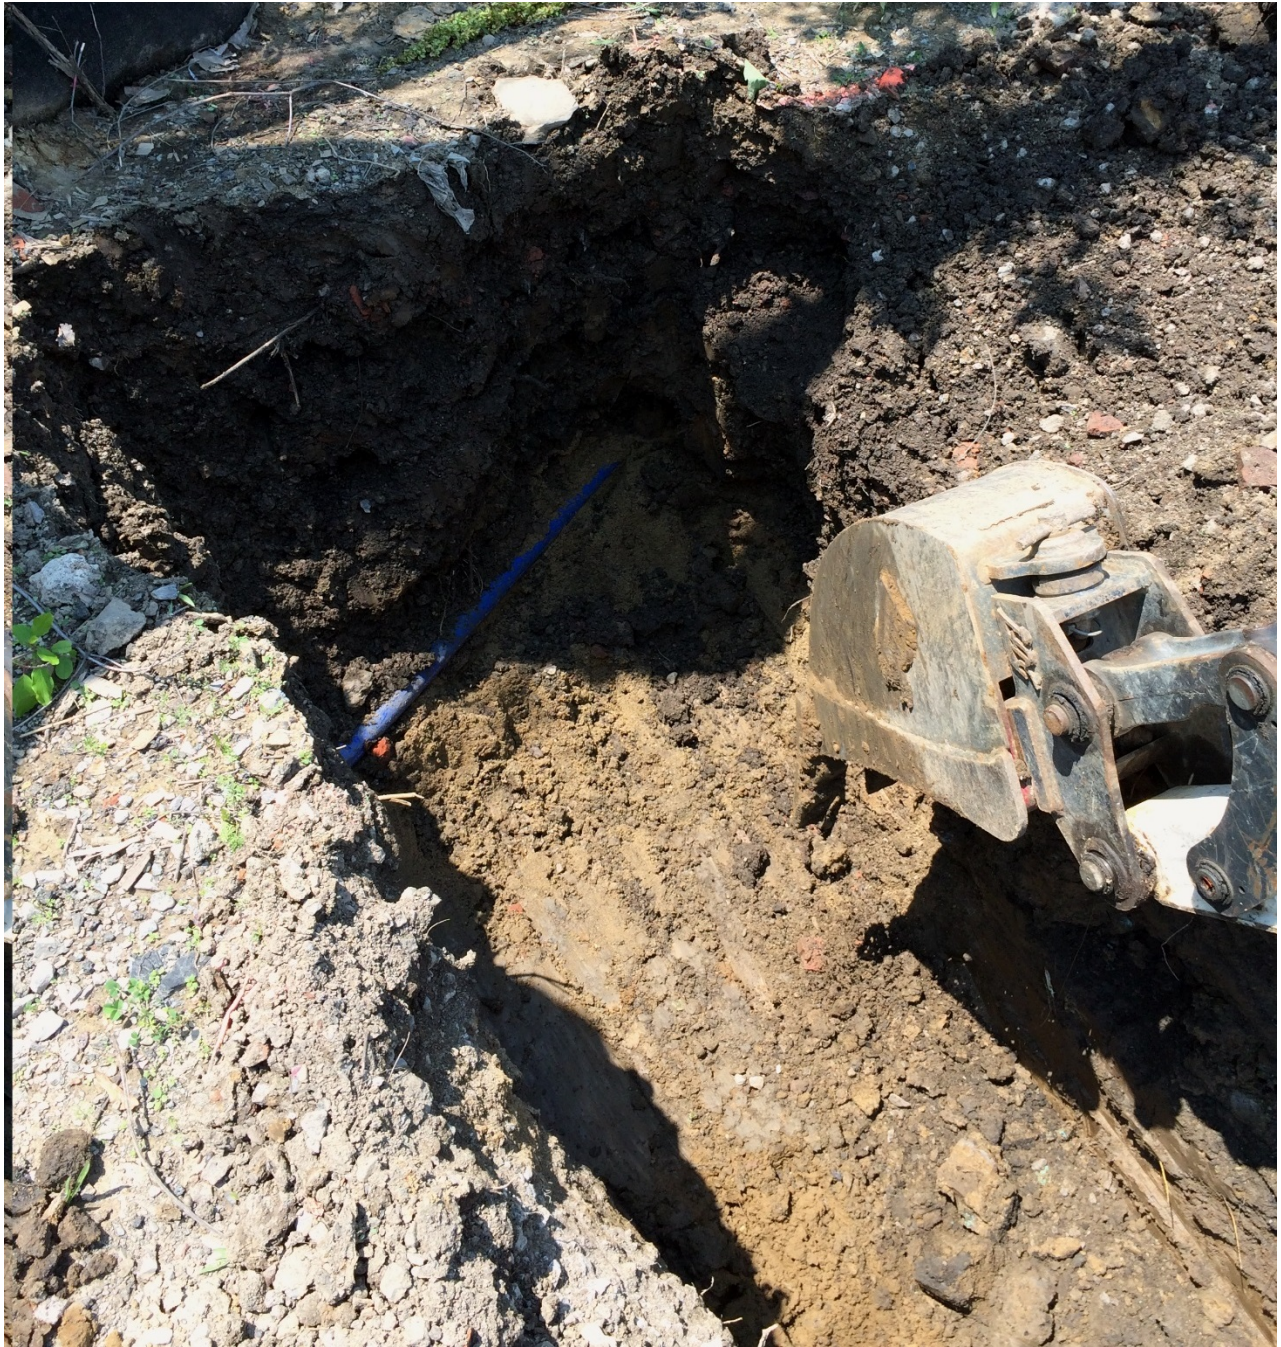
05/26/2015: Test pit activities conducted in the southwest portion of the Site to locate the 2" plastic water line.

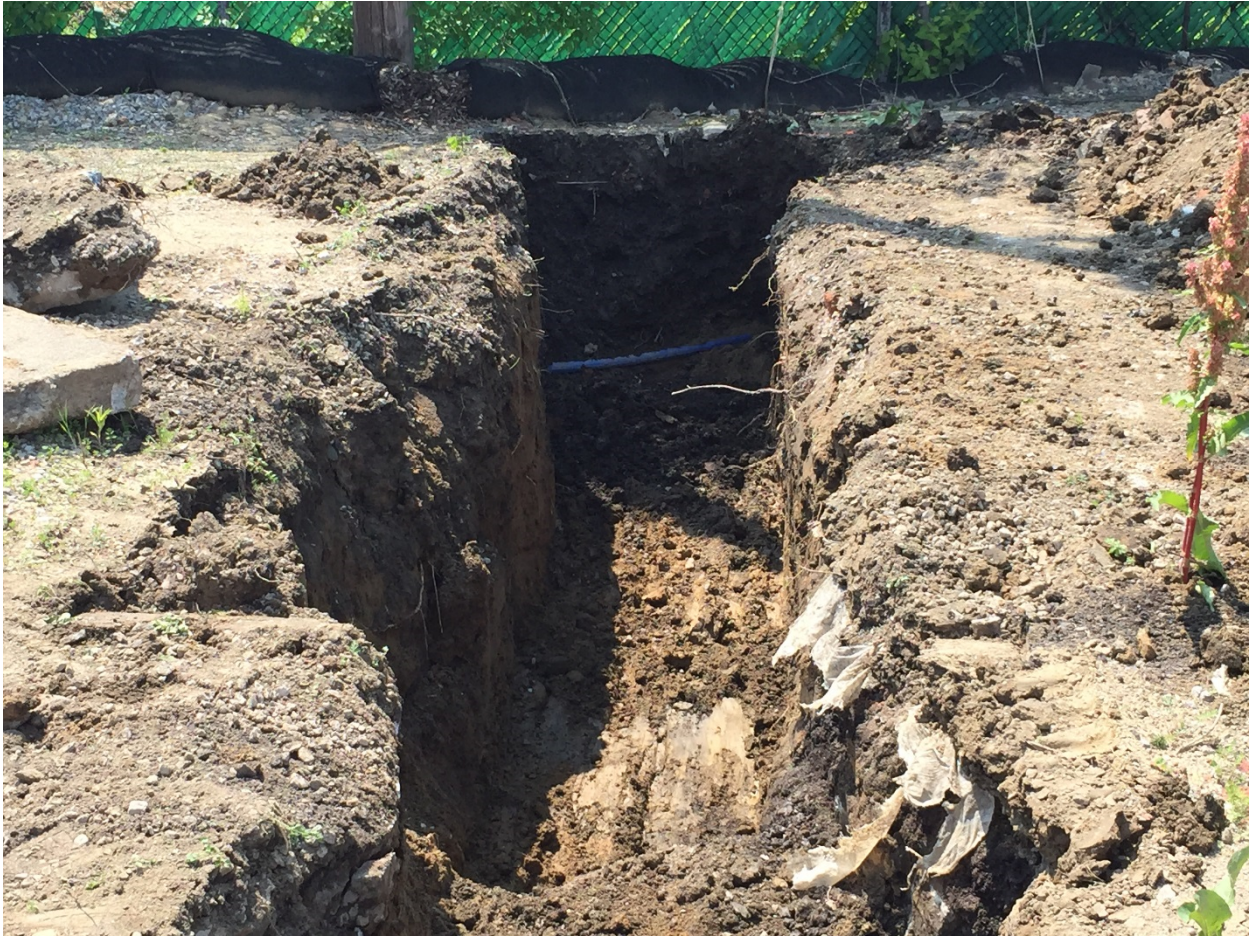
05/26/2015: Continued tracing/trenching of the 2" plastic waterline.

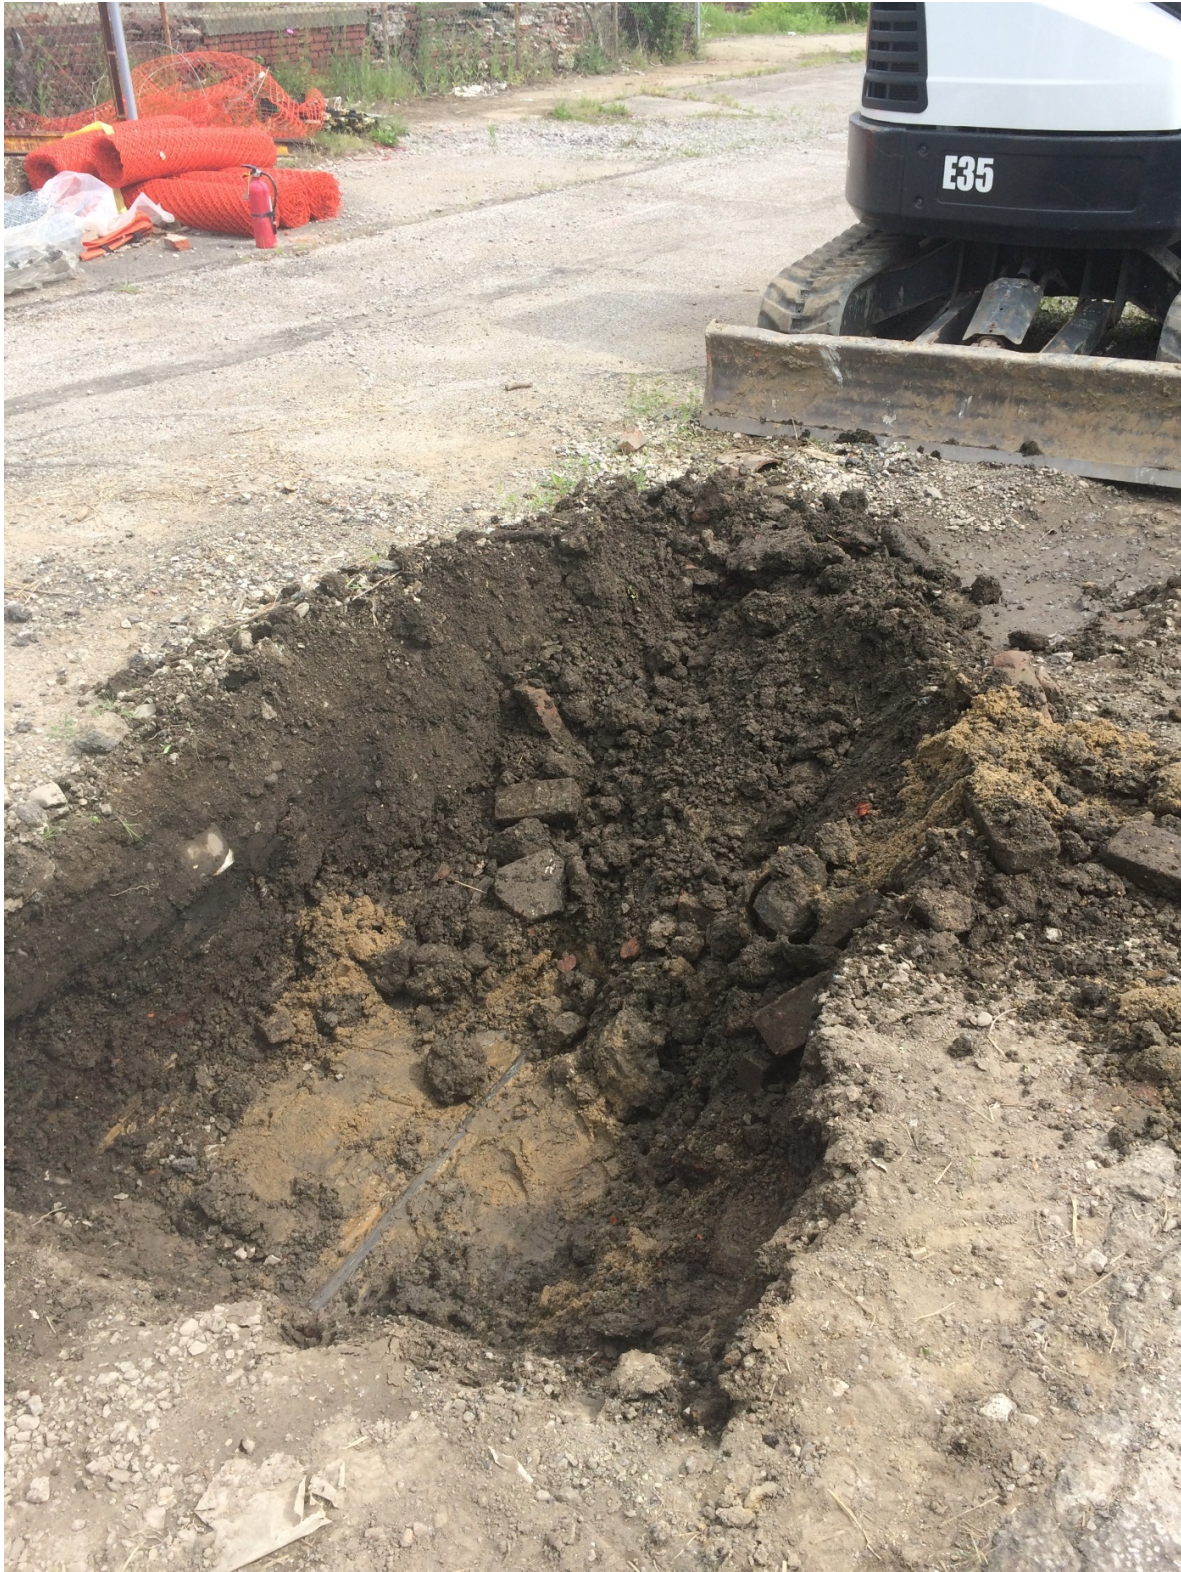
05/28/2015: Continued investigation of the 2" water line that runs to the BASF water treatment facility.  
Photo of pipe located between Boiler House and Foundry.

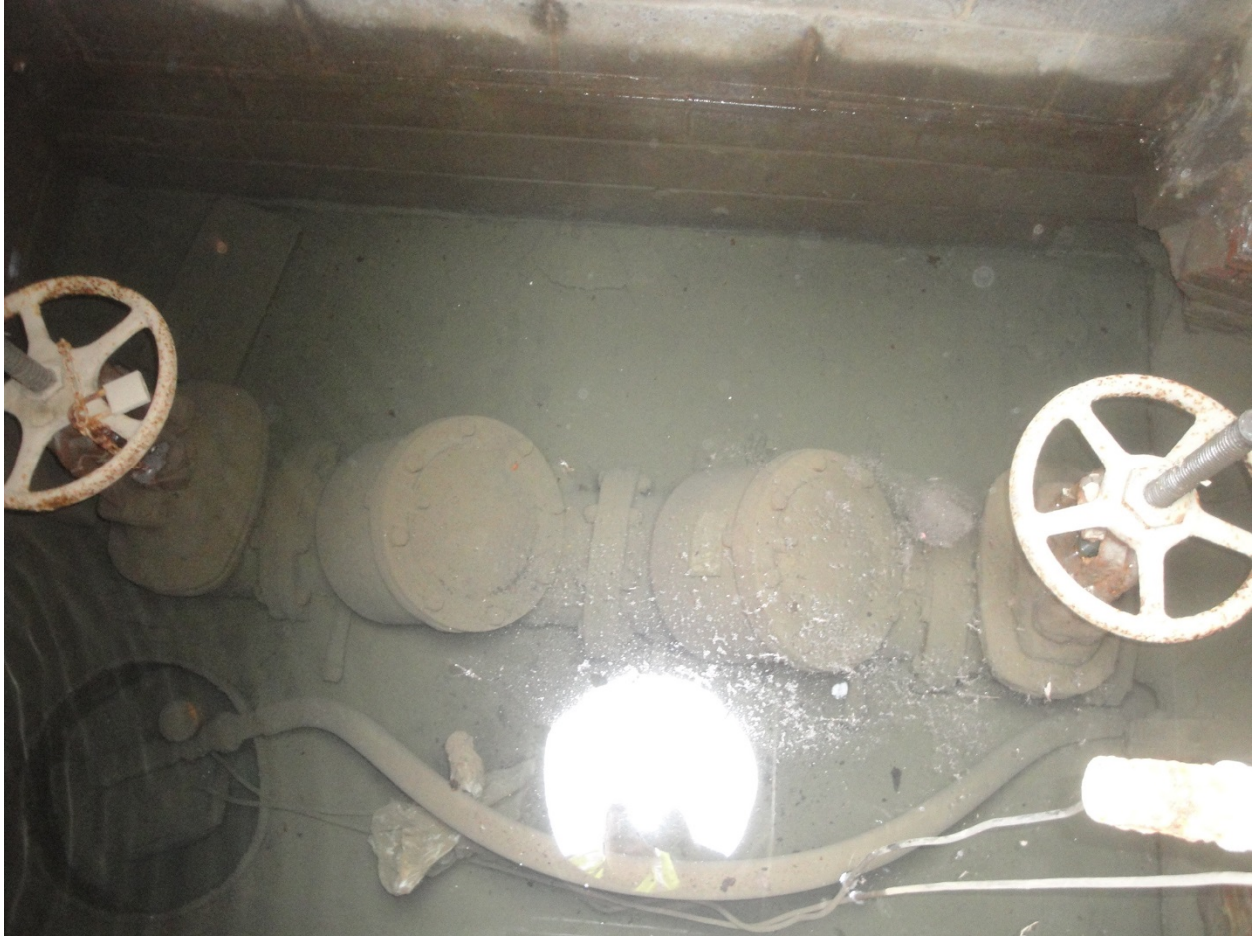
Based on the information obtained from BASF and the CWD, ECC determined that the only transmission line that remained uncertain as to its termination status was the 8-inch diameter fire suppression supply line, which entered the site from Harvard Avenue, at the southwest corner of the “warehouse” building (see Figure 1). ECC observed that the two valves in the vault to this line had been shut off; it could not verify that the valves didn’t leak, or if the line was still active. Blind flanges were subsequently installed to terminate this line.

06/01/2015: Water line utility vault for fire-suppression lines located along Harvard Avenue. Confined space permit required for entry to terminate fire suppression lines to the site. Vault was dewatered prior to entry.

Work proceeded on June 1, 2015 and June 2, 2015. It involved pumping out the vault, performing a confined space entry to remove a portion of the line, and installing two 8” diameter steel blind flanges. The removed portion of the line was left inside the vault. The existing water inside the vault was determined to be chlorinated drinking water (verified by CWD); it appeared to be originating from an adjacent leaking fire hydrant. The water was discharged to a storm sewer located on Harvard Avenue, which was authorized by the CWD. Photos 13, 14 and 15 in Attachment 1 detail portions of this work. The confined space entry permits for the two days of work are provided in Attachment 6.

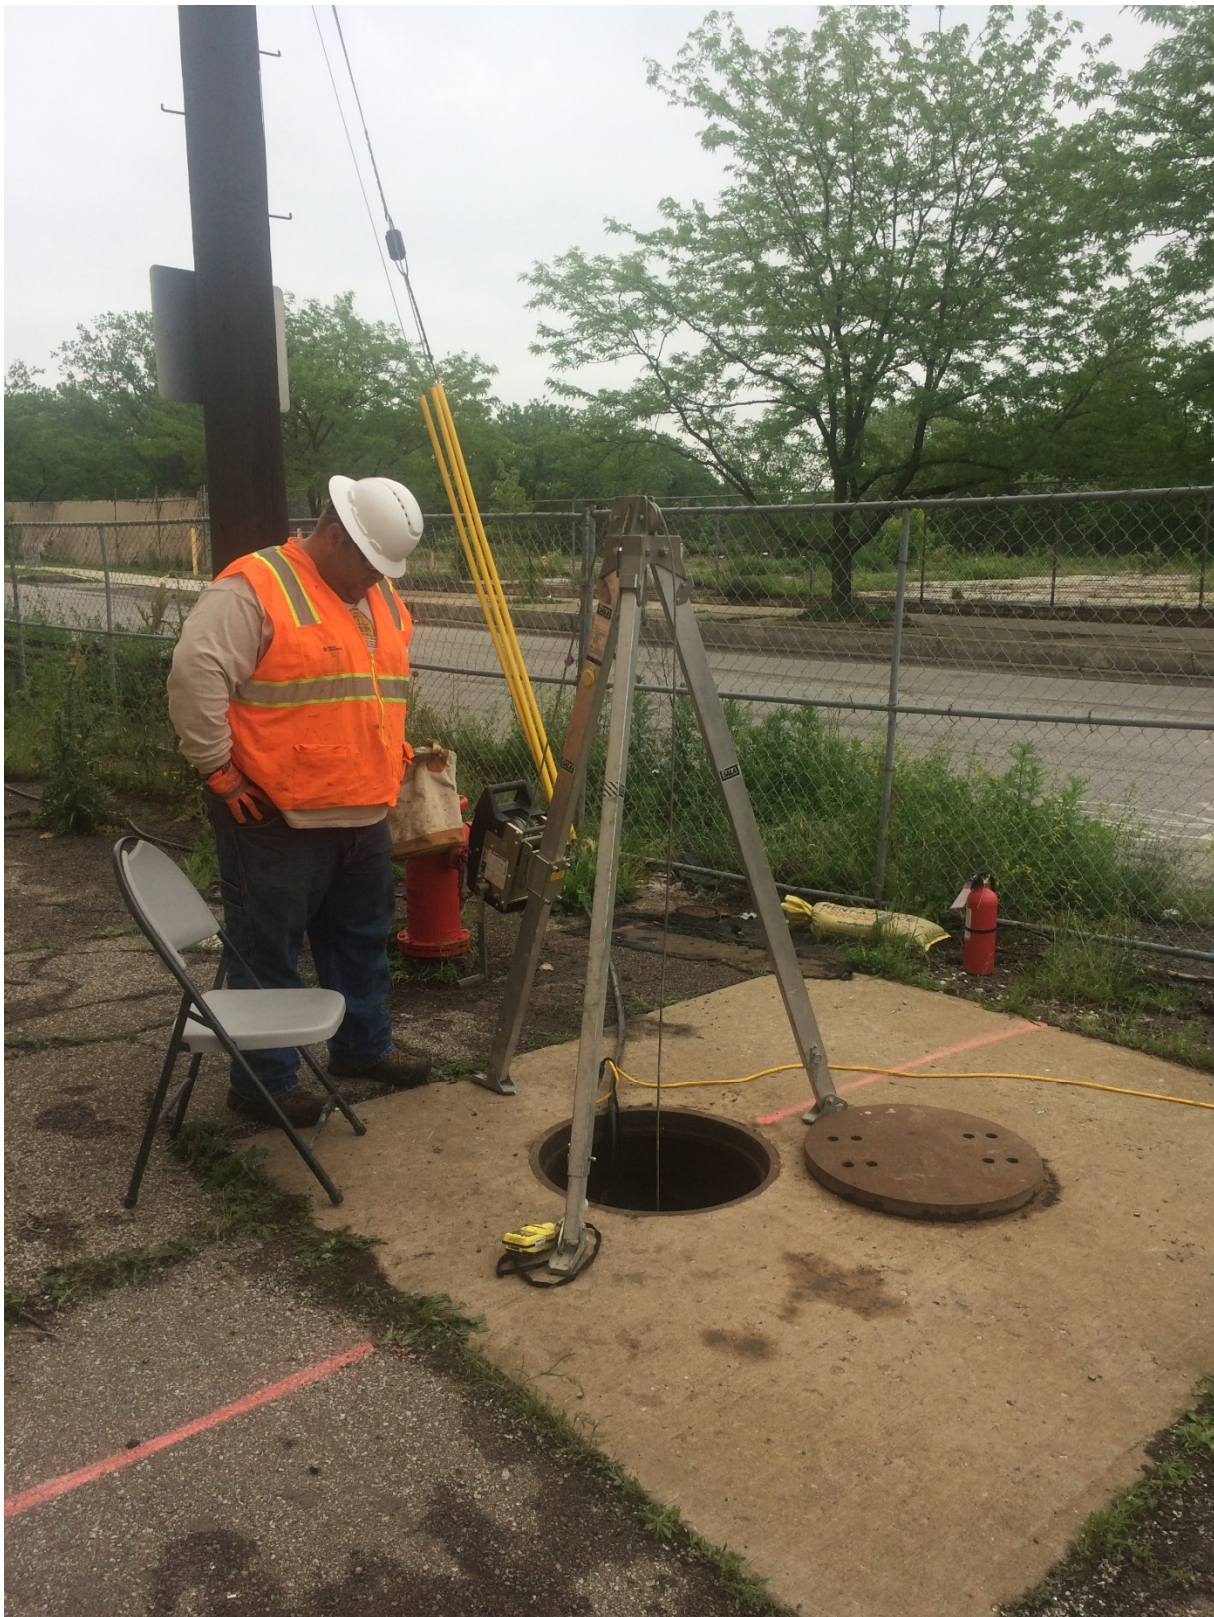
06/01/2015: Entry into confined space to perform the inspection and termination of the fire suppression transmission lines.
