**Transmission Line Report Addendum No. 1, Rev.01**  
**Additional Investigation of Site Transmission Lines and Test Pit #4**  
**FINAL**

**Building G-1 Deconstruction and Groundwater Investigation**  
**Former Harshaw Chemical Company Site**  
**Cleveland, Ohio**  
**Formerly Utilized Sites Remedial Action Program**

March 2016

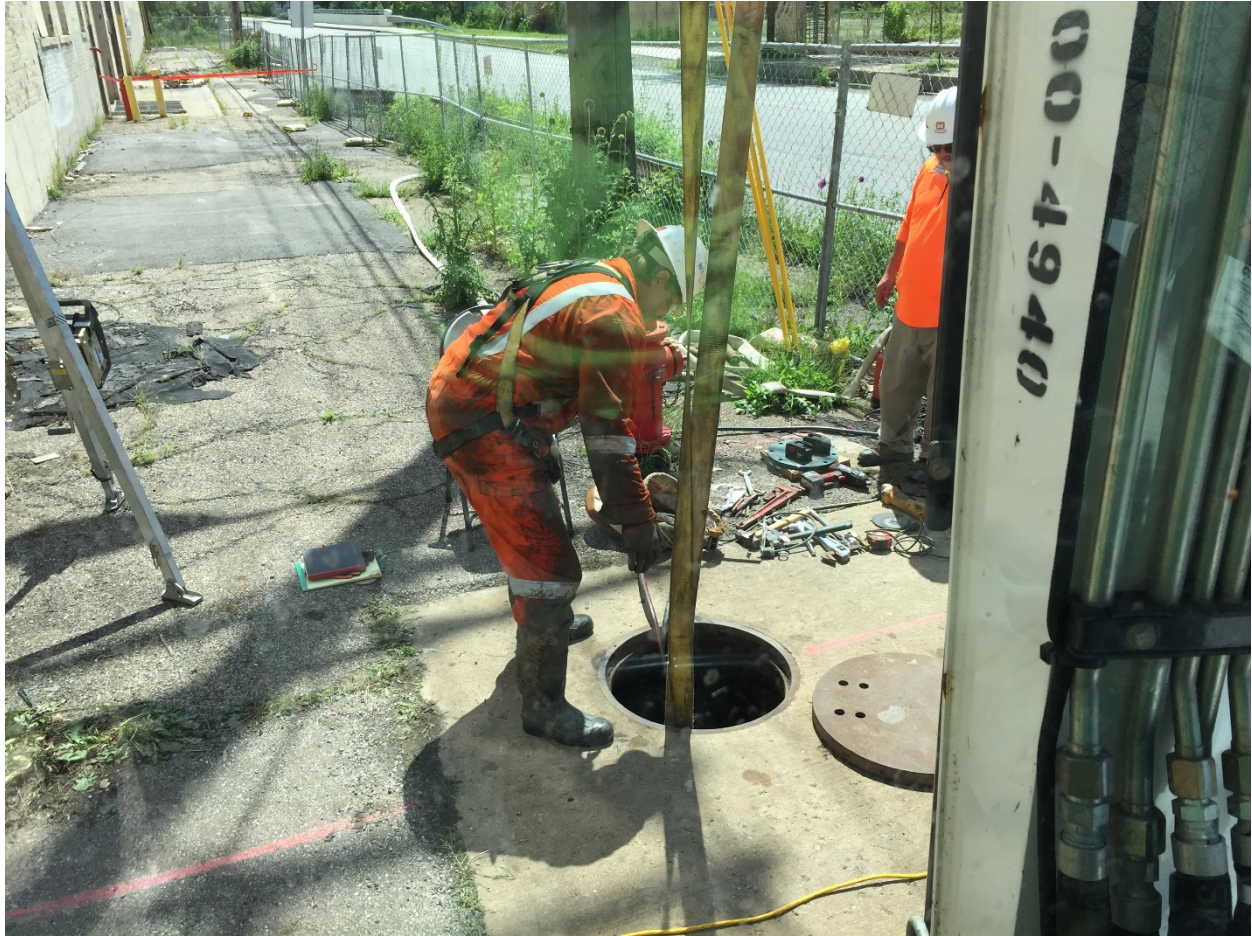
06/02/2015: Continued termination of fire suppression lines. Blank flanges installed and all sections of removed pipe / valves were left in the vault.
